Reference: REPORT ON GEOPHYSICAL SERVICES ESP Project No. GR22.305

WBS Number:	51215.01N
TIP Number:	51215.01N
Project ID:	33505
County:	New Hanover
Description:	Sanders Street Settlement/Sinkhole
Site Description:	Sanders Street, Wilmington, North Carolina

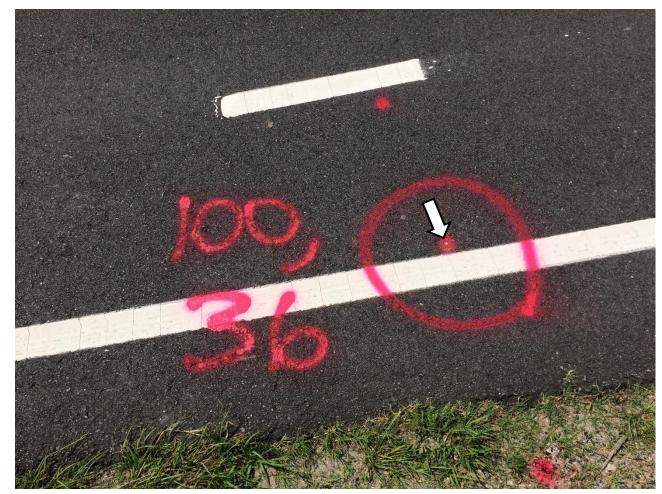
PROJECT NO. GR22.305	FIGURE 2
scale N/A	PHOTOS OF GPR G
DATE 10/18/18	SANDERS STREET SETTLE
EDB	WILMINGTON, NORT

A. Photo showing PK nail (at arrow) set at one of four corners of GPR grid.

Edward D. Billington, PG of ESP collected GPR data at the site on August 5, 2018 using our Sensors and Software Noggin GPR with a 250 MHZ antenna. The data were collected along east-west lines spaced approximately one foot apart in a 40-foot by 100-foot grid established on the site (Figure 1). The corners of the grid were marked with nails for later location by the NCDOT (Figure 2).

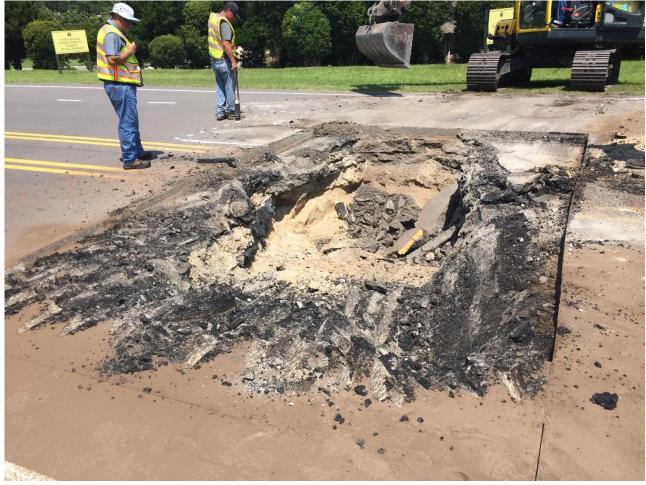
B. Photo looking north showing excavation of sinkhole location by NCDOT personnel. NCDOT person in upper left is marking area to expand excavation based on preliminary GPR results.

The GPR data were reviewed in the field as the NCDOT began excavating the sinkhole location. One possible void was noted northwest of the excavation (Figure 2). Subsequent excavation by the NCDOT did not indicate any voids at this location.

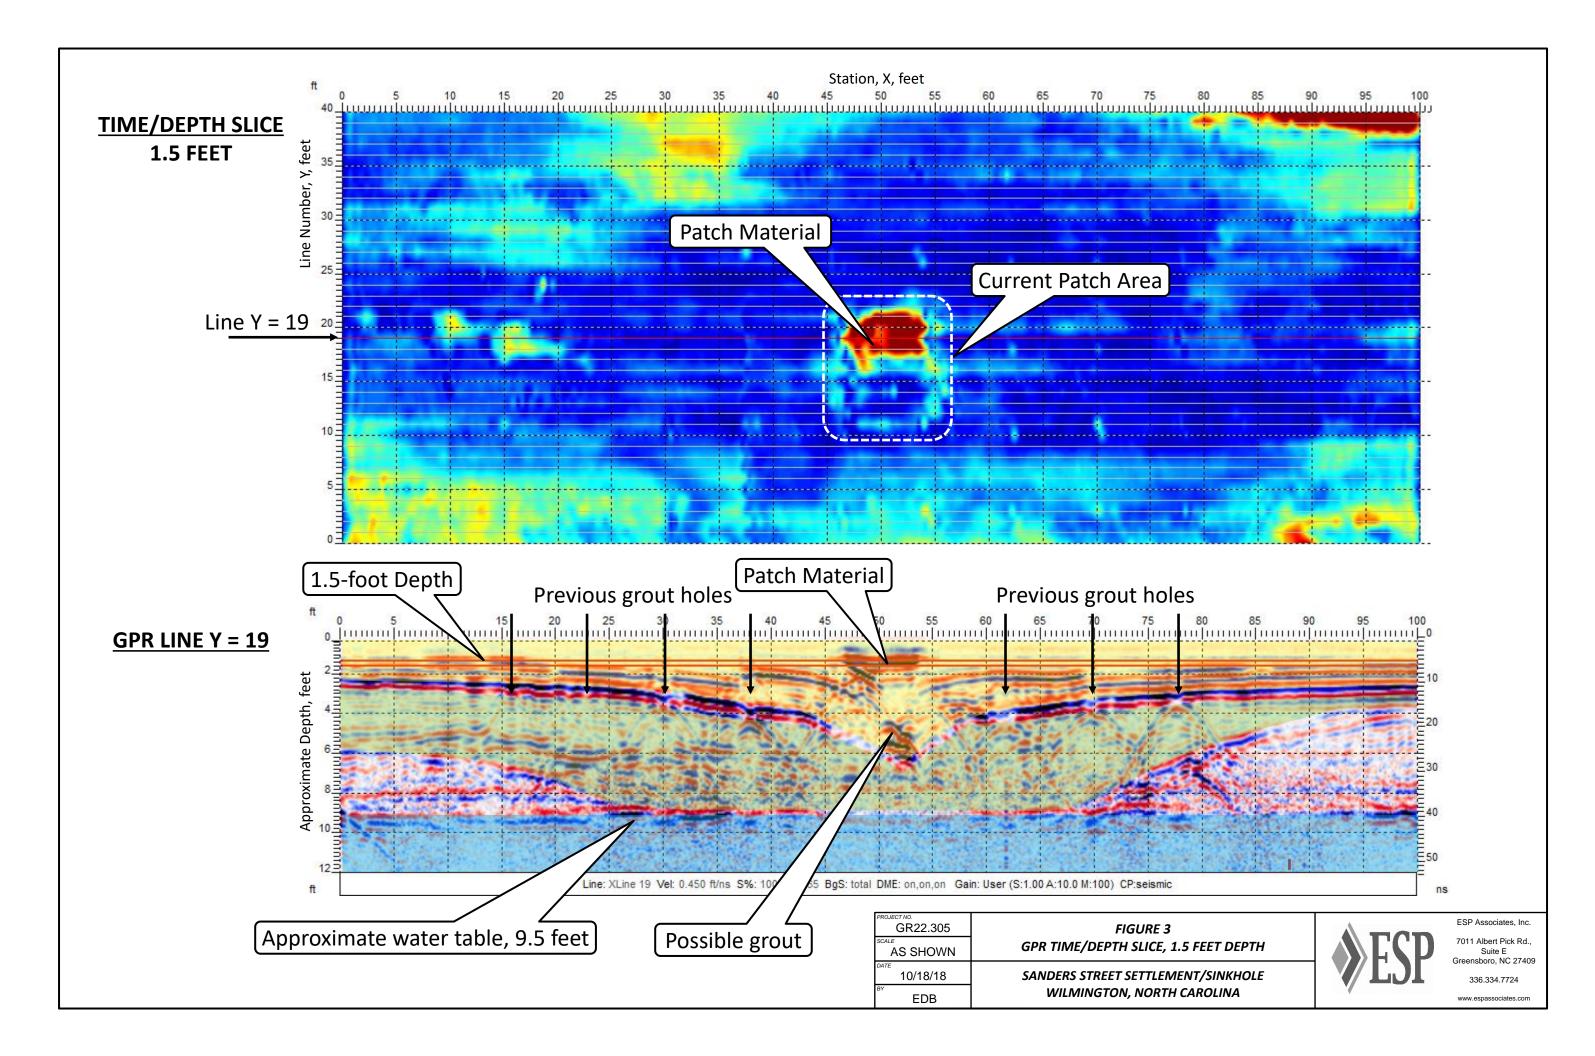
The GPR data were reviewed as 2D cross-sections and processed as a 3D data volume using the program EKKO_Project. Time-depth slices were made of the 3D GPR volume for evaluation of the lateral extent of the sinkhole and possible voids. Figures 3 through 5 show time/depth slices at approximate depths of 1.5, 4.0 and 7.75 below asphalt surface with example 2D GPR cross-sections.

Our review of the GPR data does not suggest the presence of significant subsurface voids within the imaging depth range of the GPR. The depth limit of the GPR signal appears to be the water table at approximately 9.5 feet. The GPR data shows the geometry of the subsurface depression. The depression is centered at approximate GPR grid coordinates 52X, 13Y. Evidence of the previous grouting can be seen on the GPR data by diffractions from the grout holes and reflections from what appears to be subsurface grout.
