REFERENCE: B-4729

STATE OF NORTH CAROLINA
DEPARTMENT OF TRANSPORTATION
DIVISION OF HIGHWAYS
GEOTECHNICAL ENGINEERING UNIT

STRUCTURE
SUBSURFACE INVESTIGATION

COUNTY CHATHAM
PROJECT DESCRIPTION BRIDGE NO. 306 ON SR 1303
(BEN SMITH RD) OVER NORTH PRONG ROCKY
RIVER
SITE DESCRIPTION 13+58.00 -L-

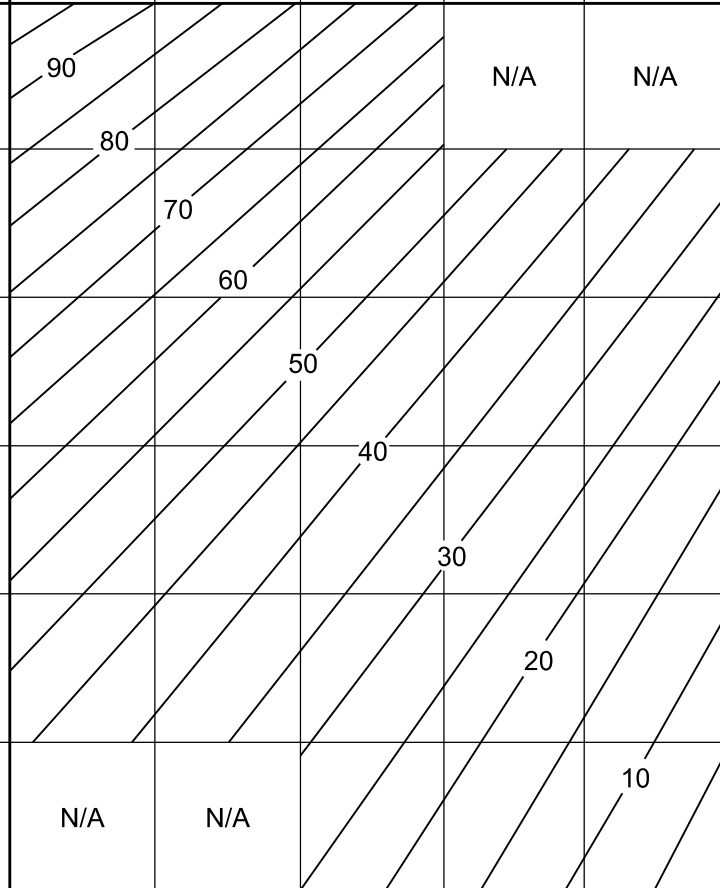
**SUPPLEMENTAL LEGEND, GEOLOGICAL STRENGTH INDEX (GSI) TABLES
 FROM AASHTO LRFD BRIDGE DESIGN SPECIFICATIONS**

AASHTO LRFD Figure 10.4.6.4-1 — Determination of GSI for Jointed Rock Mass (Marinos and Hoek, 2000)

AASHTO LRFD Figure 10.4.6.4-2 — Determination of GSI for Tectonically Deformed Heterogeneous Rock Masses (Marinos and Hoek, 2000)

GEOLOGICAL STRENGTH INDEX (GSI) FOR JOINTED ROCKS (Hoek and Marinos, 2000)

GSI FOR HETEROGENEOUS ROCK MASSES SUCH AS FLYSCH (Marinos, P and Hoek E., 2000)

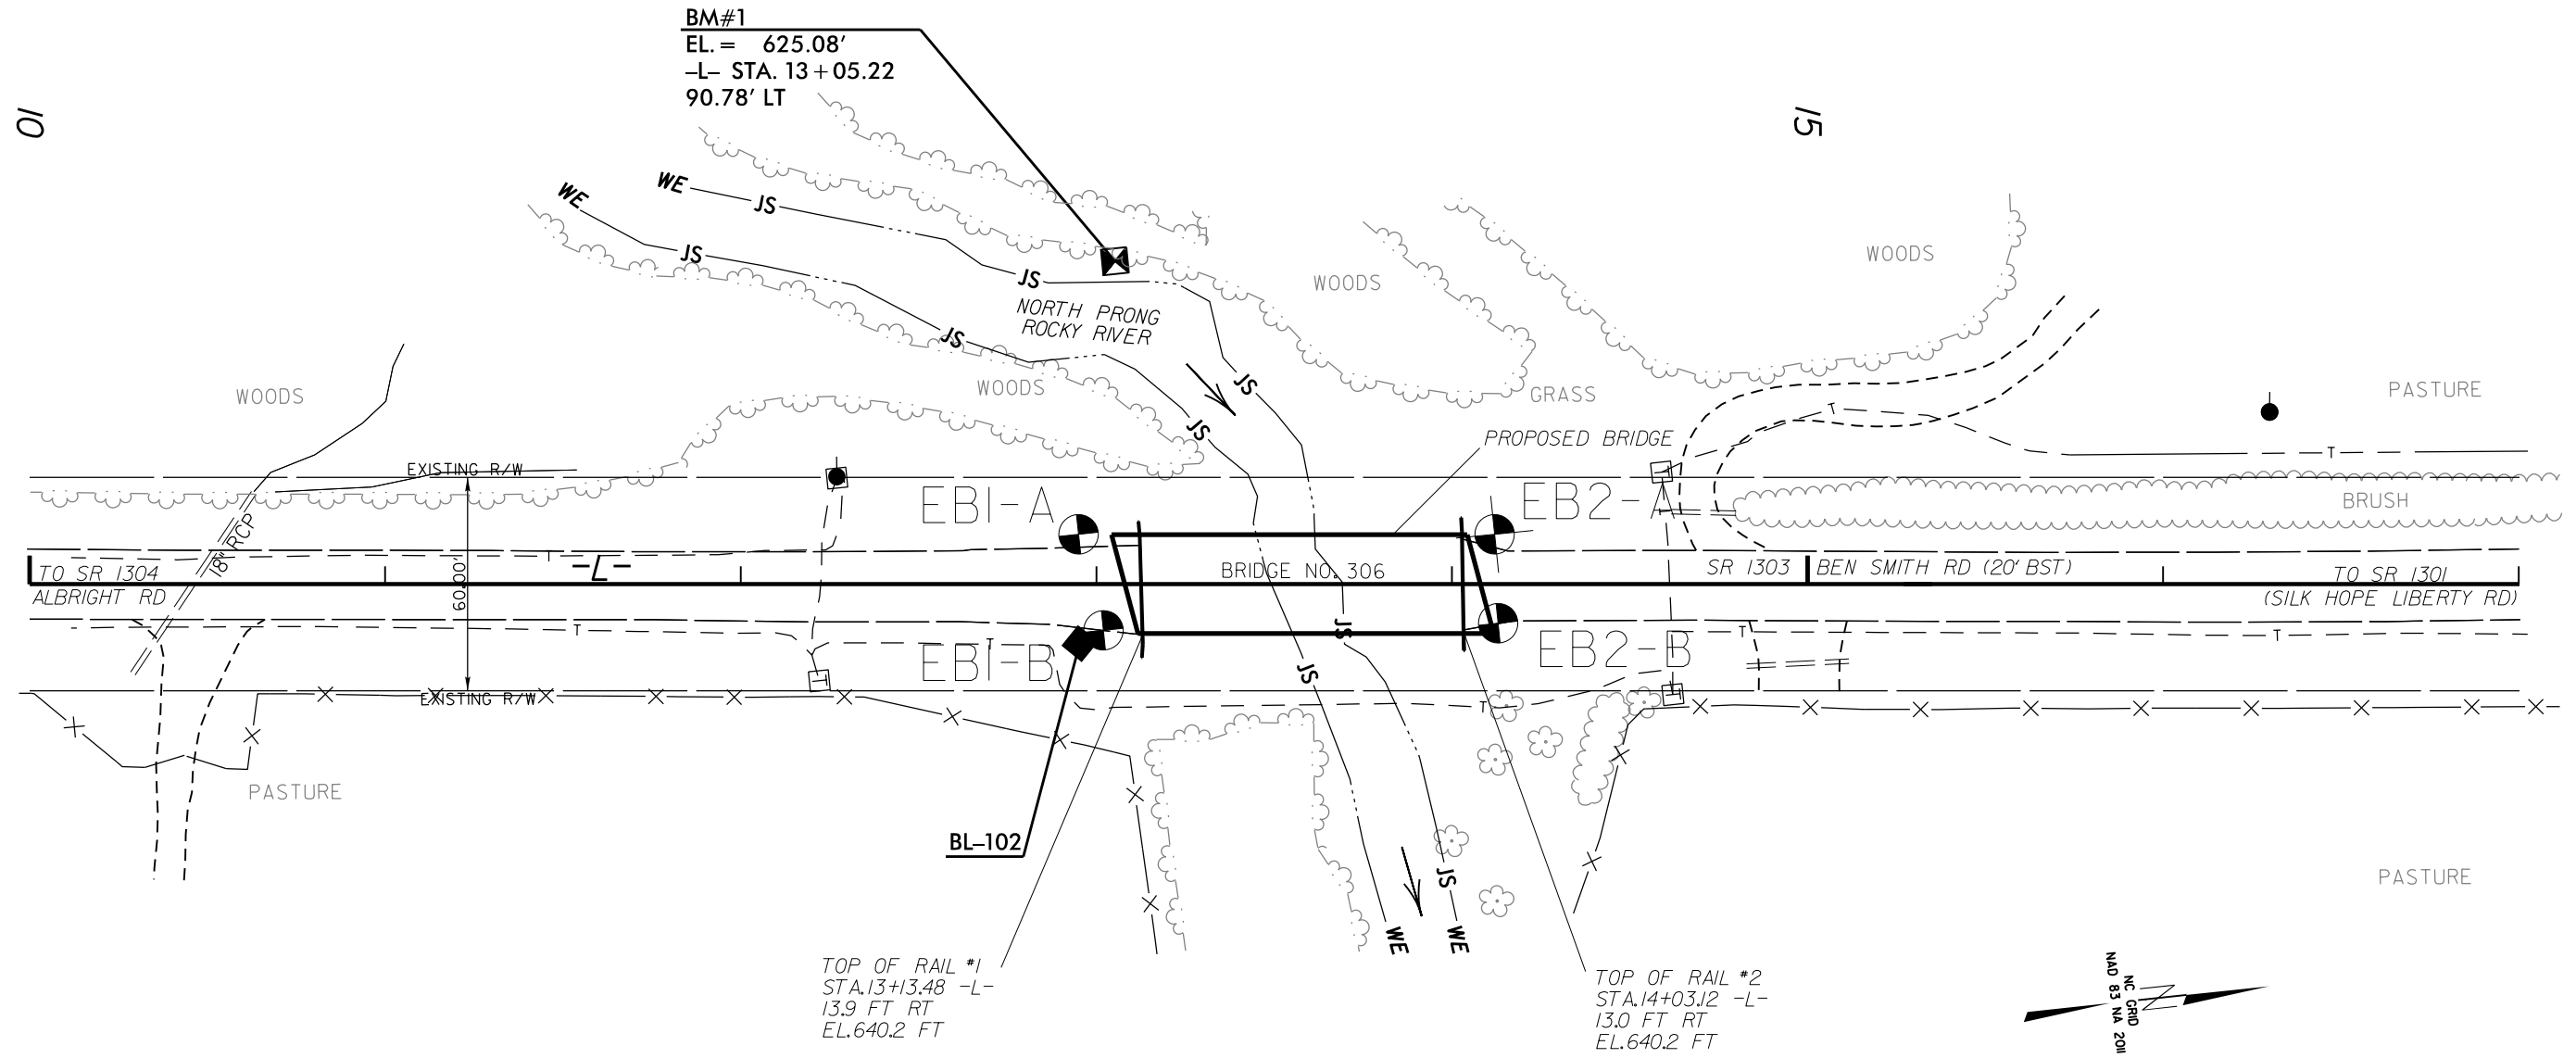
SITE PLAN

SKREW = 75 DEG.

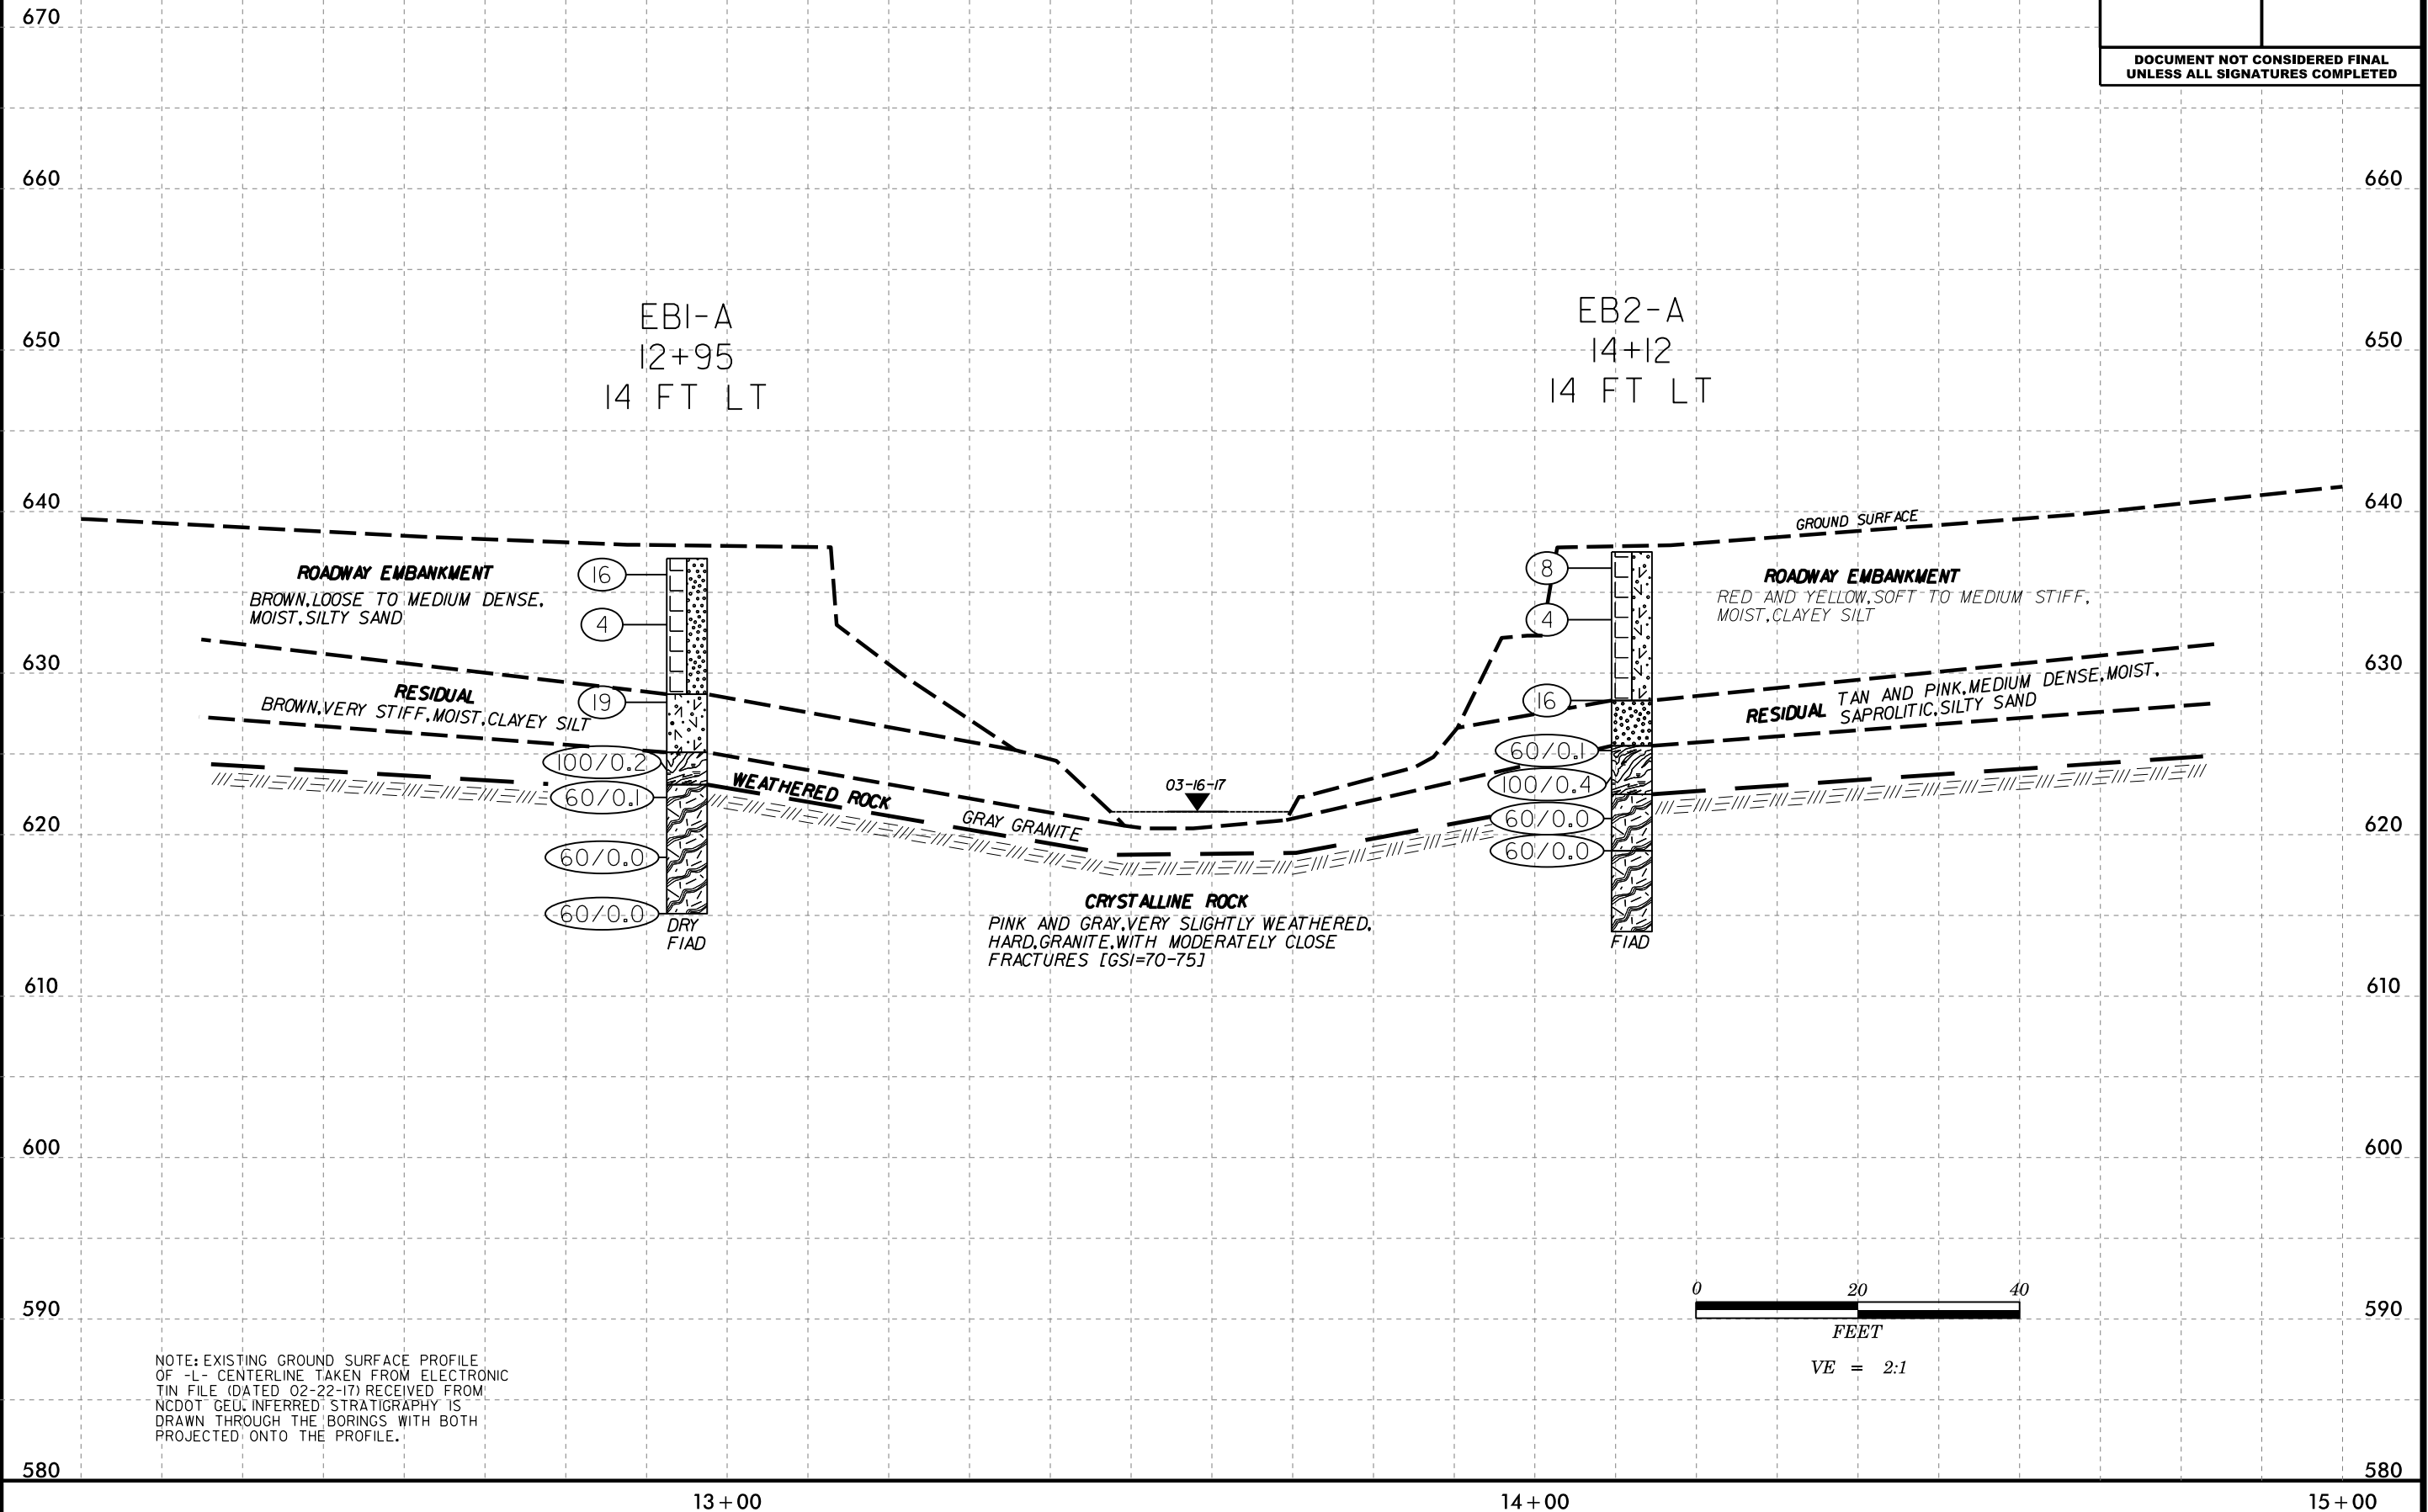
PROFILE ALONG -L- CENTERLINE BRIDGE NO. 306

NOTE: EXISTING GROUND SURFACE PROFILE OF -L- CENTERLINE TAKEN FROM ELECTRONIC TIN FILE (DATED 02-22-17) RECEIVED FROM NCDOT GEL. INFERRED STRATIGRAPHY IS DRAWN THROUGH THE BORINGS WITH BOTH PROJECTED ONTO THE PROFILE.

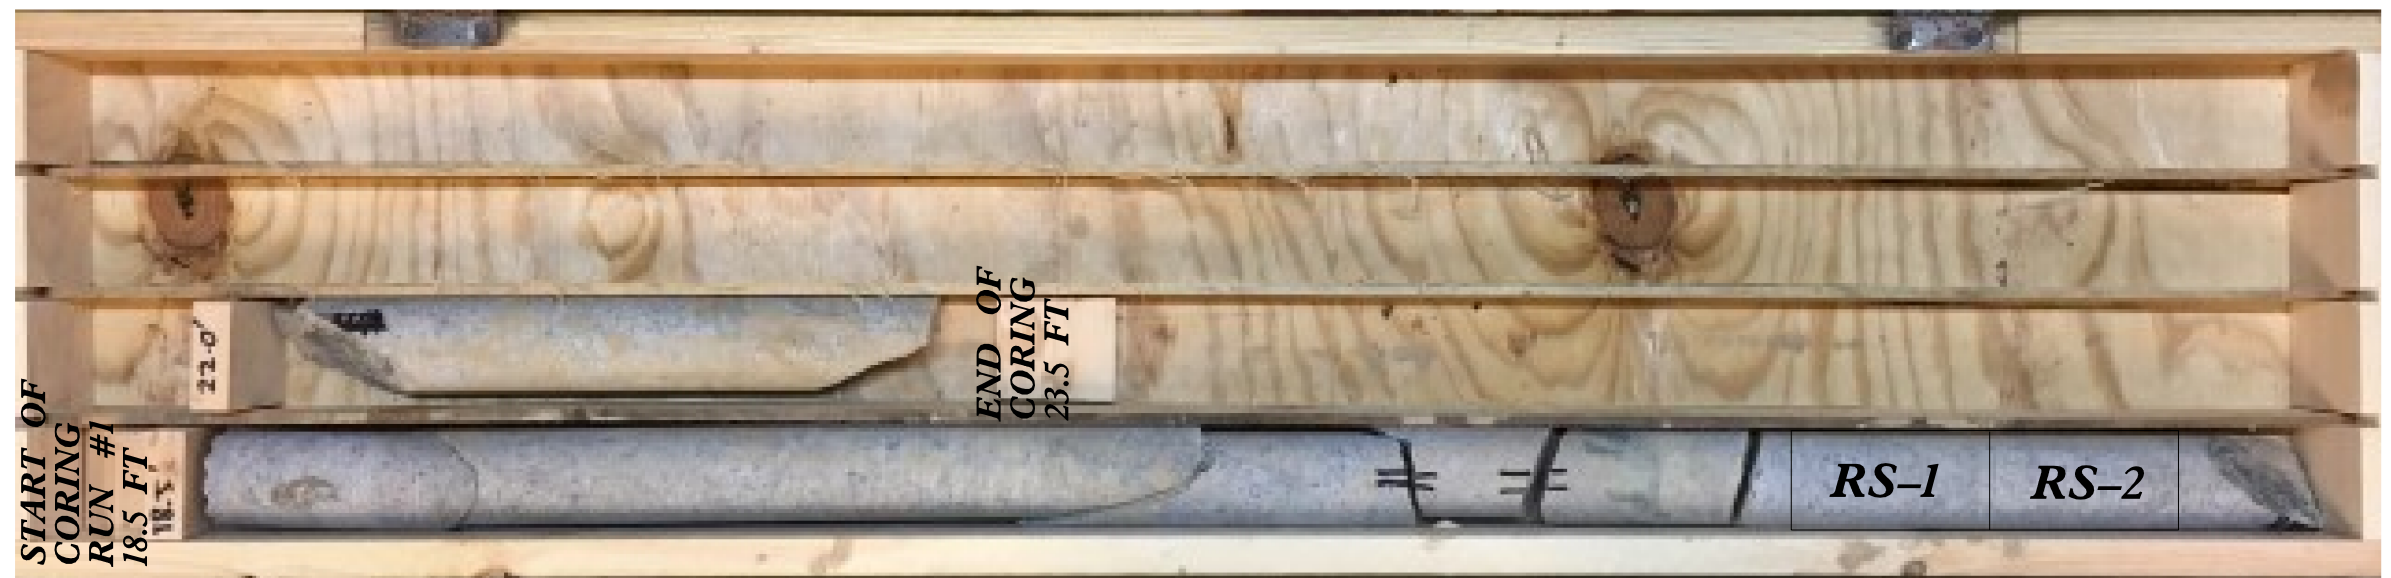
CORE PHOTOGRAPH

BORING EB2-A
STA. 14+12 -L-, 14 FT LT
DEPTH: 18.5 FT TO 23.5 FT

ELEV (ft)	LOG	DESCRIPTION AND REMARKS
619.0		Begin Coring @ 18.5 ft
619.0		CRYSTALLINE ROCK Pink and Gray, Very Slightly Weathered, Hard, Granite, with Moderately Close Fractures [GSI=70-75]
614.0		Boring Terminated at Elevation 614.0 ft In Crystalline Rock

Test 1 & 2: Pink and gray, very slightly weathered, hard, granite with moderately close fractures

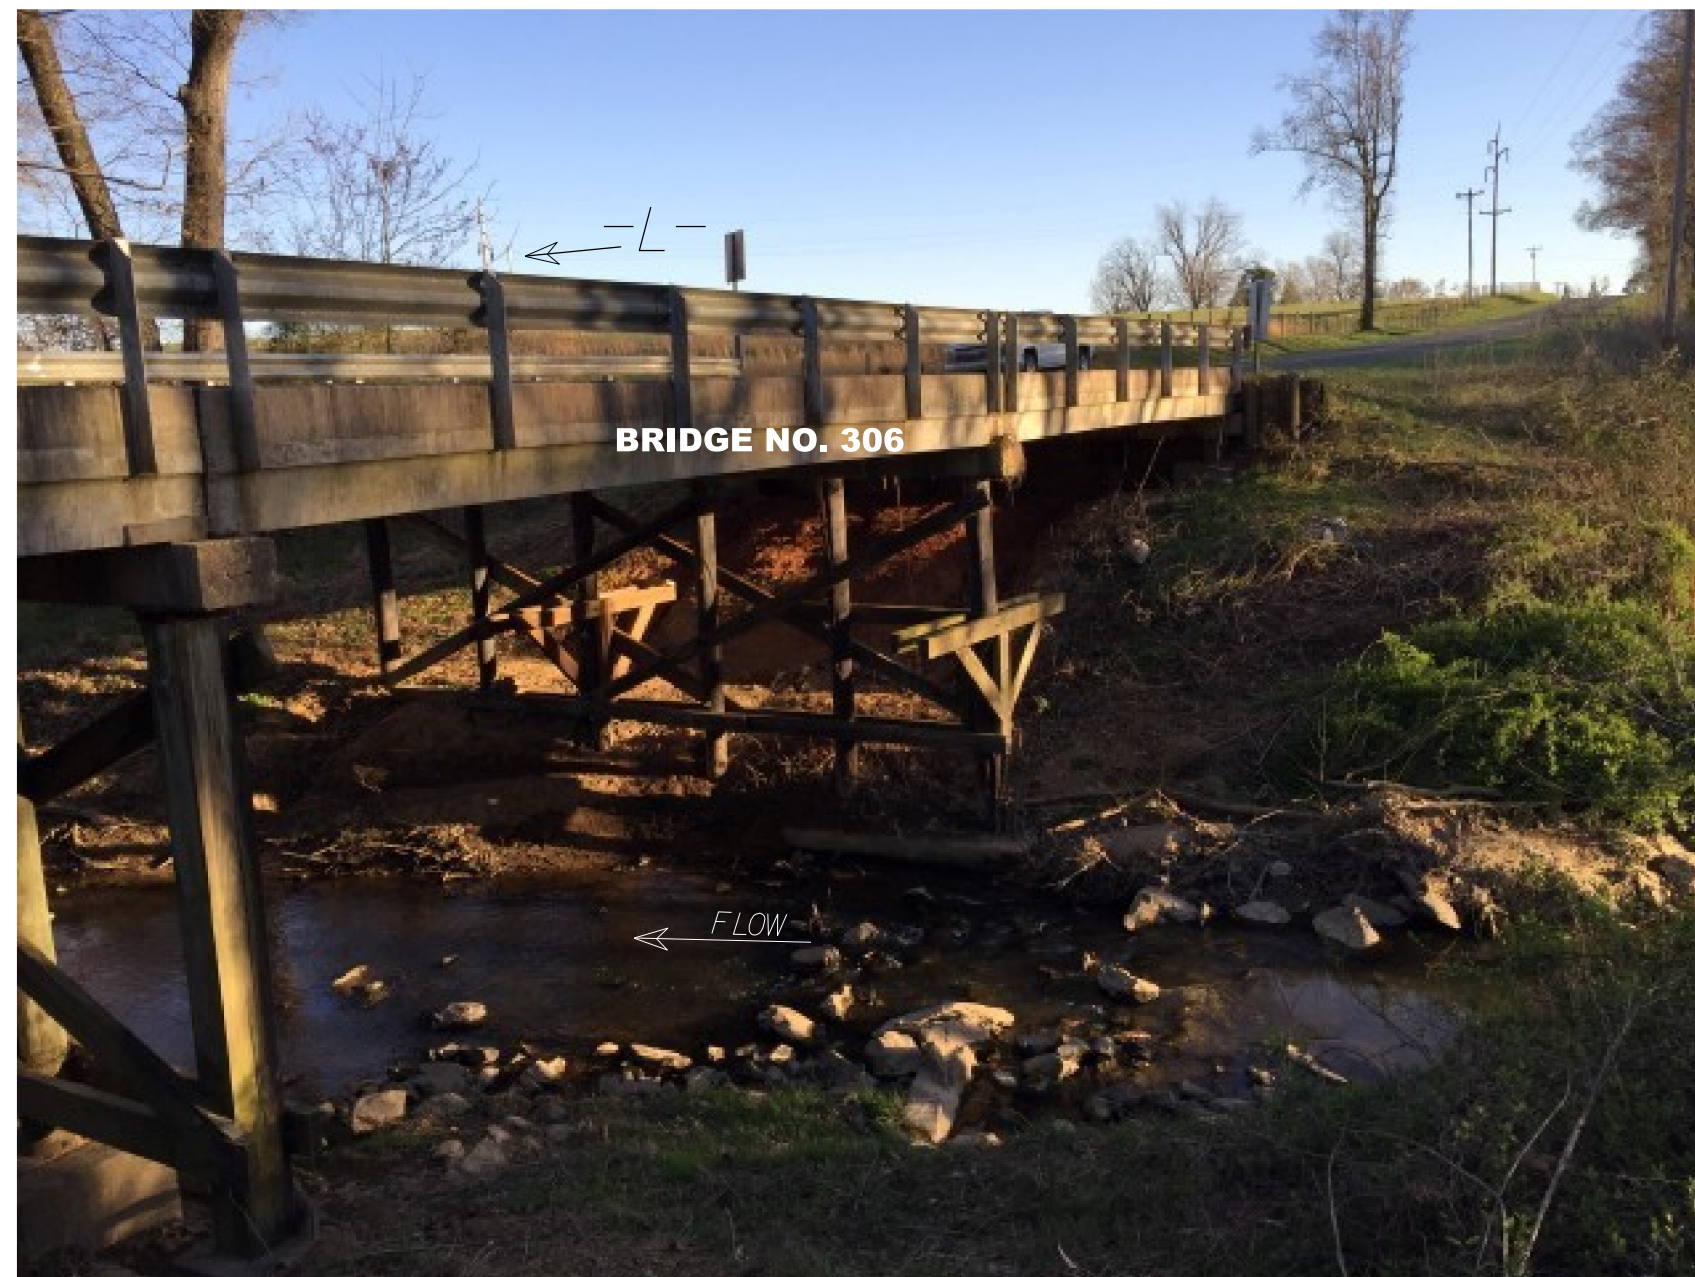
SITE PHOTOGRAPH

PHOTOGRAPH NO. 1: VIEW LOOKING SOUTH FROM END BENT NO. 2.
