REFERENCE: BP8.R002.1

STRUCTURE
SUBSURFACE INVESTIGATION

COUNTY RICHMOND
PROJECT DESCRIPTION REPLACE BRIDGE NO. 164 ON
SR 1162 (ALVIN HARRIS RD) OVER HAMER CREEK

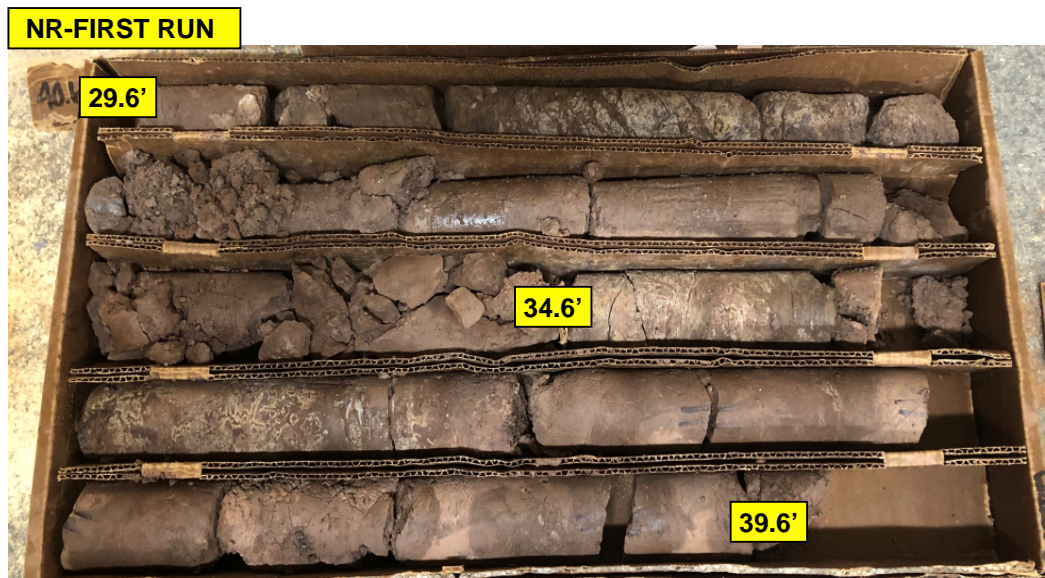
B1-A

BOXES 1 - 2 : 29.6 – 48.6 FEET

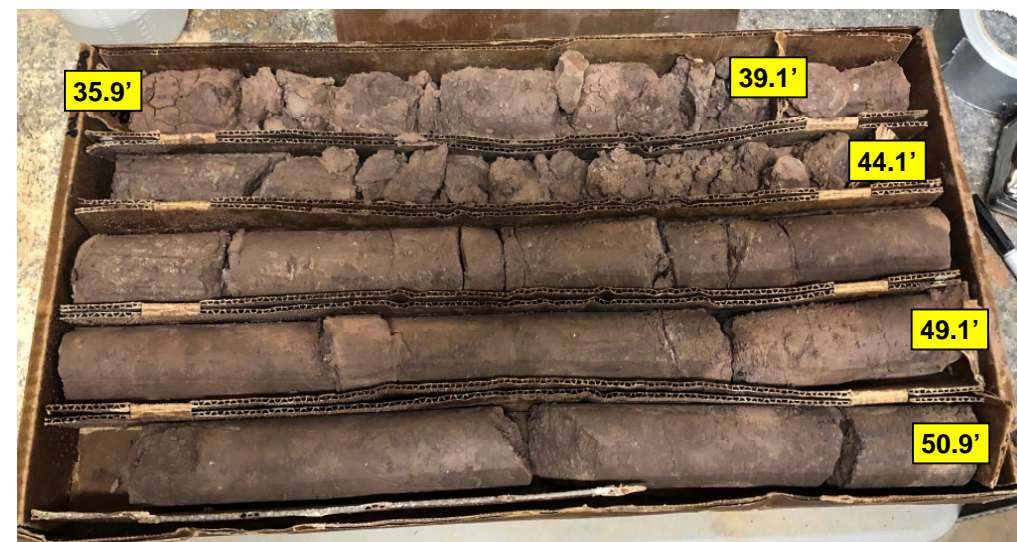
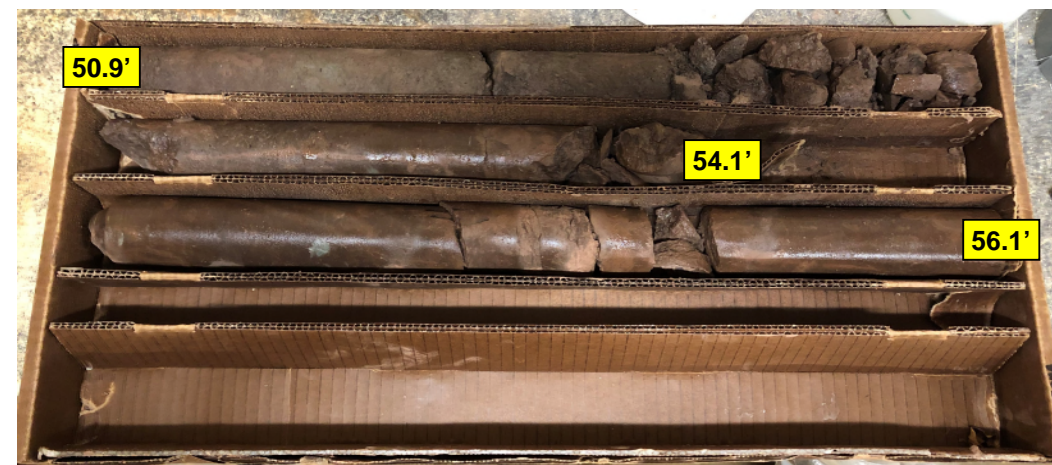
B1-B

BOXES 1 - 2: 35.9 – 56.1 FEET

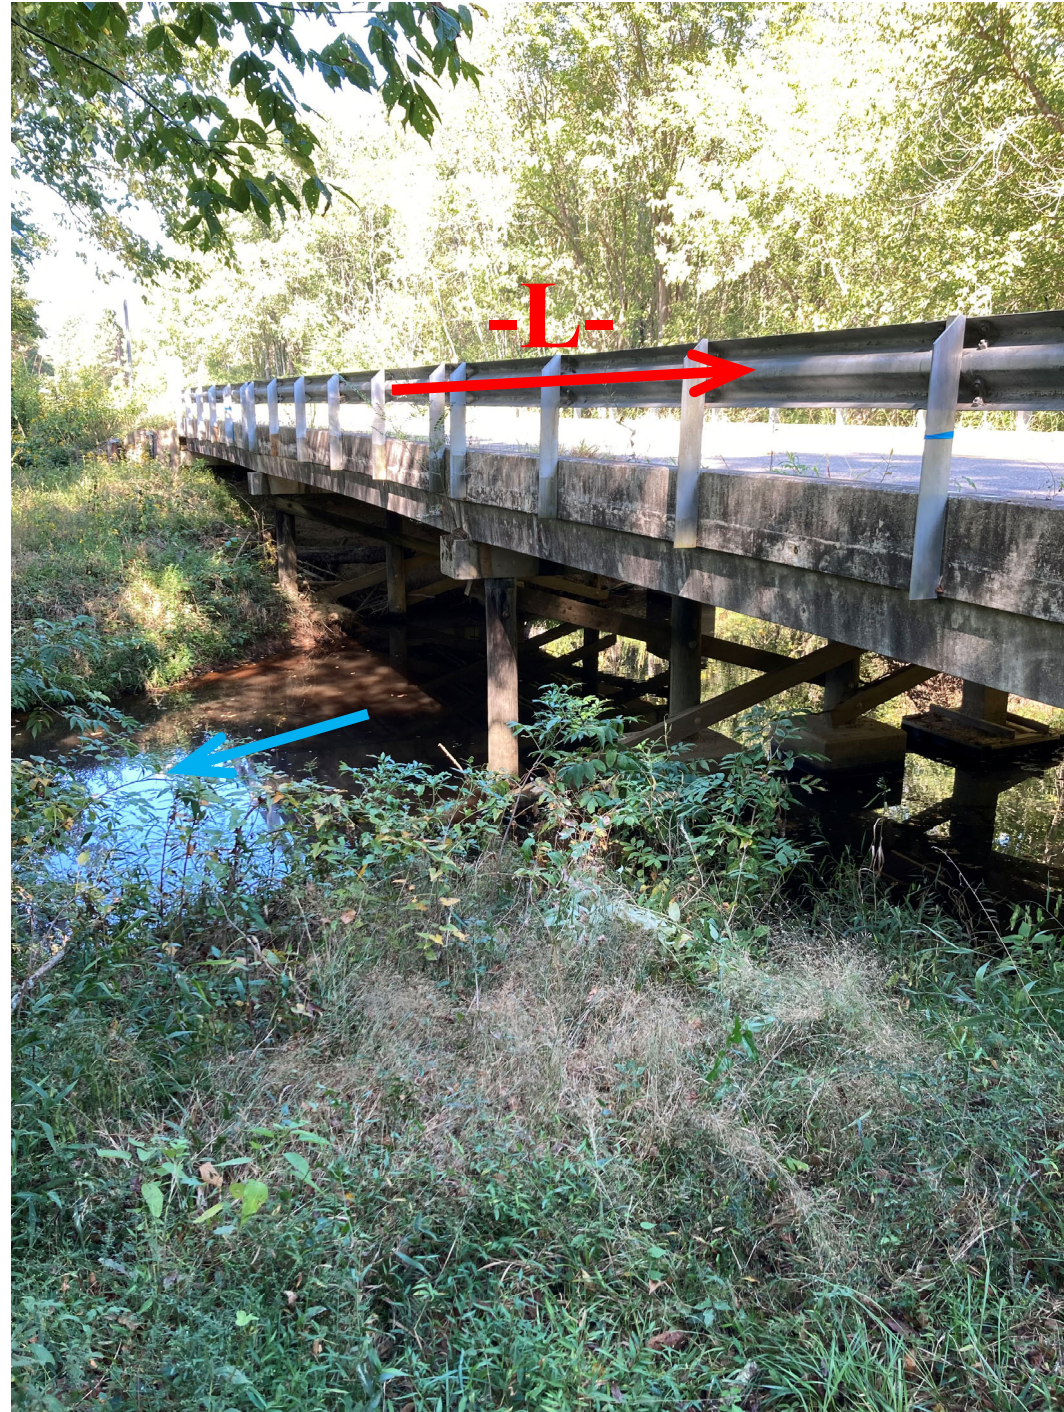
SITE PHOTOGRAPH

Bridge No. 164 on -L- (SR 1162) over Hamer Creek

Looking Northwest towards End Bent 1
