STATE OF NORTH CAROLINA
DEPARTMENT OF TRANSPORTATION
DIVISION OF HIGHWAYS
GEOTECHNICAL ENGINEERING UNIT

STRUCTURE
SUBSURFACE INVESTIGATION

COUNTY RANDOLPH
 SITE DESCRIPTION BRIDGE NO. 305 ON SR 2863
(UNION GROVE CHURCH ROAD) OVER MEADOW
CREEK

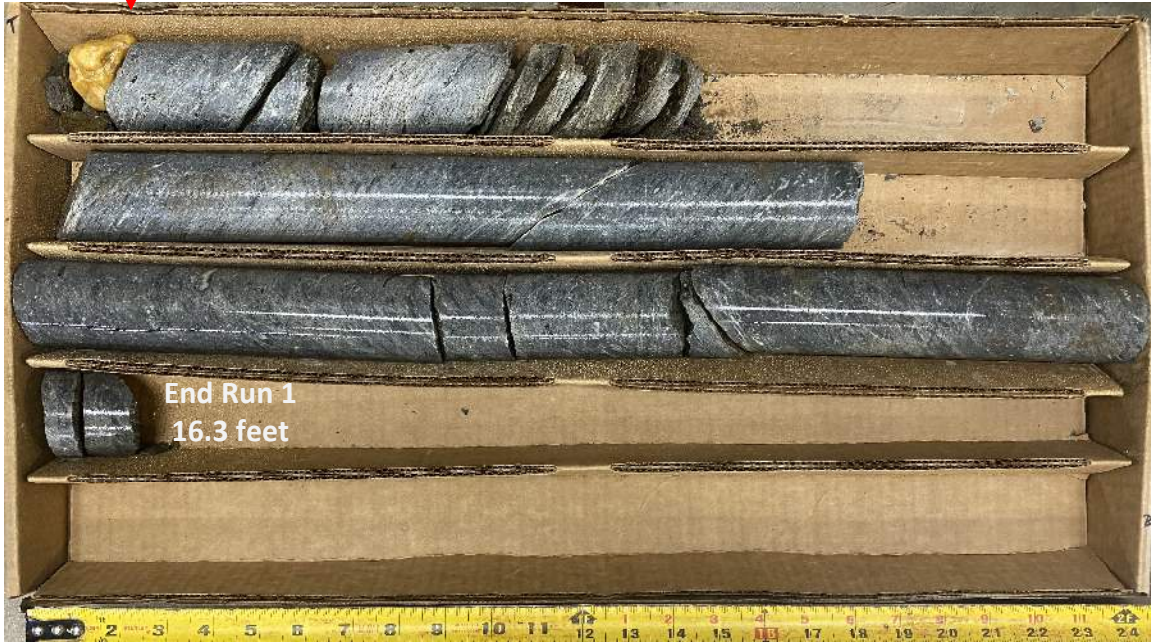
**EB1-A: -L- 15+12, 17' LT
CORE PHOTOGRAPHS:**

457.9 Green-Gray, Slight to Moderately Severe Weathering, Hard to Medium Hard, METAVOLCANIC ROCK with Close to Very Close Fracture Spacing GSI=55-70	11.3	
455	452.9	16.3

**Begin Run 1
11.3 feet**

**End Run 1
16.3 feet**

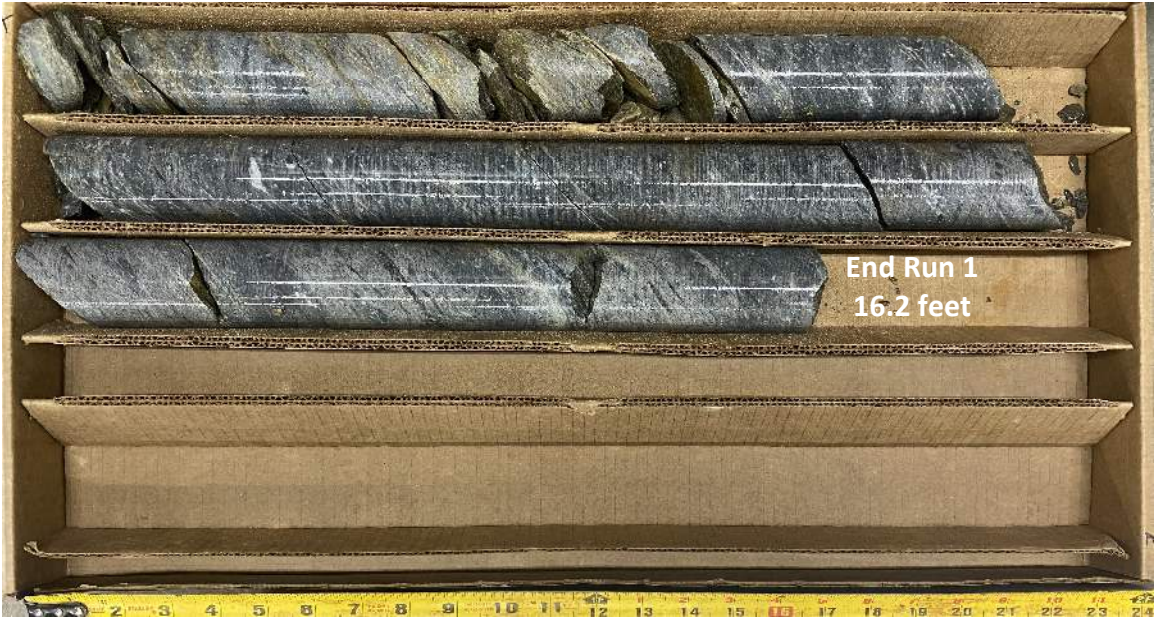
EB2-B: -L- 15+74, 13' RT

**Begin Run 1
11.2 feet**

**End Run 1
16.2 feet**

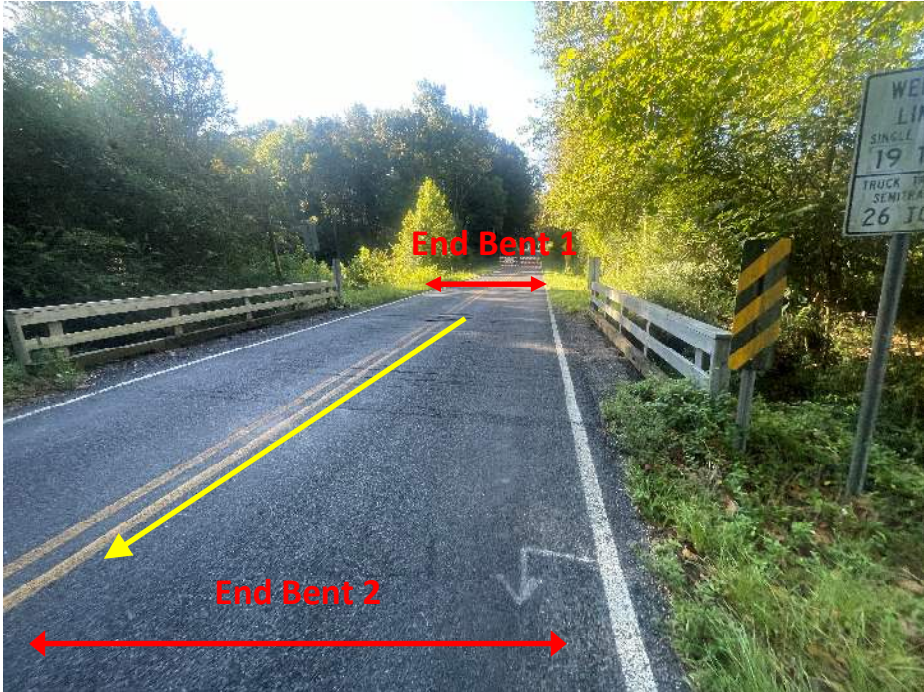
Photograph No. 1: View looking north at End Bent 1 from End Bent 2

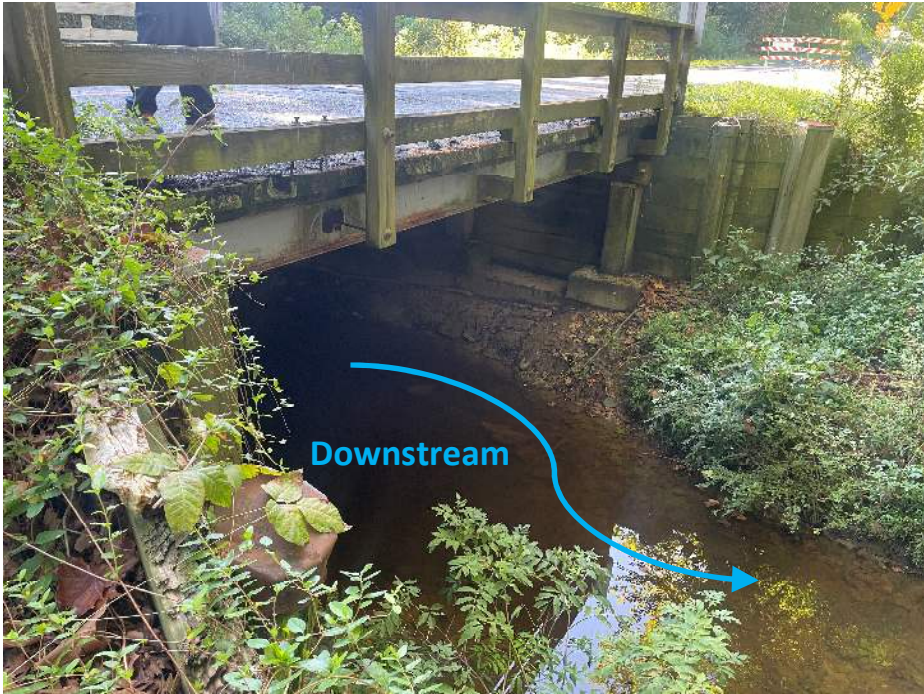
Photograph No. 2: View looking north
