REFERENCE: SF-280246

**STRUCTURE**  
**SUBSURFACE INVESTIGATION**

PROJECT DESCRIPTION BRIDGE NO. 246 ON SR 2351  
(FLAT SWAMP ROAD) OVER LICK CREEK

SITE DESCRIPTION BRIDGE STRUCTURE AT -L-  
STA. 15 + 80.00

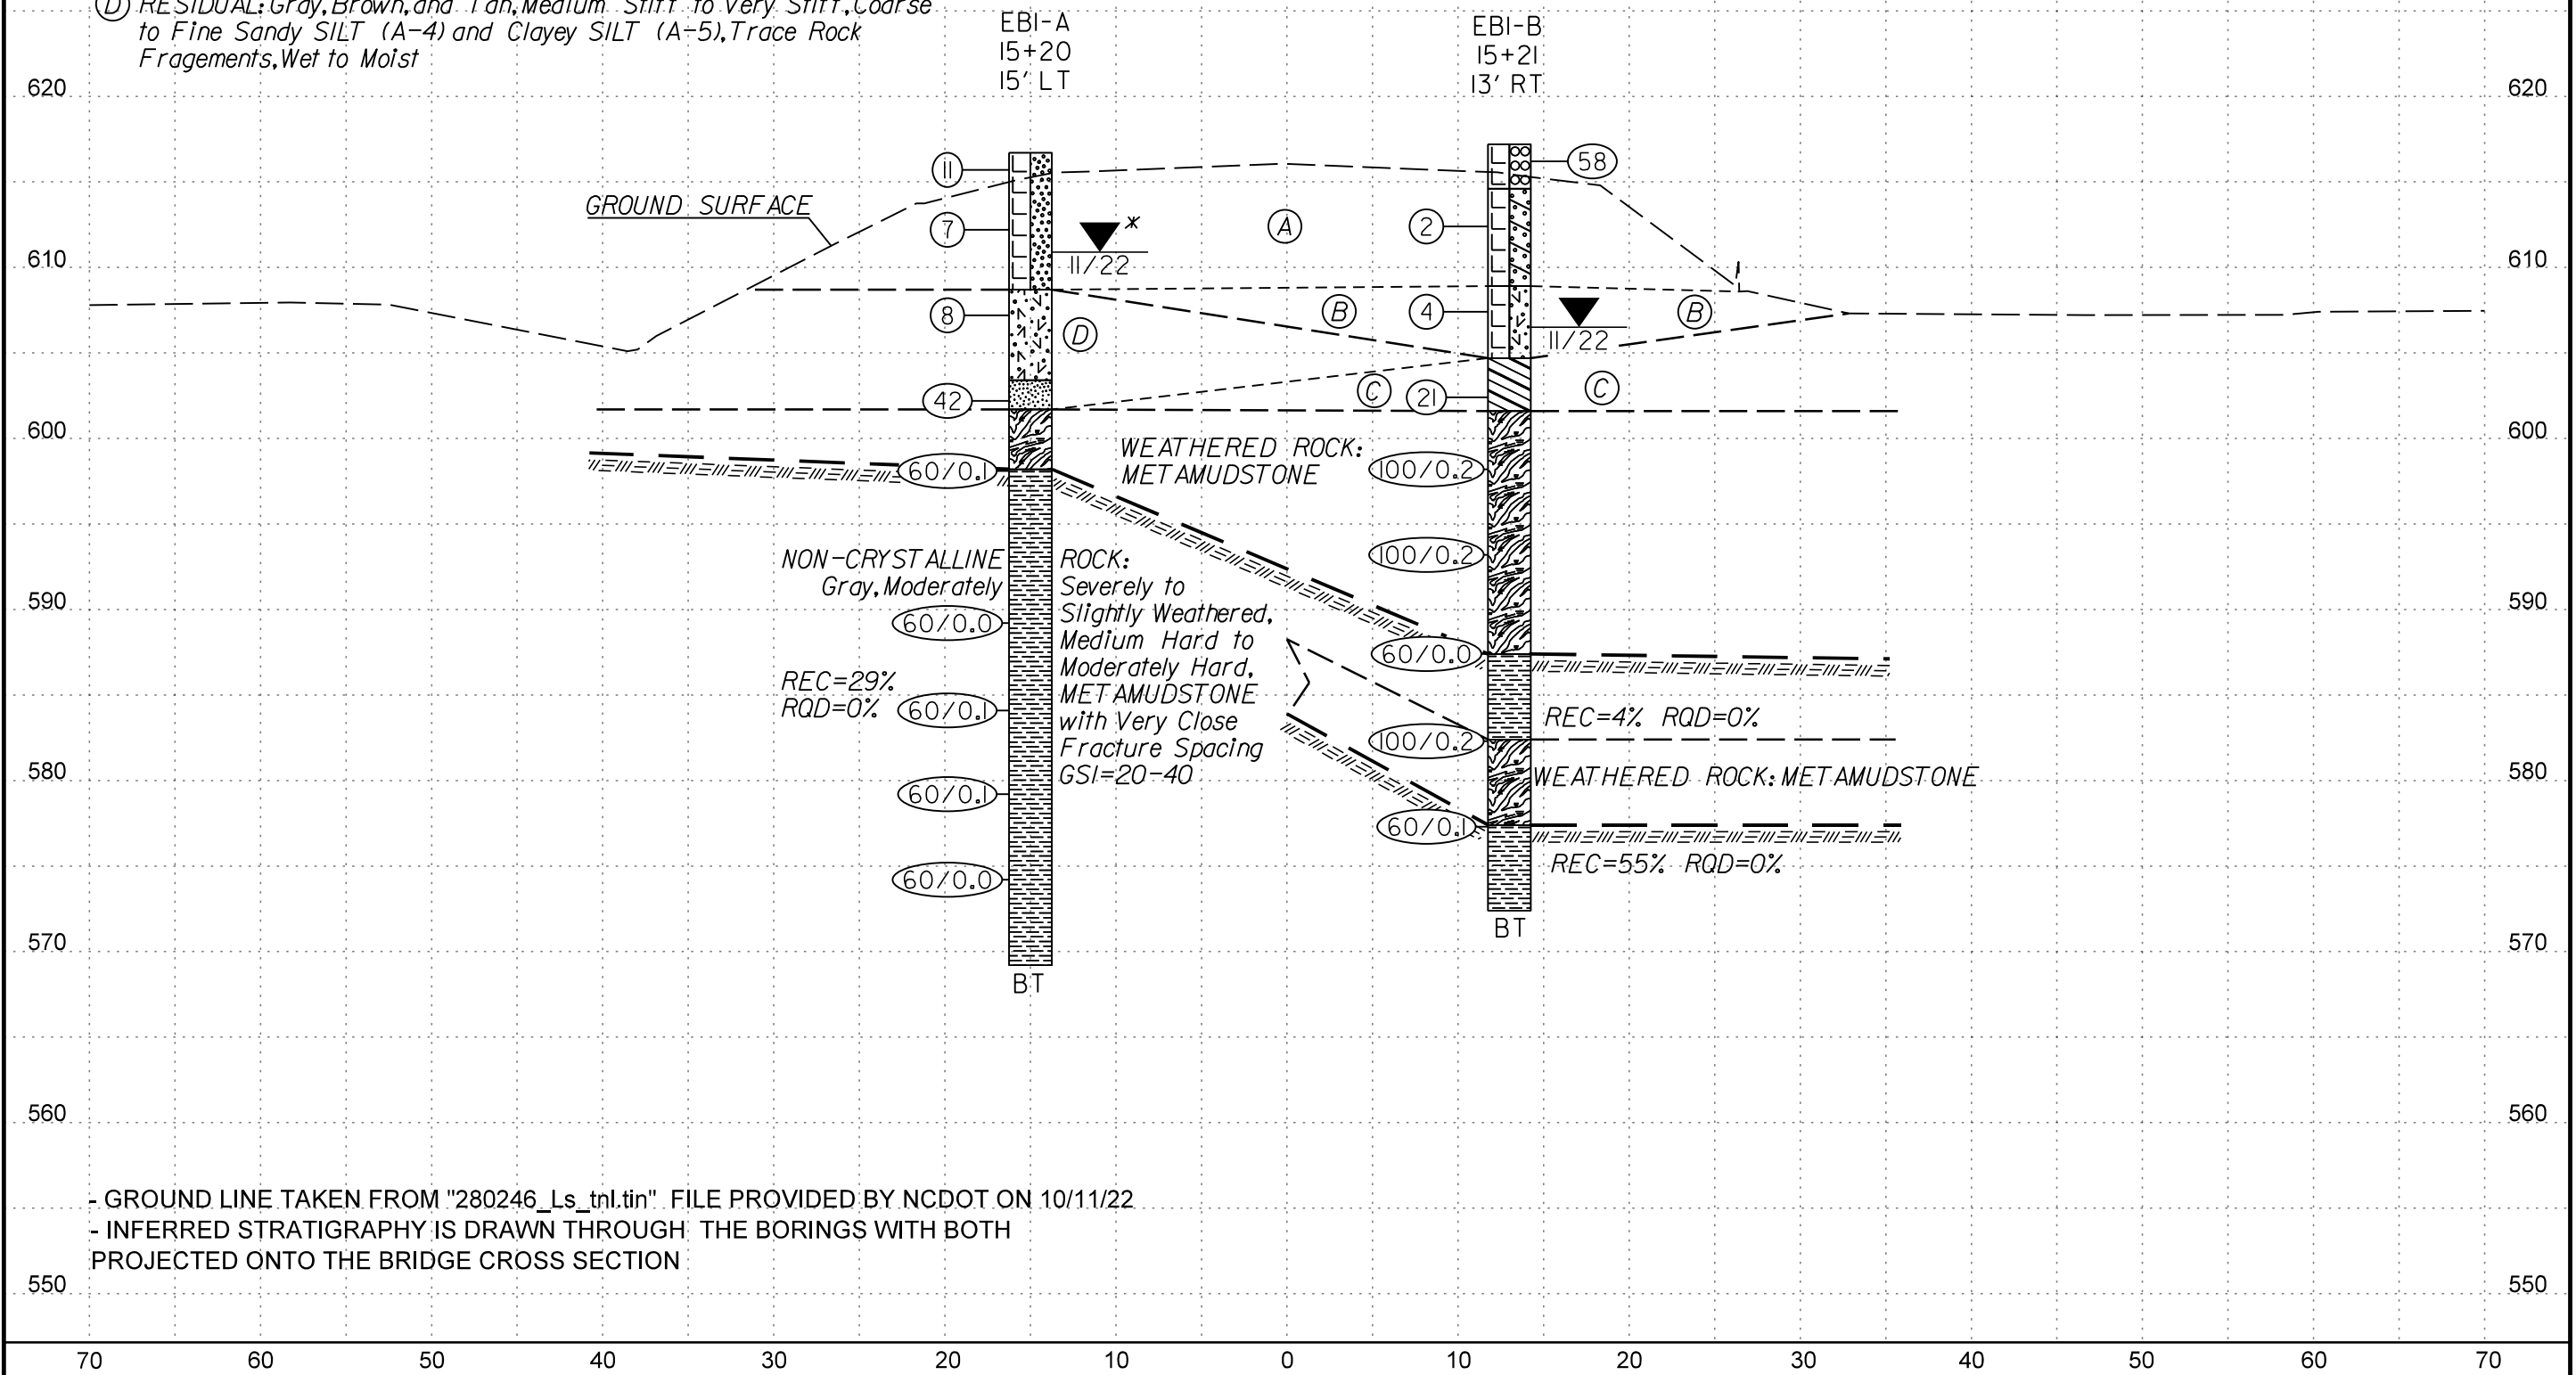
PROJECT REFERENCE NO.	SHEET NO.
SF-280246	4
CROSS SECTION AT END BENT 1	
-L- STATION 15+26.31	
SKEW = 90°00'00"

- (A) ROADWAY EMBANKMENT: Tan and Brown with Black, Very Loose to Medium Dense, Coarse to Fine SAND (A-1-b), Silty Coarse to Fine SAND (A-2-4), and Clayey Coarse to Fine SAND (A-2-6), Trace to Abundant Asphalt Fragments and Trace Gravel, Dry to Wet  
Note: Blow Count from 0.5' to 1.0' in EBI-B Influenced by Asphalt Fragments
- (B) ROADWAY EMBANKMENT: Tan and Brown, Soft to Medium Stiff, Clayey SILT (A-5), Moist
- (C) RESIDUAL: Brown and Tan with Gray, Very Stiff, Coarse to Fine Sandy CLAY (A-6), Trace Rock Fragments, Moist
- (D) RESIDUAL: Gray, Brown, and Tan, Medium Stiff to Very Stiff, Coarse to Fine Sandy SILT (A-4) and Clayey SILT (A-5), Trace Rock Fragments, Wet to Moist

\*NOTE: Heavy rain the previous day affected 24-hour water reading in EBI-A

- GROUND LINE TAKEN FROM "280246\_Ls\_tnl.tin" FILE PROVIDED BY NCDOT ON 10/11/22  
- INFERRED STRATIGRAPHY IS DRAWN THROUGH THE BORINGS WITH BOTH PROJECTED ONTO THE BRIDGE CROSS SECTION

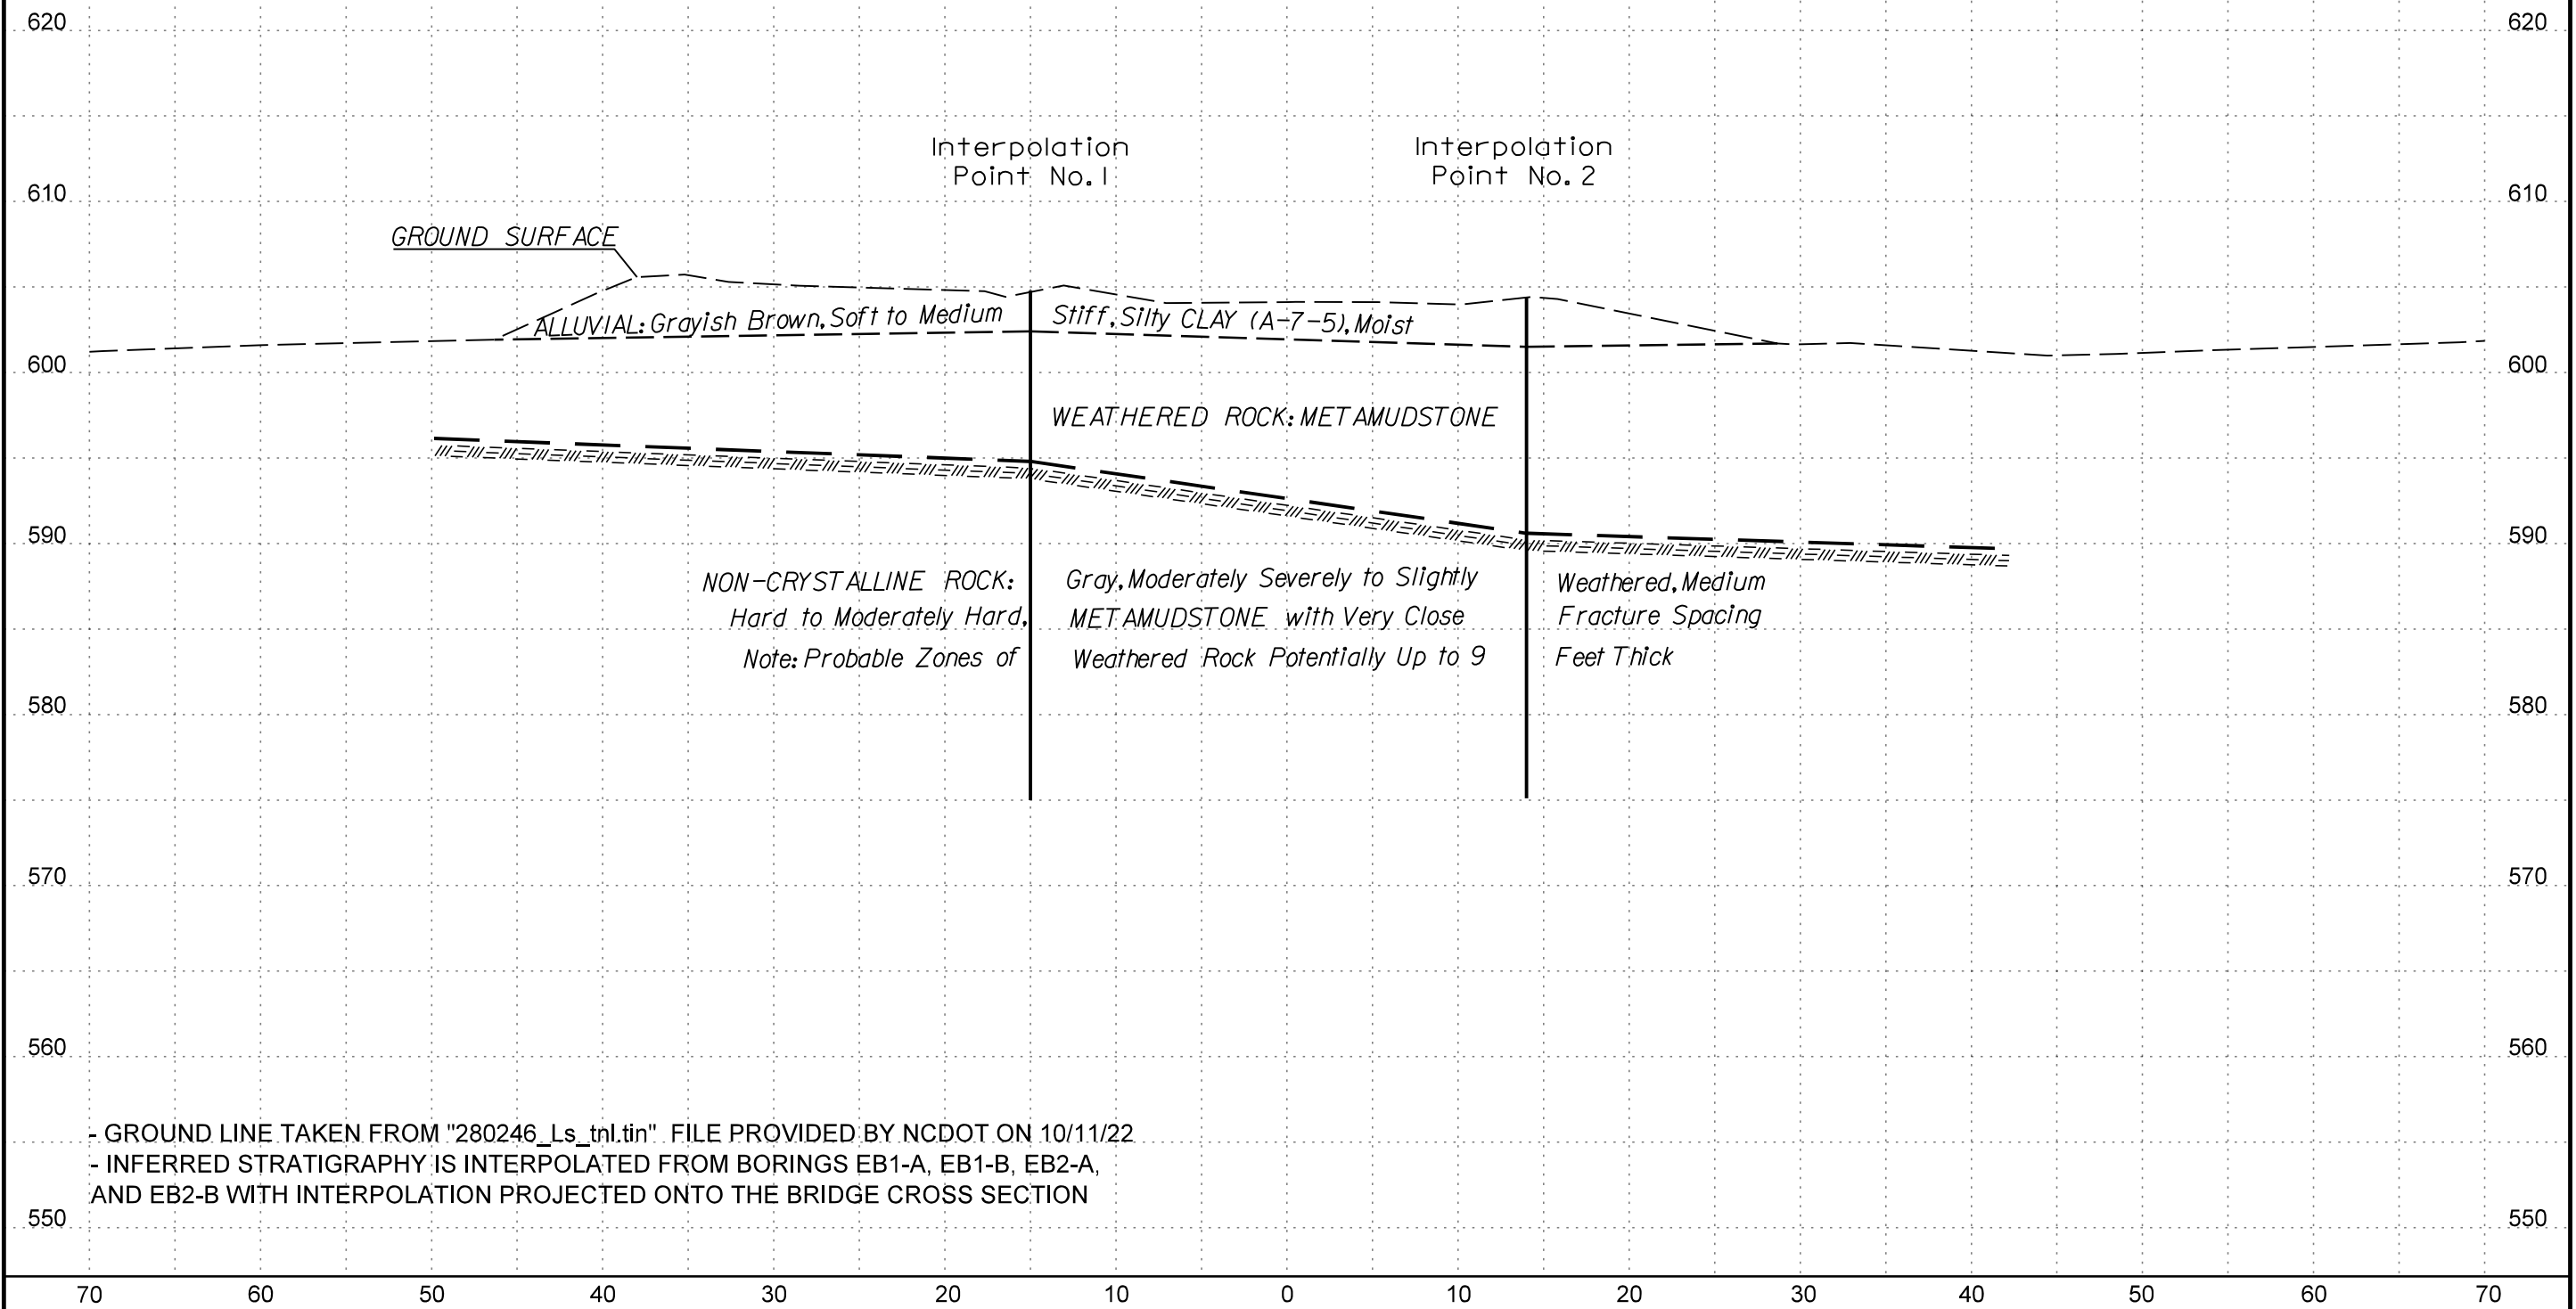
PROJECT REFERENCE NO.	SHEET NO.
SF-280246	5
<b>CROSS SECTION AT BENT 1</b> -L- STATION 15+97.50 SKEW = 90°00'00"

- GROUND LINE TAKEN FROM "280246\_Ls\_tnl.tin" FILE PROVIDED BY NCDOT ON 10/11/22  
 - INFERRED STRATIGRAPHY IS INTERPOLATED FROM BORINGS EB1-A, EB1-B, EB2-A, AND EB2-B WITH INTERPOLATION PROJECTED ONTO THE BRIDGE CROSS SECTION

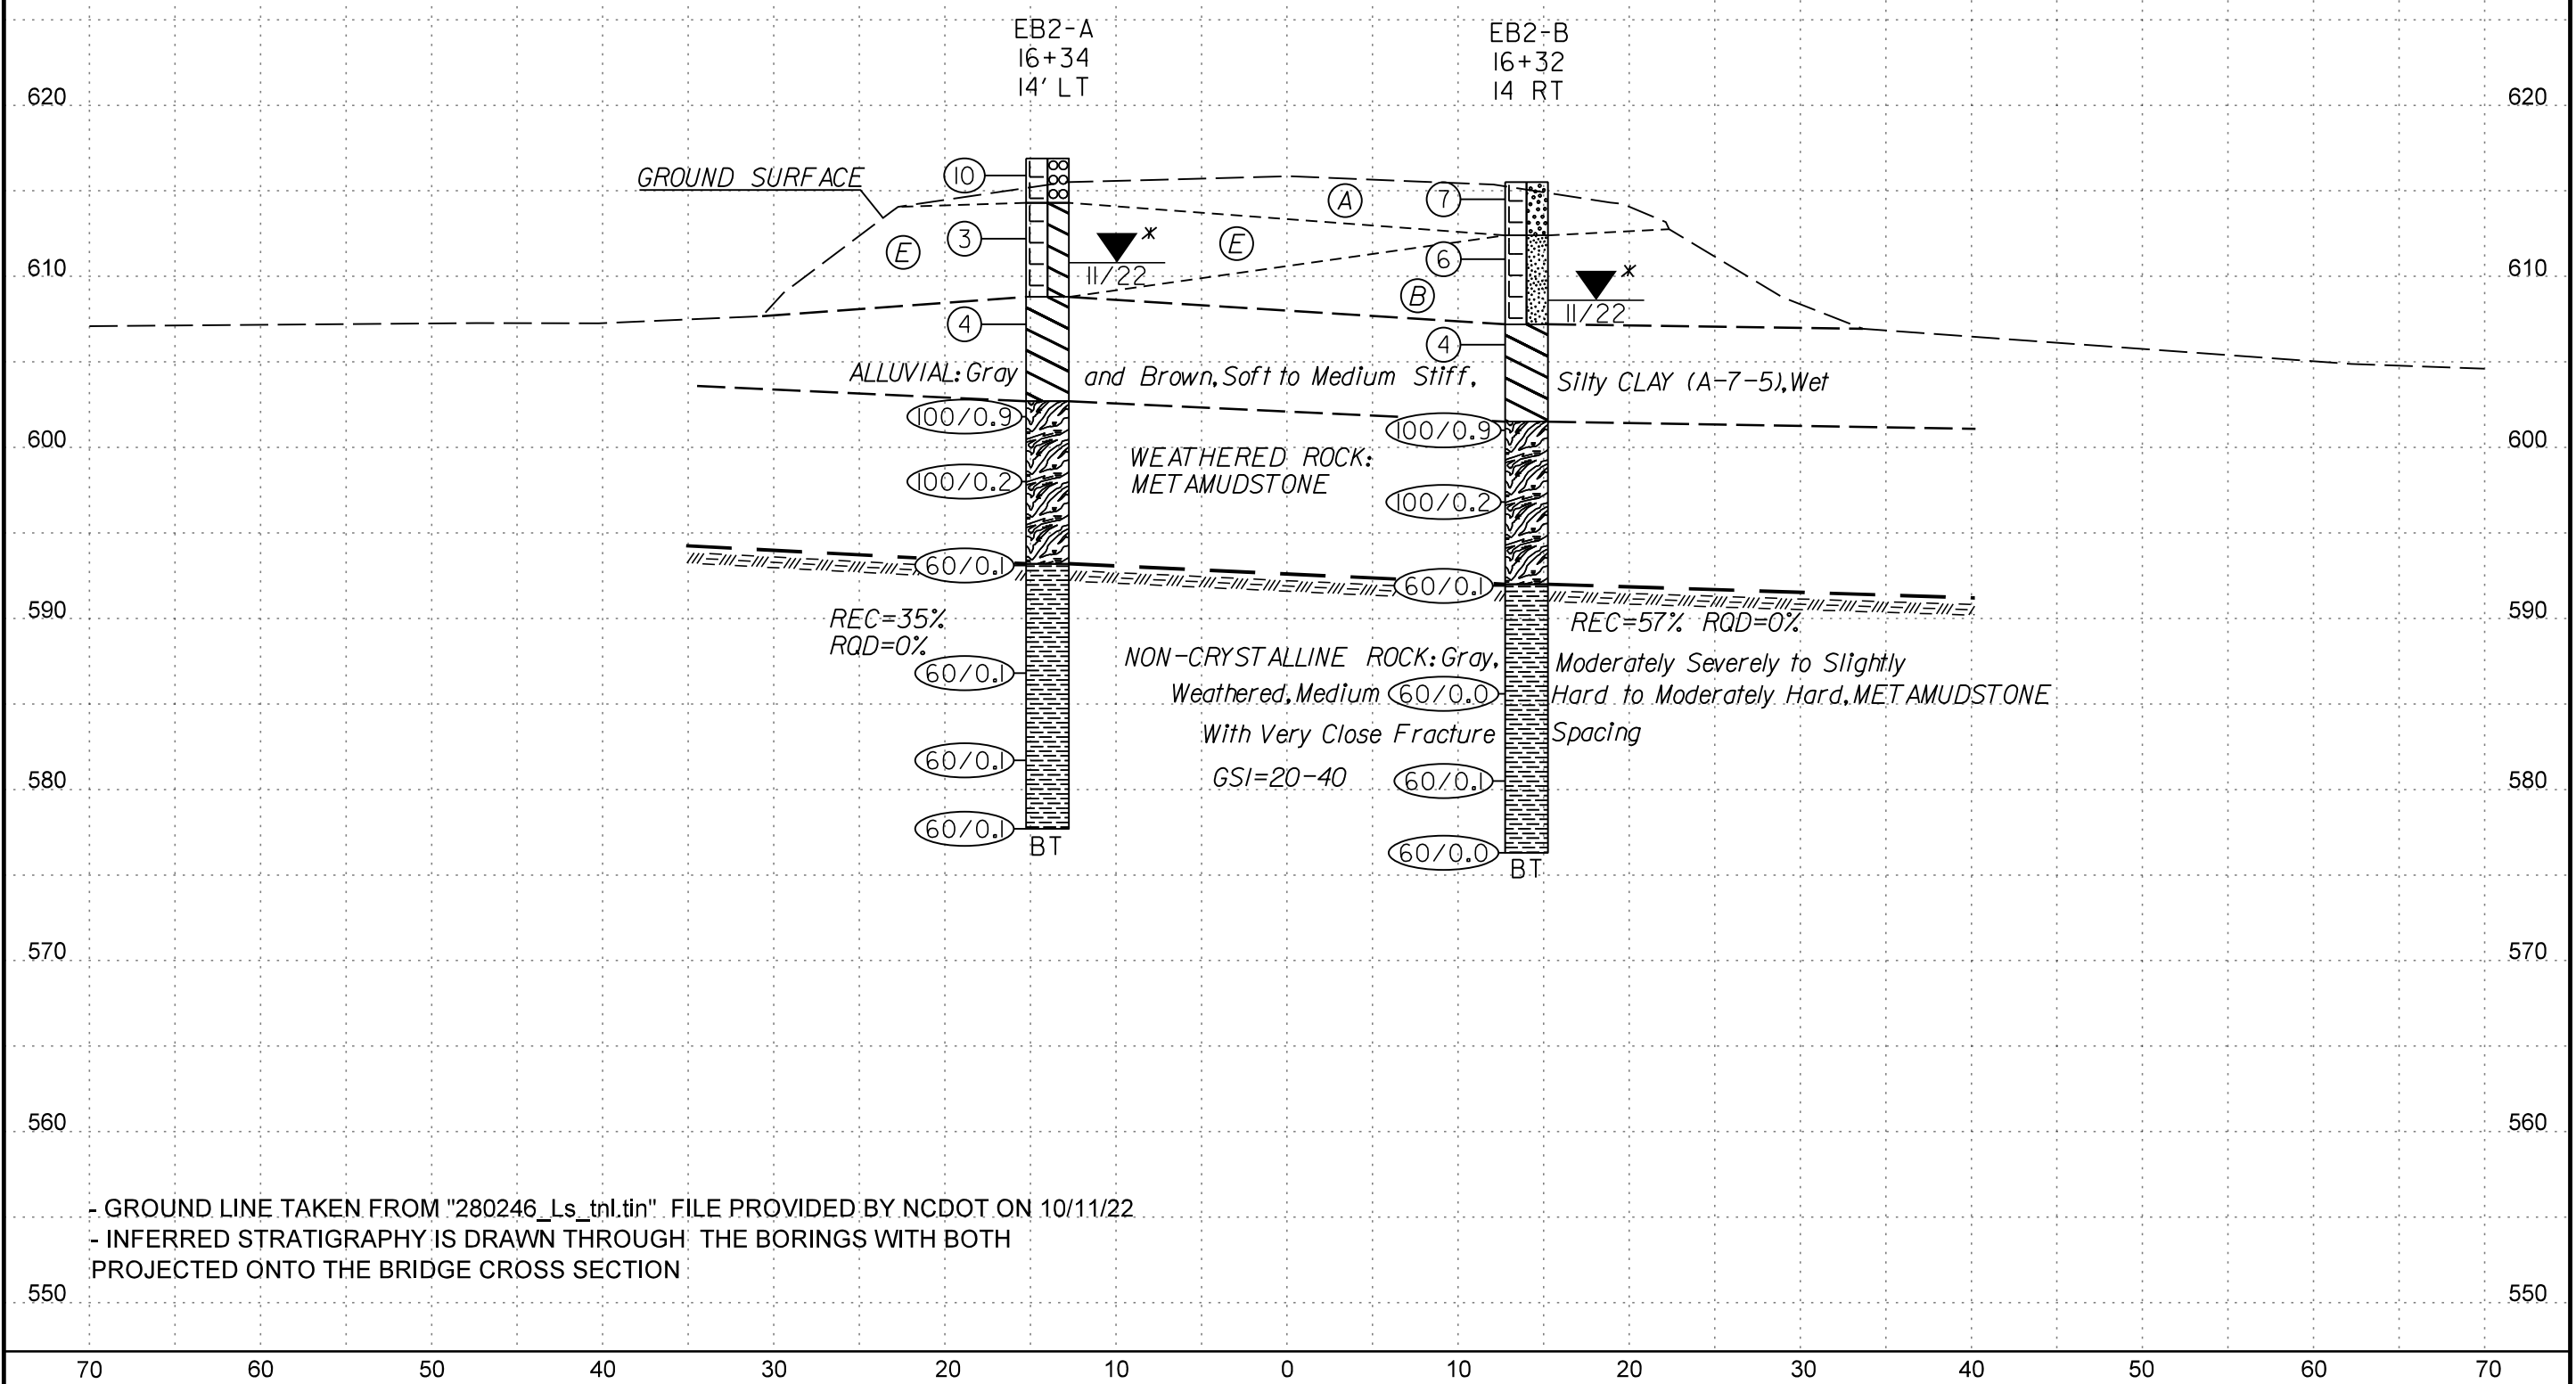
<b>PROJECT REFERENCE NO.</b>	<b>SHEET NO.</b>
SF-280246	6
<b>CROSS SECTION AT END BENT 2</b>	
<i>-L- STATION 16+33.69</i>	
<i>SKEW = 90°00'00"</i>

- (A) ROADWAY EMBANKMENT: Brown and Black, Loose to Medium Dense, Coarse to Fine SAND (A-1-b) and Silty Coarse to Fine SAND (A-2-4), Abundant Asphalt in EB2-A and Trace Asphalt in EB2-B, Trace Gravel, Dry to Moist
- (B) ROADWAY EMBANKMENT: Brown, Medium Stiff, Coarse to Fine Sandy SILT (A-4), Trace Gravel, Wet
- (E) ROADWAY EMBANKMENT: Tan, Soft, Silty CLAY (A-7-5), Wet

\*NOTE: Heavy rain the previous day affected 24-hour water reading in EB2-A and EB2-B

- GROUND LINE TAKEN FROM "280246\_Ls\_tnl.tin" FILE PROVIDED BY NCDOT ON 10/11/22  
 - INFERRED STRATIGRAPHY IS DRAWN THROUGH THE BORINGS WITH BOTH PROJECTED ONTO THE BRIDGE CROSS SECTION

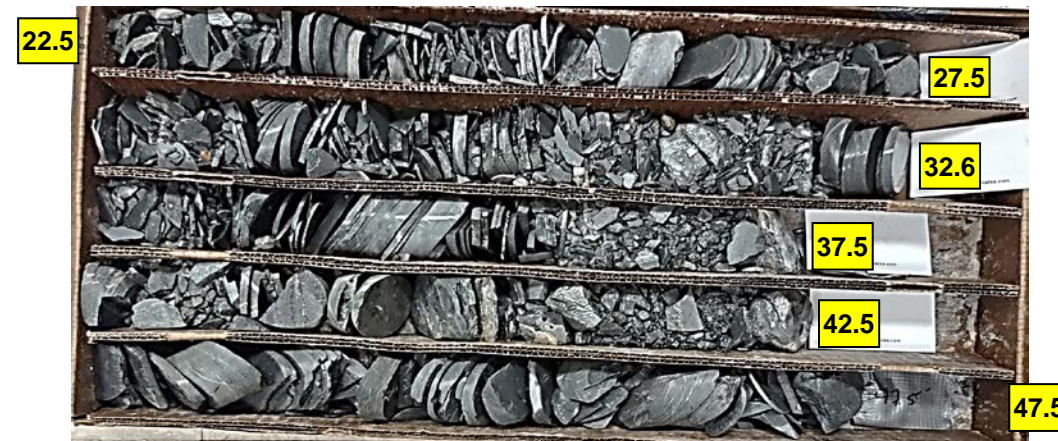
## EB1-A 22.5 FEET - 47.5 FEET

598.1	598.1	18.6	3.9	0:53/0.9 0:33/1.0 1:45/1.0 5:47/1.0	(0.0)	(0.0)		(8.4)	(0.0)			18.6
595	594.2	22.5	5.0	3:51/1.0 5:18/1.0 5:54/1.0 6:12/1.0 4:40/1.0	(1.8)	(0.0)						
590	589.2	27.5	5.0	2:11/1.0 6:11/1.0 6:55/1.0 6:23/1.0 7:07/1.0	(1.8)	(0.0)						
585	584.2	32.5	4.9	N=60/0.1 1:32/0.9 8:44/1.0 2:32/1.0 3:49/1.0 5:49/1.0	(1.5)	(0.0)						
580	579.2	37.5	4.9	2:34/0.9 2:39/1.0 1:44/1.0 2:29/1.0 3:04/1.0	(1.6)	(0.0)						
575	574.2	42.5	5.0	2:12/1.0 4:56/1.0 2:44/1.0 4:52/1.0	(1.7)	(0.0)						
570	569.2	47.5		5:25/1.0								
Boring Terminated at Elevation 569.2 ft in Non-Crystalline Rock: METAMUDSTONE												
Note: Heavy rain the previous day affected the 24-hour water reading

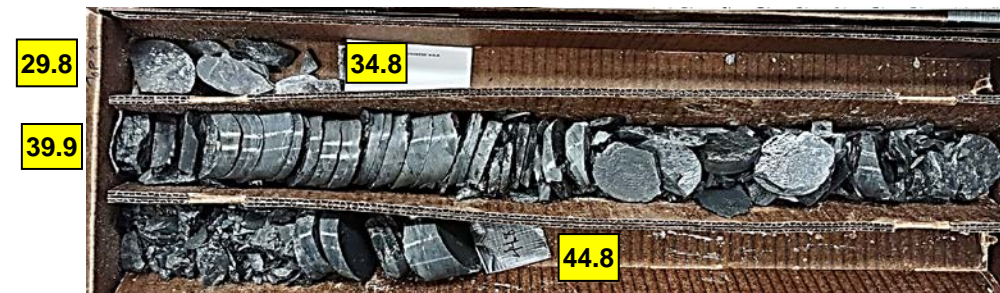
## EB1-B 29.8 FEET - 44.8 FEET

587.4												
	587.4	29.8	5.0	8:09/1.0 9:46/1.0 9:38/1.0 12:26/1.0 8:16/1.0 N=100/0.2	(0.2)	(0.0)		(0.2)	(0.0)		587.4	29.8
585												
	582.4	34.8									582.4	34.8
580

577.3	39.9									577.4	39.8
575			4.9	N=60/0.1 6:15/0.9 6:21/1.0 4:23/1.0 3:50/1.0 4:55/1.0	(2.7)	(0.0)		(2.7)	(0.0)		577.3	39.9
	572.4	44.8									572.4	44.8

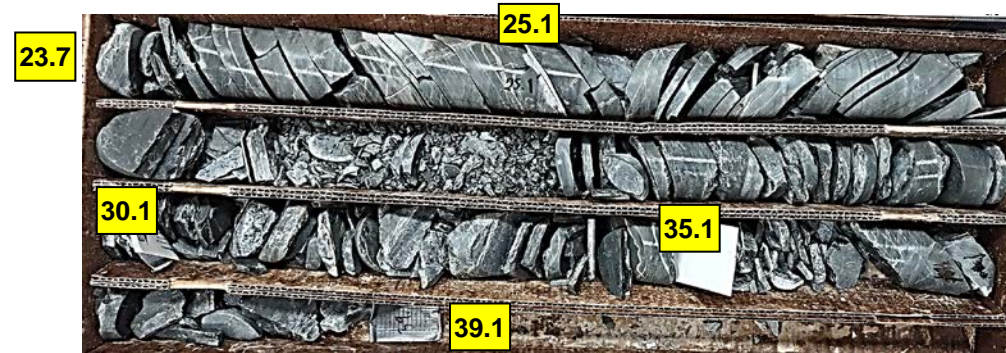
## EB2-A 23.7 FEET - 39.1 FEET

598.2	18.7	100/0.2											
595														
	593.2	23.7	60/0.0										NON-CRYSTALLINE ROCK Gray, Moderately Severely to Slightly Weathered, Medium Hard to Moderately Hard, METAMUDSTONE with Very Close Fracture Spacing	23.7
590

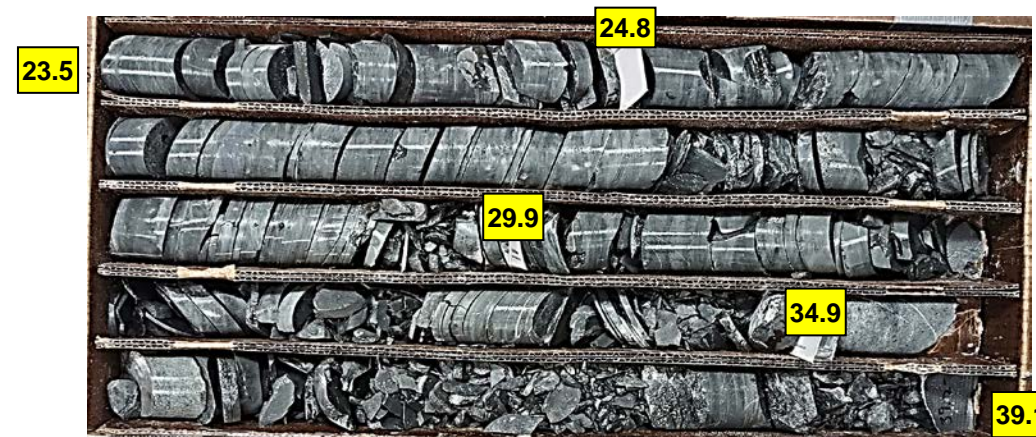
## EB2-B 23.7 FEET - 39.1 FEET

591.9	591.9	23.6	1.3	4:57/1.0	(1.1)	(0.0)		(8.9)	(0.0)		Begin Coring @ 23.6 ft	23.6
590	590.8	24.9	5.0	1:42/0.3	85%	0%		57%	0%		NON-CRYSTALLINE ROCK Gray, Moderately Severely to Slightly Weathered, Medium Hard to Moderately Hard, METAMUDSTONE with Very Close Fracture Spacing Fractures at 10 degrees to 30 degrees GSI=20-40	
585	585.6	29.9	5.0	6:38/1.0 5:44/1.0 9:45/1.0 8:36/1.0 16:21/1.0	(3.5)	(0.0)						
580	580.6	34.9	4.2	4:45/1.0 4:33/1.0 4:49/1.0 6:31/1.0 7:16/1.0	(2.3)	(0.0)

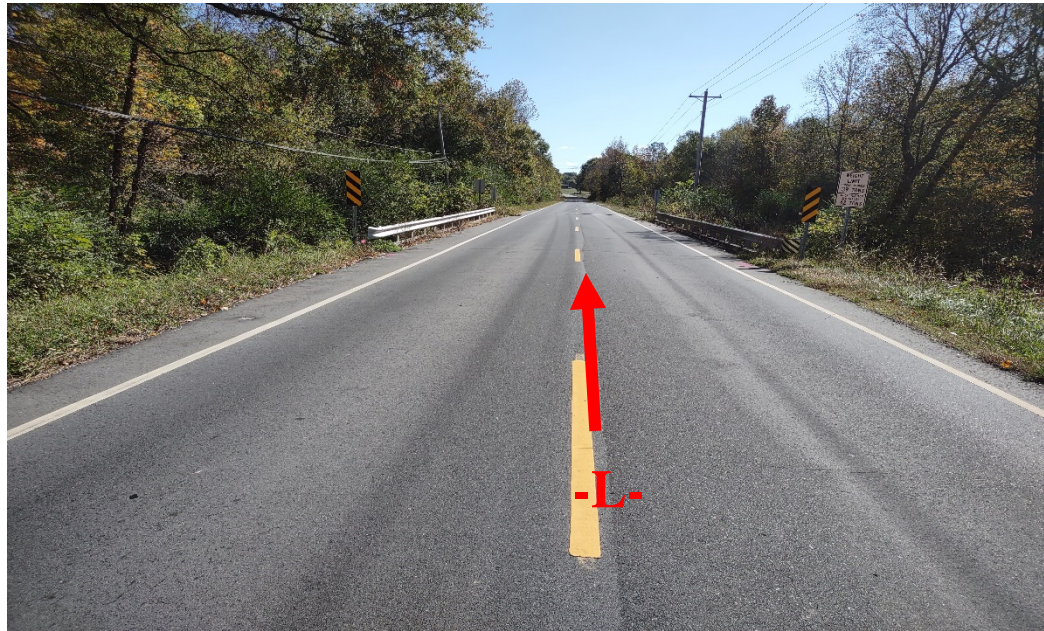
View Along Bridge 246 Looking Upstation

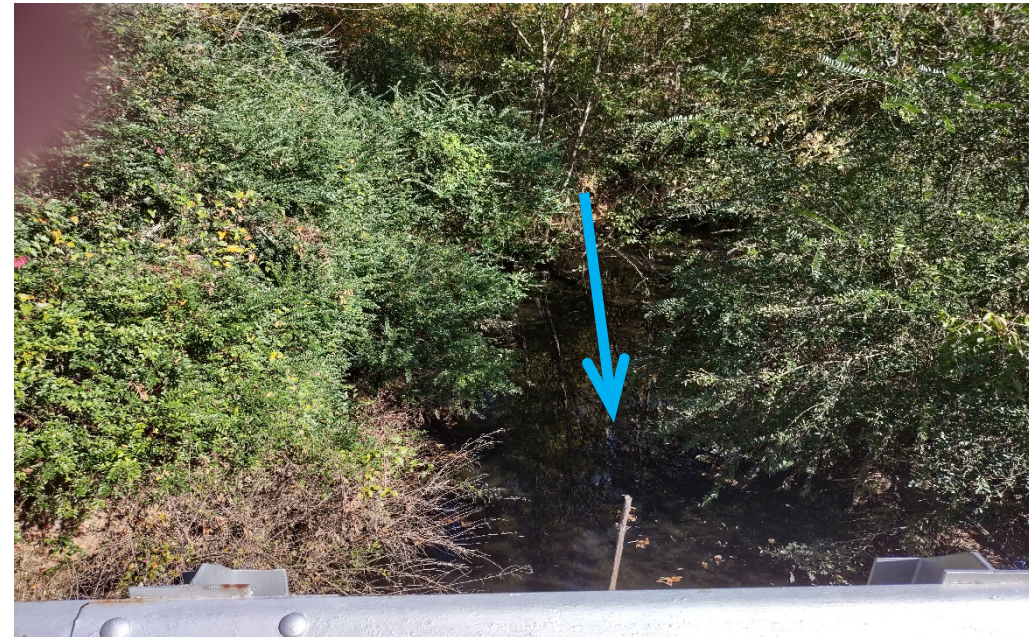
View Looking Upstream from Bridge 246

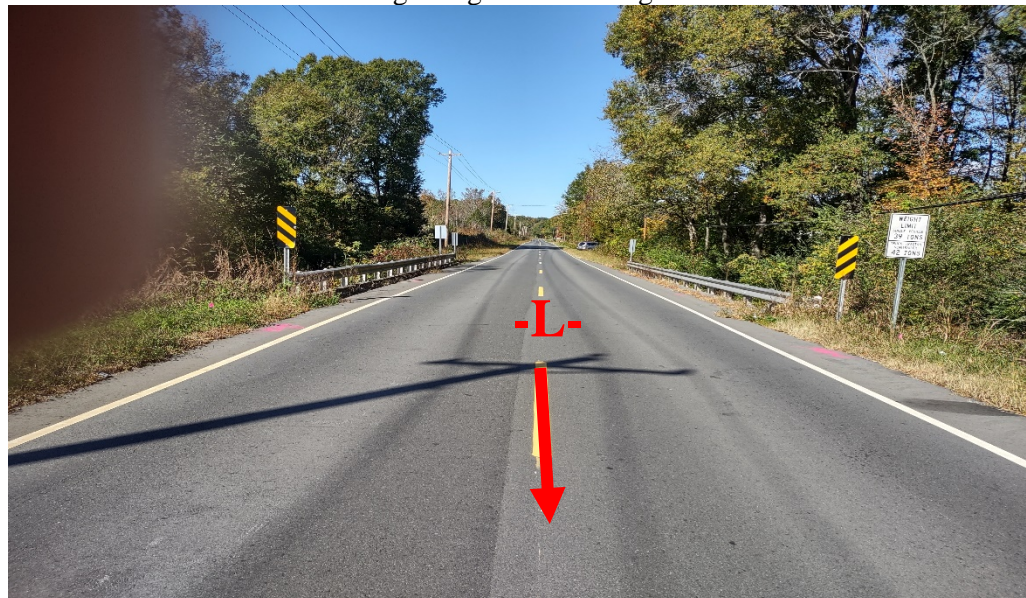
View of Along Bridge 246 Looking Downstation

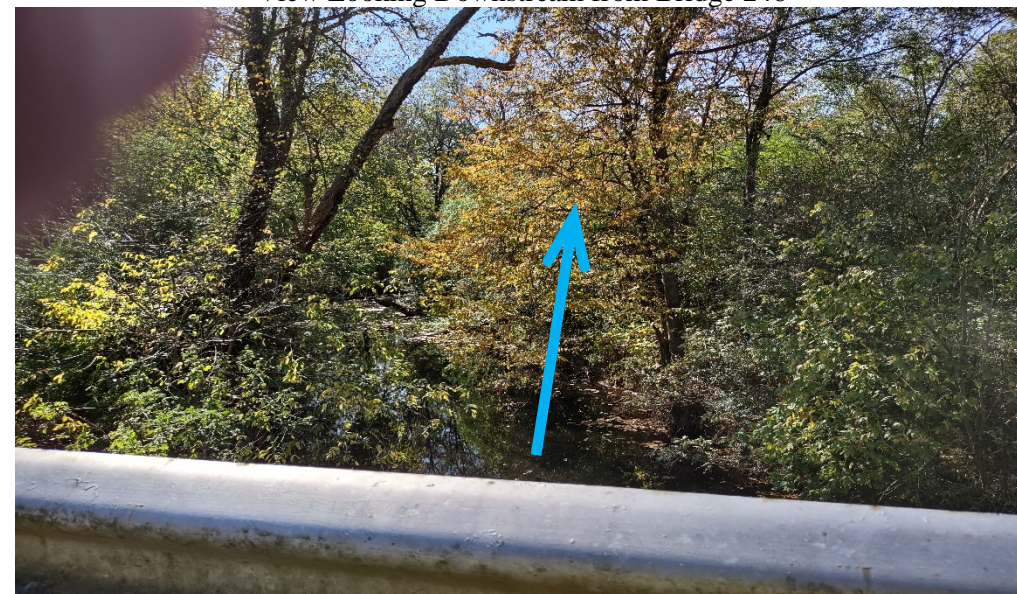
View Looking Downstream from Bridge 246
