STATE OF NORTH CAROLINA
DEPARTMENT OF TRANSPORTATION
DIVISION OF HIGHWAYS
GEOTECHNICAL ENGINEERING UNIT

STRUCTURE
SUBSURFACE INVESTIGATION

COUNTY ROWAN
 SITE DESCRIPTION BRIDGE NO. 198 AND 199 ON SR
2529 (ST. PAUL CHURCH ROAD) OVER CRANE
CREEK

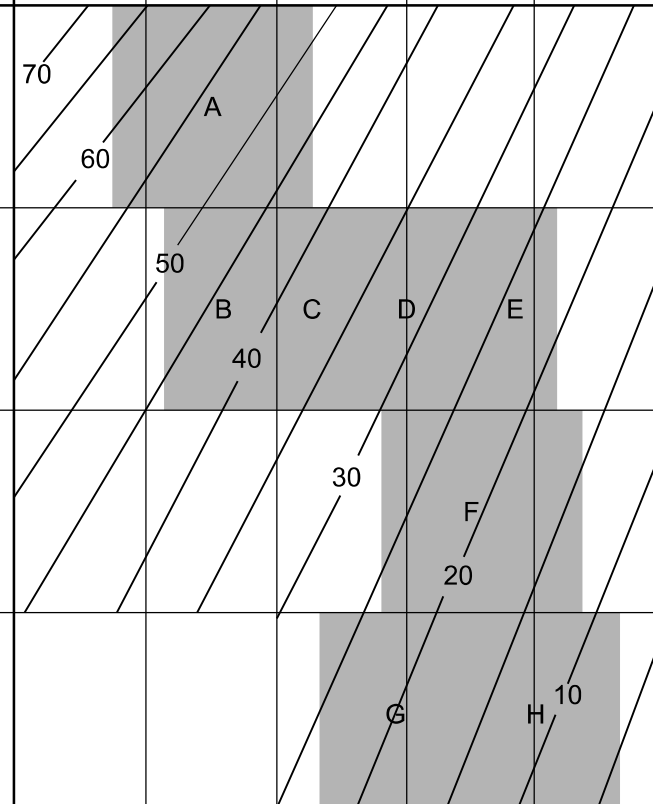
AASHTO LRFD Figure 10.4.6.4-2 — Determination of GSI for Tectonically Deformed Heterogeneous Rock Masses (Marinos and Hoek, 2000)

From a description of the lithology, structure and surface conditions (particularly of the bedding planes), choose a box in the chart. Locate the position in the box that corresponds to the condition of the discontinuities and estimate the average value of GSI from the contours. Do not attempt to be too precise. Quoting a range from 33 to 37 is more realistic than giving GSI = 35. Note that the Hoek-Brown criterion does not apply to structurally controlled failures. Where unfavourably oriented continuous weak planar discontinuities are present, these will dominate the behaviour of the rock mass. The strength of some rock masses is reduced by the presence of groundwater and this can be allowed for by a slight shift to the right in the columns for fair, poor and very poor conditions. Water pressure does not change the value of GSI and it is dealt with by using effective stress analysis.

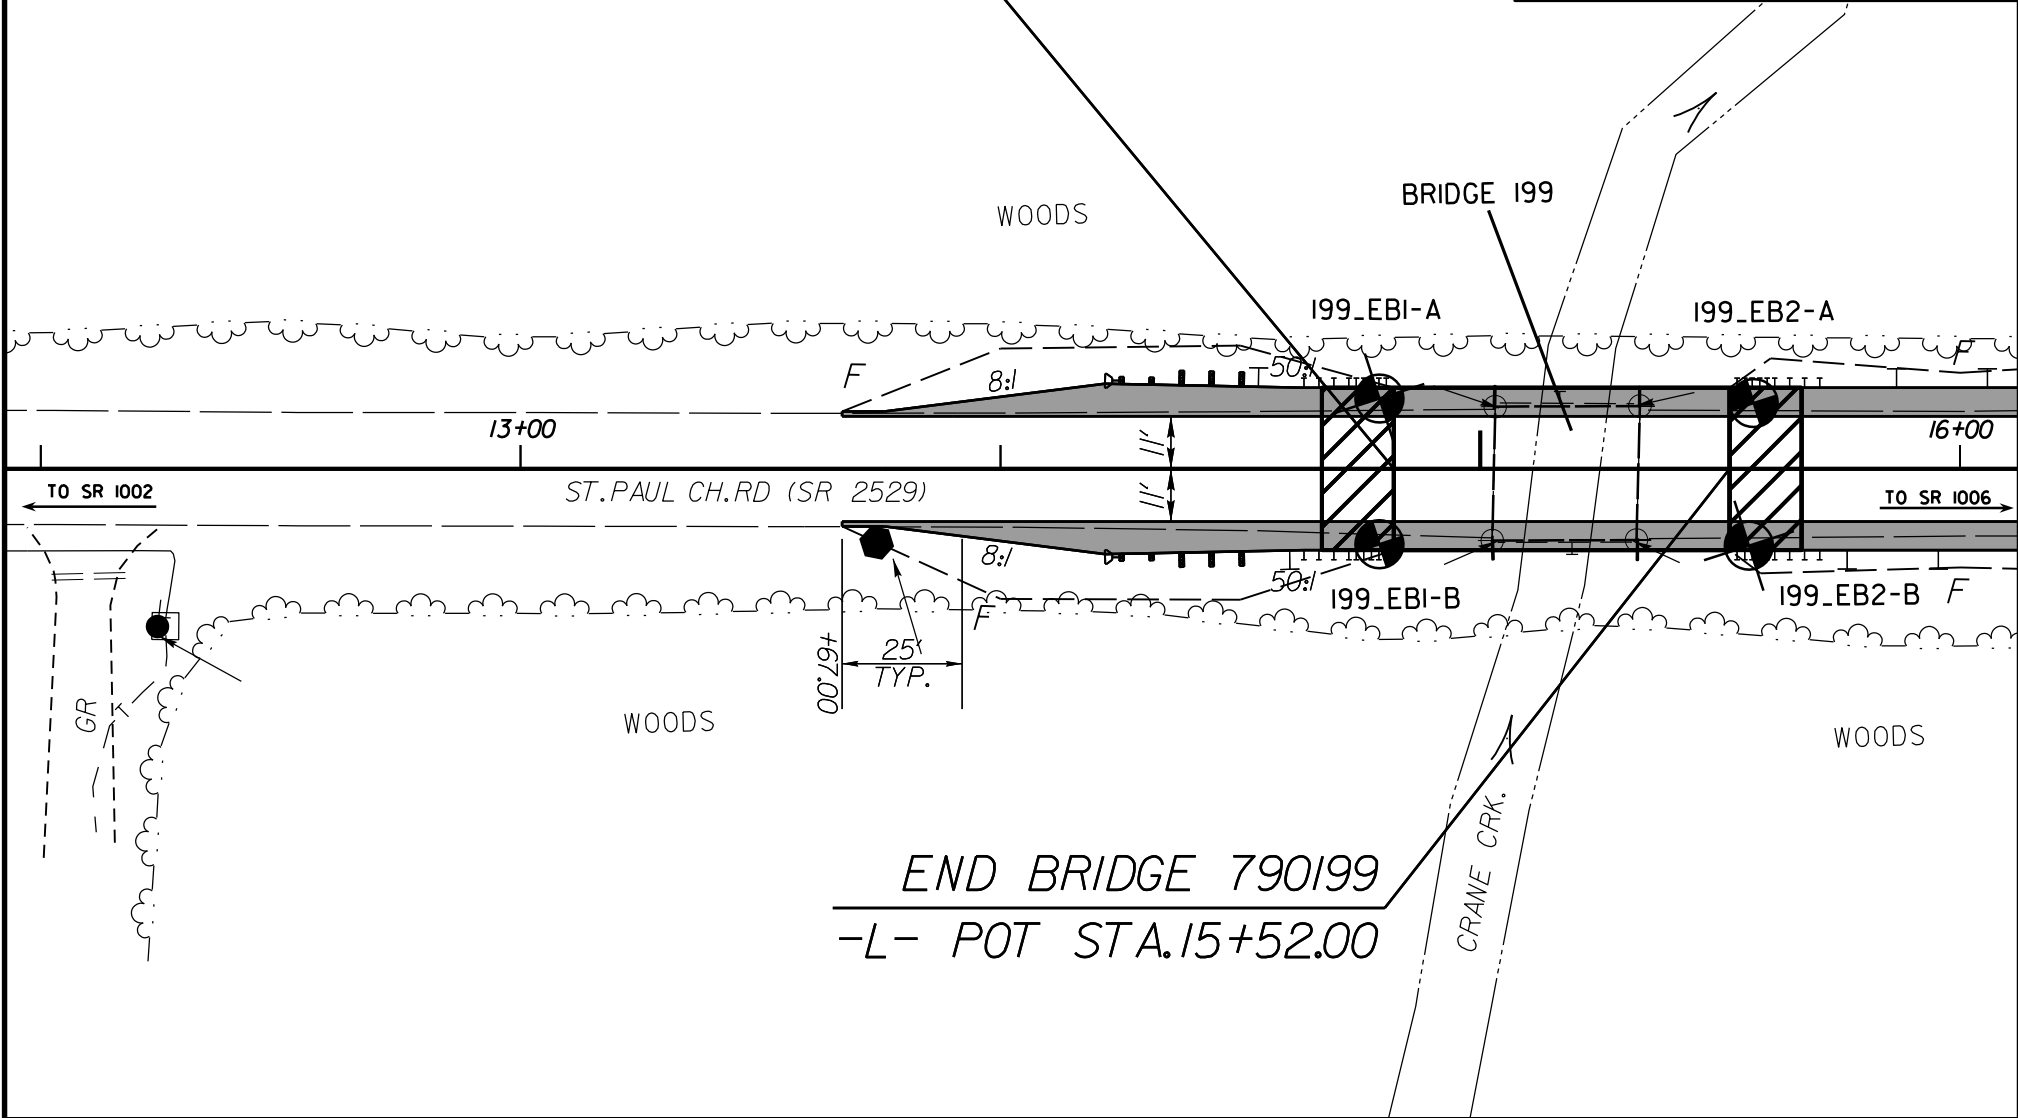
PROJECT REFERENCE NO.	SHEET NO.
17BP.9.R.85	3
SITE PLAN	
0 40 80 ————— FEET	
REPLACE BRIDGE 199 ON SR 2529 (ST. PAUL CHURCH ROAD) OVER CRANE CREEK SKEW = 90 DEGREES

BEGIN BRIDGE 790199
-L- POT STA.14+82.00

END BRIDGE 790199
-L- POT STA.15+52.00

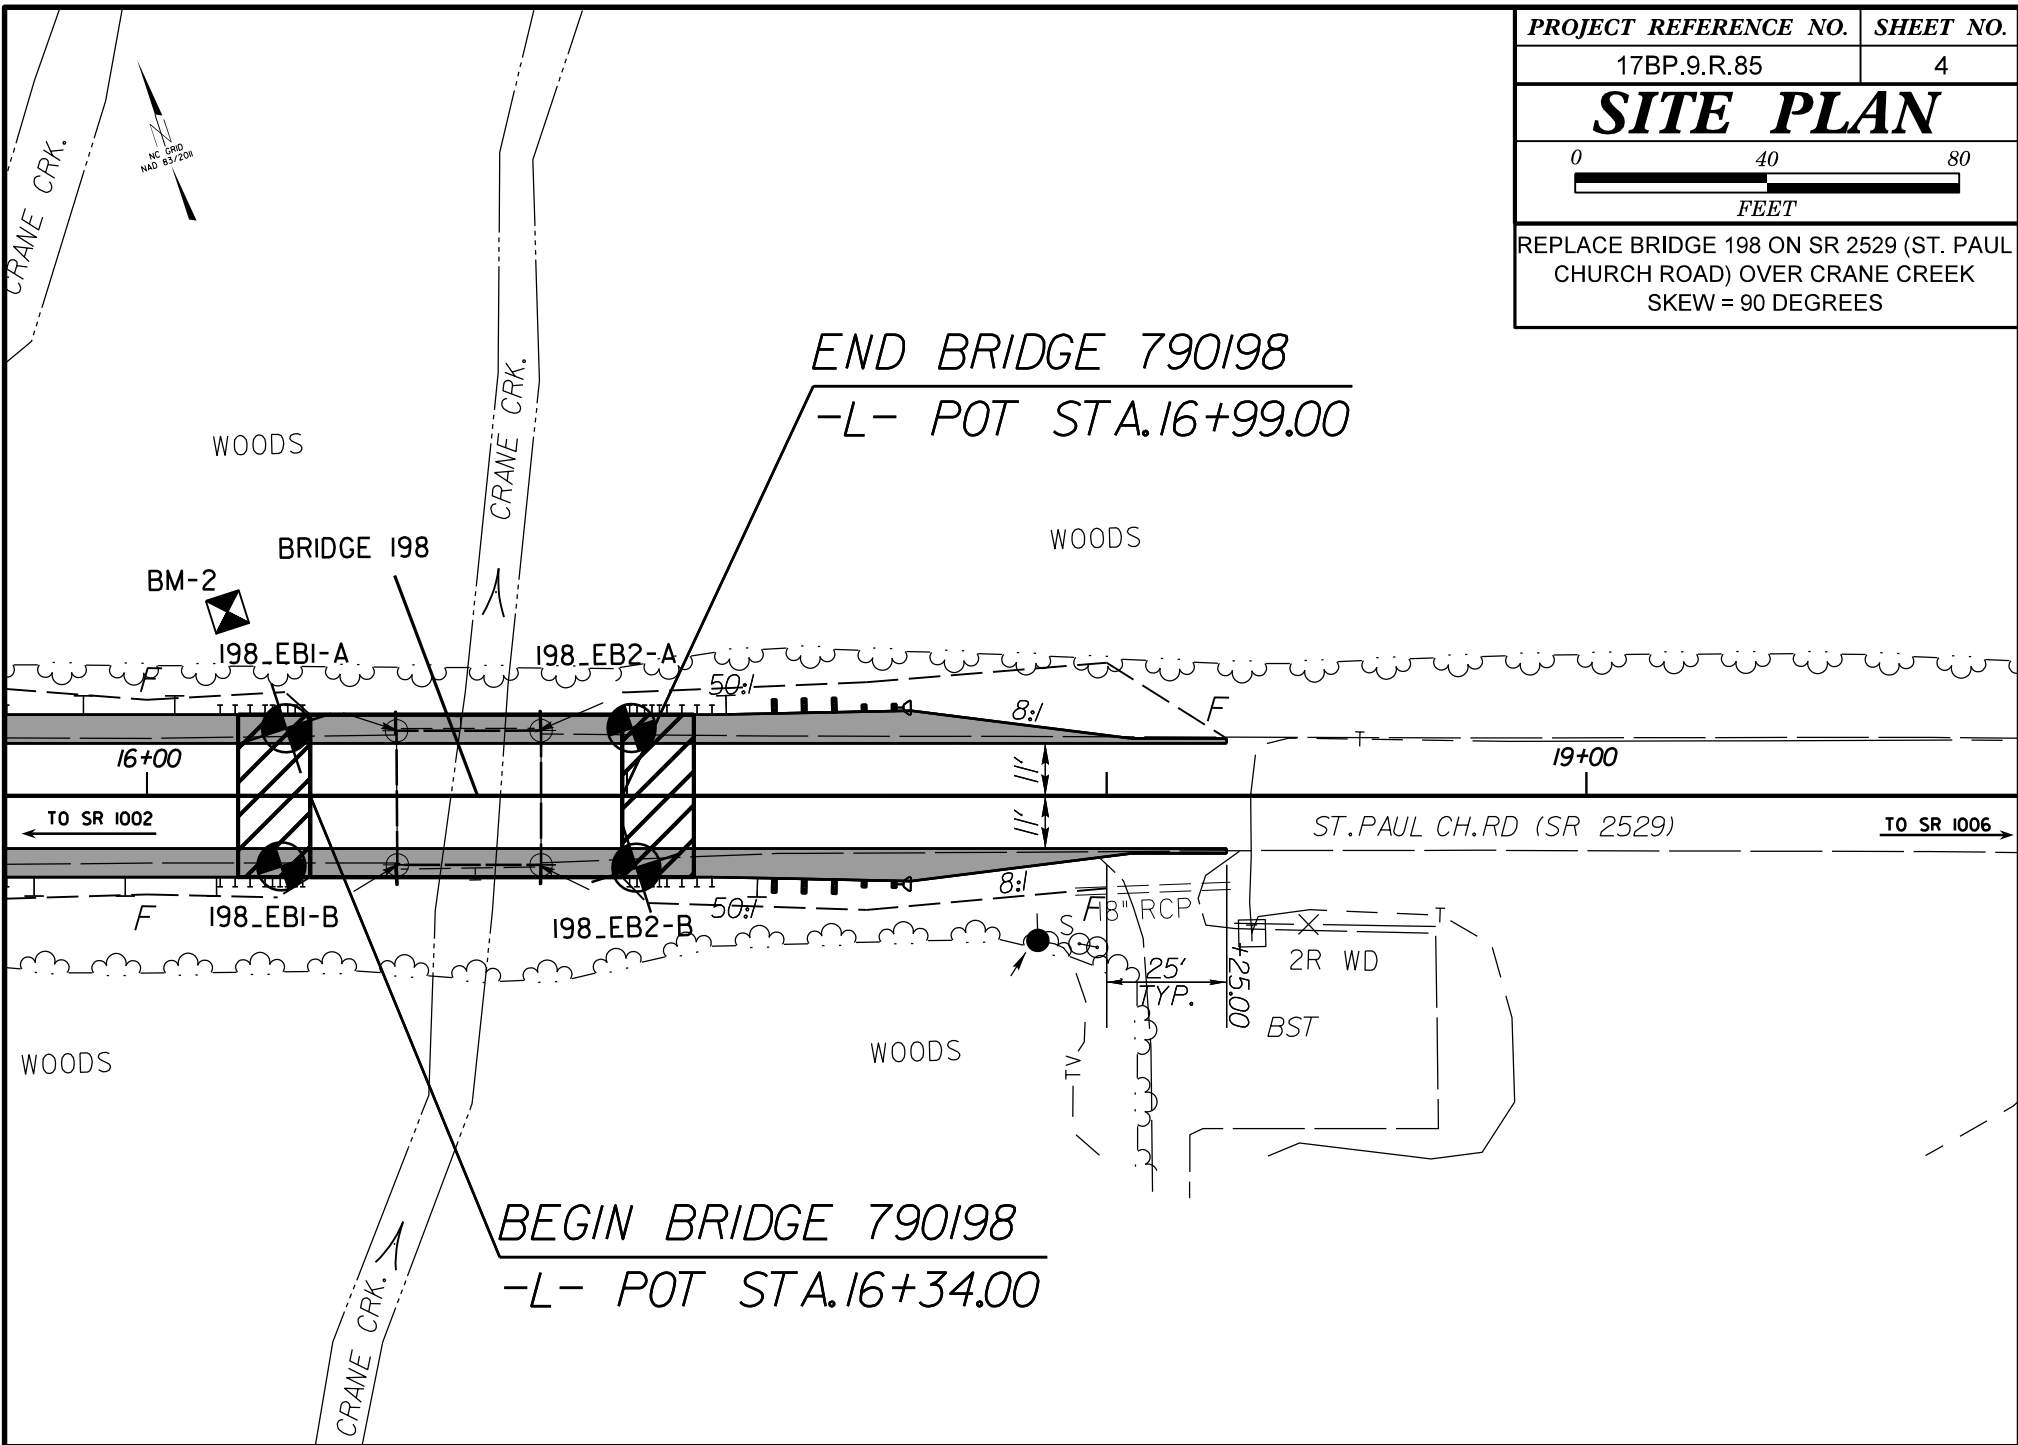
PROJECT REFERENCE NO.	SHEET NO.
17BP.9.R.85	4
SITE PLAN	
REPLACE BRIDGE 198 ON SR 2529 (ST. PAUL CHURCH ROAD) OVER CRANE CREEK SKEW = 90 DEGREES

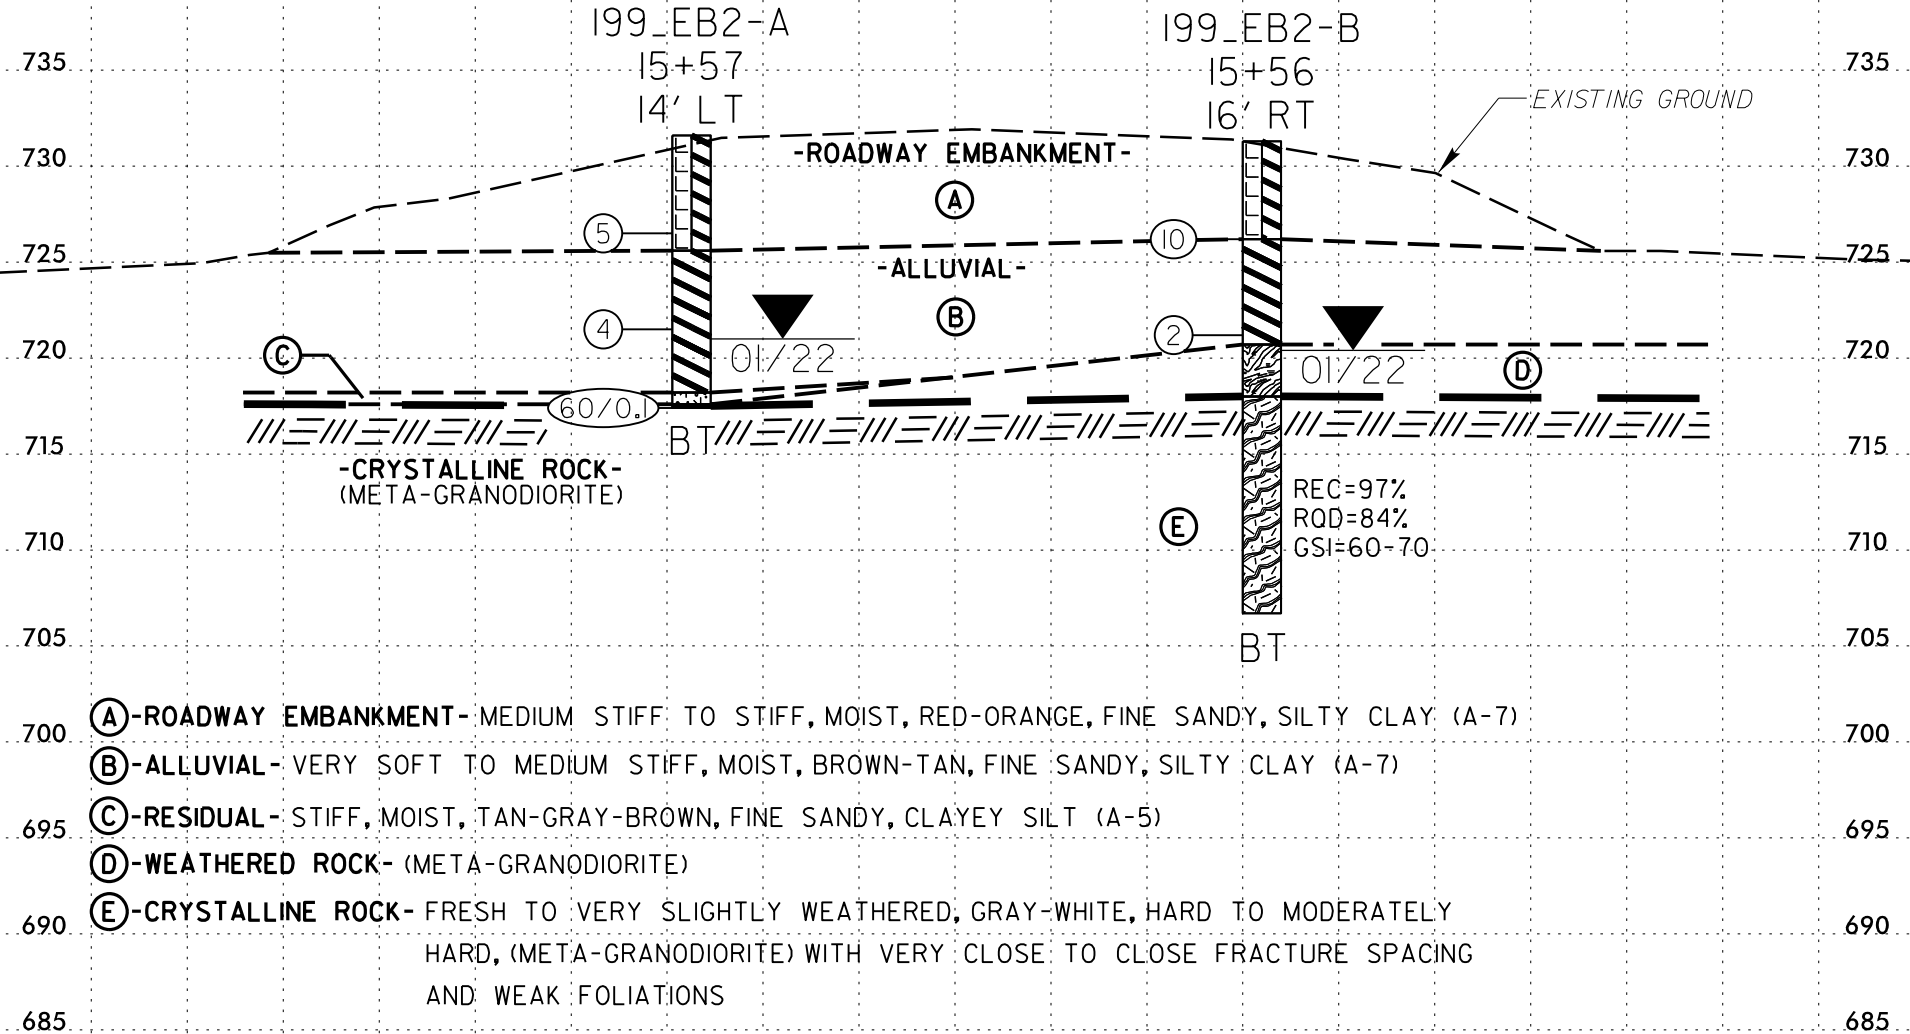
PROJECT REFERENCE NO.	SHEET NO.
17BP.9.R.85	6
REPLACE BRIDGE 199 ON SR 2529 (ST. PAUL CHURCH RD) OVER CRANE CREEK END BENT 2 SKEW = 90 DEGREES

- ① -ROADWAY EMBANKMENT- MEDIUM STIFF TO STIFF, MOIST, RED-ORANGE, FINE SANDY, SILTY CLAY (A-7)
- ② -ALLUVIAL- VERY SOFT TO MEDIUM STIFF, MOIST, BROWN-TAN, FINE SANDY, SILTY CLAY (A-7)
- ③ -RESIDUAL- STIFF, MOIST, TAN-GRAY-BROWN, FINE SANDY, CLAYEY SILT (A-5)
- ④ -WEATHERED ROCK- (META-GRANODIORITE)
- ⑤ -CRYSTALLINE ROCK- FRESH TO VERY SLIGHTLY WEATHERED, GRAY-WHITE, HARD TO MODERATELY HARD, (META-GRANODIORITE) WITH VERY CLOSE TO CLOSE FRACTURE SPACING AND WEAK FOLIATIONS

-L- EXISTING GROUND LINE ALONG END BENT 2 SKEW TAKEN FROM ROADWAY DESIGN PLANS PROVIDED BY NCDOT ON 1/22/22. INFERRED STRATIGRAPHY IS DRAWN THROUGH THE BORING WITH BOTH PROJECTED ONTO THE CROSS SECTION

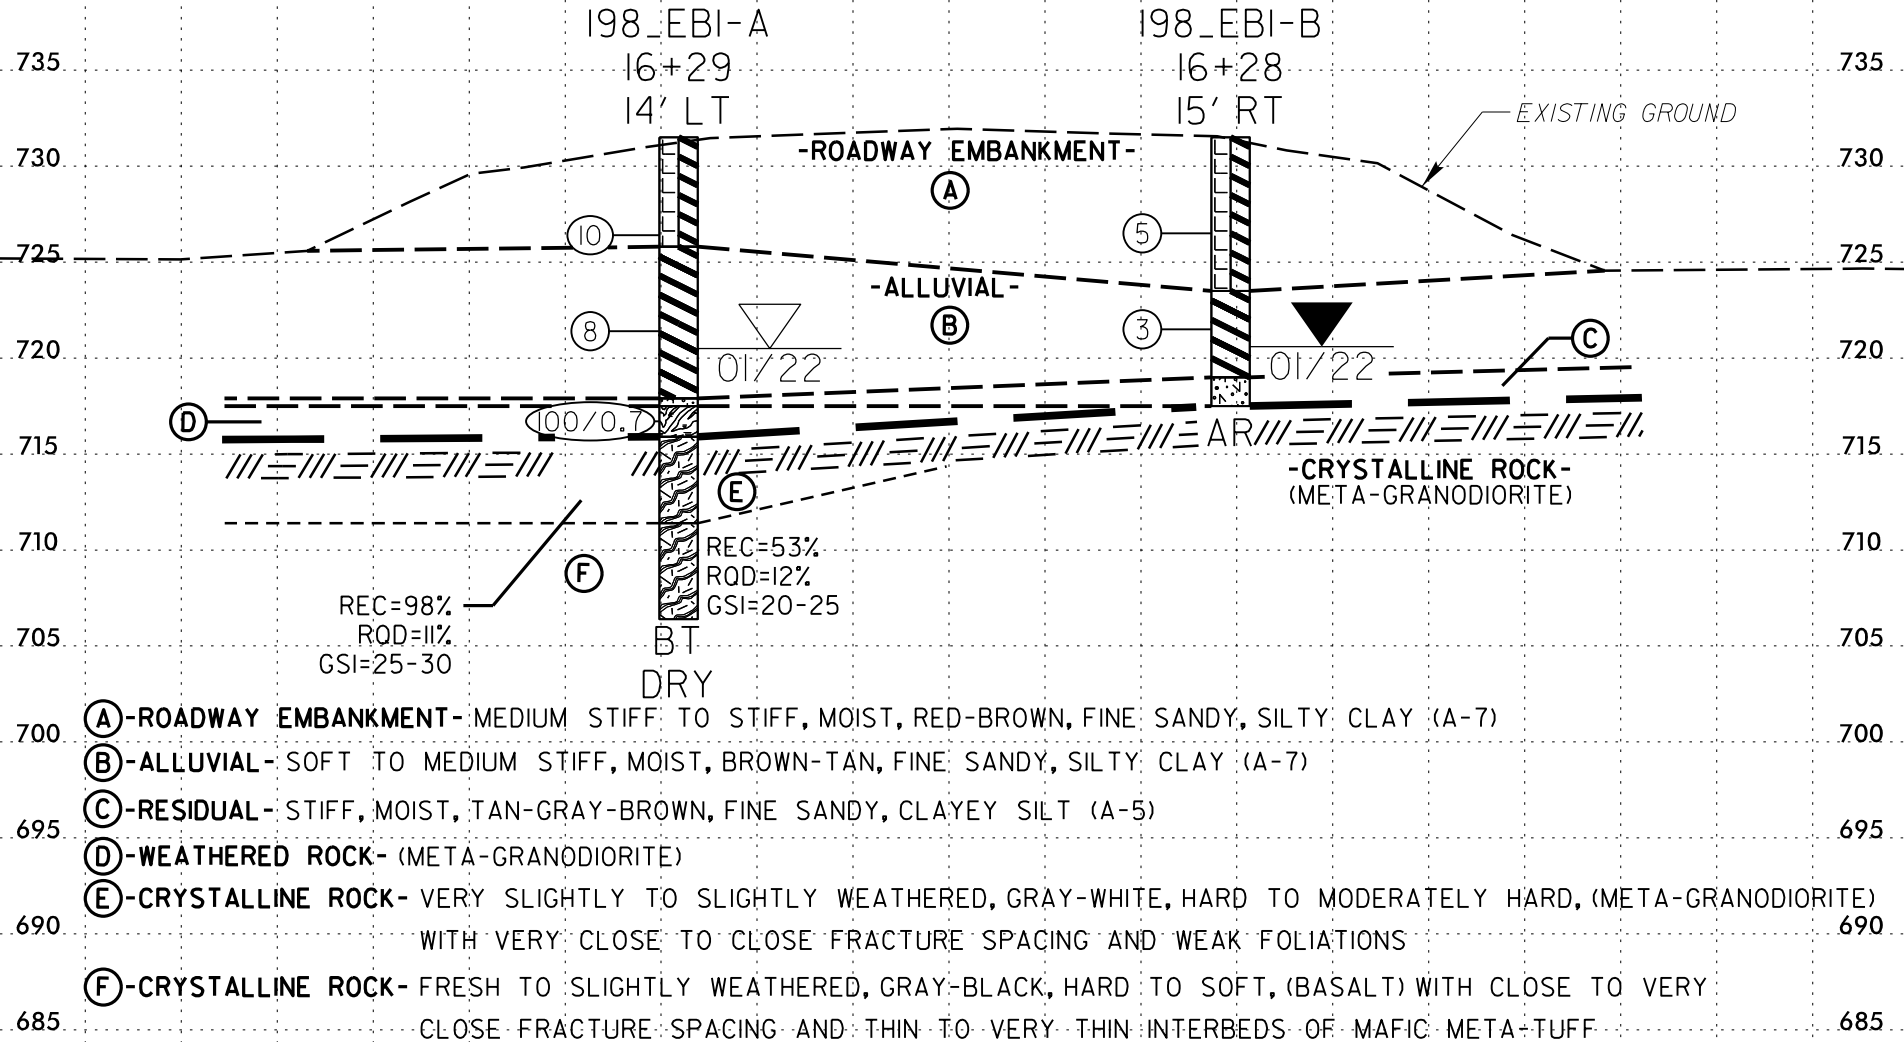
PROJECT REFERENCE NO.	SHEET NO.
17BP.9.R.85	7
REPLACE BRIDGE 198 ON SR 2529 (ST. PAUL CHURCH RD) OVER CRANE CREEK END BENT 1 SKEW = 90 DEGREES

-L- EXISTING GROUND LINE ALONG END BENT 1 SKEW TAKEN FROM ROADWAY DESIGN PLANS PROVIDED BY NCDOT ON 1/2/2022. INFERRED STRATIGRAPHY IS DRAWN THROUGH THE BORING WITH BOTH PROJECTED ONTO THE CROSS SECTION

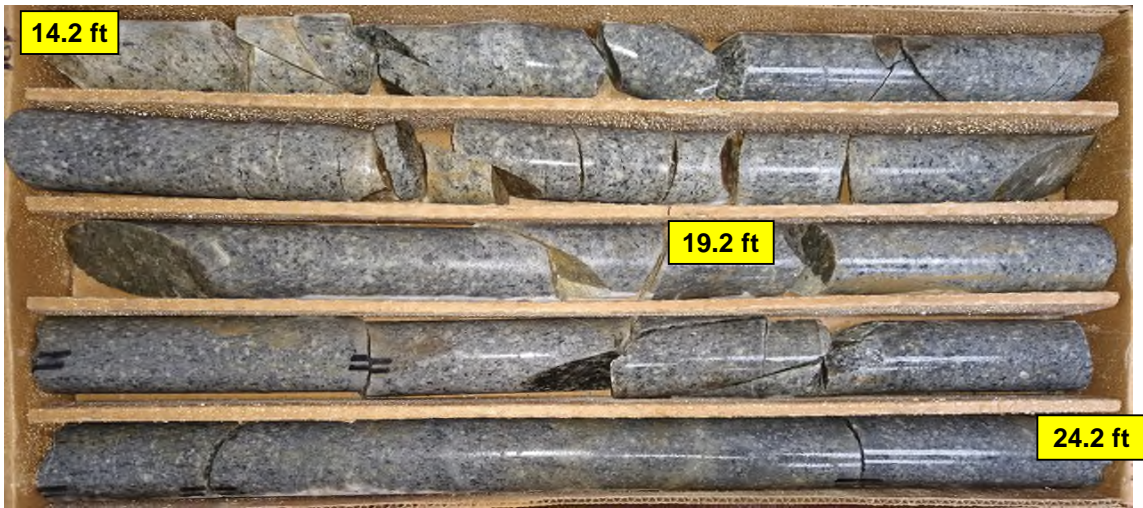
Bridge 199 on SR 2529 Over Crane Creek
Rock Core Photographs
Boring: EB1-A
Box 1: 14.2 to 24.2 Feet

717.4 CRYSTALLINE ROCK Fresh to Very Slightly Weathered, Gray-White, Hard to Moderately Hard, (Meta-Granodiorite) with very close fracture spacing to moderately close fracture spacing and weak foliations	14.2
710	712.4	19.2	5.0		(4.7) 94%	(4.1) 82%

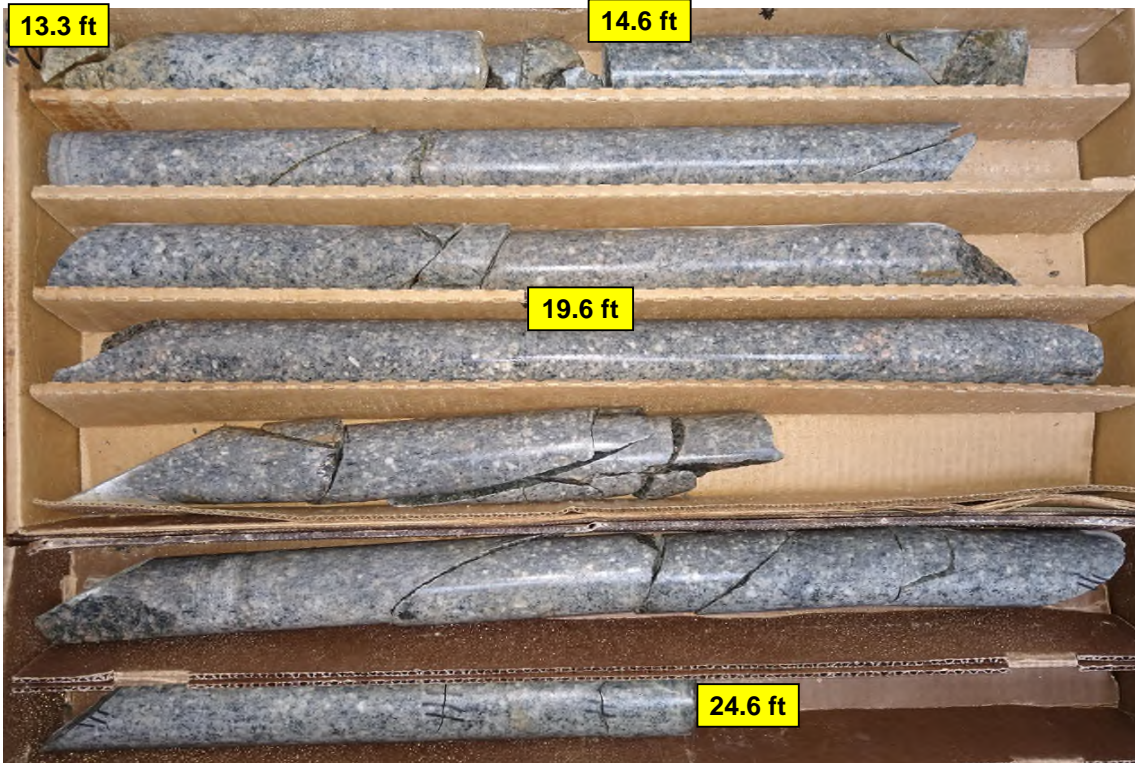
Bridge 199 on SR 2529 Over Crane Creek
Rock Core Photographs
Boring: EB2-B
Box 1: 13.3 to 24.6 Feet

718.0	13.3
					(5.0) 100%	(4.3) 86%					Fresh to Very Slightly Weathered, Gray-White, Hard to Moderately Hard, (META-GRANODIORITE) with very close fracture spacing to close fracture spacing and weak foliations	
710	711.7	19.6	5.0		(5.0) 100%	(4.5) 90%

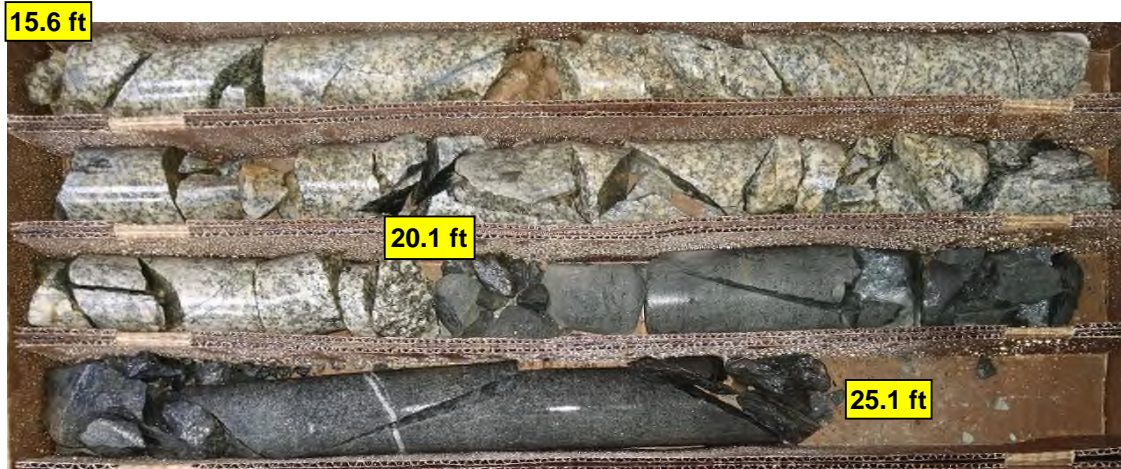
Bridge 198 on SR 2529 Over Crane Creek
Rock Core Photographs
Boring: EB1-A
Box 1: 15.6 to 25.1 Feet

715.91											Begin Coring @ 15.6 ft
715	715.9	15.6	4.5	09:03/0.5 03:29/1.0 03:45/1.0 07:51/1.0 03:15/1.0	(4.4) 98%	(0.5) 11%		(4.4) 98%	(0.5) 11%	715.9	CRYSTALLINE ROCK Very Slightly to Slightly Weathered, Gray-White, Hard to Moderately Hard, (META-GRANODIORITE) with very close to close fracture spacing and weak foliations

711.4	20.1								711.4	
710			5.0	05:55/1.0 03:27/1.0 04:52/1.0 06:42/1.0 05:49/1.0	(2.7) 53%	(0.6) 12%		(2.7) 53%	(0.6) 12%	710	Fresh to Slightly Weathered, Gray-Black, Hard to Soft, (BASALT) with close to very close fracture spacing and thin to very thin interbeds of mafic Meta-Tuff

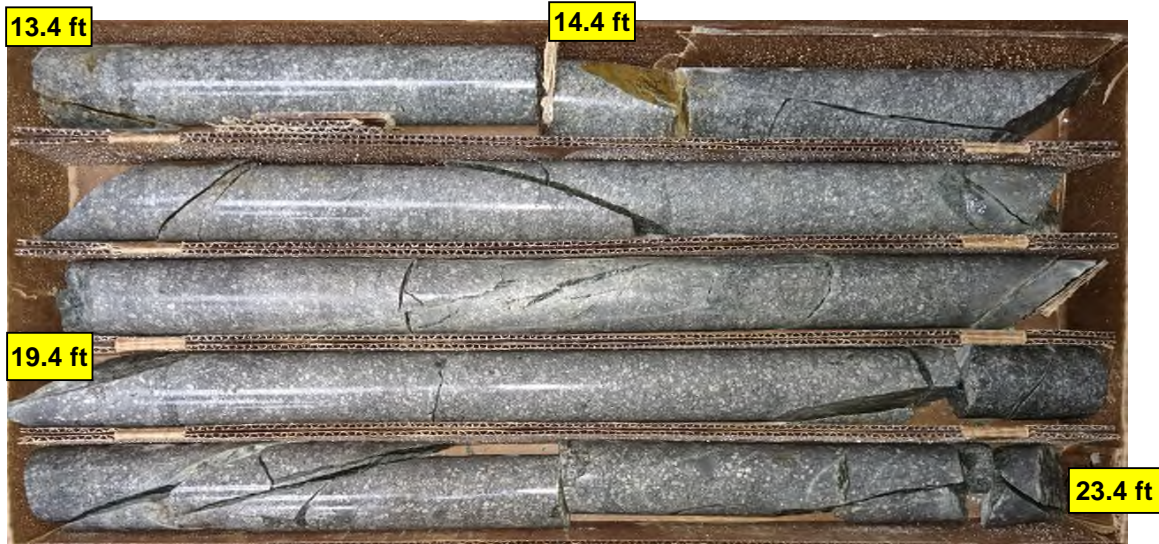
Bridge 198 on SR 2529 Over Crane Creek
Rock Core Photographs
Boring: EB2-B
Box 1: 13.4 to 23.4 Feet

718.4	
715	717.4	14.4	5.0	04:52/1.0 05:35/1.0 08:41/1.0	(4.8) 96%	(3.2) 64%					CRYSTALLINE ROCK Fresh to Very Slightly Weathered, Gray-White, Hard to Very Hard, (META-GRANODIORITE) with very close to close fracture spacing and weak foliations	13.4
