STATE OF NORTH CAROLINA
DEPARTMENT OF TRANSPORTATION
DIVISION OF HIGHWAYS
GEOTECHNICAL ENGINEERING UNIT

STRUCTURE
SUBSURFACE INVESTIGATION

COUNTY ROWAN
PROJECT DESCRIPTION BRIDGE NO. 235 OVER
BEAVER CREEK ON SR 1322 (EBENEZER RD.)

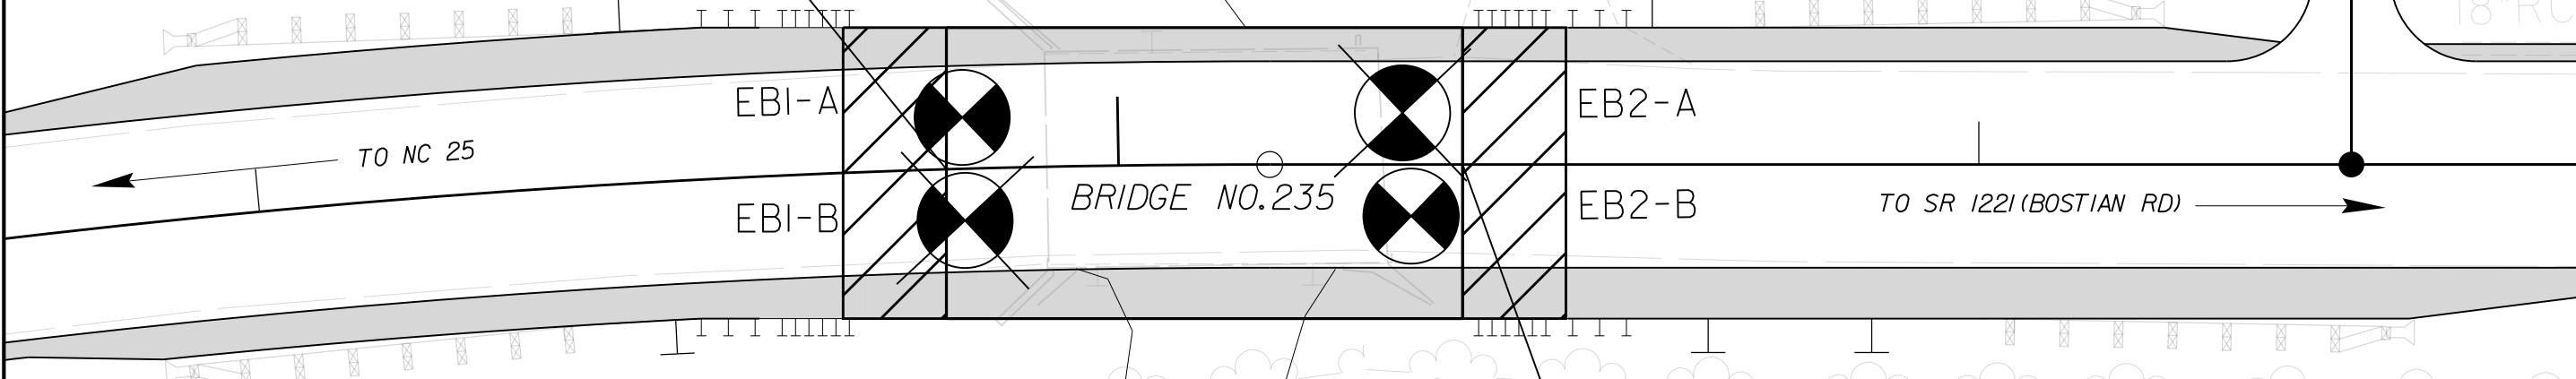
BRIDGE NO. 235

SKEW = 90°

BEGIN BRIDGE
-L- Sta. 14+79.99

END BRIDGE
-L- Sta. 15+40.00

BEAVER CREEK

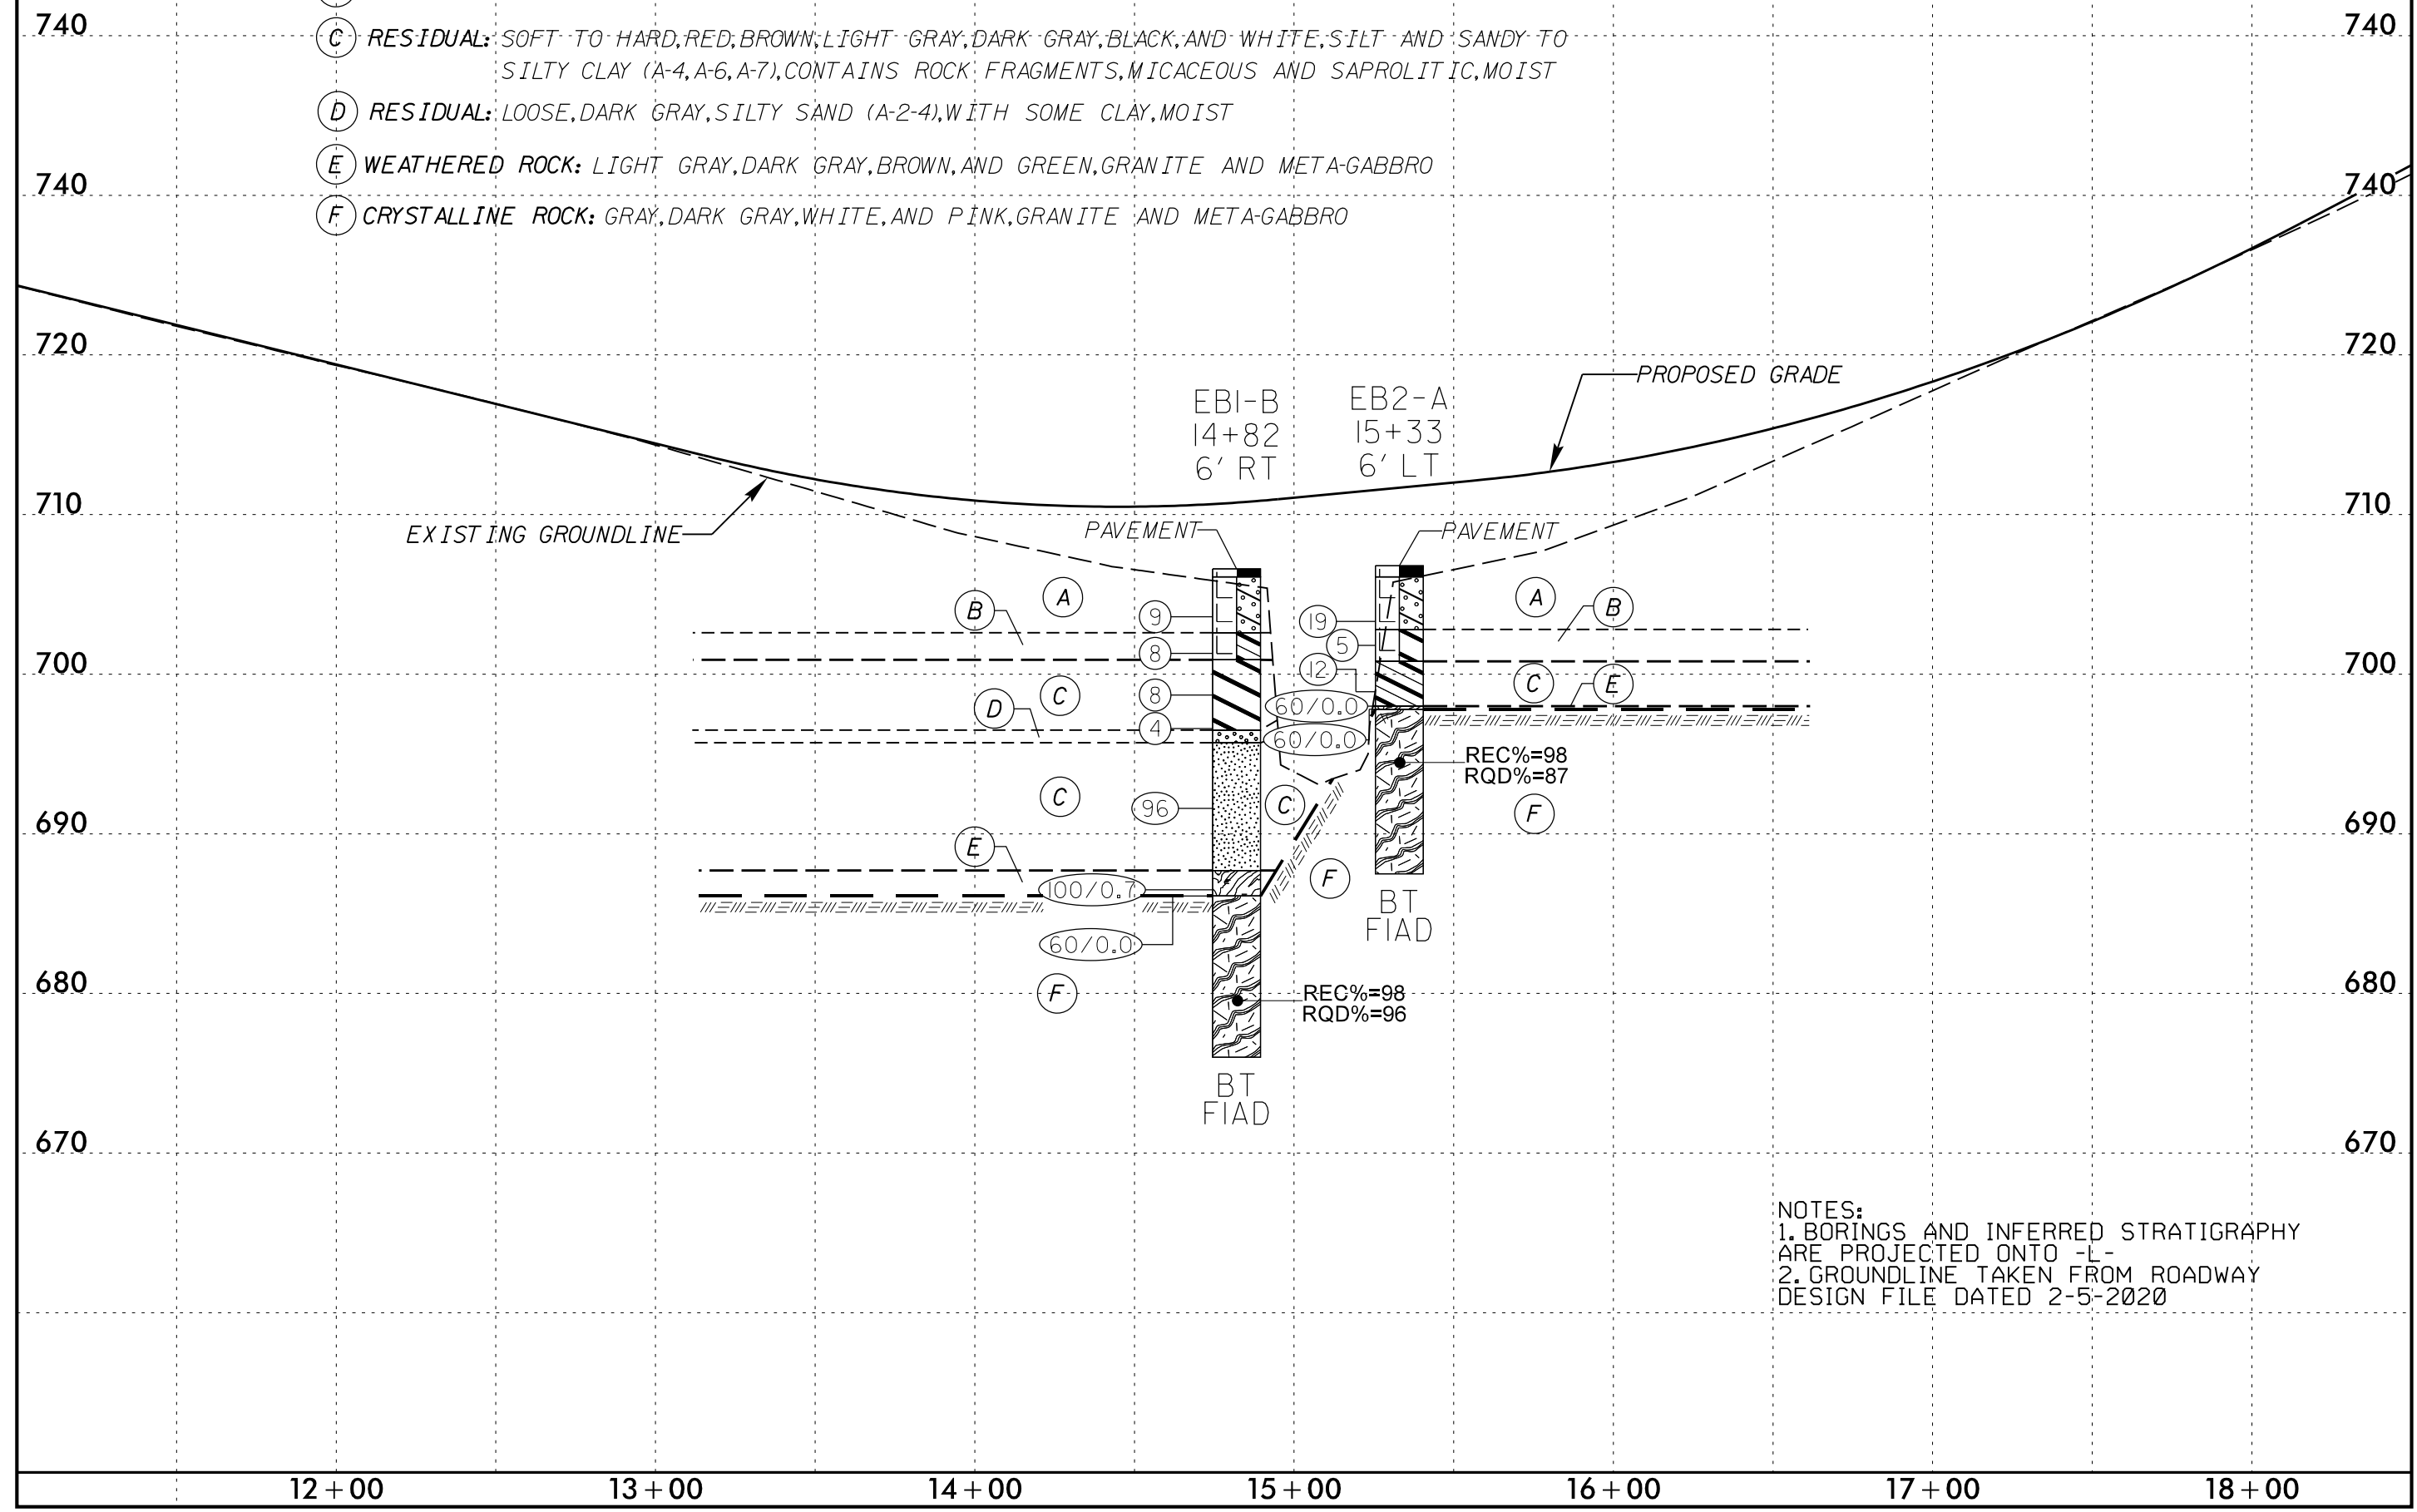
PROJECT REFERENCE NO.	SHEET NO.
SF-790235	4
PROFILE- BRIDGE NO. 235 BORING PROJECT ONTO -L-

- (A) ROADWAY EMBANKMENT: LOOSE TO MEDIUM DENSE, RED, BROWN, AND WHITE, CLAYEY SAND (A-2-6), CONTAINS GRAVEL, MOIST
- (B) ROADWAY EMBANKMENT: MEDIUM STIFF TO STIFF, RED, BROWN, AND WHITE, SANDY CLAY (A-6), MOIST
- (C) RESIDUAL: SOFT TO HARD, RED, BROWN, LIGHT GRAY, DARK GRAY, BLACK, AND WHITE, SILT AND SANDY TO SILTY CLAY (A-4, A-6, A-7), CONTAINS ROCK FRAGMENTS, MICACEOUS AND SAPROLITIC, MOIST
- (D) RESIDUAL: LOOSE, DARK GRAY, SILTY SAND (A-2-4), WITH SOME CLAY, MOIST
- (E) WEATHERED ROCK: LIGHT GRAY, DARK GRAY, BROWN, AND GREEN, GRANITE AND META-GABBRO
- (F) CRYSTALLINE ROCK: GRAY, DARK GRAY, WHITE, AND PINK, GRANITE AND META-GABBRO

NOTES:
 1. BORINGS AND INFERRED STRATIGRAPHY ARE PROJECTED ONTO -L-
 2. GROUNDLINE TAKEN FROM ROADWAY DESIGN FILE DATED 2-5-2020

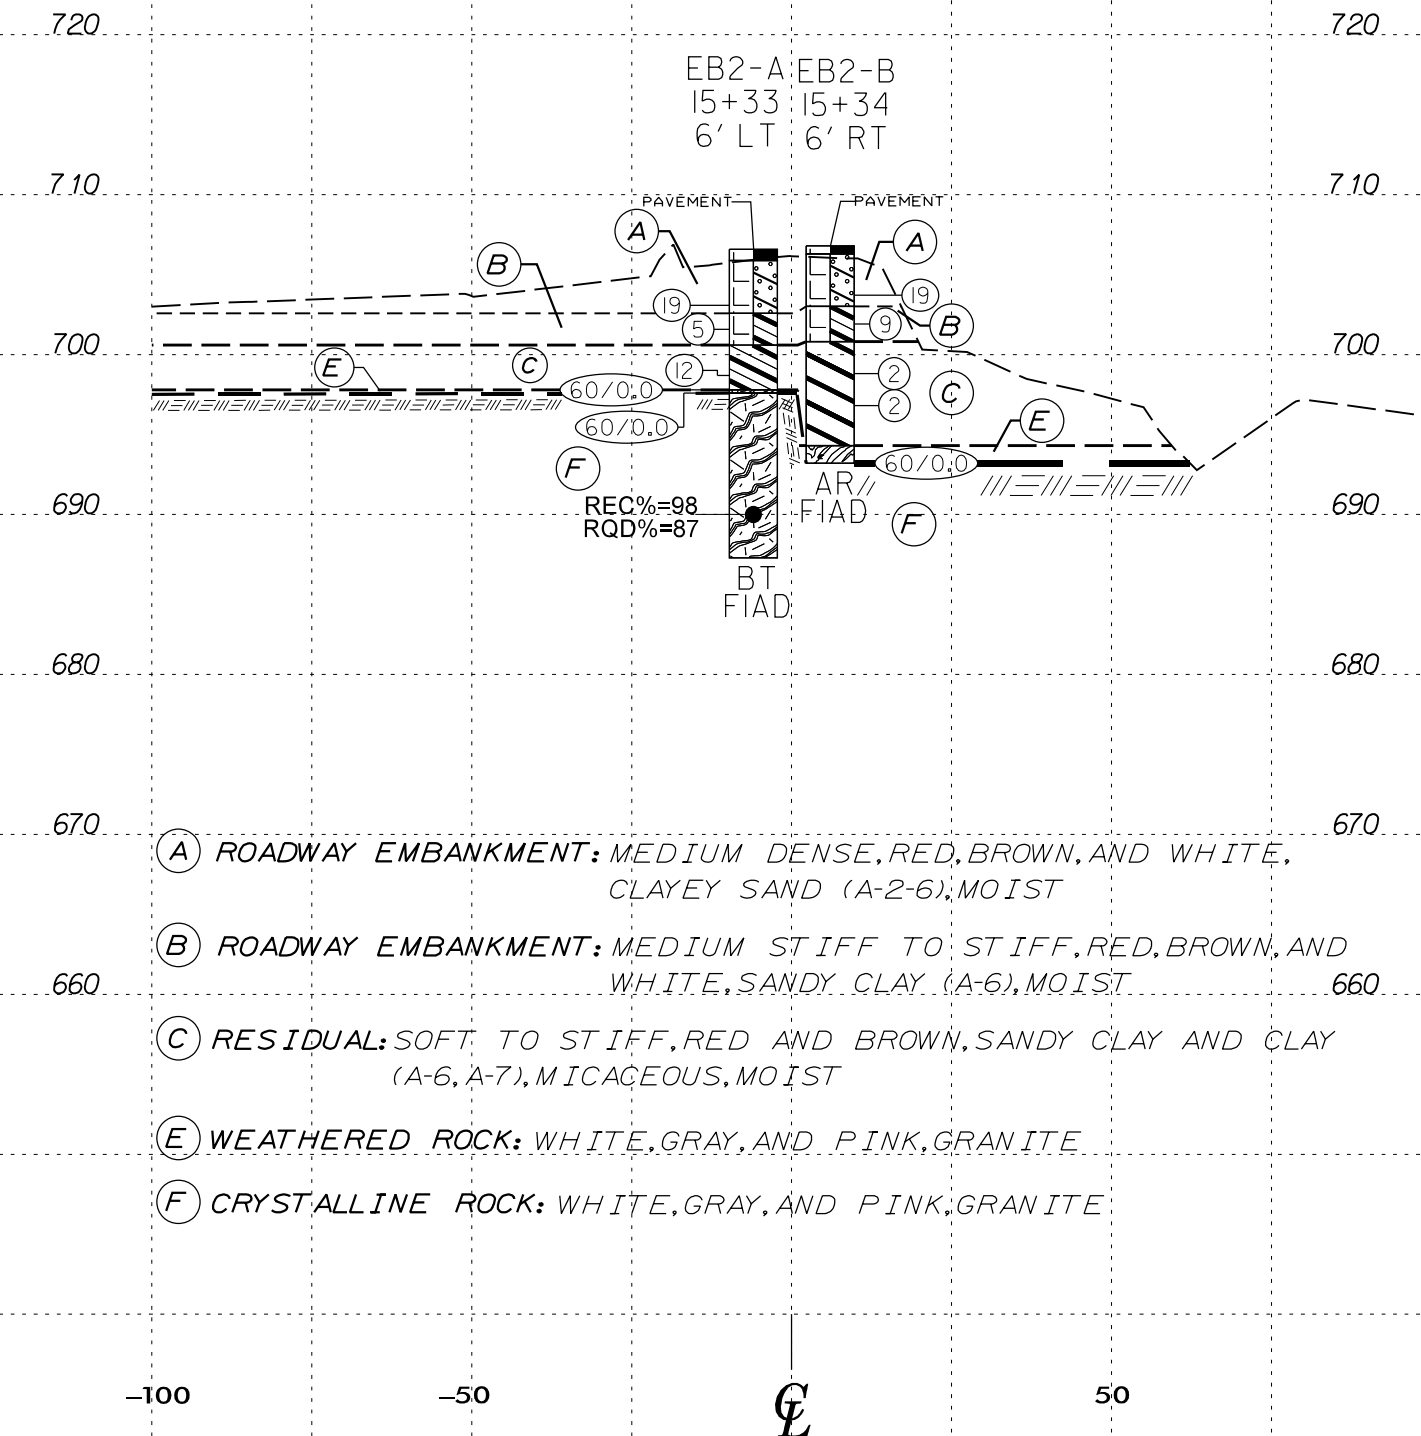
CROSS SECTION - END BENT 2
 -L- STA 15+40.29

- (A) ROADWAY EMBANKMENT: MEDIUM DENSE, RED, BROWN, AND WHITE, CLAYEY SAND (A-2-6), MOIST
- (B) ROADWAY EMBANKMENT: MEDIUM STIFF TO STIFF, RED, BROWN, AND WHITE, SANDY CLAY (A-6), MOIST
- (C) RESIDUAL: SOFT TO STIFF, RED AND BROWN, SANDY CLAY AND CLAY (A-6, A-7), MICACEOUS, MOIST
- (E) WEATHERED ROCK: WHITE, GRAY, AND PINK, GRANITE
- (F) CRYSTALLINE ROCK: WHITE, GRAY, AND PINK, GRANITE

HORIZ. SCALE 0 30 60 (FEET) VE = 2.5

NOTES:
 1. BORINGS AND INFERRED STRATIGRAPHY ARE PROJECTED ONTO THE SECTIONS
 2. GROUNDLINE TAKEN FROM ROADWAY DESIGN FILE DATED 2-5-2020. SKEW=90°

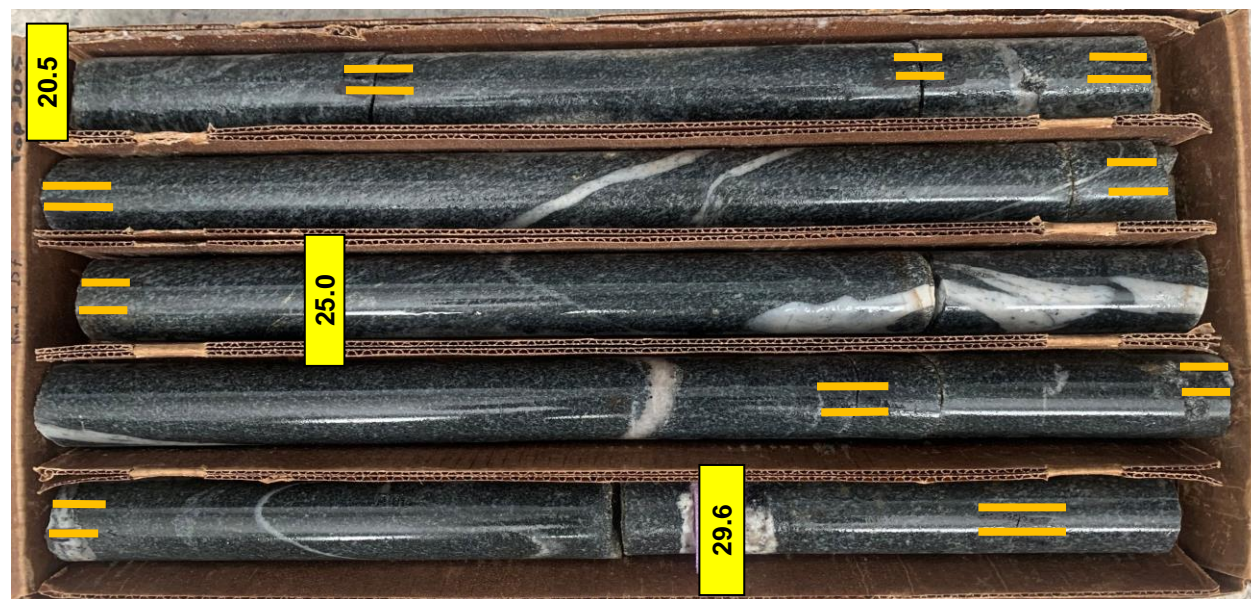
CORE PHOTOGRAPHIC RECORD
SF-790235
BRIDGE NO. 235 OVER BEAVER CREEK ON SR 1322
EB1-B
BOX 1 of 1: 20.5 - 30.6 FEET

ELEV (ft)	RUN ELEV (ft)	DEPTH (ft)	RUN (ft)	DRILL RATE (Min/ft)	TOTAL RUN		SAMP. NO.	STRATA		LOG	DESCRIPTION AND REMARKS
					REC. (%)	RQD (%)		REC. (%)	RQD (%)		
686.08											Begin Coring @ 20.5 ft
685	686.1	20.5	4.5	9:32 8:34 10:39 9:09	(4.3) 96%	(4.2) 93%					CRISTALLINE ROCK META-GABBRO, DARK GRAY AND WHITE, VERY SLIGHT WEATHERING, HARD TO VERY HARD, QUARTZ AND FELDSPAR HEALED JOINTS, CONTAINS PYRITE INFILLED FRACTURES
680	681.6	25.0	4.6	7:20/0.5 10:18 17:20 15:50 19:20	(4.6) 100%	(4.5) 98%					GSI: 75-85
	677.0	29.6	1.0	9:25/0.6	(1.0) 100%	(1.0) 100%					
	676.0	30.6		24:12							Boring Terminated at Elevation 676.0 ft in CRISTALLINE ROCK (META-GABBRO)

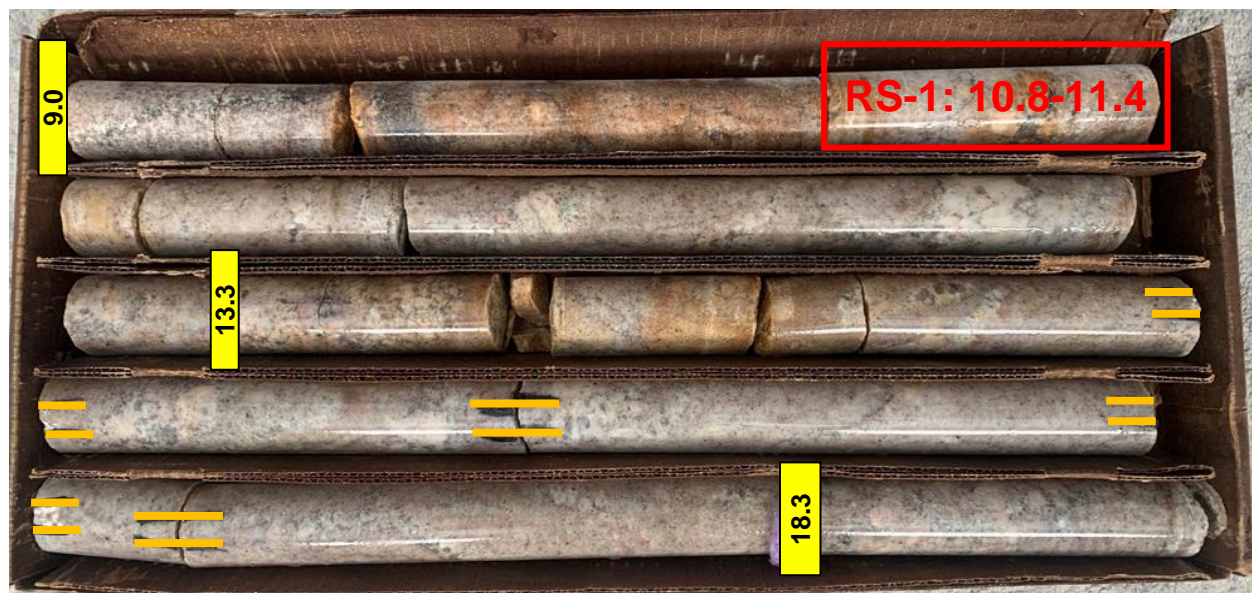
CORE PHOTOGRAPHIC RECORD
SF-790235
BRIDGE NO. 235 OVER BEAVER CREEK ON SR 1322
EB2-A
BOX 1 of 1: 9.0 - 19.3 ft

ELEV (ft)	RUN ELEV (ft)	DEPTH (ft)	RUN (ft)	DRILL RATE (Min/ft)	TOTAL RUN		SAMP. NO.	STRATA		LOG	DESCRIPTION AND REMARKS
					REC. (%)	RQD (%)		REC. (%)	RQD (%)		
697.81											Continued from previous page
695	697.8	9.0	4.3	4:29 3:19 6:38 4:34	(4.3) 100%	(3.5) 81%					CRISTALLINE ROCK GRANITE, WHITE, GRAY, AND PINK, SLIGHT WEATHERING, CLOSE TO MODERATELY CLOSE FRACTURING, IRON STAINED INFILLED FRACTURES
	693.5	13.3	5.0	1:03/0.3 4:30 5:31 6:54 5:24	(4.8) 96%	(4.5) 90%					RS-1: 10.8'-11.4 GSI= 65-75
690	688.5	18.3	1.0	8:45	(1.0) 100%	(1.0) 100%					Boring Terminated at Elevation 687.5 ft in CRISTALLINE ROCK (GRANITE)

ROCK TEST RESULTS												
BORING	SAMPLE NO.	STATION	OFFSET	DEPTH INTERVAL (ft)	LENGTH (in.)	DIAMETER (in.)	AREA (sq. in.)	VOLUME		UNIT WEIGHT (pcf)	COMPRESSIVE	TESTING METHOD
								(in. ³)	(cf)		STRENGTH (psi)	
EB2-A	RS-01	15+33	6FT LT	10.8-11.4	4.4	1.98	2.74	12.06	0.00698	160	5640	ASTM D-7012-10 METHOD C

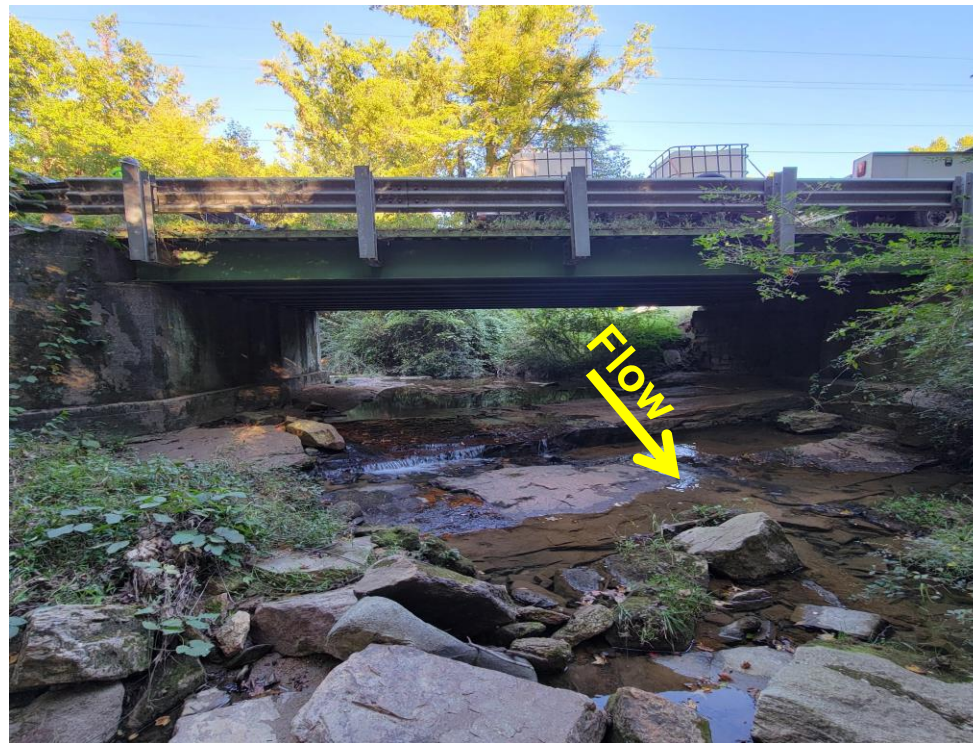
View of Bridge 235 over Beaver Creek looking northwest.

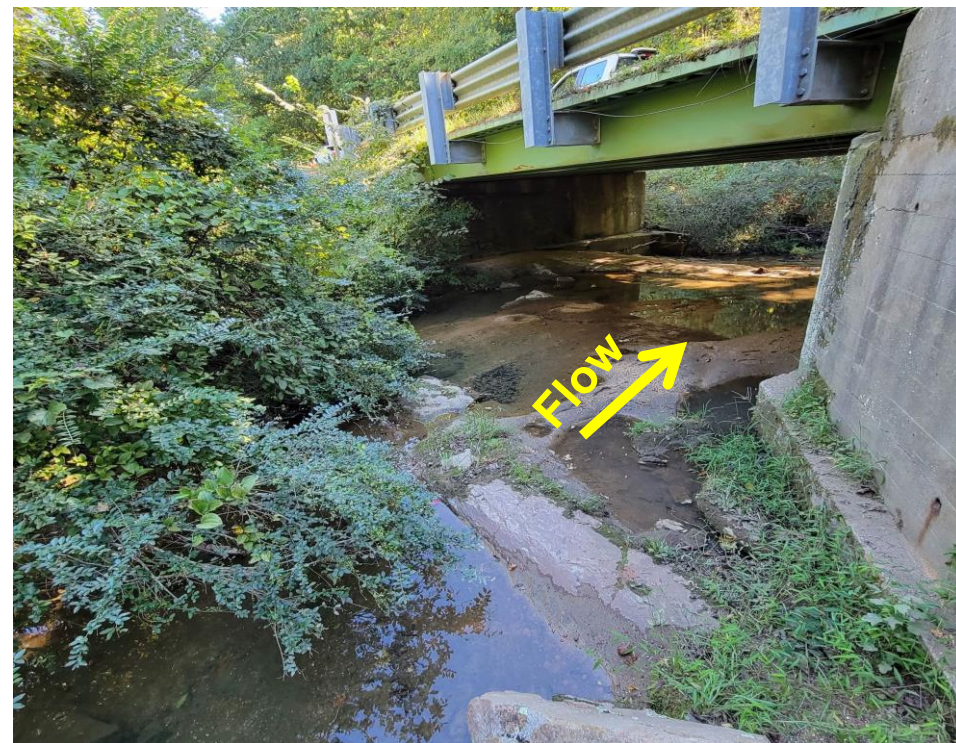
View of Bridge 235 over Beaver Creek looking east.
