ROADWAY  
SUBSURFACE INVESTIGATION

PROJECT DESCRIPTION REPLACE BRIDGE NO. 71 ON  
SR 1168 (JOHNSTOWN ROAD) OVER INDIAN CREEK

PROJECT: B-5853

STATE PROJECT: 45806.1.1 (B-5853)  
 COUNTY: Lincoln  
 DESCRIPTION: Bridge No. 71 on SR 1168 over Indian Creek  
 SUBJECT: Geotechnical Report – Inventory

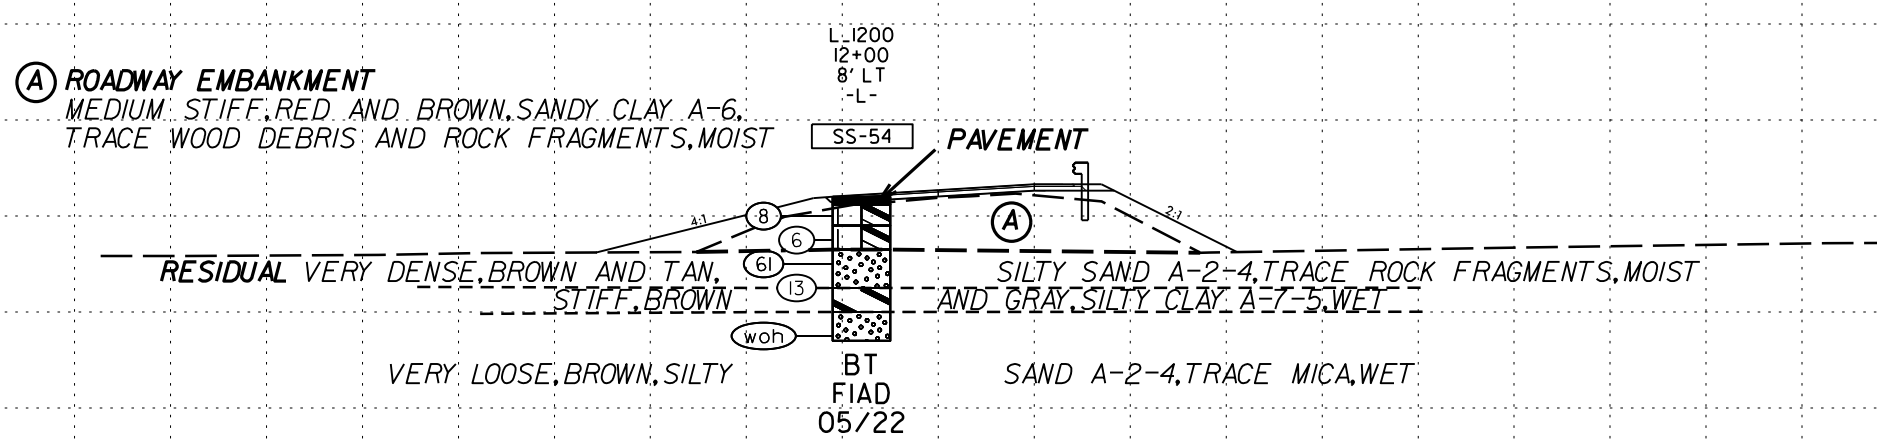
12 + 00.00

SOIL TEST RESULTS															
SAMPLE NO.	OFFSET	STATION	DEPTH INTERVAL	AASHTO CLASS.	L.L.	P.I.	% BY WEIGHT				% PASSING (SIEVES)			% MOISTURE	% ORGANIC
							C.SAND	F.SAND	SILT	CLAY	10	40	200		
SS-54	8' LT	12+00	1.0-2.5	A-6 (7)	39	16	20	25	13	42	99	86	59.5	32.1	ND

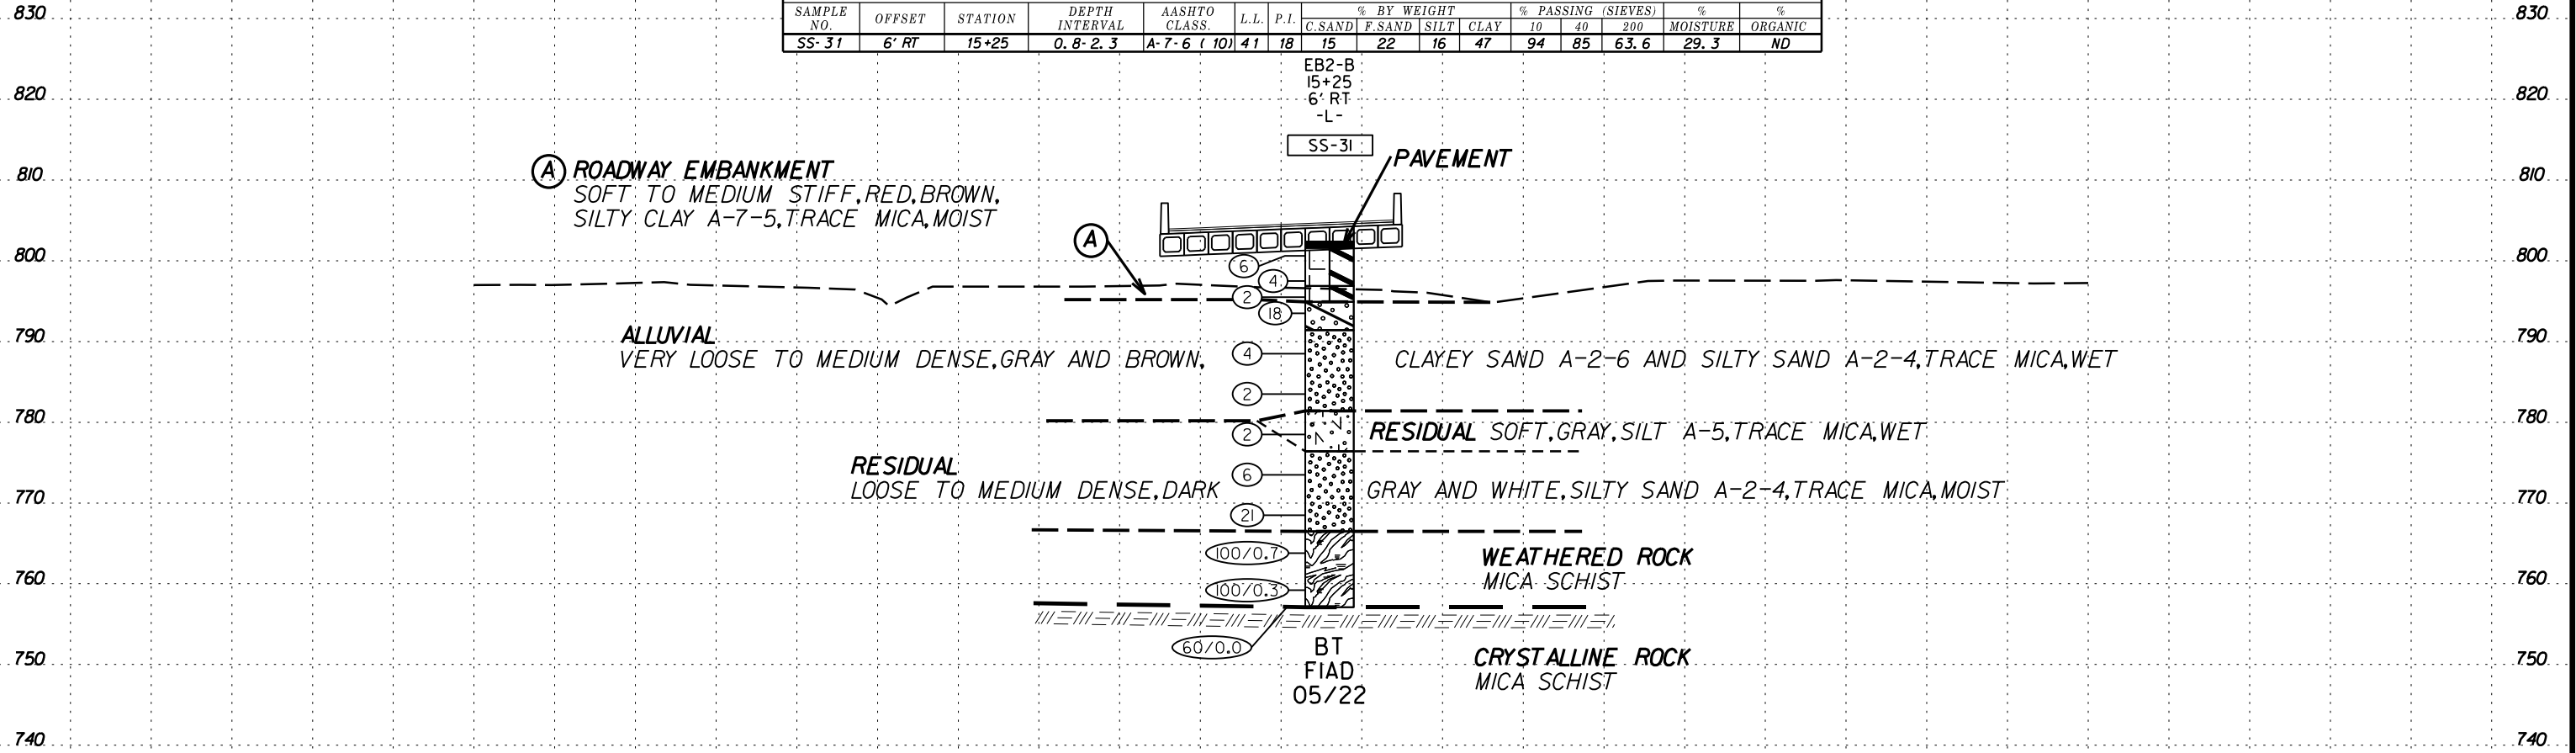
15 + 00.00

SOIL TEST RESULTS															
SAMPLE NO.	OFFSET	STATION	DEPTH INTERVAL	AASHTO CLASS.	L.L.	P.I.	% BY WEIGHT				% PASSING (SIEVES)			% MOISTURE	% ORGANIC
							C. SAND	F. SAND	SILT	CLAY	10	40	200		
SS-31	6' RT	15+25	0.8-2.3	A-7-6 (10)	41	18	15	22	16	47	94	85	63.6	29.3	ND

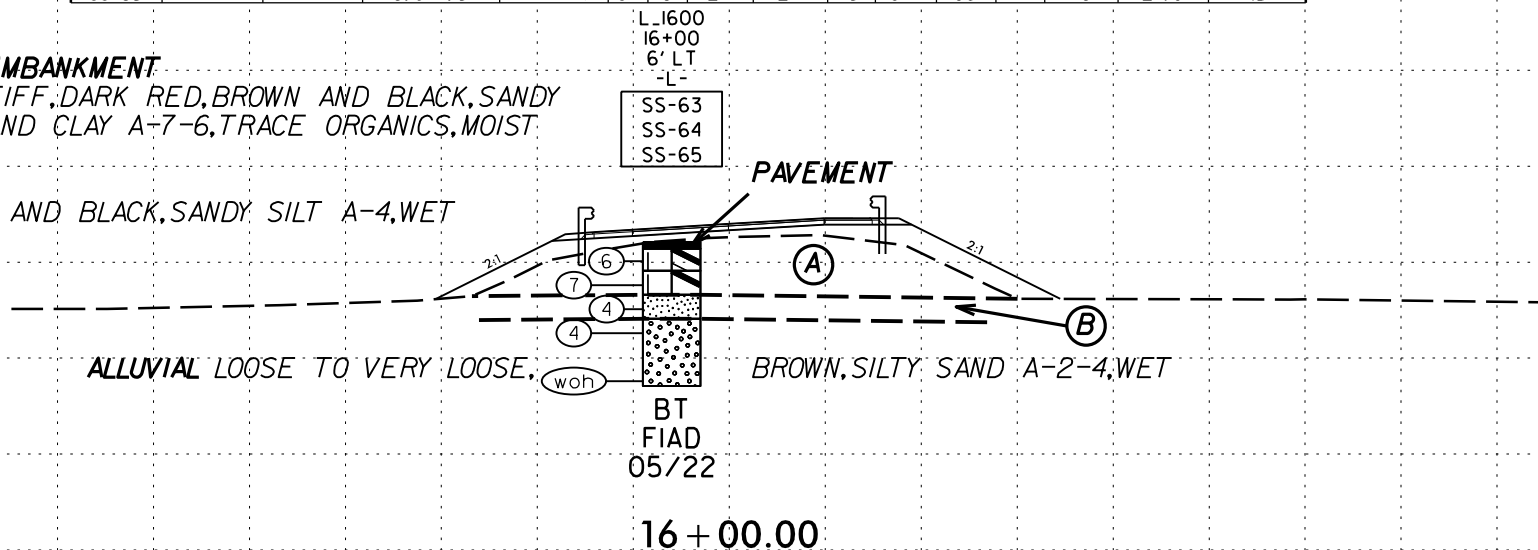
SOIL TEST RESULTS															
SAMPLE NO.	OFFSET	STATION	DEPTH INTERVAL	AASHTO CLASS.	L.L.	P.I.	% BY WEIGHT				% PASSING (SIEVES)			MOISTURE	ORGANIC
							C.SAND	F.SAND	SILT	CLAY	10	40	200		
SS-63	6' LT	16+00	1.0-1.5	A-6 (6)	35	13	17	21	24	38	92	82	60.6	21.7	0.4
SS-64	6' LT	16+00	3.5-5.0	A-7-6 (10)	41	19	16	24	16	44	98	88	62.9	49.9	ND
SS-65	6' LT	16+00	6.0-7.5	A-4 (1)	34	6	27	27	15	31	90	74	46	24.9	ND

(A) ROADWAY EMBANKMENT  
 MEDIUM STIFF, DARK RED, BROWN AND BLACK, SANDY CLAY A-6, AND CLAY A-7-6, TRACE ORGANICS, MOIST.

(B) ALLUVIAL  
 SOFT, GRAY AND BLACK, SANDY SILT A-4, WET

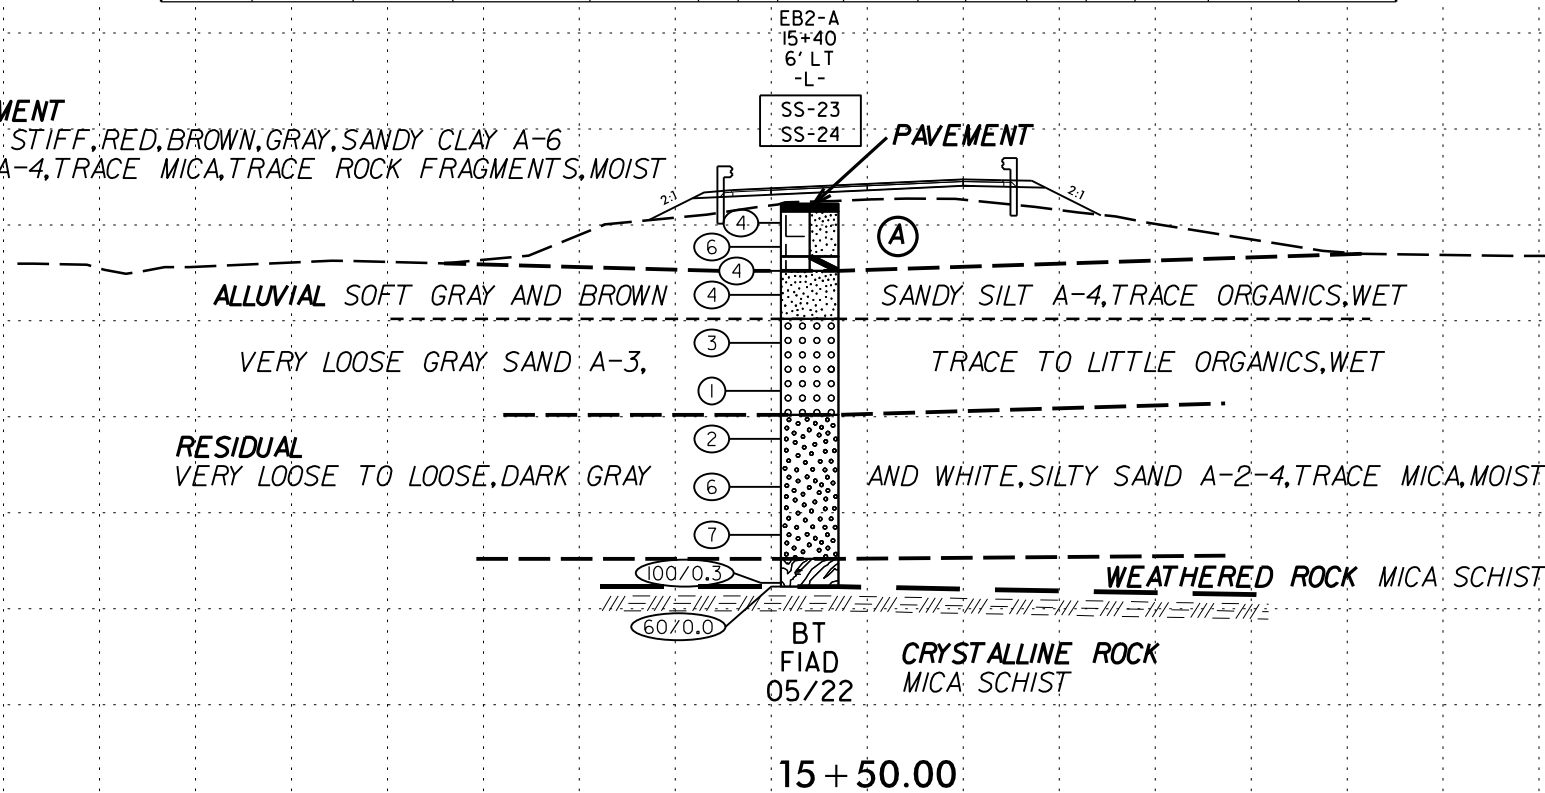
SOIL TEST RESULTS															
SAMPLE NO.	OFFSET	STATION	DEPTH INTERVAL	AASHTO CLASS.	L.L.	P.I.	% BY WEIGHT				% PASSING (SIEVES)			MOISTURE	ORGANIC
							C.SAND	F.SAND	SILT	CLAY	10	40	200		
SS-23	6' LT	15+40	8.5-10	A-4 (0)	26	6	38	29	11	22	97	70	35.9	23.5	ND
SS-24	6' LT	15+40	13.5-15.0	A-3 (1)	NP	NP	74	20	1	5	99	55	7.4	32.3	ND

(A) ROADWAY EMBANKMENT  
 SOFT TO MEDIUM STIFF, RED, BROWN, GRAY, SANDY CLAY A-6 AND SANDY SILT A-4, TRACE MICA, TRACE ROCK FRAGMENTS, MOIST.
