# STRUCTURE BULLETIN

## NCDOT Construction Unit

### Current Issue: Bridge Drainage

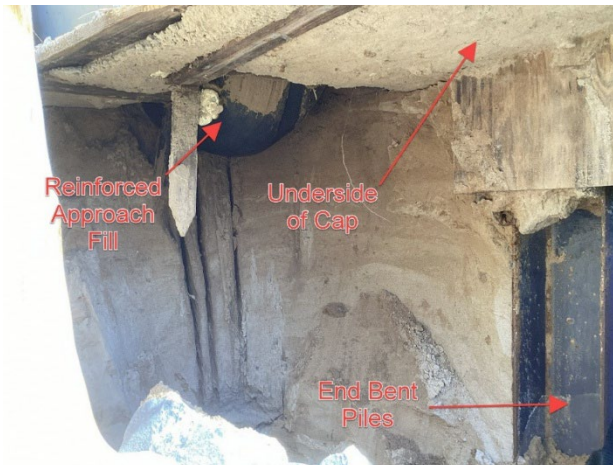
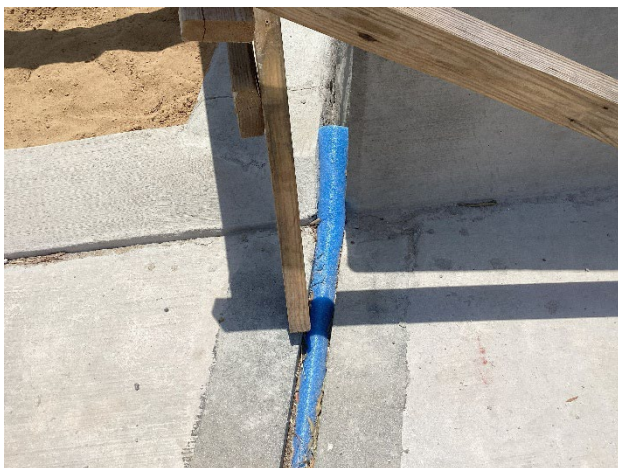
In this picture, water ran through the open expansion joint onto the end bent cap, which then ran under the cap eroding away a lot of carefully compacted fill. The repair will never be as good as the original construction.

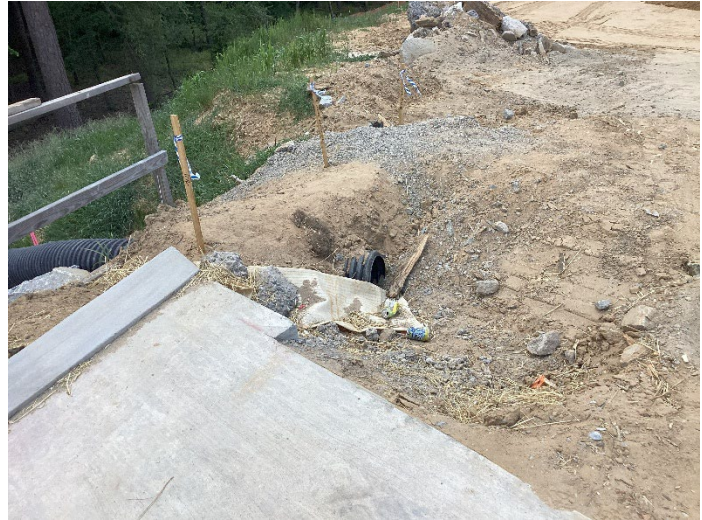
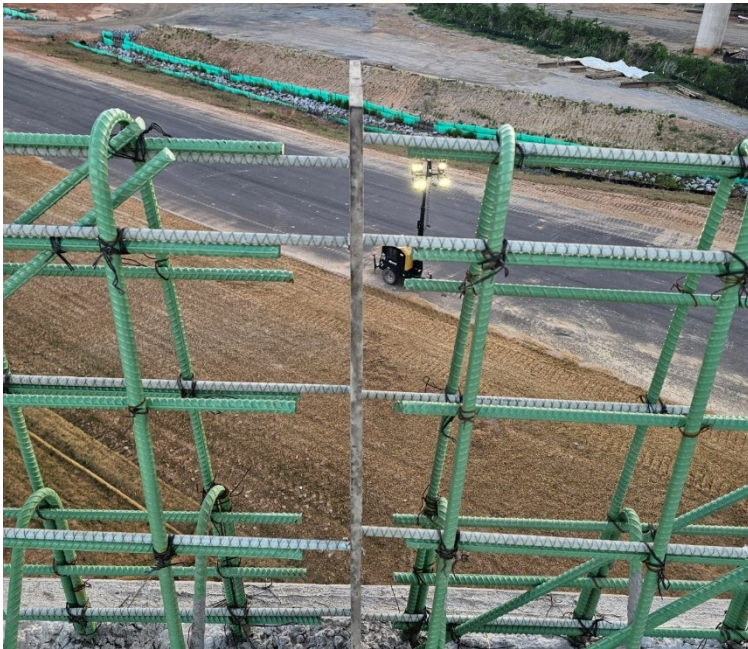
Another common location of drainage issues is at the end of the approach slab. Contractors should divert the runoff to a nearby drainage box, or use a temporary slope drain. If slope drains are used, make sure they are properly constructed and kept clear of debris. If these slope drains fail, it can lead to undermining of the approach slab and end bent cap. Additionally, always make sure water draining down the grade is diverted prior to the bridge.
