# Responding to Emergencies - Together

## NCDOT Emergency Projects

- I-40 Rockslide
- Division 14
- October 2009

- NC 12 Nor'easter
- Division 1
- November 2009

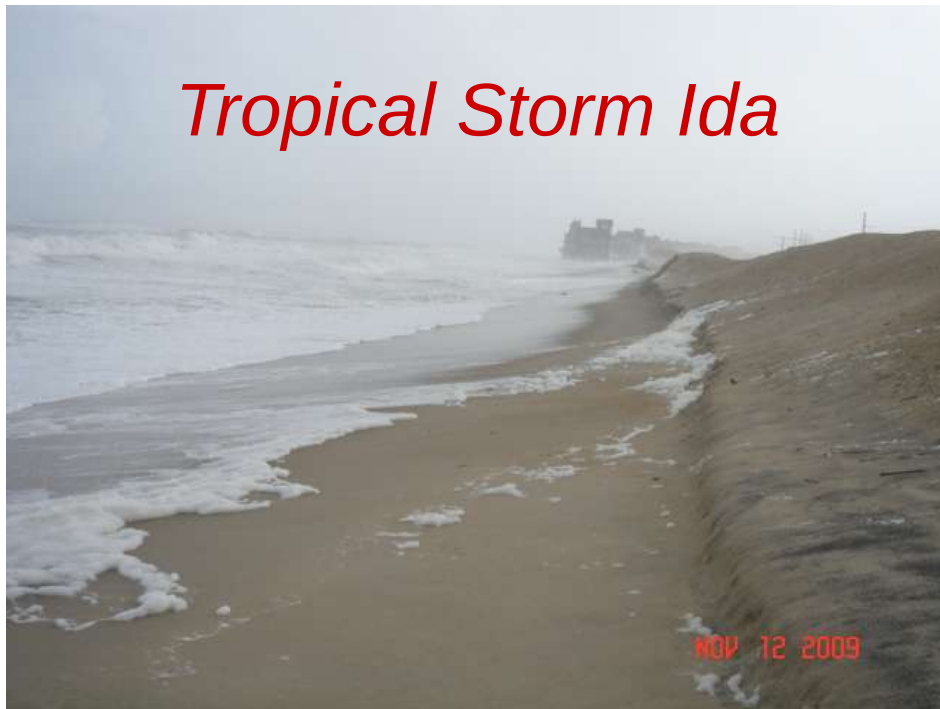
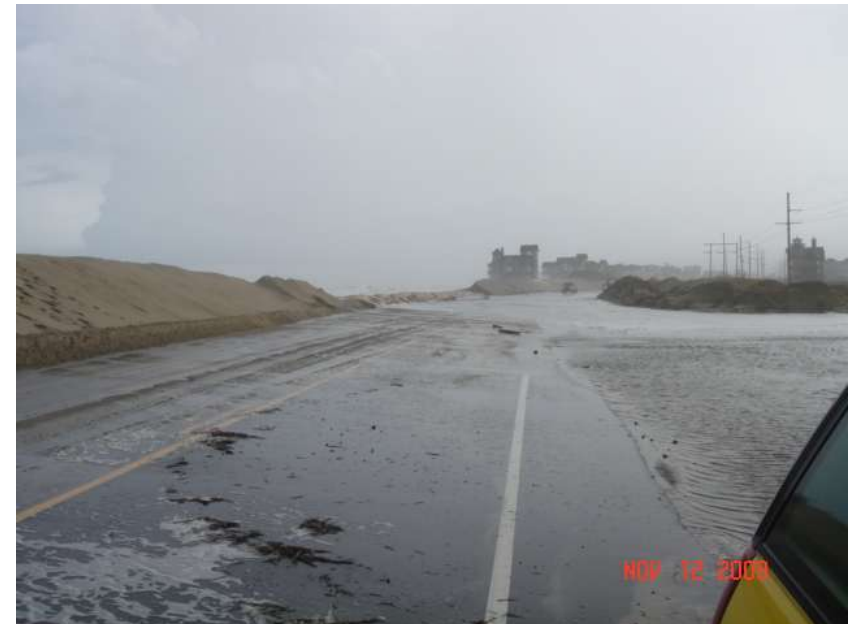
## First day of storm on Nov. 12, 2009

\* Damage to dunes and flooding on NC 12 \*

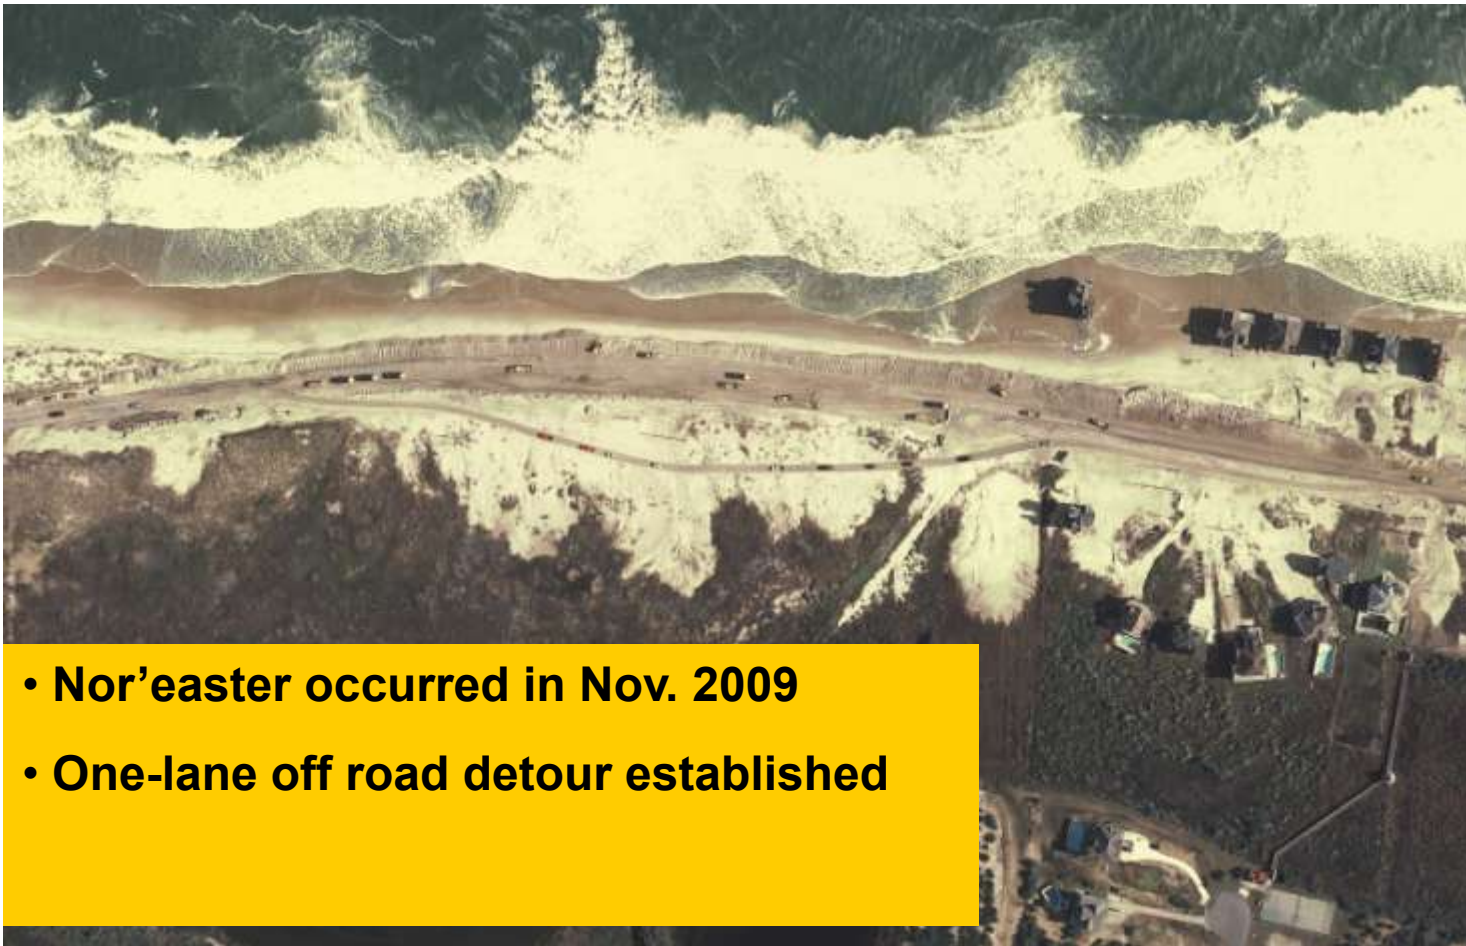
## NC 12 Aerial view w/ One-lane detour

- Nor'easter occurred in Nov. 2009
- One-lane off road detour established

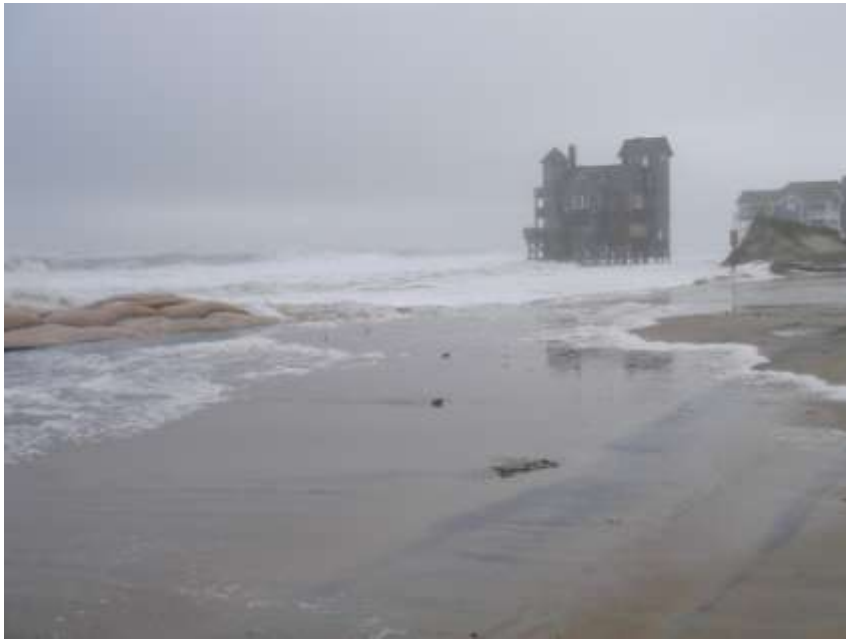
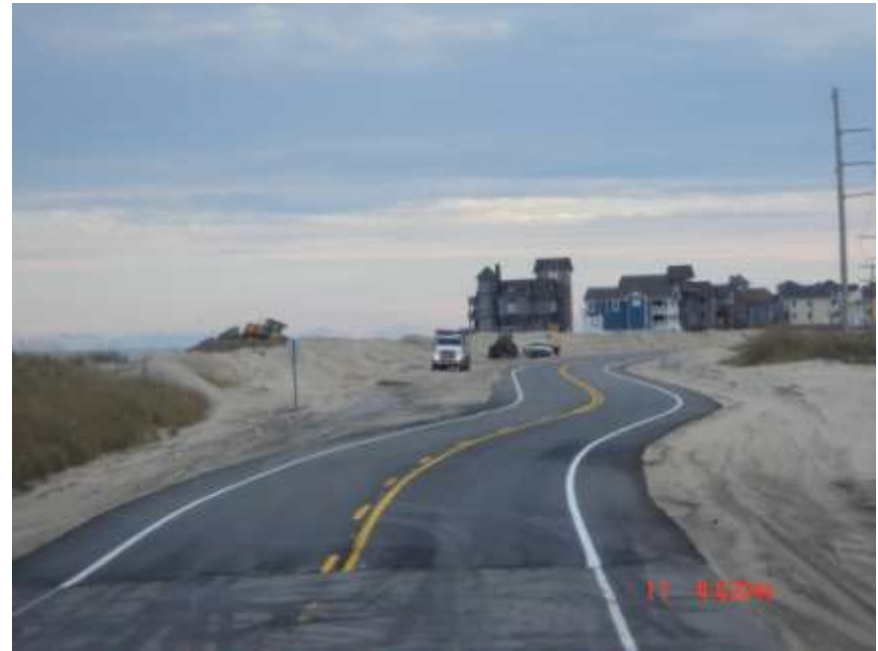
## NC 12 – Final roadway shifted 16 ft west

November 12, 2009

December 11, 2009

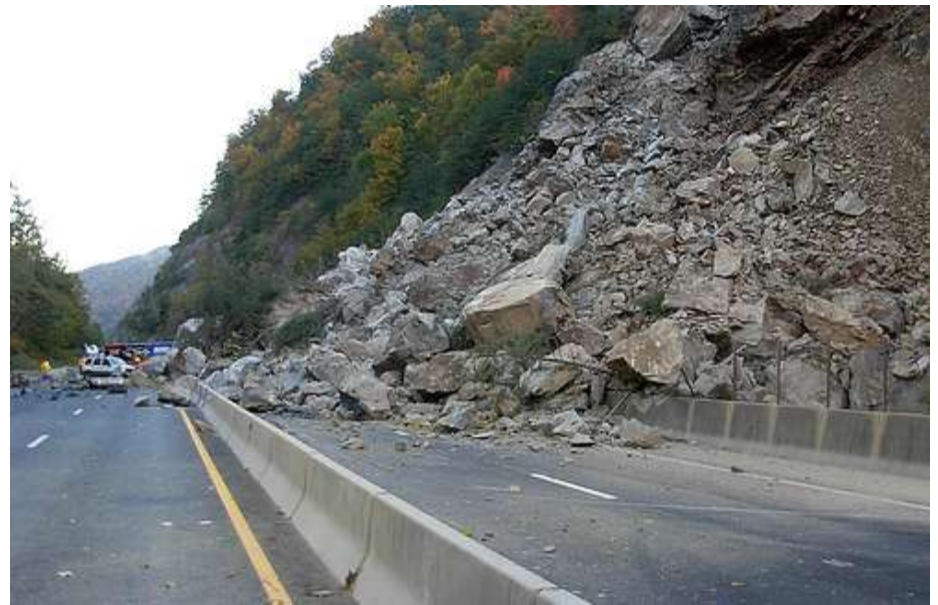
- Removed rocks will be reused to build a ramp for access
