**AN EVALUATION OF
NORTH CAROLINA DEPARTMENT OF TRANSPORTATION
WETLAND MITIGATION SITES: SELECTED CASE STUDIES**

Phase 2 Report

March 2002

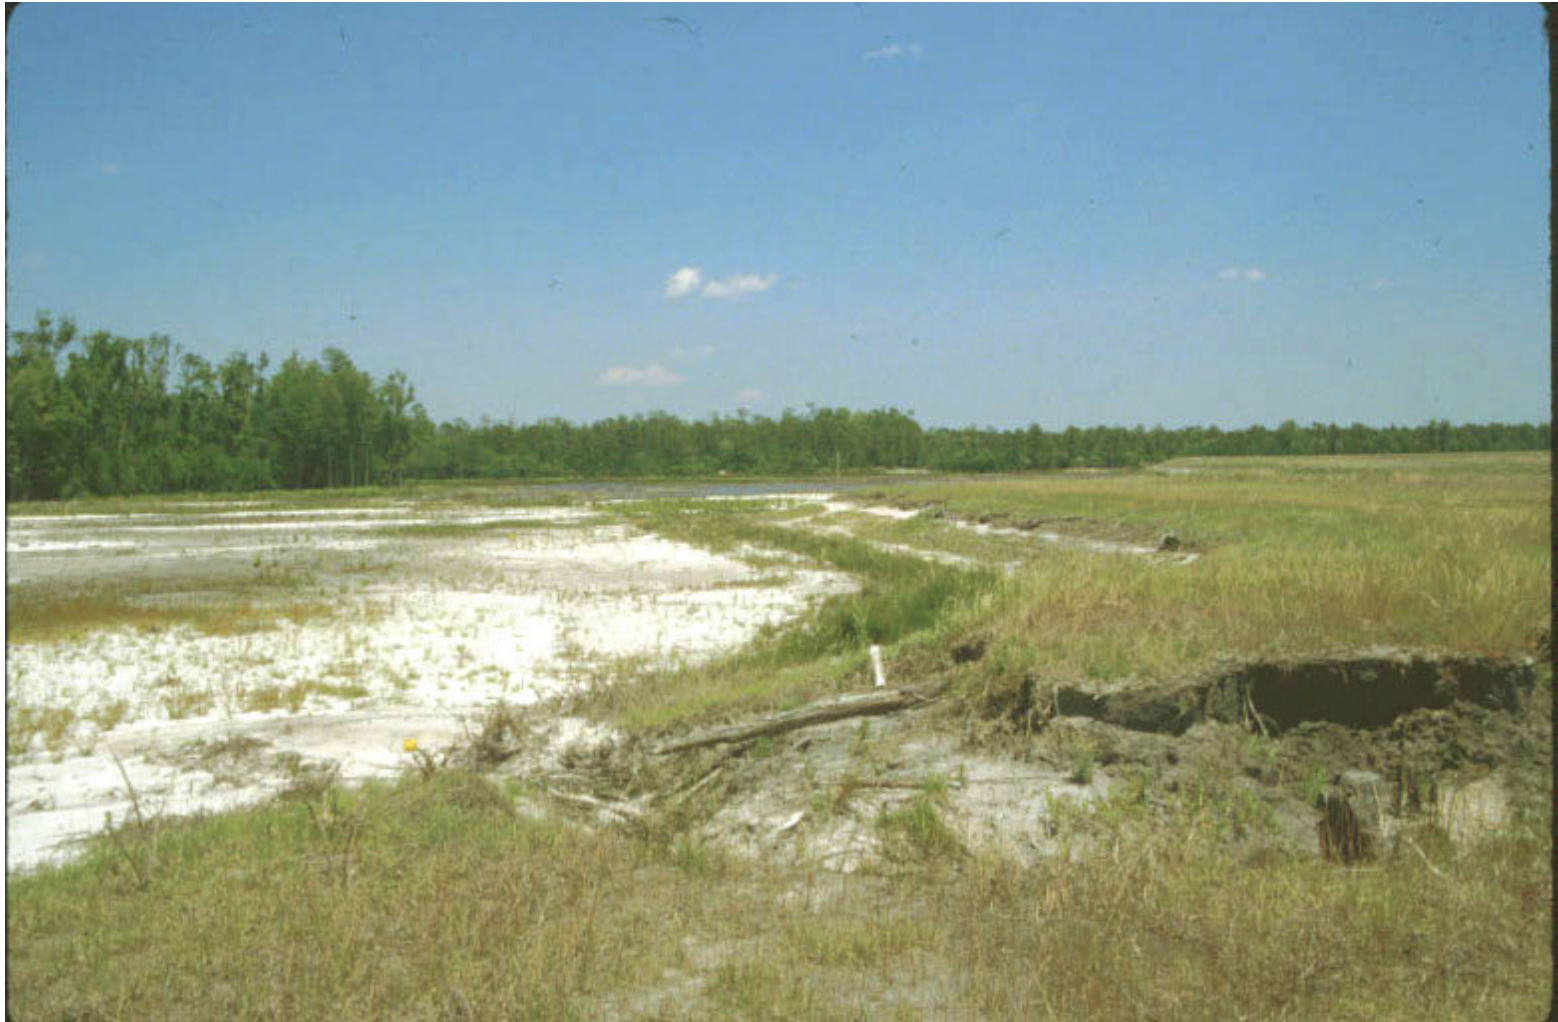
Figure 2. Edge of excavated area designed to restore a riverine swamp forest (May 2000). Note sandy, organic poor substrate in swamp “restoration” area.

At the edge of the excavated area, the land surface dropped sharply: approximately 2 m (6 feet) from the surface of the wet flat to the bottom of the excavation. Surface and groundwater no longer flow gradually to the floodplain of Sandy Run; instead overland flow down the steep embankment caused severe erosion (Fig. 2). Also, groundwater discharges along the edge of the excavation, further destabilizing the slope-face. Most of the slope face has now been stabilized (Dave Schiller, pers. comm.); one area requires further remediation.

Several studies have found that created wetlands differ from unaltered reference wetlands in soil characteristics such as pH, bulk density, and total nitrogen (Bishel-Machung et al. 1996). Cole et al. (2001) found that soil organic matter in created wetlands was only 10-50% of that found in nearby reference wetlands. Soil organic matter content is particularly important in wetlands in that under anoxic conditions soil microbes use organic matter (and its reduced forms) as an energy source for nitrate reduction and denitrification. At Haws Run, organic matter content in the "restored" swamp was only 36% of that in the adjacent forest.

The attempt to create additional swamp forest by excavating earth from the swamp/flat ecotone might not have occurred had soil standards been in place because amendments of sufficient organic matter might have proven too costly to justify. In any case, performance standards based only on survival of planted vegetation and hydrologic regime miss the importance function of soil condition in the integrity of wetlands. Thus, soil standards would not only be useful for evaluating the success of restoration projects, but would also likely discourage certain types of compensatory mitigation from being proposed in the first place.

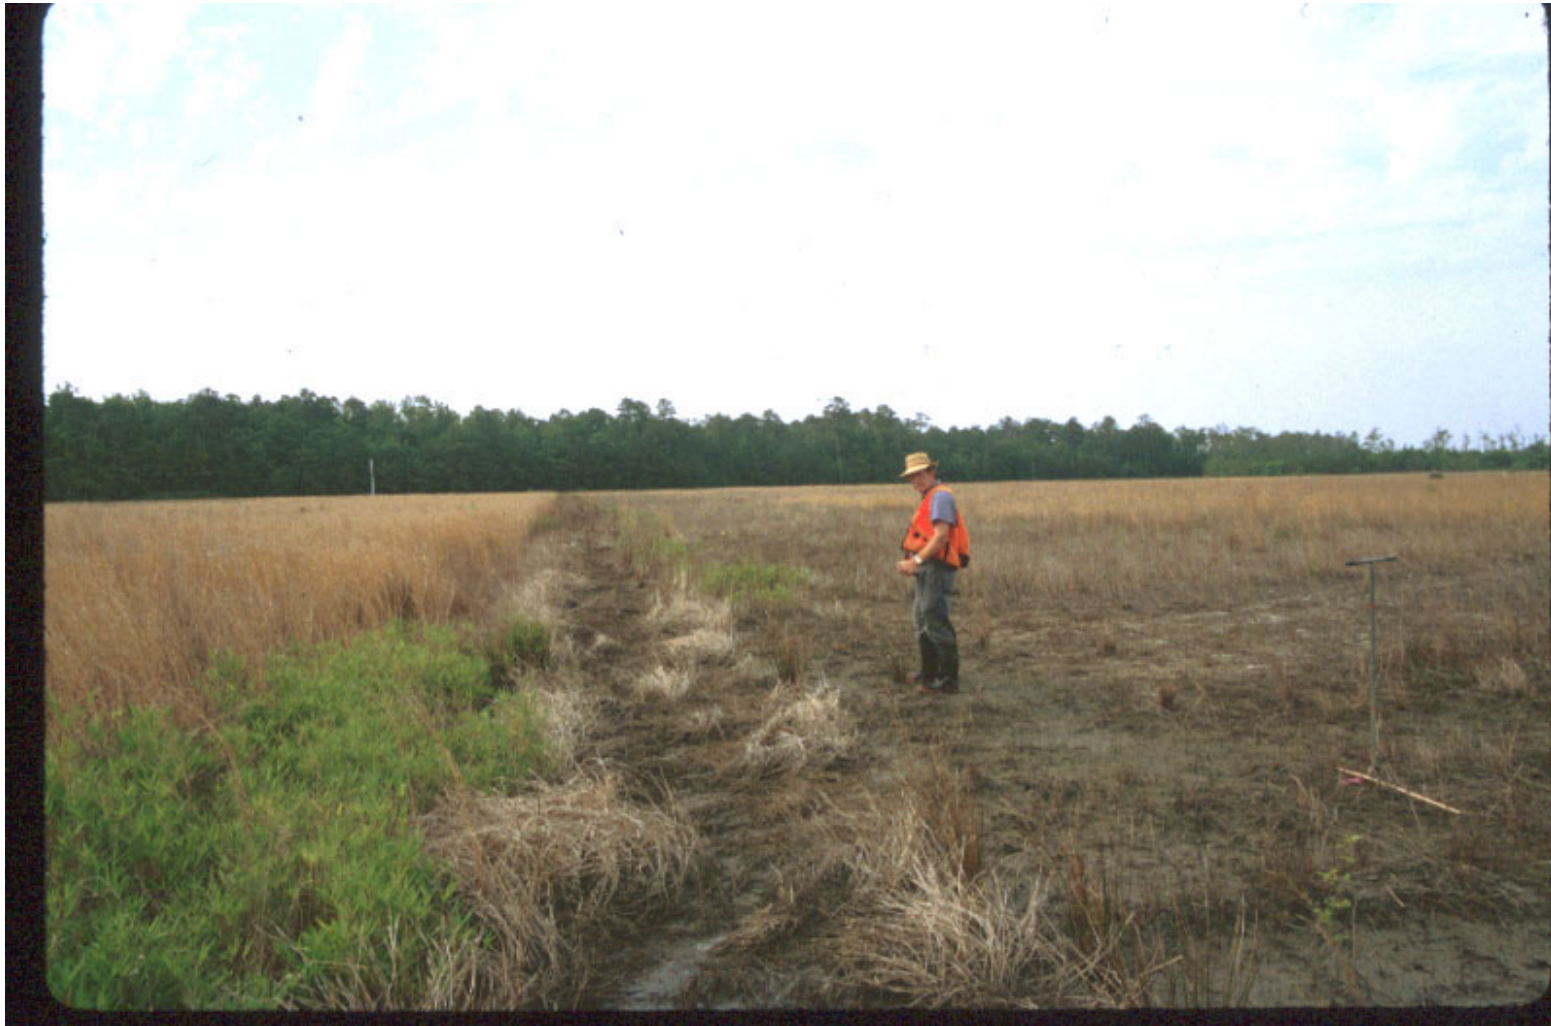
Figure 7. Vegetative growth in scraped and unscraped areas at Ballance Farm

In excavating soil to create the marsh, hundreds of truckloads of material were transported from one end of the site to the other. This traffic caused considerable soil compaction in some areas. In addition, when the planted marsh vegetation failed to survive the first year, many truckloads of plants were driven across the restoration area, causing further soil compaction along the access road and leaving deep ruts in wetter areas. These compacted areas will likely eventually recover, but initial tree survival in these areas will probably be lower than in the rest of the mitigation area. Compacted soils also reduce infiltration, groundwater movement, and subsurface water storage.

Field ditches in the interfluvial flats were filled using material scraped from adjacent, inter-ditch areas. (It seemed that both NCDOT and regulatory agencies hoped that lowering the elevation of inter-ditch areas would increase the likelihood of making the site wetter.) Even native old-field species appeared to be less dense and less vigorous in the scraped area than in the unscraped areas (Fig. 7). The reduced density of old-field species was probably a consequence of the seed bank being removed during scraping; the lack of vigor of those plants indicates lower soil fertility. The survival of planted trees was also lower in most scraped areas (Table 13), further suggesting reduced fertility. Neither scraped nor unscraped areas had an

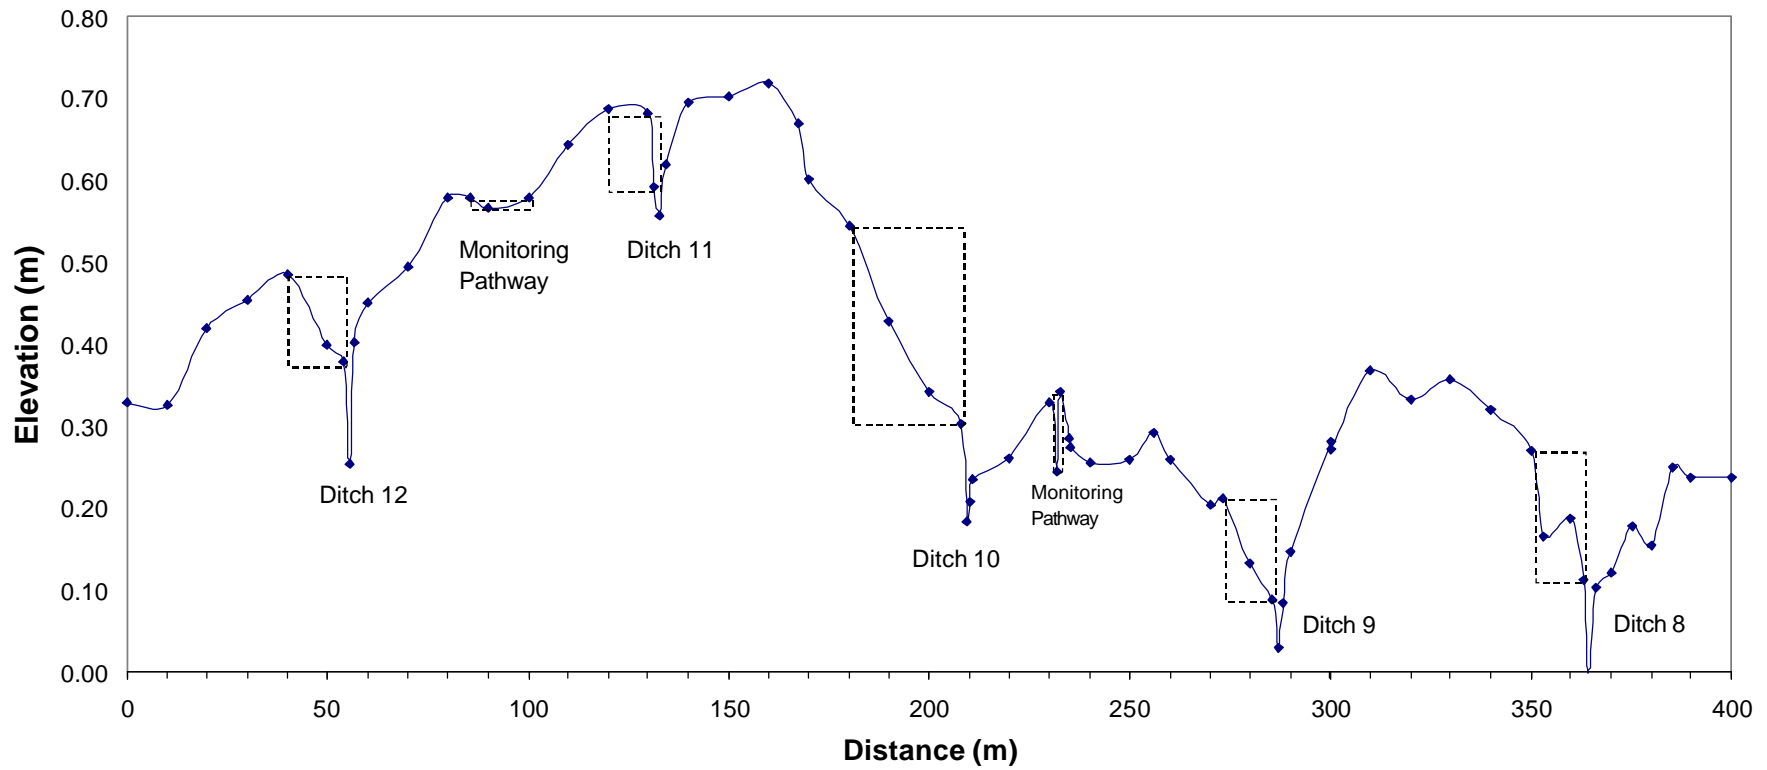
Figure 8. Surveyed cross-section of ground elevations at Ballance site (west to east) relative to the lowest elevation recorded. Ditches are numbered from east to west. Dashed rectangles mark locations of scraped areas. Monitoring pathways are dirt roadways used to access water level monitoring gauges and/or vegetation-monitoring plots. Vertical scale is exaggerated.

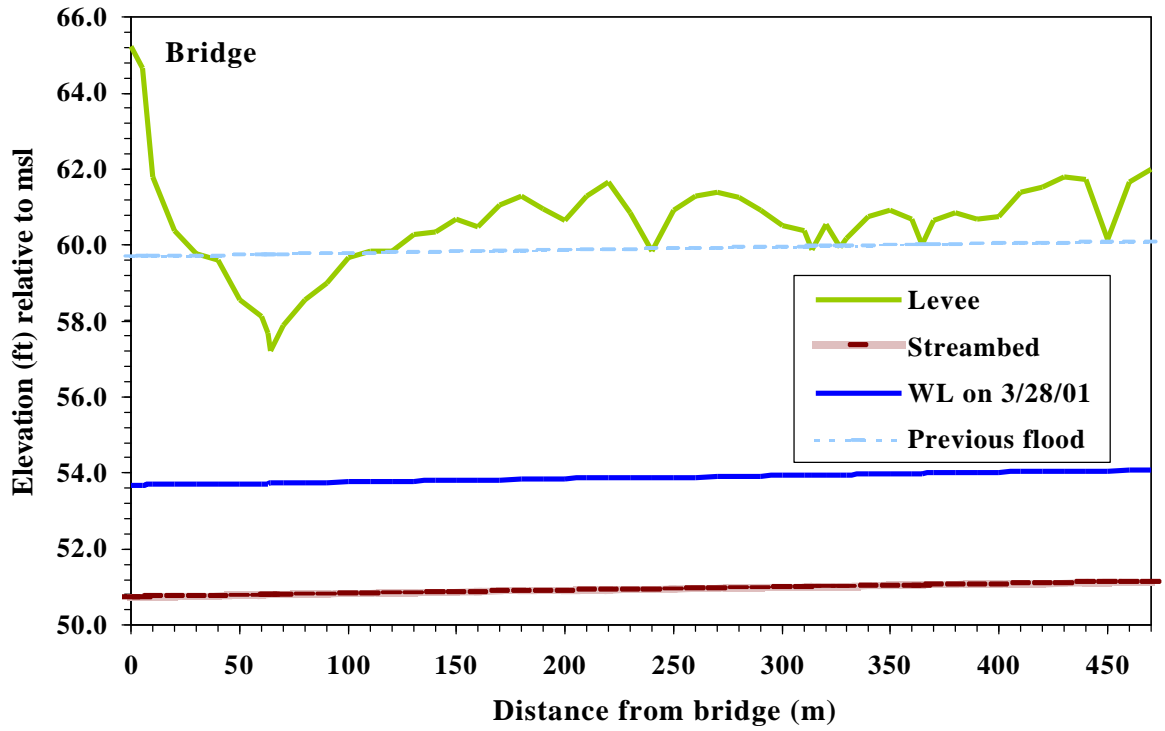
Figure 12. Surveyed elevations at Gurley of Nahunta Swamp Creek upstream from the bridge and the levee located on the north side of the creek.

Notches excavated from the existing levee were, at their lowest point, designed to be 0.5 m (1.5 ft) above the relic floodplain. This was based on the observation that streams in eastern North Carolina of similar order and drainage basin size have levees about 0.5-m high. However, the streambed of Nahunta is lower than it was prior to channelization, meaning that the former floodplain is now located higher above the streambed than it was before channelization. This also means that the stage at which overbank flow would occur is now higher. As constructed, the Nahunta would have to rise to a stage of 57.2 for water to flow through the lowest notch and onto the former floodplain.

During our initial reconnaissance of Gurley, it appeared to us that the stone rip-rap placed at intervals along the levee of Nahunta were an attempt to block drainages (a creek and ditch) entering Nahunta Creek and prevent erosion of the bank rather than facilitate overbank flow. This seemed like an excellent way to increase the duration of water retention on the former floodplain and enable it to once again process water (albeit, the water would not originate from overbank flow as it did before Nahunta was channelized). However, we later learned that notches were cut in the levee to encourage overbank flow from Nahunta channel to the former floodplain

during periods of high water level and that the rip rap was later placed in the notches to prevent erosion during overflow rather than back up water on the former floodplain.
