FINAL REPORT

**North Carolina Department of Transportation
Research Project No. HWY-2002-12**

Evaluation of Bridge Analysis Vis-à-vis Performance

Department of Civil Engineering
University of North Carolina at Charlotte
9201 University City Boulevard
Charlotte, NC 28223

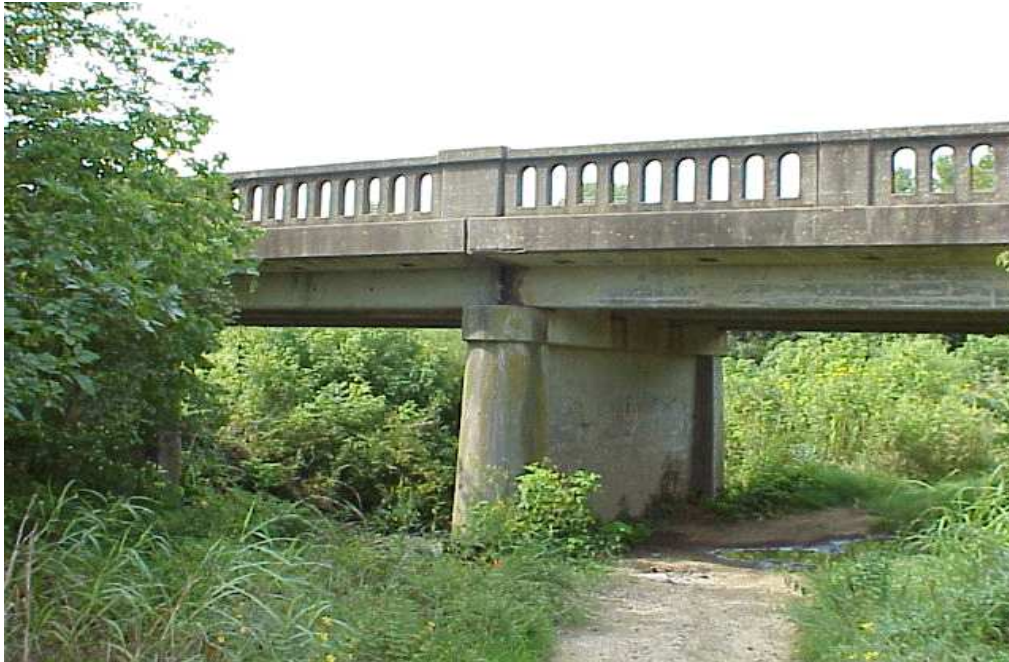
Figure 4.1 Side view of Bridge 59-361

During this project, two reinforced concrete deck girder (RCDG) bridges were analyzed, instrumented and tested. The first RCDG structure was Bridge 59-361, a rural two-lane bridge located in western Mecklenburg County, North Carolina on Bellhaven Blvd. (SR 2373). The bridge consists of three simple spans of approximately 40 ft each. The deck is supported by four reinforced concrete girders spaced at 6 ft-8 in. on center. Construction of bridge 59-361 was completed in 1935; since that time, there have not been any structural modifications made to either the substructure or the superstructure. Figure 4.1 shows an elevation view of bridge 59-361, and Figure 4.2 shows a typical

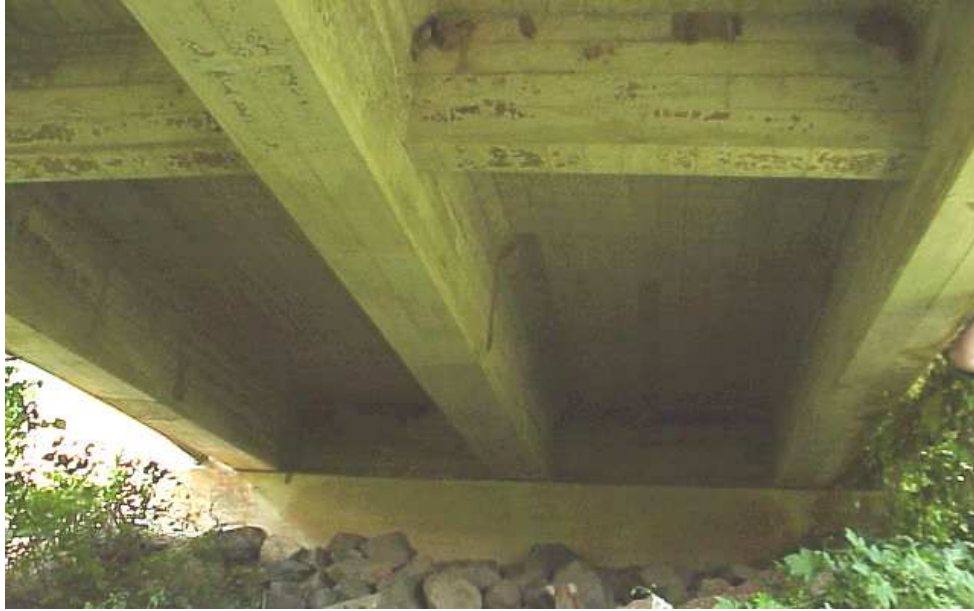
Figure 4.3 View of girders in span 1 of bridge 12-0271

The second RCDG structure tested was Bridge 12-0271 (Figure 4.3), a three-span reinforced concrete deck girder bridge with three girders. This two-lane secondary route

bridge carries SR1157, Wilshire Avenue in Concord, NC, over Irish Buffalo Creek, just east of the SR1157 and NC601 intersection. It has an overall structure length of 132 ft – 6 in. A typical cross section of the bridge is shown in Figure 4.4.

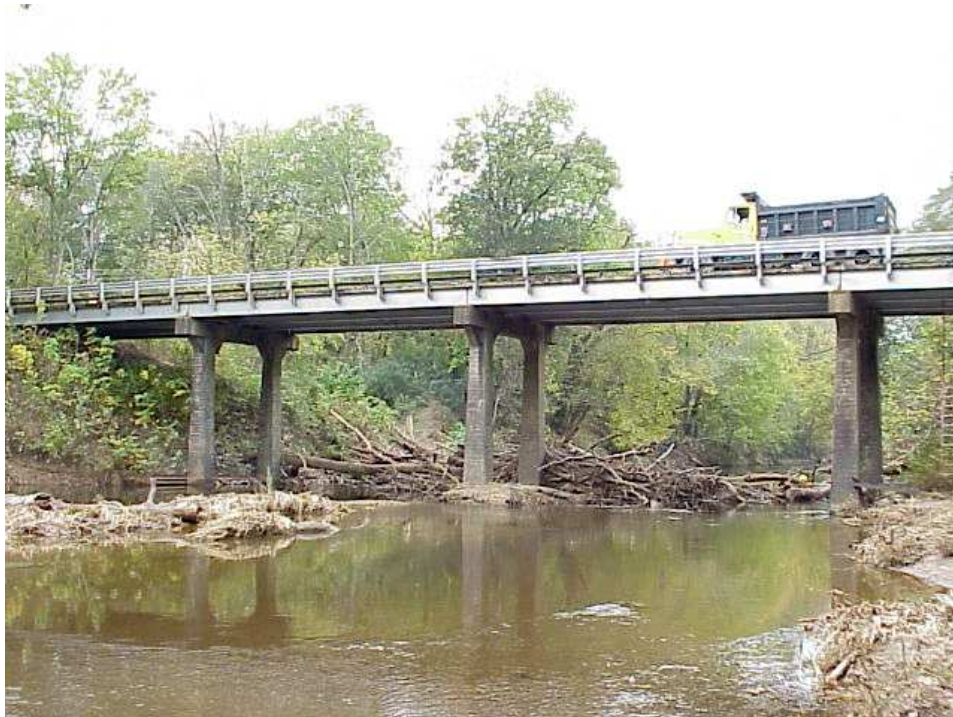
Figure 4.7 View of center spans of bridge 12-0227

As it can be seen in Figure 4.7, significant debris was present at the time of the bridge instrumentation and testing. Also, it is evident from Figure 4.8 that the add-on timber bent has been repaired in the past. An additional timber post has been installed between the first and second posts, unloading the gravity loads from one of the severely decayed original posts.

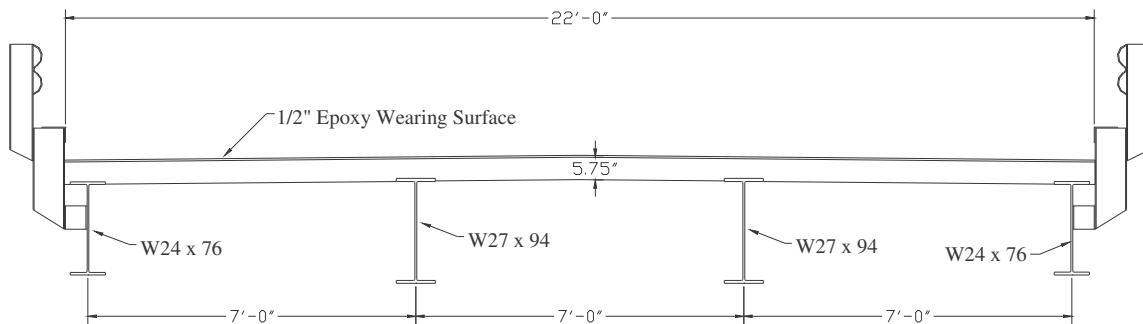
Figure 4.9 Cross section of Bridge 12-0227

For the analysis of the interior girders a 95% effective area was assumed, for the exterior girders 98% was assumed. The bridge plans do not show any shear studs that would result in composite action between the deck and girders, so the bridge was analyzed as a non-composite beam with a concrete deck.

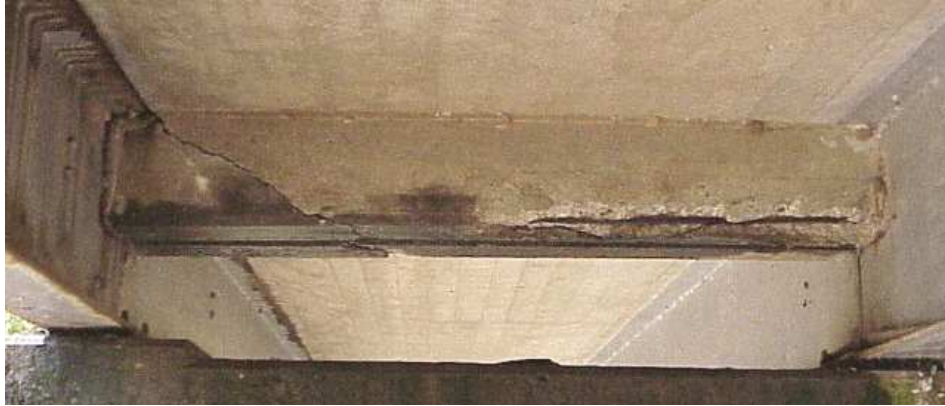
Figure 4.10 Cracked end diaphragm

spalled. The exposed rebars are severely corroded. Figure 4.10 shows a cracked end diaphragm between Girders 1 and 2 of Span 1. Similar damage was present on all end diaphragms of the exterior bays. These defects made the likelihood of effective transverse load distribution questionable.

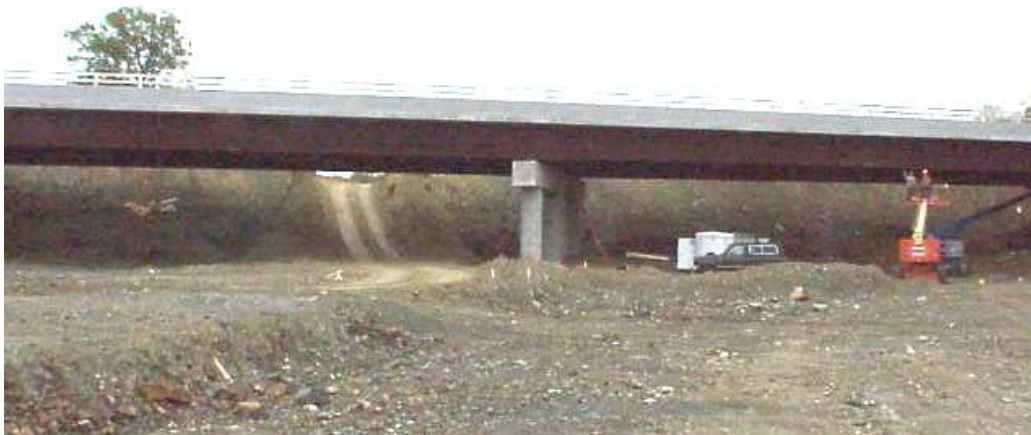
Figure 4.11 Elevation view of Bridge 59-0841

The third steel girder bridge analyzed and tested was Bridge 59-0841, a two-lane bridge spanning a portion of Interstate 485 that, at the time of testing, was still under construction. This bridge is located in eastern Mecklenburg County, North Carolina on Caldwell Road (SR 2801). The overall length of this bridge is approximately 290 ft, consisting of two continuous spans of 144 ft and 146 ft, respectively. The reinforced concrete deck is supported by five continuous steel plate girders spaced at 9 ft – 4 in. on center. Figure 4.11 shows the elevation view of the continuous span structure.

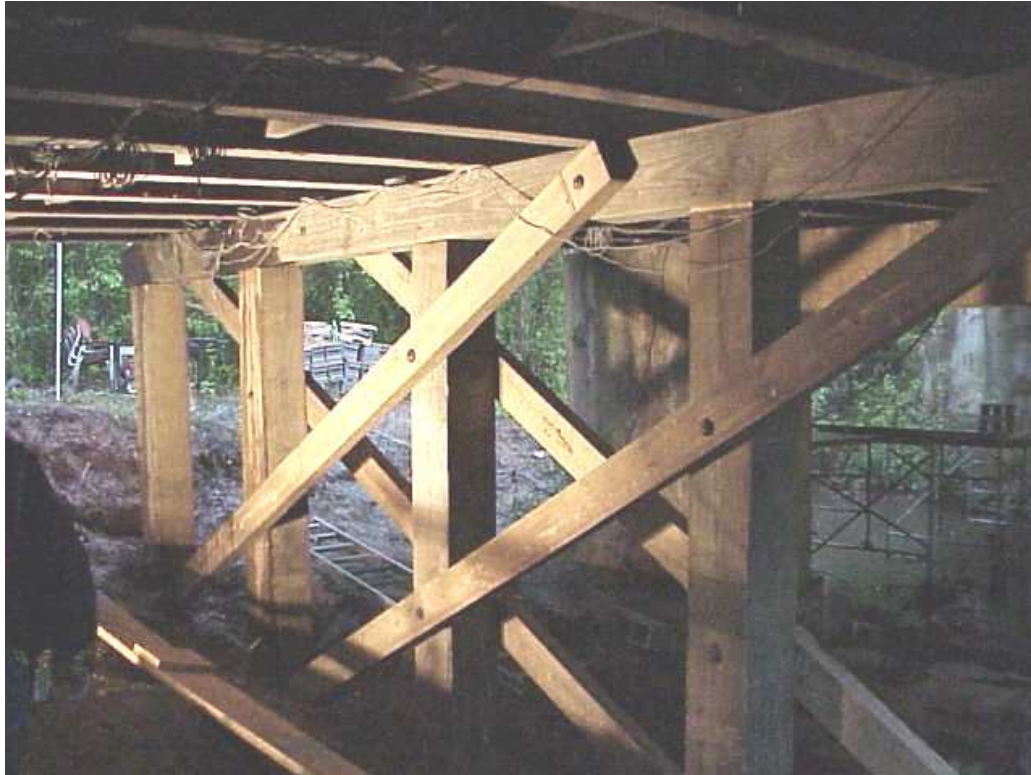
Figure 4.13 Crutch bent retrofit

The wooden crutch bent was installed for only one of the spans. This was done in order to avoid lengthy environmental permitting requirements for construction work in a creek bed. Due to the urgency of this project, only the span above dry land was retrofitted, with the second span to be done in the near future, once the environmental permit is secured. The crutch bent was designed by engineers from the NCDOT Bridge Maintenance Unit, and consisted of five (10 in. x 10 in.) timber posts at 6 ft spacing, and 10 in. x $11\frac{3}{4}$ in. cap and sill plate, properly braced (see Figure 4.13).

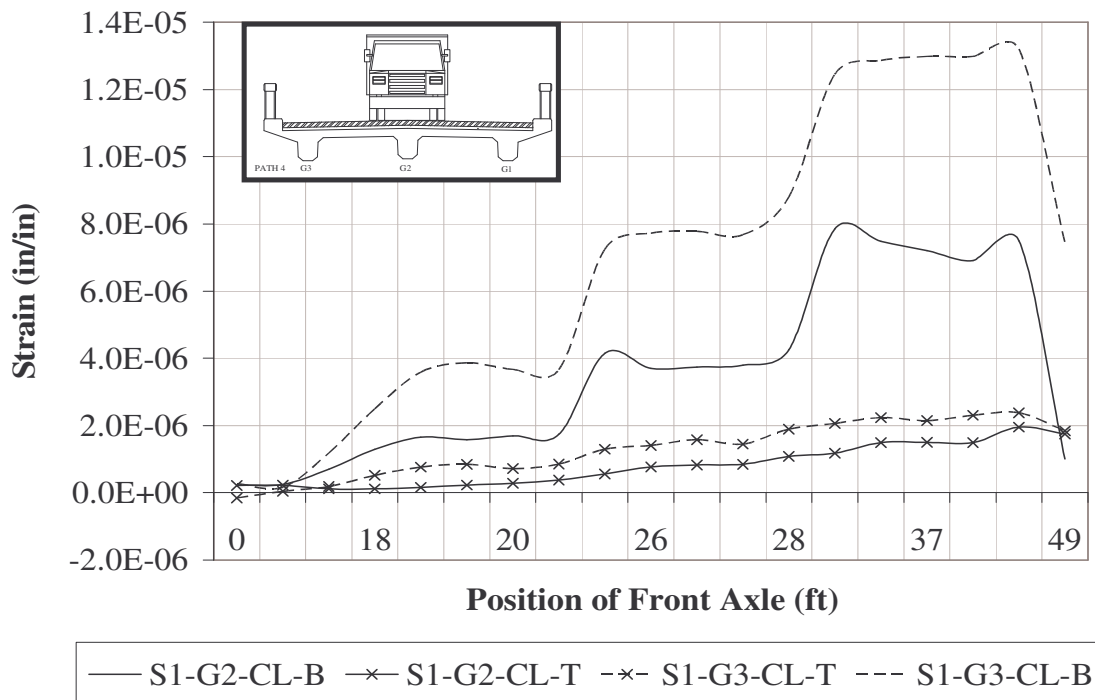
Figure 5.11 Strain levels in girders 2 and 3 – static path 4

Figure 5.11 shows the strain readings of two of the locations. In Span 1, Girders 2 and 3 were instrumented at top and bottom. Using the similar triangles method, and assuming that the material has not yielded, the neutral axis was determined. The path shown is from Path 4 of the static load sequence.

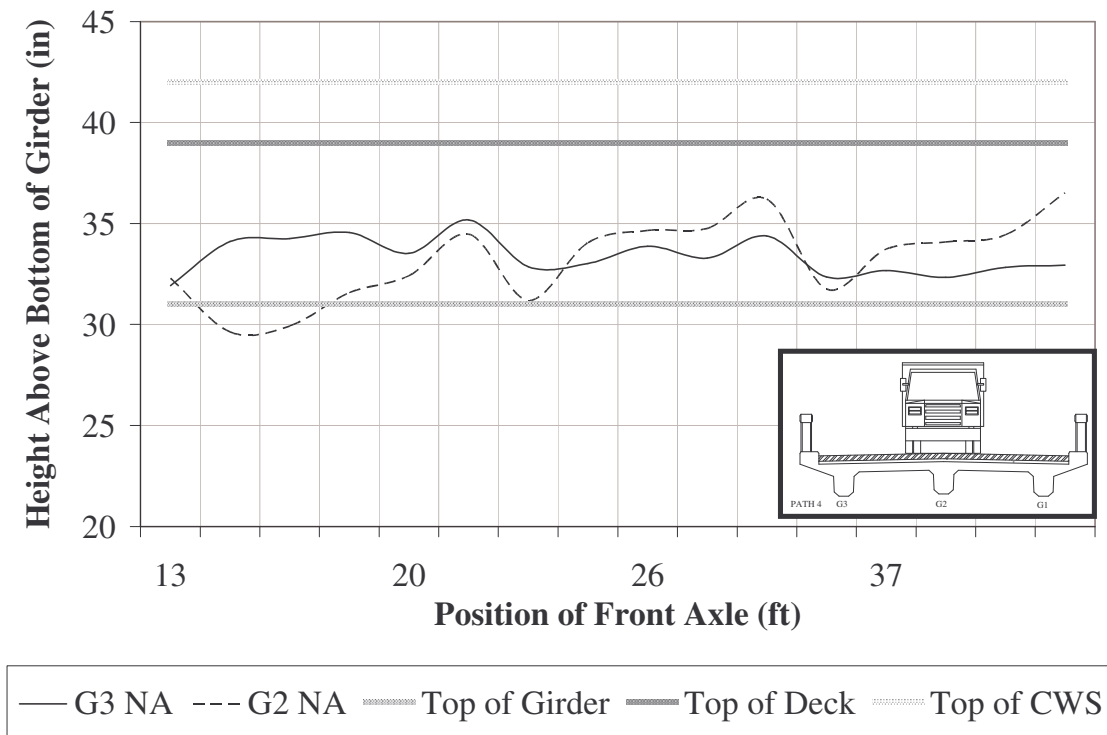
Figure 5.12 Neutral axis for girders 2 and 3 – path 4

The neutral axis was found at 33.0 in. for girder 3 and 34.1 in. for girder 2 measured from the bottom of the girders. Slightly higher NA positions were determined for path 1. Figure 5.12 illustrates the neutral axis of Girders 2 and 3 as a function of the position of the loading vehicle as it moves across the span in static load sequence along path 4.

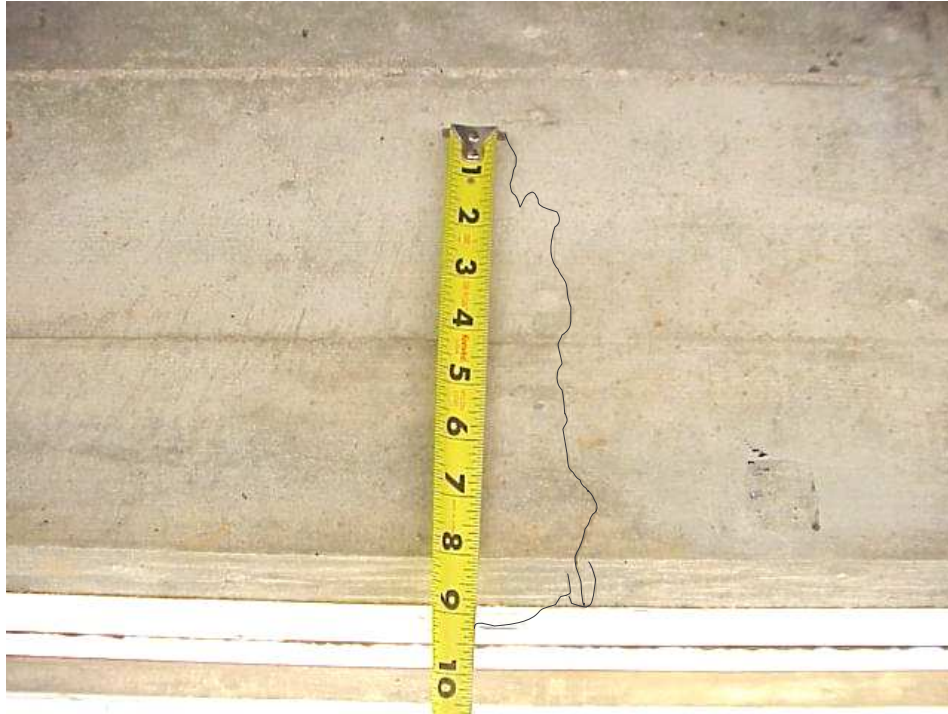
Figure 5.14 Existing vertical crack

Figure 5.14 shows a representative vertical crack. These vertical cracks up to 9 in. are seen throughout the bridge. The image shown was taken at midspan of Girder 2 in Span 1. The crack has been highlighted to aid its clarity. This type of crack is most commonly a flexural crack; although no other sign of distress was visible.

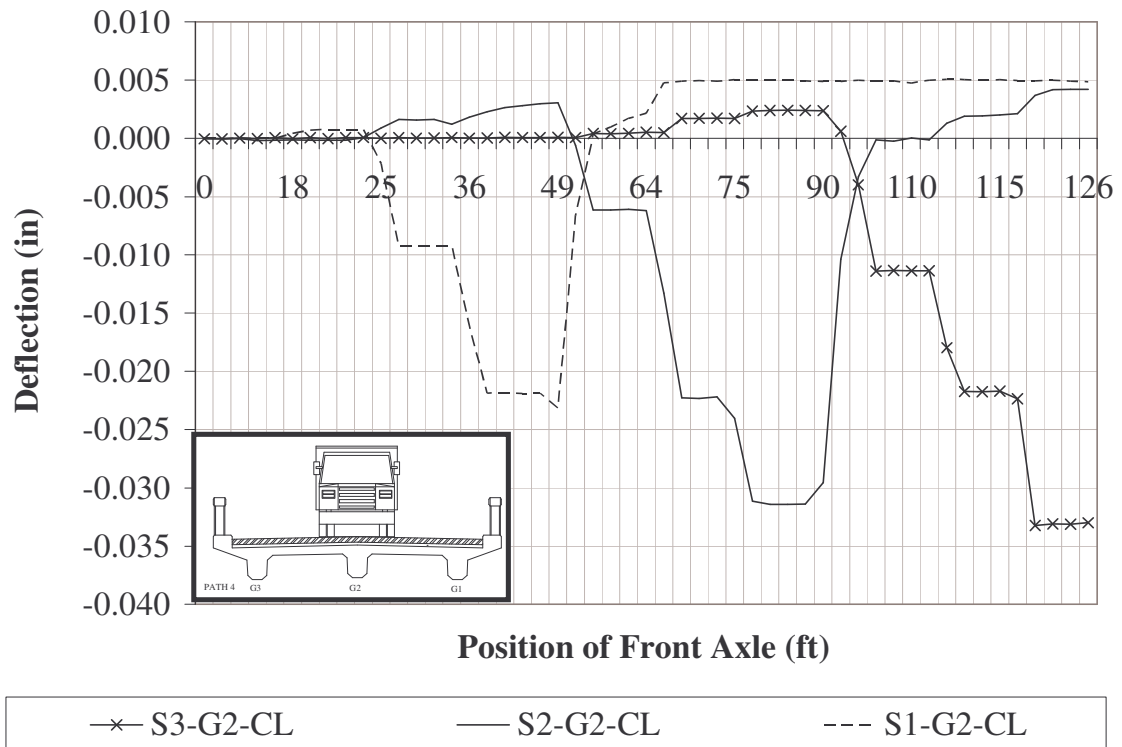
Figure 5.15 Centerline deflections of Girder 2 – static path 4

continuous span action illustrated here should be ignored since this is out of the accuracy range of the displacement transducers and could be considered noise.

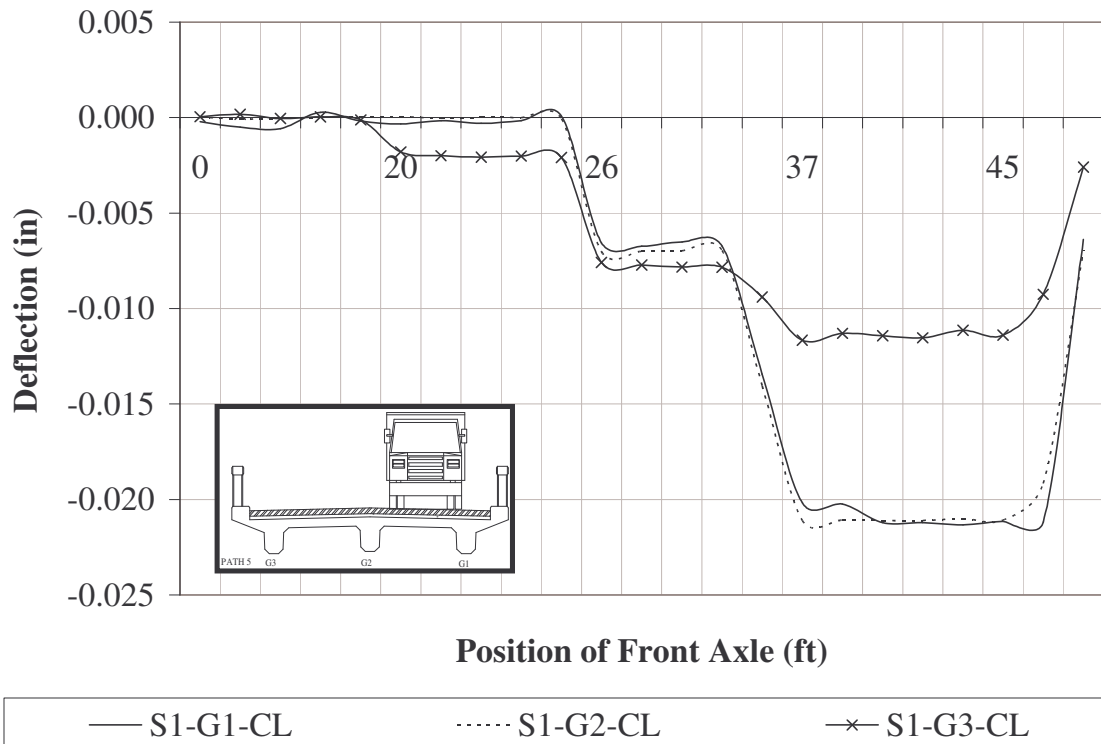
Figure 5.16 Span 1 centerline deflections – static path 5

These figures show the deflection readings of the bridge under different load locations. However, in each figure, the measured deflections never reach the predicted deflections for pinned – pinned or fixed – fixed end conditions. This would indicate that the material properties were incorrect or that some interaction from the railings and curb is truly happening and greatly affecting the bridge's load response.

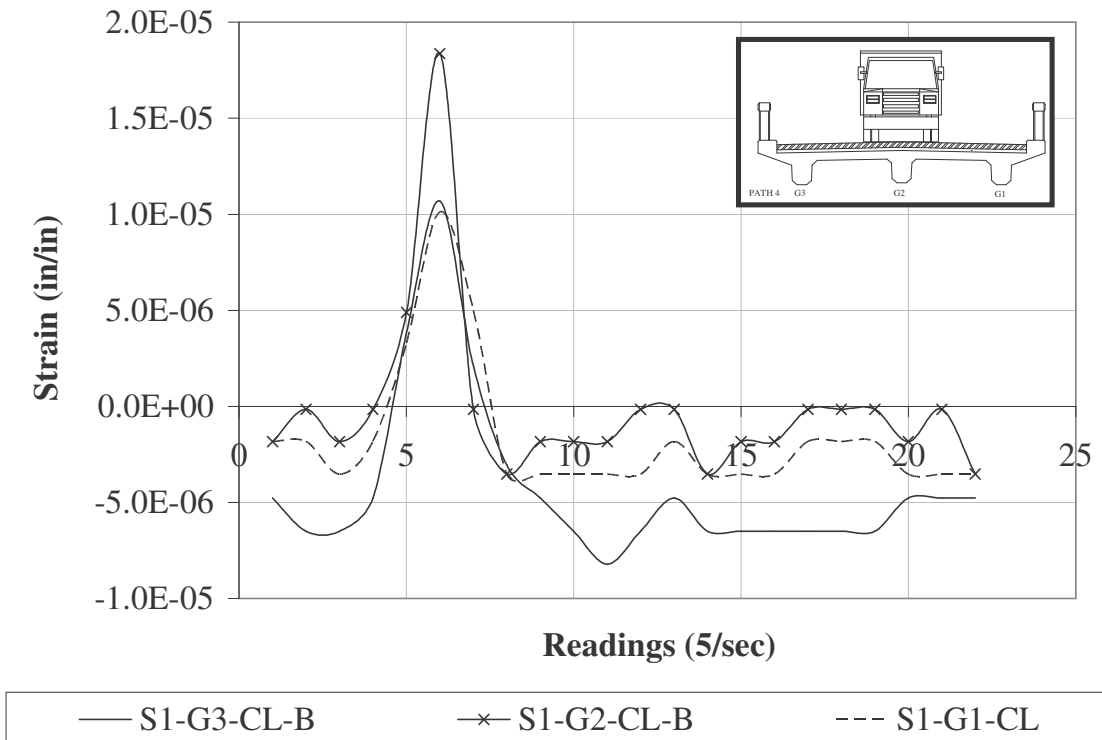
Figure 5.17 Dynamic strain readings in span 1 – path 4

Figure 5.17 shows the strain readings in all three girders of Span 1 at midspan as the load vehicle was driven through the bridge following path 4. Girder 2 had the highest strain reading of $18 \mu\epsilon$. This value is significantly higher than the $8 \mu\epsilon$ recorded in the static case load sequence seen in Figure 5.11. However, girder 3 read $11 \mu\epsilon$, less than the $14 \mu\epsilon$ seen in static path 4.

These two readings are at the two extremes measured during dynamic loading. The vast majority of the dynamic readings were approximately equal to the static data. The actual impact is greatly affected by the presence of bumps on the bridge approach (Beal, 1998). It was noticed during the bridge test that some vehicular impact was occurring as vehicles entered the bridge from the approaches. Some differences in the asphalt overlay at the bridge abutments were noticeable at both ends of the bridge. This caused the vehicles to “bounce” on to the bridge. Figure 5.18 shows one of the approaches with the unevenness of the asphalt, which contributes to the bouncing effect.

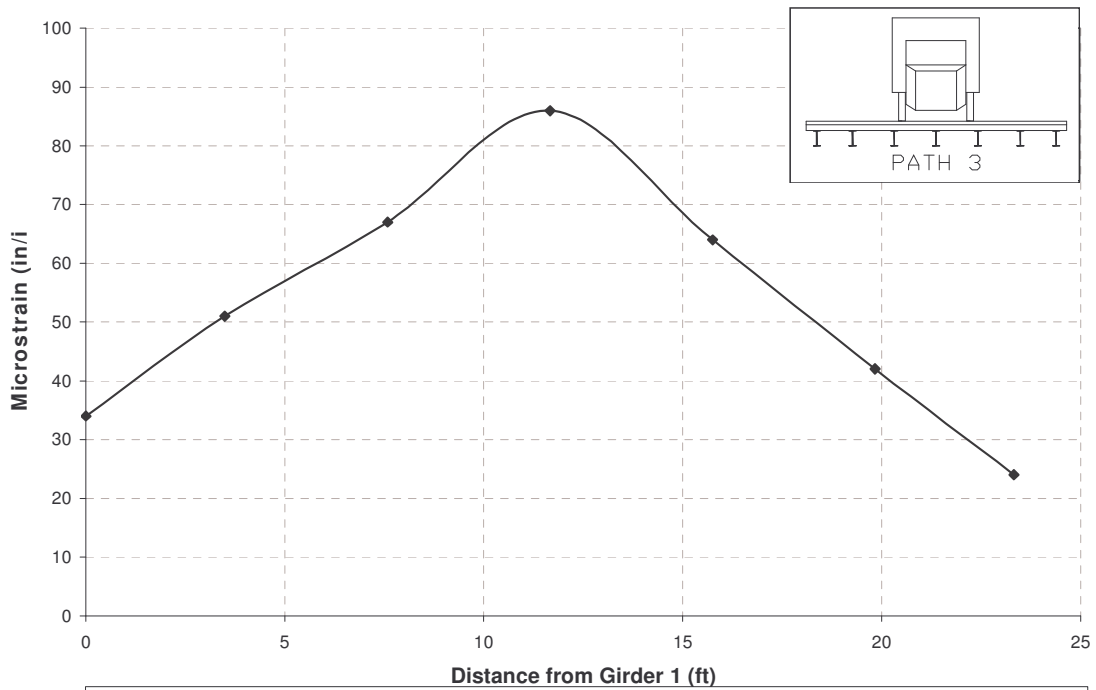
Figure 5.23 Strain distribution at mid-span – static path 3

Figures 5.22 and 5.23 show the strain distribution for paths 1 and 3. Each point on the graph indicates the position of a girder in relation to Girder 1. These graphs allow for the calculation of distribution factors. Table 5.7 summarizes the distribution factor calculations for path 1, resulting in $DF = 0.64$.

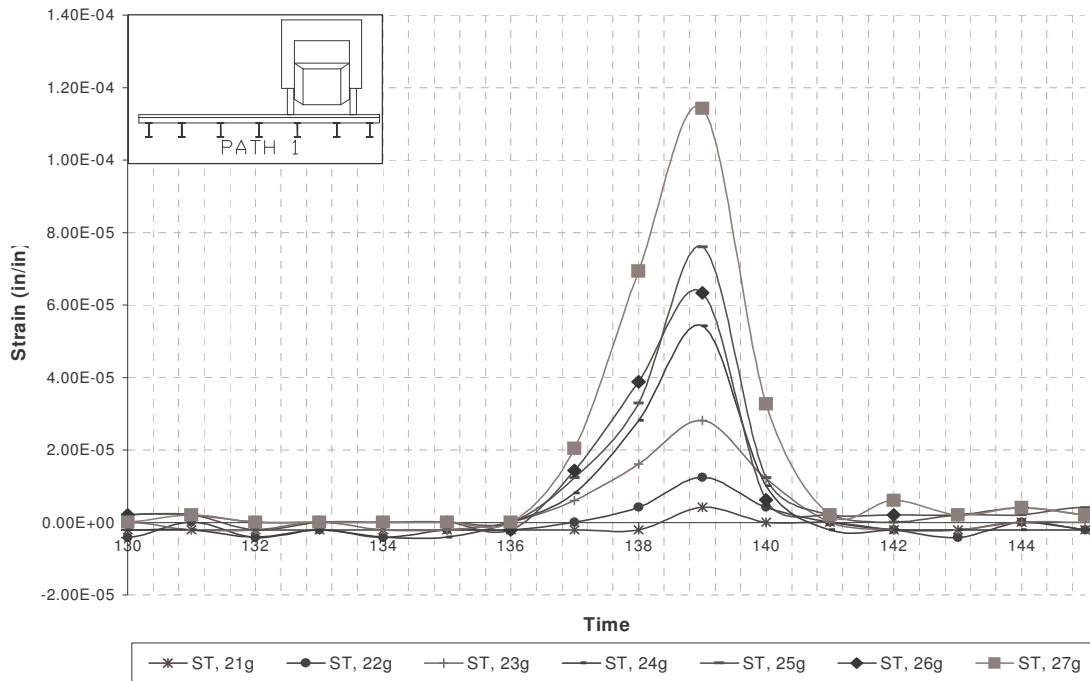
Figure 5.24 Dynamic strain readings at girder mid-span – path 1

So the obvious question could be: why has no impact effect been observed in these tests? There are several possible answers; one could be that the approach slabs leading to the bridge have been paved at the same time as the bridge. Therefore, there is a smooth transition between the road and the bridge. Another would be that bridge 59-038 has an asphalt overlay of 9 in. on a 7 in. concrete deck. This overlay could have dampened the impact effects of the dynamic loads.

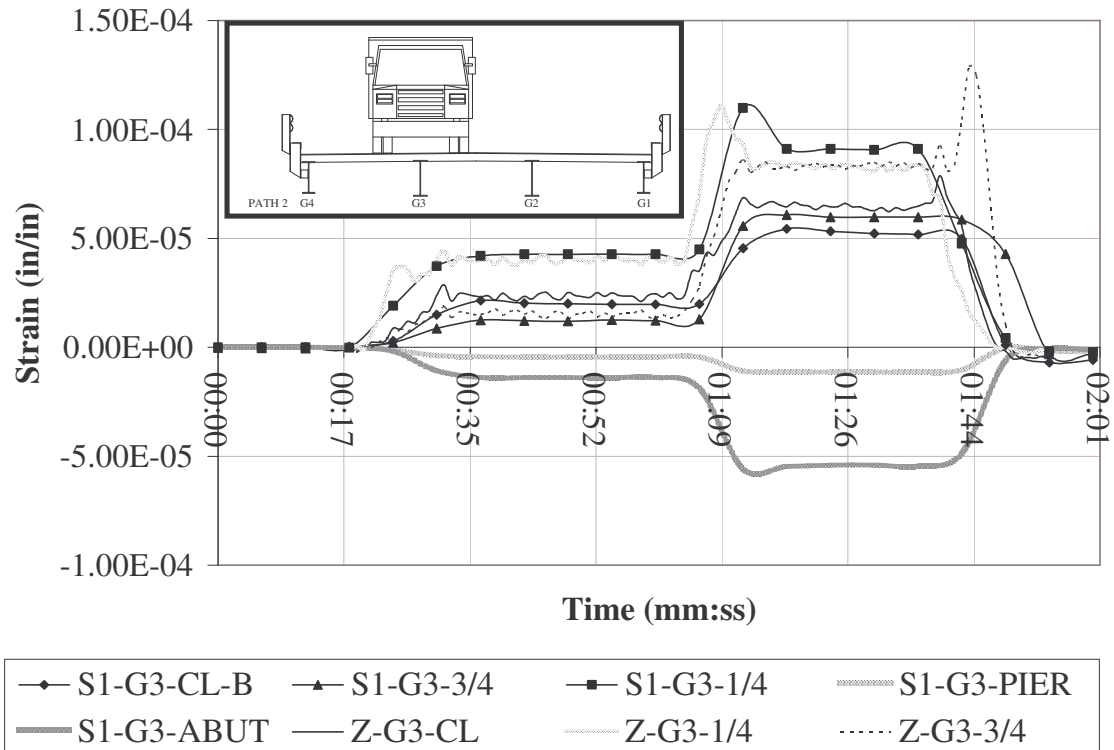
Figure 5.25 Strain readings along girder 3 – static path 2

The figure clearly indicates the loading vehicle's stopping positions on the girder. There was an average of 20% difference in the strain readings between the portable DAQ and the primary DAQ in the centerline and the quarter point instruments. The Z instruments were positioned away from the centerline of the girder, and the difference in the readings can be explained by the girder not being loaded concentrically (there was a noticeable horizontal curvature in most of the girders, a deviation from a straight line up to a few inches); thus inducing some torsion in the beam.

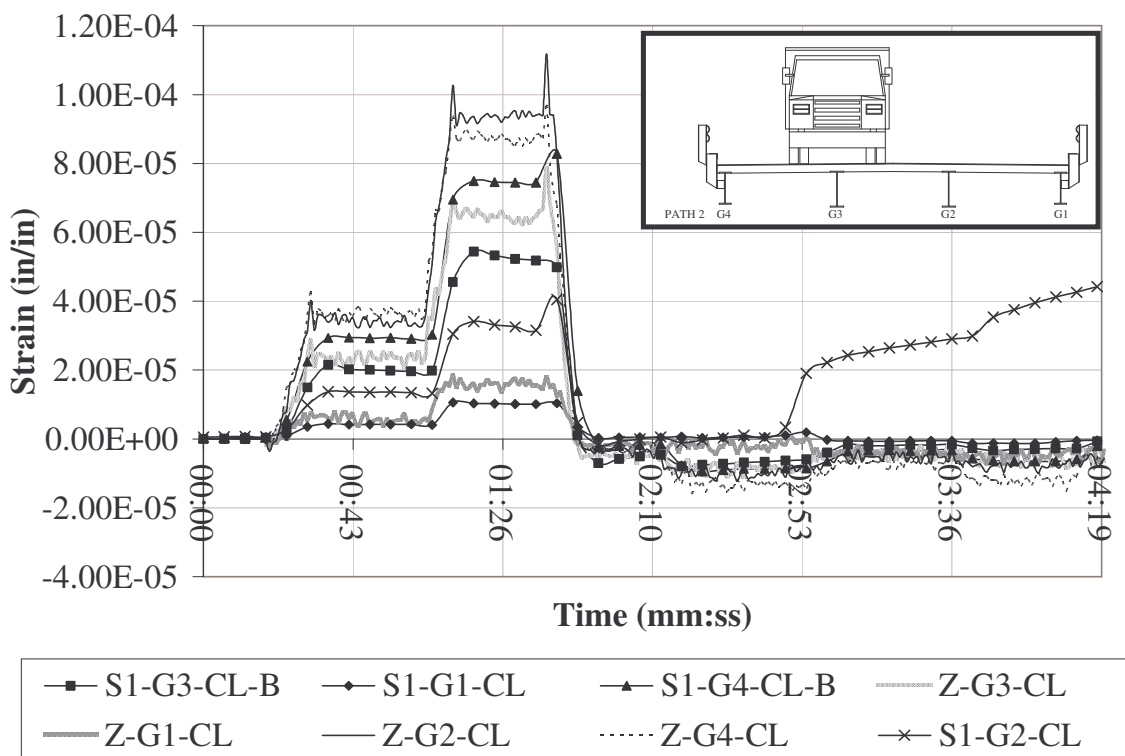
Figure 5.26 Span 1 strain readings at midspan – static path 2

While some fixity was clearly occurring, the instruments were recording close to zero strain as the load vehicle passed from one span to another, illustrating that there was no continuous action between spans. Figure 5.26 shows the readings from the four girders at the midspan of span 1.

As it can be seen on Figure 5.26, the reading for girder 2 did not follow a logical trend. A new pile was installed at this location at pier 1 (see Figure 5.27) with a noticeable gap between the top of the pile and the bottom of the concrete cap. With this knowledge, and the fact that the deteriorated pile was missing a large portion of its cross-section at ground level, the concrete span had virtually no support under Girder 2. Therefore, two displacement transducers were used to monitor the vertical displacement in the concrete cap. The displacement transducers were placed on either side of the deteriorated pile. Figure 5.28 shows the displacement readings from these two instruments as the load vehicle followed the static path 4.

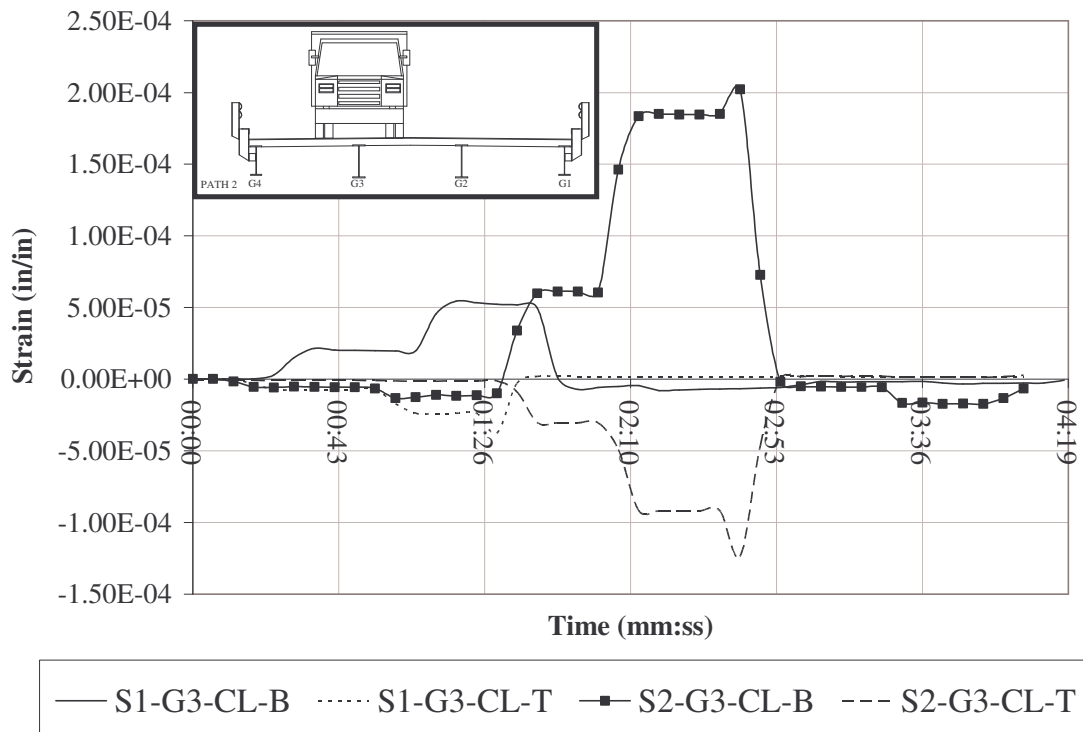
Figure 5.29 Strain readings for girder 3 in spans 1 and 2 – path 2

Again, using the similar triangles method, and assuming that the steel has not yielded, the neutral axis was determined. In span 1, the average NA was determined to be 18.46 in., while in Span 2, the average NA was 17.40 in. from the bottom flange of the girder. Considering the fact that centroid of the W27x94 interior girders are located at 13.46 in. from the bottom flange, one can conclude that there was a composite action between the steel girders and the concrete deck. However, this composite action relies only on adhesion between the two bridge components. In fact, a similar study was performed for girder 4, and the experimental NA was located at the centroid of the steel girder, dismissing any assumptions of a composite action.

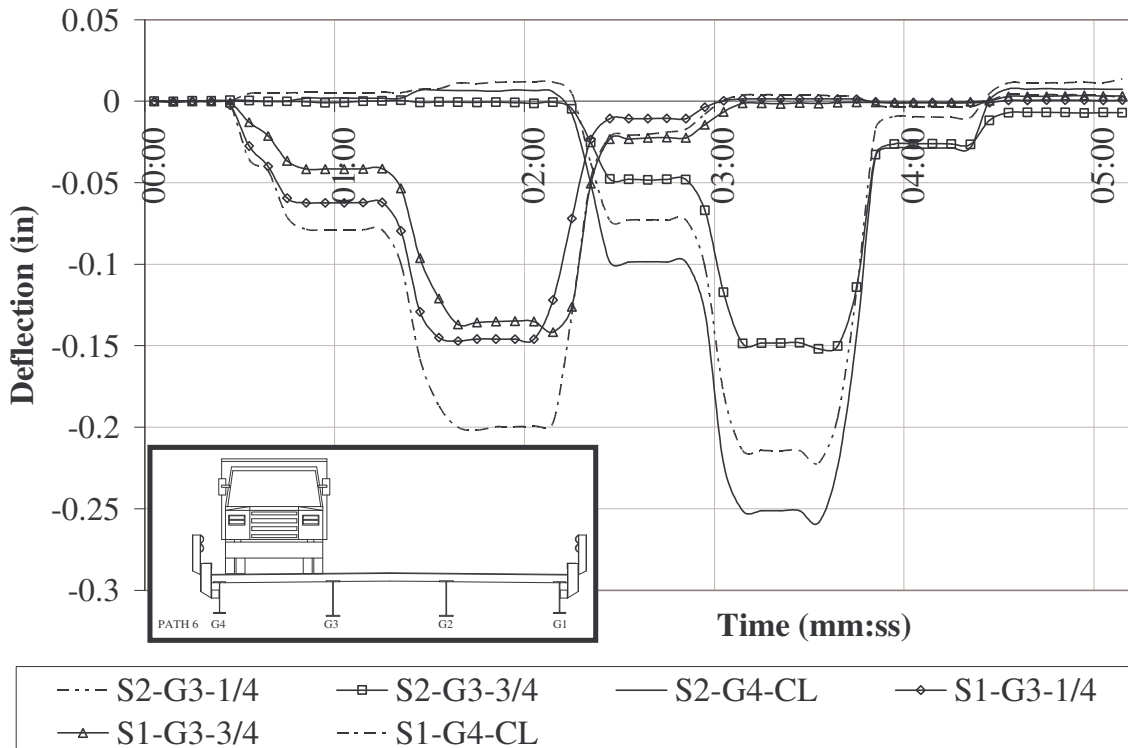
Figure 5.30 Girder deflections – static path 6

Figure 5.30 illustrates the displacement transducer readings for static path 6. The figure shows that in both spans, the instrument on girder 4 measured the highest deflections, with 0.20 in. in span 1, and 0.26 in. in span 2. This fact proves that this girder resisted more load than any other girder. Furthermore, this figure also demonstrates that there was no continuity between spans; i.e. only the instruments in the loaded span recorded meaningful deflections.

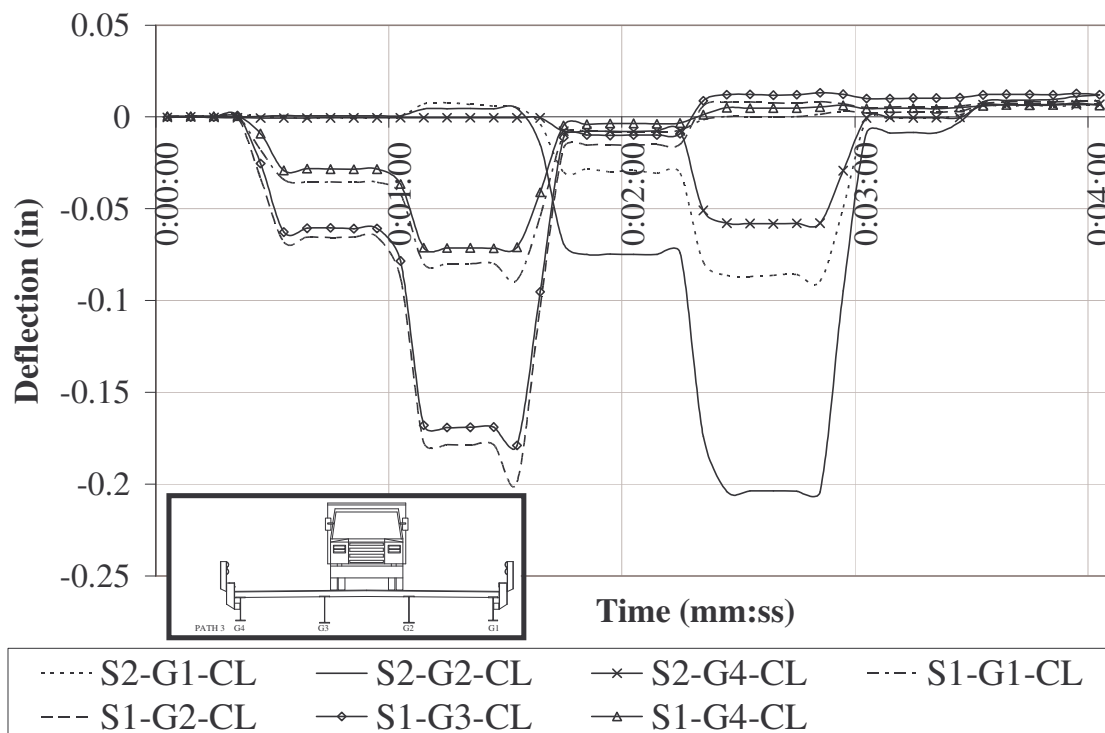
Figure 5.31 Girder deflections – static path 3

Figure 5.31 shows the deformations for static path 3. This path places the loading vehicle on the two interior girders. As expected, girders 2 and 3 showed the most deflection at midspan with girder 2 measuring 0.20 in. in both spans, and girder 3 measuring 0.18 in. in span 1. The displacement transducer at the midspan of girder 3 in span 2 recorded no data.

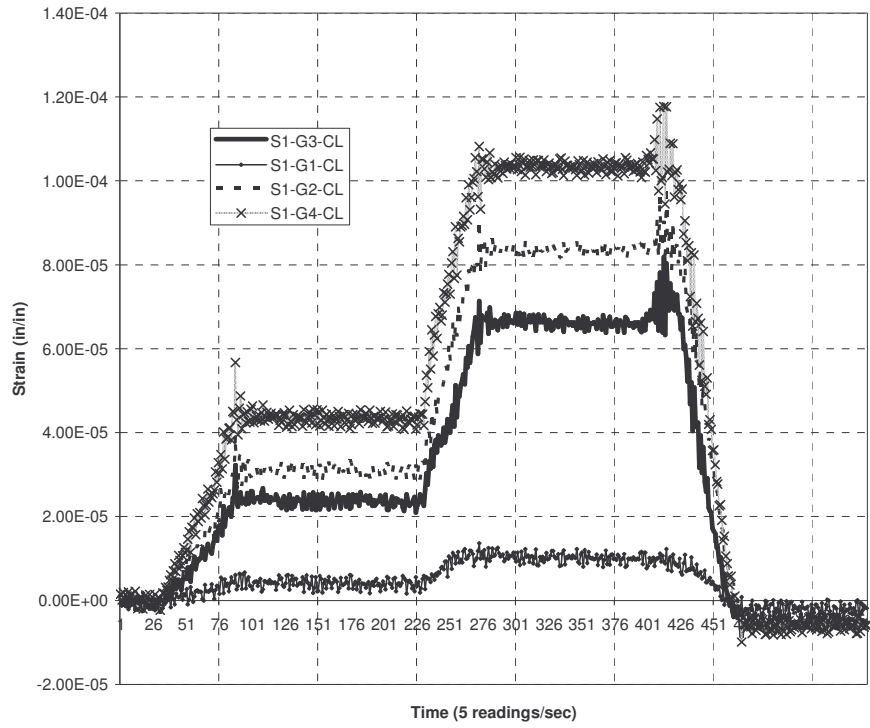
Figure 5.32 Strain readings – static path 1

Figures 5.32 and 5.33 show the results of the static and dynamic loading of span 1 along path 1. As it can be seen, both of these loadings resulted in maximum strain readings of approximately 120 $\mu\epsilon$ – suggesting no dynamic effects. However, it is clear from Table 5.9 that girder 2 recorded 23 % higher dynamic strains than static strains. This was not a real surprise, considering the condition of the expansion joints, and the uneven approach slab/bridge deck transition.

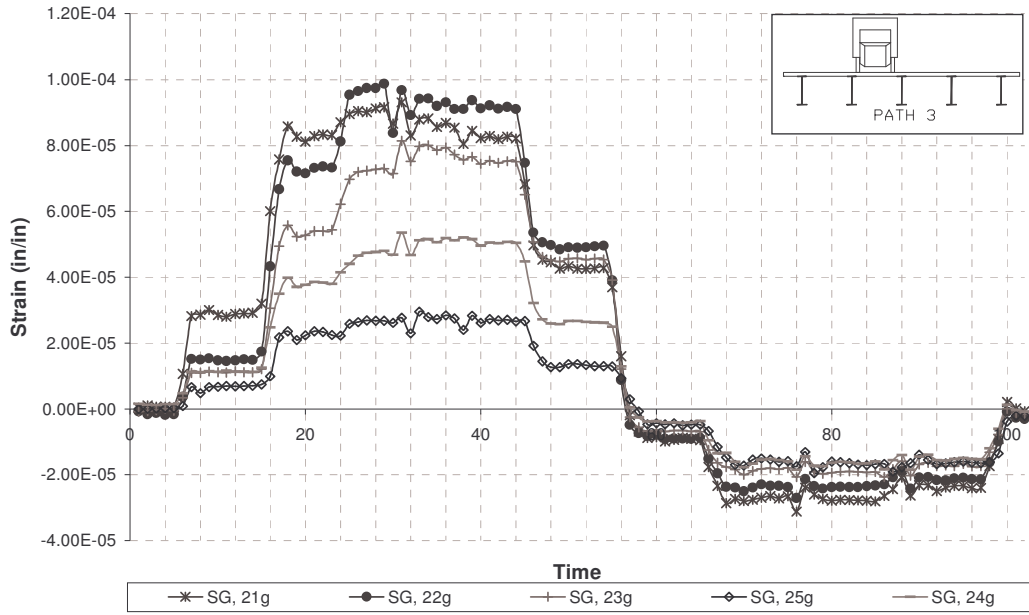
Figure 5.36 Static strain readings for span 1 – path 3

Furthermore, as opposed to the previous case, girder 2 was stressed to the same (or higher) levels as compared to girder 1. Finally, these figures clearly identify the moment when the loading trucks move from one span to the other. It is interesting to note, that the stresses completely reverse when the trucks are on the adjacent span. Although the strain levels were in the $30 \mu\epsilon$ range, this reversal must be accounted for in fatigue calculations.

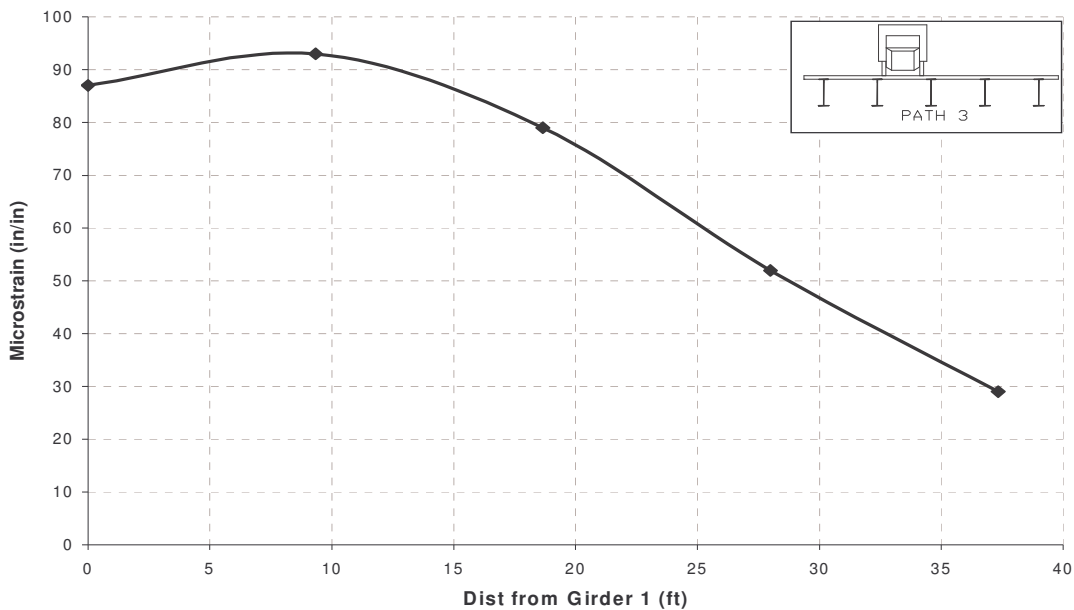
Figure 5.39 Strain distribution at midspan – path 3

Path 3 however, did not generate the highest distribution factor. Bridge 59-0841 has an unusually large space on both sides of the traffic lane, suitable for either a bicycle or for additional traffic lanes to be added in the future. Path 1 for example, positioned the right wheel line of the trucks directly above girder 1, generating a distribution factor of 0.94. However, this factor does not represent the current traffic conditions; therefore, in this report the 0.90 value will be used.

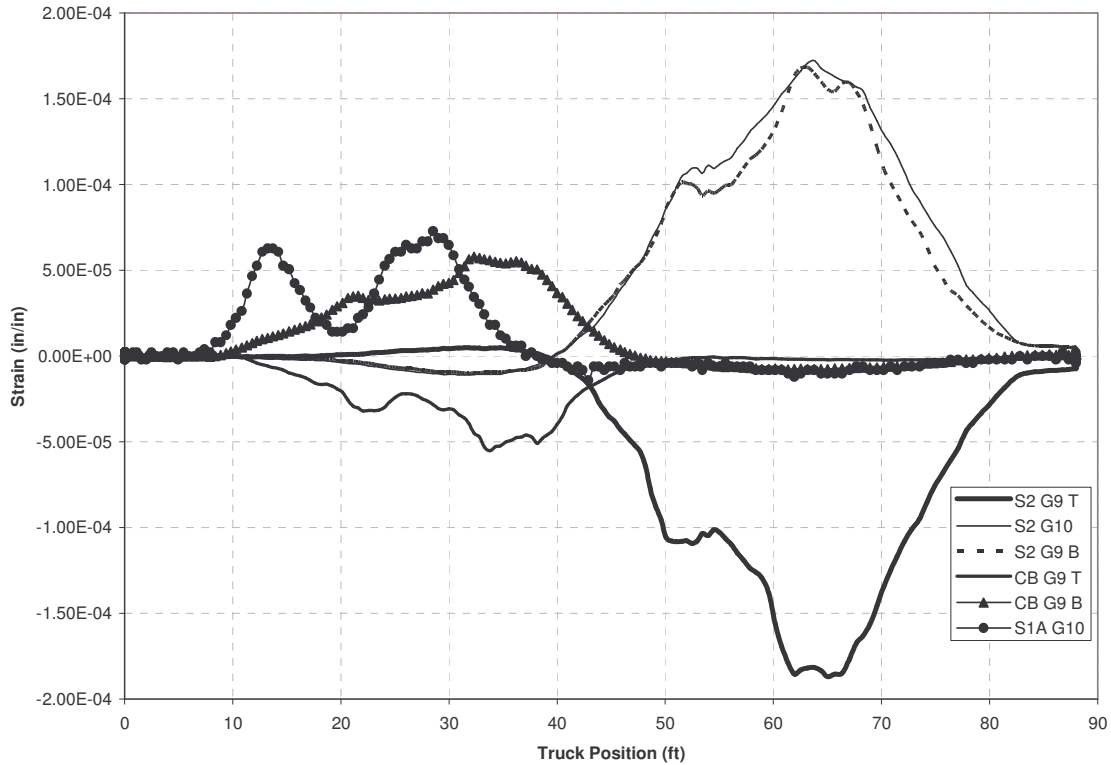
Figure 5.40 Strain readings for girders 9 and 10 – path 1

Figure 5.40 shows the readings from selected strain gages and strain transducers. As expected, girders 9 and 10 recorded the highest strain levels in span 2, reaching strain values up to 180 $\mu\epsilon$. These values are significantly lower than the strain recorded in span 1 and at the crutch bent location, at which location the highest strain values were in the 70 $\mu\epsilon$ range – clearly indicating the benefits offered by the crutch bent retrofit. This relatively simple and fast repair method lowered the demand on the girders by 250%, a significant reduction.

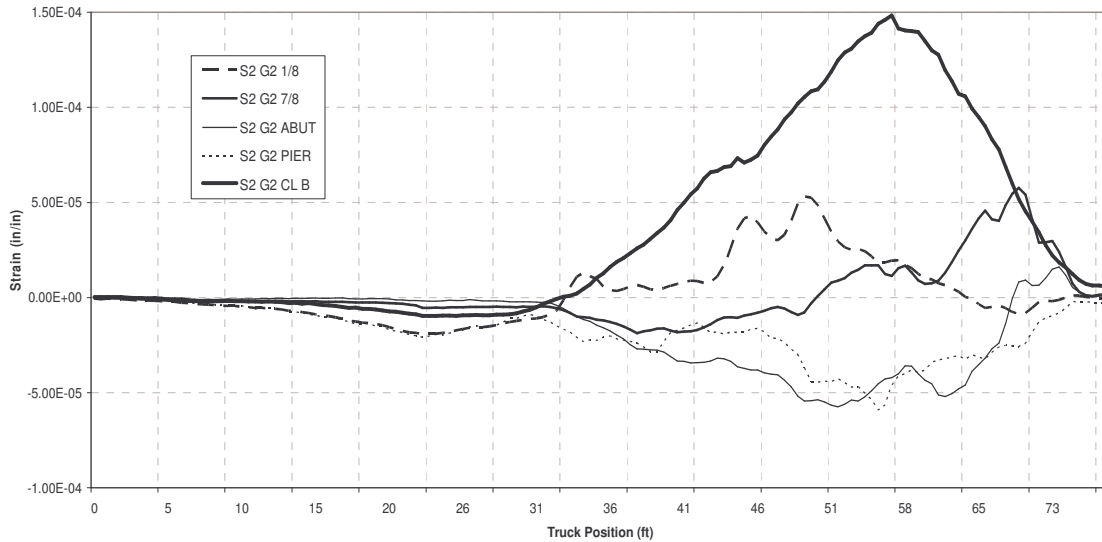
Figure 5.41 Girder 2 strain reading in span 2 – path 3

Similarly to previous bridges, the condition of the supports was also investigated. Theoretically, the original spans were simply supported. However, as it evident from Figure 5.41, negative strain readings were recorded at the bottom flange of girder 2 in span 2 (the span without retrofit). In fact, at the pier, $59 \mu\epsilon$ were recorded, a third of the peak strain values at midspan, clearly indicating a certain level of end restraint.

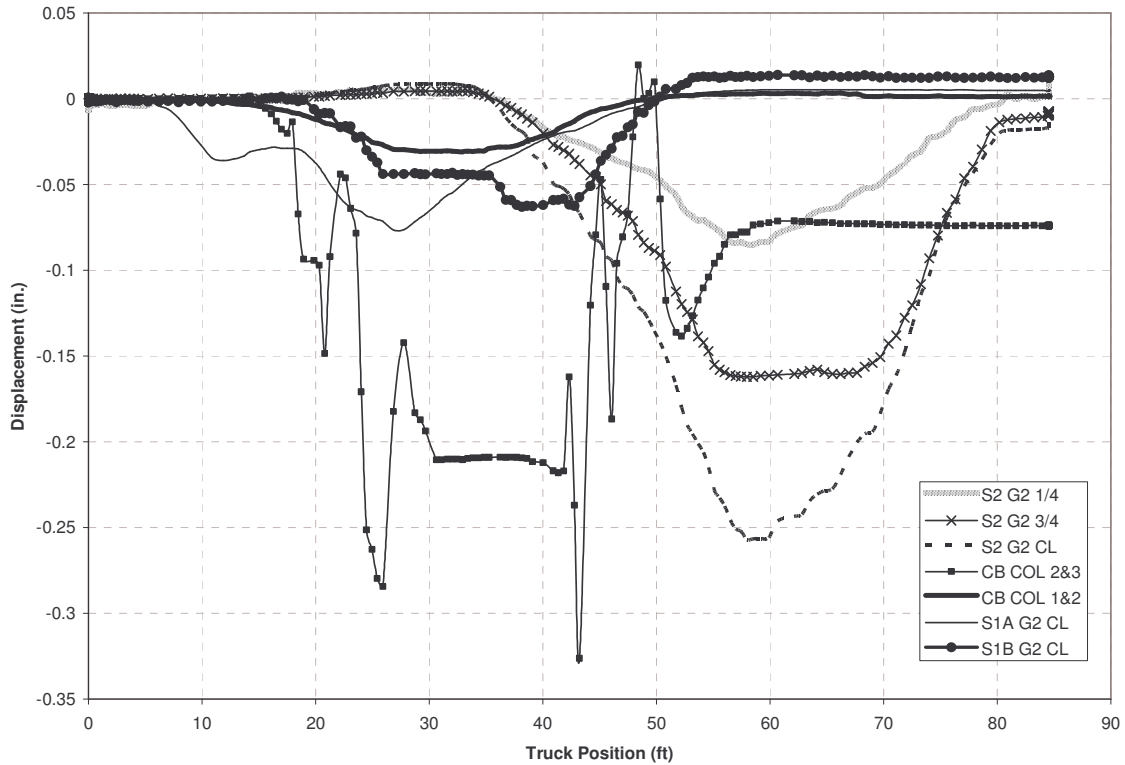
Figure 5.42 Girder 2 deflection readings – path 3

This latter value represents a significant settlement, especially if one considers that 0.07 in. was permanent deformation, clearly indicating that the crutch bent was still in the initial settlement phase. After this, the magnitude of the secondary settlement should be minimal in the future, unless a heavier-than-posted truck travels on the bridge.
