FINAL REPORT

**North Carolina Department of Transportation
Research Project No. HWY-2002-12**

Evaluation of Bridge Analysis Vis-à-vis Performance

Department of Civil Engineering
University of North Carolina at Charlotte
9201 University City Boulevard
Charlotte, NC 28223

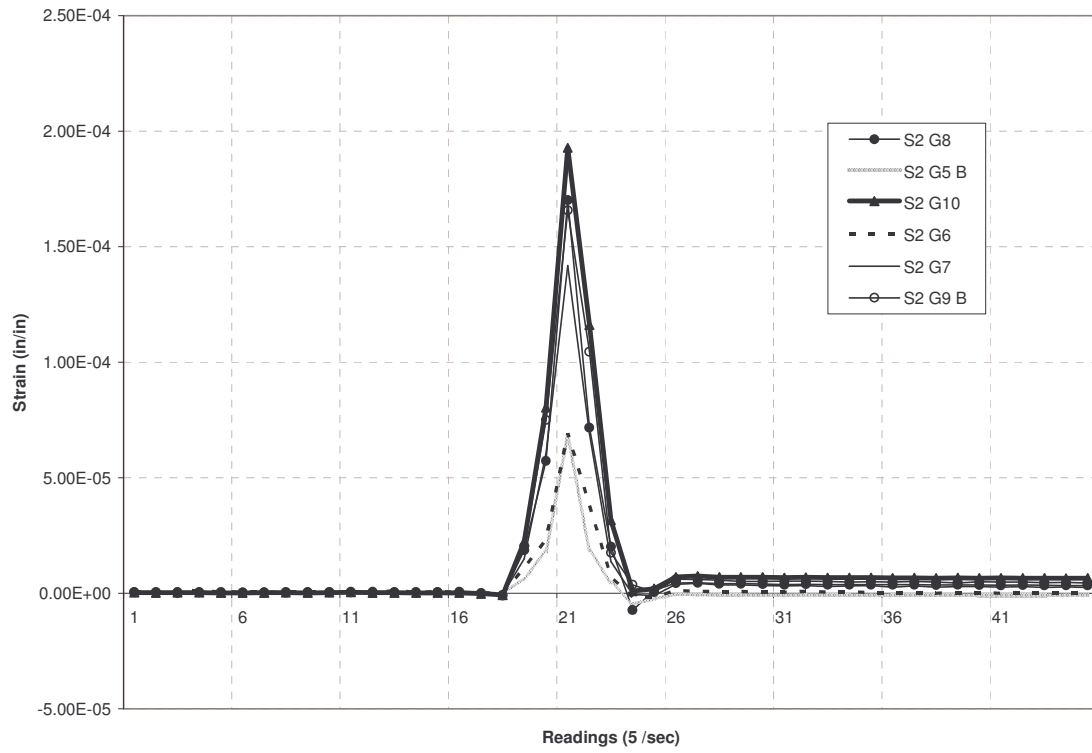
Figure 5.43 Dynamic strain readings in span 2 – path C

Figure 5.43 shows the readings for the span 2 girders (except girder 4, for which the instrument delivered unreliable data – therefore, those readings have been eliminated). The 194 $\mu\epsilon$ strain reading for girder 10 was the highest of all the dynamic tests performed for this bridge. As compared to the slow test results for the same path and girder (shown in Table 5.12), this dynamic value is barely larger (~3 %) than the 188 $\mu\epsilon$ recorded for the path slow C. Therefore, for this bridge, there was no real impact factor determined experimentally.

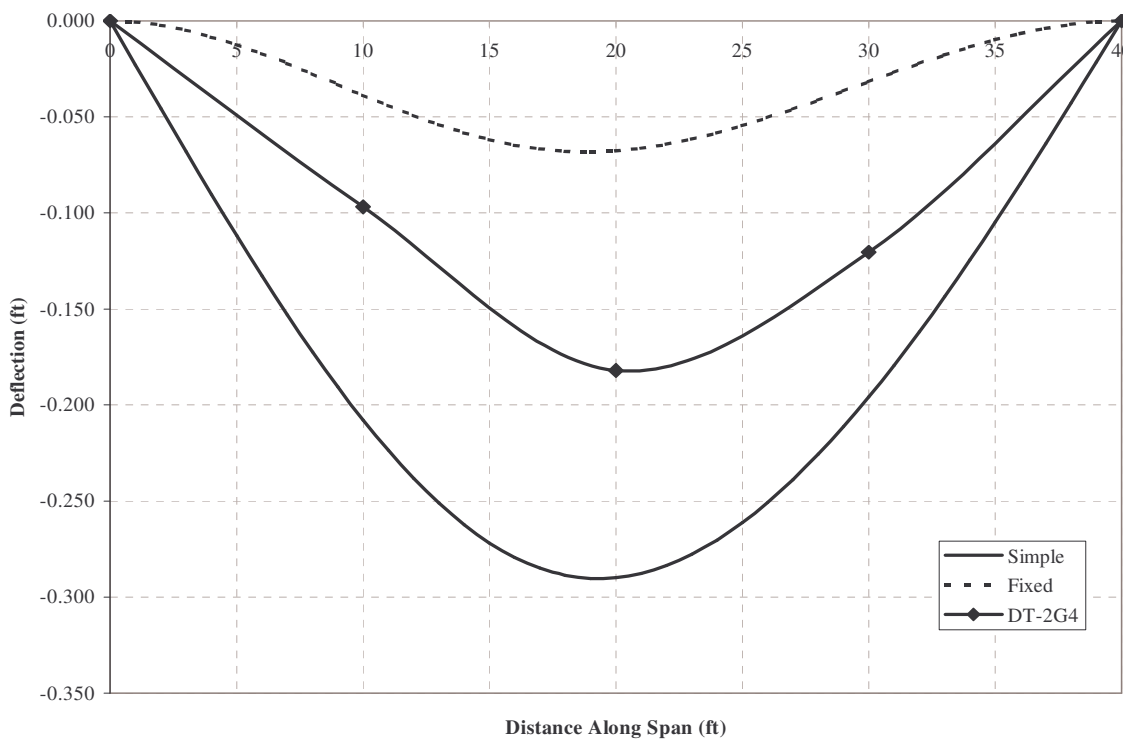
Figure 6.1 Deformation profile of bridge 89-0022

This fact was also confirmed by the compression strain readings at the bottom flanges near the end walls, as well as the tension strain readings at the top flanges. The uncertainties of these end conditions make it difficult to set up a reliable analytical model – as these partial fixities greatly influence the stiffness of the bridges, and lower the flexural demand of the girders around the mid-span.

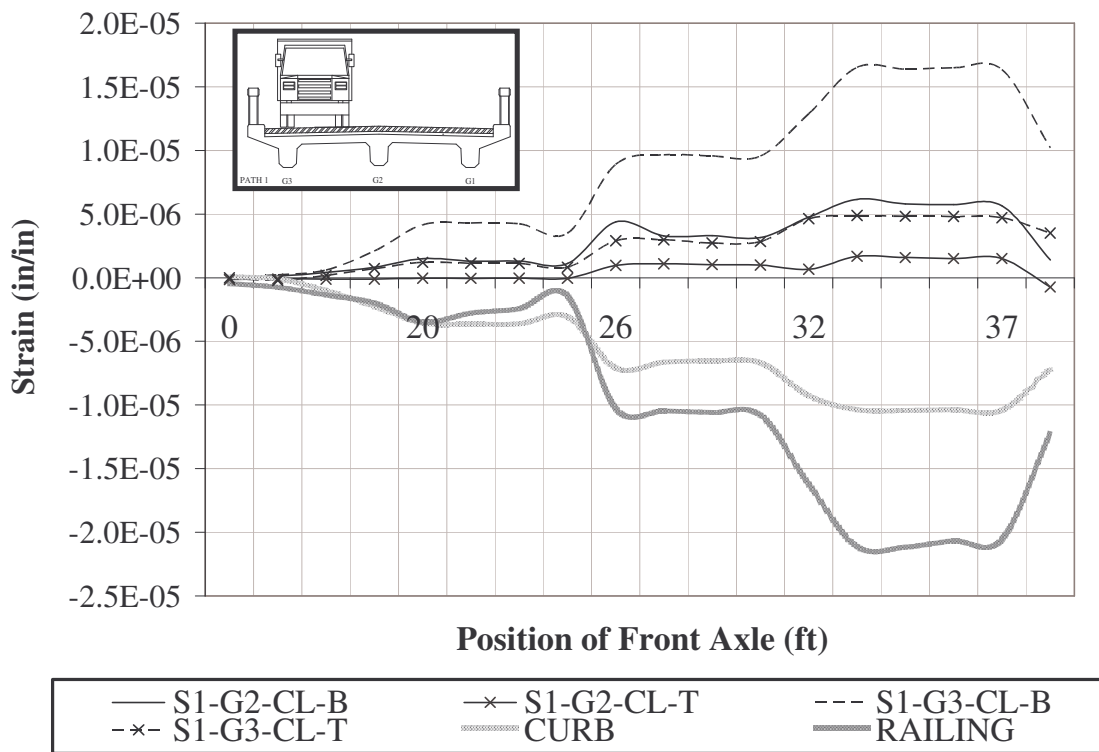
Figure 6.2 Strain readings at midspan – path 1

These relatively large compression members can not be ignored, but they are extremely difficult to incorporate in the analysis or in preliminary calculations. Especially since insufficient details exists on the curb and the rail connection to the concrete deck. Without this information, one could only guess their contribution to the strength and stiffness of the superstructure.

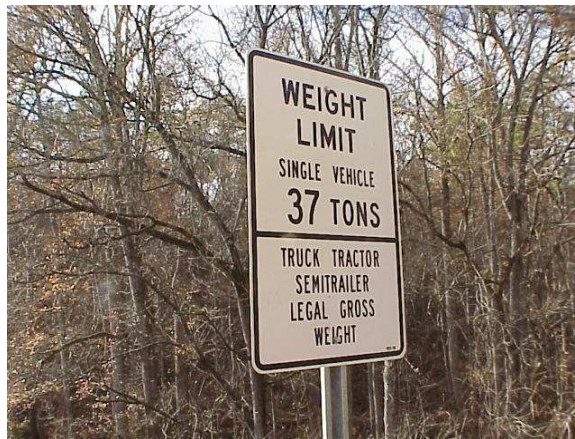
Figure B.1: Load limit sign

The bridge over Mill Creek carrying New Salem Road through its course in Union County was first constructed in 1944. The structure spans 42 feet between masonry abutment walls. The bridge superstructure, steel plank flooring on steel girders, has seen many cars and trucks safely across Mill Creek. This structure has since seen many resurfacings and repairs in its lifetime. As with all structures, time and elements will contribute to weakening of components. County Inspectors began to notice settlement of the approach slab, rusting of the metal deck, and cracks in the concrete. As the structure became weakened, NCDOT posted the span, limiting the amount of load the structure could carry to 37 tons (see Figure B.1).

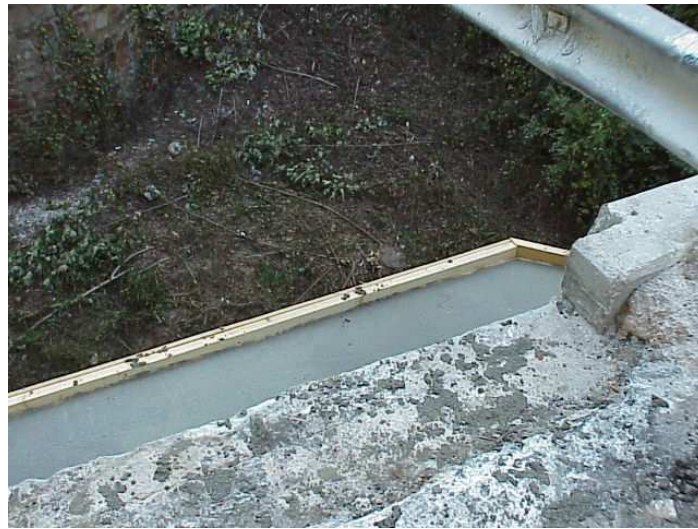
Figure B.2: Bridge seat formed and poured

jackhammer was used to remove approximately 3” of mortar and stone from the bridge seat at each abutment. In addition to the removal of concrete from the bridge seat, concrete was removed from the front face of each abutment as well, which was required due to longer girder length. This concrete was removed with the jackhammer at the East abutment. However, this proved to be a difficult operation and a contractor was hired to cut the concrete along the West abutment wall. This method took about the same amount of time but resulted in a cleaner and more accurate cut. To prepare a level surface for the bearing, a quick set concrete was mixed and placed at both abutments (see Figure B.2).

This concrete type was selected to allow a quick installation. Properly mixed, this concrete sets in 45 minutes and attains a compressive strength of 2000 psi in approximately two hours.

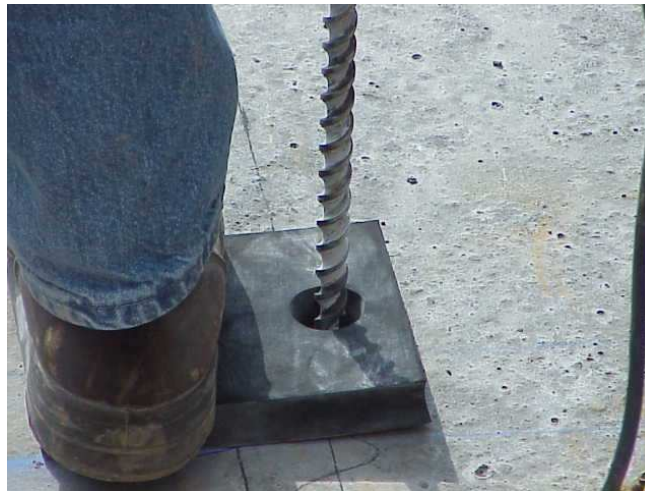
Figure B.4: Bearing pad used as a template for drilling

Due to time constraints, work had to be halted after the holes were drilled in the first abutment. At the start of the next workday the existing holes had to be dried out with a torch due to the presence of water from a previous rainstorm that weekend. Once all the holes were drilled out and dried, an air compressor was used to blow the dust and debris out of the holes. The holes were then filled one thirds full with HIT-HY 150 epoxy/resin. The anchor bolts were placed, sometimes forcibly, into the epoxy filled holes. Care was taken not to damage the threads when more than hand pressure was required to seat the bolts to the depth of the whole (see Figure B.5).

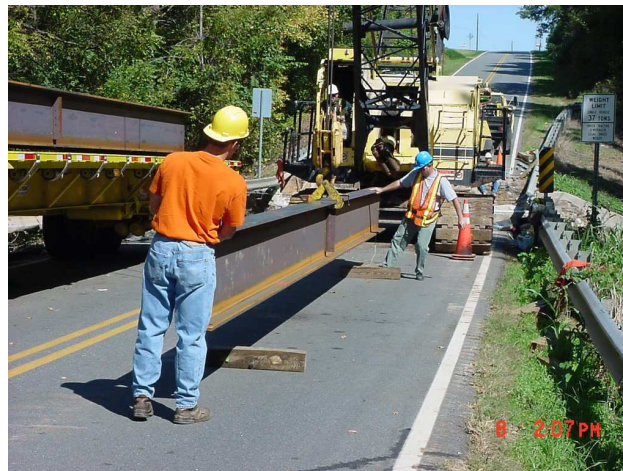
Figure B.6: Girder placement on blocks

After the epoxy had time to cure, the W24X94 steel girders were brought to the site. Using a crane onsite, the center girder (G4) was removed from the truck and placed on blocks to the side of the trailer (see Figure B.6). Blocks were used to protect the strain gages that were previously installed on the bottom of the girder. This girder was then fitted with a “lifeline” that was used for protection when walking on the girders. This girder was lowered carefully onto the anchor bolts allowing workers to snug the nuts and washers onto the bolts. The remaining girders were then placed in the following order: G3, G5, G2, G6, G1, and finally G7.

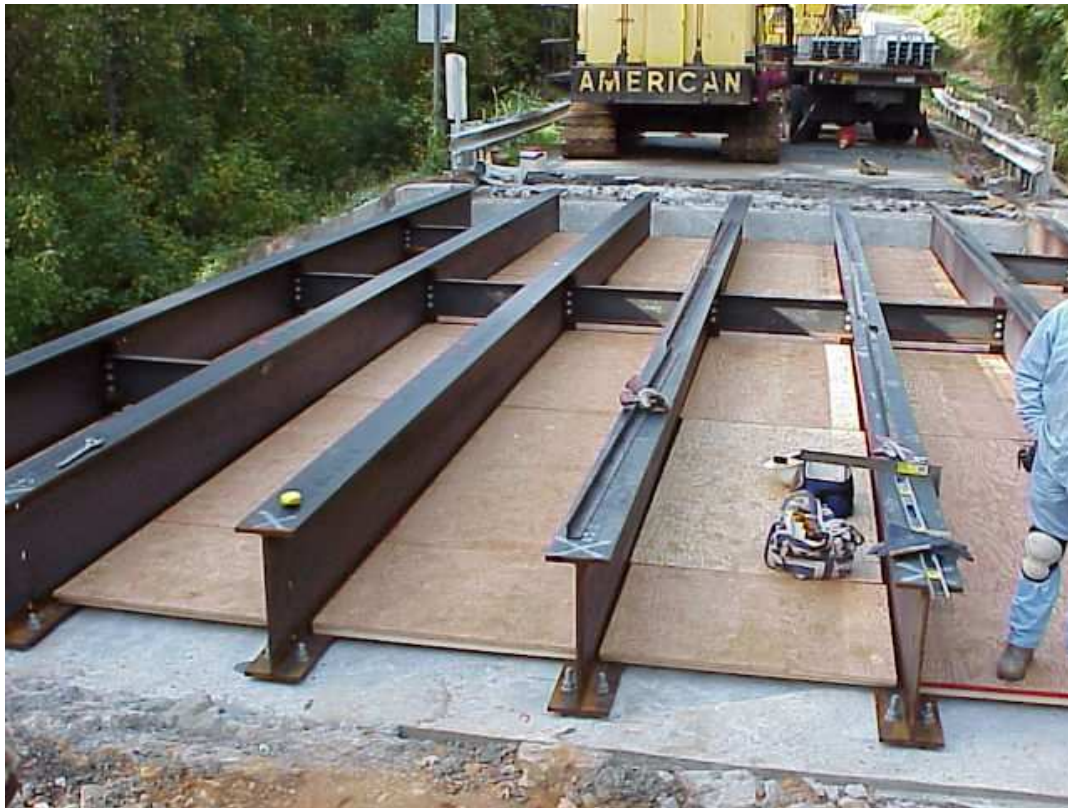
Figure B.7: Girders and temporary flooring in place

Once the girders were in place, plywood panels were cut to fit on top of the bottom flange of the girder. Due to the wide spacing of the new girders some intermediate support was required. This support was provided by 2X4 construction grade studs placed under the panels at the center and at the ends. The panels were attached to the supports using wood screws. Once this temporary flooring was in place, the lifeline attachment was no longer a necessity (see Figure B.7).

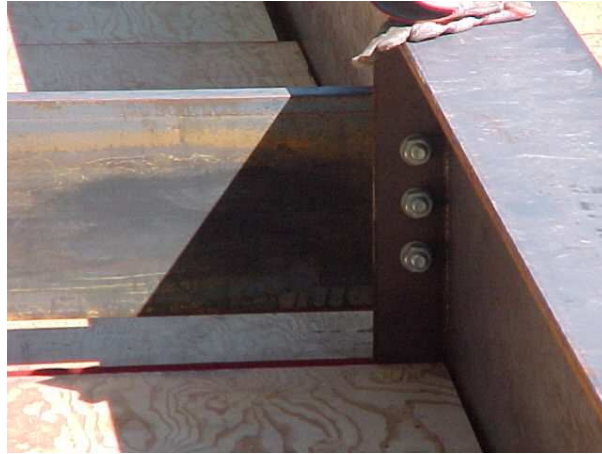
Figure B.8: Diaphragm bolted in place

After the girders were secured, and the temporary flooring was in place, the diaphragms (10 – C12X20.7) were bolted into place (see Figure B.8). The diaphragms were bolted to a 3/8” thick connector plate welded to the web of the girder. For more information on the connector plate, see the Connector Plate Detail on Sheet 2 of the NCDOT Preliminary Bridge Plans supplied in Appendix A. The holes in the girder were located and placed by the fabricator of the girders. For more information on the location of the diaphragm, see the Diaphragm Detail on Sheet 1 of the bridge plans supplied in Appendix A. The connection was made using 7/8” diameter bolts. The bolts were classified as HDG Structural Screws made from A325 steel. They were 3” long and required both a nut and a washer.

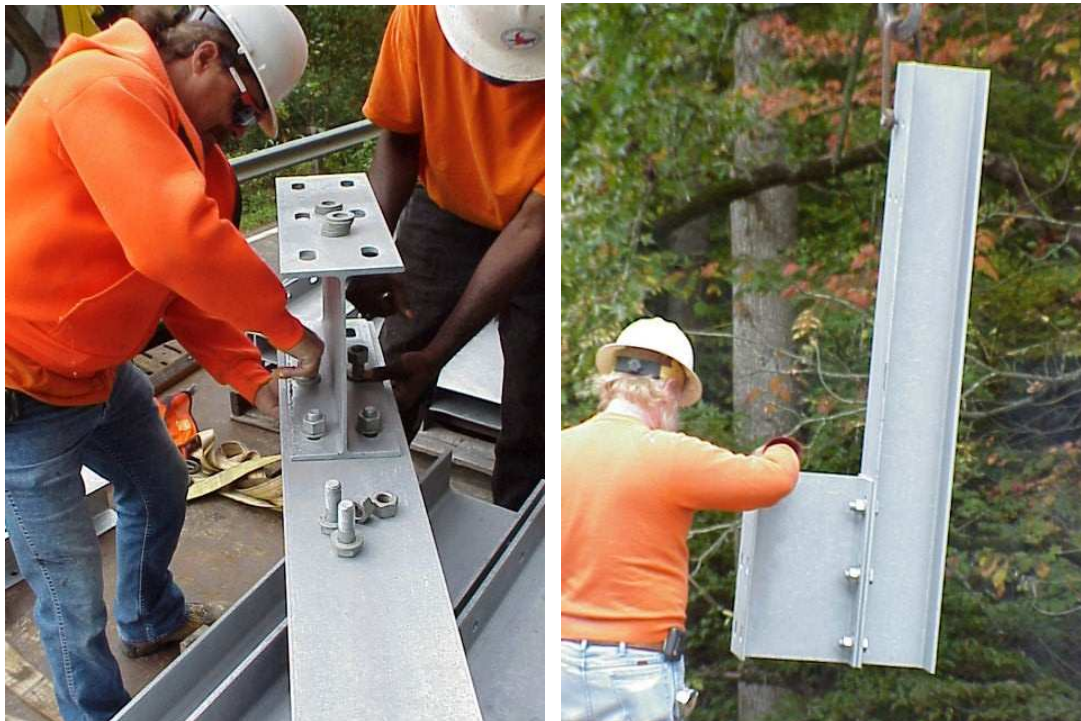
Figure B.9: Post and block assembly

After the cross members were in place, two events occurred simultaneously. First, the posts and blocks used to attach the barrier rail were installed on the exterior girders. These members were pre-assembled on the back of a boom truck and lowered into position (see Figure B.9). The same type of bolts used in the cross member connection, were used to secure the post and block to the girder.

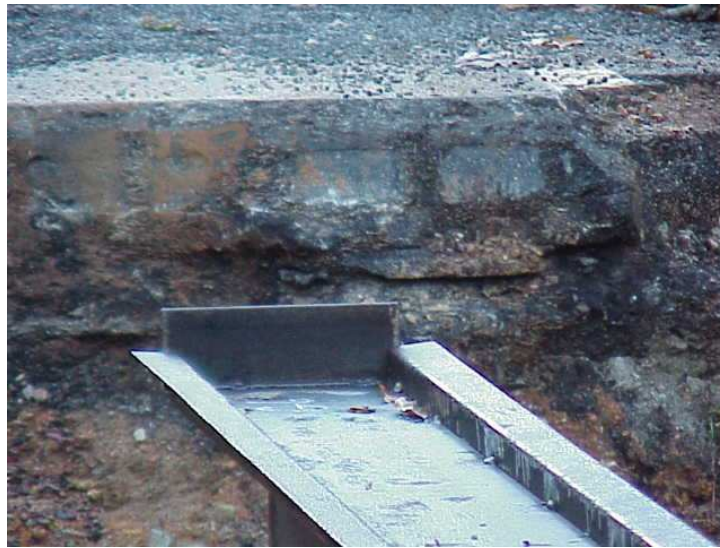
Figure B.10: Angles at end of girders

The process of placing the panels began with the installation of angles at the east end of the girders. These angles were welded in place to allow the end of the FRP panel to fit flush with the end of the steel girder (see Figure B.10).

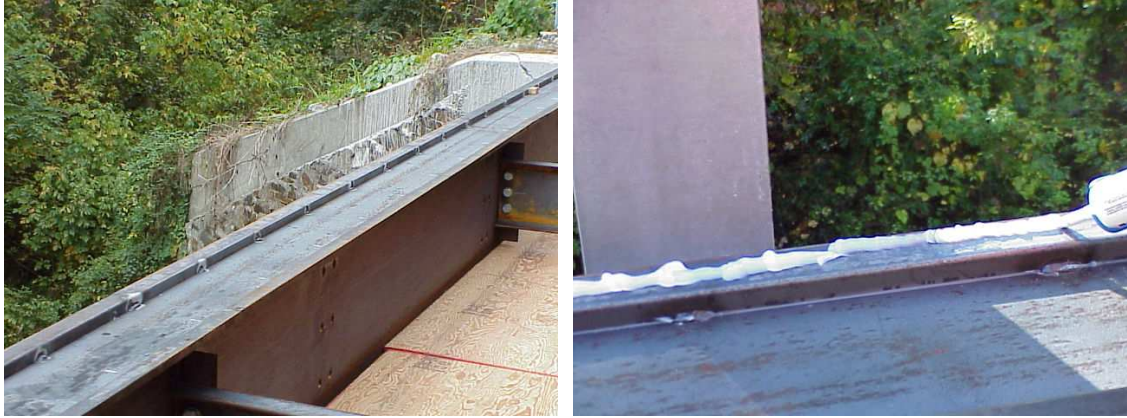
Figure B.11: Caulk being applied to angles

A standard silicone caulk was used to seal any gaps between the longitudinal angles, and the girder. The same caulk was placed on the top of the longitudinal angles to act as a sealant between the FRP panel and the angle (see Figure B.11). The purpose of making the seal was to prevent grout from escaping the shear stud pockets, thus creating a void in the concrete.

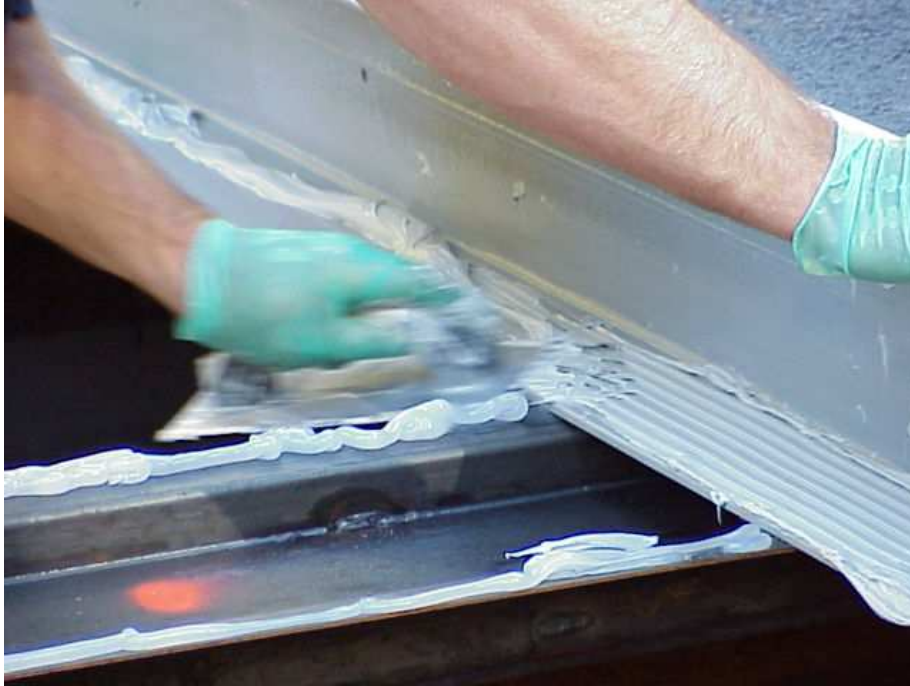
Figure B.14: Epoxy after spreading

After the first panel was positioned, the next panel was prepared for assembly. This preparation consisted of first attaching the lifting straps. Secondly, epoxy was mixed to create a permanent bond between the panels. The epoxy was mixed with the same ratio as the primer, and thoroughly mixed using the same electric drill. Once mixed, the epoxy was applied to the male end of the next panel to be installed, and to the female end of the panel already positioned on the girders. The epoxy for the female end was placed on the "bottom lip" of the bonding surface only. See Figure B.12 for joint details. On both panels, the epoxy was initially placed using a flat trowel, then spread using a 1/4" grooved trowel (see Figure B.14).

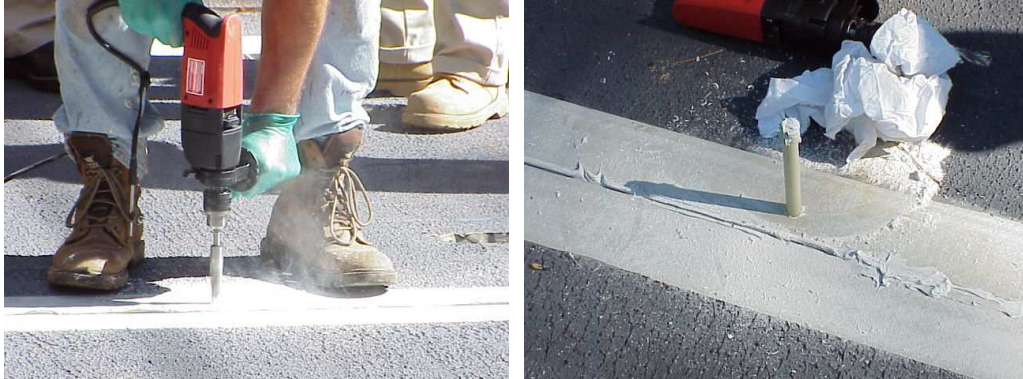
Figure B.16: Dowel Placement

While the jacks were holding the pressure, a 5/8" hole was drilled through the panel joint at a point roughly centered between two girders (see Figure B.16). The holes

were drilled between girders G1 & G2, and between G6 & G7. Then, an epoxy coated composite dowel was driven into the hole to secure the two FRP panels while the adhesive cured (see Figure B.16).

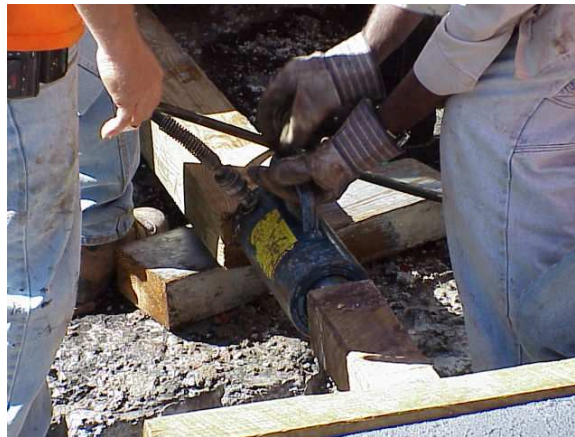
Figure B.17: Jack Placement at End Panel

Once the dowels were in place, the jacks were released and the temporary angle braces removed. This process of epoxy application, panel placement, jacking, drilling and doweling was repeated for all the remaining panels. The jacking of the last panel required some modification. The last panel covered the ends of the girders, so the jack brace could not be welded to them. A brace was made from scrap wood on-site to transfer the jacking force to the approach pavement (see Figure B.17).

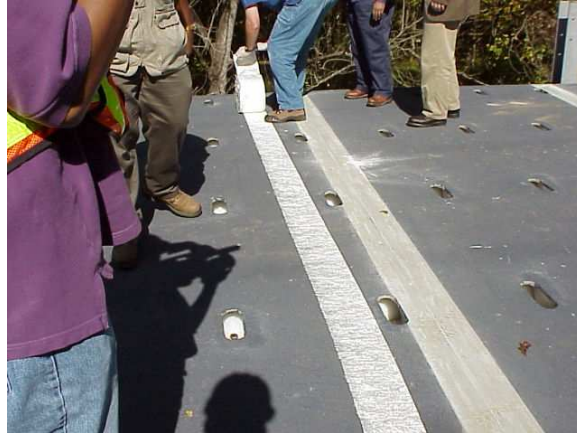
Figure B.18: Joint tape rolled out

The next step was the measurement of the fiber strips. The material for the strips was brought to the site on a large spool. The spool was unrolled across the width of the deck panel and cut, allowing for an overhang at the ends (see Figure B.18). The material itself was a triax E-glass fabric produced by Johnson Industries. The triax term comes from the direction of the fibers in the fabric. The fibers were oriented in a [90/+45/-45] pattern. This material was placed over the deck panel joint and bonded in place with a vinylester material (Atlac 580). This material was chosen due to the flexibility of the material.

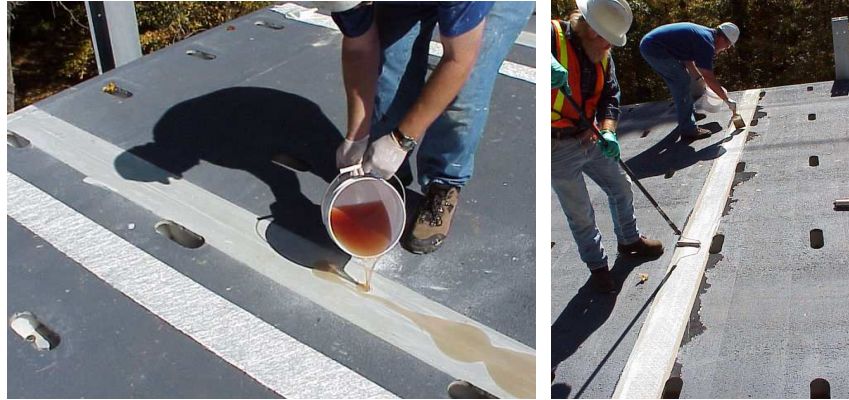
Figure B.19: Resin Application

Once mixed, some of the resin was poured onto the deck joint. The material was then spread out in a thick layer over the area where the fabric would be placed (see Figure B.19). Then, the fabric was placed over the joint. A grooved steel roller was used to press the material into the underlying resin (see Figure B.19). Another layer of resin was then brushed on the top surface of the fabric. This process resulted in the material being completely soaked, and in full contact with the panels on either side of the joint.

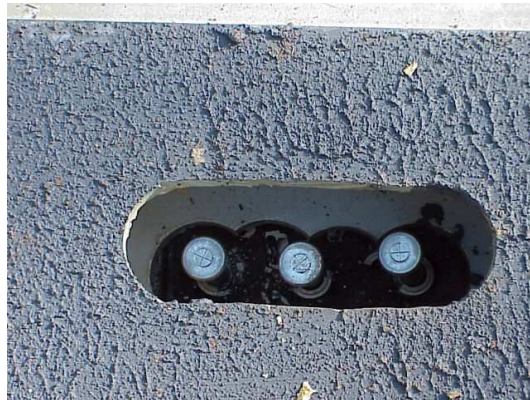
Figure B.20: Shear stud pocket

Once the panels were completely connected to each other, the connection between the panels and the deck was established. This connection was achieved through the use of shear studs. The deck itself was manufactured with pockets along the length of the girder, which allowed the placement of shear studs. Each pocket was designed to have three $\frac{3}{4}$ " diameter shear studs (see Figure B.20).

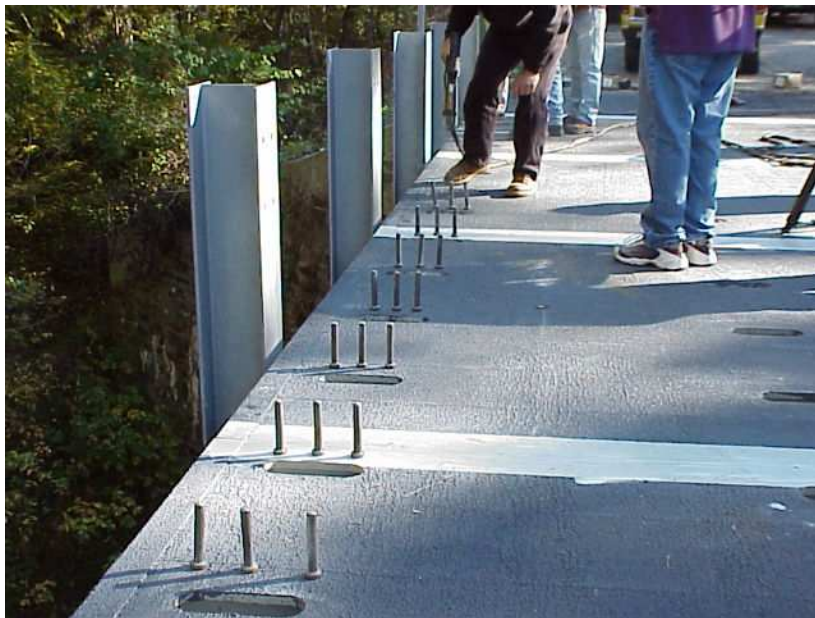
Figure B.21: Studs arranged for welding

With the amperage set, the studs were positioned in place to allow the welder to move quickly from one pocket to the next. Insulators, which are used to keep the heat produced from the weld localized to the stud, were placed in the pocket at each location a stud was desired. The studs were set besides each opening (see Figure B.21) resulting in an efficient installation procedure.

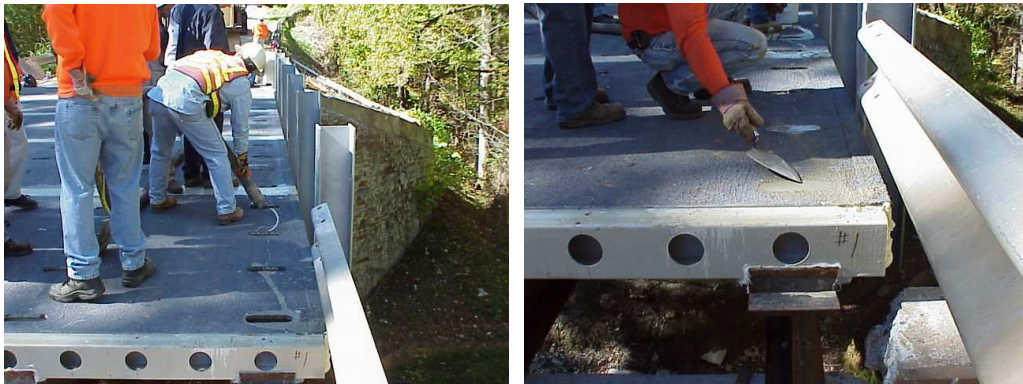
Figure B.22: Grout placement and finishing

Once the studs were in place, the next step in the connection was the placement of the grout in the stud pockets. The grout pump was primed with Slick Willy to promote a better flow of the grout. The grout itself was mixed in a gasoline powered rotary mixer at a ratio of 50 lbs of grout to ½ gallon of water. The materials were allowed to mix for approximately 10 minutes before being placed in the hopper of the pump. The NCDOT personnel placed several batches of the mix into the pump before starting the process to ensure an adequate supply. After checking the slump of the mixture, which was approximately 11”, the process was started at the girder line farthest from the pump. Each pocket was filled to deck level before moving to the next pocket in the girder line (see Figure B.22). The crew noticed that as they worked down the line, previous pockets had settled down below deck level. These pockets were back filled manually, using a bucket of grout and a trowel (see Figure B.22). According to the manufacturer, the grout had a setting time of three hours, and a curing time of one day.

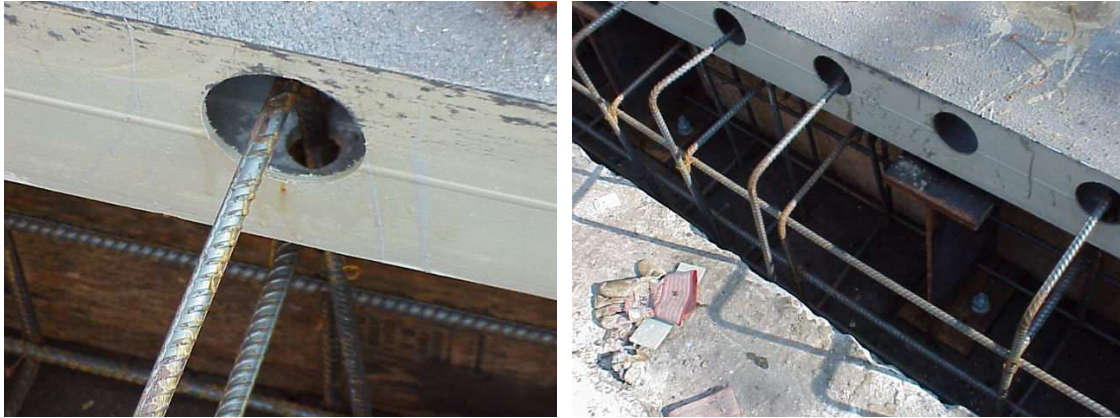
The next step in the construction of the bridge was the construction of the concrete end wall. The end wall was designed to be semi-integral with the deck slab, i.e. the deck would be tied to the concrete abutment. This tie was made through the use of rebars passed through holes pre-cored in the deck (see Figure B.23). The reinforcement was then tied into the cage placed around the girders and bearing pad.

Figure B.23: Endwall Connection

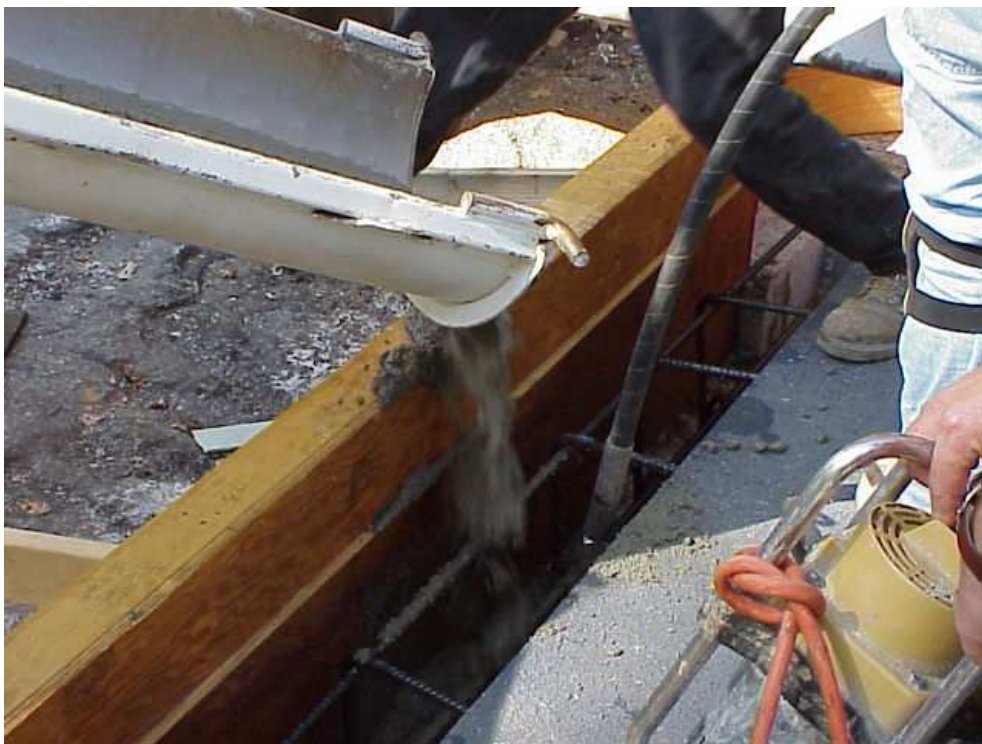
Metromont Materials supplied the concrete. Two trucks were required, one at each abutment. The first truck arrived at the West abutment with 5 yards of class AA concrete. The concrete was poured directly from the truck into the forms. A mechanical vibrator was used to remove any trapped air from the mixture as it was placed (see Figure B.24). The surface was hand finished using a trowel. The same process was repeated on the East abutment. In order to test the 28-day strength of the mix, three cylinders were collected from each truck. The samples were taken in accordance with ASTM C31-91.

Figure B.24: Concrete Poured at Endwall

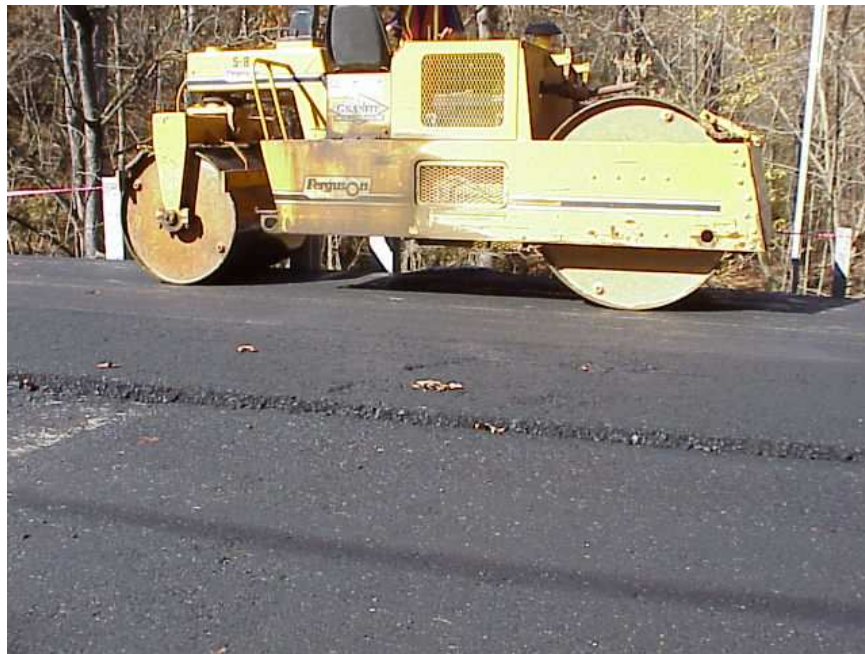
Once the superstructure was finished, the next step in the construction process was to prepare the approaches to the bridge. The area surrounding the end walls had been excavated to allow access to the abutment. Therefore, the soil had to be replaced and compacted in those areas. Once the soil was in place, the structure was ready for the asphalt pavement. The I-2 asphalt was placed in 2" layers (or lifts). Three layers of binder were placed in the approaches to raise them to the desired level. After placing three layers of binder in both approaches with a layer on the deck of the bridge, crews began to place the asphalt. Each lift of binder and asphalt was compacted by a vibratory drum roller before the next layer was applied (see Figure B.25).

Figure B.25: Vibratory Drum Roller

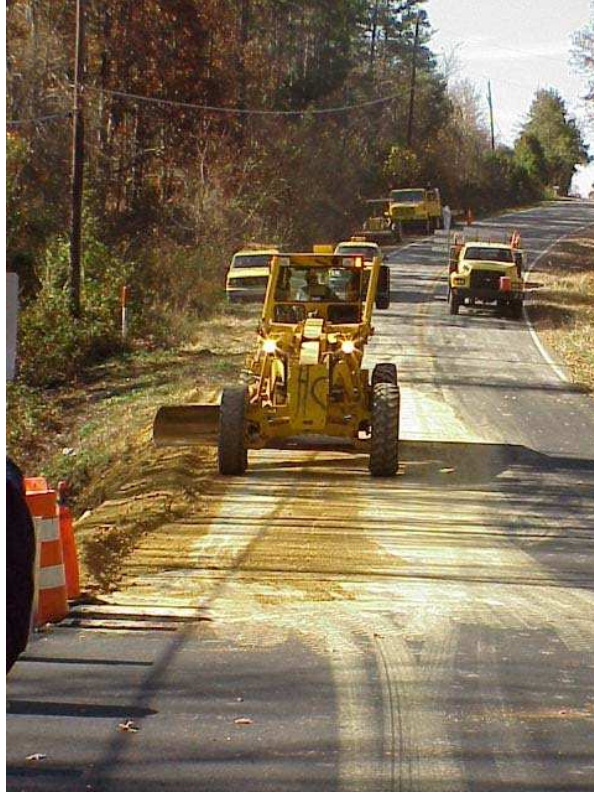
With the raised level of the approach, some grading was required to bring the shoulder of the road up as well. In order to set the new shoulder height, the existing barrier rail had to be removed. Soil was placed along the side of the road and leveled out with a motor grader (see Figure B.26).

Figure B.26: Motor Grader Finishing the Shoulder

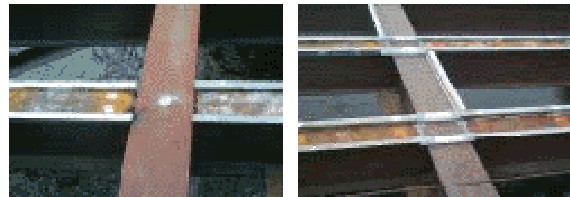
Steel flanges on stringers and floorbeams shall be prepared in accordance with DOT specifications, including grinding at stud locations if necessary. Light gauge stay-in-place steel angles are the preferred method of forming the haunches. These are the same angles that are used for the stay-in-place forms for concrete decks and shall be designed to support the weight of foot traffic, deck, and construction loads. Typically elevations are shot at 1/10th points along the beams and the height of the haunch is determined by subtracting this elevation from the finished grade elevation minus the deck and overlay depths. On framing systems that have a transverse floorbeam/longitudinal stringer configuration as shown, the angles will be typically be installed on the stringers only but the haunch will be continued over the floorbeams as shown. On the job shown, this was accomplished with screws and tape.

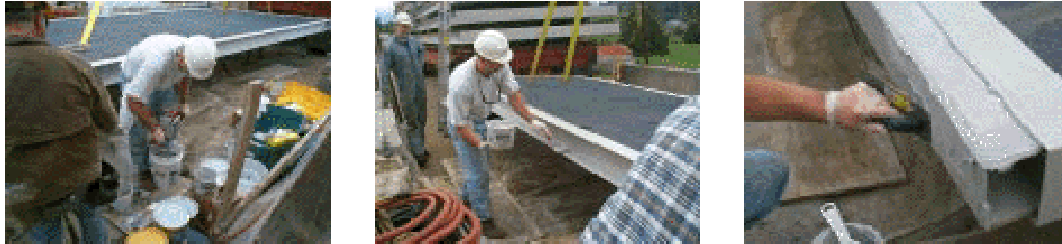
Prior to application of the adhesive, both surfaces of the bondlines shall be cleaned with acetone. A liquid primer will be rolled on to both mating surfaces (100% coverage) and allowed to tack up. Upon sufficient set of the primer coat, the paste coat will be applied on the vertical web and flanges (100% coverage on one side of the joint only) using 3/16" notched trowels. MMC will supply the adhesive (probably 3-4 gallon buckets) and the contractor will apply it. MMC will keep track of temperature and time to ensure proper working time is not exceeded. Working time will vary depending on temperature, but in general a minimum one hour working time can be achieved.

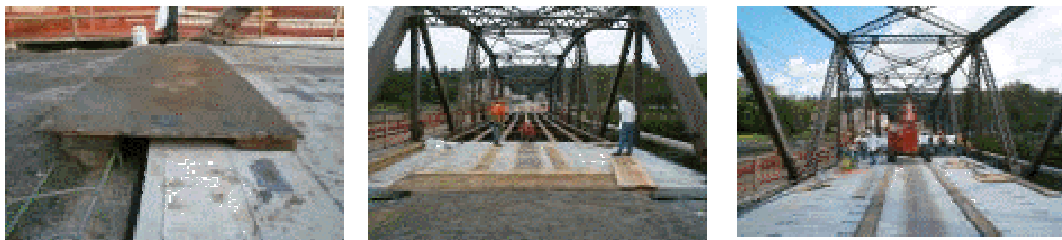
For thru-truss or longer span structures where cranes do not have sufficient reach to install the panels, panels may be lifted and placed with the lightest weight equipment (typically forklifts) possible. For this type of installation, the specific piece of equipment shall be approved by the manufacturer. In order to help spread the tire load over the wet bondlines, timber/steel planking running the full length of the tire contact area will be required as shown in the following pictures. A steel plate (or other acceptable means) shall also be placed at the beginning of the bridge to protect the unsupported edge of deck during installation.

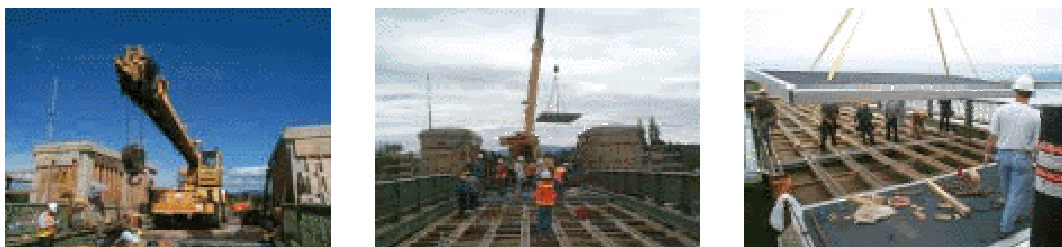
For short to medium span structures, a crane with sufficient reach to place all panels without sitting on the bridge is the preferred option and should be used whenever possible. This method not only protects the integrity of the bondline while it cures but also allows for smaller angles and welds to be used for the haunches.

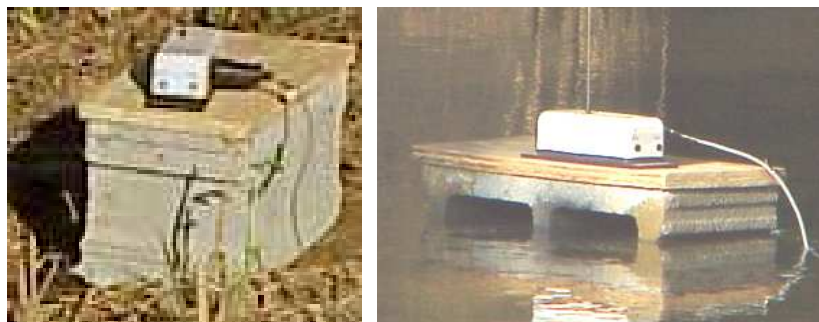
The Celesco displacement transducers used in this project utilize a voltage source to record displacement by measuring the change in resistance of the potentiometer. The displacement transducers were calibrated by UNC-Charlotte Cameron Research Facility's Metrology Lab to an accuracy of ± 0.01 in. Each instrument had a maximum stroke of 20 in. Figure C.1 shows several views of displacement transducers mounted in position. Since the instruments required a stable base, especially on uneven ground, a concrete masonry unit with an attached plywood-mounting strip was used.

Figure C.1 Mounted 20 in. displacement transducers

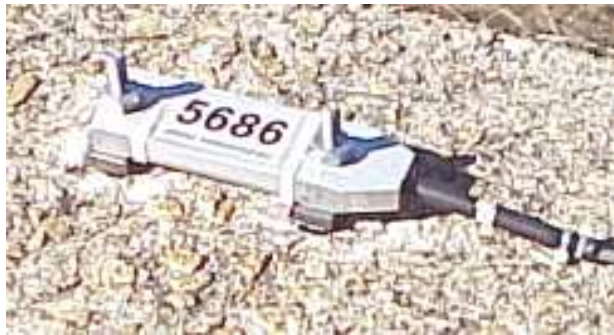
range of $\pm 4,000$ microstrains ($\mu\epsilon$). There were two mounting possibilities for these instruments. The preferred method was using two mounting tabs attached to the surface of the bridge member at the predetermined location (see Figure C.2). These tabs required that the surface be free of soil, debris, rust, and paint. Therefore, each location was grinded down to ensure a smooth, clean surface to adhere the tabs. The tabs were adhered using either a two-part epoxy, or Loctite's 410 Adhesive and 7452 Accelerator.

Figure C.2 Strain transducer

However, the performance of these adhesives was dependent on the current atmospheric conditions. Cold and rainy days made the curing process extremely difficult to control. Therefore, in cases where it was necessary and possible, c-clamps were used to secure the instruments to the bottom flanges of steel girders.

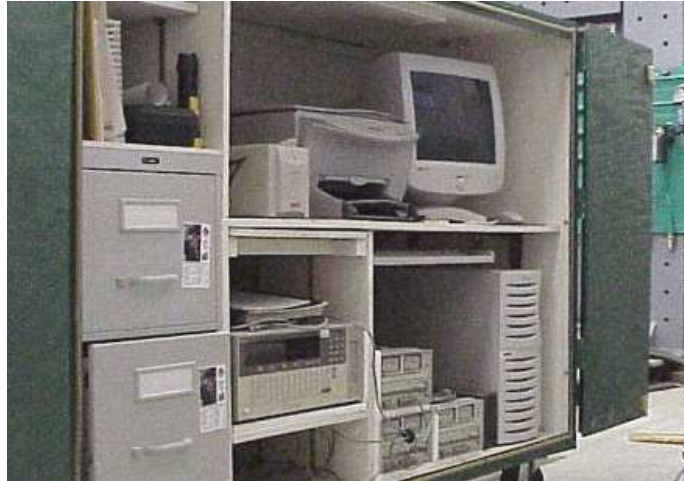
Each of the previously described instruments was connected to a numbered data cable that ran to the data acquisition (DAQ) system. The DAQ was a system consisting of an HP mainframe and digital multimeter, a dual processor Gateway server (see Figure C.4), and power supplies. Each numbered cable (ranging in length between 80 ft and 180 ft) was then plugged into a designated channel, which read the gathered information into a data acquisition computer program. At maximum, 112 instruments were used at one of the bridges

Figure C.4 Data acquisition system

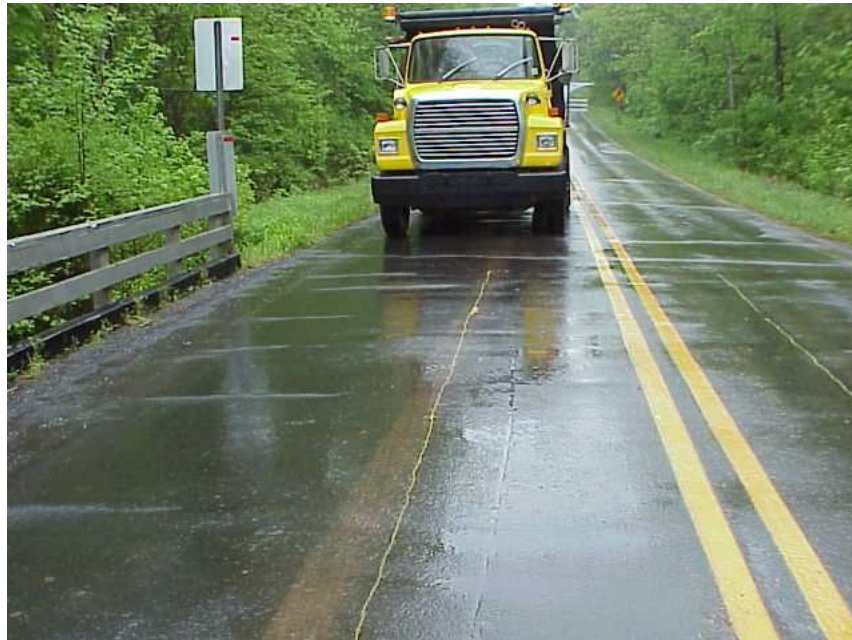
The second truck type was a NCDOT tandem truck loaded with aggregate at different levels (see Figure C.10). This loading system resulted in gross weights between 18 to 25 tons, close to most of the posting levels of the bridges considered. For bridge 59-0841 two of these trucks were used to simulate the effects of the governing lane load (for all of the other bridges truck loads governed the design and analysis).

Figure C.10 Tandem truck loading bridge 89-0219

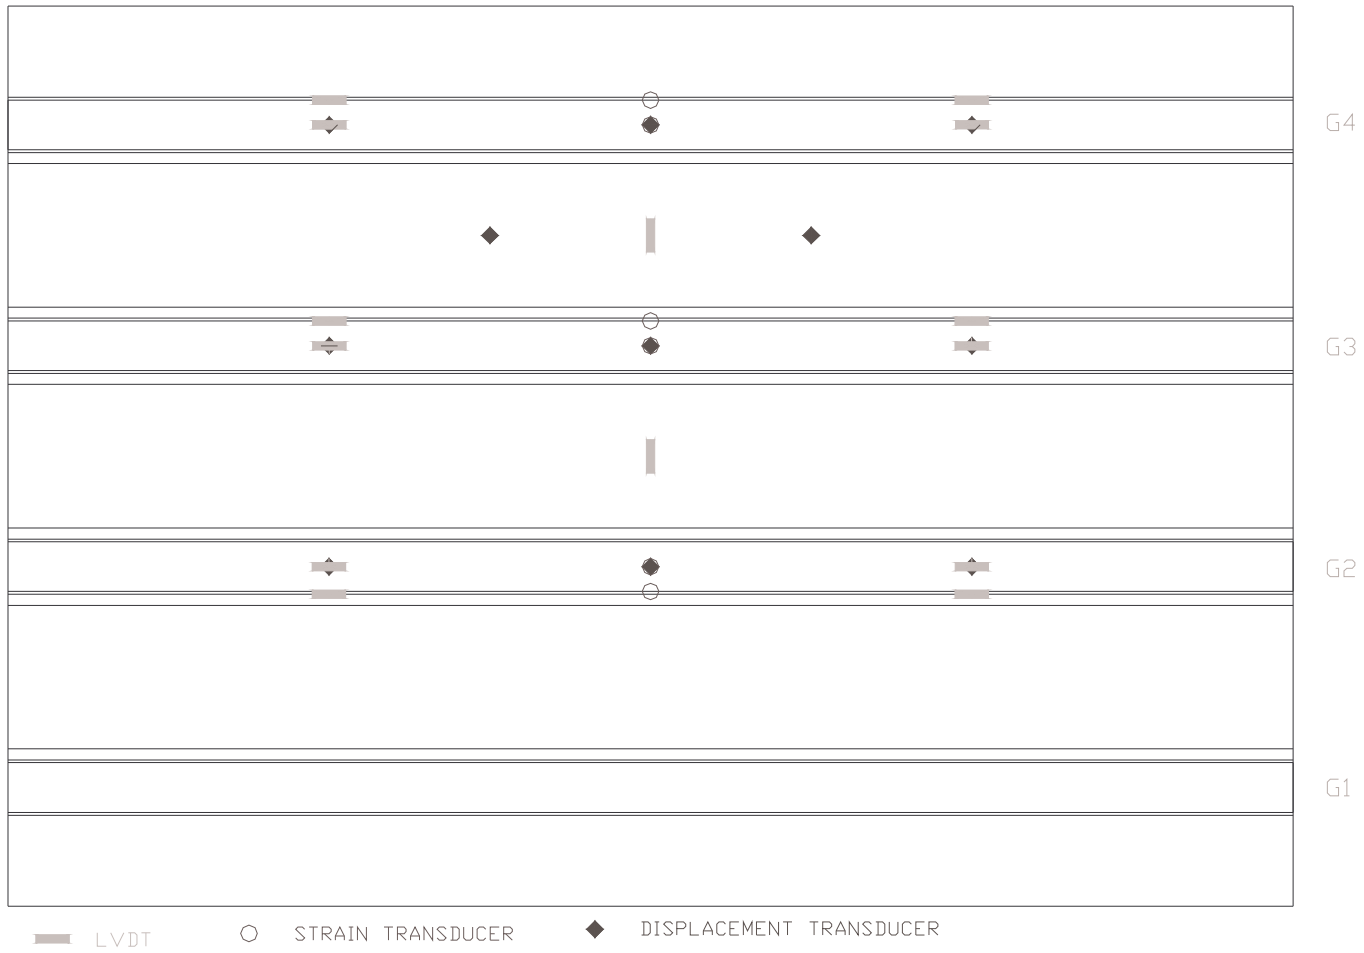
Figure C.17 Instrumentation on Span 1

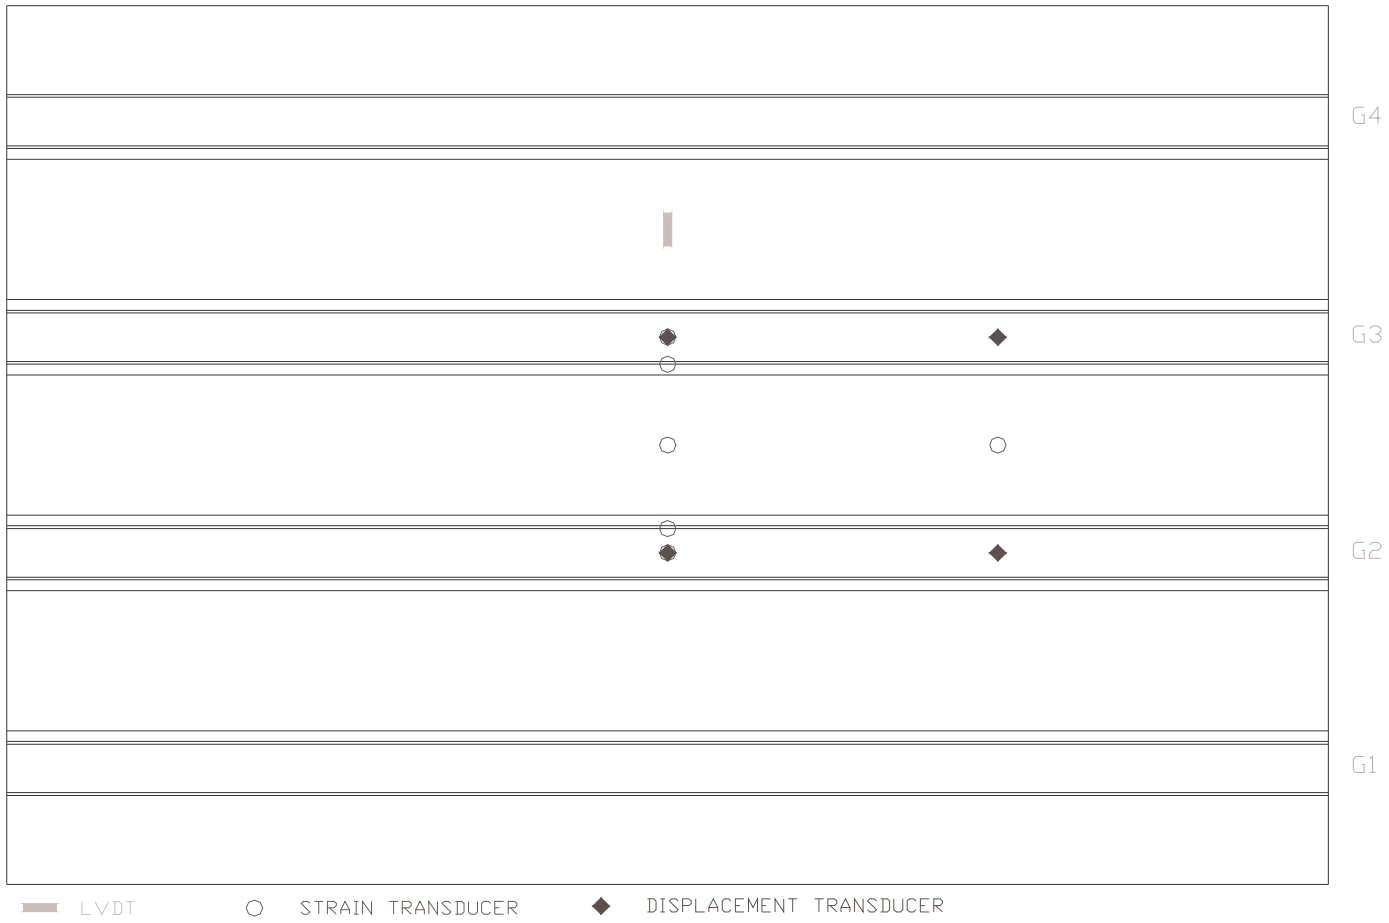
Figure C.18 Instrumentation on Span 2
