Final Report  
**MONITORING THE EFFECTS OF HIGHWAY CONSTRUCTION IN THE  
SEDGEFIELD LAKES WATERSHED**

September 15, 2006

1. Report No. <b>FHWA/NC/2006-07</b>	2. Government Accession No.	3. Recipient's Catalog No.	
4. Title and Subtitle <b>Monitoring the Effects of Highway Construction in the Sedgefield Lakes Watershed</b>		5. Report Date <b>September, 2006</b>

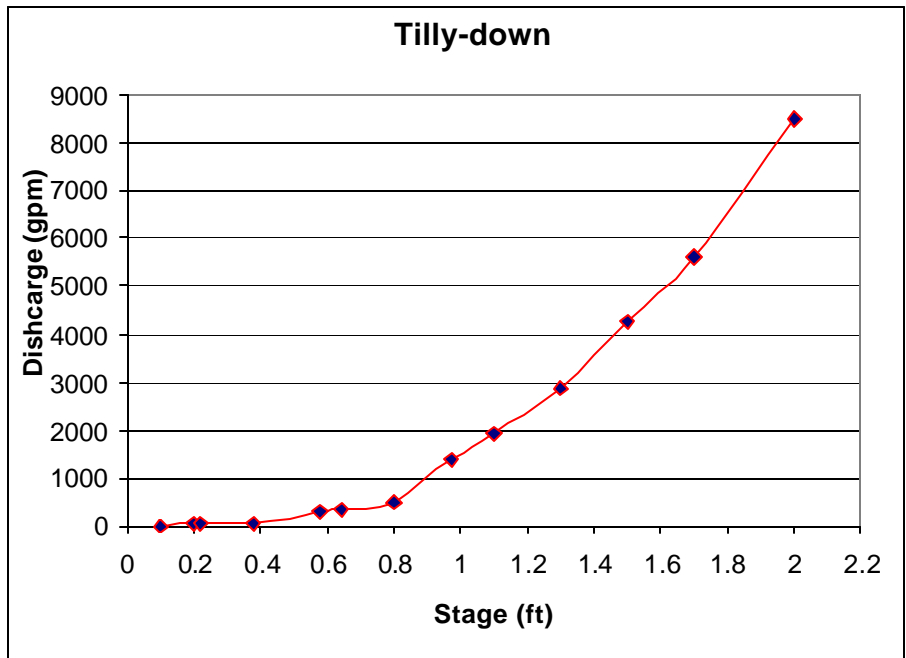
**Figure 3. Tilly-down stage-discharge rating curve.**

The Tilly-down site was located just upstream of the lake (N36' 2.0"; W79' 53.6") on the Tilly tributary (fig. 2). The channel was too wide and deep for a weir, so a staff gage was installed and a stage-discharge relationship developed for the site (fig. 3). This relationship was developed from several standard discharge measurements using a pygmy current meter and continuous depth and velocity measurements made with the automated sampler. The stage-discharge relationship was entered into an automated sampler thereby allowing it to convert its continuous stage measurements into discharge. Flow proportional samples were collected based on the discharge measurements.

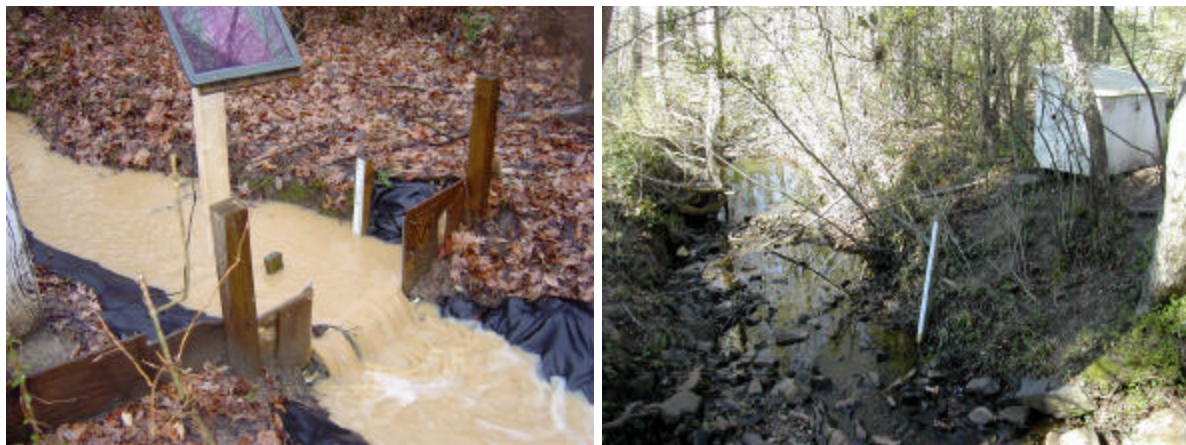
**Figure 4. Ellery-up (left) and Ellery-down (right) monitoring sites.**

The Ellery up site was located (N36' 2.28"; W79' 53.5") just downstream of the highway corridor along a relatively stable and straight reach of an intermittent channel of the Ellery tributary. The site was equipped with a 2 ft rectangular weir, an automated sampler with a bubbler flowmeter (fig. 4). A standard weir equation was used to convert water stage measurement into discharge. Flow-proportional samples were collected based on the discharge measurements. The Ellery-down site was located just upstream of the lake (N36' 2.18"; W79' 53.6") on the Ellery tributary (fig. 4). The channel was too wide for a weir, so a staff gage was

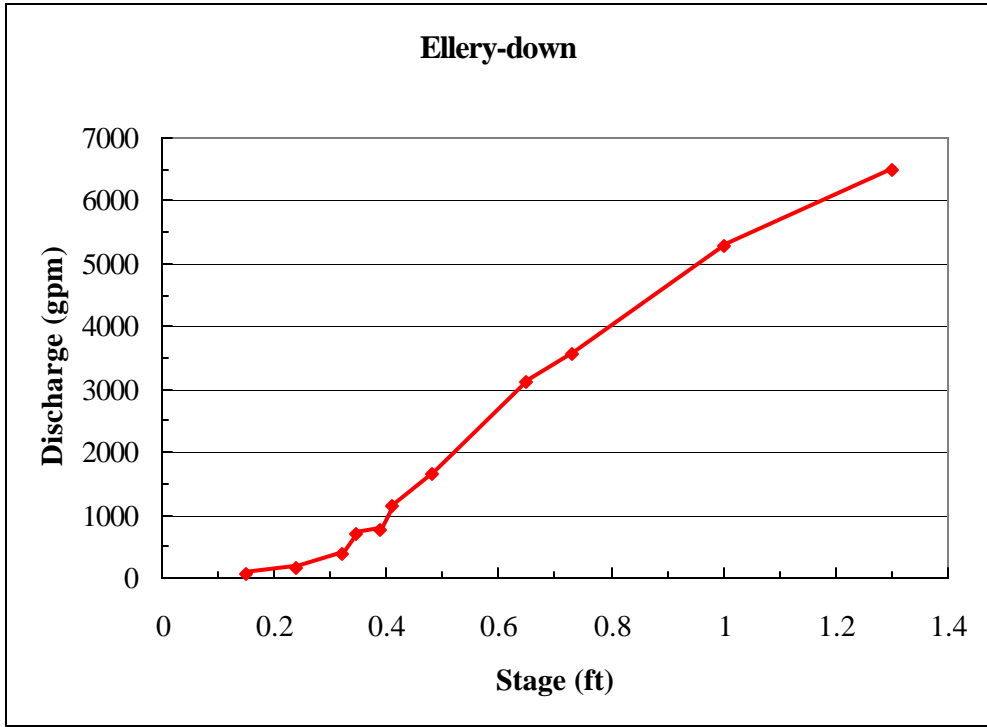
Figure 5. Ellery-down stage-discharge rating curve.

installed and a stage-discharge relationship developed for the site (fig. 5.). This relationship was developed from several standard discharge measurements using a pygmy current meter. These measurements were supplemented with continuous depth and velocity measurements made during several storms with the automated sampler. The stage-discharge relationship was entered into an automated sampler thereby allowing it to convert its continuous stage measurements into discharge. Flow proportional samples were collected based on the discharge measurements.

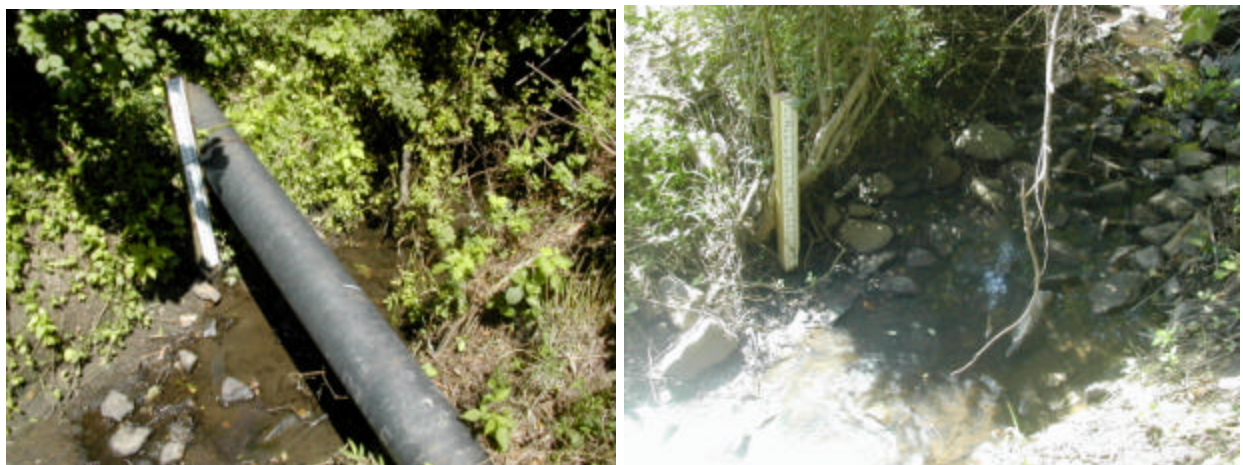
Figure 7. King's Mill up (left) and down (right) monitoring sites.

The King’s Mill monitoring stations, which will be referred to as KM-up (N36’ 1.24’’; W79’ 52.35’’) and KM-down (N36’ 1.19’’; W79’ 52.39’’), were located on an unnamed tributary in the King’s Mill residential area (fig. 6). The two monitoring stations were installed upstream and downstream of the highway corridor after the trees and houses had been removed (fig. 7). Thus, pre-construction hydrology could not be adequately characterized here either, but the drainage area to the upstream station had no highway construction in it, so it could serve as a background or a measure of pre-construction sediment yield for the area. A staff gage was installed at each station and a stage-discharge relationship was developed for each site (fig. 8). The relationship was developed from several discharge measurements made using the standard current meter and supplemented by continuous measurements of stage and velocity made by an area-velocity meter attached to the automated sampler during several storm events.

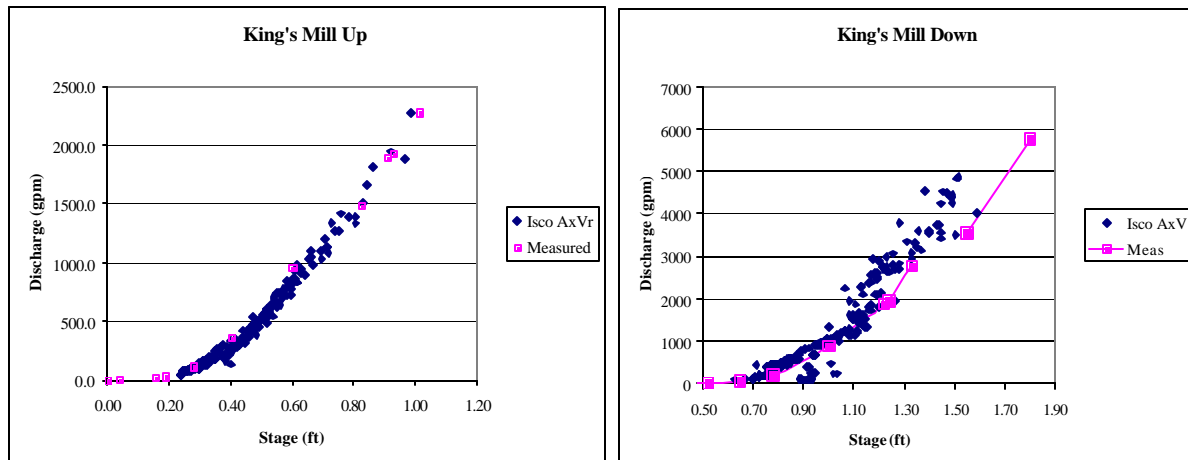
**Figure 8. Stage-discharge rating curve for King's Mill up (left) and down (right) sites.**

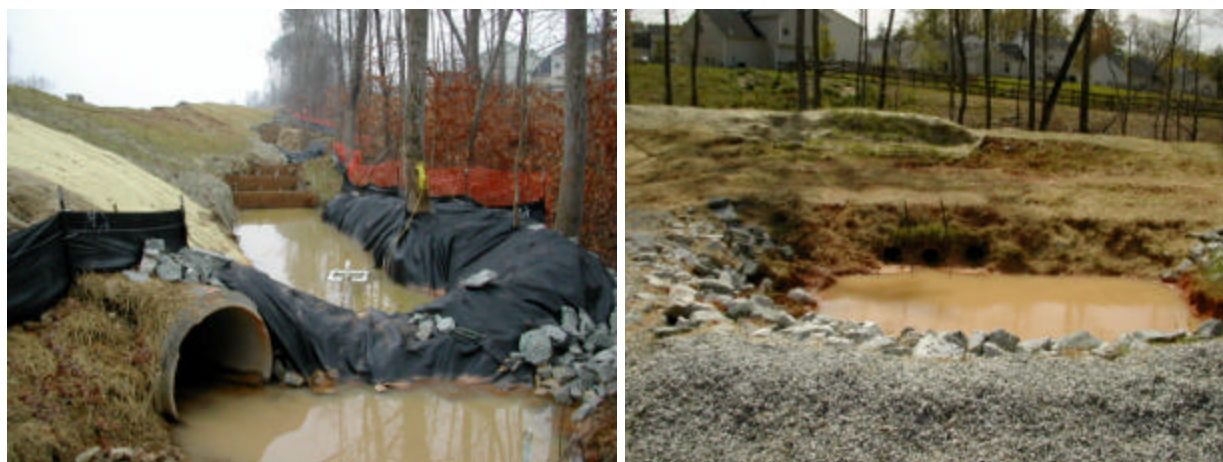
**Figure 9. Additional sediment traps drainage area of Tilly-up.**

within 2 weeks of each other made sediment and erosion control associated with them particularly difficult. The second storm system, while producing about the same amount of rainfall, resulted in more than twice as much sediment loss (see exhibit 1 in appendix). The probability of two tropical systems hitting an area in a three-week period is unknown, but is likely pretty low. During the following month, additional erosion and sediment control measures such as sediment basins and traps and slope stabilization matting (fig. 9) were installed in the drainage area to reduce erosion. Seed and mulch were also applied to the sideslopes of the fill areas so that by April, 2005 the slopes were well vegetated.
