# **Comparison of Mobile Asset Data Collection Vehicles to Manual Collection Methods**

**Institute for Transportation Research and Education**

**NCDOT Project 2011-02**

**February 2013**

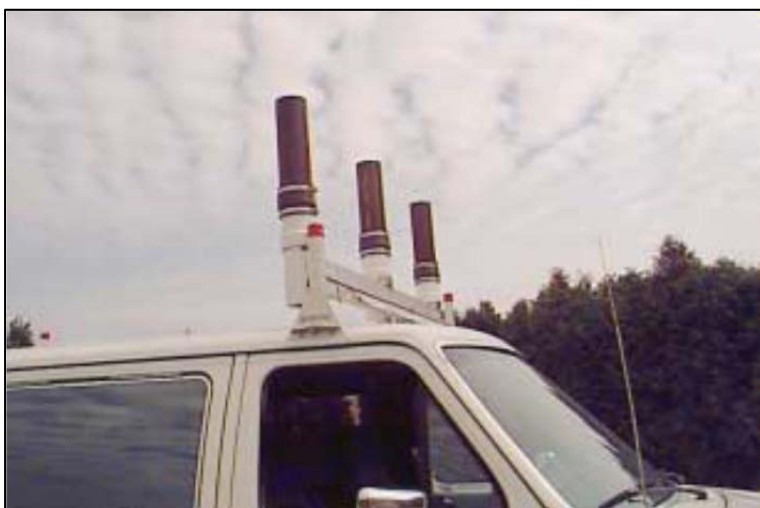
**Figure 1 Device for automated vertical clearance measurement (16).**

A prototype device developed by the Federal Highway Administration (FHWA) was tested to measure vertical clearances of bridge decks (16). The vehicle-mounted device uses a laser and sensor to measure vertical clearances from a moving vehicle. The research concluded that the device’s accuracy did not depend on the reflectivity of the paint covering the bottom of the bridge deck, but rather was dependent on the sensor sampling rate and vehicular speed. A minimum sensor rate of 500 Hz was needed for a vehicle traveling at 50 mph. The equipment used by this prototype device is similar to the technology found in LiDAR systems. Figure 1 displays the device used to measure vertical clearances of bridge decks.

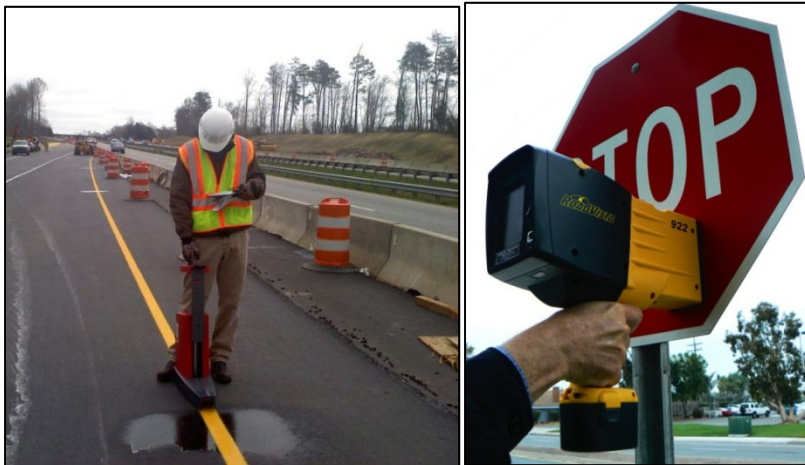
**Figure 4 Manual collection of pavement marking and sign retroreflectivity (24).**

Five study methods are proposed to evaluate and maintain retroreflectivity (23): 1) routine visual nighttime inspections, 2) retroreflectivity measurements, 3) expected life method, 4) the blanket replacement method, and 5) the control method. These five are categorized as assessment methods (1 and 2) and management methods (3, 4, and 5). Assessment methods evaluate individual signs by means of routine inspections and measurements. Method 1, routine nighttime inspection, is the typical method used because it is simple and safe. Method 2, field measurement, is the most accurate method but is time consuming and can be unsafe (see Figure 4). Management methods are used to sustain sign retroreflectivity over time without having to assess individual signs.

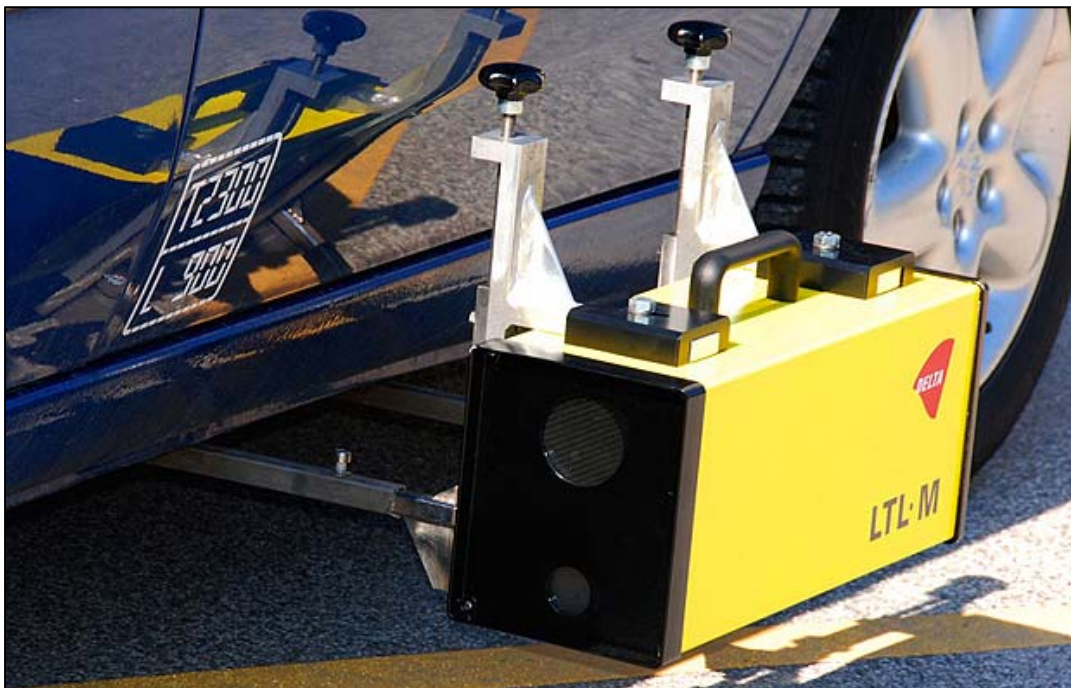
**Figure 5 Mobile pavement retroreflectometer (24).**

With respect to new management methods, there has been extensive research on automated pavement marking and sign retroreflectivity. Regarding pavement marking retroreflectivity, highway agencies have recognized the mobile retroreflectometer unit (MRU) as a safer and more efficient alternative to handheld retroreflectometers. Many times pavement marking retroreflectivity is done in conjunction with automated pavement monitoring efforts. An example is provided in Figure 5.

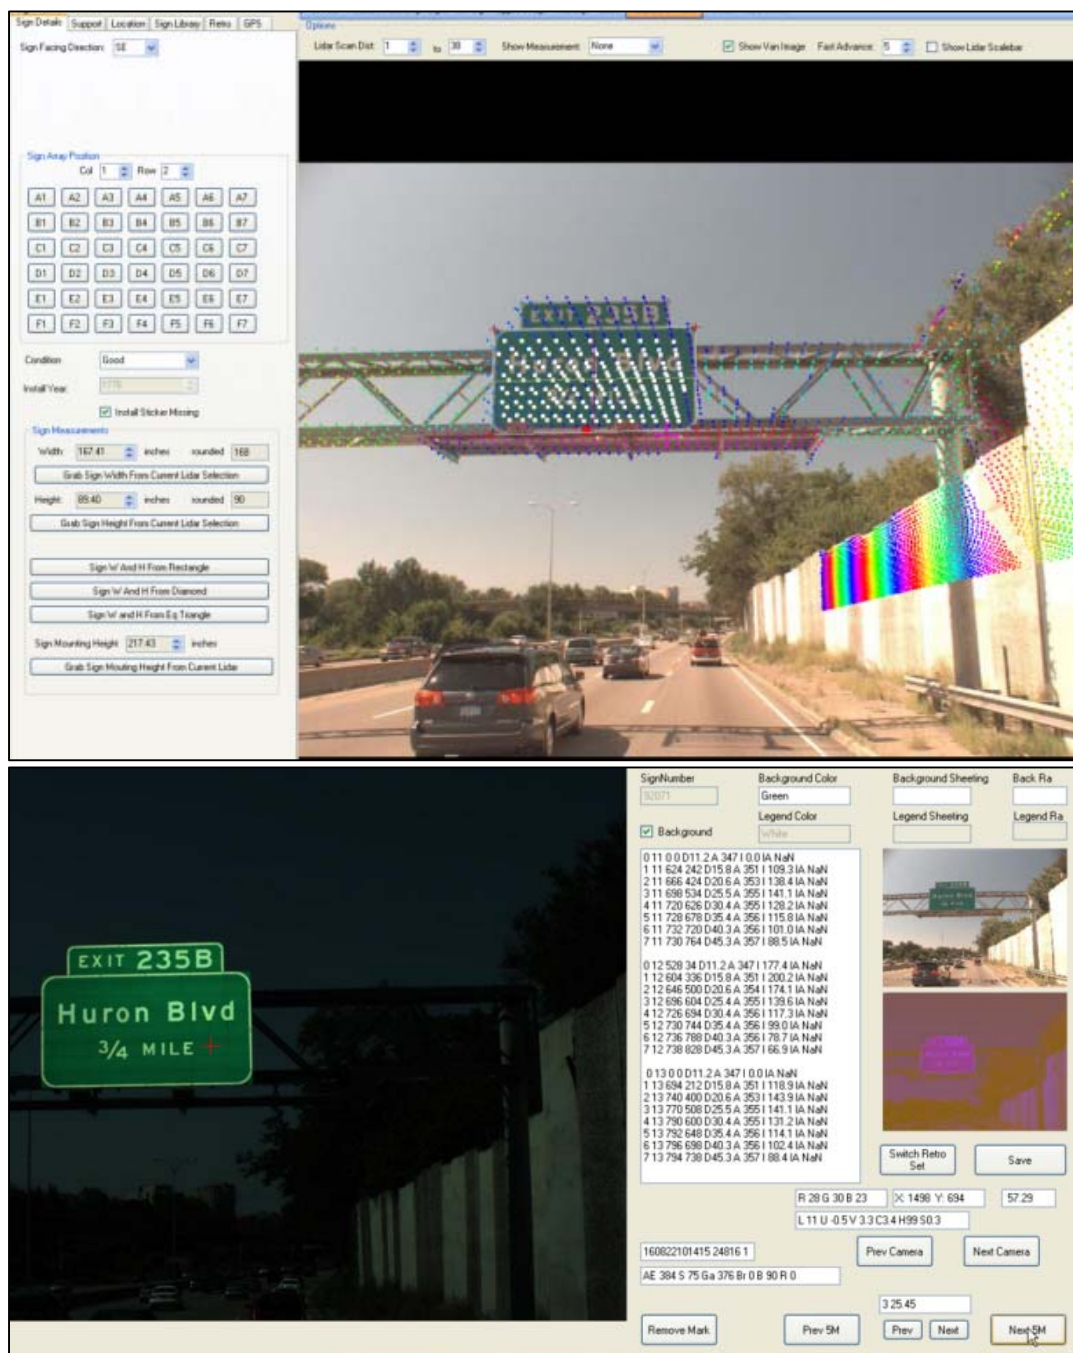
Figure 6 Facet's new sign inventory software utilizing LiDAR and mobile retroreflectometer (24).

have been slow to pick up on this idea, likely due to the very challenging aspects of collecting this element on the move. In addition, with the onset of LIDAR, there may be methods developed in the future that calibrate LIDAR to retroreflectivity measurements. Private vendor's methods that have been produced are mobile but manually operated and results on their accuracy have yet to be formally tested as of this report. An example of Facet's new automated sign inventory, classification, and mobile retroreflectivity software are provided in Figure 6.

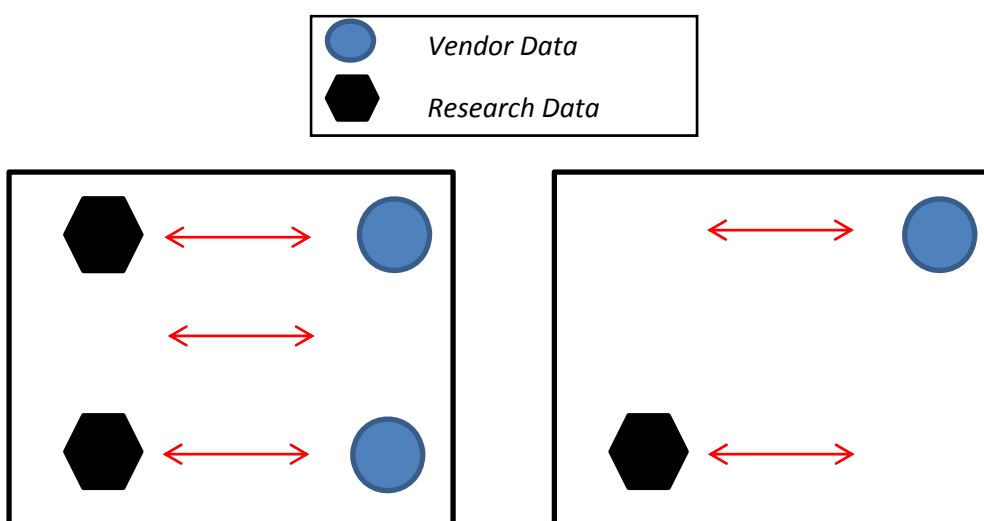
**Figure 20 A) true positives and a true negative (left); B) a false positive and a false negative (right).**

Scenarios 2 and 6 represent errors made by the vendor during data collection. Scenario 2 reflects when the vendor has failed to correctly identify the presence of a data point or line (a false negative). Scenario 6 is a false positive: the asset is not present, but the vendor has incorrectly noted the asset in that location. Scenario 2 and 6 are illustrated in Figure 20B.

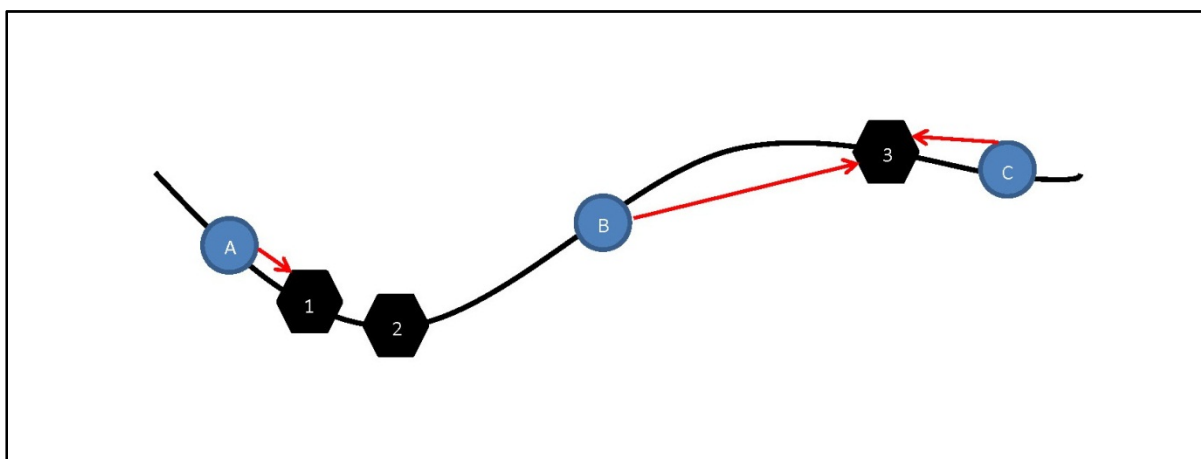
**Figure 21 Vendor to research (V2R) join (vendor data point in circle and research data point in hexagon)**

Vendor false negatives were revealed through V2R joins, while R2V joins revealed vendor false positives. Figure 21 visualizes V2R matches using the join feature created by the software, which results in the join of A to 1, B to 3, and C to 3.

The multiple joins of the research data to vendor data point 3 in Figure 21 reveals a vendor false negative at research point B. Notice there is not a vendor point in close proximity to the research point B; therefore, this point is joined to the closest data point, vendor point 3. The second error in Figure 21, a vendor false positive denoted by vendor point 2, is not clear to the researcher as a result of the join tool output being observed. The join tool output will not reveal any non-joined data points; therefore, the creation of R2V joins as seen in is used to reveal the false positive vendor data point (Figure 22).

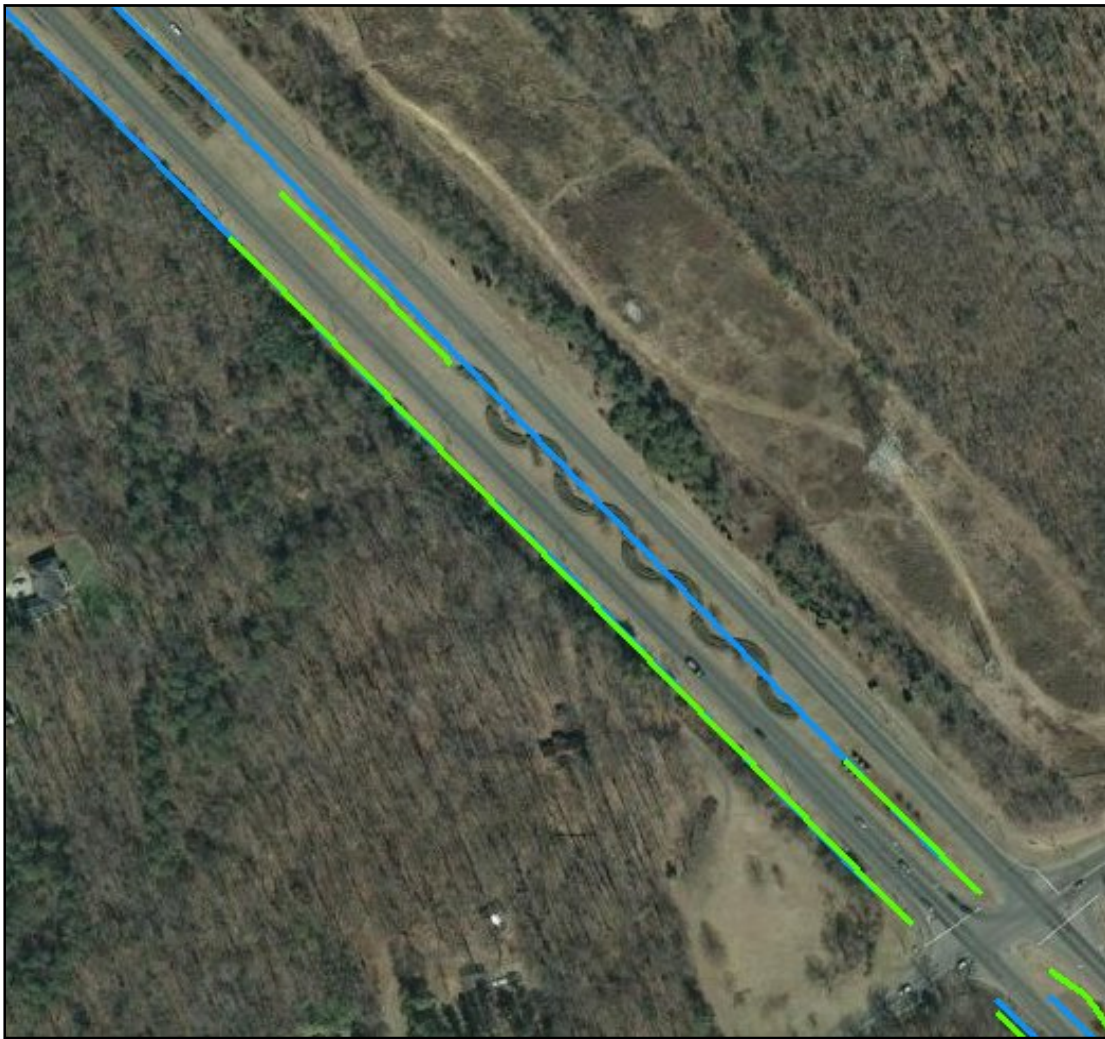
**Figure 25 Data lines displayed in ArcMap 10.**

One challenge for linear element analysis included the format of the vendor submitted dataset. Due to the format of the example spreadsheets provided to the vendors, the linear datasets provided by vendors were displayed by a start point and an end point, thus displaying the linear element as two point features in ArcMap. To create a fair comparison of the two datasets, the research team connected the start and end points of the vendors' data, and then displayed the vendor and research data layers for evaluation in ArcMap as seen in Figure 25.

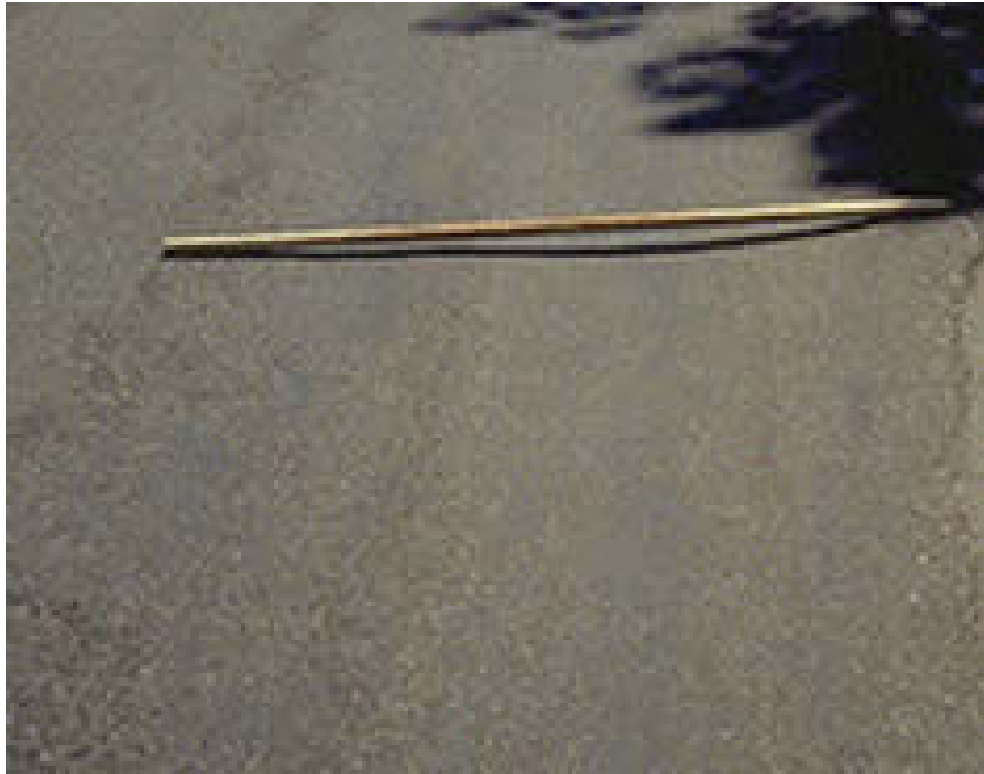
**Exhibit 1: Paved Shoulders - Rutting**

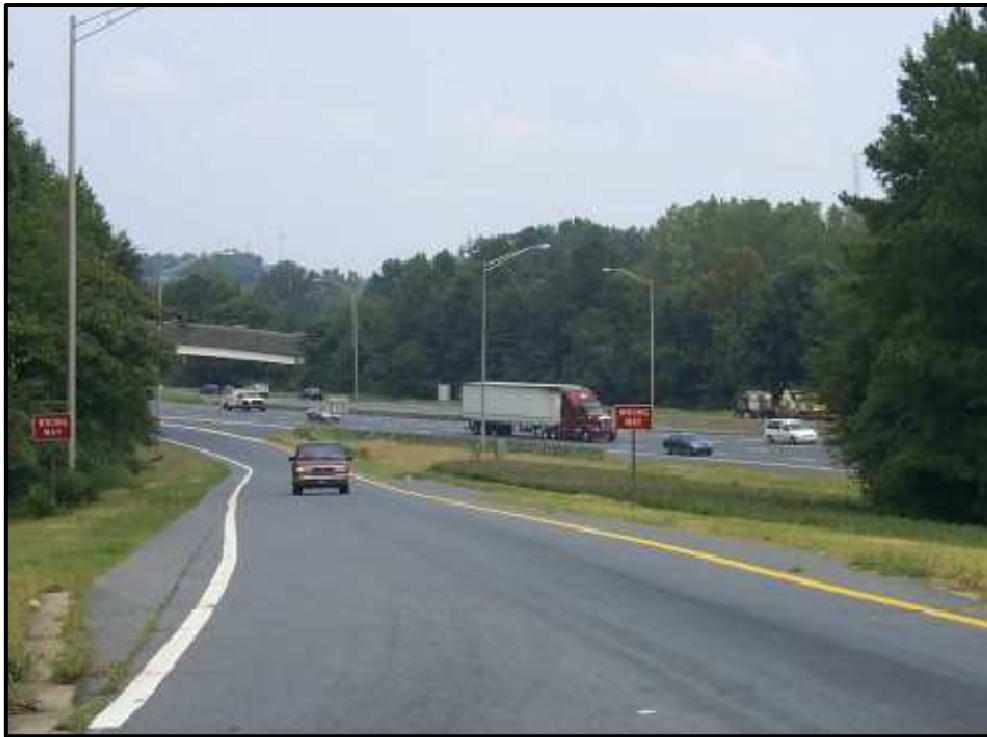
**Exhibit 2: Paved Shoulders – Unsealed crack with vegetation (Right of travel way).**

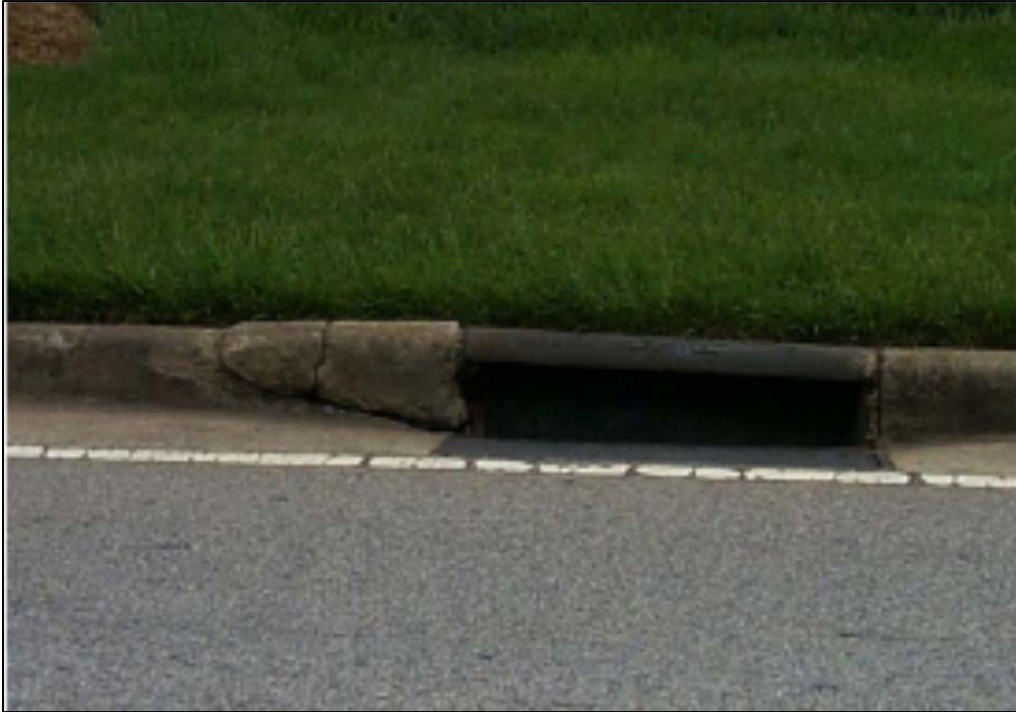
**Exhibit 13: Curb/Gutter Damaged**

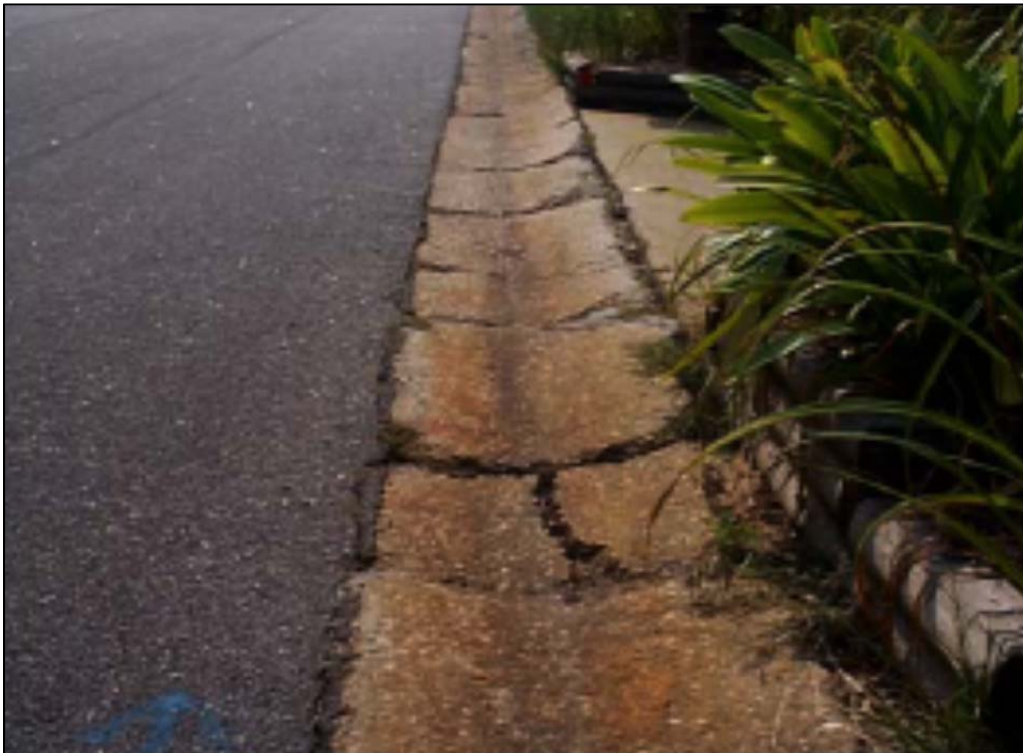
**Exhibit 14: Curb/Gutter Damaged**

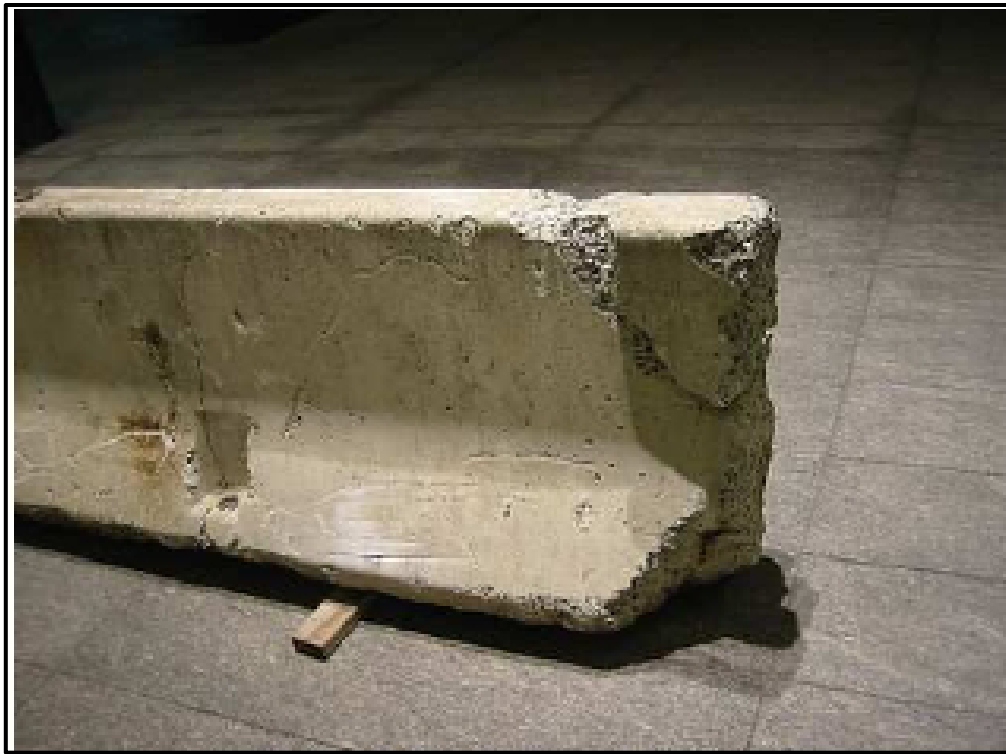
Exhibit 21: Damaged Concrete Barrier

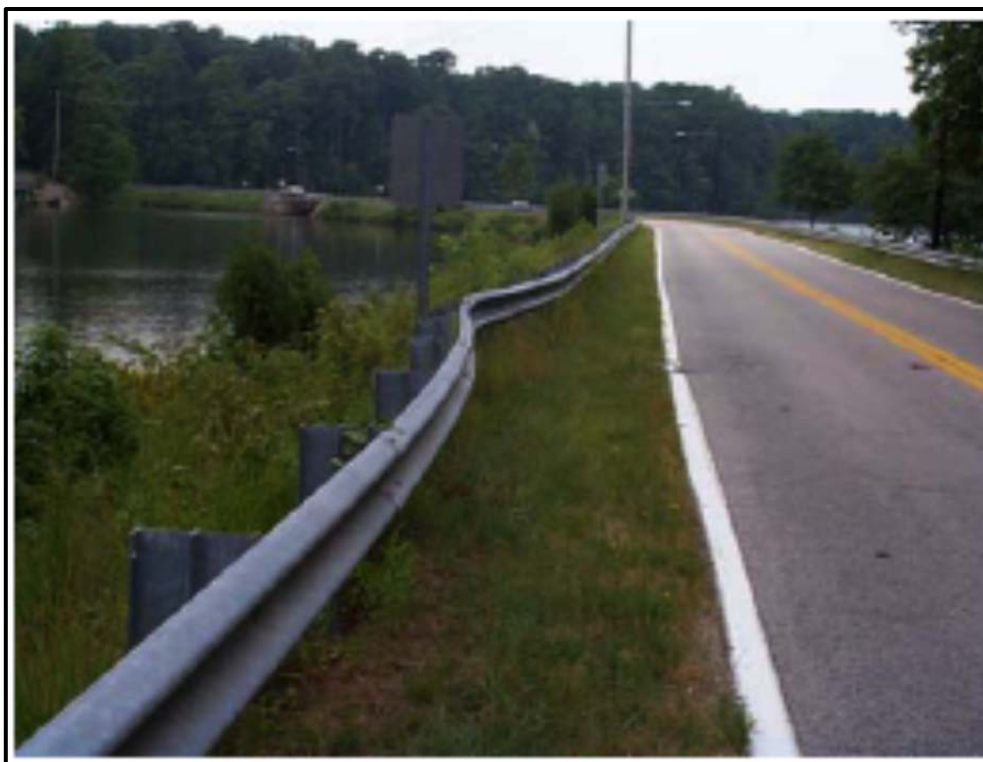
Exhibit 23: Damaged W-Beam Guardrail

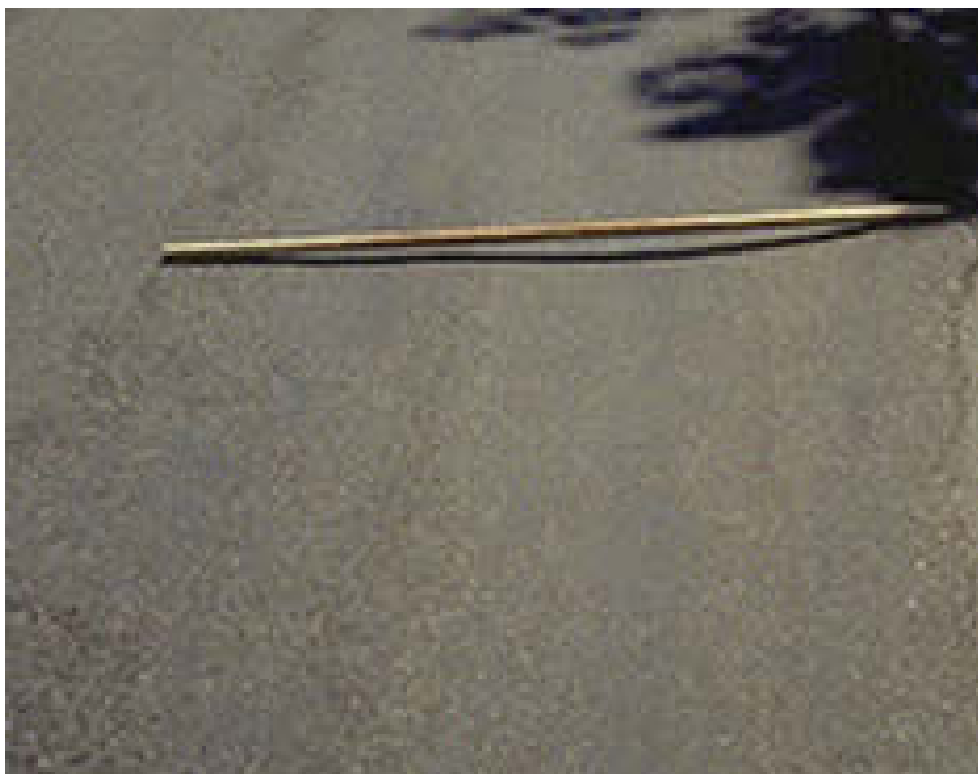
**Exhibit 25: Rutting of Pavement**

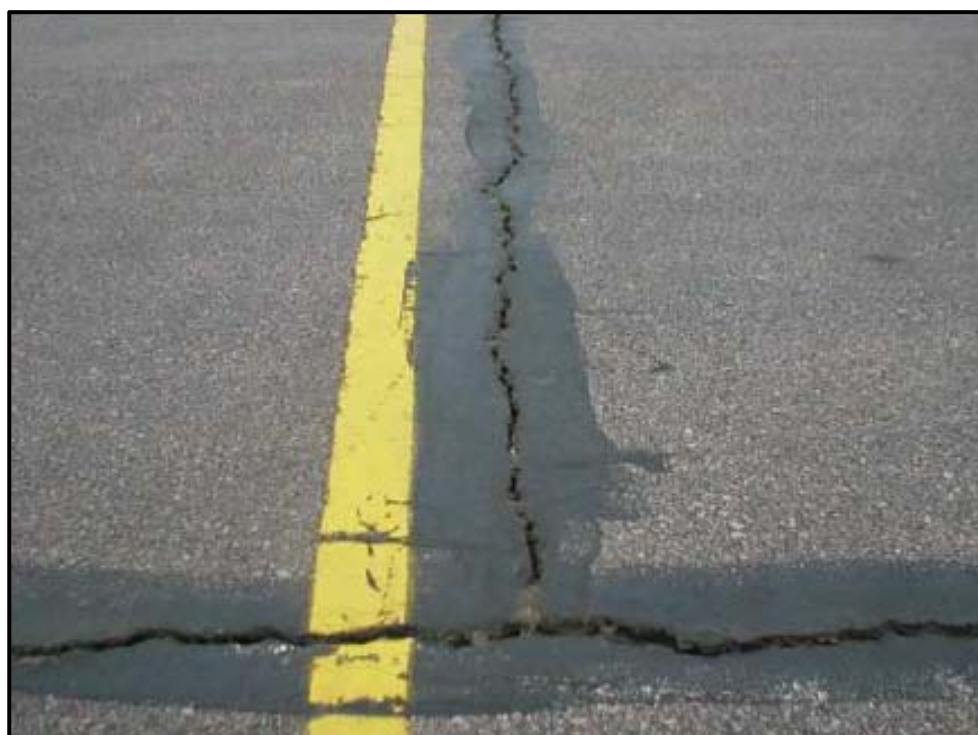
**Exhibit 26: Cracked Asphalt Pavement**

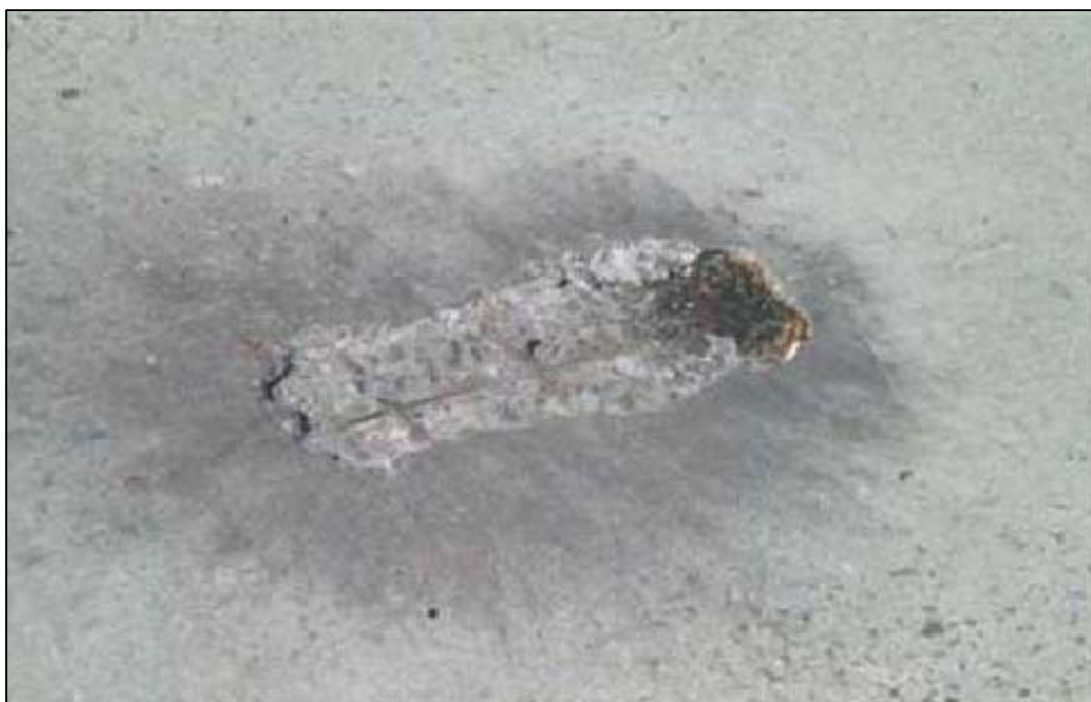
**Exhibit 28: Concrete Pavement Spall**

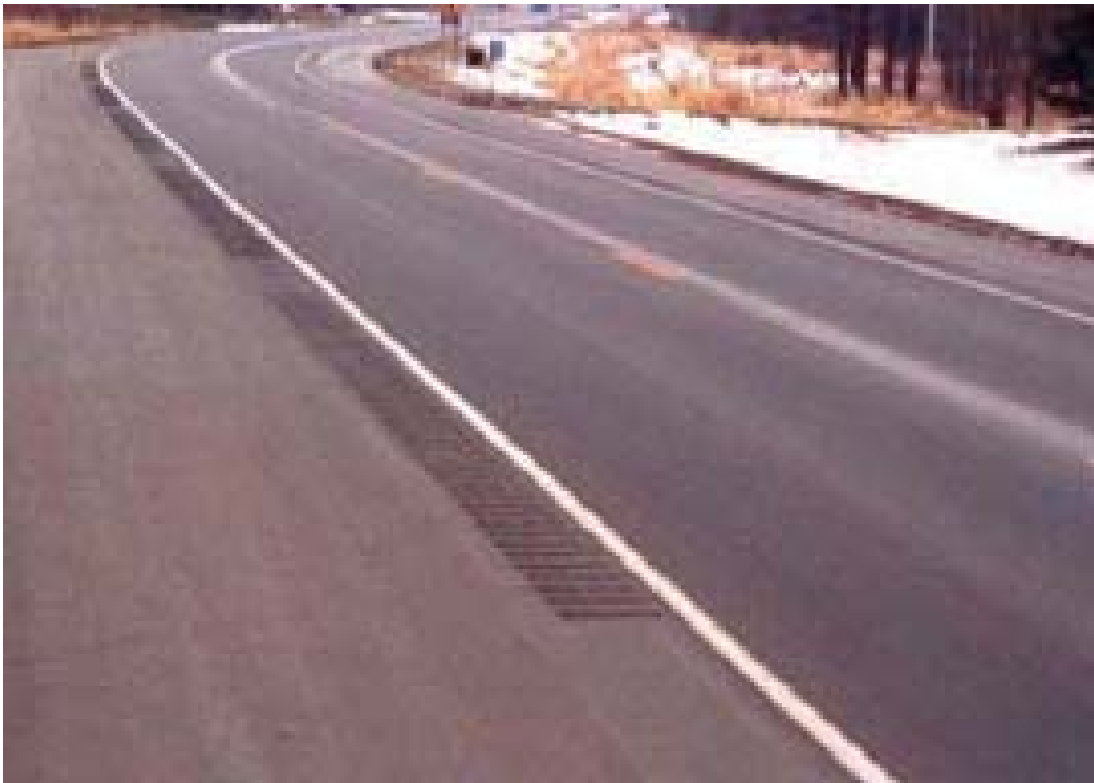
**Exhibit 38: Gapped Rumble Strips along the travelway.**

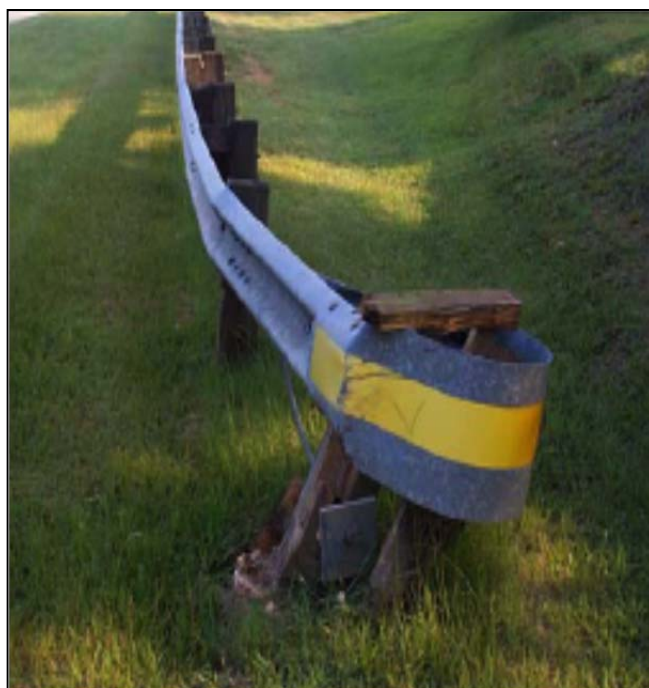
**Exhibit 49: Damaged End Treatment**

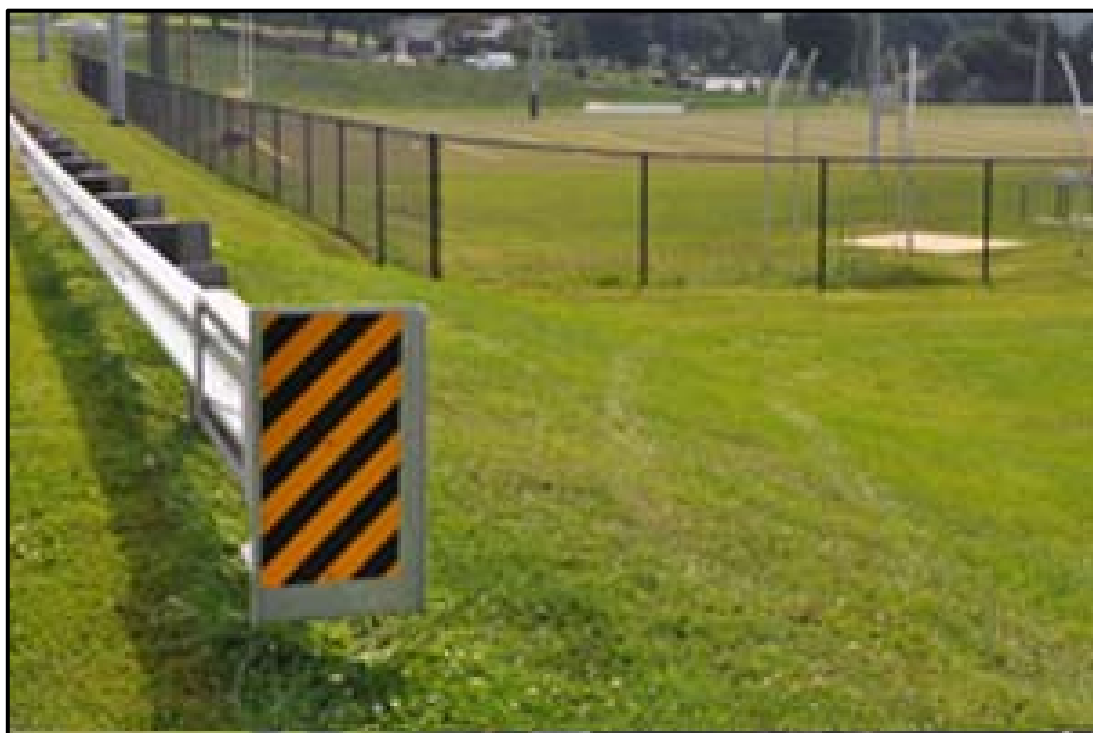
**Exhibit 50: Type 350 Attenuator**
