Performance of Weathered Steel Guardrail in NC

North Carolina Department of Transportation

Final Report

Project: 2011-11

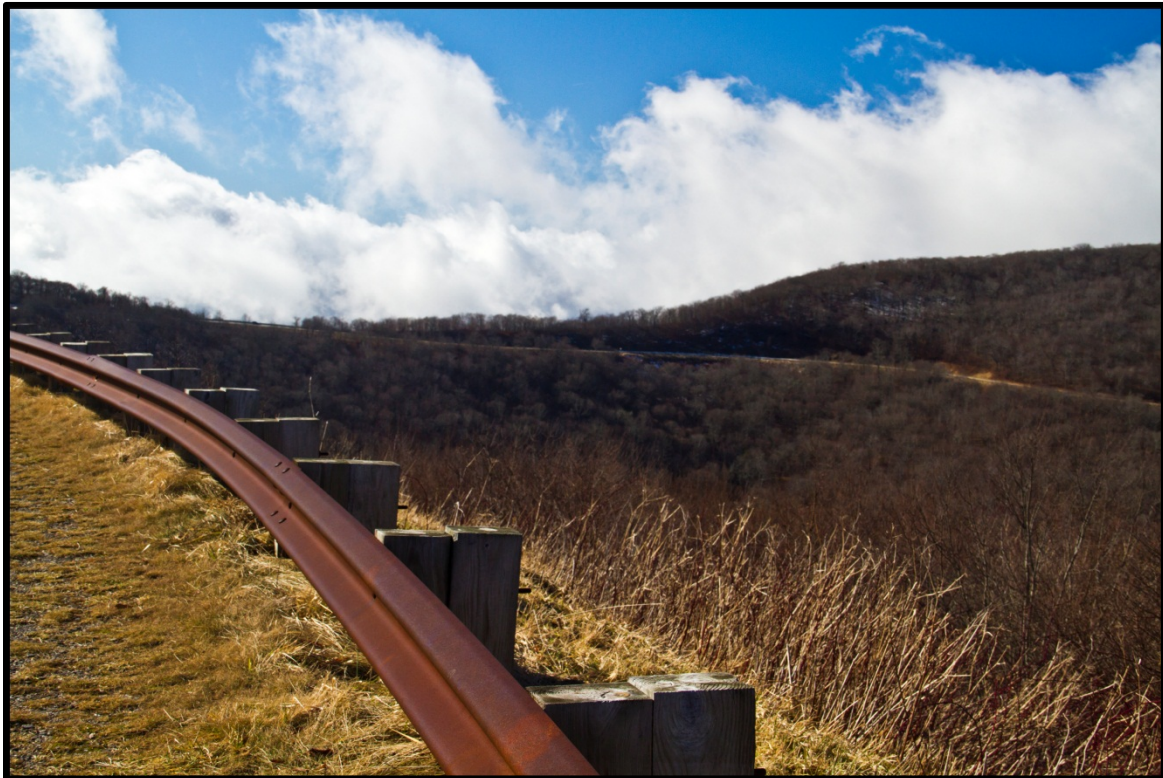
Exhibit 1. WSBG Installation in National Forest (Photo by J. Findley)

Efficient use of resources within the North Carolina Department of Transportation (NCDOT) is an important topic as budgets become tighter and staff availability becomes limited. The use of weathered steel beam guardrail (WSBG) has provided motorists of North Carolina with the dual benefit of a protective and aesthetic barrier. The primary use of WSBG is to protect errant motorists from a more dangerous roadside hazard behind the guardrail. As a secondary benefit, WSBG provides a more appealing aesthetic environment than traditional galvanized steel guardrail (GSG), particularly along roadways that pass through National Forests (Exhibit 1).

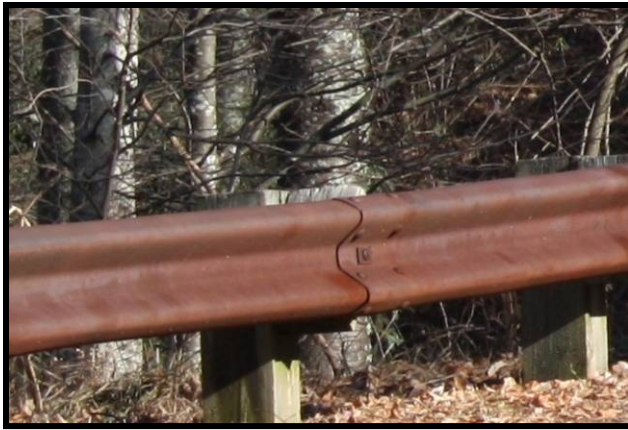
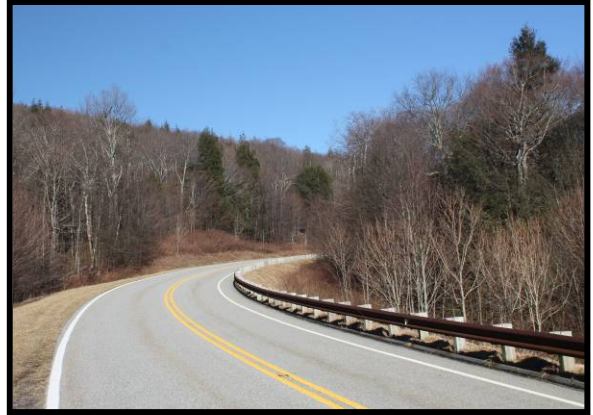
Exhibit 5. Weathered Steel Beam Guardrail Installation on NC 143 (Photos by D. Findley)

Exhibit 5 shows examples of WSBG installations that have been in service for approximately 15 years in Graham County, NC on the Cherohala Skyway (NC 143). Exhibit 6 shows an example of WSBG installed in New Hampshire between ten and twenty years old. Notice the amount of deterioration of the guardrail and accumulation of snow in Exhibit 6.

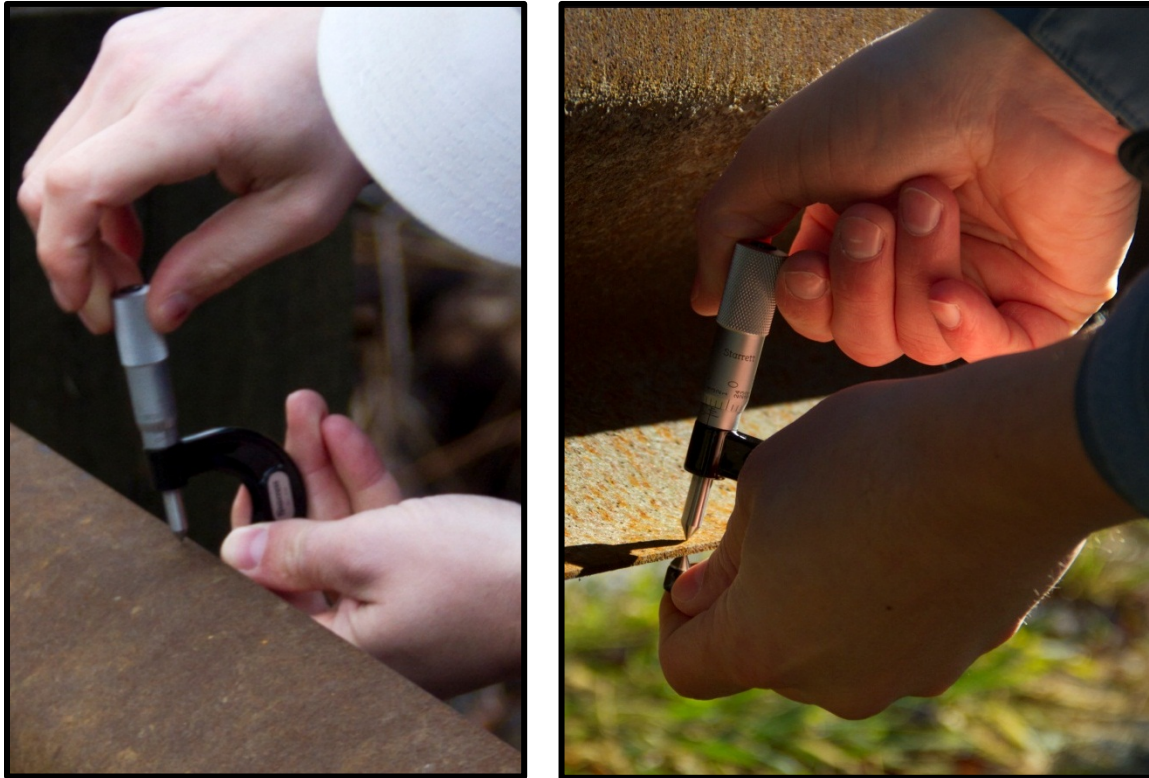
Exhibit 12. Measurement of Top (left) and Bottom (right) Edge (Photos by J. Findley)

The collection of structural data involved inspecting and measuring the thickness of the guardrail which have been exposed to various climates, altitudes, de-icing activities, and offset location. The research team took five measurements on the top and bottom of each span of guardrail studied. A minimum of 20 measurements were taken at each location. Along longer roadway sections containing WSBG, measurements were taken every mile, provided a vehicle could be safely parked for safe data collection. Guardrail spans were measured in tangent sections of the roadway to avoid the potentially higher crash curve locations that might have been replaced by newer guardrail.

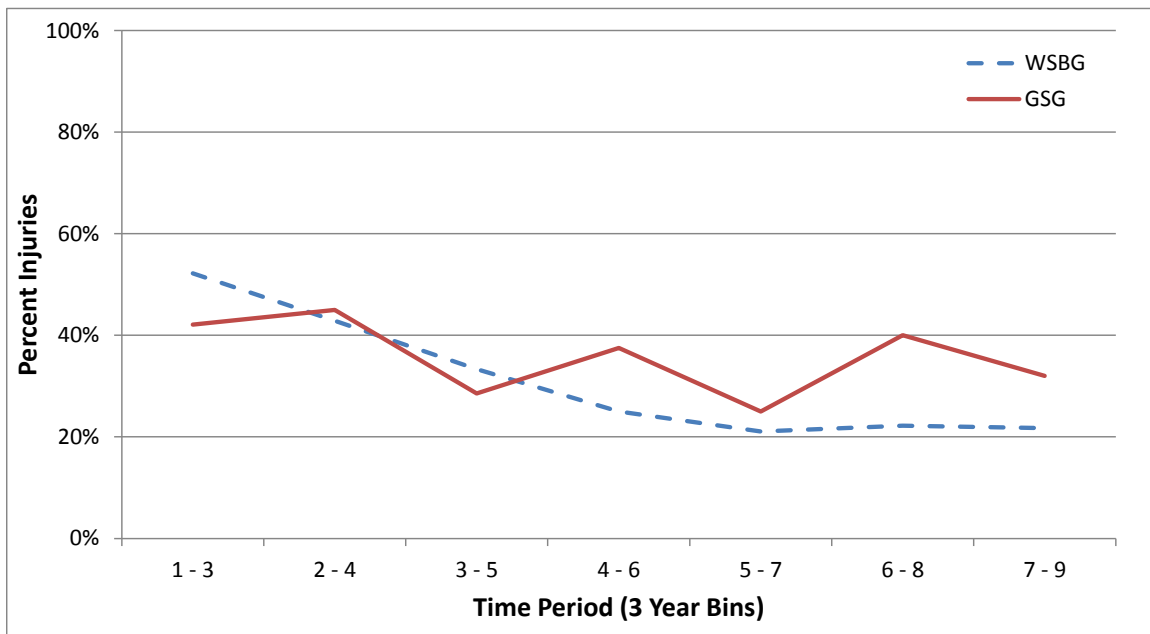
Exhibit 25. Percentage of Injuries (K, A, B, and C) for All Routes

Exhibit 25 provides a visual comparison of the WSBG and GSG grouped sites. The graph provides further evidence that the null hypothesis was rejected during $t = 1-3$ and $t = 3-5$ because the percentage of GSG injury collisions were lower, while time periods $t = 4-6$, $7-8$, and $8-9$ rejected the null hypothesis because the percentage of WSBG injury collisions were lower. Time periods $t = 2-4$ and $5-7$ confirmed the null hypothesis, shown by the two data points so closely related on the graph. As noted earlier in Exhibit 24, and now shown graphically below, the overall hypotheses was rejected that the two proportions were equal, the proportion of injury collisions (overall) were lower for WSBG versus GSG.
