Evaluating the Hydrologic and Water Quality Benefits Associated with Retrofitting Vegetated Swales with Check Dams

NCDOT Project 2014-17

FHWA/NC/2014-17

October 2016

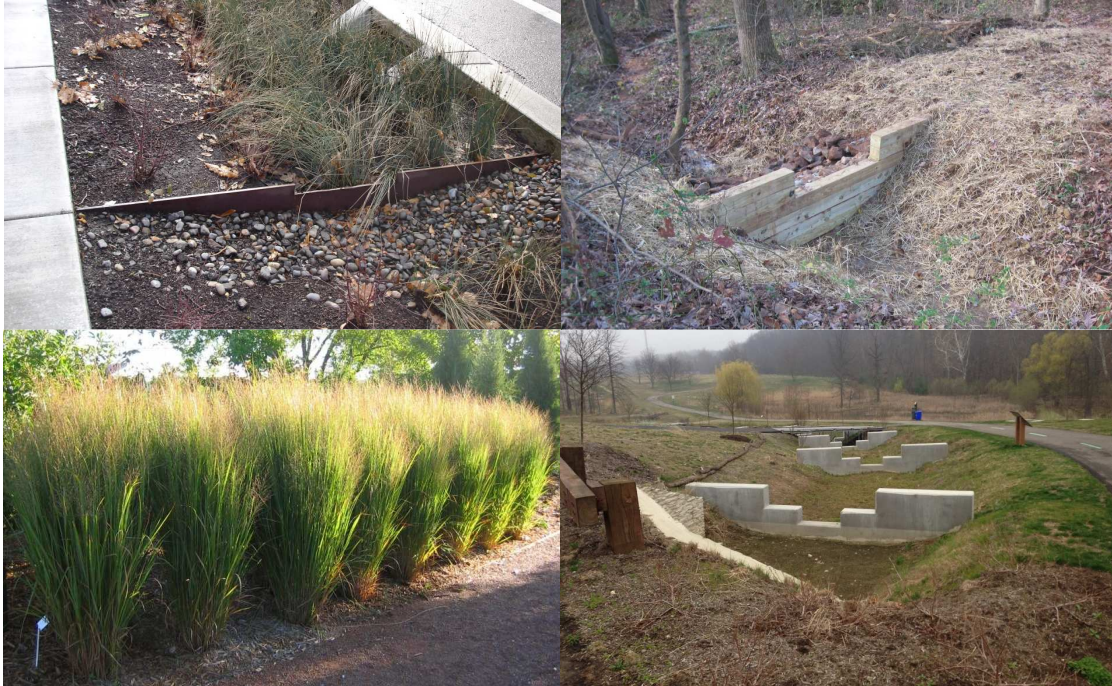
Figure 1-1. Examples of check dams constructed of metal (top left), wood (top right), grass (bottom left, Stagge et al. 2012), and concrete (bottom right).

Because swales are so common, simple retrofits to existing swales are desired to further ameliorate urban hydrologic impacts. Check dams (Figure 1-1) are often proposed in stormwater design manuals as a method to improve swale hydrologic performance (ODNR 2006; NCDEQ 2009; MPCA 2016). Check dams are structures placed perpendicular to flow to temporarily retain stormwater in the swale during a rainfall event, increasing hydraulic retention time, reducing flow velocity, and potentially improving infiltration (Yu et al. 2001). Davis et al. (2012) found that vegetated check dams reduced the duration of outflow from swales. While effects were not observed for small and large events, volume reduction and flow rate attenuation was improved during moderate-size events (0.9-1.3 inch depth). Perhaps the inclusion of a more robust check dam, built of wood, concrete, or metal, would provide more consistent benefits than vegetated ones? One potential drawback, however, noted by Kaighn and Yu (1996) is that check dams may interfere with highway maintenance operations.

Check dams are often proposed in stormwater design manuals (e.g., ODNR 2006; NCDEQ 2009a) as simple modifications which can improve the water quality performance of a grass swale (Figure 1-1). They are installed perpendicular to flow to reduce velocity and temporarily detain runoff (NCDEQ, 2009a), thereby theoretically improving sediment trapping efficiency. Line and White (2001) and McLaughlin et al (2009) have shown rock and straw wattle check dams to be effective turbidity-reduction strategies for construction sites. For a post-construction grass swale, Davis et al. (2012) found that check dams provided improved hydraulic retention time (or the amount of time water is retained within a swale) for rainfall events of less than 1.2 inches. Kaighn and Yu (1996) found that two nearby swales, one with and one without a check dam, removed 87% and 23% of TSS load, respectively. Yu et al. (2001) showed 77% and 50% TP capture for swales with and without check dams. Stagge et al. (2012) concluded that vegetated check dams (pictured in Figure 1-1) had a negligible effect on overall water quality treatment, improving only nitrate treatment. The check dams in this study actually detracted from TSS treatment. Mixed results from previous studies show that further research is needed on check dams so that design guidance can be refined.

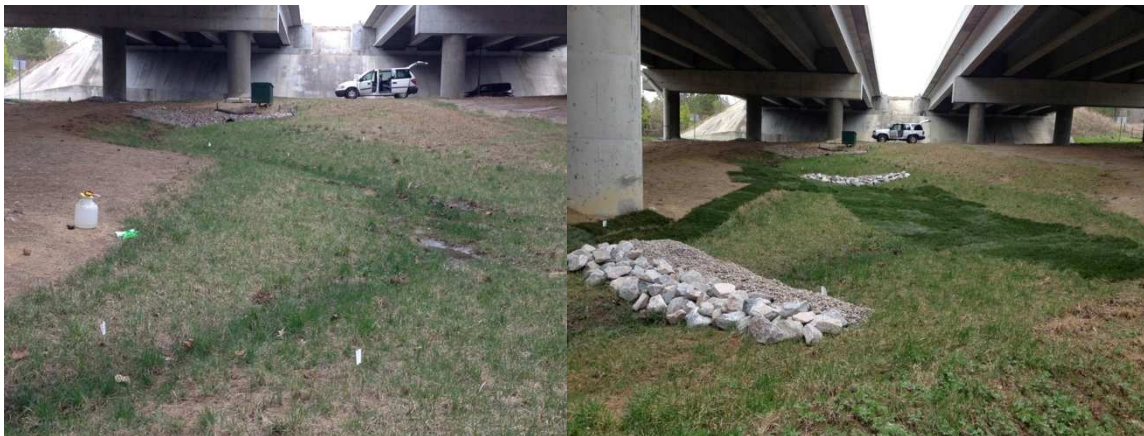
Figure 1-2: View of the Mango Creek swale pre-retrofit (left, looking upstream) and following check dam installation (right, looking upstream).

time. On March 28, 2014, the Mango Creek swale was retrofitted with two rock check dams (Figure 1-2 and Figure 1-3), concluding the pre-retrofit monitoring period (NCDOT, 2012). These were constructed using Class B erosion control stone fronted with No. 57 aggregate (0.19-1.0 inch nominal diameter) as a filtration layer (Appendix C). The check dams were 1-ft tall at the thalweg, approximately 12 ft wide, and built at a constant top elevation to promote maximum ponding volume. They were spaced such that the base of the upstream check dam was at the same elevation as the top of the subsequent downstream check dam, again maximizing ponding volume. It should be noted that while installing the rock check dams, NCDOT crews repaired some rutting in the swale (see new sod in Figure 1-2) caused by equipment. Once the check dams were installed, the swale was monitored for an additional twelve months (April 2014 to March 2015), during which sixty-two storm events were observed.

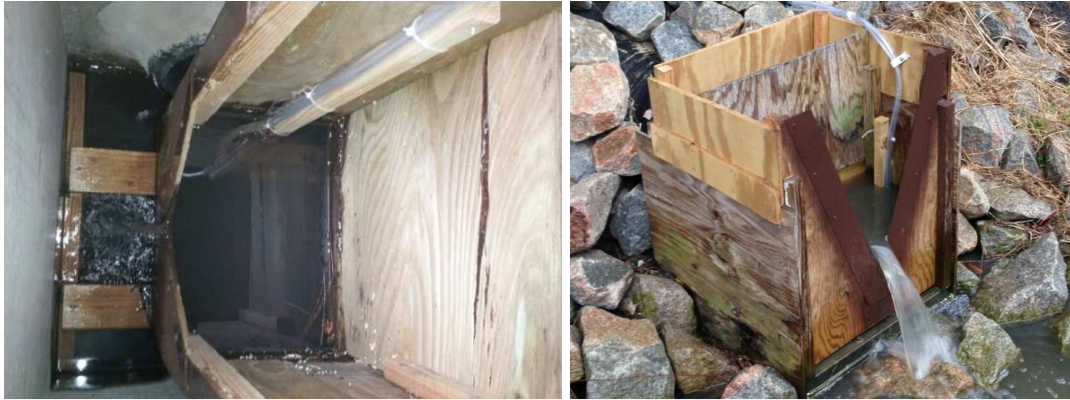
Figure 1-4: Mango Creek inlet (left) and outlet (right) weirs during a storm event.

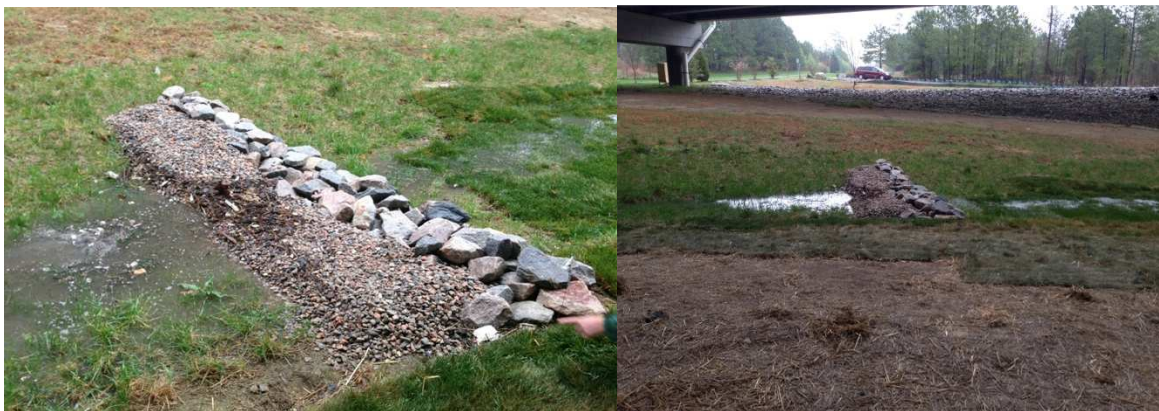
Figure 1-5: Two views of the upslope rock check dam in the Mango Creek swale during a storm event.

characteristics, the check dams were expected to pond water and dissipate flow velocity, thereby furthering infiltration. Figure 1-5 provides a picture of the upslope check dam during a storm event on April 15, 2014. Visual observations during this and other events showed that a differential head existed across the rock check dams, confirming their ability to retard flow. Observed differences in head from the upstream to downstream end of the rock check dam ranged from 1 to 6 inches and were dependent on the flow rate through the swale. Greater head differences existed at higher flow rates.

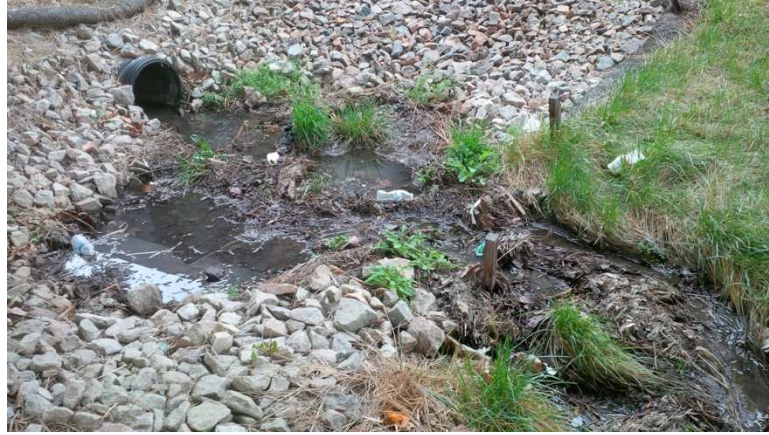
Figure 1-8: The forebay failed to pond a substantial water volume during storm events, partly because it was overwhelmed by gross solids.

The forebay of the Mango Creek swale was not successful in capturing large debris or gross solids, because it did not have adequate storage (Figure 1-8). Because of this, the first check dam in the swale began filtering and collecting gross solids upon installation. The mass of gross solids began to blind, or cover the surface of, the first check dam within two months of installation. The second check dam functioned as designed due to the “effectiveness” of the first check dam acting as a forebay (Figure 1-9).

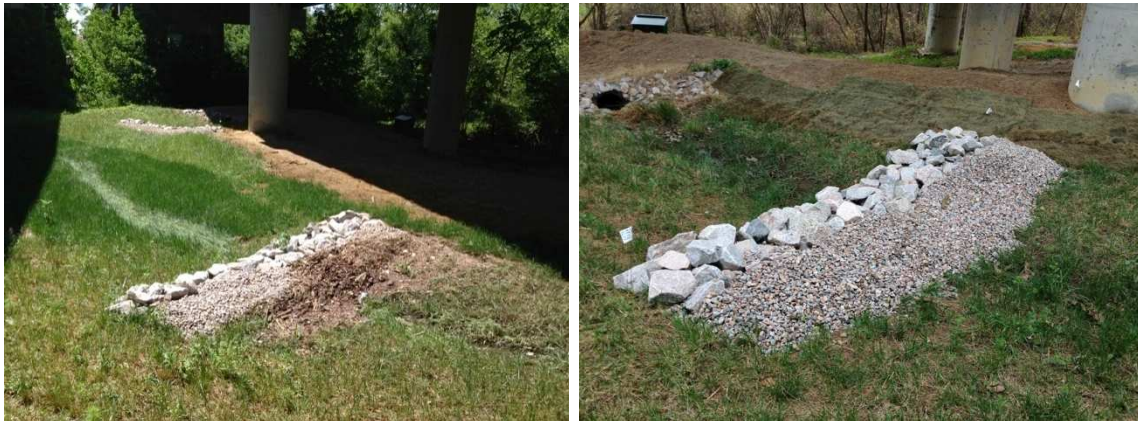
Figure 1-9: The first check dam in the Mango Creek swale blinded by debris and gross solids (left) and the second check dam in the Mango Creek swale (right), with photographs taken in May 2014, two months after check dam installation.

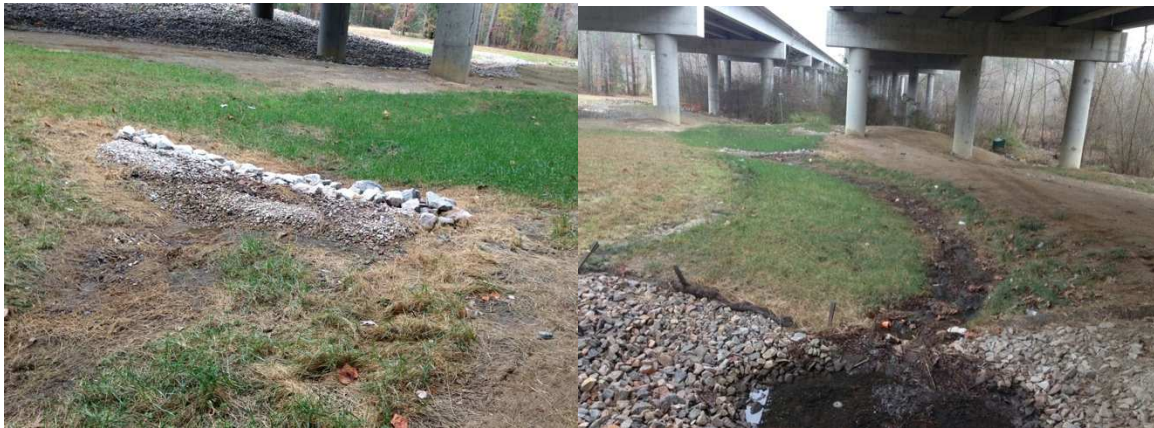
Figure 1-10: Clogged first check dam (left) and view of the swale upstream of the clogged check dam (right). Pictures taken in November 2014, approximately seven months after check dam installation. Note vegetation loss along thalweg of channel.

These observations suggest that maintenance of check dams is a critical to their ability to properly function over time. Clogged check dams will negatively impact the health of the vegetation in the swale, subsequently undermining the water quality performance of the swale, specifically with respect to reduced sedimentation and filtration of sediment-bound pollutants (Barrett et al. 2004; Winston et al. 2012). Saturated soils upslope of clogged check dams maintenance by mowers. Debris removal from check dams will thus be a critical factor to ensure these systems augment the hydrologic (and water quality) performance of grass swales. Appendix F provides further photographic evidence comparing vegetation health in the swale before and after check dam clogging.

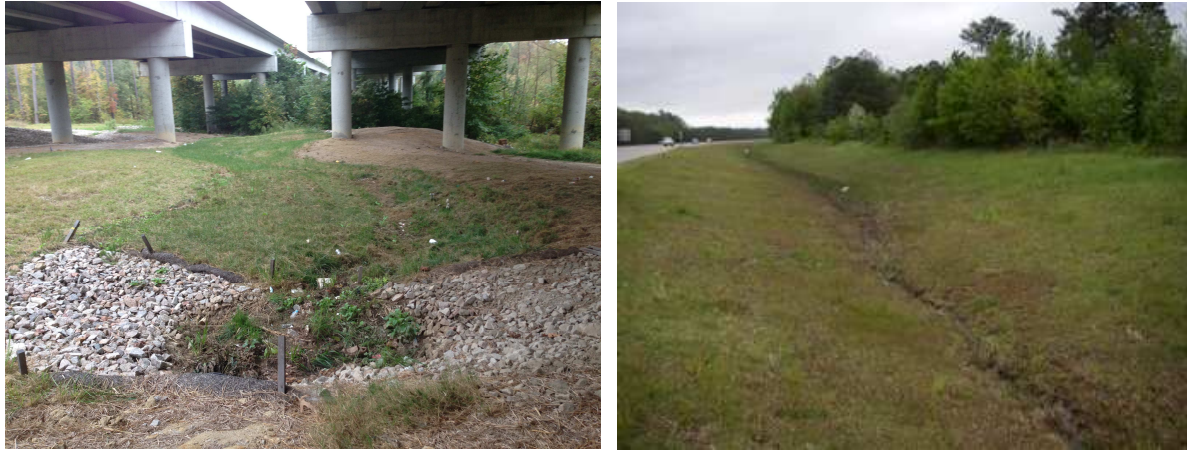
Figure 2-1: Pre-retrofit photographs of the Mango Creek swale (left) and the I-40 swale (right).

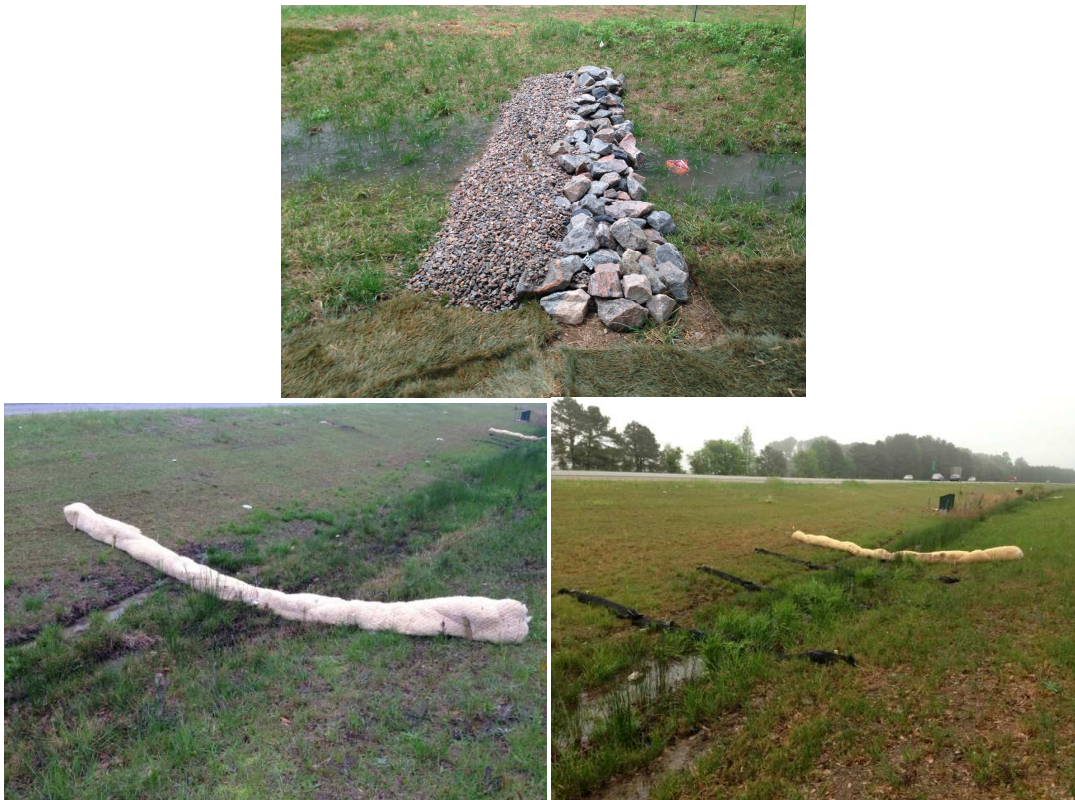
Figure 2-3. Rock check dam at Mango Creek (top), standard excelsior fiber wattle check dam at I-40 (bottom left), and an excelsior wattle with ViroPhos™ supplement bags check dam at I-40 (bottom right).

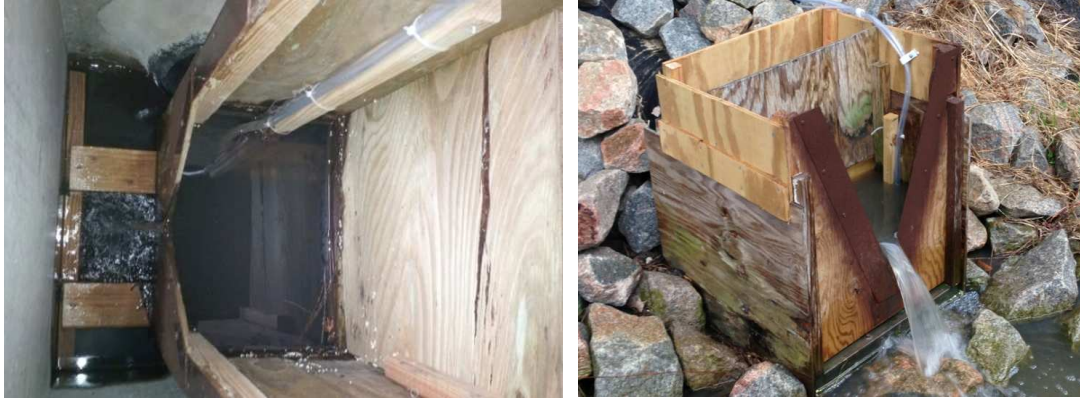
Figure 2-4: Mango Creek inlet (left) and outlet (right) weirs during a storm event.

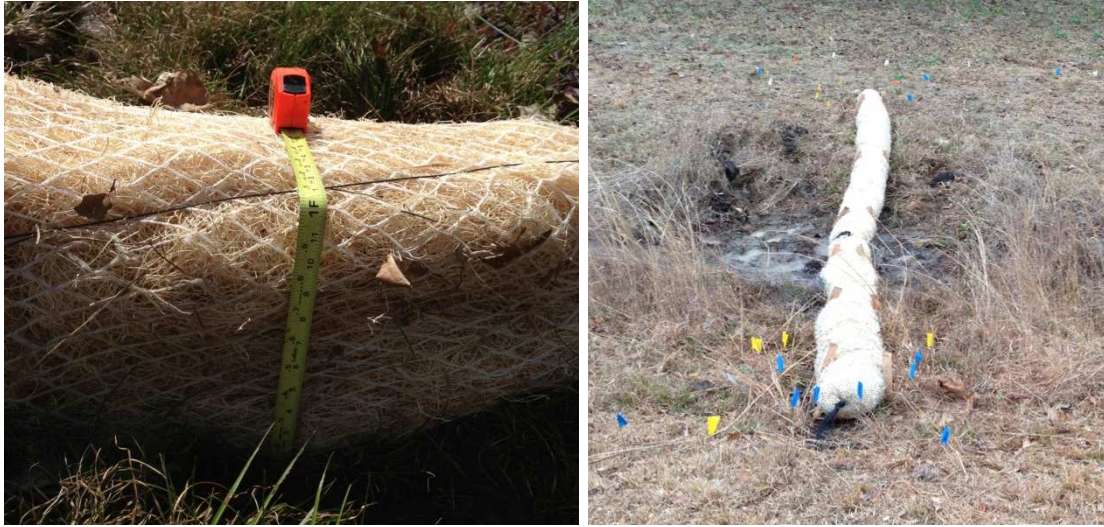
Figure 2-8: Close up view of an excelsior fiber wattle (left) and an excelsior fiber wattle installed in the I-40 swale with wood grade stakes.

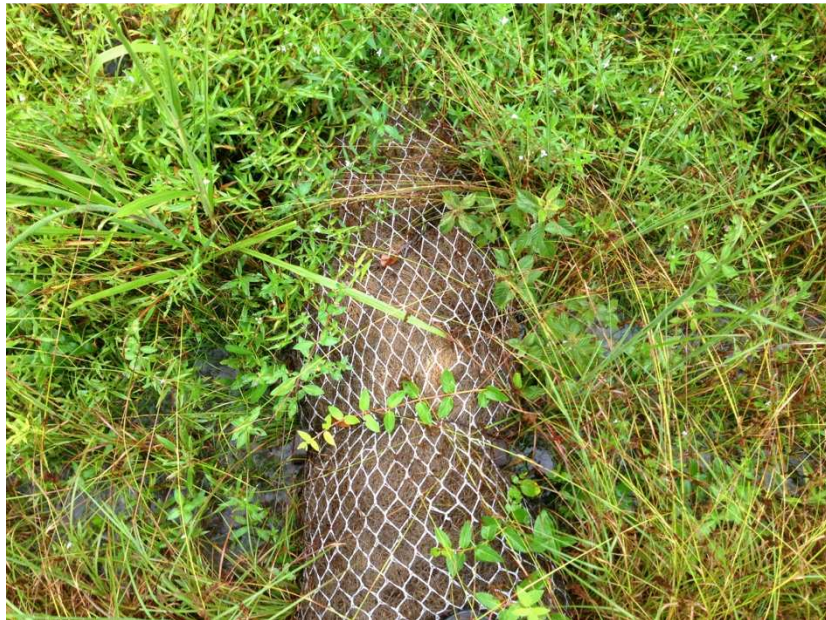
Figure 2-9: Close up view of an excelsior wattle during a storm event (9/8/14). Note that water levels are the same on both sides of the check dam, indicating minimal flow impedance.

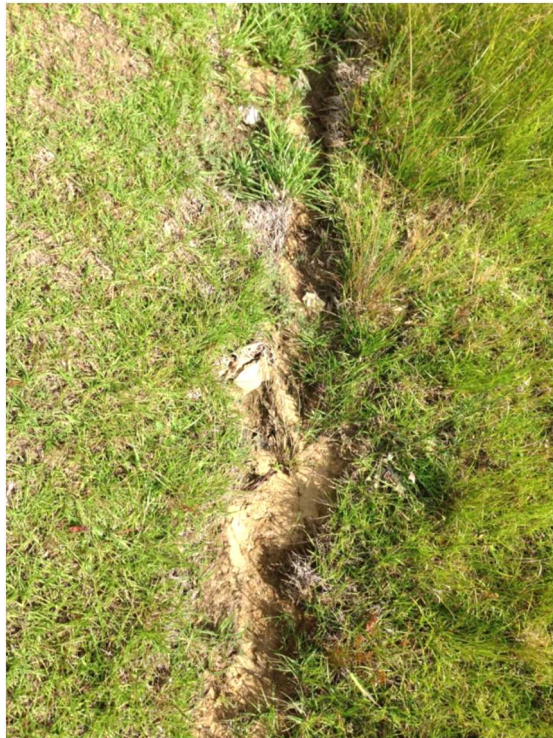
Figure 2-10: Channel degradation between the inlet and first check dam of the I-40 swale.

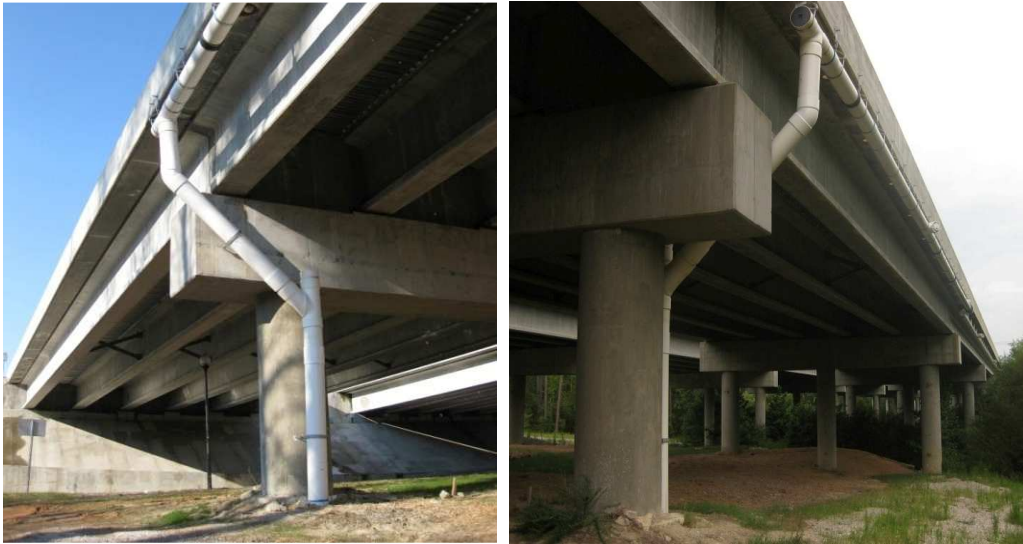
Figure 4-1: I-540 bridge deck PVC runoff conveyance pipe downspout (left) and view of pipe extending towards Mango Creek (right).

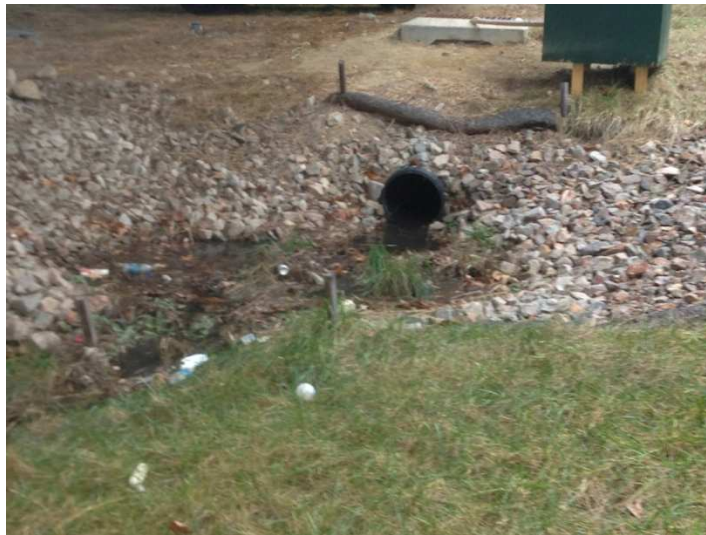
Figure 4-2: Upstream view of the Mango Creek swale forebay.

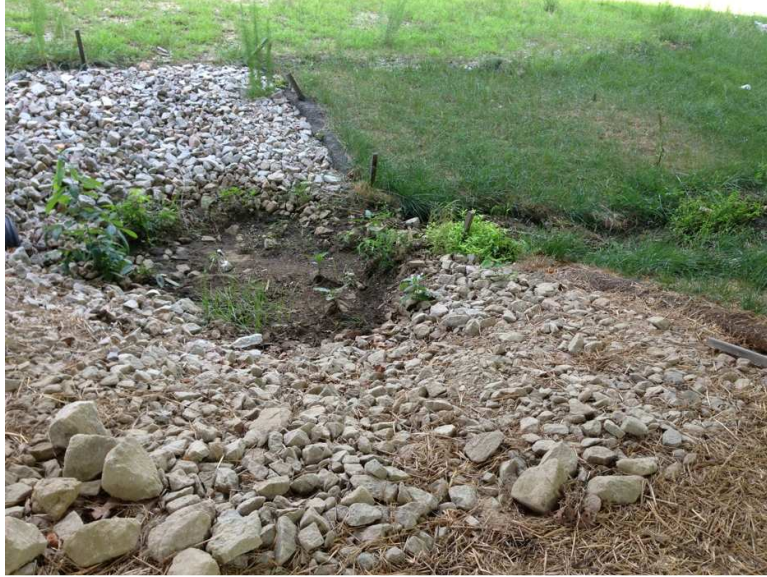
Figure 4-3: View from the top edge of the Mango Creek swale forebay.

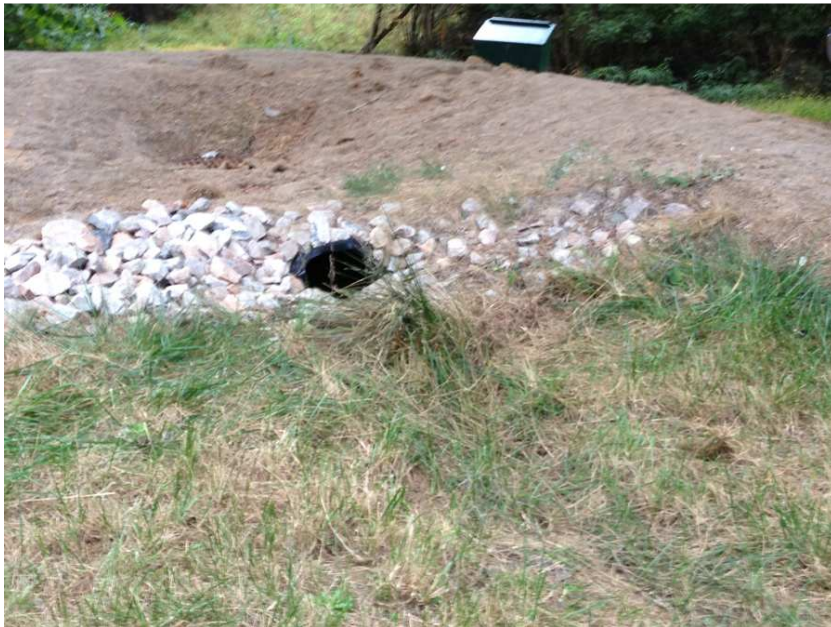
Figure 4-4: View of the Mango Creek swale outlet pipe.

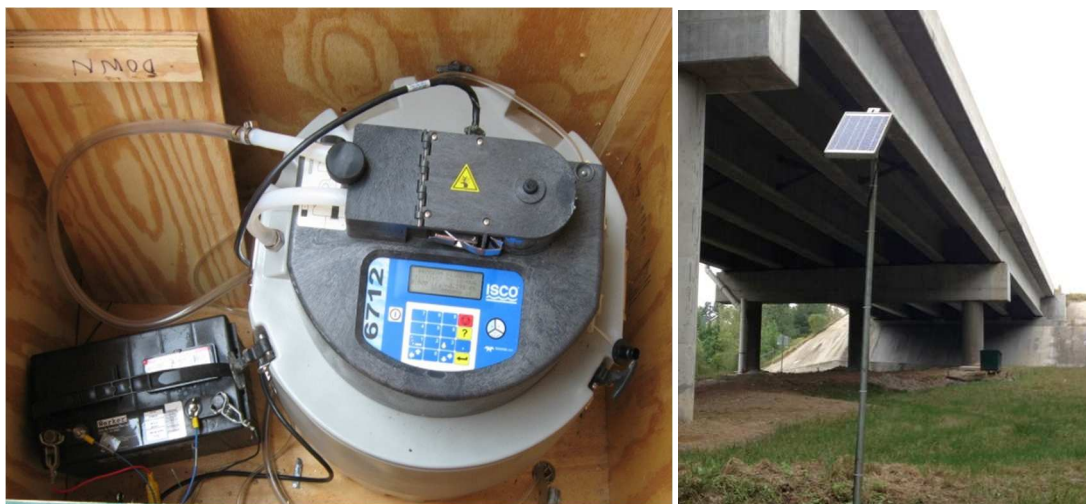
Figure 4-5: ISCO 6712 automated sampler and a 12-volt deep cycle battery in housing (left) and a mounted 20-watt solar panel (right).

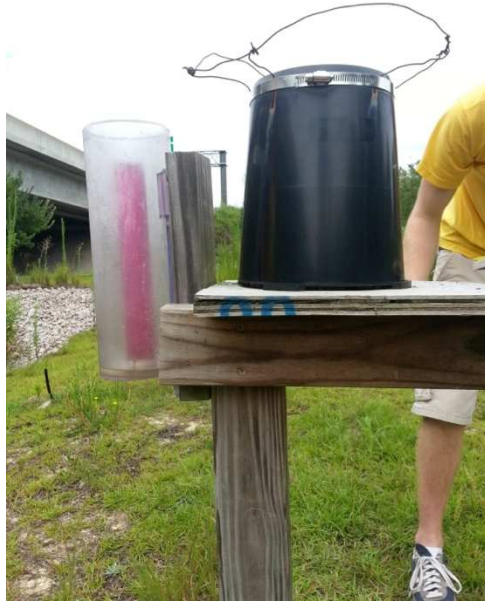
Figure 4-6: Automatic, tipping bucket and manual rain gauges at Mango Creek site.

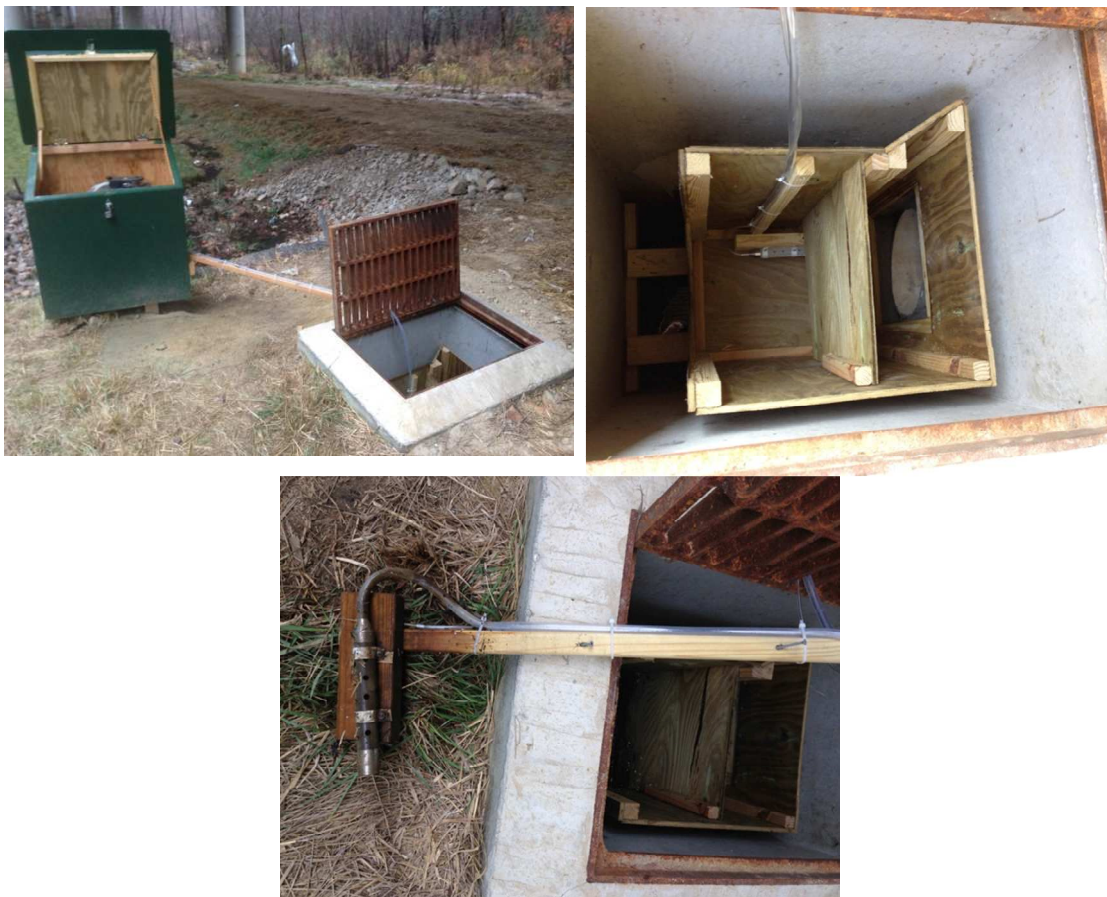
Figure 4-7: Clockwise from top left: Mango Creek inlet monitoring point showing ISCO sampler housing and catch basin, weir box with baffle placed within the catch basin, and the mounted sampler head with a bubbler attachment for measuring flow rates.

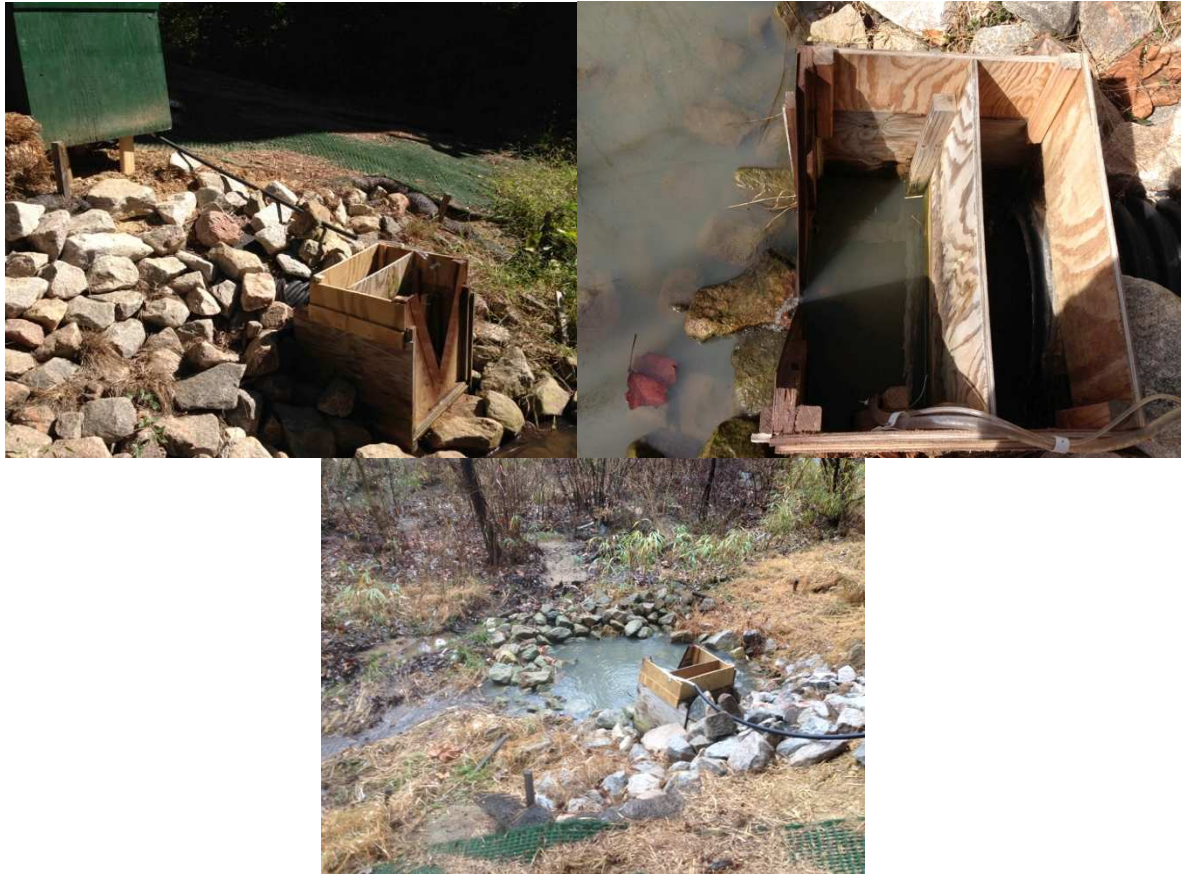
Figure 4-8: Clockwise from top left: Mango Creek outlet monitoring point showing ISCO sampler housing and weir box, weir box from above with baffle placed inside, and the outlet weir during a storm event.

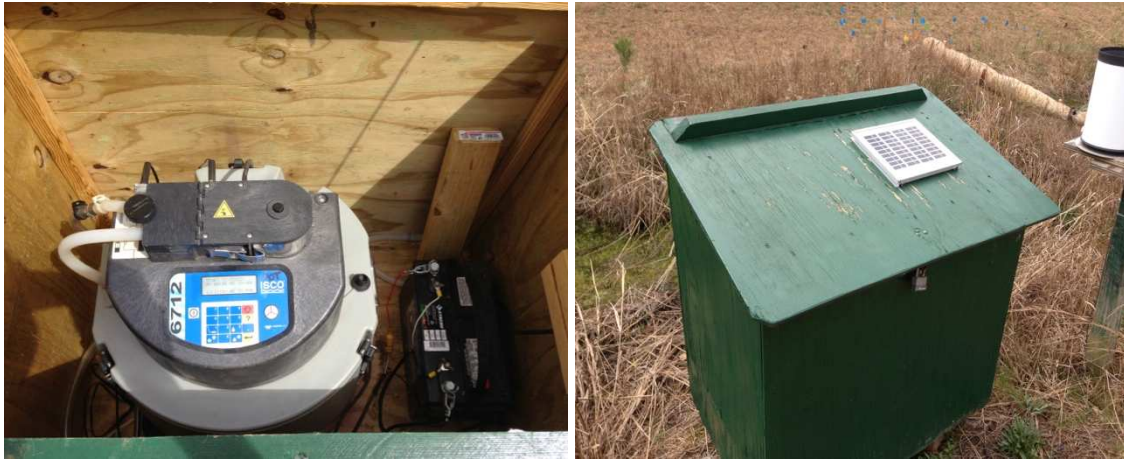
Figure 4-9: ISCO 6712 automated sampler and a 12-volt deep cycle battery in housing (left) and a mounted 5-watt solar panel (right).

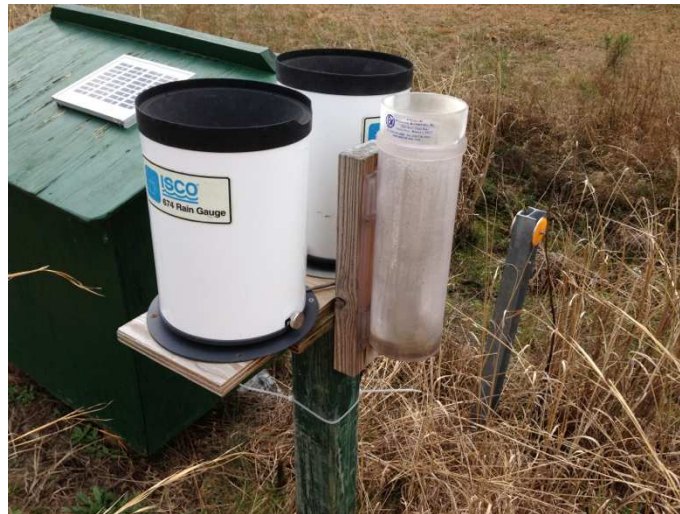
Figure 4-10: ISCO 674 rain gauges and manual rain gauge at the I-40 site.

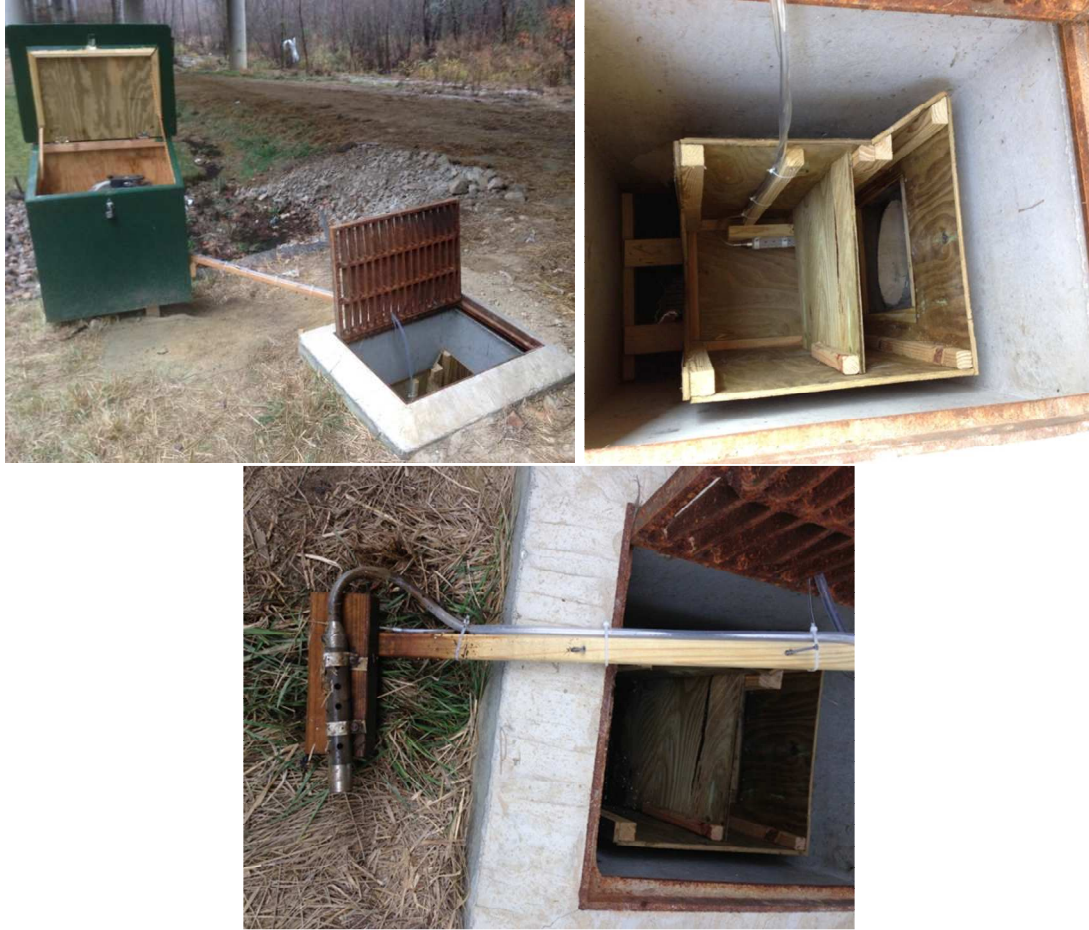
Figure 4-11: Mango Creek inlet monitoring point showing ISCO sampler housing and catch basin (top left), weir box with baffle placed within the catch basin (top right), and the mounted sampler intake with a bubbler attachment for detecting flow rates.

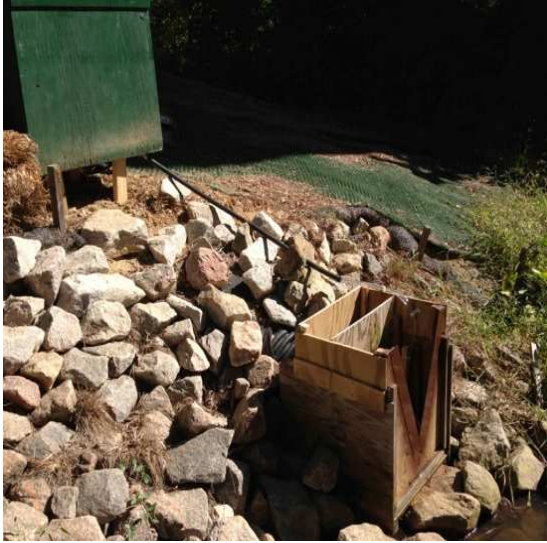
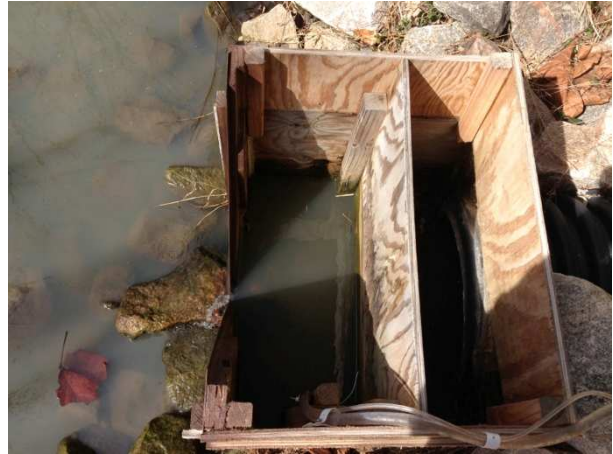
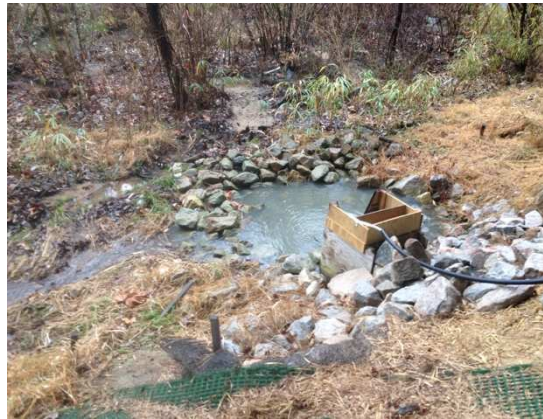
Figure 4-12: Mango Creek outlet monitoring point showing ISCO sampler housing and weir box (top left), weir box from above with baffle placed inside (top right), outlet weir during a storm event (bottom).

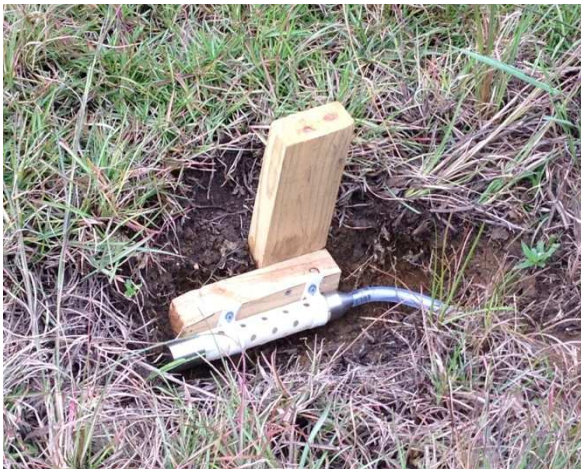
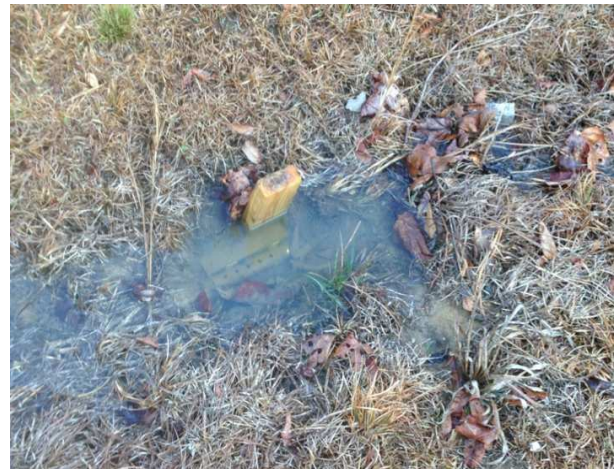
Figure 4-13: A sampler intake strainer set up for monitoring at the I-40 swale inlet (left) and a view of the sampler intake during a storm event (right).

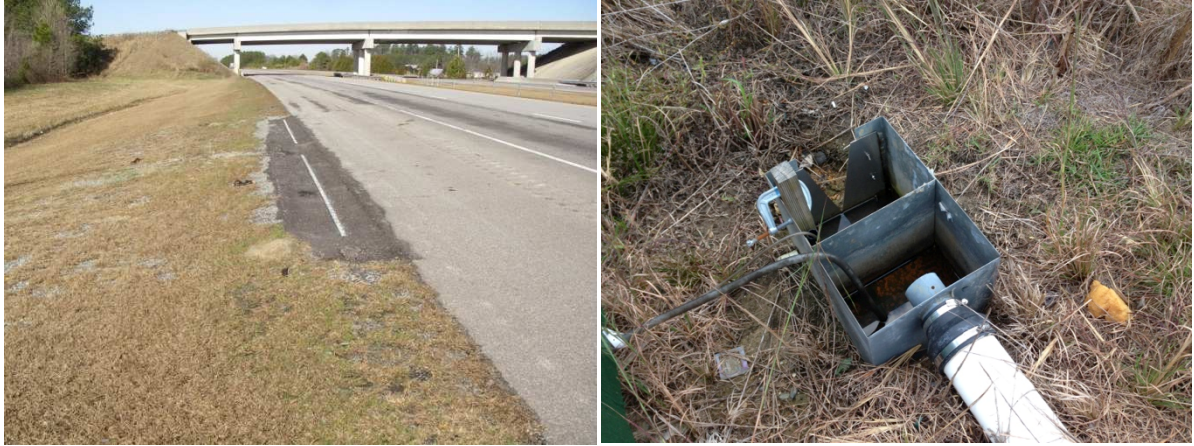
Figure 4-14: Slot drains installed alongside the highway (left) and the weir box used to collect highway runoff water quality samples (right).

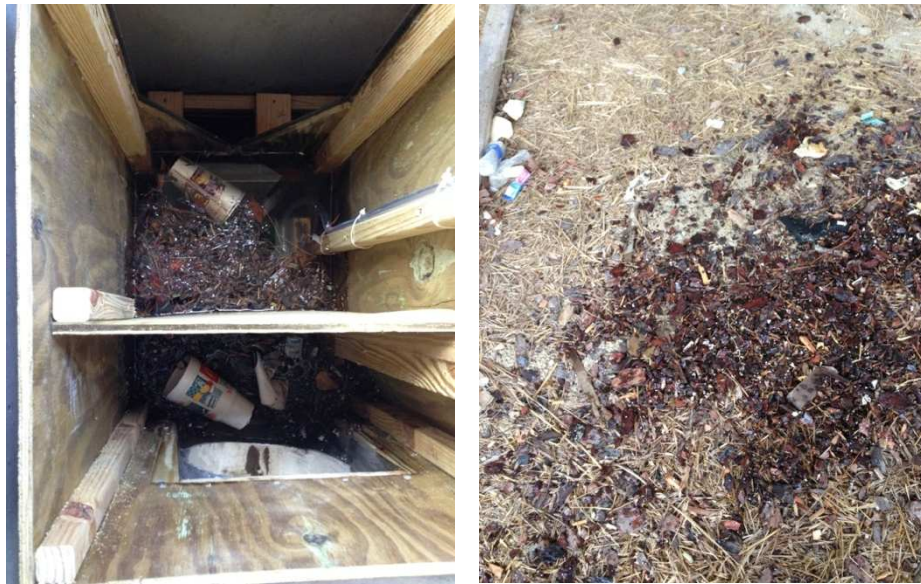
Figure 4-15: The inlet weir box clogged with debris and litter (left) and a pile of the debris and litter removed from the weir box (right).

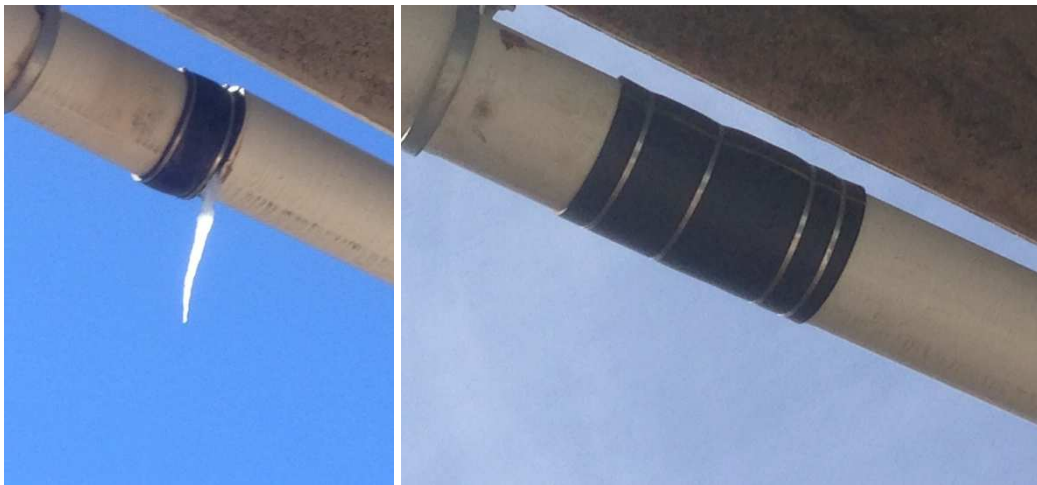
Figure 4-16: The first observed disconnected PVC drainage pipes leaking on 10/22/13 (left) and the same PVC pipes mended on 1/14/14 (right).

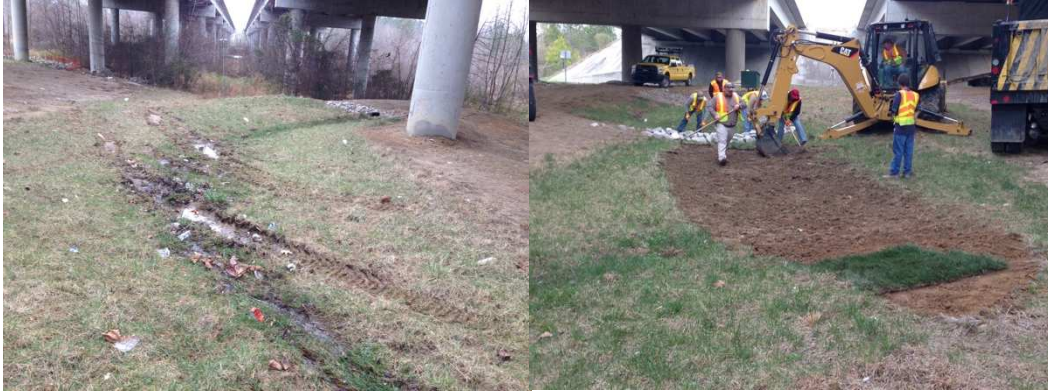
Figure 4-17: Rutted track damage caused by a large vehicle driving across the swale on 2/4/14 (left) and the repair of this damage by NCDOT on 3/28/14 (right).

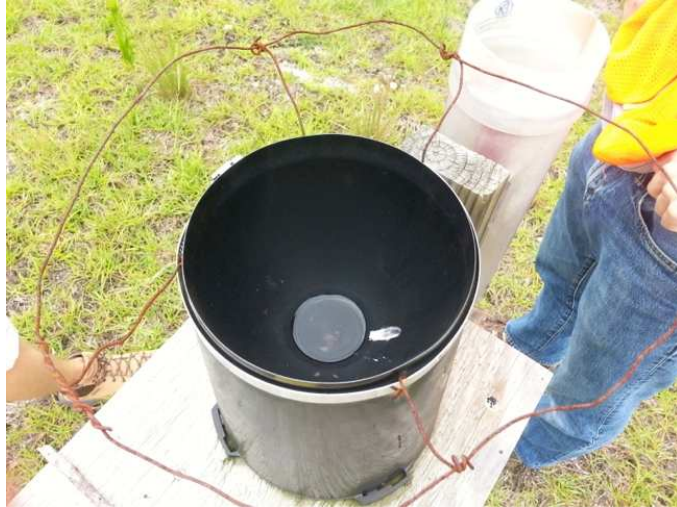
Figure 4-18: ISCO 674 rain gauge bucket clogged due to bird feces.

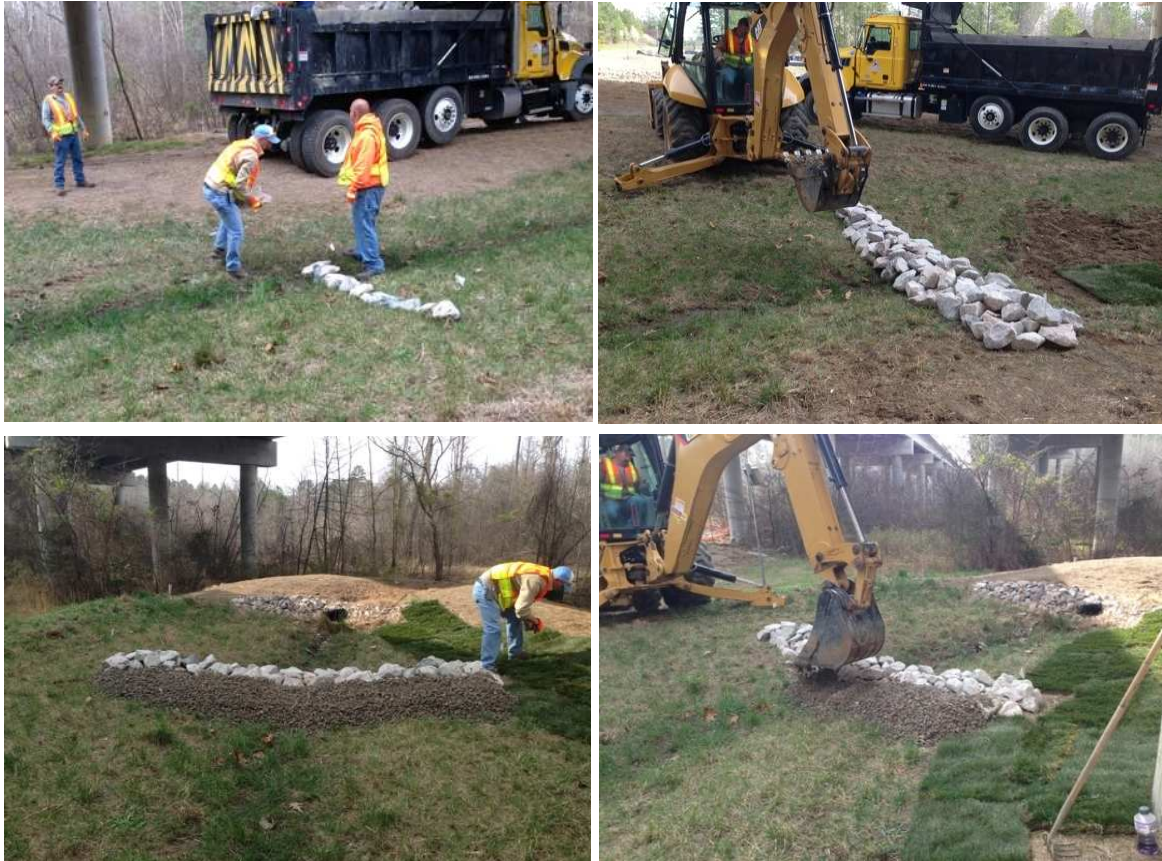
Figure 4-19: Installation of a rock check dam at the Mango Creek swale (proceeds clockwise from top left).

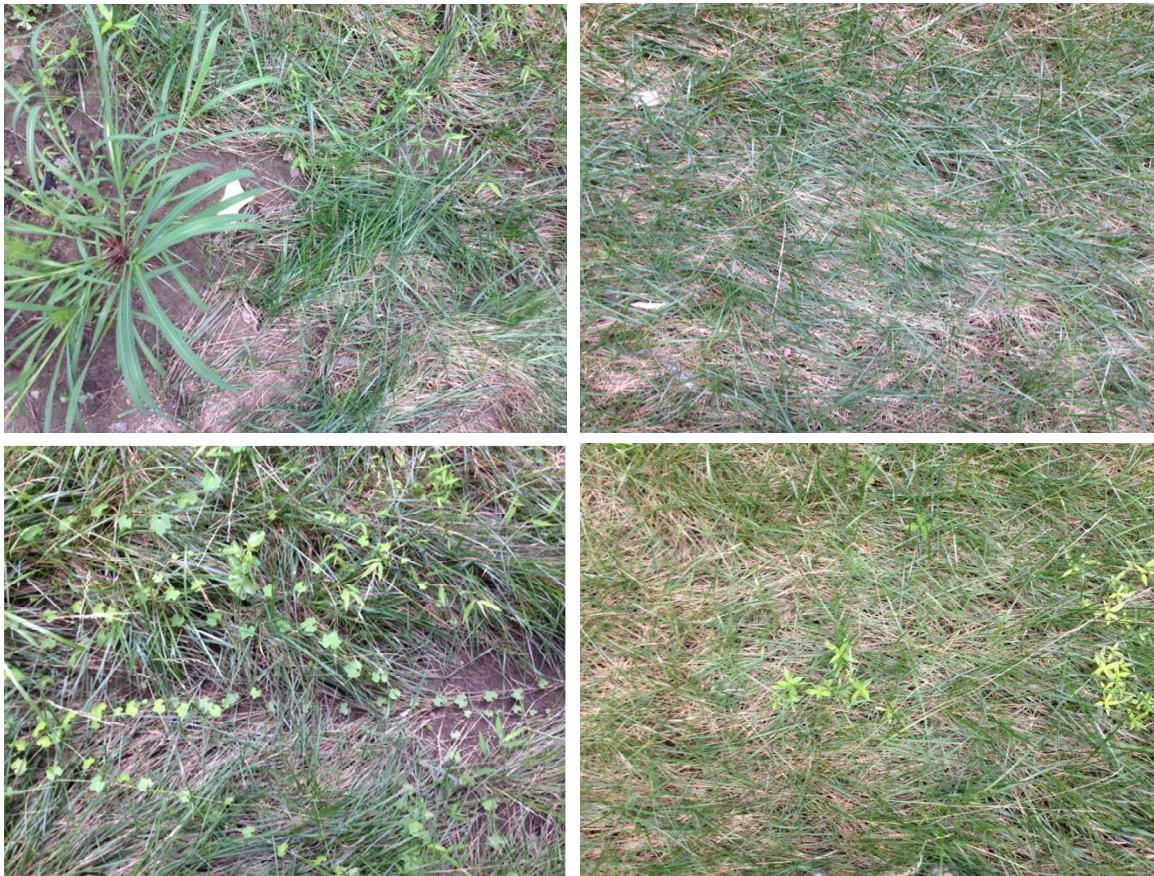
Figure 4-20: Mango Creek swale vegetation upstream of the first check dam prior to clogging (photos taken August 12, 2014). Photos are in order moving downstream (clockwise from top left).

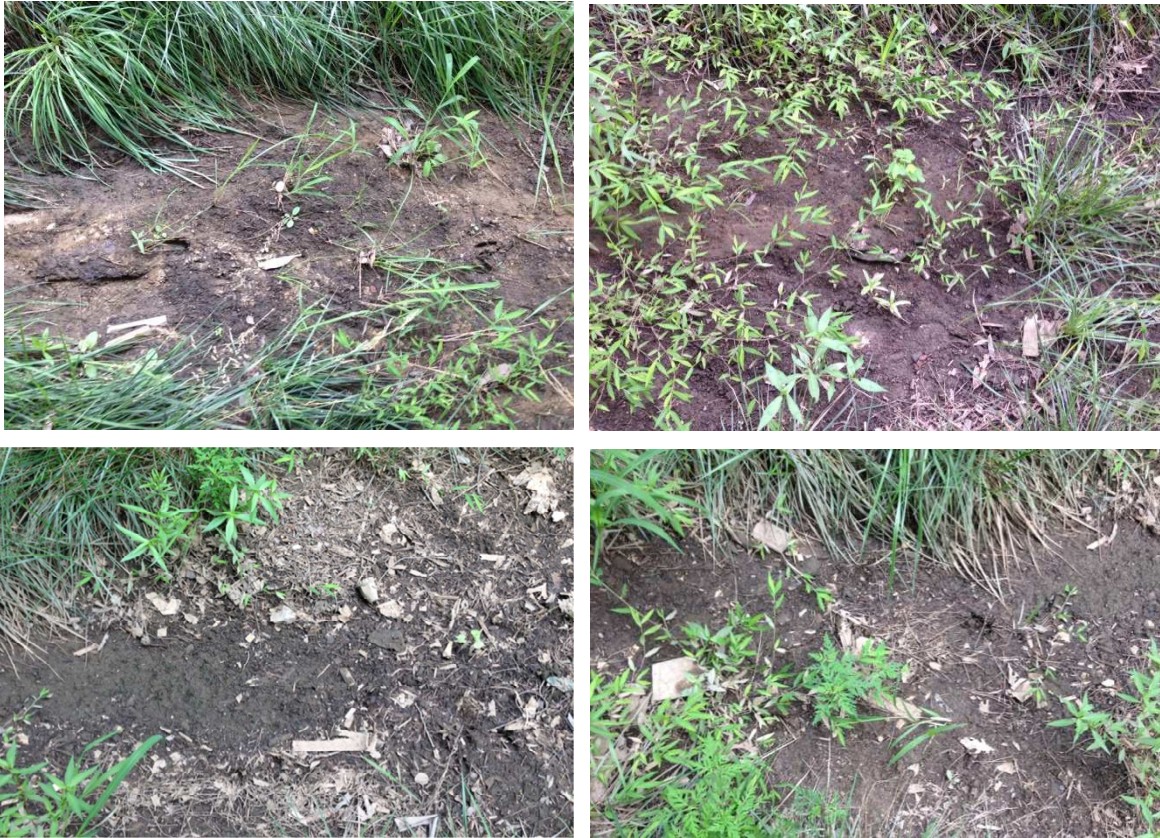
Figure 4-21: Mango Creek swale vegetation upstream of the first check dam after clogging had been present for approximately ten months (photos taken July 21, 2015). Photos are in order moving downstream (clockwise from top left).
