Evaluating the Hydrologic and Water Quality Benefits Associated with Retrofitting Vegetated Swales with Check Dams

NCDOT Project 2014-17

FHWA/NC/2014-17

October 2016

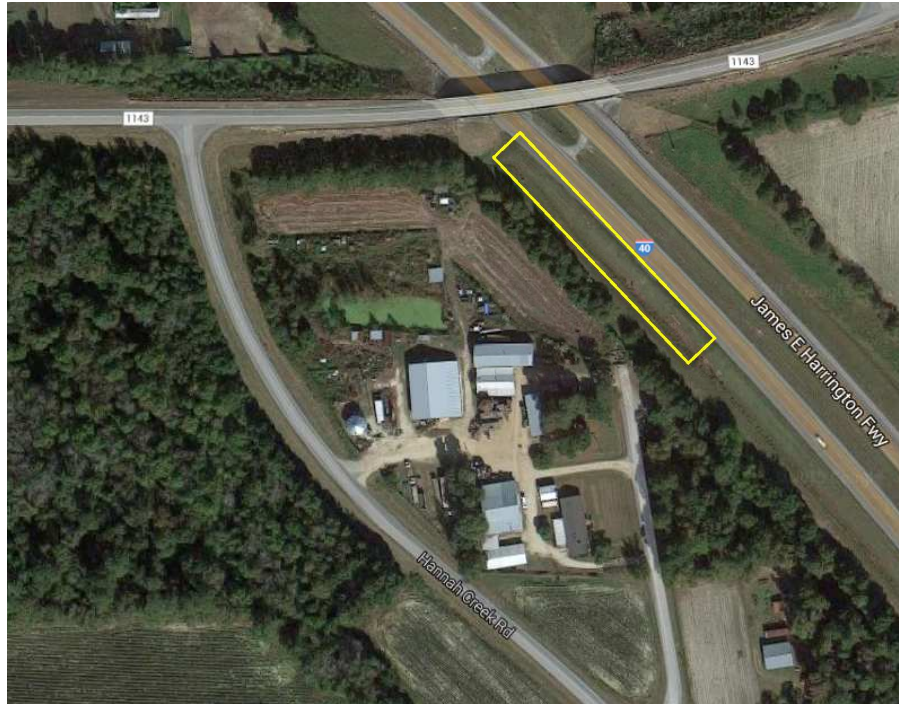
Figure 4-22: The I-40 study site with the swale outlined with the yellow box.

Orthoimagery and contour data for the project site were retrieved from Johnston County, NC Geographic Information Systems website (Table 4-6). Orthoimagery of the I-40 swale and surrounding area is displayed in Figure 4-22. The contour lines overlaid the orthoimagery for use in delineation of the watershed (Figure 4-23).

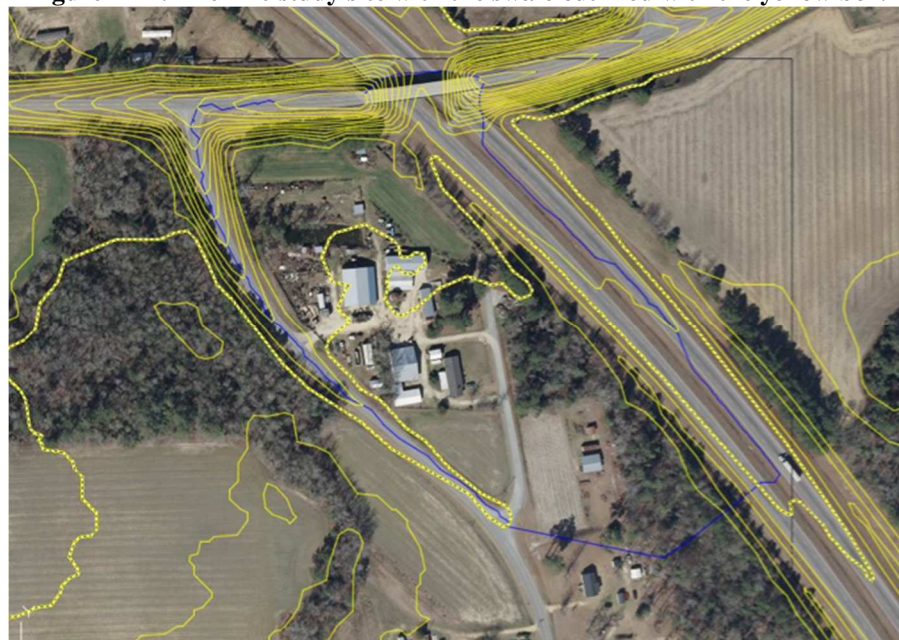
Figure 4-23: Two-foot contour lines overlaying the I-40 study site.

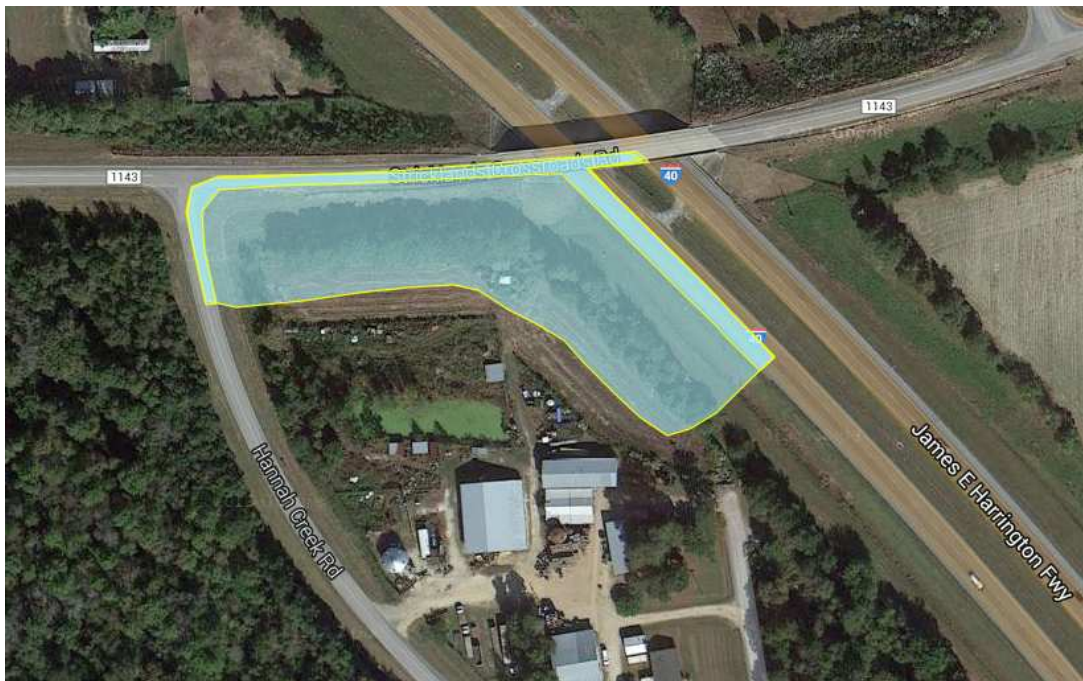
Figure 4-24: Delineated watershed for the I-40 swale.

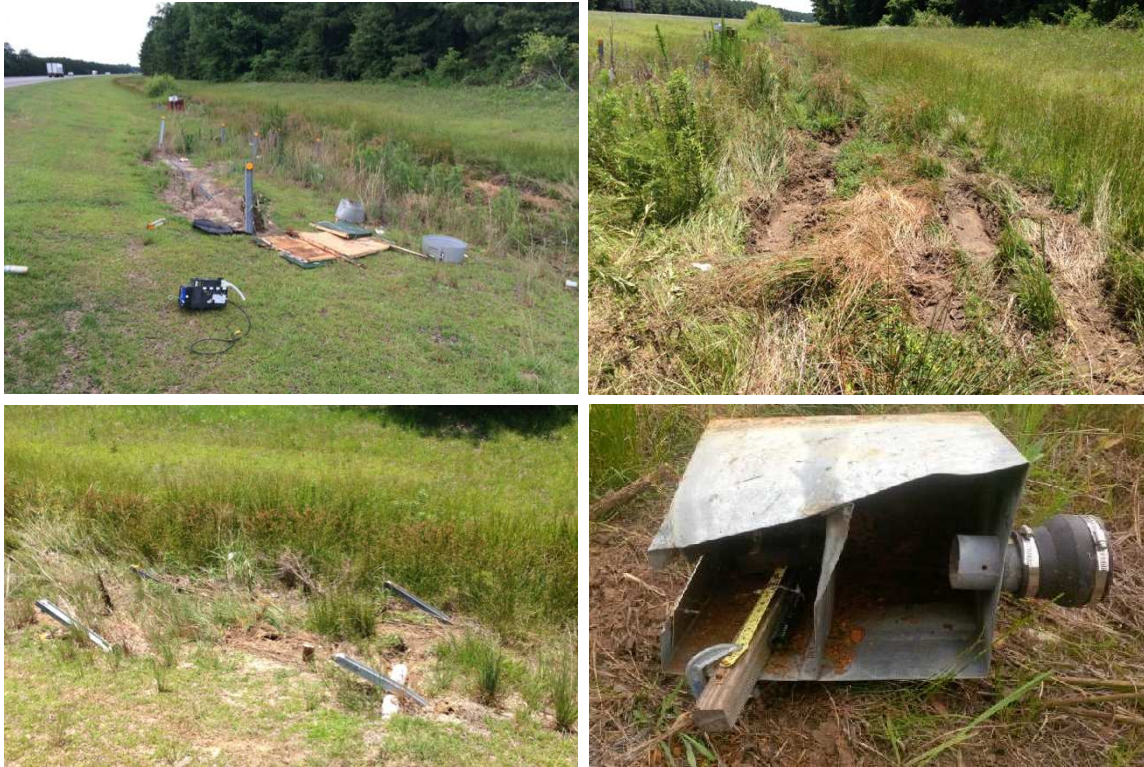
Figure 4-25: Clockwise from top left: Job box housing and ISCO 6712 sampler remains from vehicle incident on June 28, 2014, rut damage in the swale, the damaged weir box from the Road Runoff sampling point, and bent steel reflector beams.

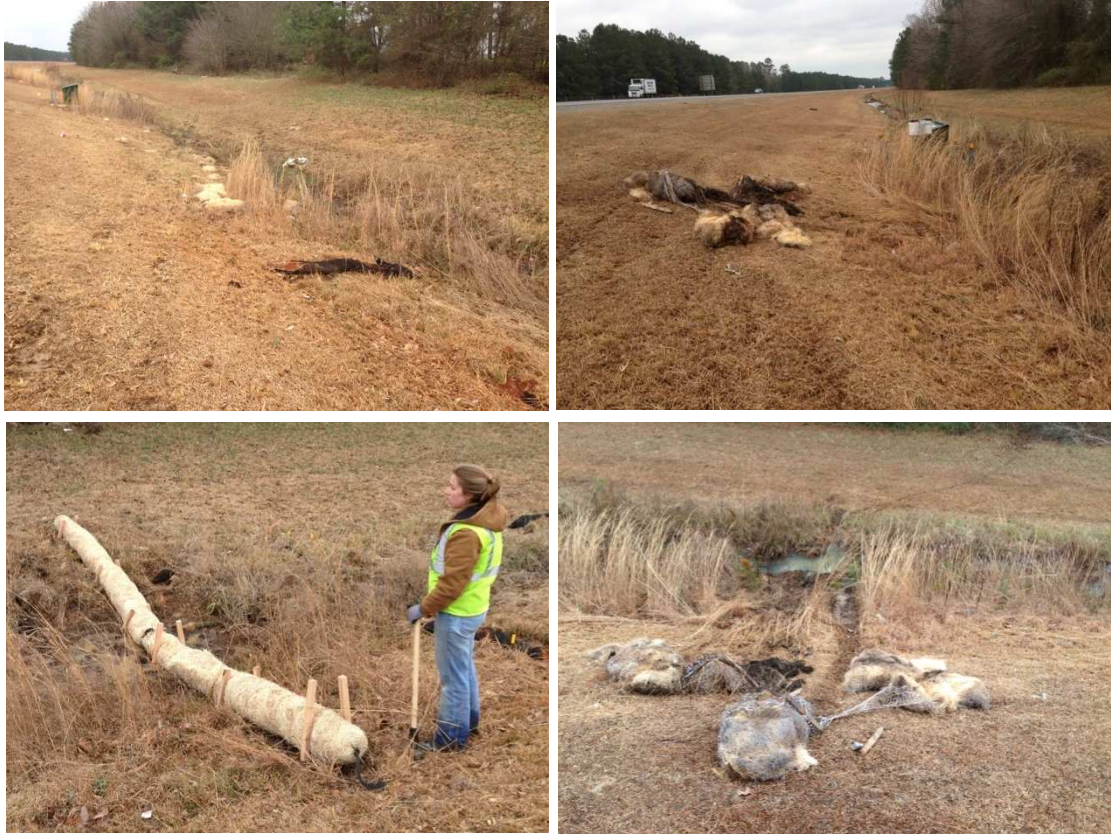
Figure 4-26: Clockwise from top left: Vehicle tracks running through the second check dam from incident on January 13, 2015, the remains of the third check dam, vehicle tracks from the tow truck pulling the vehicle out, and a newly installed replacement wattle check dam on January 23, 2015.

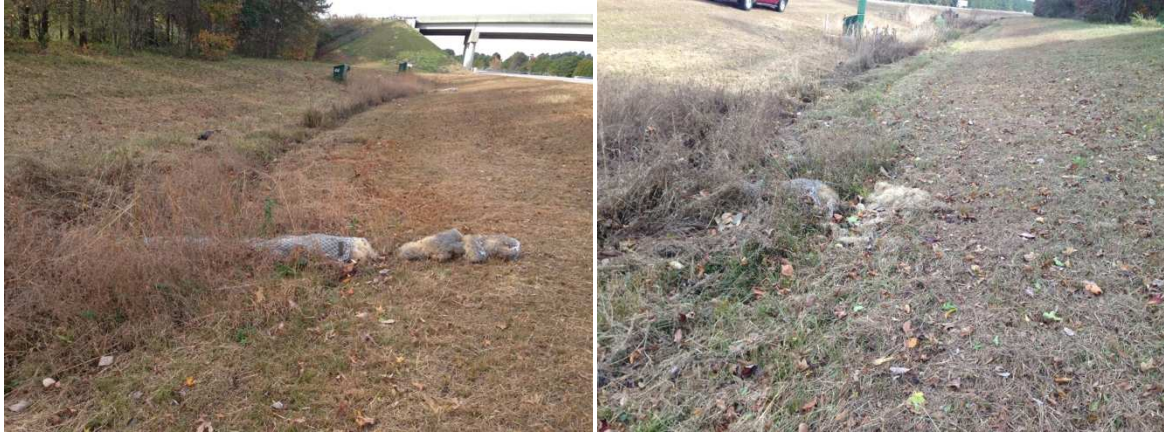
Figure 4-27: Photographs of damage to wattle check dams from mowers.

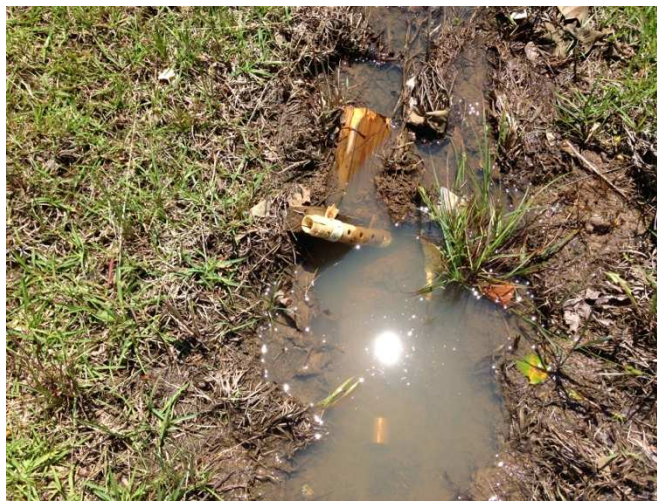
Figure 4-28: Damage to the inlet sampler head from a mower.

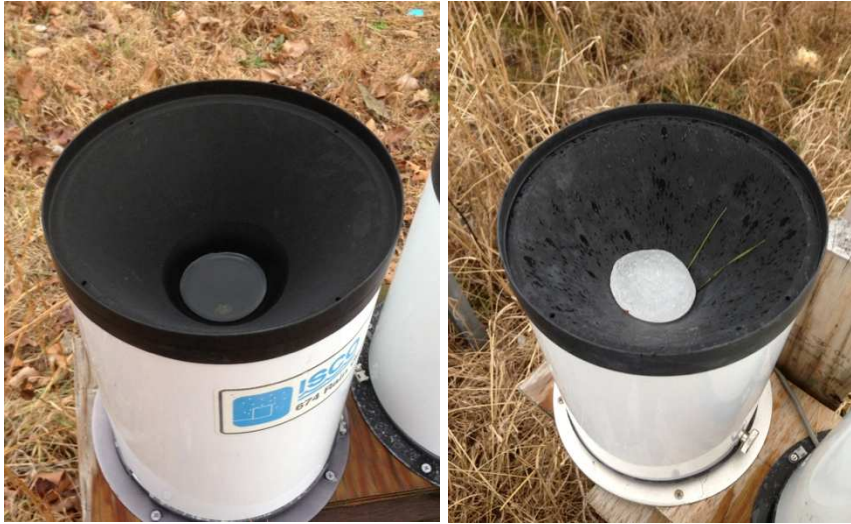
Figure 4-29: ISCO 674 rain gauges clogged from bird feces (left) and from frozen precipitation (right).

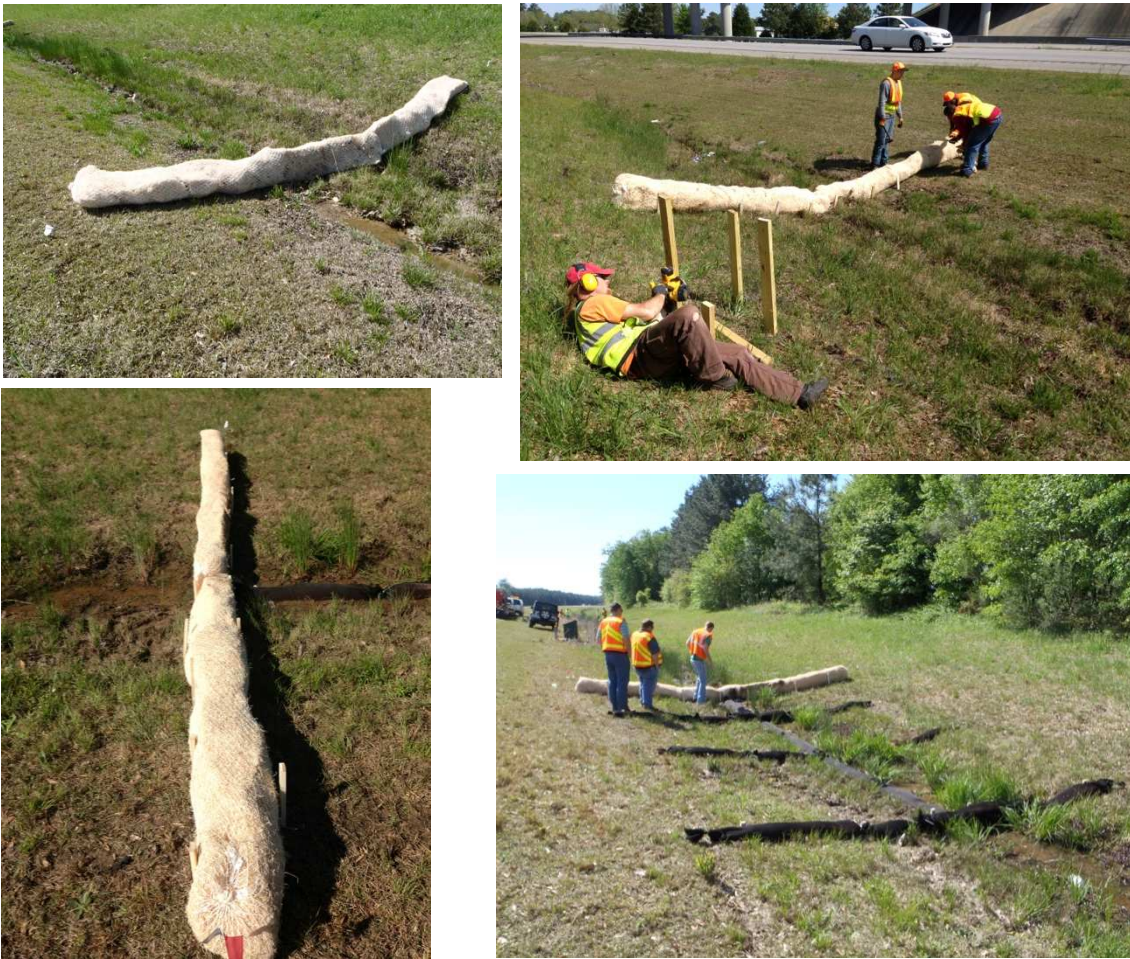
Figure 4-30: Installation of excelsior fiber wattle check dams and ViroPhos media bags at the I-40 swale.
