Comparing Low-Cost Methods for Stabilizing Diversions and Ditches

NCDOT Project 2014-21

North Carolina Department of Transportation

Technical Report Documentation Page

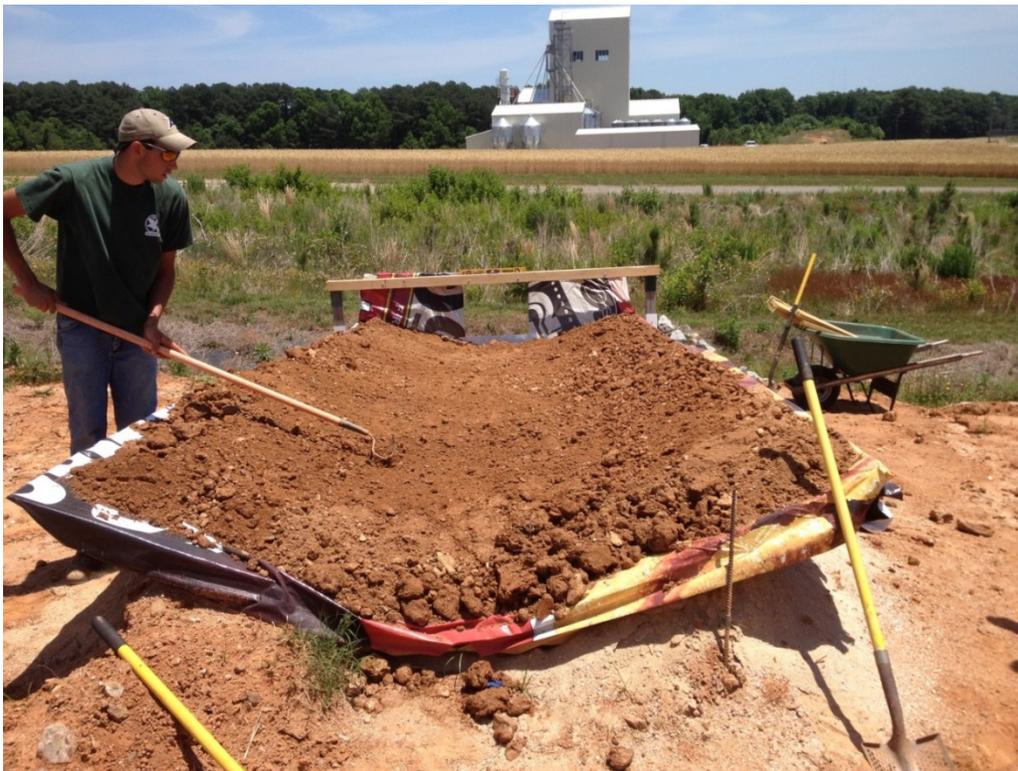
Figure 1. Spreading soil in the flume prior to packing.

The three flumes were positioned to achieve slopes of 4%, 8%, and 12%. The flumes were repeatedly surveyed and small changes to the elevations were made using a mixture of soil and sand, until the slopes could be achieved. The flumes were packed with soil to a depth of approximately 20.3 cm (8 inches) (Figure 1). Soil was compacted, by hand using a soil tamp, to a bulk density of between 1.3 g/cm³ and 1.8 g/cm³. Two soil cores were taken from randomly selected areas in each flume. Each sample was weighed, dried for 24 hours, and then weighed again to determine water content and bulk density. A local Wake County, NC Sandy Clay Loam (54% sand, 25% silt and 21% clay) subsoil was used for all tests.

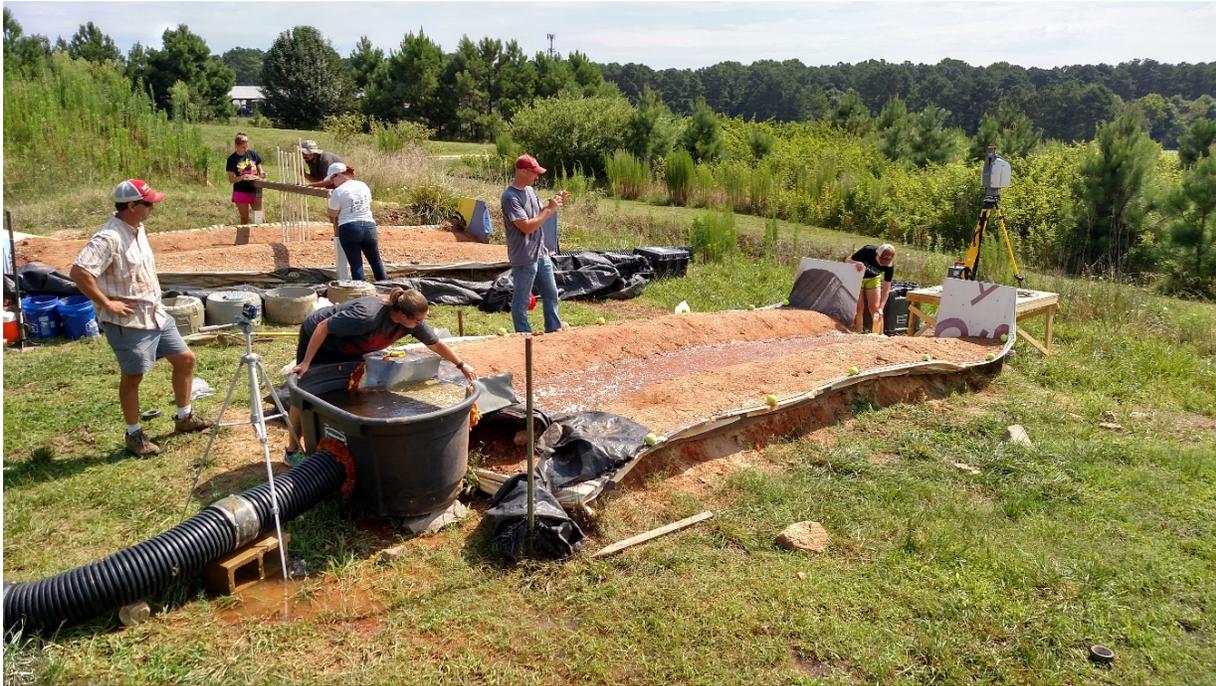
Figure 3. Measuring erosion with a pin device (background) and testing bare soil in the medium (8%) slope. Surveys were also conducted via georeferenced photographs and a LiDAR unit, shown at the end of the closer flume, for several tests. Manual collection of inlet and outlet samples is also occurring in this ditch.

Most of the measurement operations described below are illustrated in Figure 3. For each test, water samples were taken manually at the inlet and outlet of the test ditch at one minute intervals. After 10 minutes, flow was stopped and erosion measured using a pin device at set intervals of 60 cm (24 in) along the flume (see below). After that, the test was resumed at the next higher flow rate until all three rates were completed. Flow was affected by the water level in the source pond but the three rates were 0.3-0.5 cubic feet per second (cfs), 0.7-0.8, and 0.9-1.2 cfs. Water samples were analyzed for turbidity and total suspended solids (TSS) in the laboratory. In addition, for a few tests the ditch surface changes were recorded photographically and a program was used to generate a three-dimensional image, and a ground-based LiDAR system also recorded the surfaces. These latter two systems were used just to determine their utility for this type of surface analysis as part of the summer intern project. An ISCO

Before and after each test a detailed survey of the flume was produced using the Ditch Pin Measuring Apparatus (DPMA). The DPMA contained 13 individual “pins” (spaced 6” apart) that are able to slide up and down within the device. The DPMA was placed at known points and elevations along the ditch (spaced at 2’ intervals) and the pins were allowed to slide down until they came in contact with the flume soil. Measurements were taken for each pin and compared with the before measurements to determine soil loss at each pin.

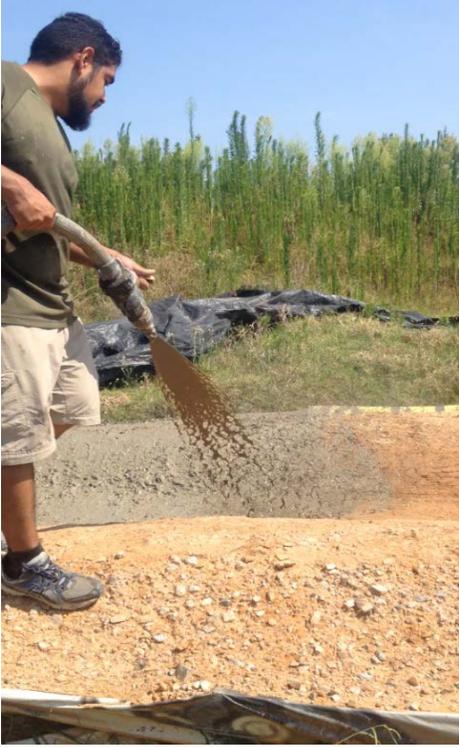
Figure 4. Posi-Shell being applied to the simulated ditch at SECREP.

Examples of the Posi-Shell application and testing are shown in Figures 4 and 5.

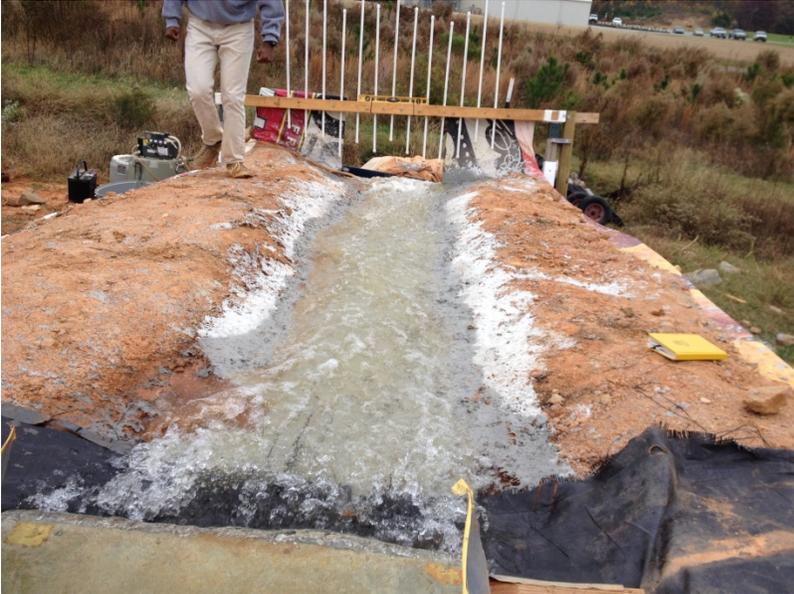
Figure 5. Testing the hydraulically applied concrete product with a 1 cfs test flow.

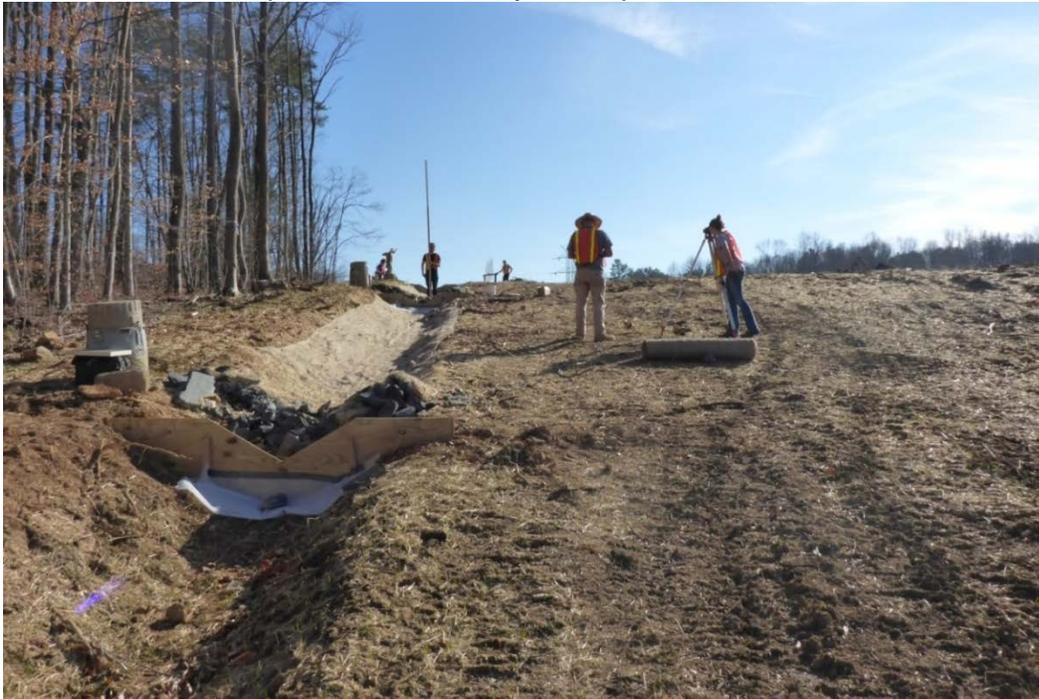
Figure 6. Measuring the slope of each ditch section. Note V-notch weir and sampler placed to measure flow and sediment loss.

The first suitable site was on the I-840 Urban Loop extension around Greensboro, NC, between US 70 and US 29 (STIP # U-2525B), just north of US 70. Two ditches were lined with a series of liners (jute, jute + PAM, excelsior, Posi-Shell). On one set, we installed weirs and samplers at the end of each section in order to measure sediment in runoff from that section. For both ditches, we established three locations where we measured the contours of the ditch after a number of storm events to detection erosion. The ditch with the water quality monitoring included a V-notch flume after each check dam, which marked the change to a different liner, and an automatic sampler to obtain flow and samples (Figure 6).

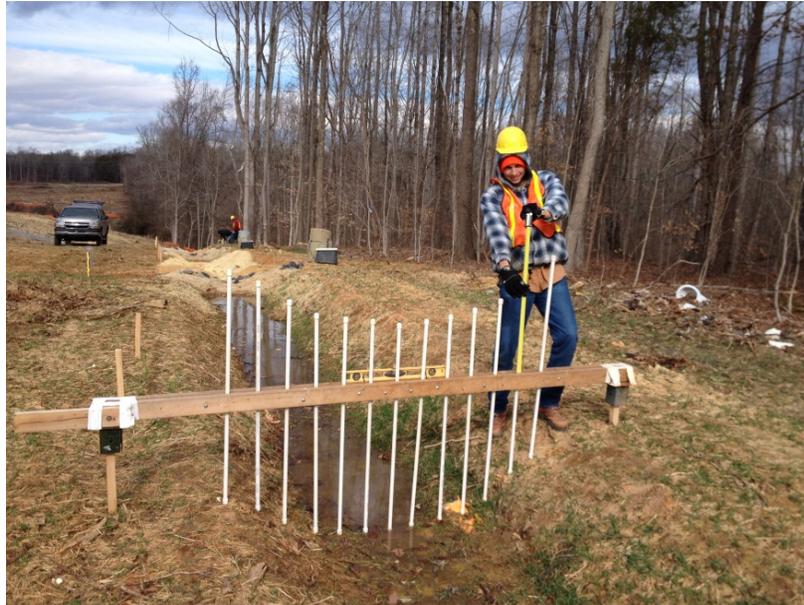
Figure 7. Using the cross-section pin measurement device in a bare soil (control) treatment section of the ditch.

Three cross-sections were measured in each section of ditch that had been treated and compared with the initial measurements that were taken at the site. Figure 7 shows the cross-section pin measurement device being used to record changes in a bare soil (control) treatment ditch at the site. After placing the device on permanently installed stakes along each ditch and pushing the individual pins down until they contact the soil, each of the pin lengths above the cross-member were measured and recorded. More views of the Greensboro site are shown in Figures 8-9.

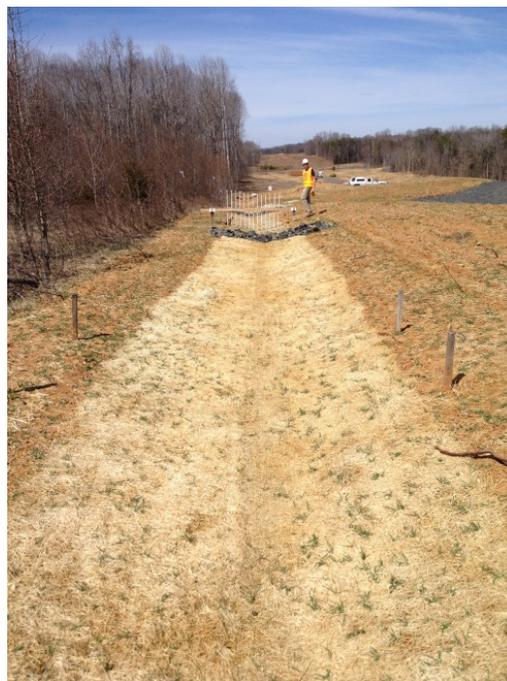
Figure 8. The rolled erosion control blanket (excelsior) treated section of Ditch 2 shows very few signs of erosion.

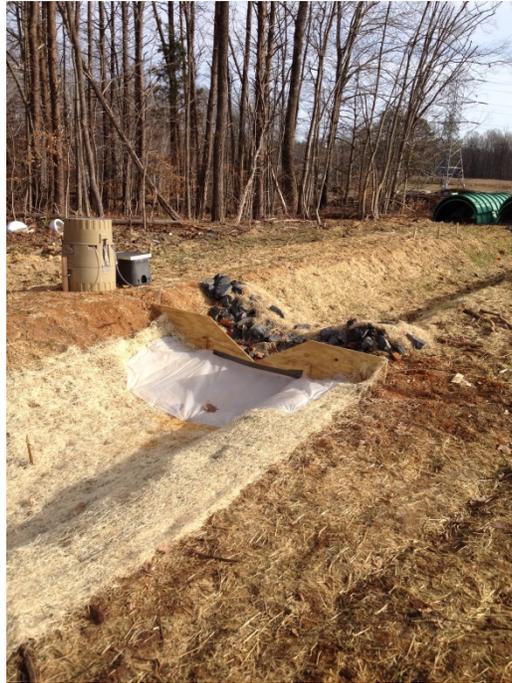
Figure 9. Automated sampler and V-notch weir for collecting water quality and quantity data.

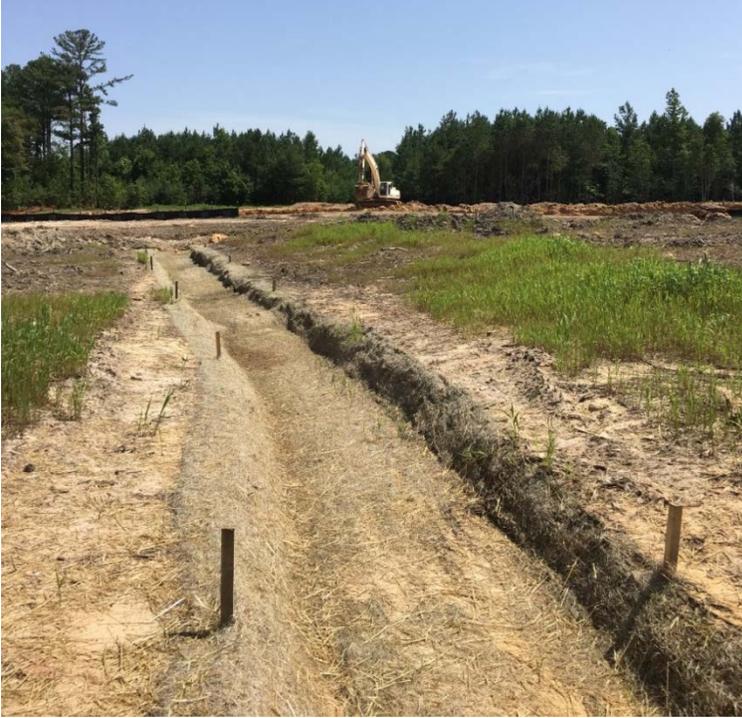
Figure 10. Excelsior-lined ditch at the Apex site after flow was cut off to it during grading. Stakes along each side are level across the ditch so the pin tool could be laid on them to measure changes in the cross-section.

A second site was located at the construction of an interchange on I-540 at Old Holly Springs Apex Road. Ditches lined with excelsior, Posi-Shell, jute+PAM, and an unlined ditch was also monitored. However, grading activities often reduced or eliminated flows in the diversion ditches and eventually most were no longer receiving runoff or obliterated by grading (Figure 10). The hydroseeder with which we applied the Posi-Shell had mechanical difficulties and could not produce enough pressure to make a good application anyway, and that lining did show evidence of erosion (Figure 11).

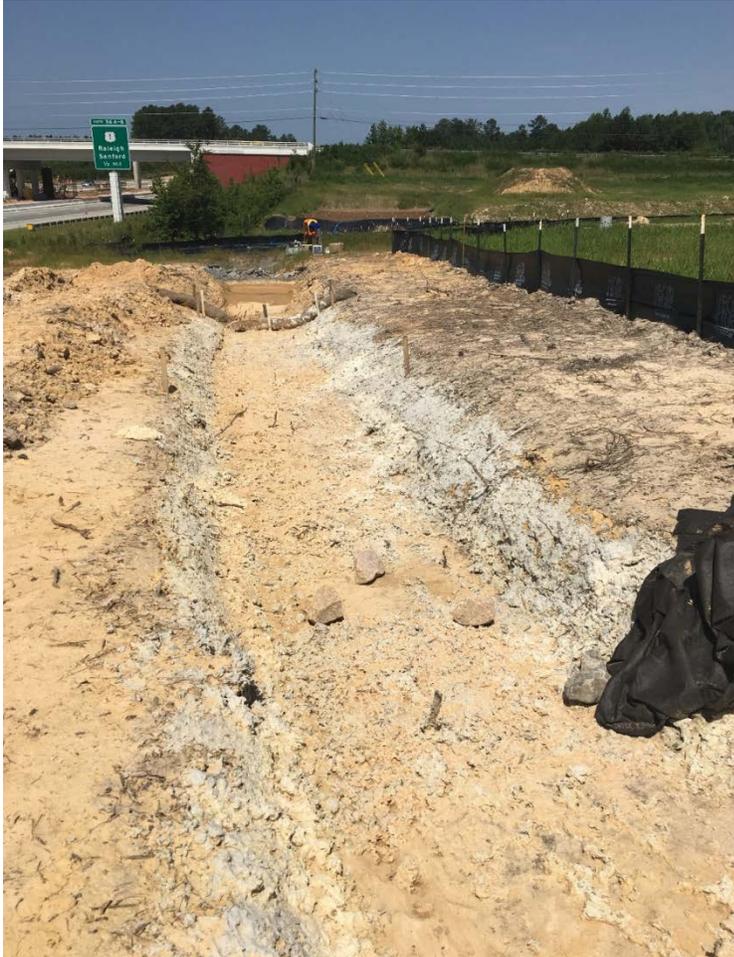
Figure 11. Posi-Shell-lined ditch at the Apex site showing erosion due to poor distribution of the material as a result of inadequate pressure in the hydroseeder.

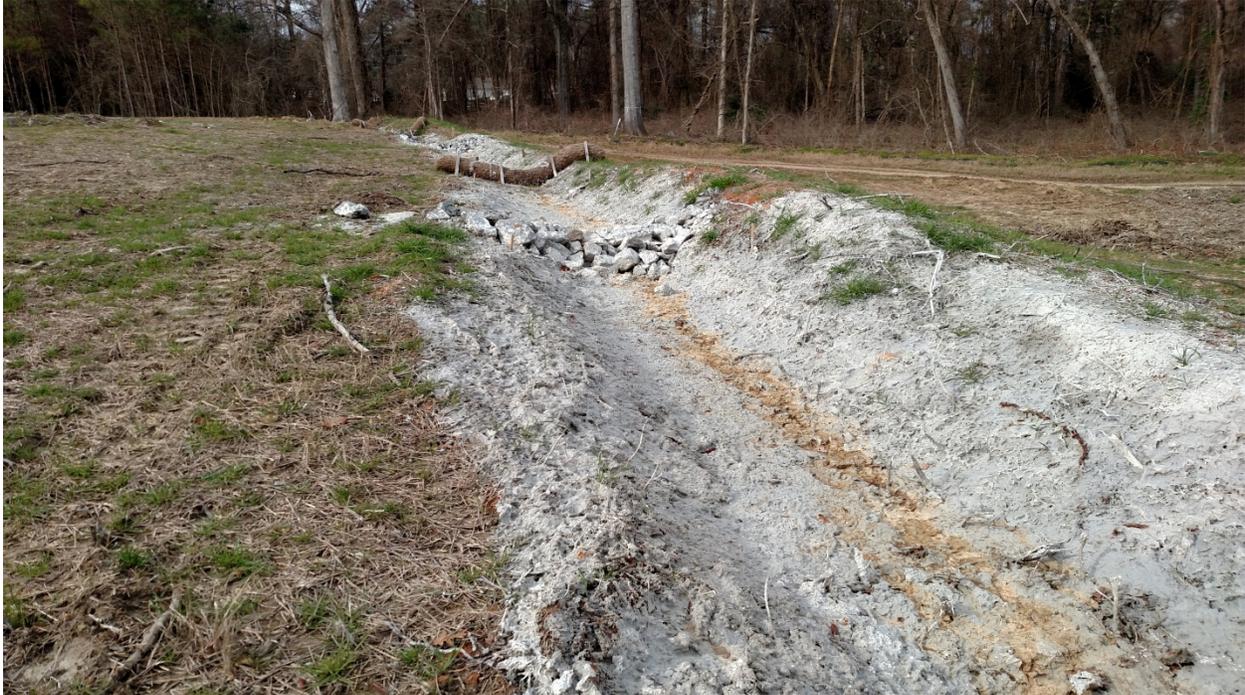
Figure 12. Diversion ditch lined with Posi-Shell after several flow events.

The third and last active site was located on the Durham East End Connector project (STIP # U-0071). With the assistance of the project staff, we were able to locate four ditches running roughly parallel on one portion of the project. We applied four treatments: jute, jute + PAM (on soil under jute), excelsior, and Posi-Shell. These were applied to the upper portion of each ditch. V-notch weirs were installed to measure flow and obtain exit samples using automatic samplers. Polyacrylamide was being applied to the check dams by the contractor. An example of a Posi-Shell lined ditch at this site is shown in Figure 12.

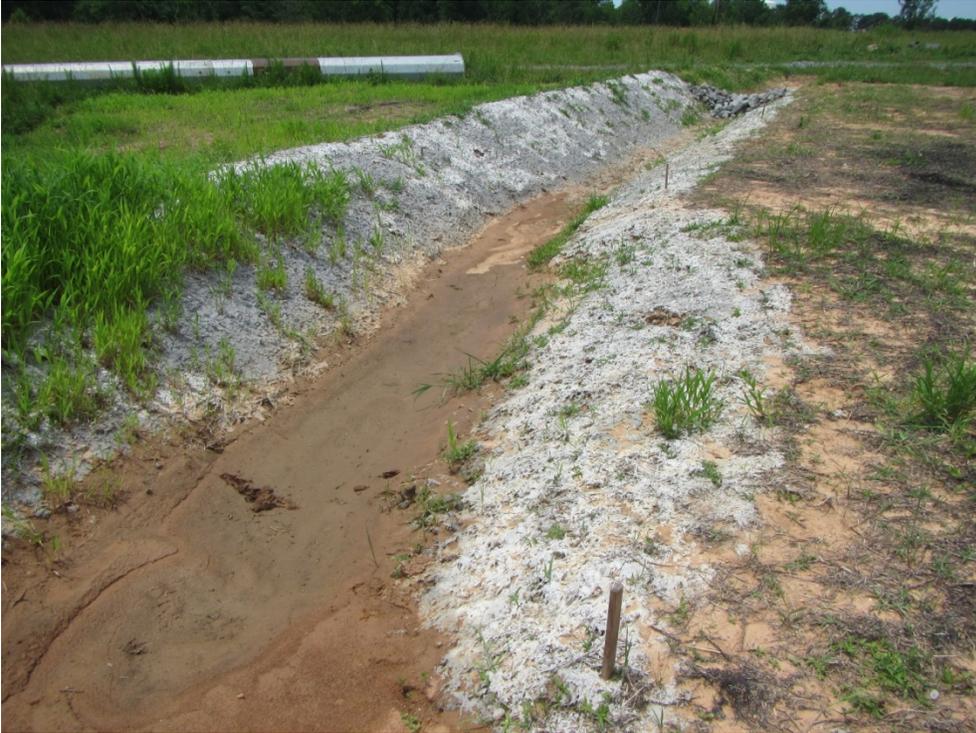
Figure 13. Posi-Shell-lined ditch in May 2017, one month after application.

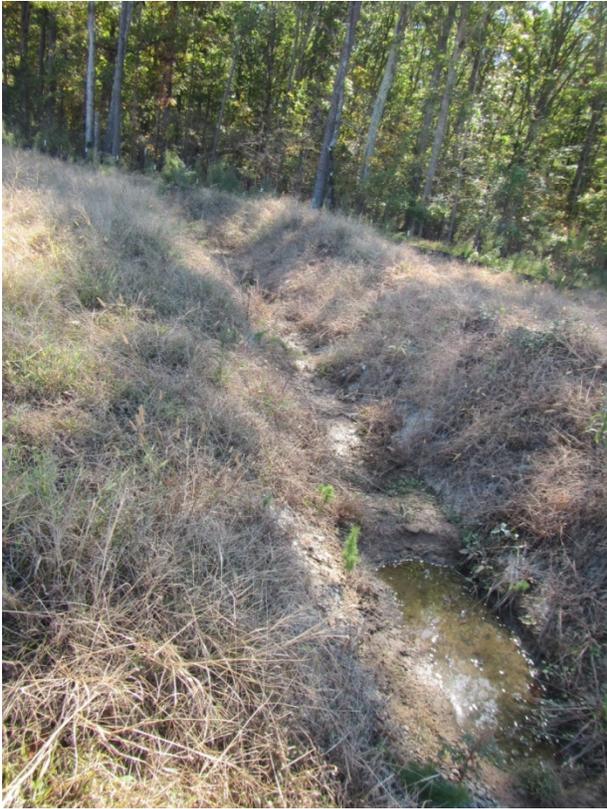
Figure 14. Second Posi-Shell-lined ditch in September 2017, also showing considerable volunteer vegetation.

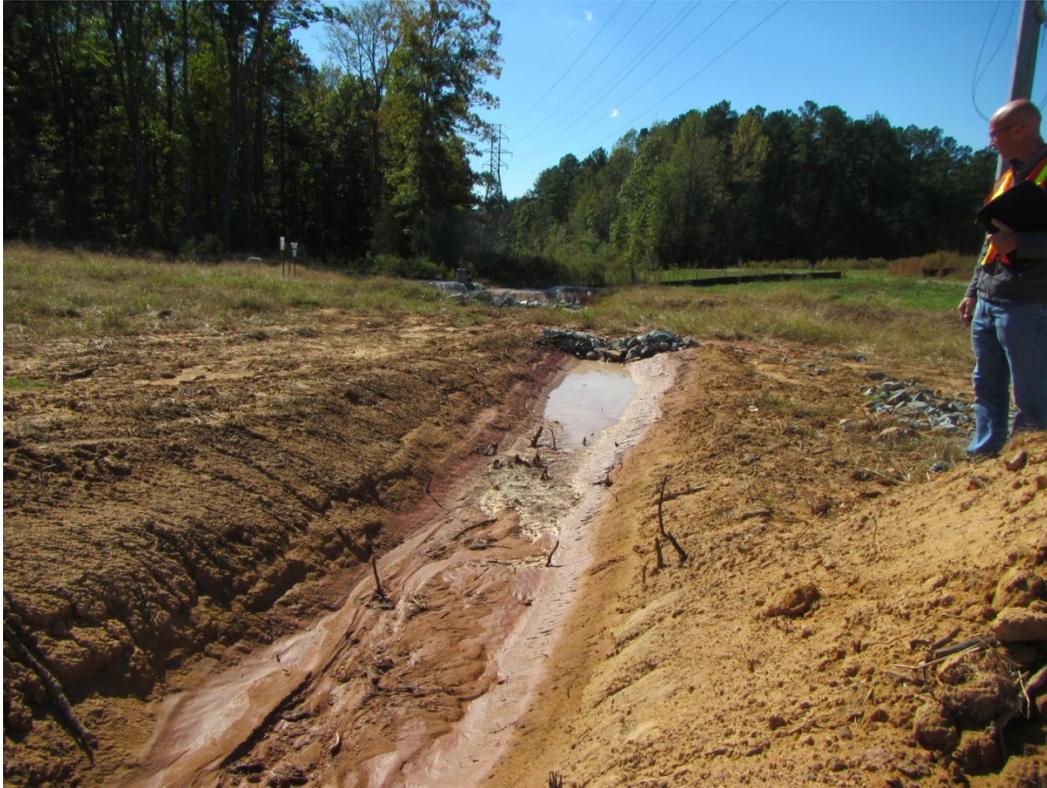
Figure 15. Unlined ditch in September 2017, showing no vegetation and eroding side walls.

We also applied Posi-Shell to a second site on the same project. This site had two diversion ditches which discharged into a sediment basin. The site had just been seeded and straw applied when we selected it, so the straw was removed from the ditches manually before applying the Posi-Shell. Weeds and grass grew through the lining over the course of monitoring these ditches (Figures 13-14). Although no monitoring occurred on the adjacent basin, we did observe the conditions in the unlined

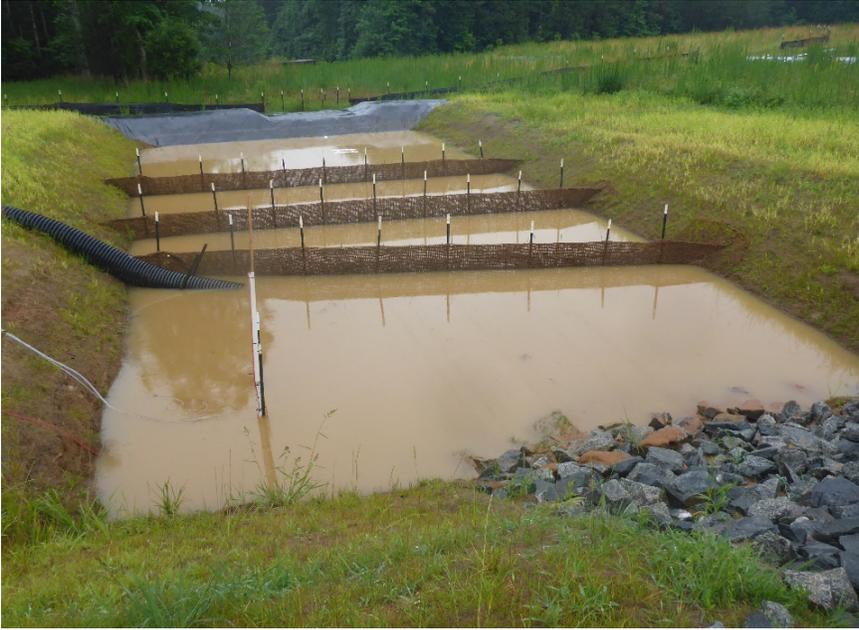
Figure 16. Sediment basin which has Posi-Shell applied to the two diversion ditches leading to its inlet.

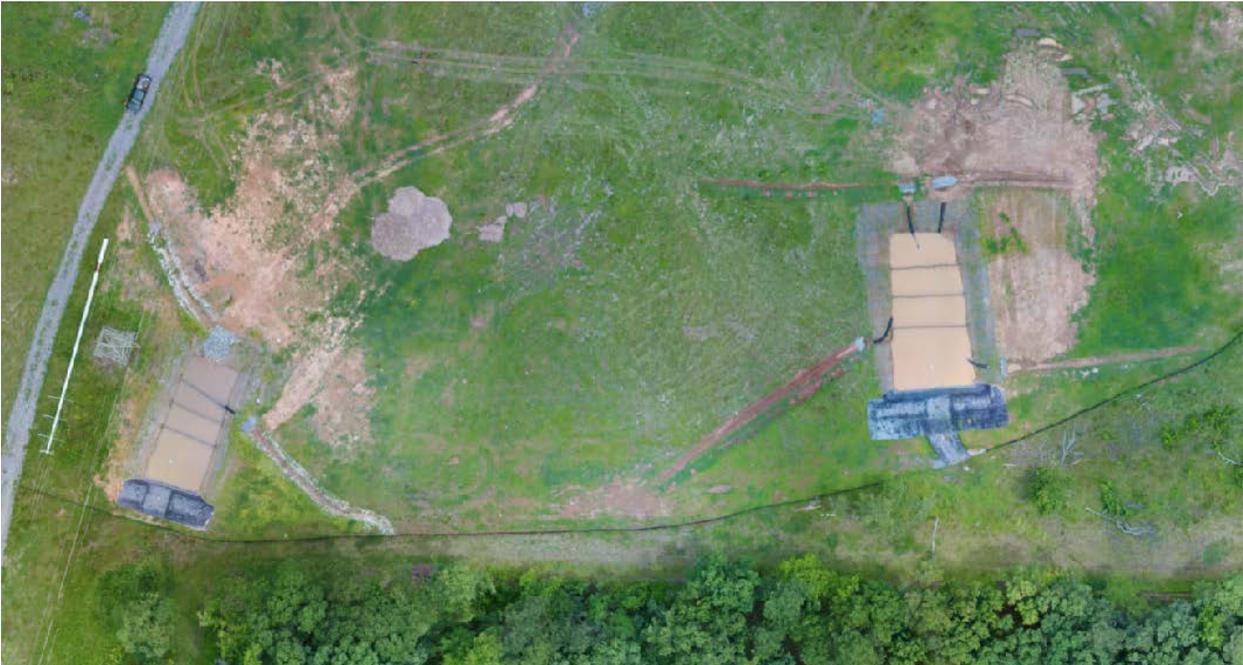
Figure 17. Posi-Shell-lined basin on left and unlined inlet basin on right illustrating potential effects on turbidity.

ditches there (Figure 15). Water quality (turbidity) was monitored with automatic samplers at a ditch outlet and basin outlet. The basin with Posi-Shell diversion ditches (Figure 16) was monitored for water quality and level, while the adjacent standard basin was observed for contrast in water quality (Figure 17).

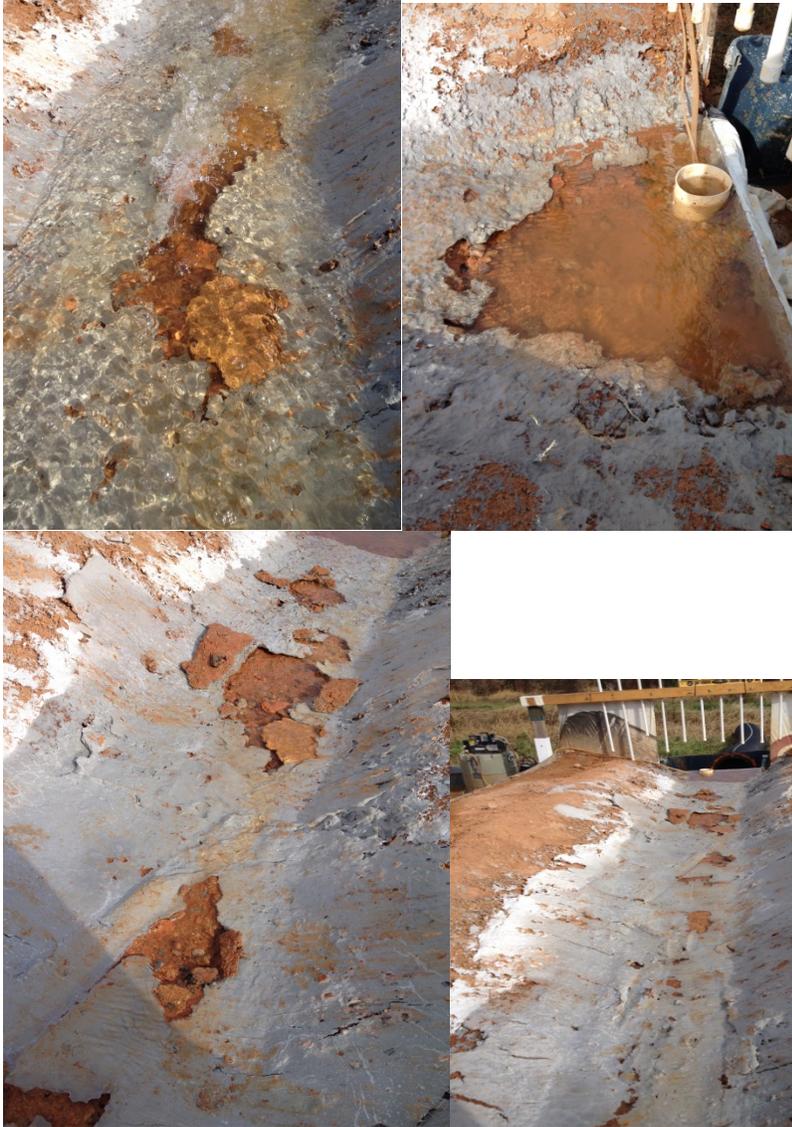
Figure 27. Failures, and resulting erosion, in the hydraulically applied concrete product after poor application to a test ditch.

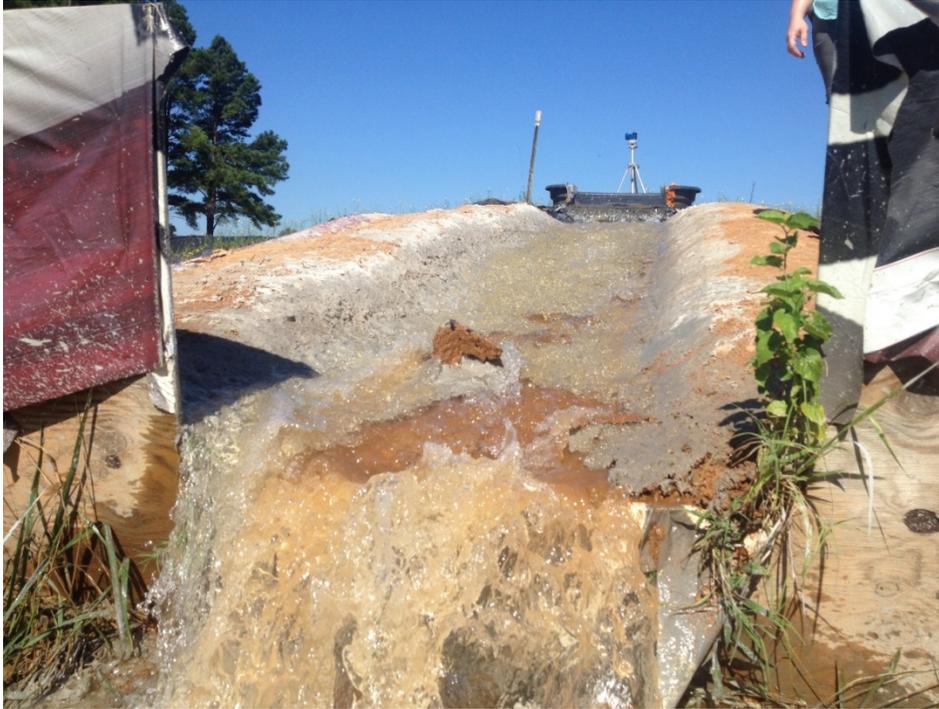
Figure 30. Failure of the Posi-Shell at the steepest (12%) slope. This may have been an artifact due to the high turbulence at the point where the liner meets the weir – notice how it started at the bottom.

having far more sediment than the other two. If that replication was removed, the high slope, high flow sediment loading would drop from 8 kg to 0.27 kg. This illustrates the sensitivity of Posi-Shell to application techniques, as it is likely the high-sediment replication failed due to an error in application (Figure 30).

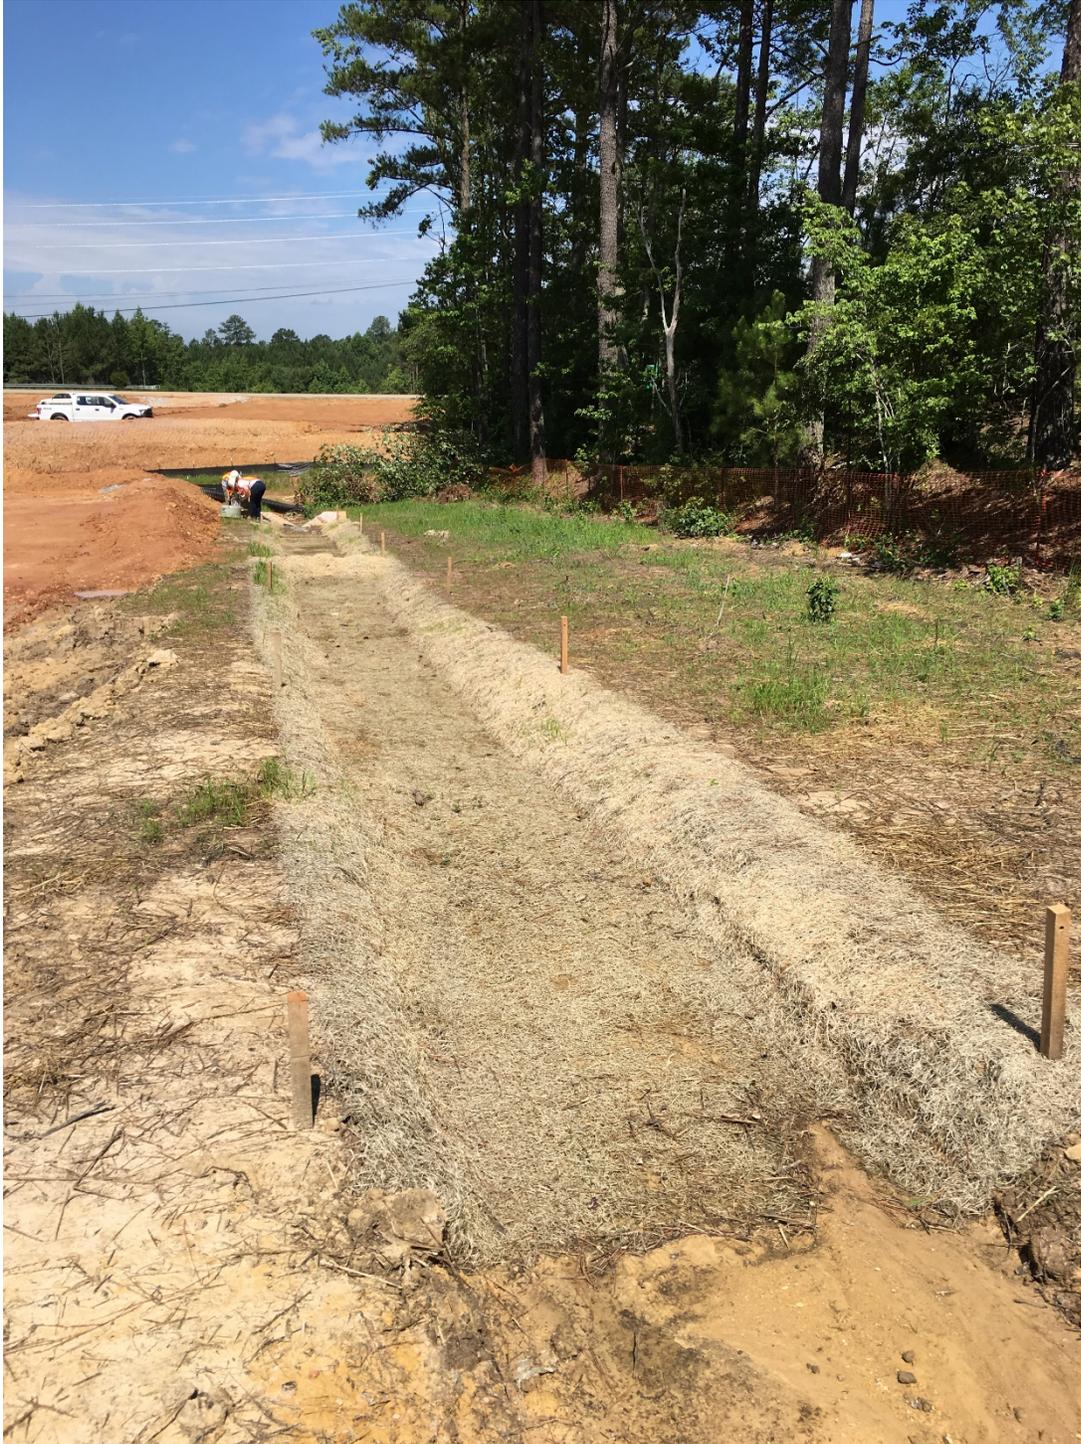
Figure 34. Excelsior-lined ditch in Apex showing the pin stations (stakes) and the V-notch weir at the outlet. Picture was taken July 6, 2016.

The I-540 interchange site in Apex had relatively flat ditches resulting in more deposition than erosion and often very little change (Figure 34). In addition, grading activities regularly cut through the ditches, diverting flow so that the ditches carried little storm flow. For that reason monitoring was limited to a little more than a month. Some examples of erosion pin data are presented to illustrate these points. The excelsior+PAM, excelsior, and Posi-Shell ditches had little evidence of erosion or deposition, with the possible exception of the excelsior ditch right bank (Figures 35-37). The bare soil ditch showed evidence of both erosion and deposition as measurements were made down the slope (Figures 38-41). Almost 20 cm of deposition was evident in that ditch at station 7, suggesting that a check dam was adjacent. For various reasons, there was only one storm which generated flow in all four ditches (Figure 42). Turbidity was high in the Posi-Shell and bare ditches, but with relatively little erosion evident the turbidity likely originated from the surrounding areas. There were too few samples to draw any conclusion for the excelsior and excelsior+PAM ditches.

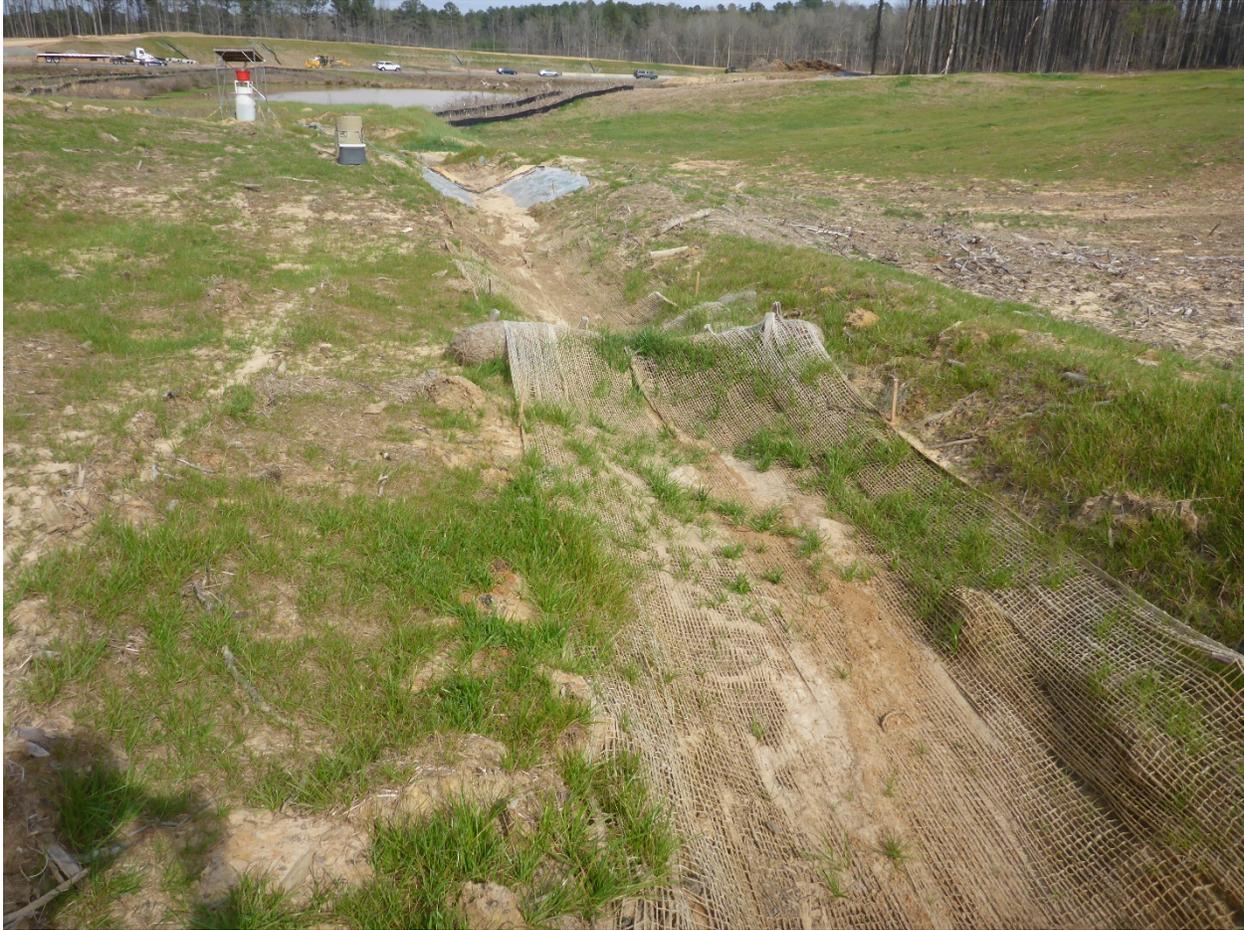
Figure 55. Vegetation establishment around the jute-lined ditch at the Durham location, at the time of the March 2 survey.
