The Effects of Late Lane Merges on Travel Times

Institute for Transportation Research and Education

NCDOT Project 2015-08

FHWA/NC/2015-08

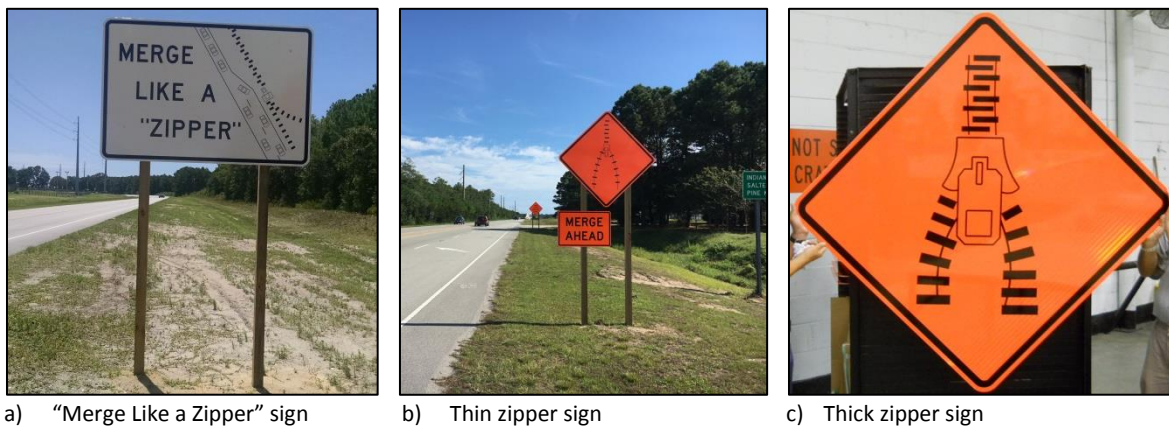
Figure 1 Zipper Merge signage

The NCDOT had predetermined unconventional plaques that they wanted to use for the zipper merge in conjunction with other conventional signs and message boards. The new plaques were discussed internally among NCDOT staff, and then presented to the research team. One of the plaques instructed traffic to “Merge Like a Zipper”, with a picture showing the comparison of traffic taking turns merging beside a picture of a zipper. The other sign was implemented in two phases, both of which simply picture a zipper closing. The NCDOT received feedback from the public after the first orange zipper sign was installed suggesting that it was difficult to see because the picture was too thin, which brought about the second orange zipper sign (Figure 1c), which featured a thicker, more visible rendition of the first sign’s zipper. These signs are pictured in Figure 1a, b, and c.

Other conventional signs used include signs that directed traffic to “Use All Lanes”, which was intended to counteract the traditional early merge ideology. Likewise, message boards were strategically placed at the two permanent lane drop sites in Durham and Carteret Counties which informed drivers that they were approaching the zipper merge and to use all of the available lanes until reaching the merge point. The merge point at the Carteret and Vance/Warren County sites was identified using plaques that indicated “Take Turns Merging Here”.

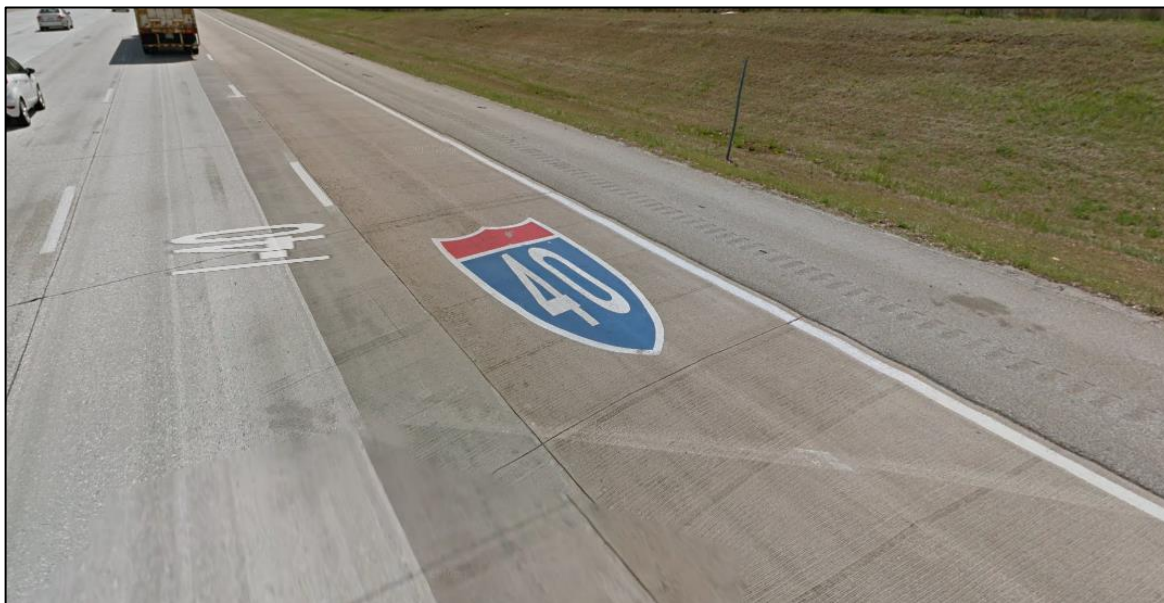
Figure 2 Example of elongated route shield

Another treatment observed for this study was elongated route shields, or pavement shield markings. These markings are most often installed on freeways to indicate diverge segments to drivers, particularly where two freeways diverge. These are intended to reduce driver confusion and because these markings generally start more than one mile before a diverge segment, they have the potential to greatly reduce last second lane changes that cause crashes. An example of an elongated route shield is shown in Figure 2.

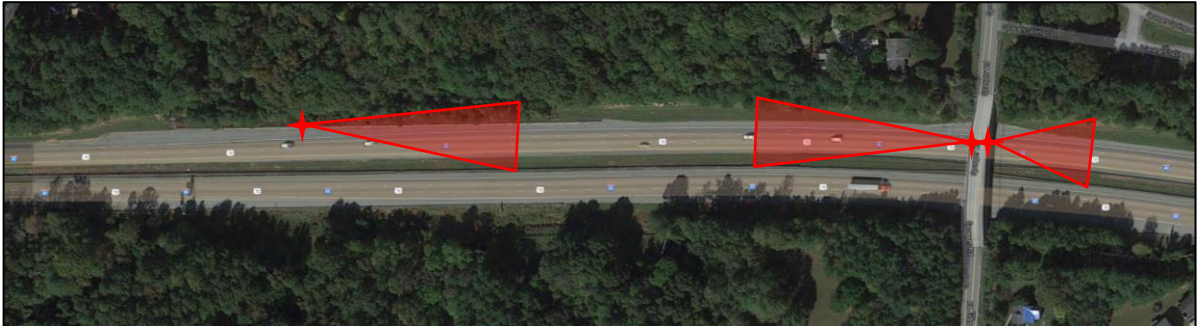
Figure 4 Durham I-85 site camera configuration

Three cameras were installed at this site. Two cameras were installed on the Sparger Road bridge that overpasses the freeway (only shown as one star), with one facing upstream to capture lane utilization rates prior to the lane drop before the right lane begins to taper and the other facing downstream traffic towards the lane drop. A third camera was installed on a sign post approximately 300 feet from the end of the lane drop on the right shoulder of the freeway. This camera was used to determine the merge location of vehicles in the ending lane. This location was chosen because it was close enough to the end of the lane, with only six feet of lane width available in the right lane, while still allowing the camera to observe merging vehicles prior to the end of the lane. Noted earlier, a vehicle was considered merging when the vehicle's front left tire crossed the lane line, and if the front left tire did not cross the lane line, the merge occurred past the camera, meaning the vehicle would have been traveling at least partially on the shoulder of I-85. The third

camera facing downstream from the bridge was used as a backup in case either of the other two cameras malfunctioned. Figure 4 shows the location and orientation of the cameras at the Durham site.

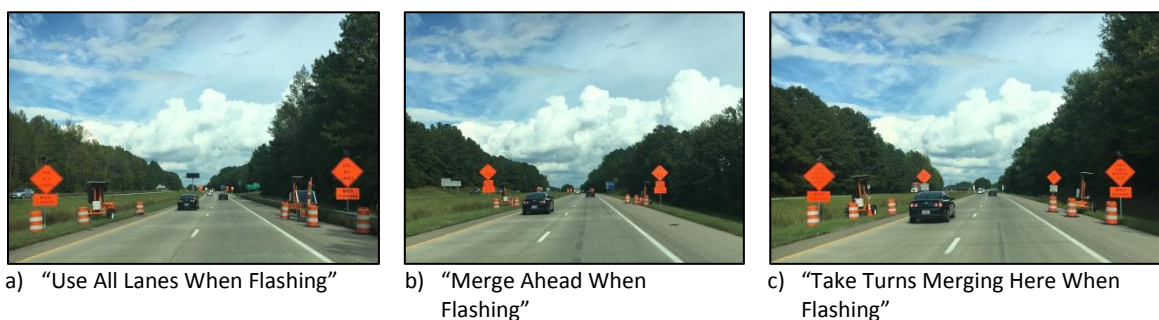
Figure 10 Work Zone Zipper Merge Signage

For the after study period, the NCDOT enlisted one of their regular contractors to install dynamic signage in the zipper merge corridor. When any vehicle was detected going below 40 miles per hour, this equipment would activate flashers attached to signs telling drivers to “Use All Lanes When Flashing” and “Merge Ahead When Flashing” upstream from the lane drop and to “Take Turns Merging Here When Flashing” near the end of the right lane, and these flashers would deactivate whenever average speeds reached above 50 miles per hour. Images of these signs installed at this site are in Figure 10.

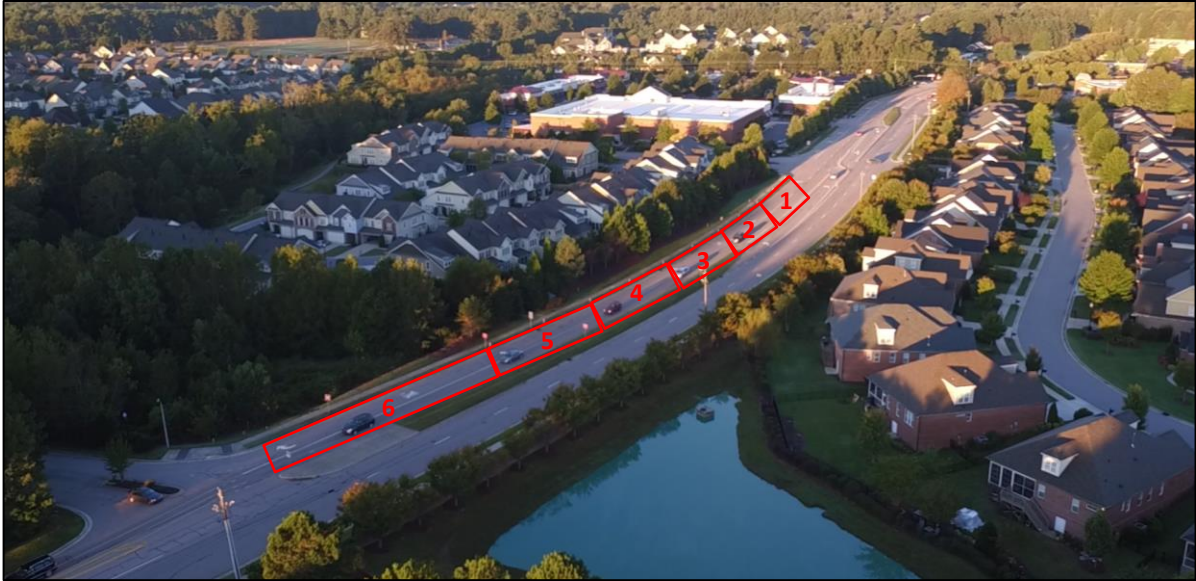
Figure 14 Diagram of merging zones for Ten-Ten Road site

- *Zone 1: 0-100 feet* – Vehicles that merged within 100 feet of the intersection with Andrews Pond Drive,
- *Zone 2: 100-200 feet* – Vehicles that merged between 100-200 feet from this intersection,
- *Zone 3: 200-300 feet* – Vehicles that merged between 200-300 feet from this intersection,
- *Zone 4: 300-400 feet* – Vehicles that merged between 300-400 feet from this intersection,
- *Zone 5: 400-500 feet* – Vehicles that merged between 400-500 feet from this intersection,
- *Zone 6: After 500 feet* – Vehicles that merged farther than 500 feet from the Andrews Pond Drive intersection but before the end of the right lane.

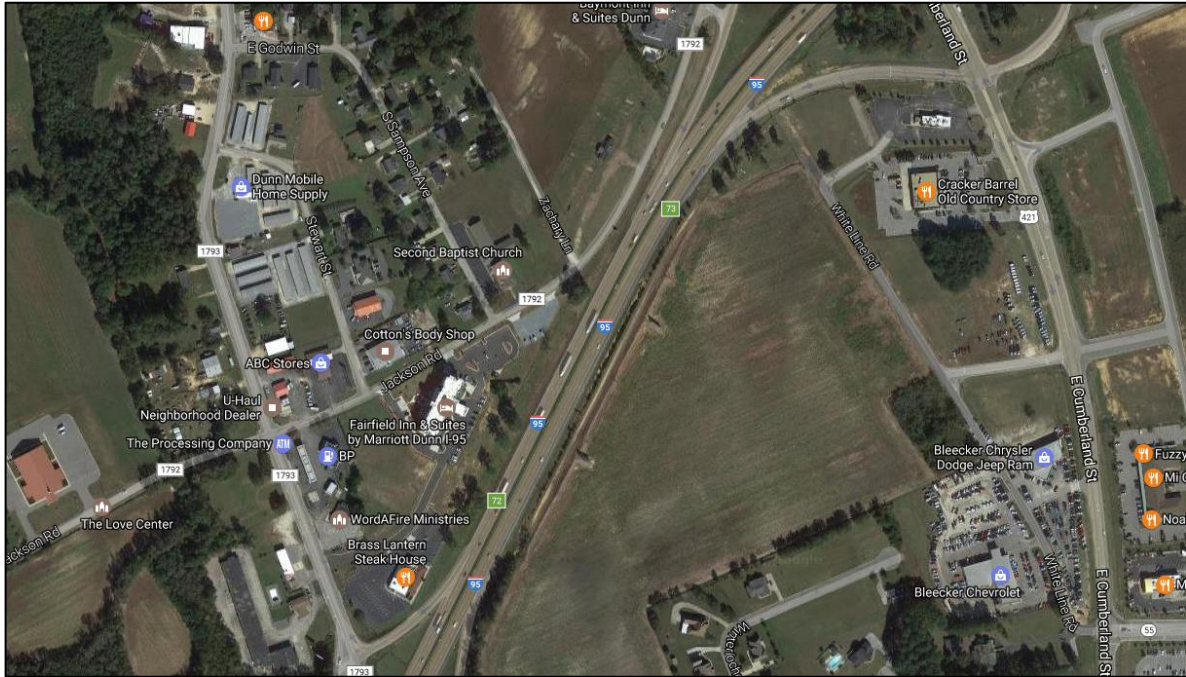
being about 1,500 feet long from gore to gore. The auxiliary lane was previously marked with standard skip lines from gore to gore in each direction, but once this portion of I-95 was repaved, the northbound auxiliary lane was marked with the wide dotted white lane lines for the full length of the lane. Note that construction activity was not immediately adjacent to the study area during data collection and therefore did not affect the data collection or driver behavior. An aerial image of this site is shown in Figure 16.

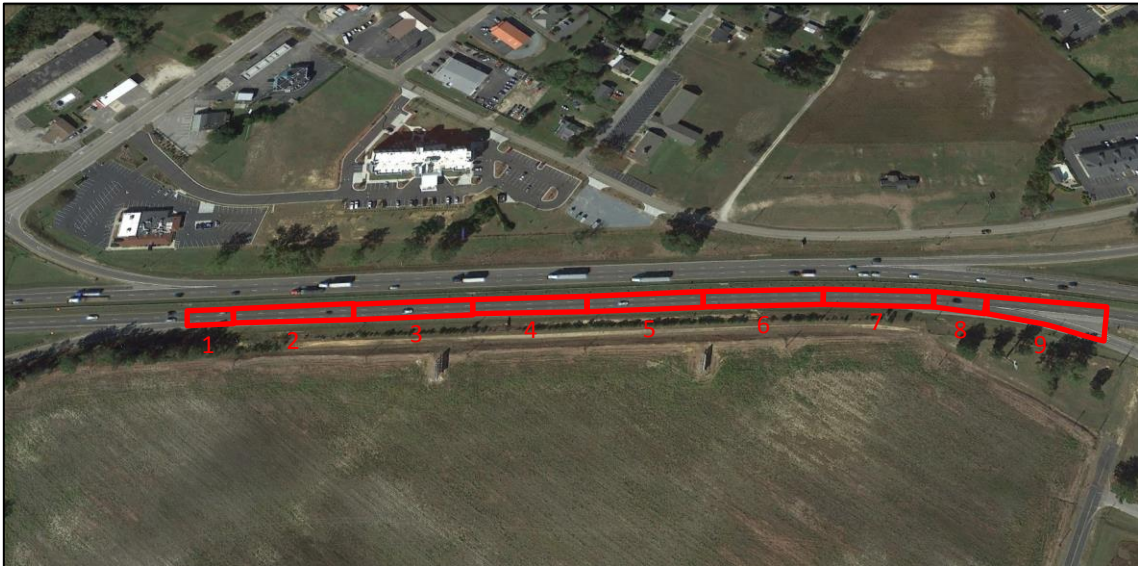
Figure 17 Merging distances on northbound I-95 in Dunn, NC

- *Zone 5: 790-1,020 feet* – Vehicles that merged between 790-1,020 feet from the entrance ramp gore point,
- *Zone 6: 1,020-1,250 feet* – Vehicles that merged between 1,020-1,250 feet from the entrance ramp gore point,
- *Zone 7: 1,250-1,480 feet* – Vehicles that merged between 1,250-1,480 feet from the entrance ramp gore point,
- *Zone 8: 1,480-Gore Point (1,585 feet)* – Vehicles that merged between 1,480 feet from the entrance ramp gore point to the exit ramp gore point (1,585 feet from the entrance ramp gore point),
- *Zone 9: Gore Point-1,810 feet* – Vehicles that merged beyond the exit ramp gore point, but before the beginning of the ramp median grass (1,710 feet from the entrance ramp gore point).

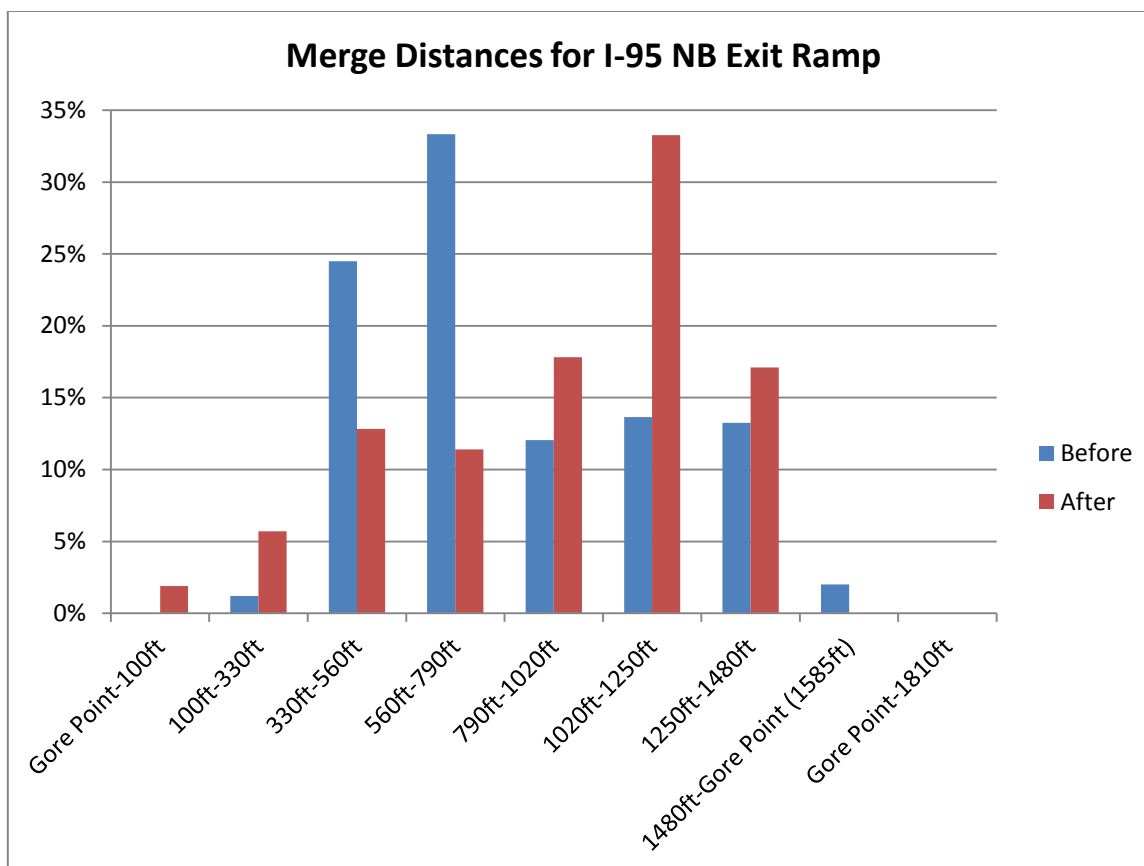
Figure 20 Exit ramp merge distributions before and after treatment on NB I-95 in Dunn, NC

Likewise, prior to receiving the treatment, the northbound side of traffic had 2,060 vehicles at the exit ramp gore point – 238 vehicles in the auxiliary lane (11.6%), 1,027 vehicles in the lane directly adjacent to the auxiliary lane (49.8%) and 795 in the lane adjacent to the freeway median (38.6%). After receiving the treatment, 5,733 vehicles were observed adjacent to the northbound exit ramp gore point – 534 vehicles in the auxiliary lane (9.3%), 2,438 vehicles in the lane directly adjacent to the auxiliary lane (42.5%) and 2,761 vehicles in the lane adjacent to the median (48.2%). As can be seen in Figure 20, the distribution changed for this ramp, shifting from a right-tailed distribution to one that is left-tailed, which means vehicles were merging into the auxiliary lane to exit the freeway later. This is a favorable outcome, as this means that vehicles merging onto the freeway were allowed time to merge into traffic without being disrupted by exiting vehicles that would be slowing down in the auxiliary lane – a decrease in interactions between vehicles entering and exiting the freeway. A chi-squared test of these merging zones before and after the installation shows that there was in fact a significant difference at the 99% confidence level ($p\text{-value} < 0.0001$).

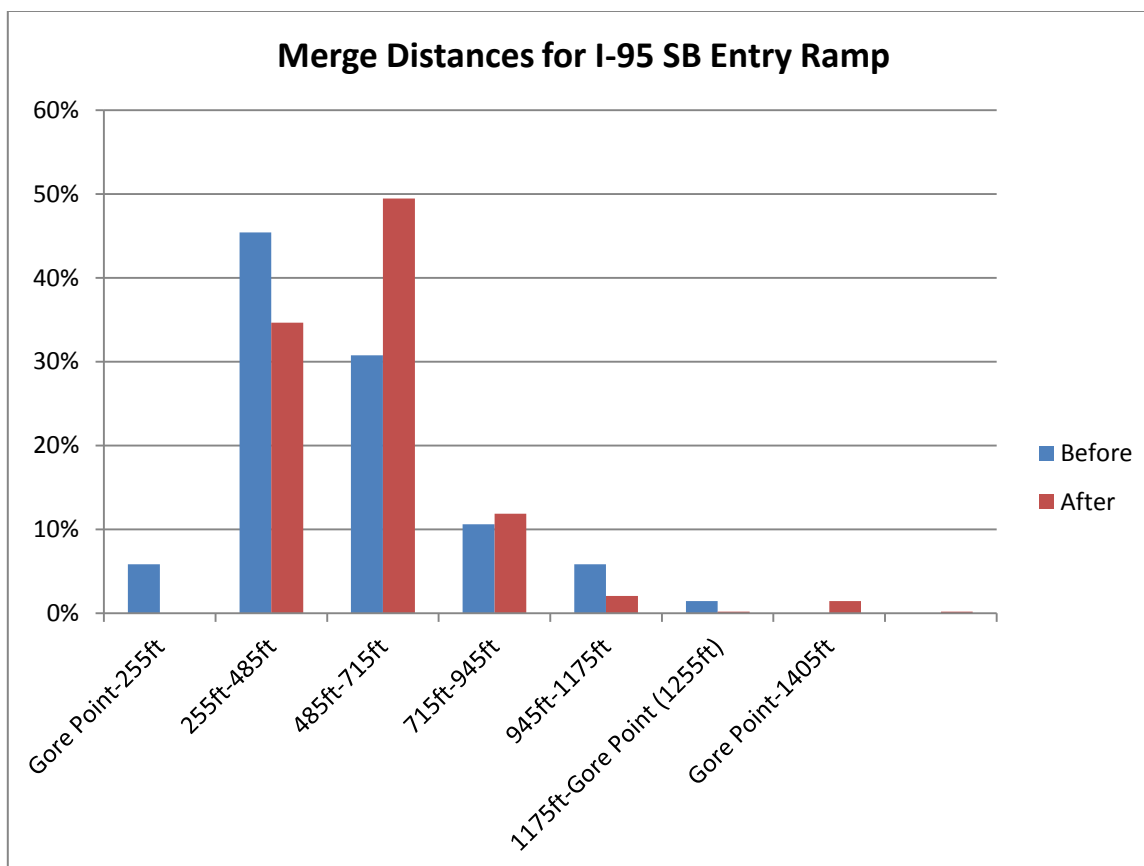
Figure 21 Entrance ramp merge distributions before and after treatment on SB I-95 in Dunn, NC

On the southbound side of the freeway, 2,310 vehicles were observed traveling in and adjacent to the entrance ramp at this ramp's gore point prior to treatment on the northbound side – 247 vehicles in the auxiliary lane (10.7%), 939 vehicles in the lane directly adjacent to the auxiliary lane (40.6%) and 1,124 in the lane adjacent to the freeway median (48.7%). After installation of the wide dotted white lane lines on the northbound side, 5,728 vehicles were observed adjacent to the entrance ramp gore point on the southbound side – 560 vehicles in the auxiliary lane (9.8%), 2,323 vehicles in the lane directly adjacent to the auxiliary lane (40.5%) and 2,845 vehicles in the lane adjacent to the median (49.7%). When the merge distance distributions for this ramp (shown in Figure 21) were compared using a chi-squared test, the difference between the two was significant at the 99% confidence level ($p\text{-value} < 0.0001$), as vehicles previously merged early and now are merging later, very similar to the northbound entrance ramp merge behavior. This is an interesting finding, as the southbound side of the freeway did not receive the wide dotted white lane line treatment. It is suspected that the change in behavior on the northbound side translated to the southbound side, possibly because of the familiarity of drivers who travel through this corridor in both directions regularly.

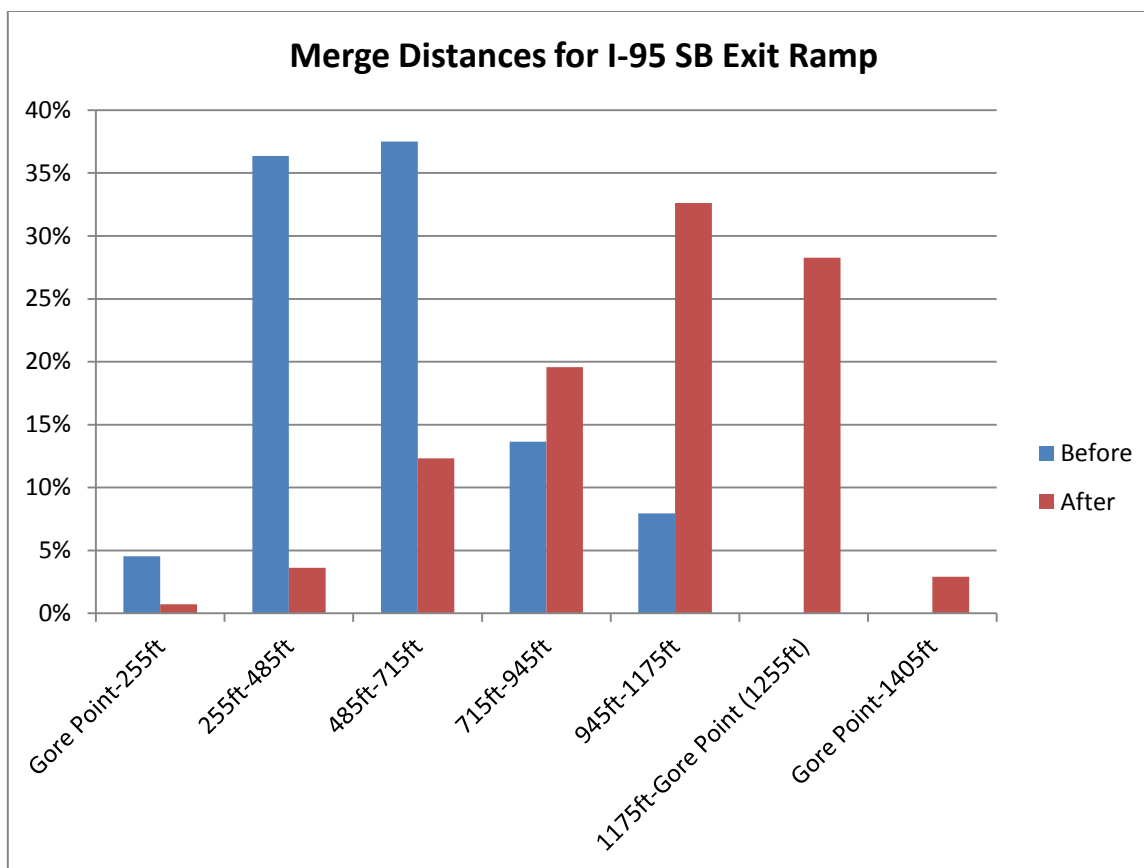
Figure 22 Exit ramp merge distributions before and after treatment on SB I-95 in Dunn, NC

At the southbound exit ramp gore point, 2,330 vehicles were observed prior to treatment on the northbound side – 108 vehicles in the auxiliary lane (4.6%), 1,098 vehicles in the lane directly adjacent to the auxiliary lane (47.1%) and 1,124 in the lane adjacent to the freeway median (48.3%). After installation of the wide dotted white lane lines on the northbound side, 5,845 vehicles were counted adjacent to the southbound exit ramp – 182 vehicles in the auxiliary lane (3.1%), 2,779 vehicles in the lane directly adjacent to the auxiliary lane (47.6%) and 2,884 vehicles in the lane adjacent to the median (49.3%). The distributions of merges for the periods before and after treatment installation for the southbound exit ramp are shown in Figure 22. These distributions are very different, as the before period observations were right-tailed and the after period observations were left-tailed. This was confirmed in the chi-squared test performed on this data, which resulted in a p-value less than 0.0001, indicating that the two distributions were different. Once again, note that the southbound side did not receive the treatment, so this change may indicate that drivers traveled both directions regularly and their behavior changed in both directions because of the markings on the northbound side.

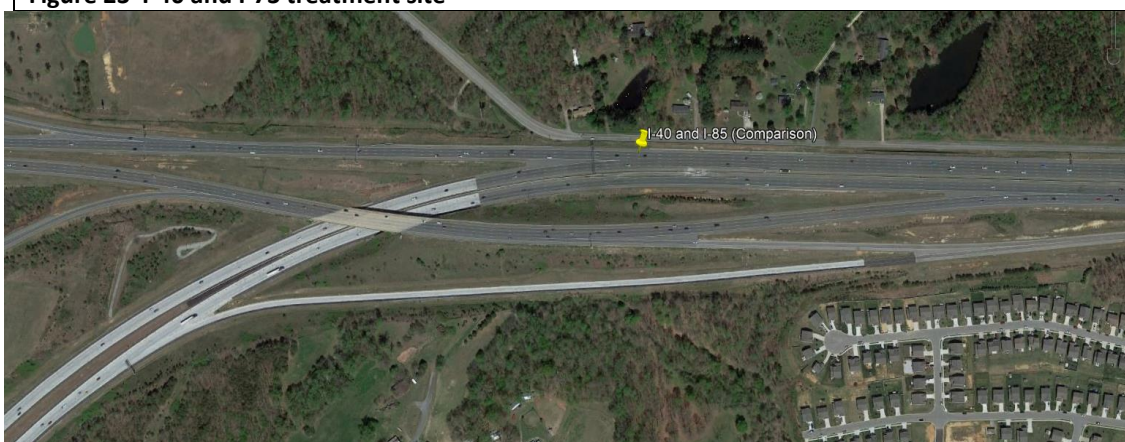
Figure 24 I-40 and I-85 comparison site

Comparison Site
Freeway Diverge

One freeway comparison site, the interchange of I-40 and I-85 on the other side of Greensboro, was utilized and was approximately 13 miles from the treatment site. This interchange contains five lanes on I-40/85 which split to continue three lanes on I-40 and three onto I-85 (two of the original lanes and one additional). The AADT was 105,000 vehicles per day in 2009, during the before period, and 112,000 vehicles per day during the after period (2013). A diagram of this diverge is shown in Figure 24. In addition, four signalized intersections at nearby interchanges were chosen to provide several comparison group combinations for consideration in the analysis. These intersections are in much closer proximity and will likely account for seasonality better than the freeway segment. Figure 25 shows the treatment site, freeway comparison site, and three nearby intersection comparison sites.

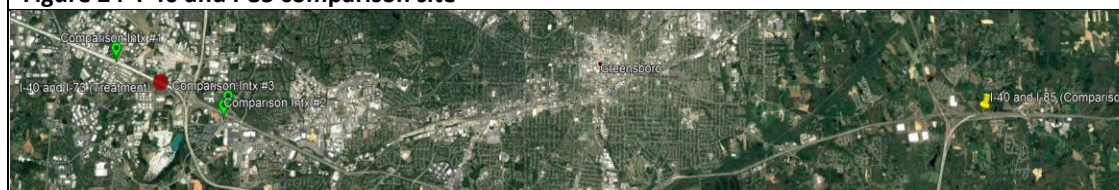
Figure 25 I-40 and I-85, treatment and comparison sites (includes 3 additional *intersection* comparison sites from nearby interchanges)

Comparison
Intersection
