# **Performance of Straw Mulch Binding Agents**

**NCDOT Project 2015-17**

**FHWA/NC/2015-17**

**January 2018**

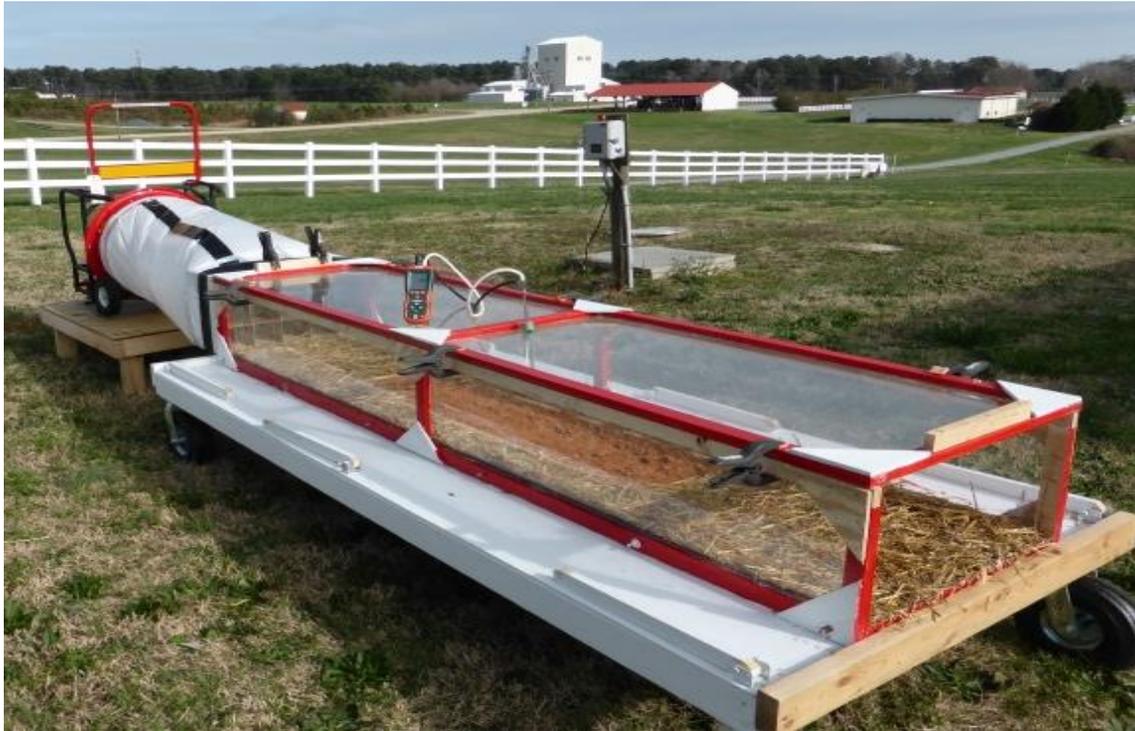
Figure 1: Fully operational wind tunnel with the fan properly attached and a bare soil box inside. The orange wind speed meter sits on top, exterior to the box, with only the probe on the inside.

The wind tunnel in this study is an example of an open design tunnel (Advanced Thermal Systems, 2009), meaning that ambient air enters the wind tunnel and then exits into ambient air after passing through the testing chamber (Advanced Thermal Systems, 2009). There are also three components to a portable wind tunnel: a self-contained power source or engine, a fan, and transportation of wind from the fan to the working section, either an actual soil area, or an enclosed testing space (Pelt and Zobeck, 2013). For this design, a gasoline-engine powered fan was attached to the testing tunnel via a segmented wooden frame with baffles to create a laminar flow pattern (Figure 1). Maximum wind speeds of 72 to 80 km h<sup>-1</sup> (45-50 miles h<sup>-1</sup> (mph)) were achieved with this design, with minimums between 24-32 km h<sup>-1</sup> (15-20 mph).

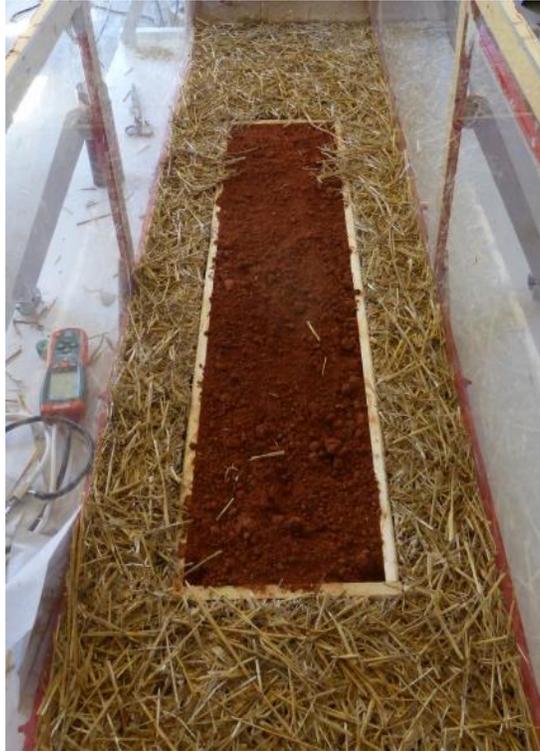
Figure 2: Test box filled with soil and installed in the wind tunnel. During testing, the box also has straw with or without tackifier applied to the soil.

Each box was 0.27 x 1.18 m (0.88 x 3.88 ft) and 0.05 m (2 in) deep. They were filled with a clay loam soil to the top edge to create an even surface. Each box then received straw with or without tackifier, which were both spread by hand evenly over the surface of the soil. Each tackifier was tested at 50%, 100%, and 200% of the manufacturer's recommend rates (Table 2). After tackifier application, each soil box was left for a minimum of two days after the liquid tackifier application, which allowed time for moisture to evaporate. All combinations of treatments were tested in triplicate.

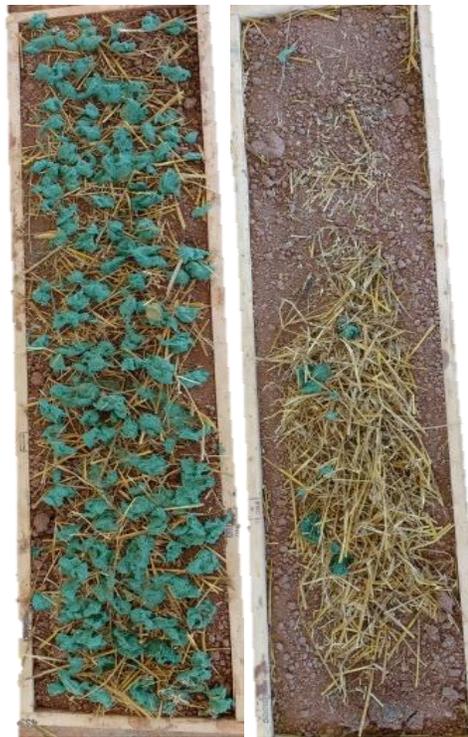
Figure 4: A before (left) and after (right) view of a soil test box with an application of hydraulic tackifier. This illustrates a “failure” with less than 50% of the straw remaining.

created a faster acceleration of wind speed in the gusty tests, as compared with the steady flow. Testing was completed when either a failure occurred or maximum wind speed (72-80 km h<sup>-1</sup> (45-50 mph)) was reached. Each test was monitored with an anemometer as well as a video camera. The anemometer recorded wind speed continuously and showed the current wind speed on a display during the testing. The video camera recorded both the wind tunnel and the wind gauge, which was later used as a reference when needed. During the first 15 seconds of each video a sign was placed in view to denote which test was being run. In addition, any notable observations during the test were also recorded by hand, and the failure wind speed was documented. If the straw/tackifier combination was not a full failure, a brief description was added, to provide a more detailed analysis. A failure was defined as the point at which more than 50% of the straw had blown off (Figure 4). After the test was completed each box was photographed to record the amount of failure.

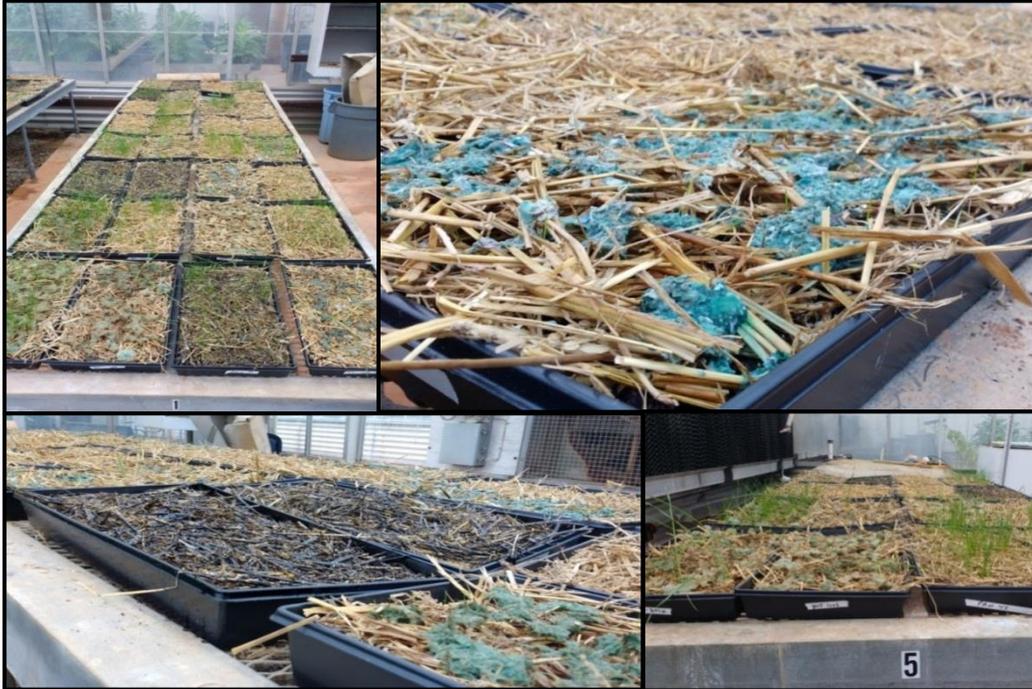
Figure 5: Photographs of the greenhouse bioassay project in progress, showing one bench (block).

The greenhouse bioassay study was initiated in December 2016 (Figure 5). Instead of using a grass seed mix, each grass species was tested individually so

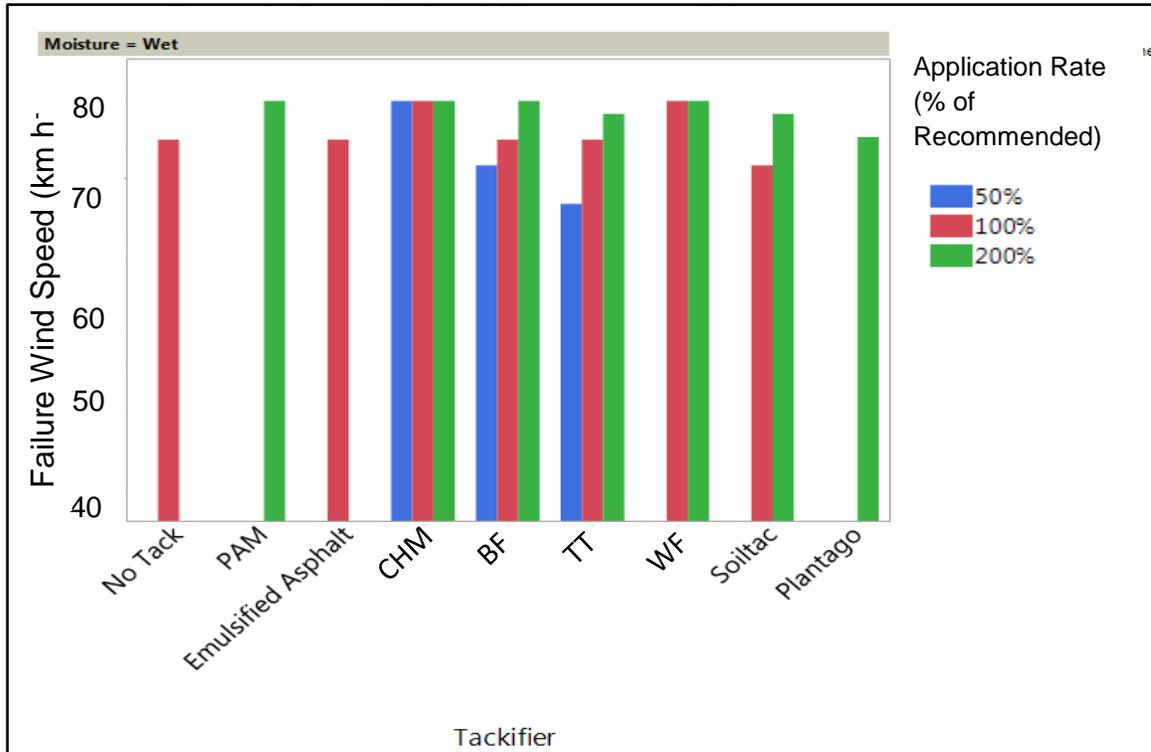
**Figure 6:** Effect of wet moisture conditions and tackifier application rate on tackifier treatments.

Wet straw was able withstand higher wind speeds than dry straw. In fact, the other factors, including tackifier, tackifier application rate, and wind condition had little effect when the straw was wet, and in many tests the maximum wind speed (80 km h<sup>-1</sup> [50 mi h<sup>-1</sup>]) was reached with no failure (Figure 6). An interaction was also found between tackifier type and straw application rate ( $p = 0.0003$ ), indicating that

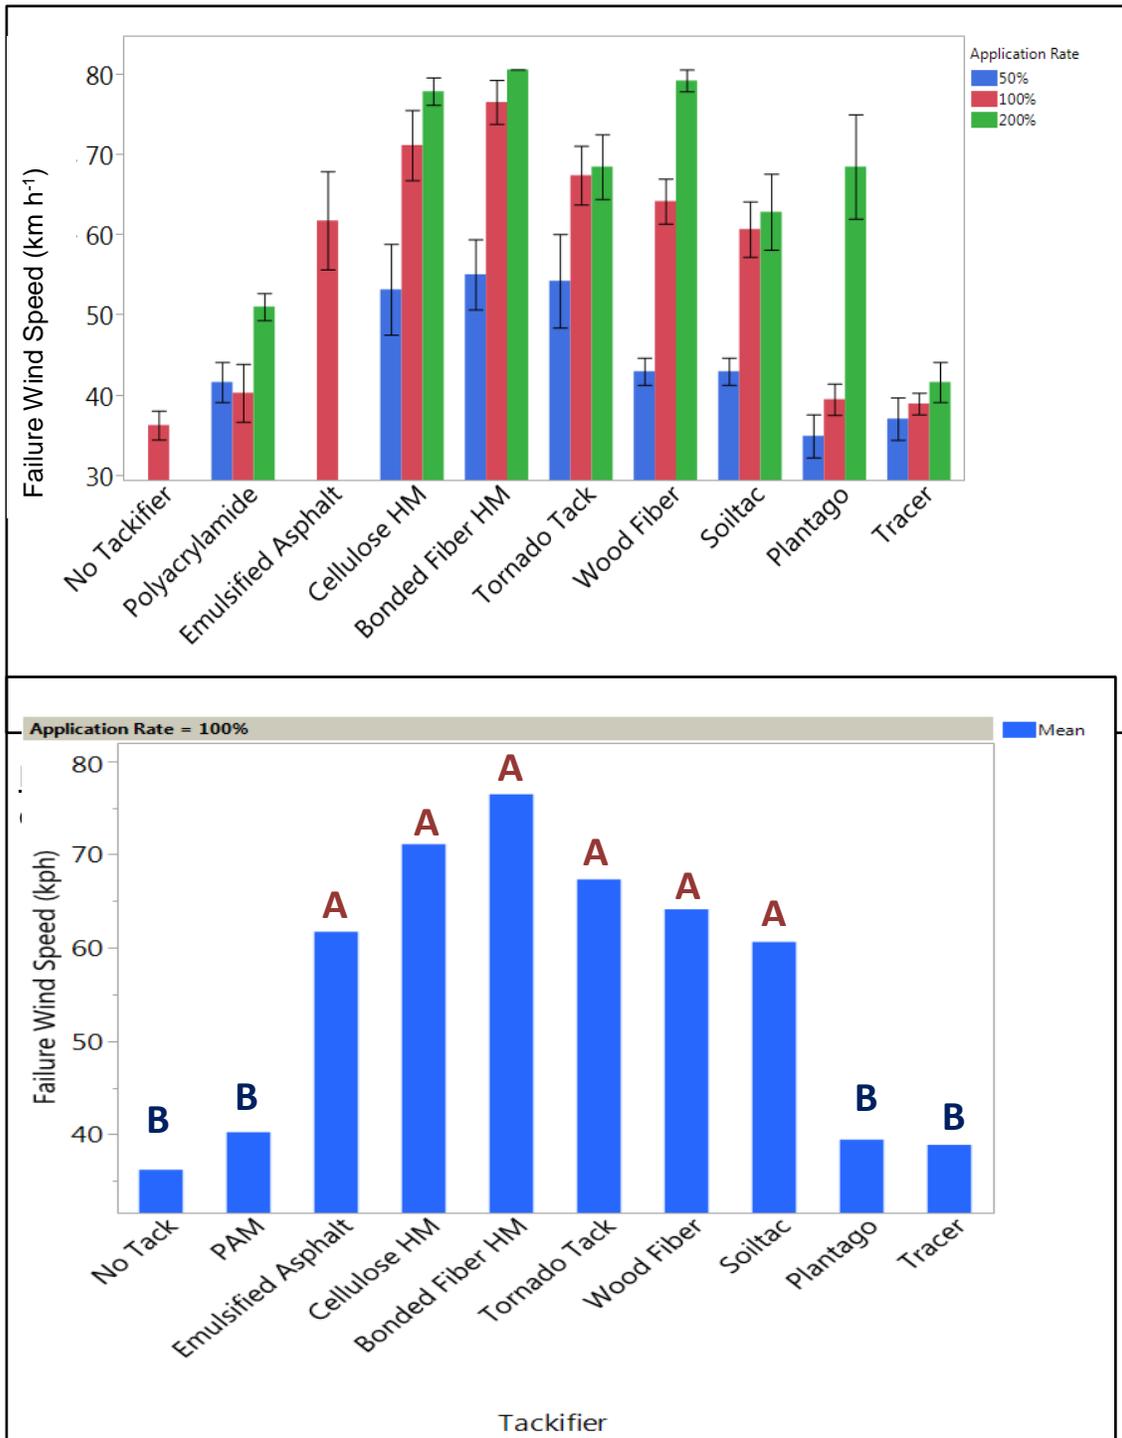
Figure 8: Differences in tackifier treatments at the recommended rate for dry straw and steady conditions. Differences ( $p < 0.05$ ) are indicated if values do not have a common letter.

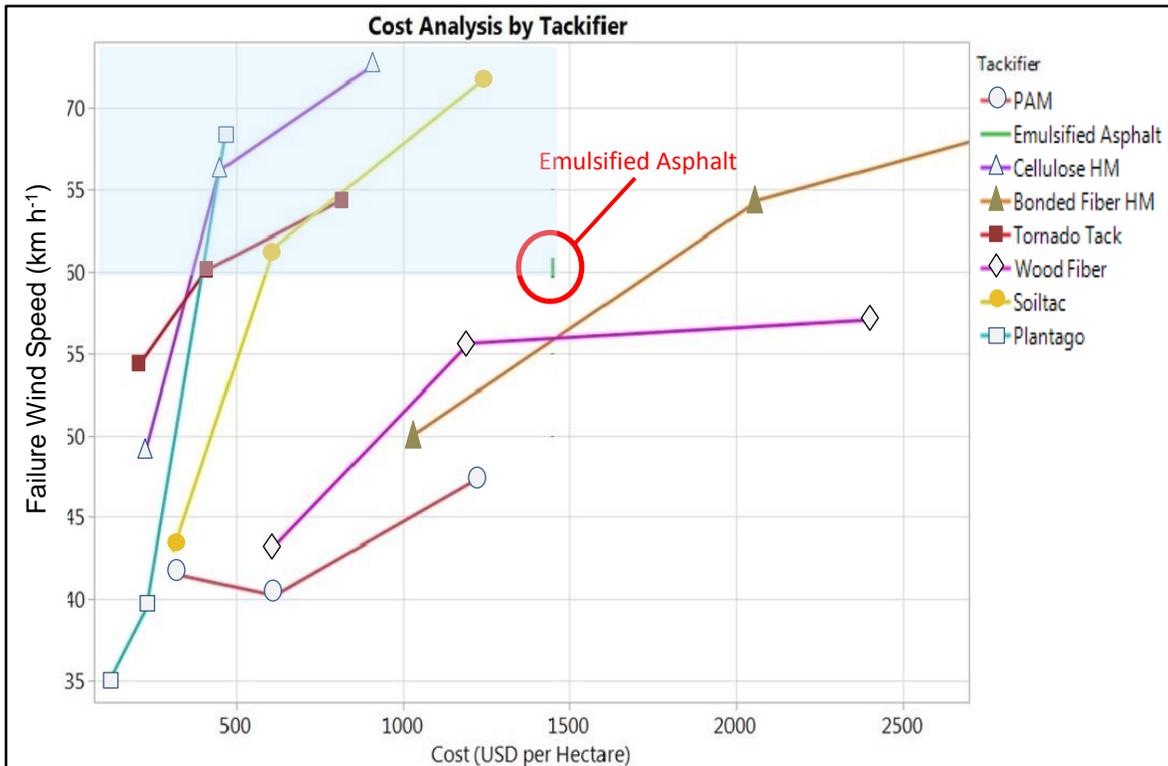
Figure 9: Cost-benefit analysis for each tackifier under dry straw conditions, at three application rates, as reflected in the cost. Emulsified asphalt is shown as a straight line since it is only applied at one rate. The light blue box represents tackifier and application rates that would be recommended to replace emulsified asphalt.

There are a wide range of material costs depending on the type and brand of the tackifier, with national brand name hydromulches being relatively expensive, and off brand or alternative tackifier products being much cheaper (Table 1). A cost-benefit graph (Figure 9) compares product prices to their effectiveness at holding straw against wind, which can be used to determine the least cost to attain the greatest resistance to failure. From this analysis, either plantago at 200% the recommended rate or cellulose HM and wood fiber HM at the recommended rate appear to be the best options for cost and performance.

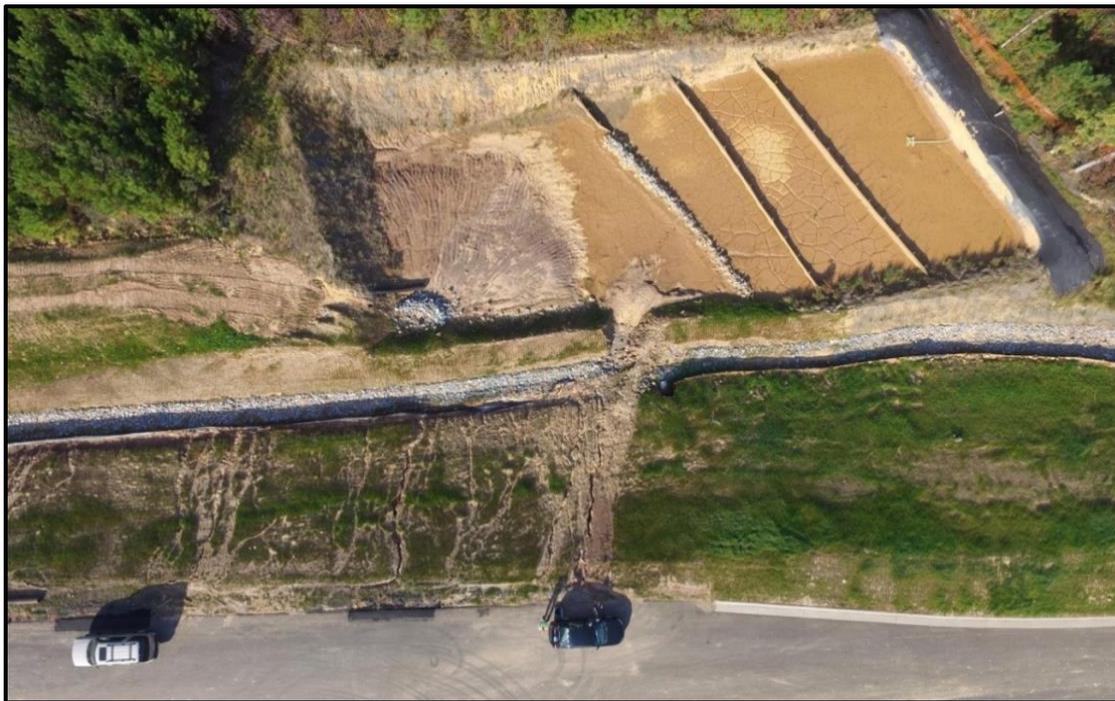
Figure 10: Aerial photograph of the Apex DOT site after Hurricane Matthew (10/31/2016).

The Apex site was prematurely terminated due to a severe erosion during Hurricane Matthew on October 8<sup>th</sup> (Figure 10), during which the estimated rainfall at the site was >20 cm (8 in). The erosion during this storm event was due primarily to the lack of a curb to protect the slope from the paved road runoff. However, one set

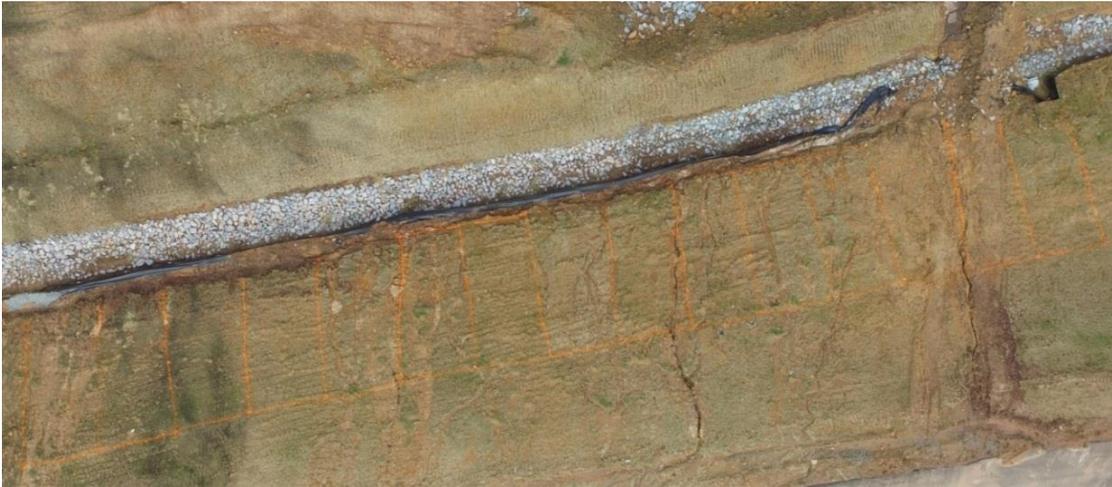
**Figure 11:** Tackifier treatment plots located at the Apex Active site, September 29<sup>th</sup>, 2016

of aerial photographs (Figure 11) was taken prior to Hurricane Matthew 13 days after planting, which was processed through the GIS software in the same manner as the LWFL plots. There were no differences in grass cover between any of the tackifier treatments (Figure 12). This indicated that these tackifier treatments did not have different effects on grass germination or growth.

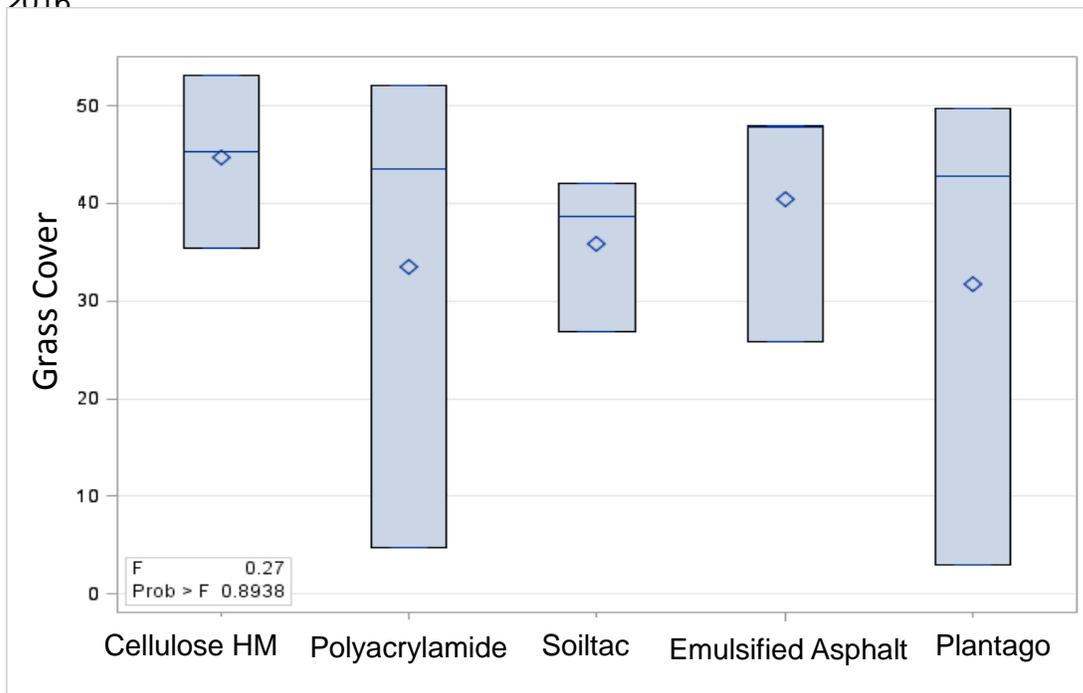
**Figure 12:** Grass cover results from the Apex, NC active DOT site on September 29<sup>th</sup>, 2016. For each tackifier the upper edge of the box represents the 3<sup>rd</sup> quartile (75<sup>th</sup> percentile), the line inside the box represents the median (50<sup>th</sup> percentile), the diamond represents the mean and the bottom edge of the box is the 1<sup>st</sup> quartile (25<sup>th</sup> percentile). There were no significant differences between any of the tackifier treatments ( $p > 0.05$ ).

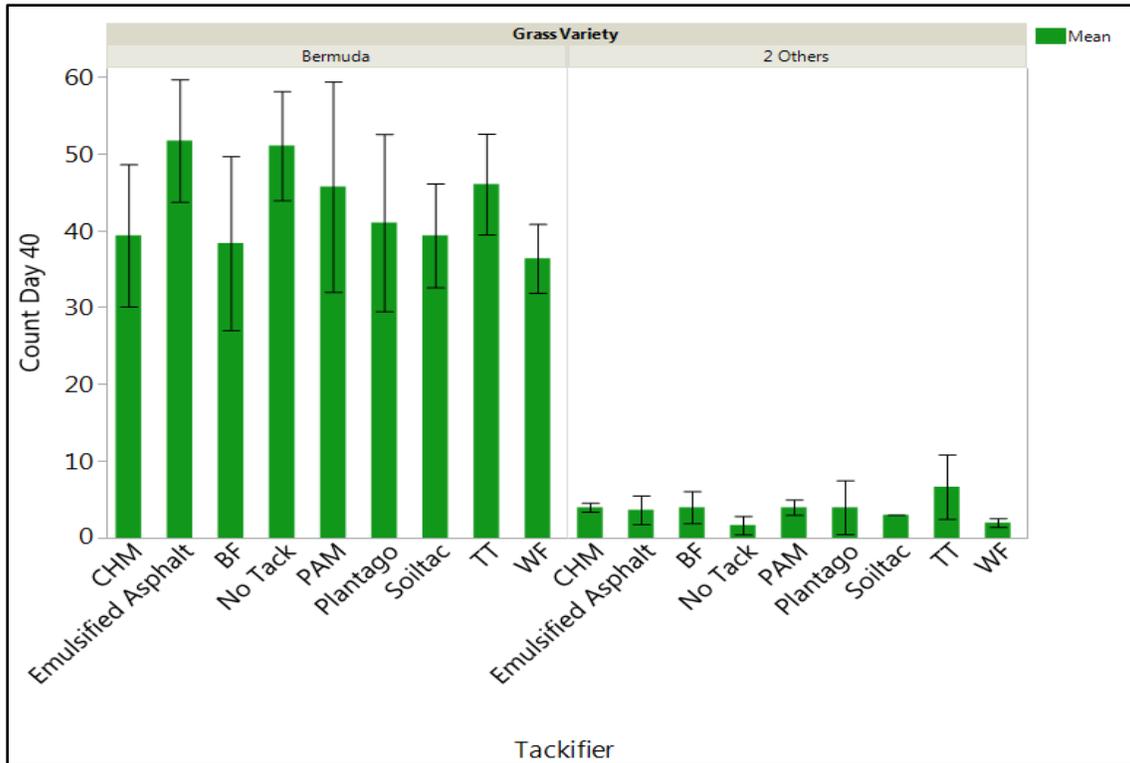
**Figure 13:** Blade count results for centipedegrass and Bermudagrass on day 40, the final day that grass blade count was recorded. No significant differences ( $p < 0.05$ ) in grass blade count between tackifier treatments, but bars represent standard error. **Key:** CHM = cellulose HM, BF = bonded fiber HM, PAM = polyacrylamide, TT = Tornado Tack, and WF = wood fiber HM.

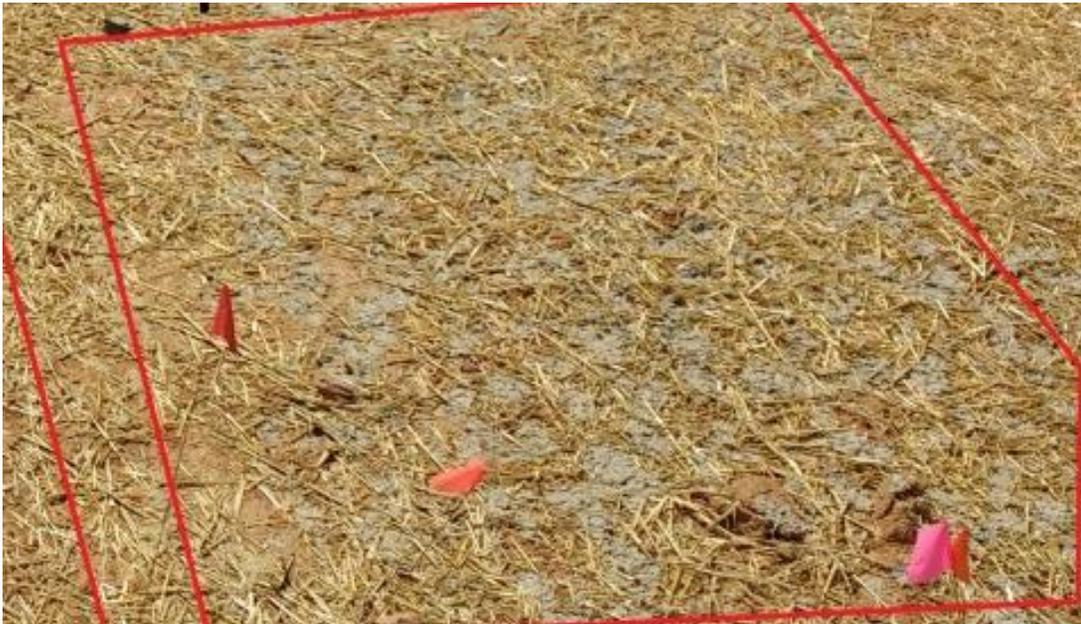
Figure 14: Example of cellulosic hydromulch applied at the recommended 1,120 kg ha<sup>-1</sup> (1,000 lb ac<sup>-1</sup>).

- Phase out emulsified asphalt and begin using either cellulose HM or Tornado Tack at the recommended rates, or plantago at the double recommended rate. Examples of hydromulch application are shown in figures 14-15.

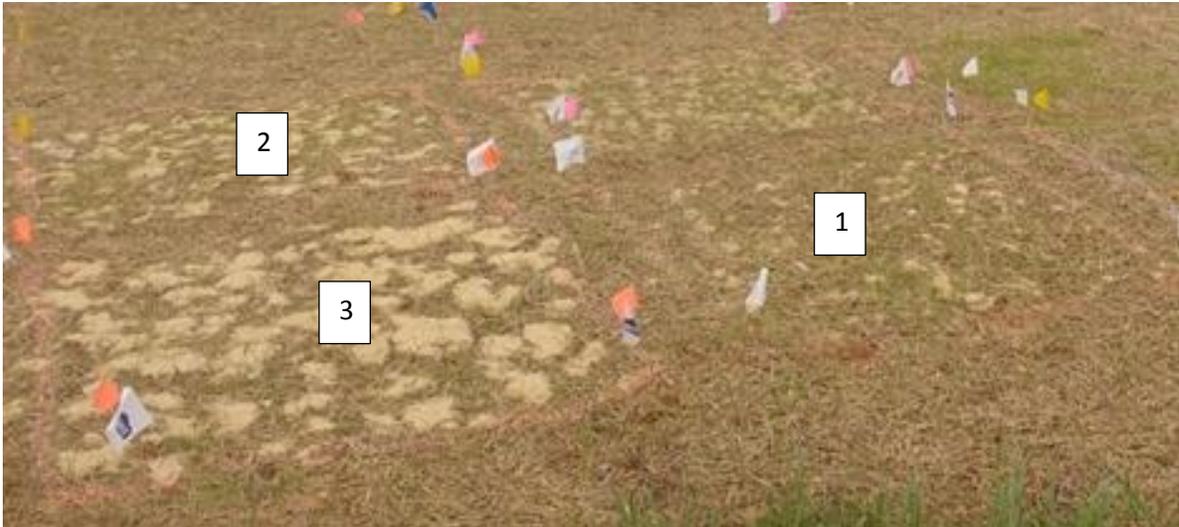
**Figure 15:** Examples of different rates of wood fiber hydromulch: 1.  $560 \text{ kg ha}^{-1}$  ( $500 \text{ lb ac}^{-1}$ ), 2.  $1120 \text{ kg ha}^{-1}$  ( $1,000 \text{ lb ac}^{-1}$ ), and 3.  $2240 \text{ kg ha}^{-1}$  ( $2,000 \text{ lb ac}^{-1}$ ). The original green color had faded at the time of the photograph.

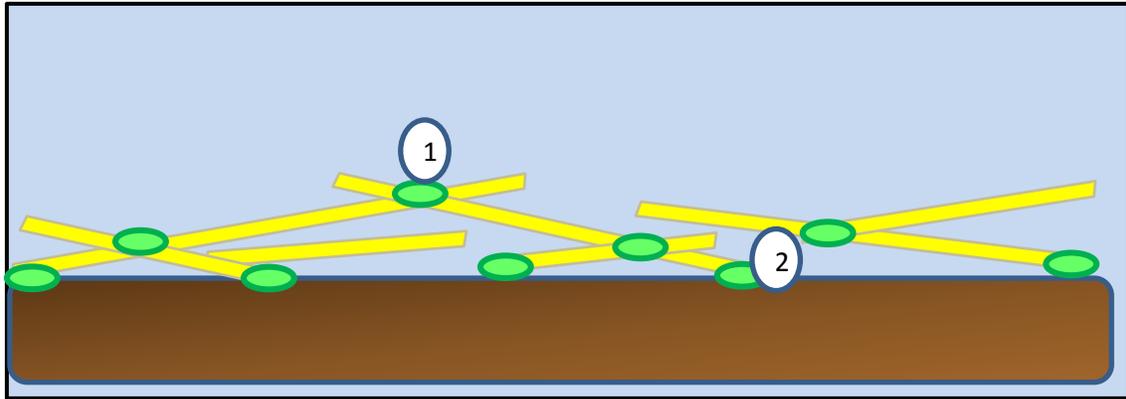
Figure A1: Illustration of tackifiers function with a straw cover. Yellow represents the straw and green the tackifier, which can both bind the straw together (1) and bind the straw to the soil (2).

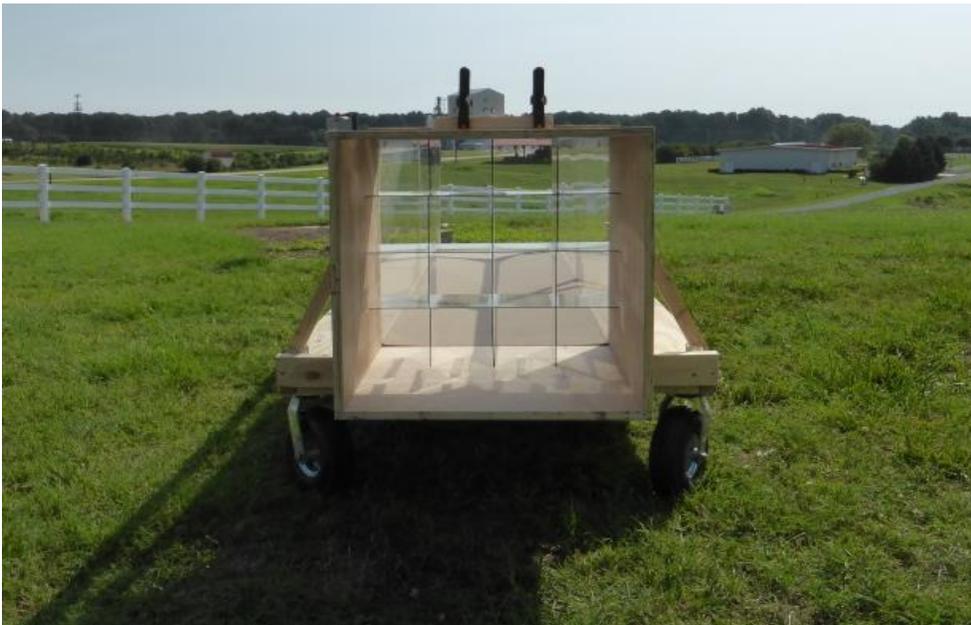
Figure A2: View of the wind tunnel through the section connecting the fan to the tunnel, with laminar flow baffles.

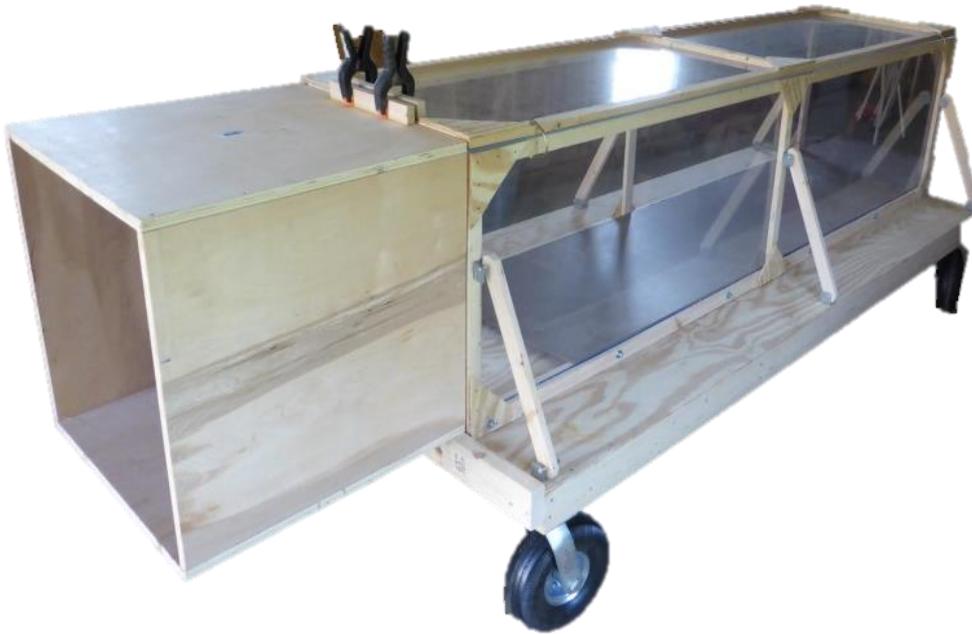
Figure A3: View of the wind tunnel with the laminar flow baffle section attached.

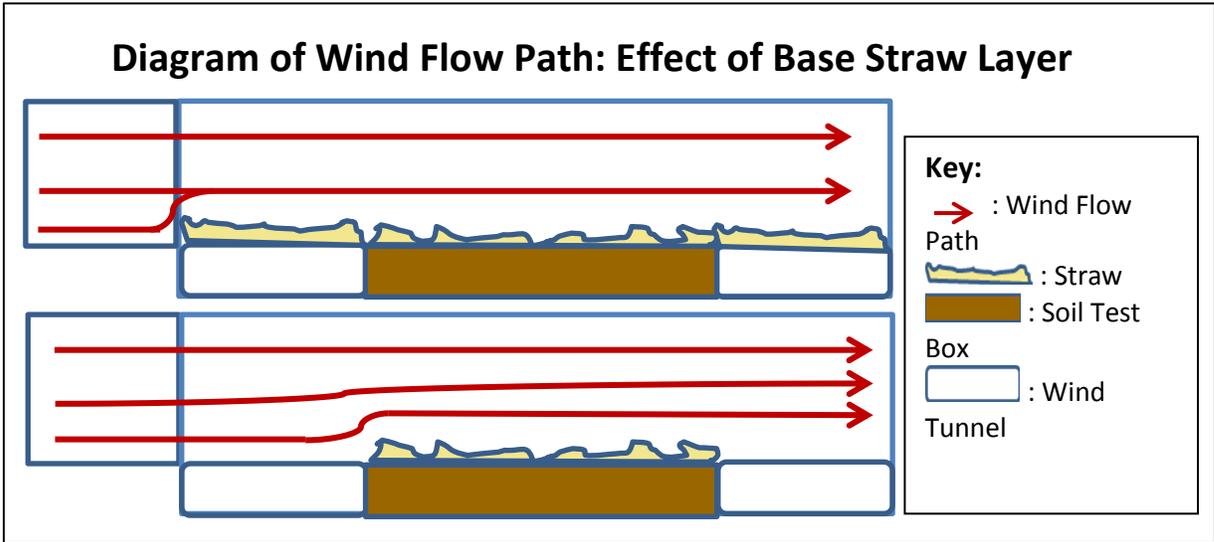
**Figure A4:** Illustration of potential wind flow paths with and without a base straw layer on the floor of the wind tunnel. The top figure illustrates flow paths with a base layer of straw, while the bottom figure illustrates flow paths with no straw glued to the tunnel floor.

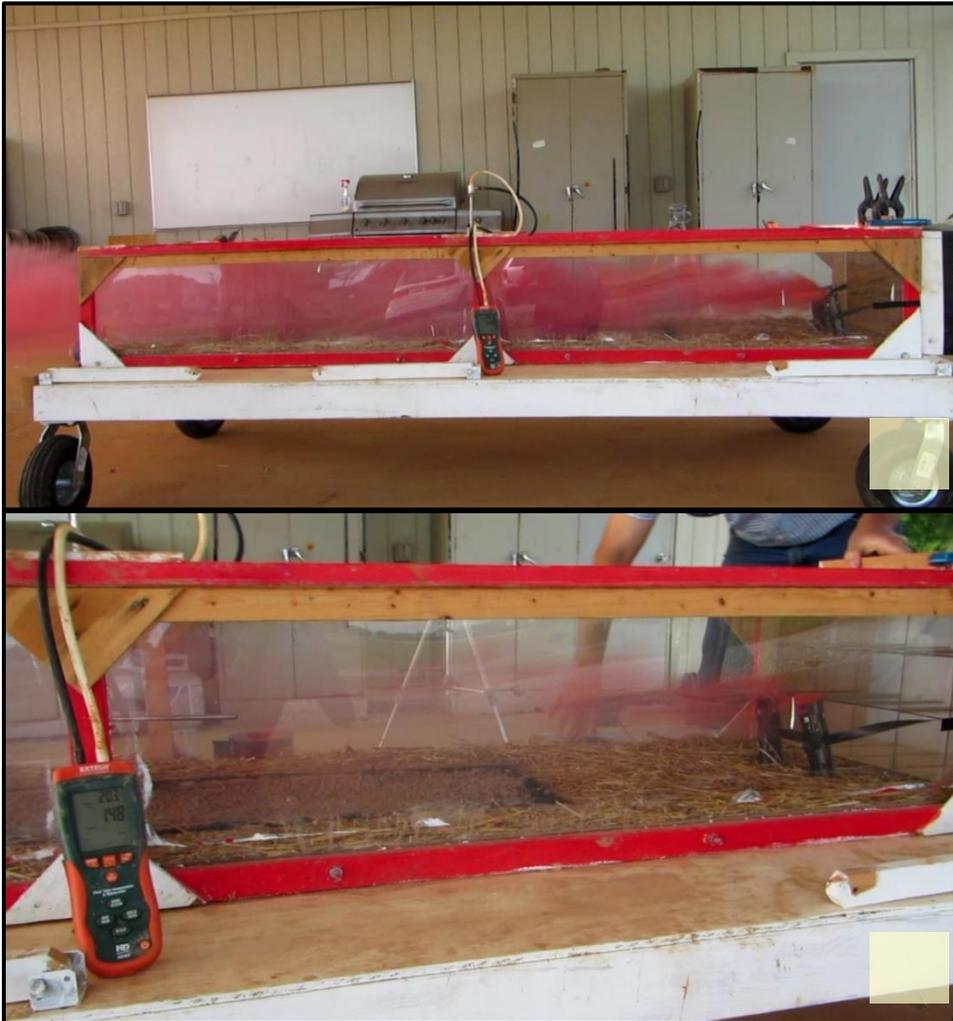
Figure A5: (a) Smoke emitter affixed to the wind tunnel for testing the flow pattern. (b) Red smoke shows wind pattern inside the tunnel.

To examine the flow pattern within the wind tunnel a series of videos were taken using colorful smoke emitters (Burst Wire-Pull Smoke Grenades, Enola Gaye, Pahrump, NV, USA). These emitters were fastened to the wind tunnel such that either one or two emitters were suspended in the middle of the tunnel entrance.

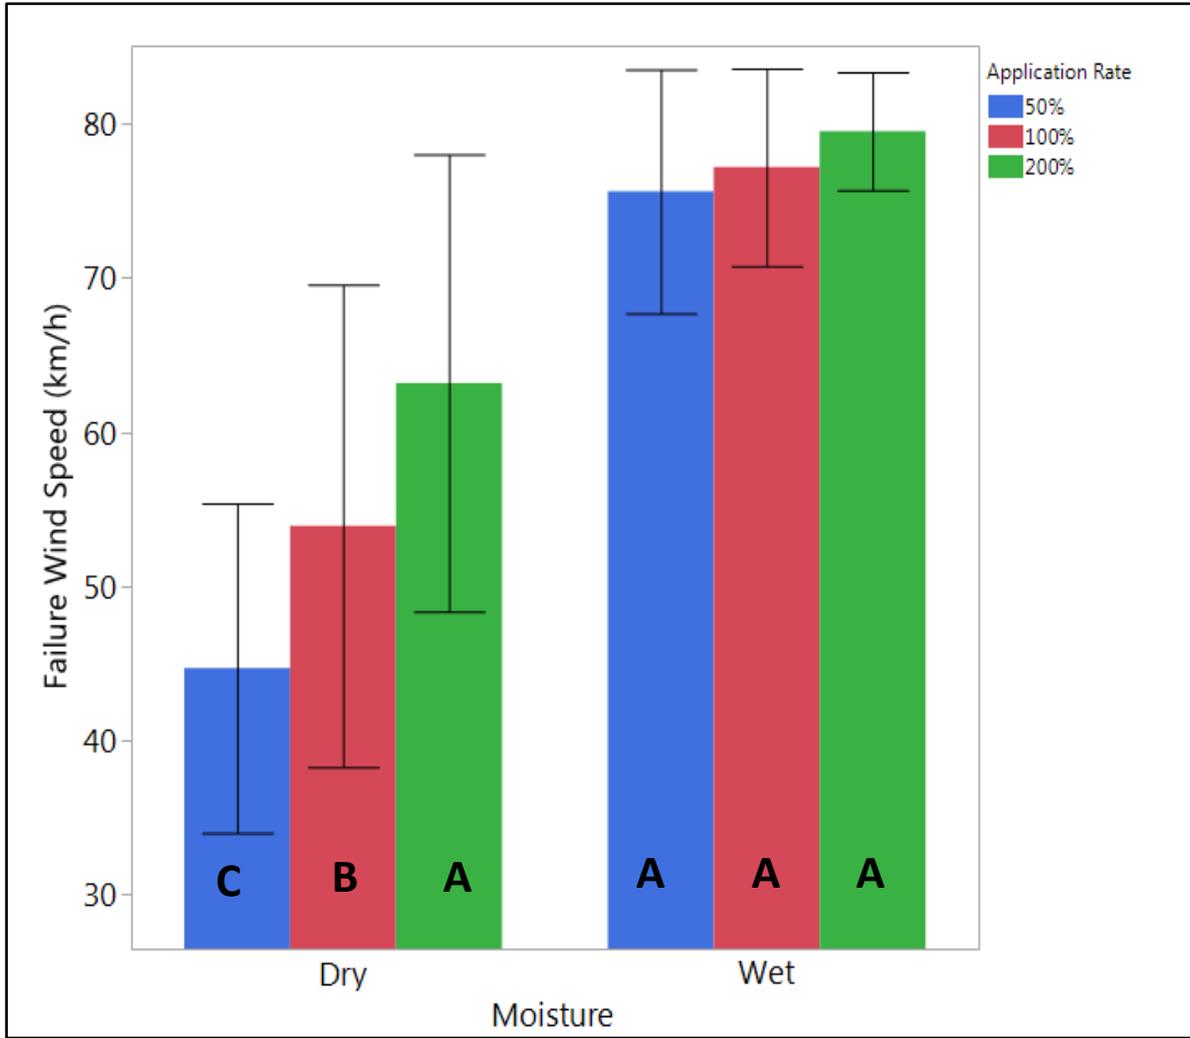
**Figure A6:** Variation in failure wind speed due to moisture and tackifier application rate (% of manufacturer's recommended rate).

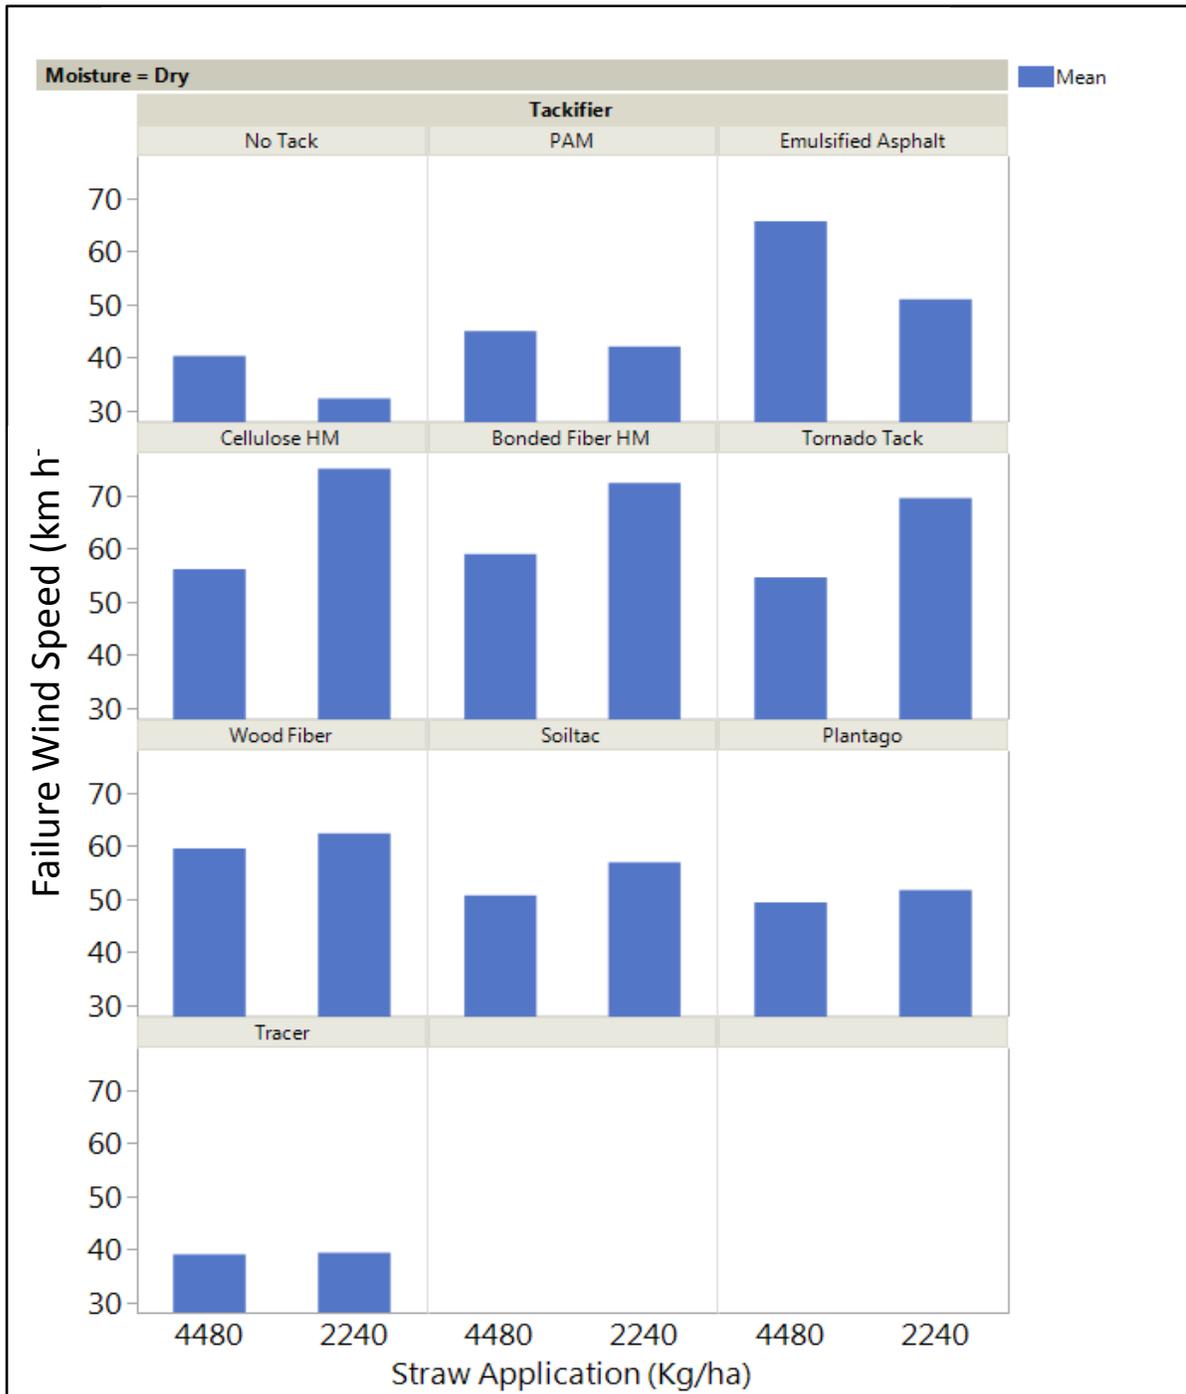
Figure A7: Effect of straw application rate on the ability for tackifiers applied under dry straw conditions, at the manufacturer's recommended rate, to withstand wind.

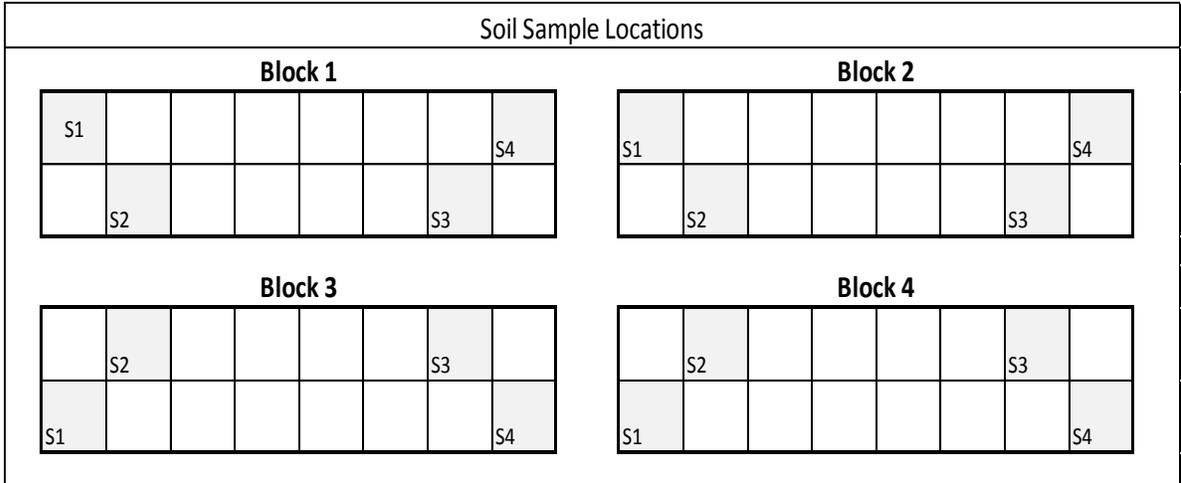
Figure A8: The locations of each of the four soil samples (S1-S4) taken in each block.

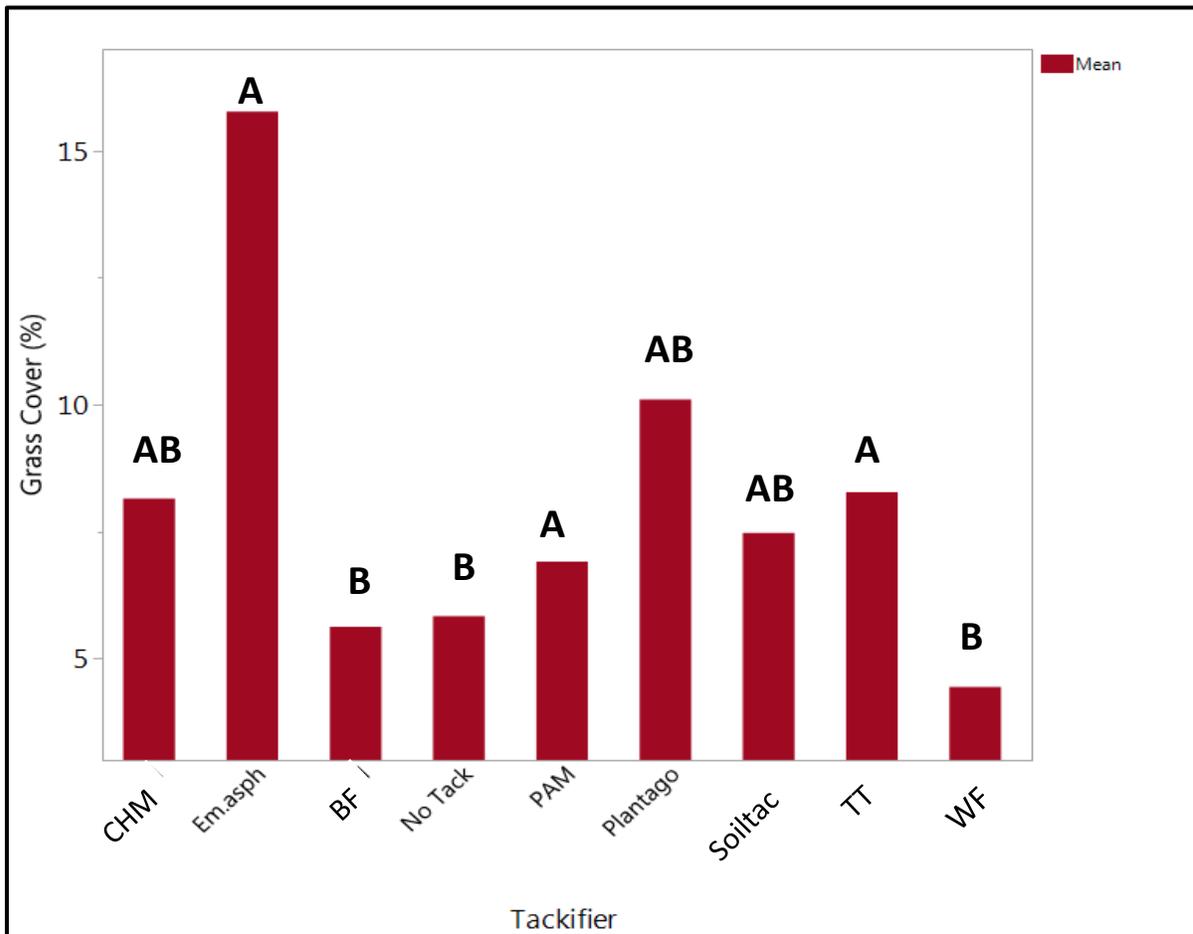
Figure A10: Grass cover results from September 28<sup>th</sup>, 2016 at the LWFL field

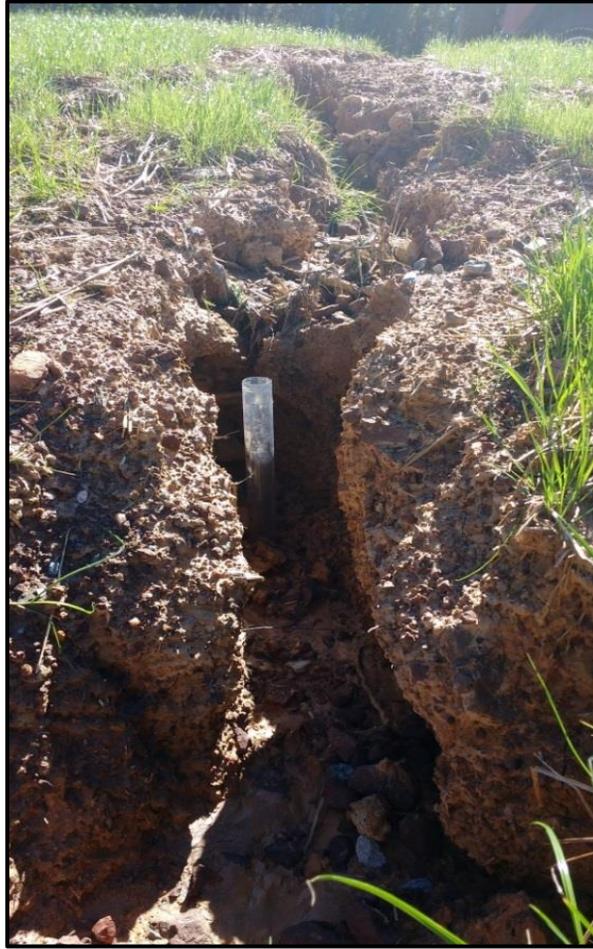
Figure A11: One of the gullies at the Apex site resulting from Hurricane Matthew, with a rain gauge to depict the scale.

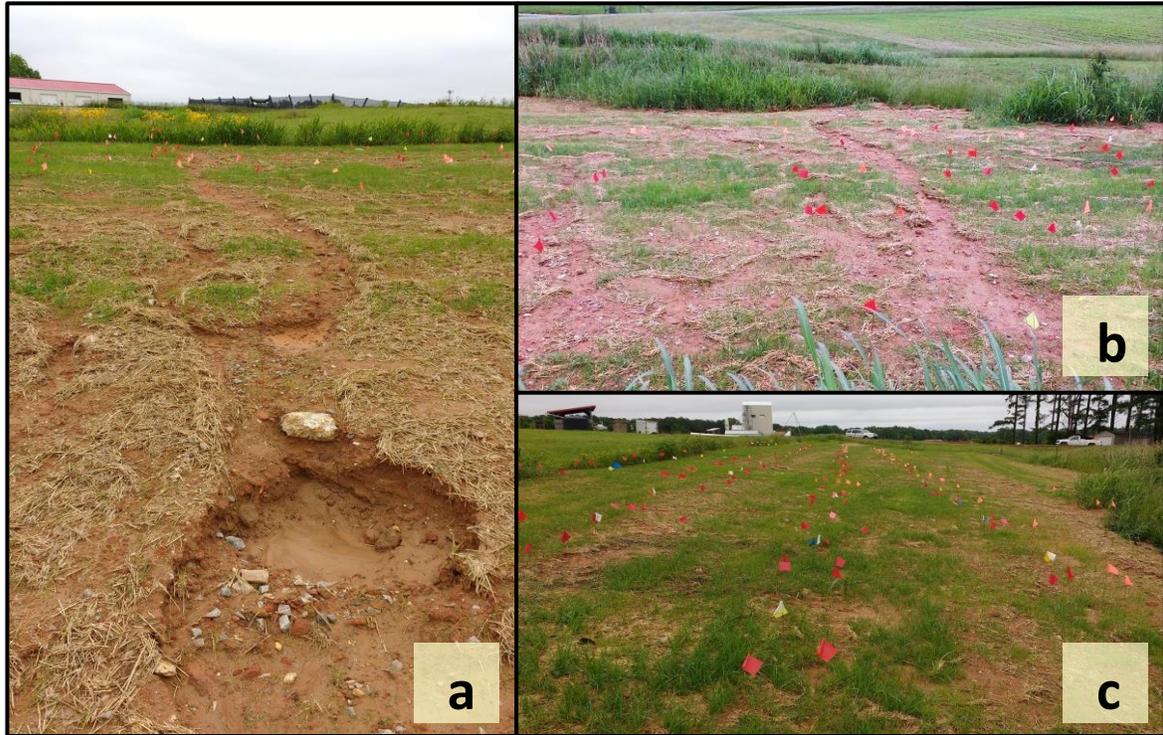
**Figure A12:** Photographs of the spring field test of tackifiers at the Lake Wheeler Field Laboratory, after a heavy rainstorm approximately one month after planting. The photograph on the left (a) shows the most extreme erosional damage, the top right (b) shows the plots affected by the damage and the bottom right (c) shows the entire grass stand on the same date (May 18<sup>th</sup>, 2016).

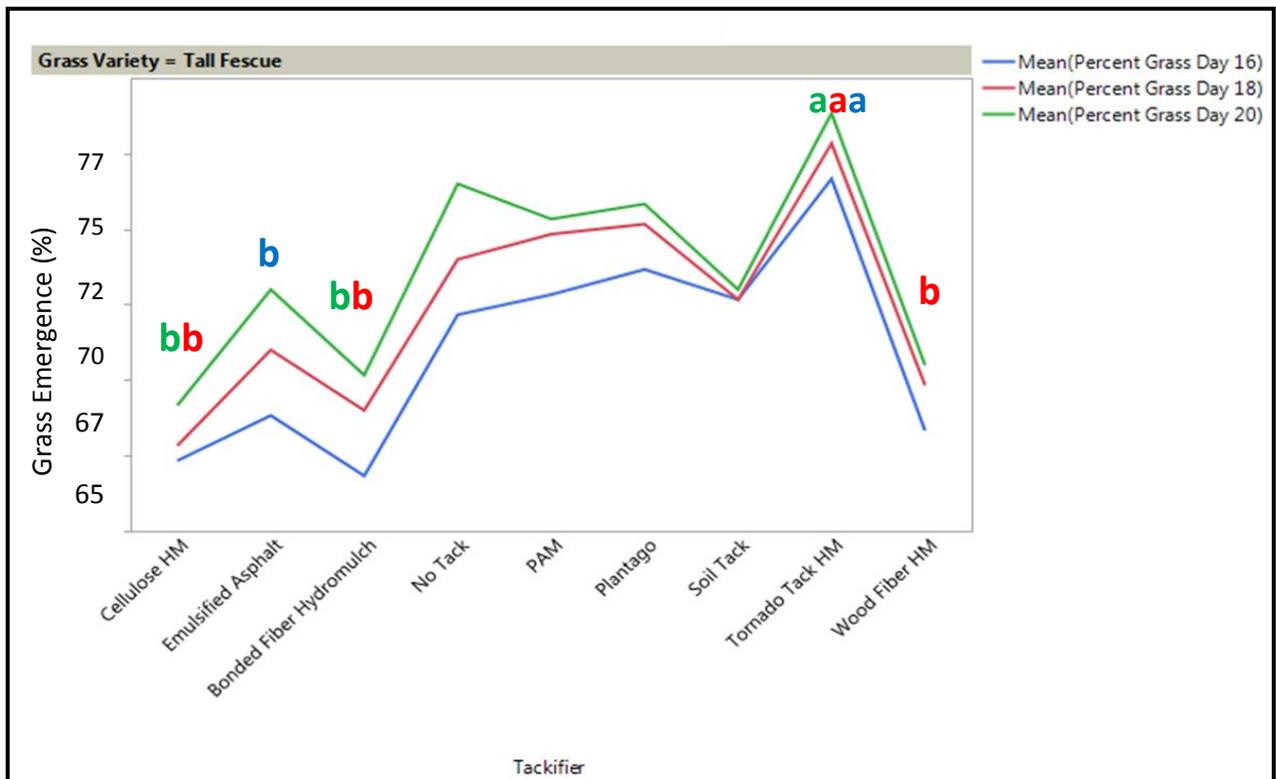
Figure A14: Grass emergence for each treatment for the three measurement periods where differences were evident. The plus symbols represent results that are significantly better, and stars indicate results that are significantly worse. The color of the symbol signifies with which sampling date the result is associated.
