# **Performance of Straw Mulch Binding Agents**

**NCDOT Project 2015-17**

**FHWA/NC/2015-17**

**January 2018**

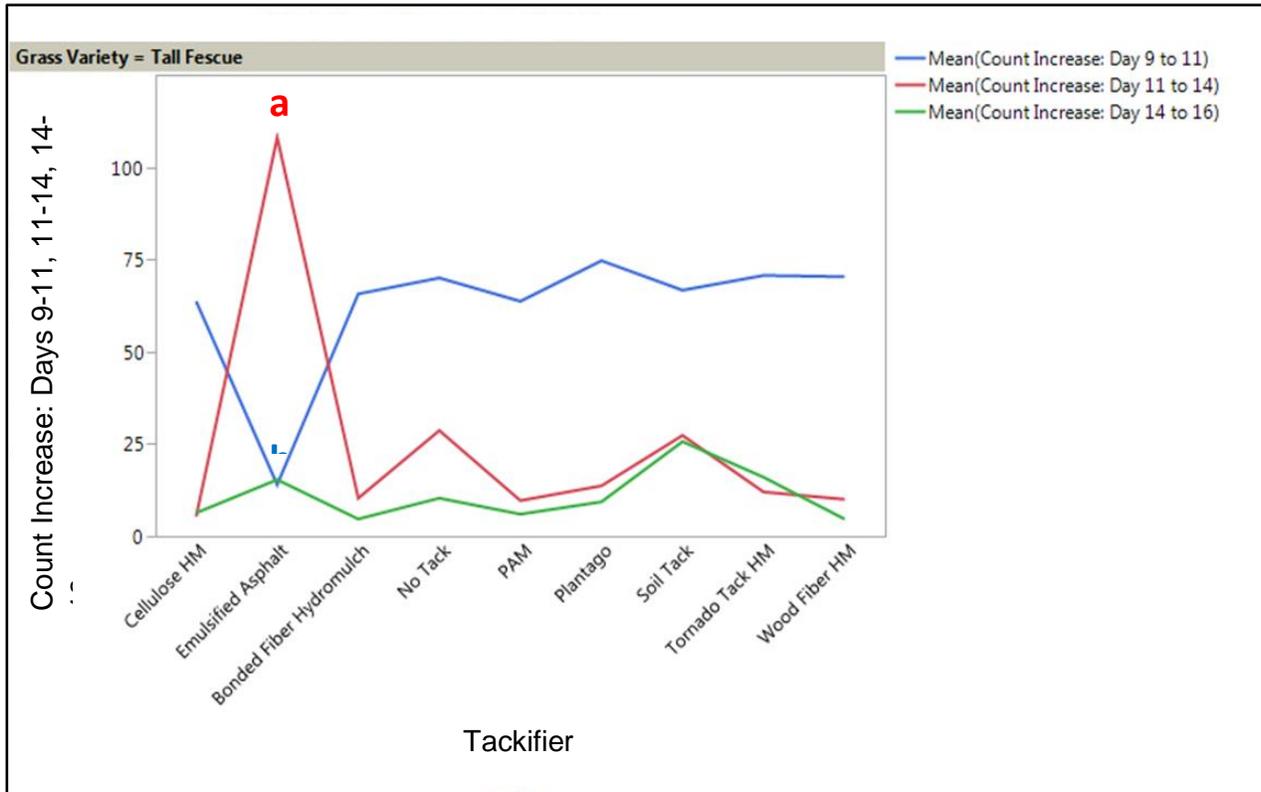
Figure A15: Tall fescue blade count increases on days 9-11, 11-14 and 14-16. Significant differences denoted with letters ( $p > 0.05$ ).
