# **Quantifying the Impact of Crack Sealant on Pavement Surface Friction**

**North Carolina State University**

**NCDOT Project 2017-04**

## **FINAL REPORT**

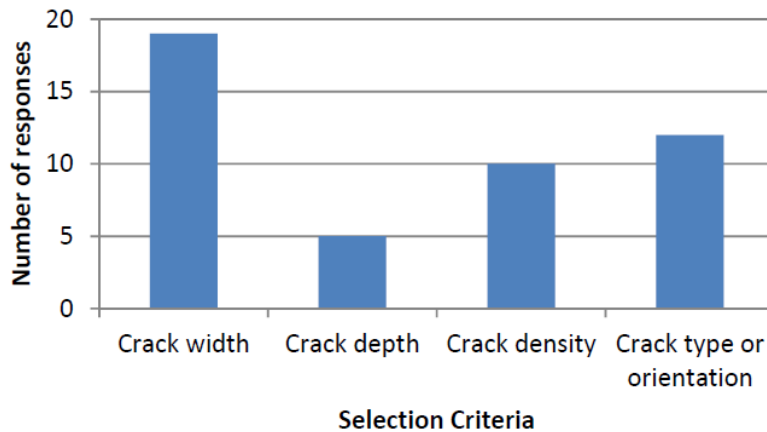
**Figure 2.1.** Pavement selection criteria for crack sealing based on survey results of Truschke et al. (2014).

The national surveys indicate that pavements with transverse, longitudinal, and block cracks are generally good candidates for crack sealing but that pavements with alligator cracking should not be sealed (Truschke et al. 2014, Decker 2014). The literature indicates cracks with widths between  $\frac{1}{4}$  in and  $\frac{3}{4}$  in are ideal for crack sealing (Smith and Romine 1999, Truschke et al. 2014). Wider cracks can be sealed but ride quality is often diminished and specialized crack sealant material is required (Truschke et al. 2014). National best practice guidelines indicate that crack sealing should be limited to pavements with low to moderate crack density as defined by

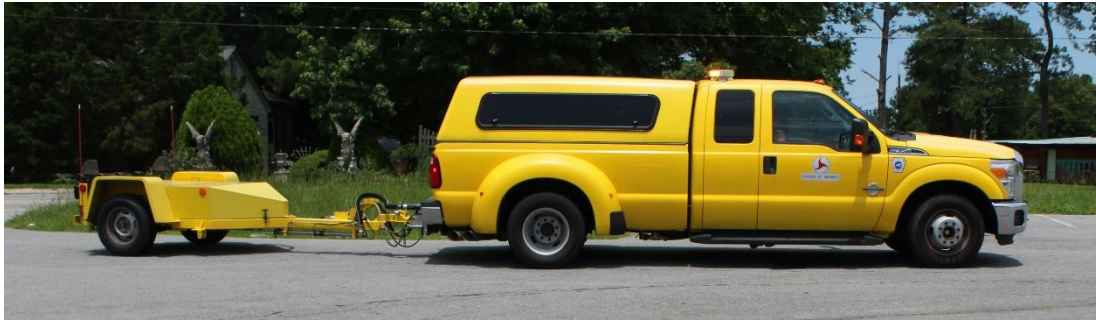
**Figure 3.1. Locked-Wheel Skid Tester.**

The LWST was used to measure the skid resistance of pavements with varying amounts of crack in the wheel path in accordance with ASTM E274. The LWST consists of a trailer with a test wheel, water supply and dispensing system, and instrumentation system to measure frictional force. The trailer is towed by a vehicle traveling at 40 mph (64 km/h). Once up to speed the LWST sprays water 12 in to 18 in in front of the test tire as well as 1 in to the left and right of the tire to ensure a wetted surface for the tire. The trailer's test wheel is positioned in the left wheel path and is locked and dragged over wetted sections of pavement in order to measure the steady-state friction. The LWST used in this study is a smooth, single tire and is shown in Figure 3.1.

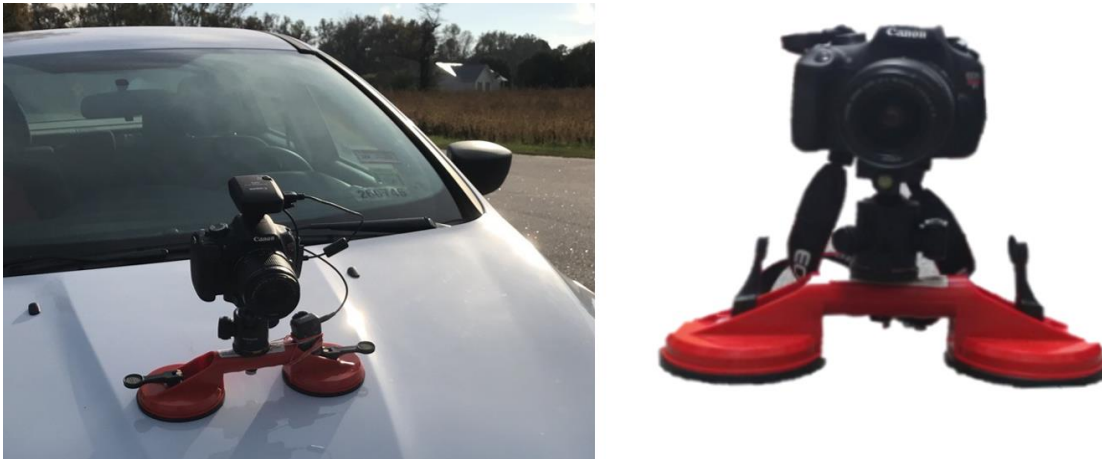
**Figure 3.2.** *Camera with GPS unit attached mounted to hood of car.*

A vehicle with a camera mounted to its hood closely followed the LWST to obtain images of the pavement sections over which SN values were measured to allow for the comparison of skid resistance with crack sealant coverage. The camera mounted to the vehicle is shown in Figure 3.2. The location of each LWST test was easily identified by the watermark left on the pavement. Two photographs were taken for each skid mark. The camera contained a Global Positioning System (GPS) unit, which allowed for reconciling the images with the corresponding LWST result. A handheld GPS unit was also used to record the location of each photograph in case of failure of the camera's GPS unit.

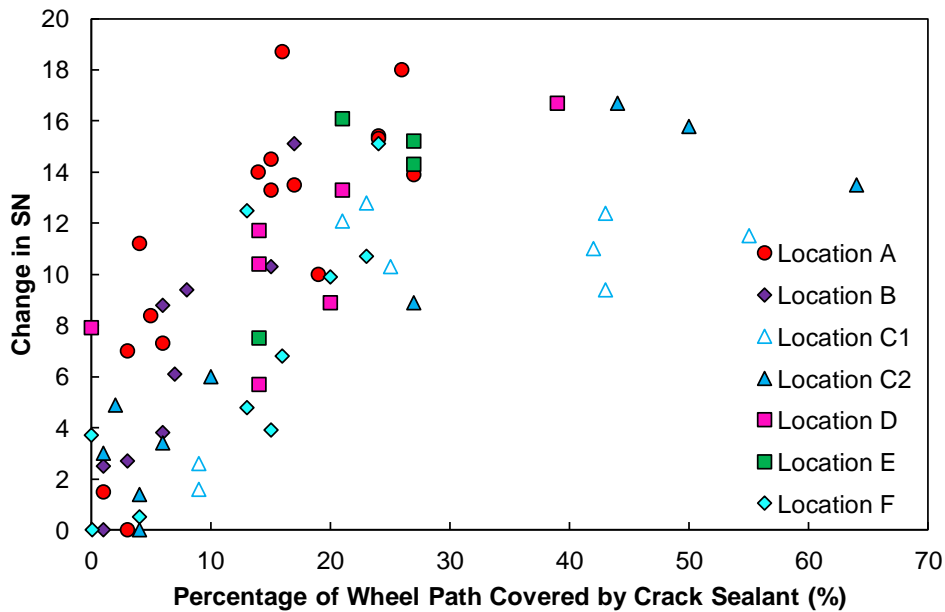
**Figure 4.6.** Relationship between the change in skid numbers from the baseline and the percentage of the wheel path covered by crack sealant for all test sections.

The change in SN versus the percentage of wheel path covered by crack sealing for all locations is shown in Figure 4.6. The results of Location C fall towards the lower bound of the scatter of the results for the other test sections and deviate from the trends of the other sections at relatively high percentages of crack sealant coverage in the wheel path. Based on these results, it does not appear that the change in SN can be used to unify the results of all test sections. However, the data corresponding to Location C extend to higher crack sealant coverages than the other sections, so definitive trends are difficult to ascertain.

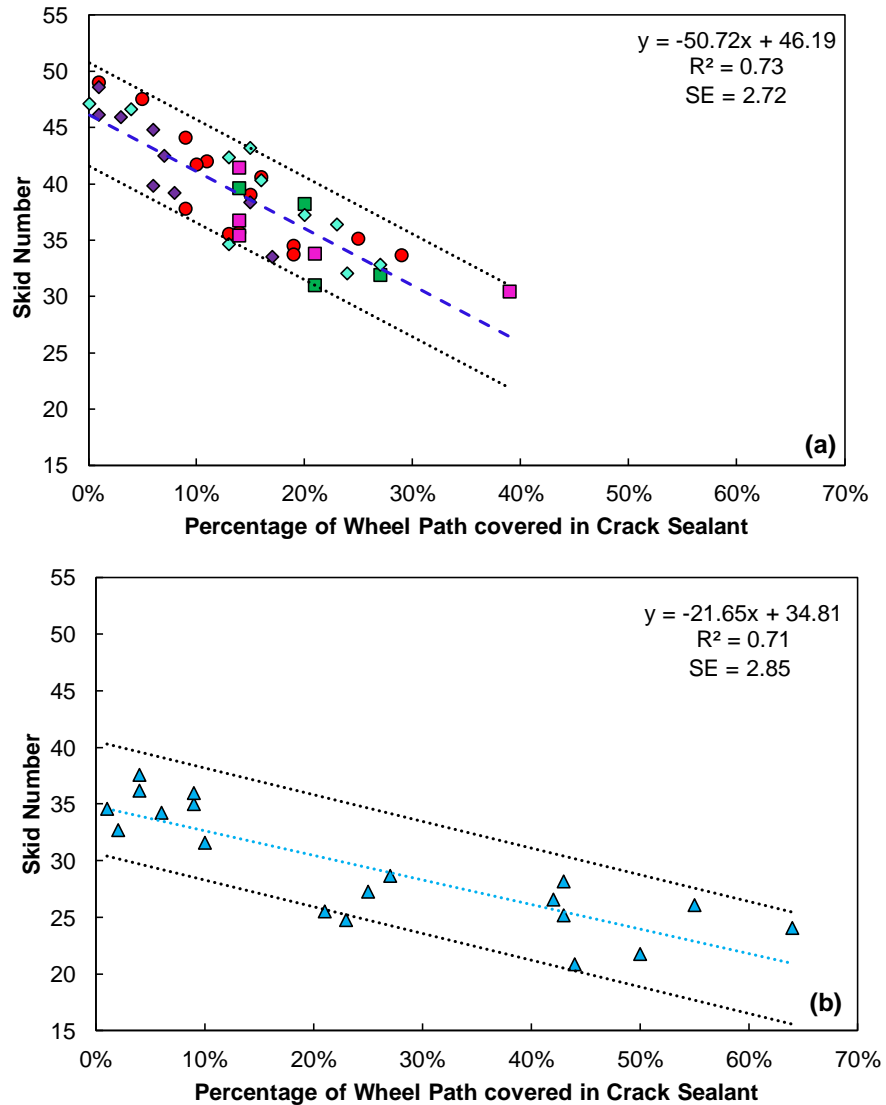
**Figure 4.7.** Relationship between LWST skid number and the percentage of the wheel path covered by crack sealant with 90 percent confidence intervals (dotted lines) for (a) Locations A, B, D, E, and F, and (b) Location C.

Where  $\hat{y}$  is the SN value predicted by the regression line,  $SE$  is the standard error of the regression line, and  $t_{crit}$  is the critical value on the t distribution for the desired confidence level. To define the two-sided confidence interval bounds, an  $\alpha$  value of 0.1 was used, meaning that there is a 5 percent probability of a value falling below the lower bound and 5 percent probability of a value falling 5 percent above the upper bound. Given the sample sizes, the  $t_{crit}$  value for the poor baseline SN results is 1.734 and the  $t_{crit}$  value for the good baseline SN results is 1.680. The results are shown in Figure 4.7.

The linear regression models and confidence intervals were used to establish limits for the percentage of the wheel path that can be covered by crack sealant in pavements with good and poor baseline skid resistance without dropping below critical the SN thresholds for low and high volume roads of 30 and 35, respectively (Jayawickrama et al. 1996). When establishing these limits, two reliabilities were considered: 50 percent and 95 percent. The reliability concept employed herein is analogous to the reliability concept implemented in Pavement ME (ARA Inc. 2003). The 50 percent reliability thresholds corresponds to the Figure 4.7 regression model predictions of the percentage of the wheel path covered by crack sealant that correspond to SN values of 30 and 35. The 95 percent reliability threshold corresponds to the lower confidence interval bound predictions of crack sealant covered in the wheel path for SN values of 30 and 35

in Figure 4.7; that is, there is 95 percent confidence that the established limit for crack sealant coverage will not lead to an SN value lower than the critical safety threshold.

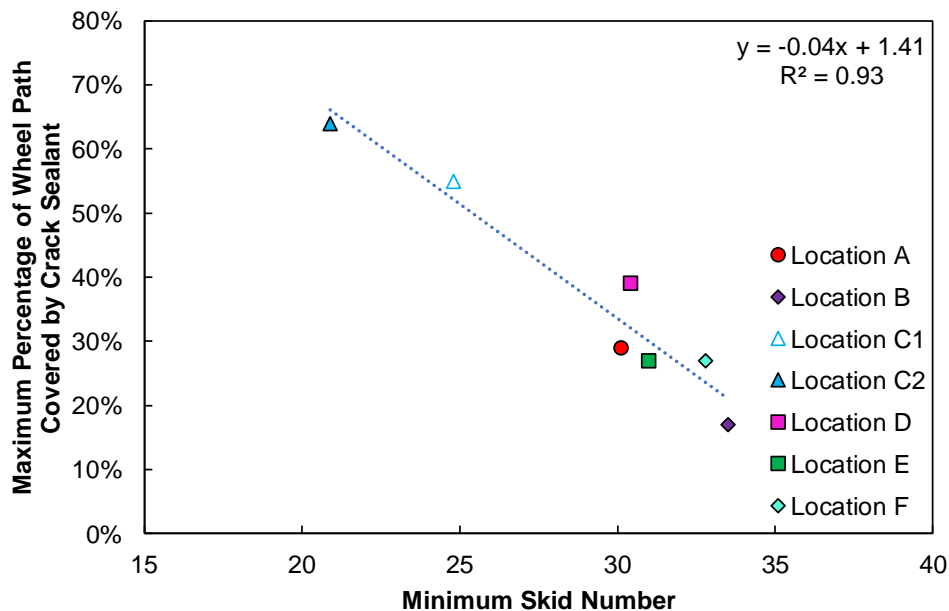
**Figure 4.9.** Relationship between location minimum skid number and max crack sealant coverage in the wheel path.

The relationship between maximum crack sealant coverage in the wheel path and minimum skid numbers of the different locations is shown in Figure 4.9; the results indicate the two values are highly correlated and thus, demonstrate the validity in using the maximum crack sealant coverage in the wheel path in the analysis to establish safety thresholds in terms of existing pavement condition. Interestingly, Locations C1 and C2 follow the same trends as the other locations despite their lower baseline SN values.

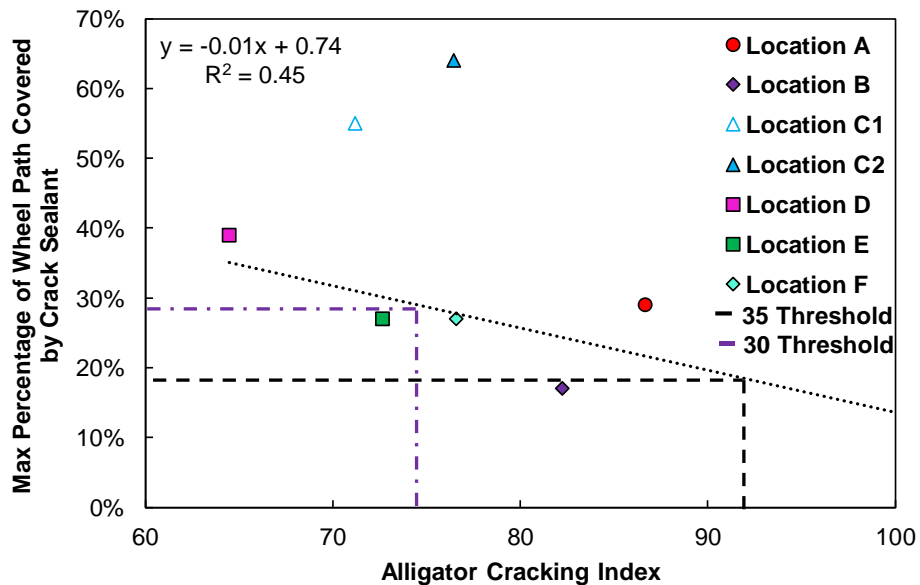
**Figure 4.10.** Relationship between alligator cracking index and maximum percentage of wheel path covered by crack sealant.

The relationship between the alligator cracking index and maximum crack sealant coverage in the wheel path is shown in Figure 4.10. It can be seen that a relationship exists between maximum crack sealant coverage and alligator cracking index, with the exception of Location C which shows outlier behavior. Location C was omitted from the analysis to establish thresholds for acceptable alligator cracking indices for sealing because the low baseline SN value prohibits safe application of sealant, as previously discussed. The scatter in the relationship between maximum crack sealant coverage in the wheel path and alligator cracking index is somewhat expected because each section exhibited a wide range of values in the percentage of the wheel path covered by crack sealant but only a single alligator index is given for the entire section. Thus, the exact location of alligator index measurement may not align with that of the maximum sealant coverage. A regression analysis was performed to obtain a functional relationship between alligator cracking index and maximum sealant coverage in the wheel path for all other locations. This relationship was used to establish alligator cracking index thresholds to maintain SN values of 35 and 30 using the 95 percent reliability thresholds for crack sealant coverage in the wheel path given in

Table 4.2. The corresponding alligator index thresholds are shown in Table 4.4. Note that the established thresholds pertain to pavements with good baseline skid resistance (i.e., SN of 43 or higher). It is recommended that the established threshold be strengthened in the future by incorporating a larger database of locations.
