# **Protocol for Outlet Analysis at Highway Sites**

**Department of Biological and Agricultural  
Engineering**

**North Carolina State University**

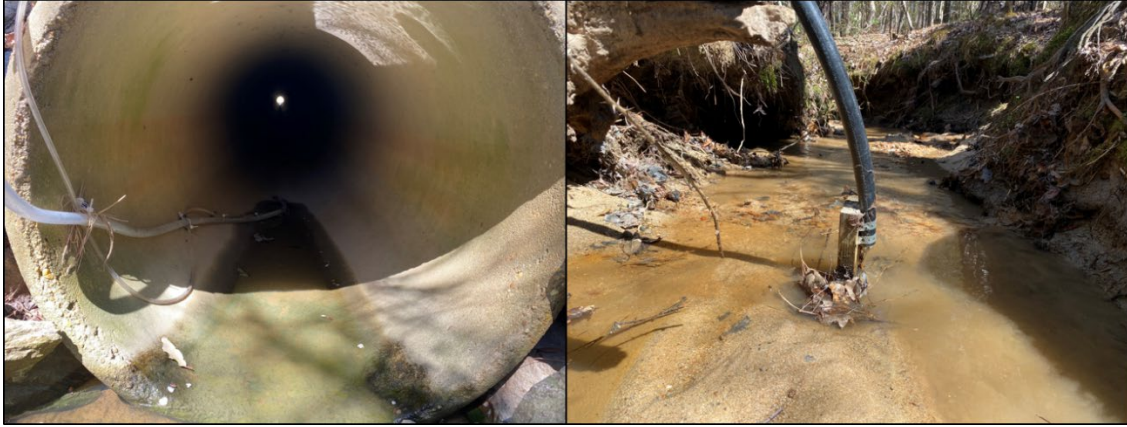
Figure 4. Monitoring setup of bubbler and sampler tubing in pipe (left) and channel (right)

An ISCO 730™ bubbler flow module (Teledyne-ISCO™, Lincoln, Nebraska) and an automated ISCO 6712™ sampler (Teledyne-ISCO™, Lincoln, Nebraska) were installed at all of the sites to collect flow-paced water quality samples and hydrologic data every two minutes during storm events. Monitoring equipment was installed within the pipe or an area immediately downslope of the pipe if debris build-up was present (Figure 4). The equipment was located in areas that had minimal turbulence. Rainfall depth and intensity were recorded every two minutes by an ISCO 674™ (Teledyne-ISCO™, Lincoln, Nebraska) or 6466 Davis AeroCone (Davis Instruments, Hayward, California) automatic tipping bucket rain gauge. Efforts were made to install the rain gauges in areas (1) free of overhead obstructions and (2) that did not interfere with traffic. Storm events were defined as those that had a rainfall depth greater than or equal to 0.10 in with an antecedent dry period of at least six hours (Driscoll et al., 1989). Within 48 hours of a storm event, samples were collected, composited, and transported on ice to the Center for Applied Aquatic Ecology (CAAE) in Raleigh, North Carolina for TSS analysis (Std. Method 2540D) (APHA, 2005). After each storm event, the sample bottles were cleaned onsite using deionized water, and the monitoring equipment was calibrated.

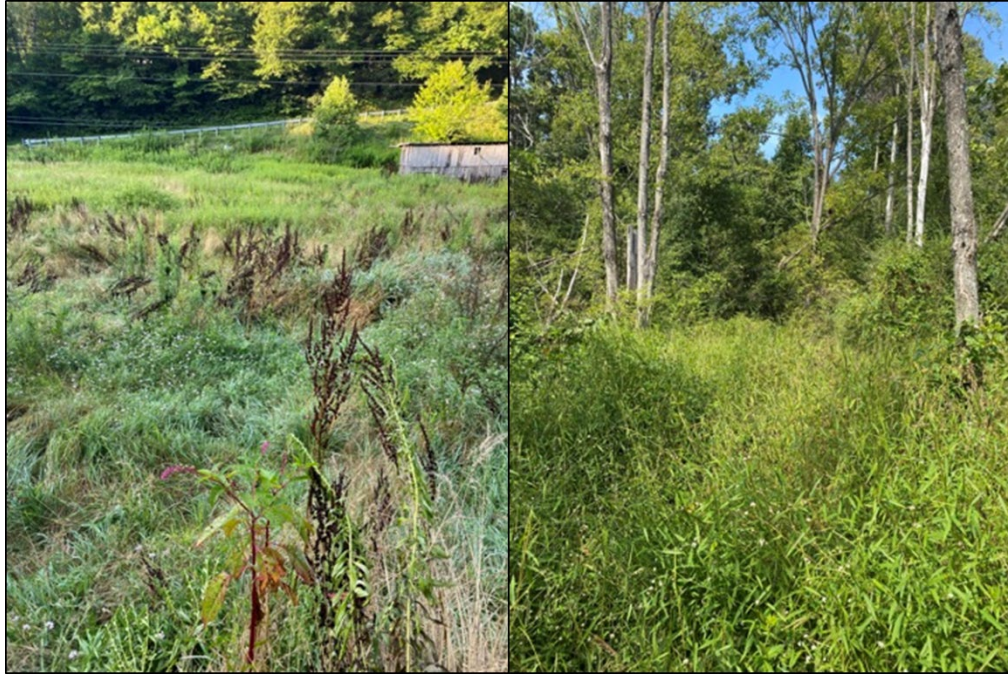
Figure 10. Assessed sites free of downslope erosion

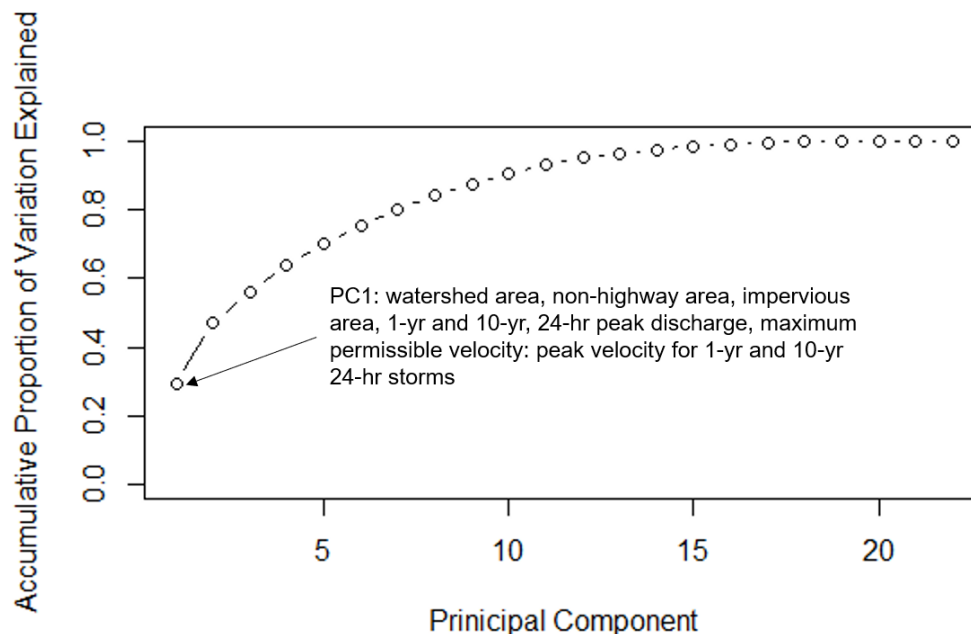
Figure 12. Principal components proportion of variance explained with key predictors for PC1 shown

PC coefficients and a threshold of 0.25 determined the most influential predictors in each PC. Influential predictors for PC1 included watershed and hydrologic characteristics that either directly (e.g., peak velocity) or indirectly (e.g., impervious area) affect erosion. These characteristics also had some of the most variability (Table 7). Predictors that repeatedly had PC coefficients with a magnitude greater than or equal to 0.25 included the percentage of HSG soils,  $\rho_b$ , percentage of sand and clay in the pipe outlet's channel banks, duration of the 10-yr,

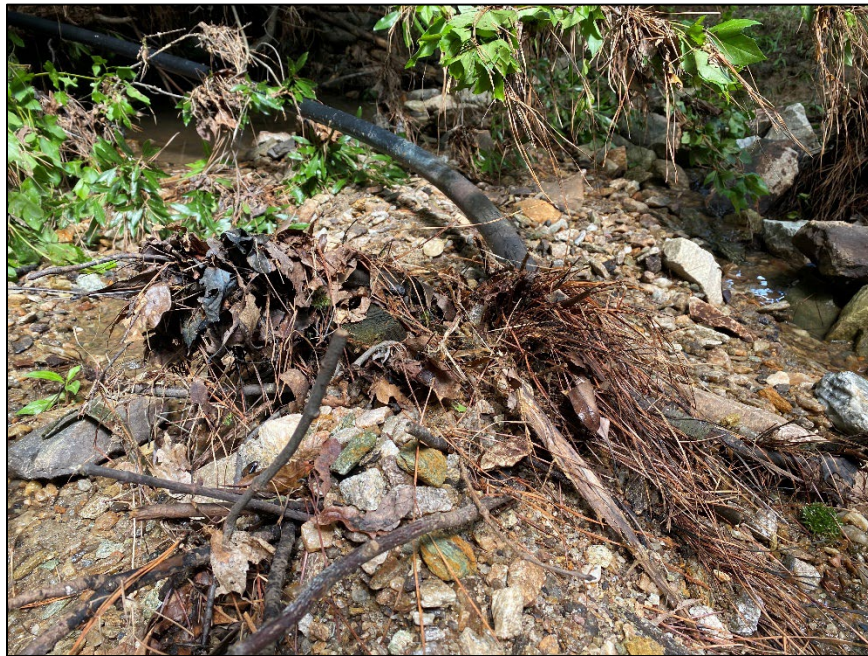
Figure 18. MP459 equipment buried by sediment transported during 2.99 in storm

Monitoring occurred from July 2021 to August 2022. However, due to equipment damage from a 2.99 in storm, monitoring at MP458 and MP459 stopped July 2022 (Figure 18). Debris from overhanging vegetation often clogged the tipping bucket and compromised rainfall data. Additionally, battery failure and wires cut by routine mowing caused a loss of data. MP458 and MP459 were most affected by these issues. Due to proximity (8 mi), rainfall data collected at MP467 was substituted for missing MP458 and MP459 rainfall data. The nearest weather station maintained by the North Carolina State Climate Office (NCSCO) was 9 mi away. The minimum number of storm events recorded was 57, and rainfall ranged from 0.10 to 5.42 in. Antecedent dry periods varied between 0.26 and 30 days, and the average rainfall intensity ranged from 0.02 to 1.37 in/hr (Table 11).

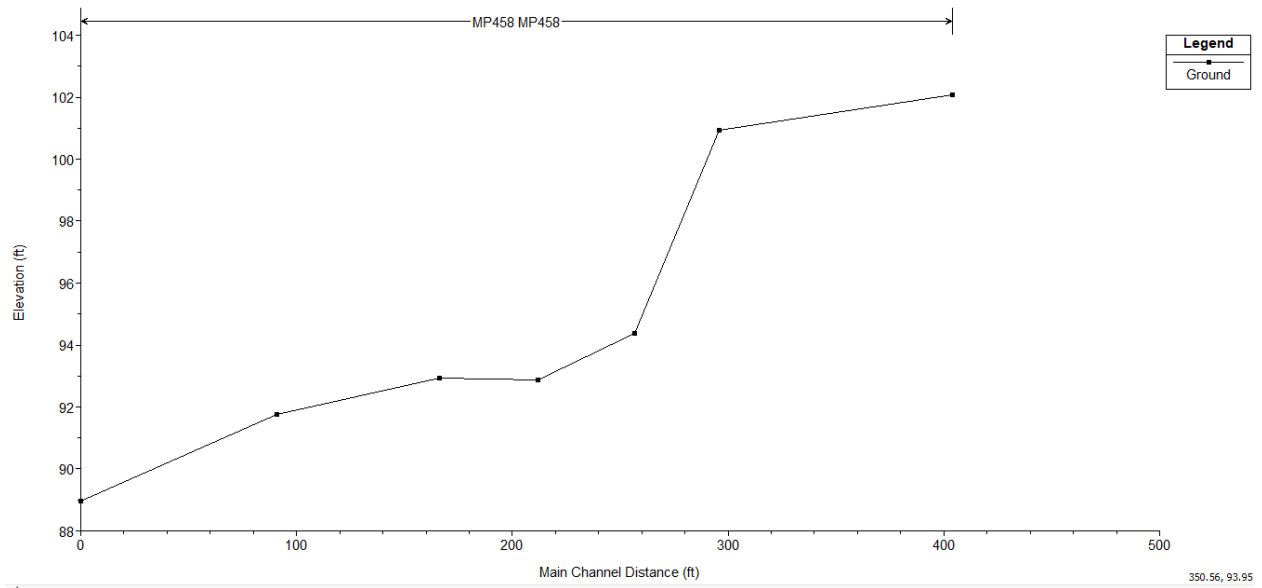
Figure 20. Longitudinal profile of MP458 channel bed

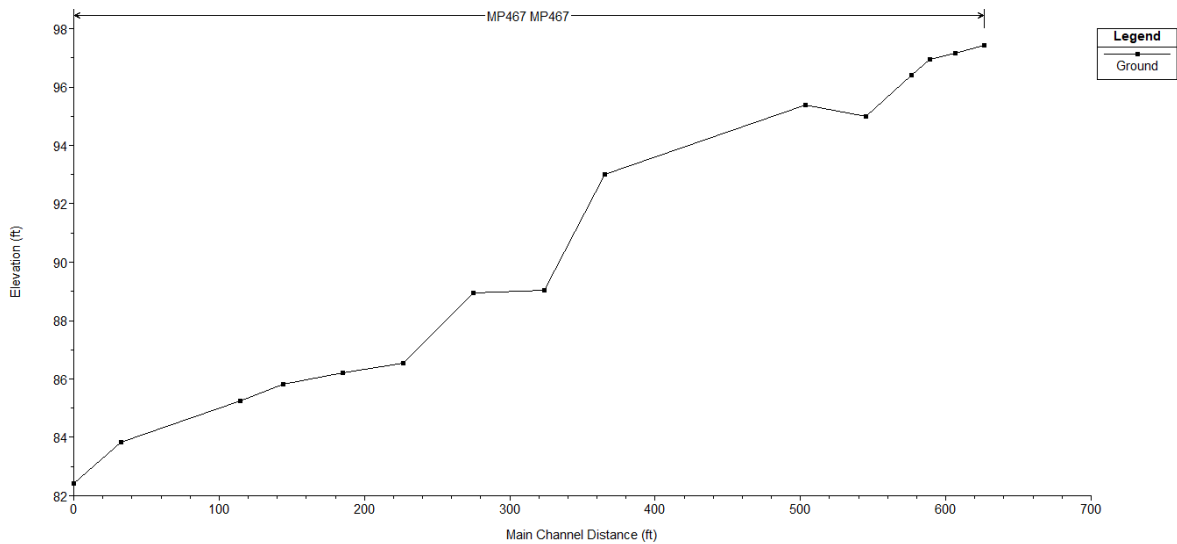
Figure 22. Longitudinal profile of MP467 channel bed

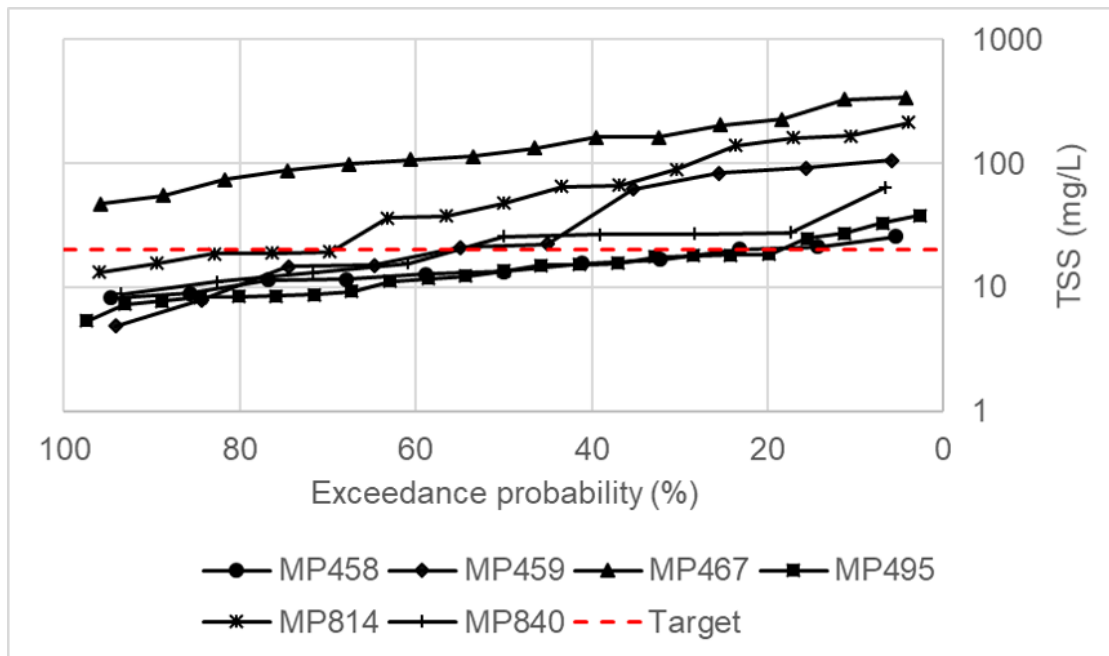
Figure 24. Exceedance probabilities for TSS standard (15A NCAC 02B .0101, 2019)

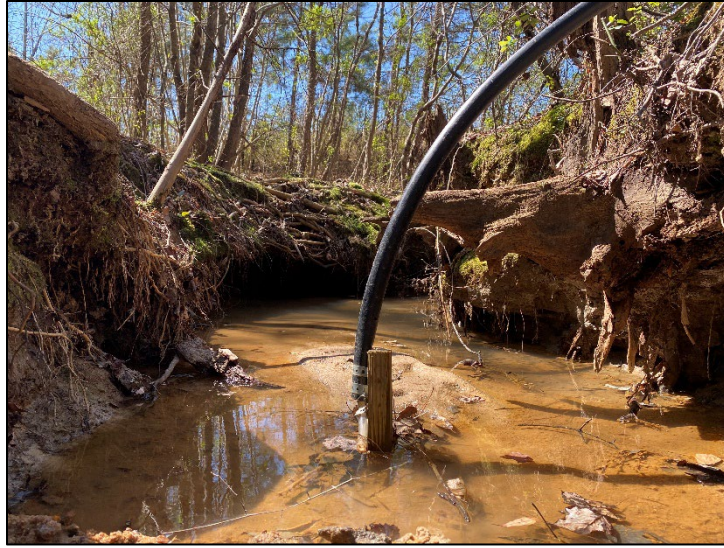
Figure 25. Evidence of unstable undercuts at MP467

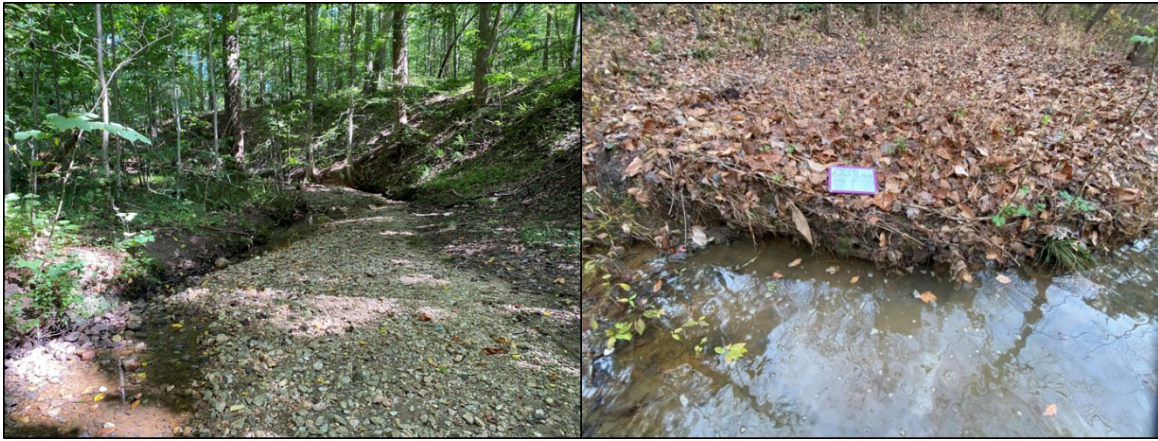
Figure 26. MP840 channel sediment deposition (left) and outfall bank (right)
