RP# 2020-09

# FINAL REPORT

## Monitoring and Modeling Sound-Side Erosion near Oregon Inlet to Support Feasibility Level Transportation Planning

AUGUST 2022

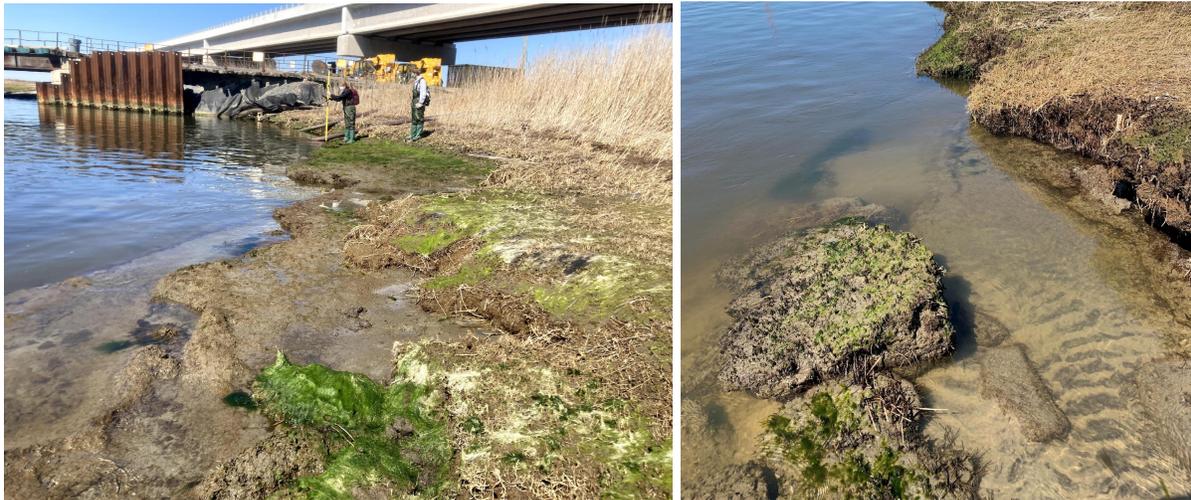
**Figure 1.** Eroding shoreline edge on the estuarine side of the Pea Island National Wildlife Refuge near the abutment of the Marc Basnight Bridge (Pictures taken in March, 2021)

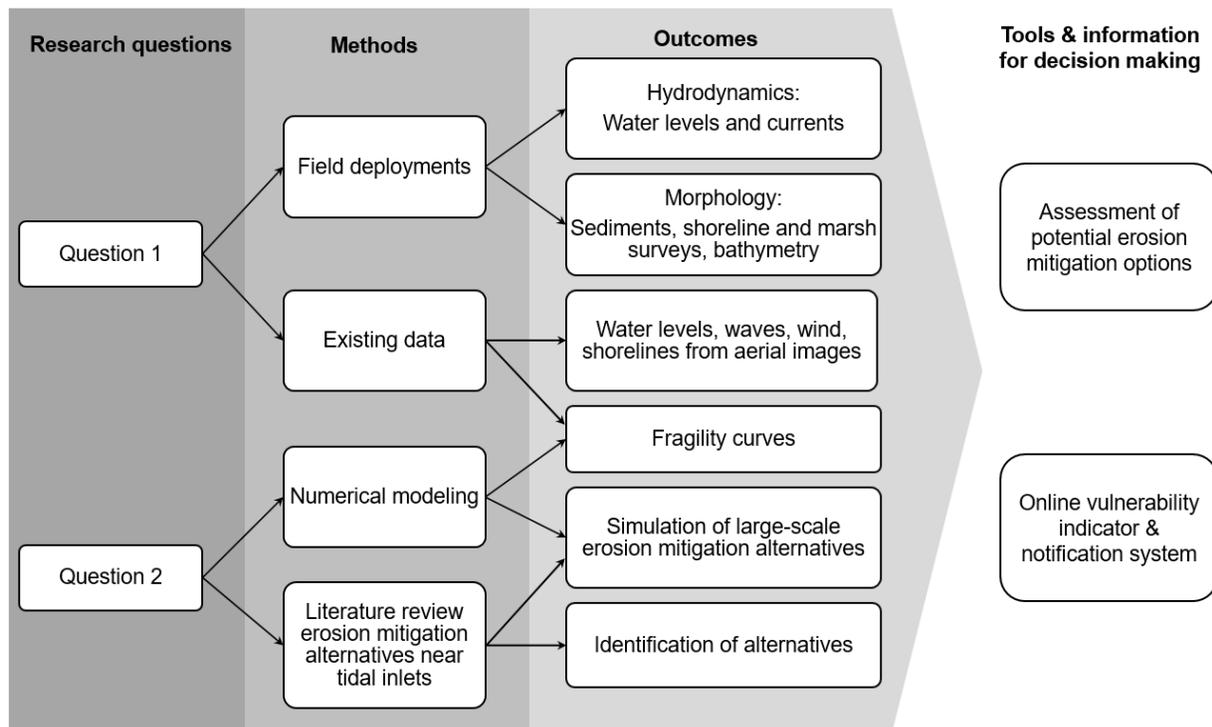
**Figure 2.** Schematic of the research project approach and outcomes.

The methodology outlined in Figure 2 summarizes the approach taken to answer the research questions. To identify the conditions leading to estuarine erosion in the study area (Question 1), field measurements of currents, water levels, wave heights, and wind conditions were performed, as well as analyses of existing data sets. Details of the field investigations are provided in previously submitted interim reports, included here in Appendix A. This information was used along with numerical modeling to develop fragility curves, which quantify the conditions likely to lead to shoreline or roadway “failure” as defined in Section III.B. To identify technically feasible mitigation options that could potentially be implemented in the study area (Question 2), a literature review of a wide range of erosion mitigation projects was used to establish a list of potential mitigation measures (Appendix B). A subset of these measures were evaluated using numerical modeling techniques.

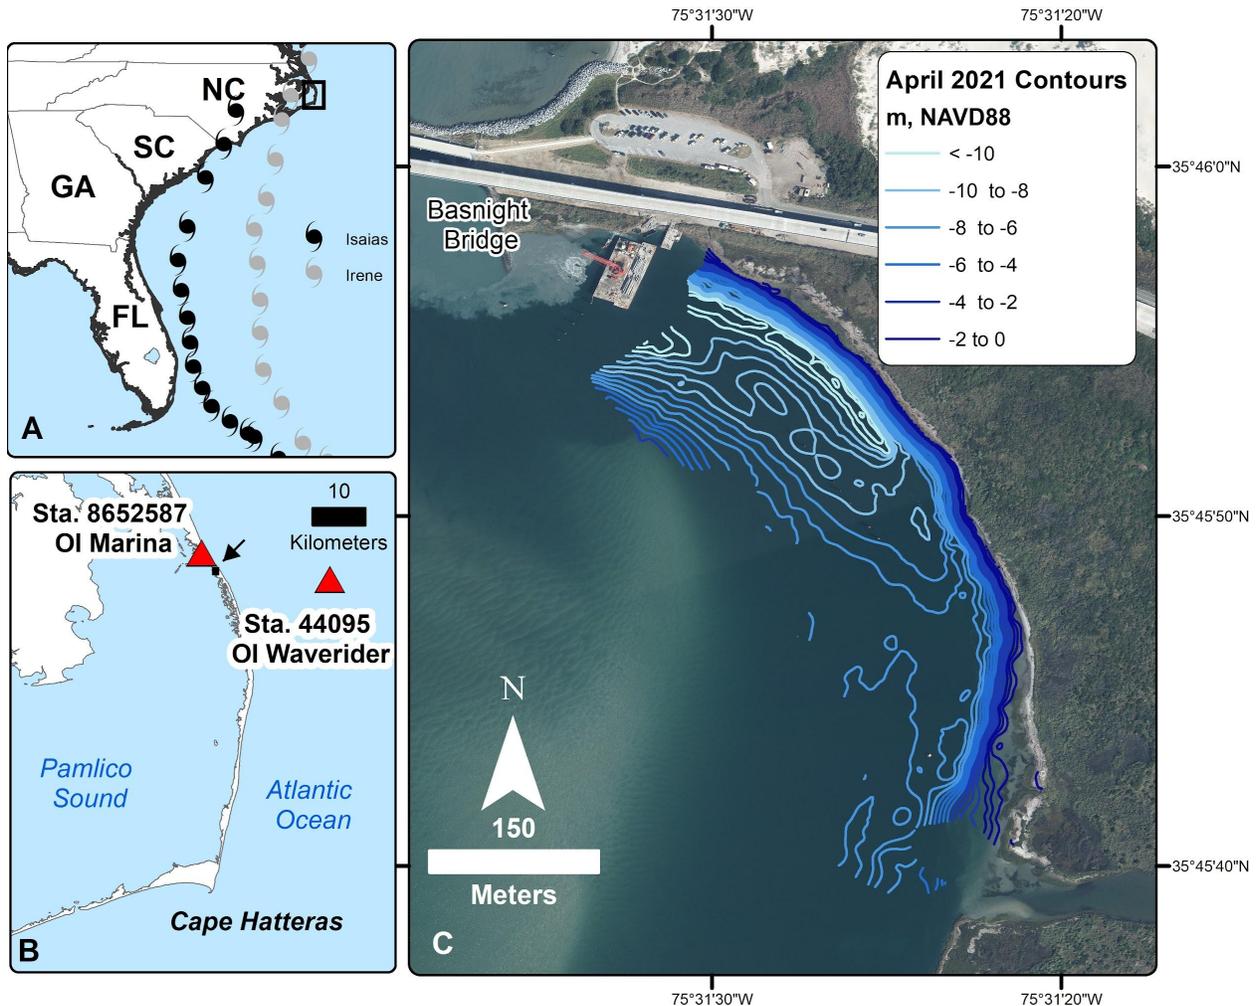
**Figure 3.** Panel A indicates the region of Panel B along with the paths of the two most recent bay-approaching hurricanes (Hurricane Irene in 2011 and Hurricane Isaias in 2020). Panel B shows the location of the two permanent data collection stations near the study area. Panel C shows the region of focus for this study, including the estuarine shoreline, adjacent channel, and marsh at the north end of Hatteras Island. NCDOT photo: 30 September 2021.

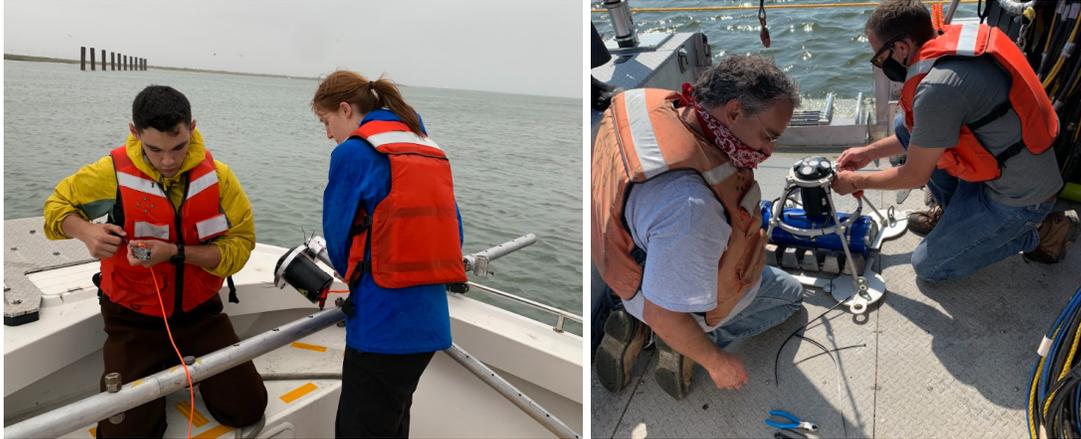
**Figure 4.** Spatial variability in currents were measured from a boat in 2019 and 2021 (left hand image, October 2019) and temporal variability in currents were measured from a bottom structure in 2020 (right hand image, August 2020).

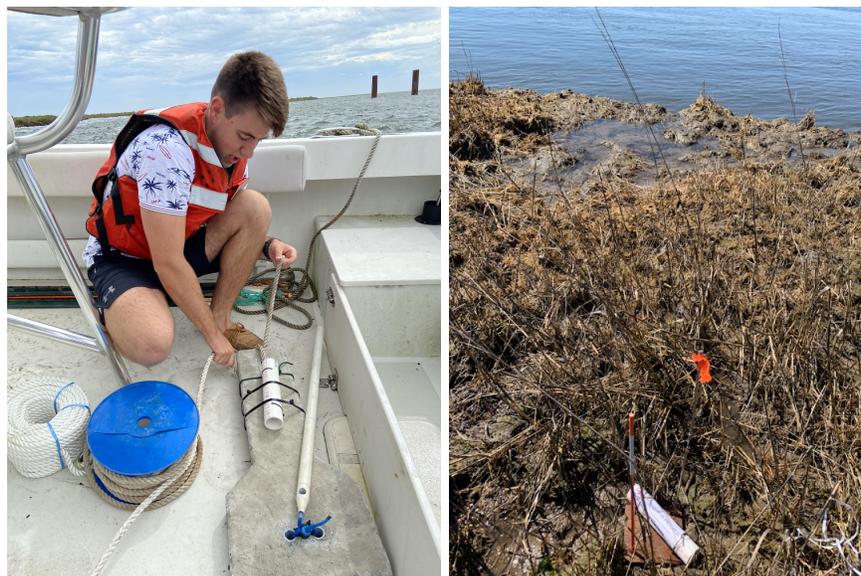
Water levels and marsh flooding were measured with Onset HOBO pressure gauges<sup>3</sup> fixed to the seafloor on concrete structures or onto the land on a metal base (Figure 5). These hydrodynamic measurements of marsh flooding levels, water levels, and currents from 2019 to 2021 were used to understand the drivers of flood events and to compare local hydrodynamics with those measured at existing monitoring stations, the results of which informed the development of fragility curves (Section IV) and the online vulnerability indicator (Section V). The hydrodynamic measurements in 2019 and 2020 were also used to calibrate and validate the numerical model (Section IV).

**Figure 5.** To measure water levels, pressure gauges were deployed in PVC cases on concrete structures near the shoreline edge (left hand image, September 2021). Marsh flood depth was measured by a pressure gauge in a PVC case fixed to the ground (right hand image, March 2020).

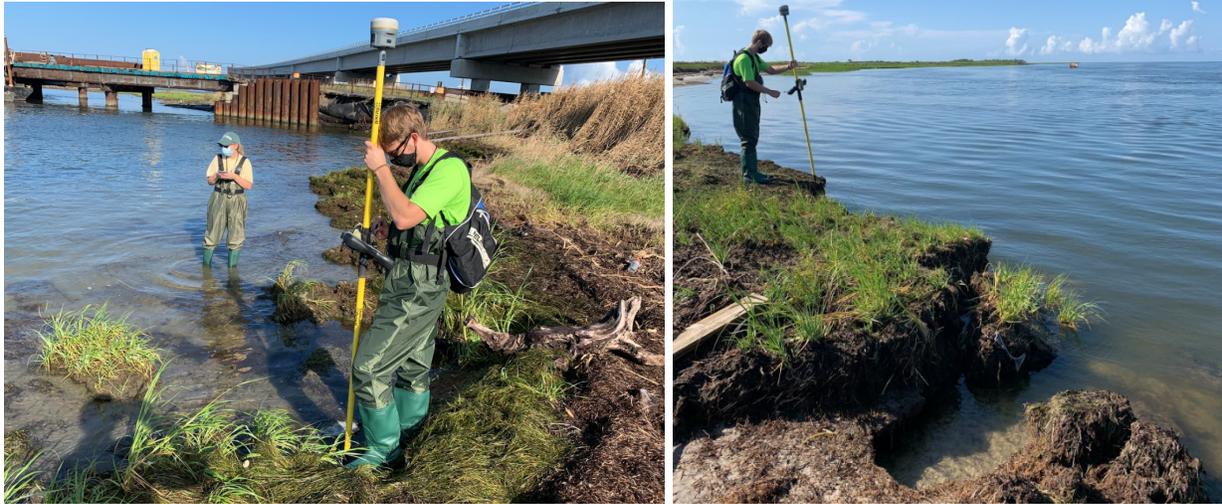
**Figure 6.** Trimble GPS System and Shoreline Surveys (August 2020).

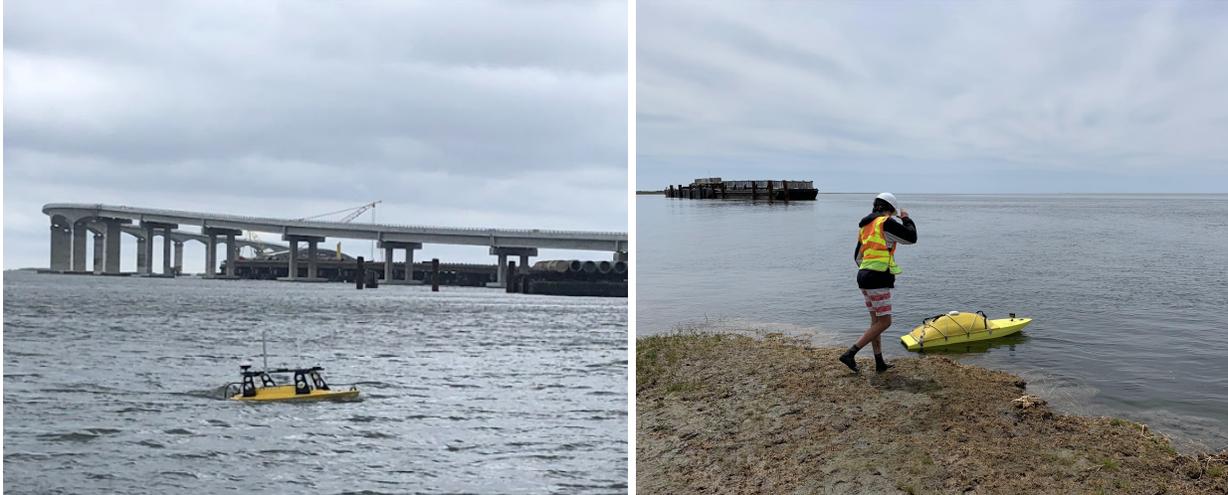
**Figure 7.** Z-boat measuring channel bathymetry using a single-beam echosounder (left hand image, October 2019); remotely-driven kayak measuring bathymetry (right hand image, April 2021).

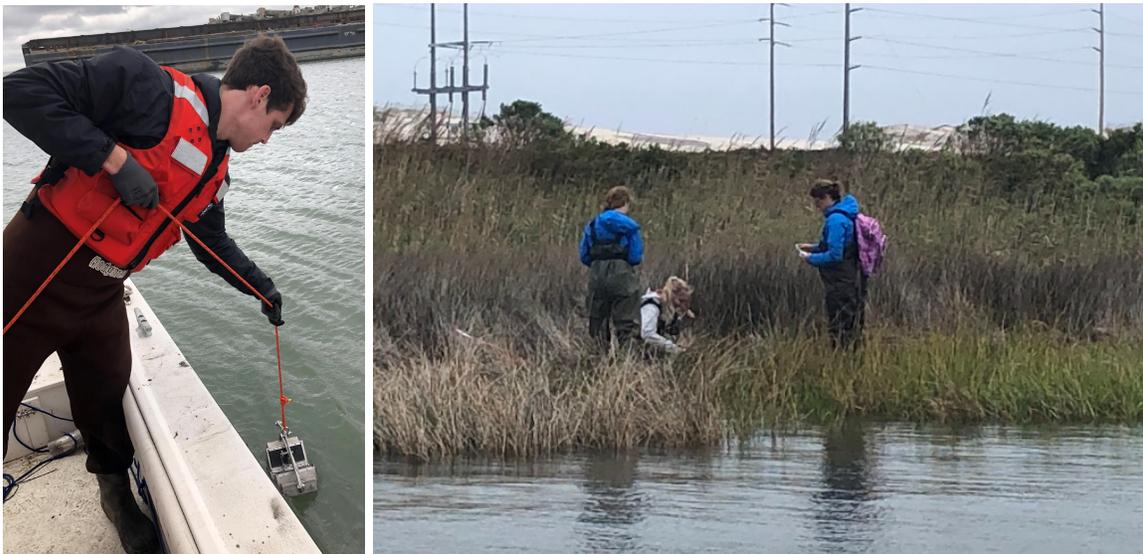
**Figure 8.** Seafloor sediment samples were taken with a grab sampler (left hand image, October 2019) and sediment samples on land were gathered with a trowel (right hand image, October 2019).

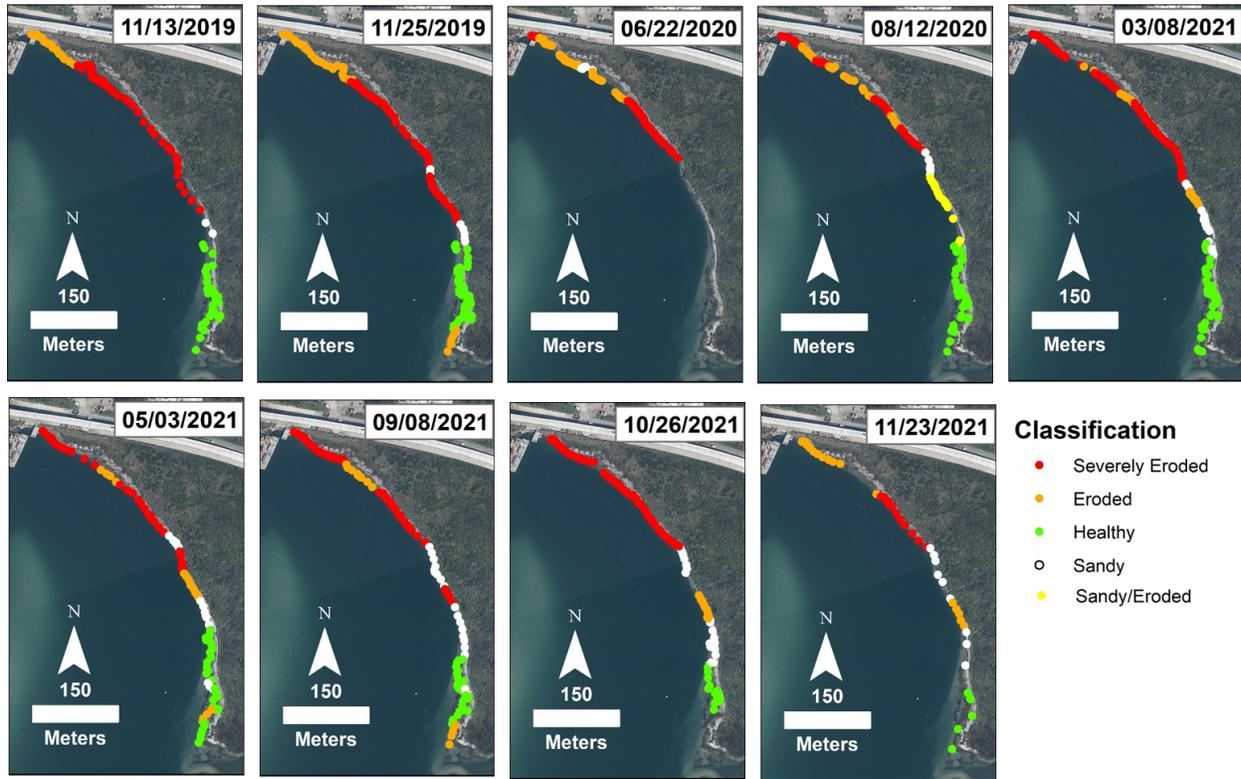
**Figure 9.** Marsh shoreline surveys with classifications for each survey date. Note that due to access and time constraints there were portions of the shoreline that were not surveyed on some of the dates.

In addition to the shoreline position surveys, a classification system was developed to determine whether the marsh shoreline condition was healthy, eroded, or severely eroded (Table 4). During each of the surveys, the shoreline was assessed using this system and a category assigned to each survey point. In addition to the marsh shoreline classification, another category for a sandy shoreline was used, where the marsh was not adjacent to the sound. The most severely eroded shoreline was consistently observed in the northern portion of the study area (see Figure 9).

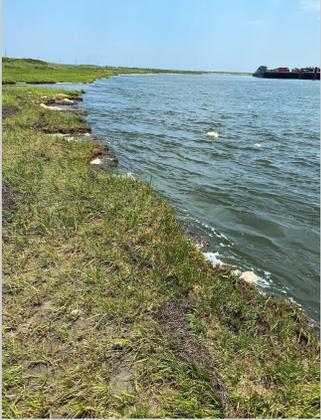
System Rating	Shoreline Condition	Marsh Condition	Example
<b>Healthy</b>	Gentle slope; plant growth on or adjacent to shoreline; minimal to no exposed root mat	Slope < 1:30*; all or majority of marsh above 2' elevation; consistent plant growth throughout marsh, including juvenile plants; intact root mat

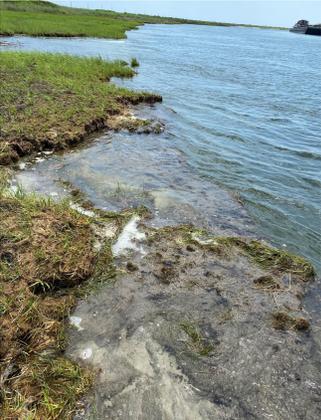
<b>Eroded</b>	Scarp < 1'; evidence of offshore (in-water) plant growth  <i>May include:</i> Evidence of undercutting or cracks, chunks of marsh breaking off along shoreline	Slope between 1:30 and 1:10*; 50% of marsh above 2' elevation; evidence of dead or otherwise removed plants; intact or exposed root mat.  May also show signs of semi-regular flooding, evidence of channel incursion or paleo inlets.

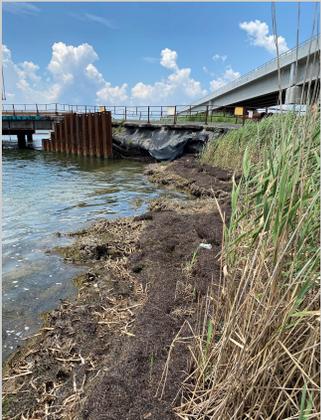
<b>Severely Eroded</b>	Scarp > 1'; evidence of offshore (in-water) plant growth  <i>May include:</i> Visible chunks of marsh sloughed off into water	Slope > 1:10*; less than 50% of marsh above 2' elevation; significant evidence of dead plants/ no plant growth; exposed root mat, or no evidence of root mat present.  May also show signs of regular flooding, evidence of channel incursion or paleo inlets.

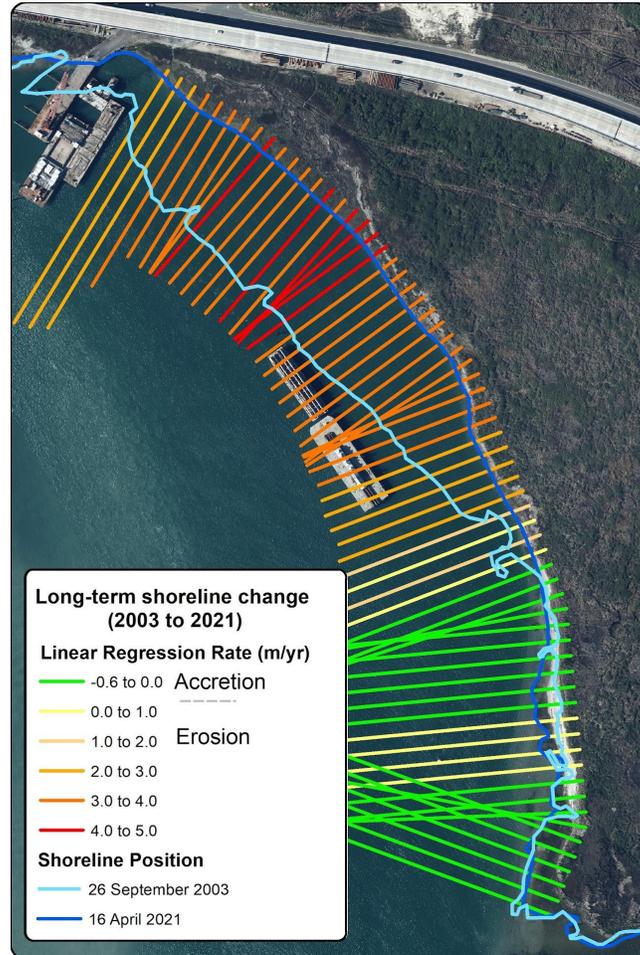
**Figure 10.** Long-term linear-regression shoreline change rate (m/year) at each transect (shore-perpendicular green-to-red lines), determined using bimonthly aerial imagery. 26 September 2003 shoreline position (light blue) and 16 April 2021 shoreline position (darker blue) are shown to illustrate the severity of ongoing erosion in the study area. Note that the shoreline change and the classifications shown in Figure 9 follow the same patterns.

In order to supplement the data collected by the marsh shoreline surveys with a longer-term comparison, estuarine shoreline changes were computed using shorelines digitized using aerial photography provided by NCDOT. The photographs span the timeframe September 2003 to April 2021, with images available approximately bimonthly. Figure 10 shows the linear regression shoreline change rates determined using the aerial photo shorelines. Long-term erosion rates over 2 m/year were observed along the northern portion of the study area, with localized rates over 4 m/year.

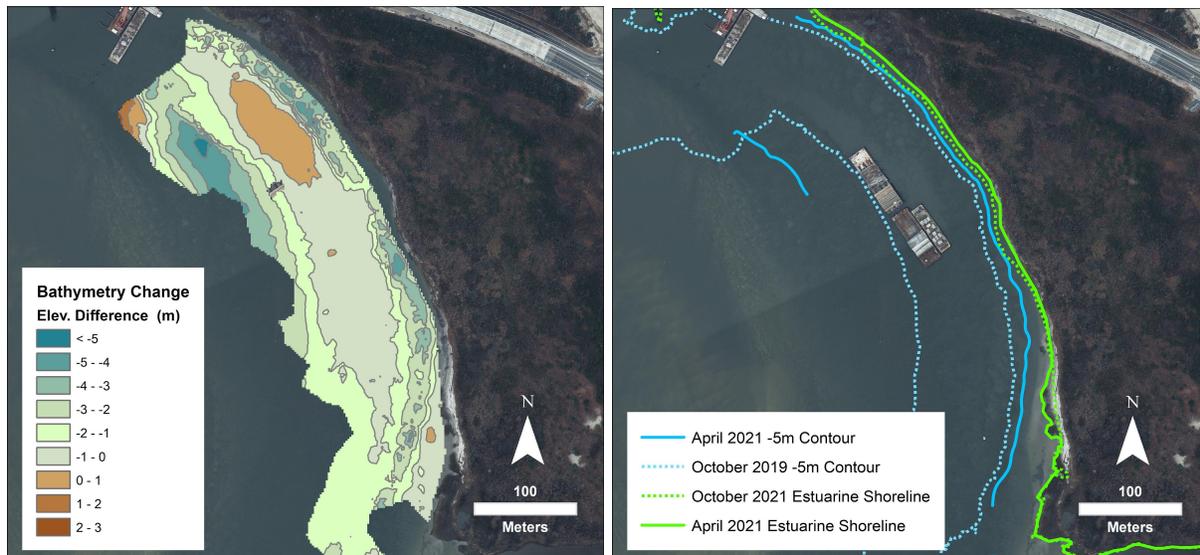
**Figure 11.** Left panel shows the change in bathymetry from 2019 to 2021. Brown colors indicate infilling of the channel to the west with deepening shown by blue colors near the shoreline. Right panel shows the changes in the -5 m elevation contour from 2019 to 2021 along with the shoreline positions. Both panels show that the channel is rapidly migrating closer to the shoreline.

The bathymetric surveys collected during the project were used to determine the position of the deepest part of the channel and to track channel migration along the study area via changes in the 5 m NAVD88 depth contour adjacent to the estuarine shoreline. This contour was chosen because it marks the boundary of the deeper portions of the channel, where velocities are higher. Figure 11 illustrates the channel migration observed in the surveys. As the channel moves closer to the shoreline, particularly in the northern part of the study area, the shoreline also recedes. This supports the conclusion that ongoing channel migration has contributed to the high rates of erosion.

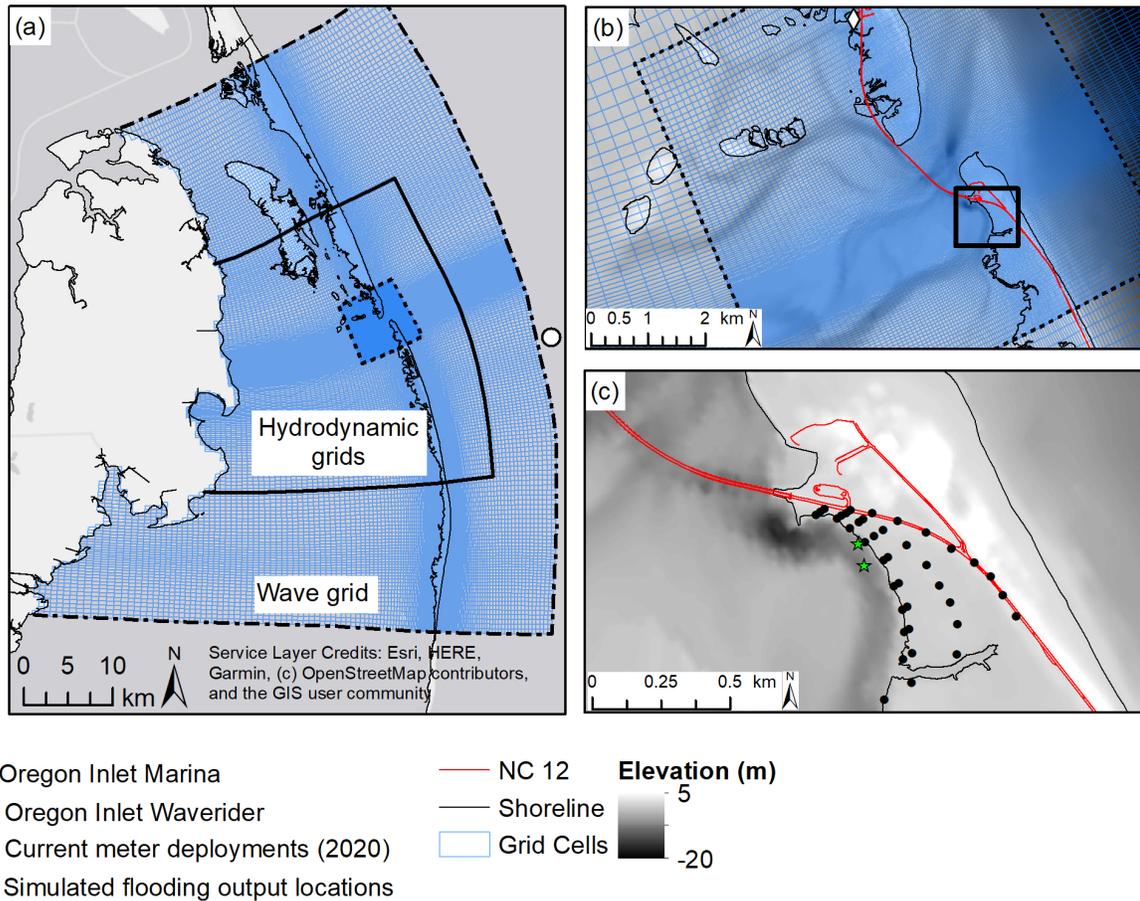
**Figure 12.** (a) Numerical model domain. (b) Hydrodynamic grid and bathymetry near Oregon Inlet. (c) Location of numerical modeling outputs in the study site

A two-dimensional depth-averaged numerical model based on Delft3D (Lesser et al., 2004) was set up to simulate the hydrodynamic conditions at Oregon Inlet under 2019 or “present” conditions. The hydrodynamic model extends 35 km alongshore and 27 km cross-shore, including mainland N.C. to the west and ocean depths of about 25 m to the east (Figure 12). The hydrodynamic model has two subdomains that allow for increased resolution near the inlet, where the computational cells reach 15 m in length. Water level boundary conditions are obtained from large-scale simulations of the Advanced Circulation Model (ADCIRC) (Westerink et al., 2008; Luetlich and Westerink, 2004) part of Coastal Emergency Risk Assessment (CERA) archives.

The hydrodynamic model is coupled with the third generation wave model Simulating WAVes Nearshore (SWAN) (Booij et al., 1999). The wave model extends 70 km alongshore with Oregon Inlet located in the middle of the domain to prevent boundary artifacts from reaching the area of interest. Wave boundary conditions are extracted from the Waverider buoy (Figure 3B). Spatially constant, time-varying wind speed and direction are extracted from the Oregon Inlet Marina meteorological station (Figure 3B), and are used for wind- wave growth in SWAN and wind-driven flows in Delft3D.

locations of current meter deployments in 2020 (green stars Figure 12C) were also compared. The model shows excellent agreement with observed major-axis flows (WS score over 0.90) and a high correlation and BSS (Table 5). More details about the model calibration and validation process can be found in Appendix D.

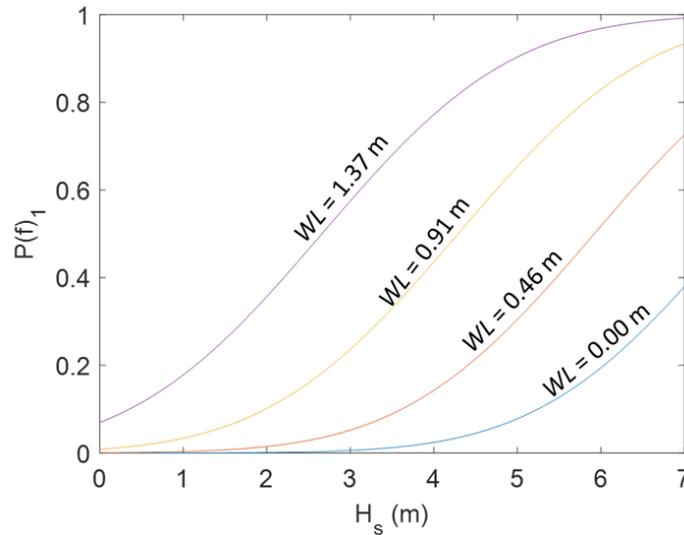
**Figure 13.** Probability of roadway failure  $P(f)_1$ , defined as roadway closure due to flooding based on TIMS data, as a function of peak significant wave height  $H_{s,max}$  (waverider buoy) for four peak water levels (NAVD88, marina tide gauge).

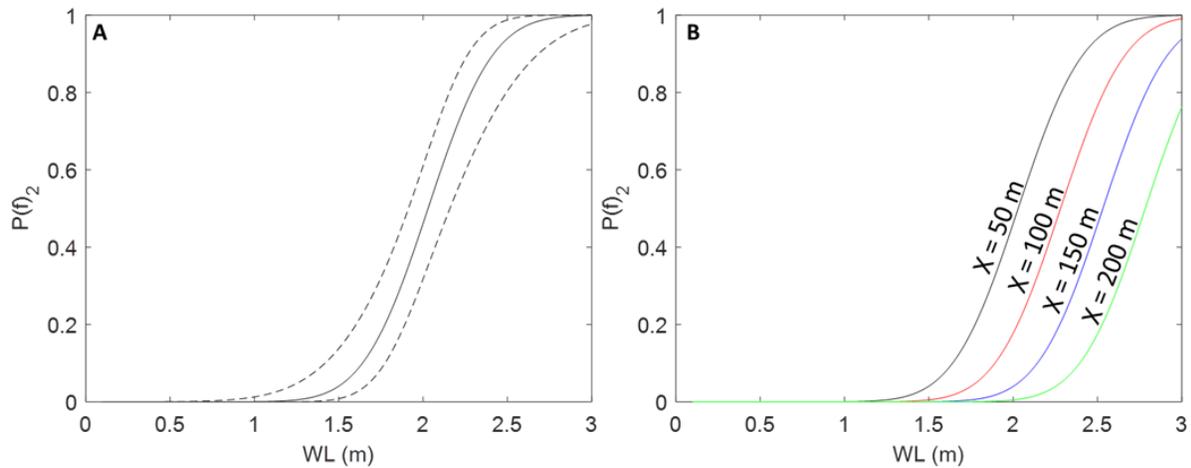
**Figure 14.** Probability  $P(f)_2$  of roadway transect flooding as a function of water level  $WL$  at the marina tide gauge (NAVD88) for (A) buffer distance  $X = 50$  m (black curve) and 95% confidence intervals (black dashed curves); (B) buffer distances  $X = 50$  m, 100 m, 150 m, and 200 m (black, red, blue, and green curves, respectively).

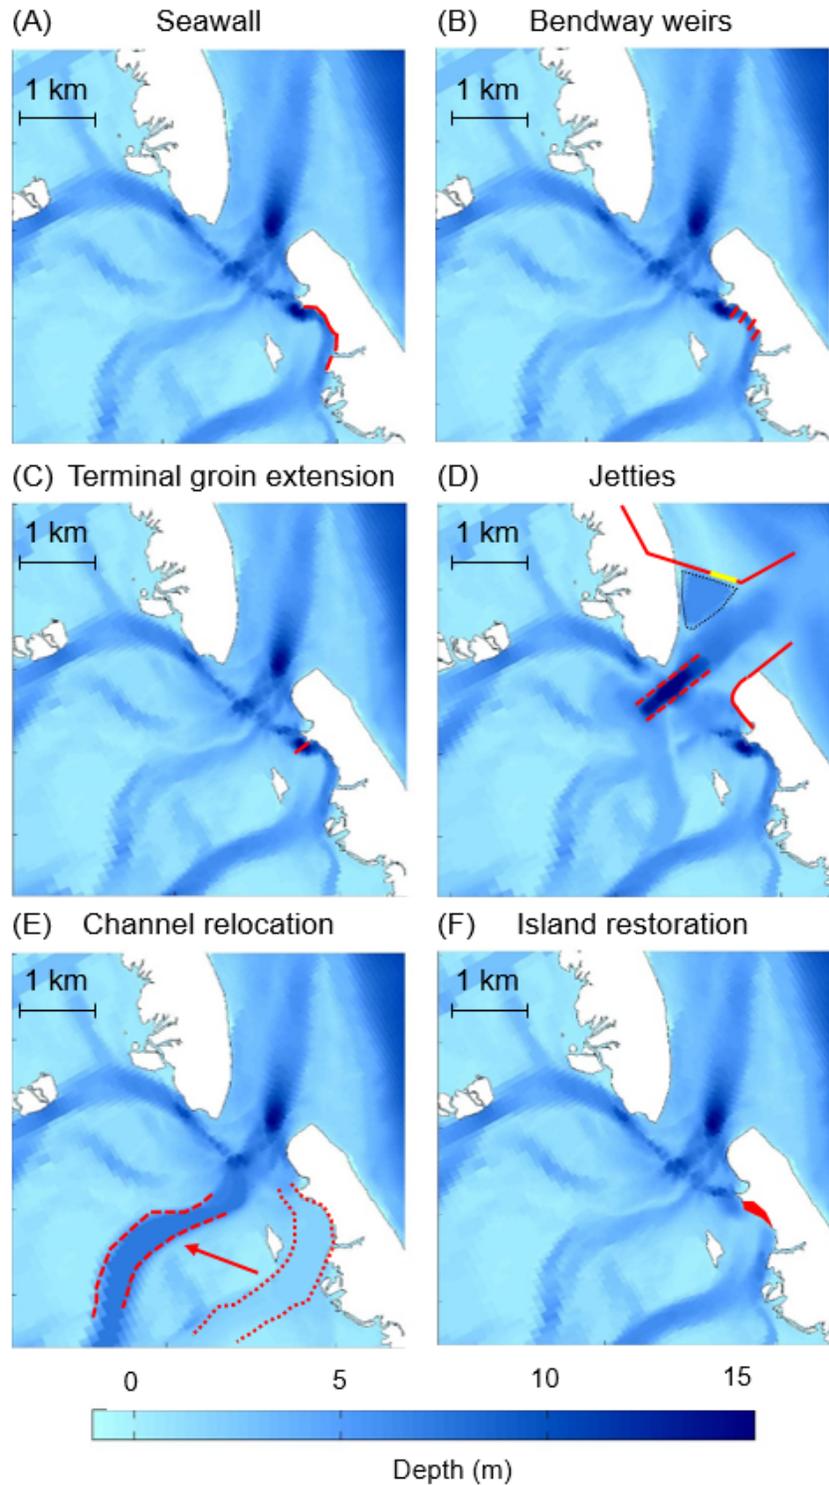
**Figure 16.** Coastal protection alternative (red highlights) on bathymetry (blue color contours) and the existing island shape (black outline) for (A) Seawall, (B) Bendway Weirs, (C) Terminal Groin Extension, (D) Jetties, where the dashed red line indicates the new position of central channel, the dotted black line indicates the area of the sedimentation basin, and the yellow line indicates the position of the weir (E) Channel Relocation, where dashed line indicates new flood channel position and dotted line indicates filled region (old channel) (F) Island Restoration.

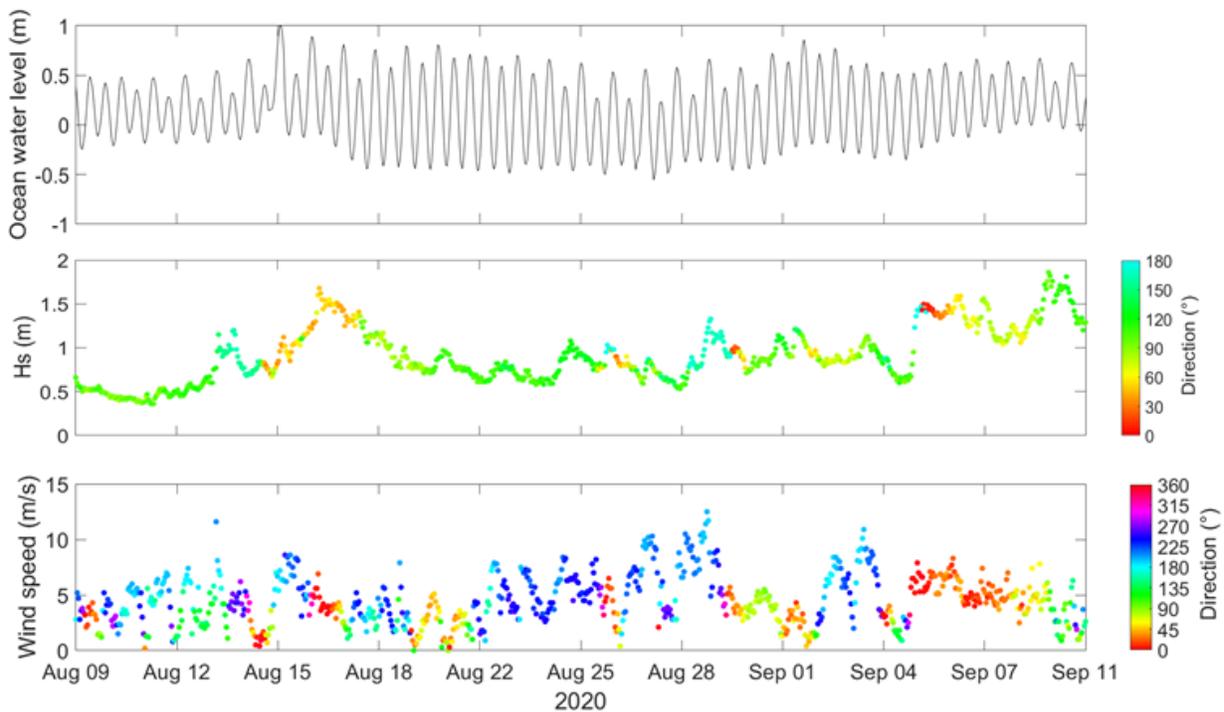
**Figure 17.** Water levels, waves, and wind speed boundary conditions used for the 30-day simulation period.

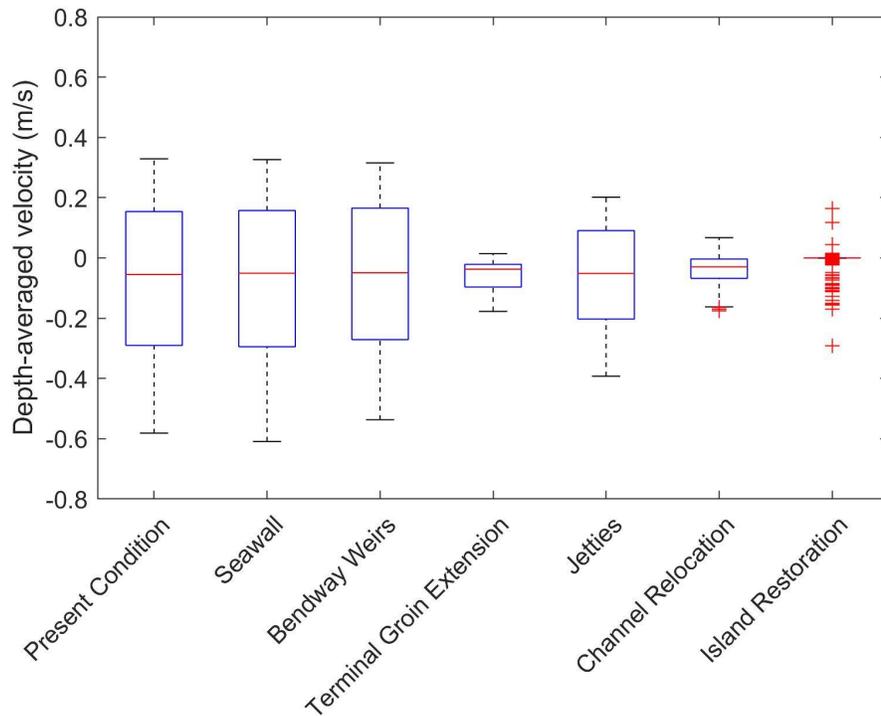
**Figure 18.** Box-and-whisker plots of depth-averaged along-channel velocity versus present condition and alternative at the south flood channel. Negative velocities indicate ebb flows, while positive velocities indicate flood flows. The horizontal red line indicates the median velocity. The vertical length of the blue boxes indicates the 25th and 75th percentiles of velocity. The black whiskers extend to the maximum and minimum velocities, excluding outliers, which are represented with red plus symbols.

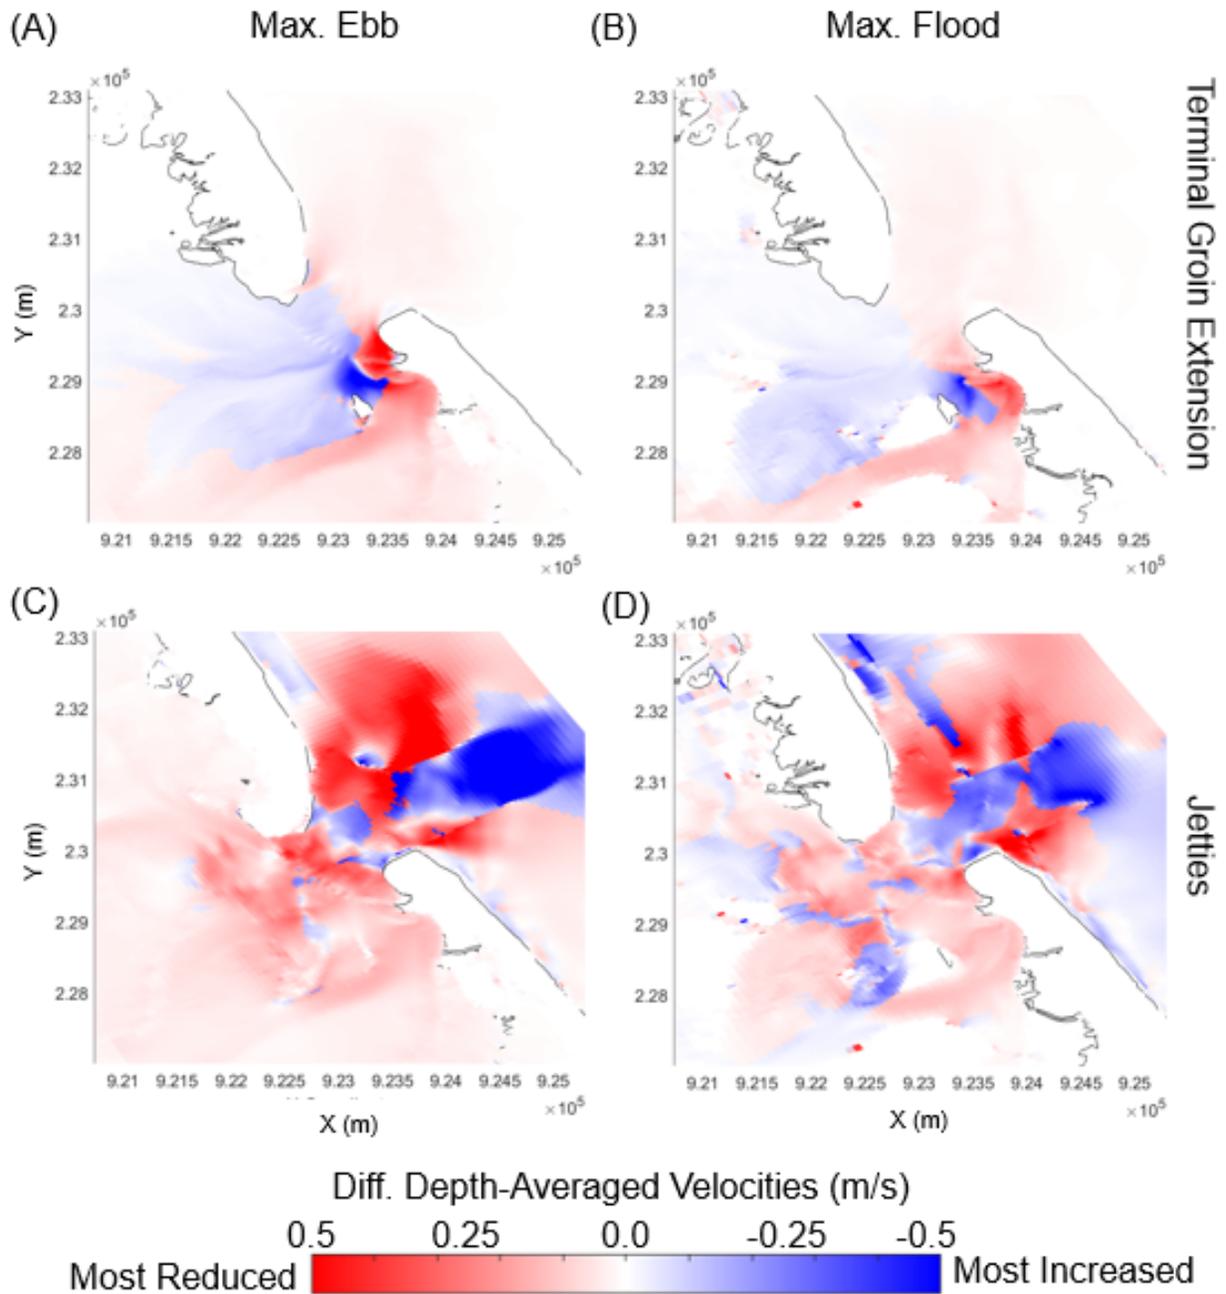
**Figure 19.** Difference in depth-averaged velocity for the present conditions and for the (A, B) terminal groin extension and (C, D) jetties during (A, C) maximum ebb and (B, D) maximum flood. Red and blue colors indicate reduced and increased velocity, respectively, relative to present conditions.

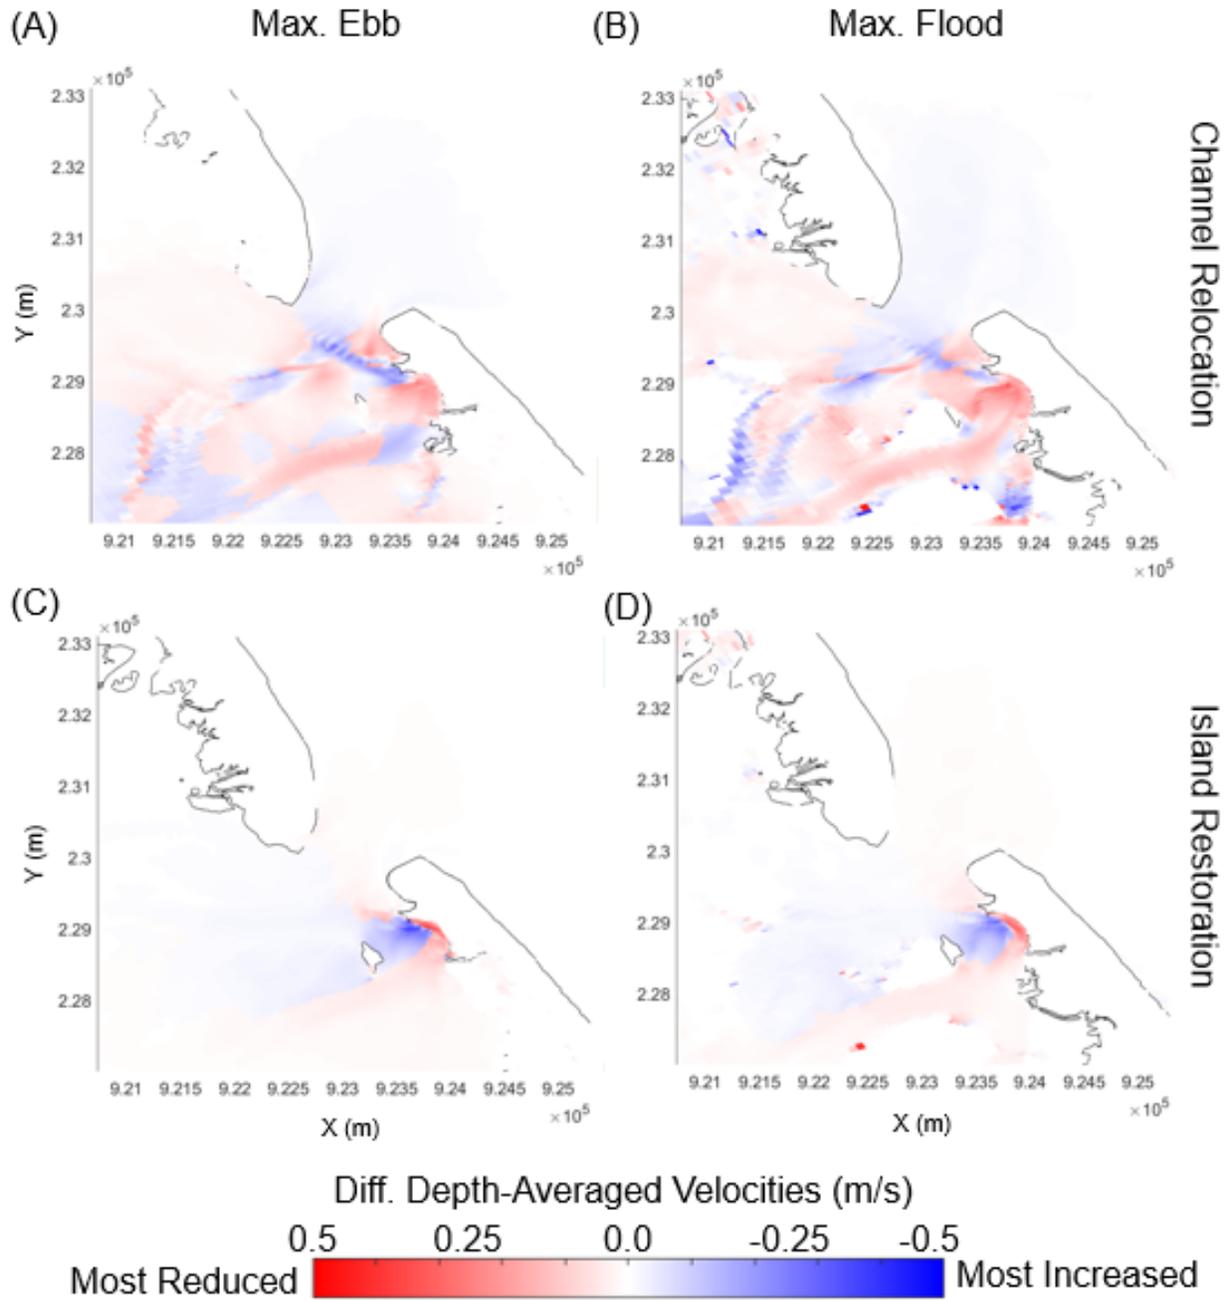
**Figure 20.** Difference in depth-averaged velocity for the present conditions and for the (A, B) channel relocation and (C, D) island restoration during (A, C) maximum ebb and (B, D) maximum flood. Red and blue colors indicate reduced and increased velocity, respectively, relative to present conditions.

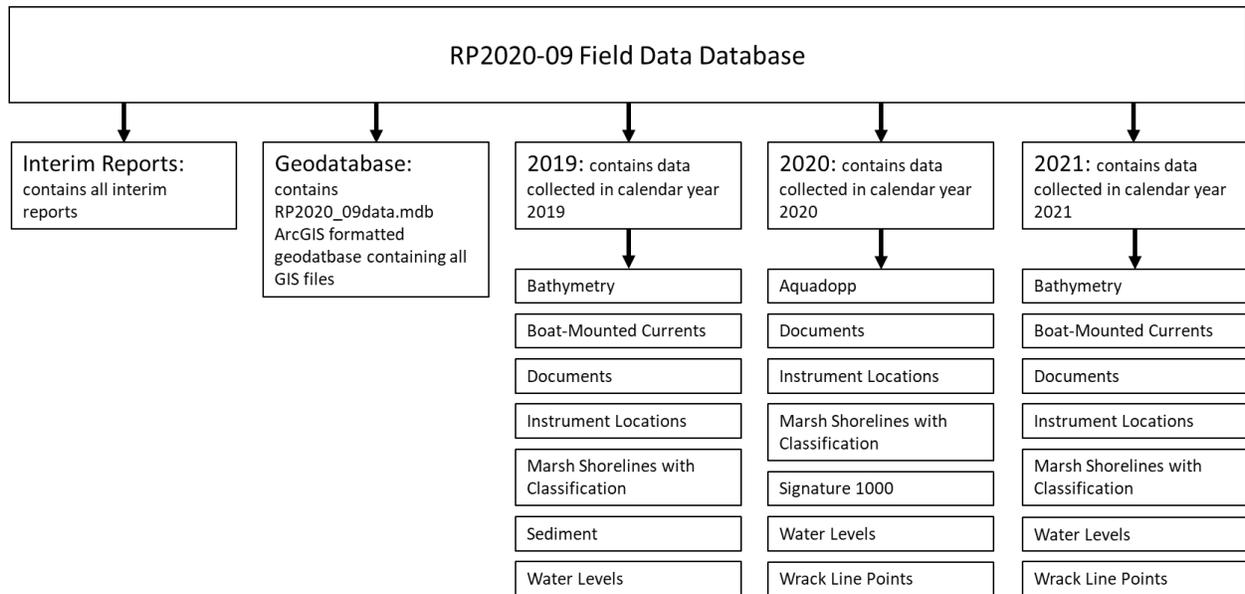
Figure 22. File organization for the field data database provided.

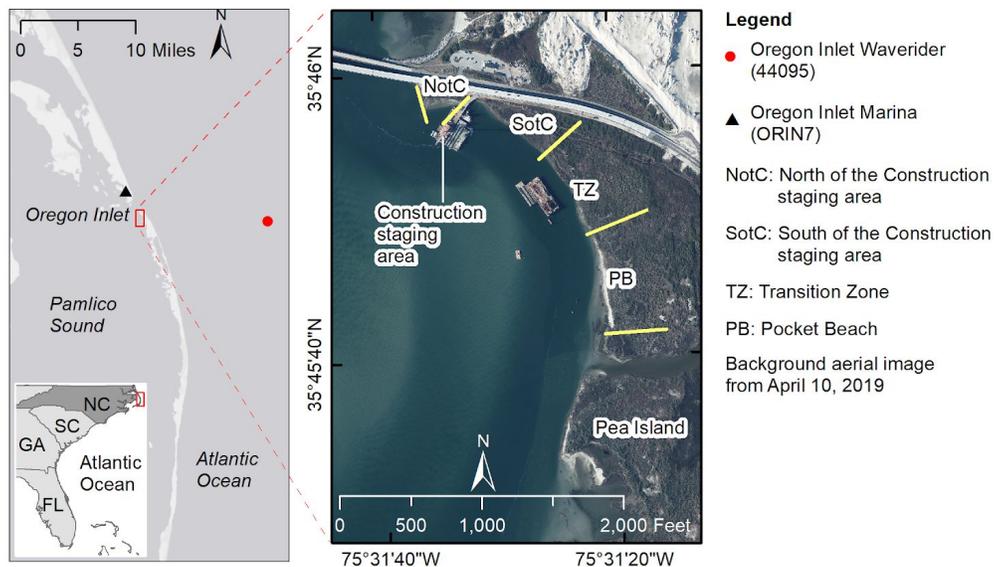
Figure 1: The left hand map shows the study area and nearby tidal gage (black triangle) and waverider buoy (red circle) The right hand map shows the study area divided into roughly 4 regions, each with distinct soil and vegetation characteristics.

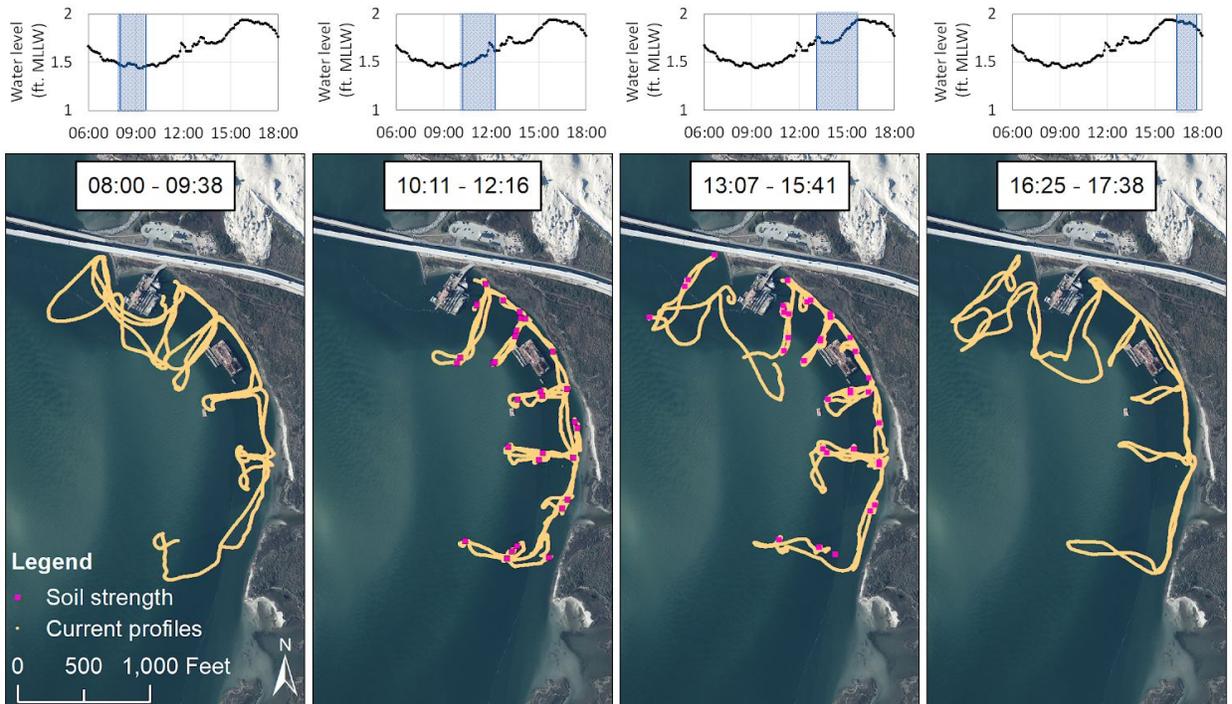
Figure 6. Locations of boat-mounted current measurements (orange transects) and soil strength measurements (pink points) at four different stages of the tidal cycle (shown in the figures on top).

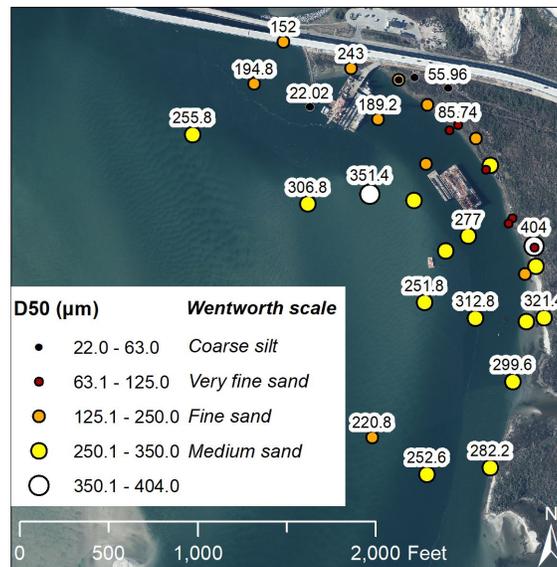
Figure 8. Median sediment grain size (d50) in the flood channel and on land.

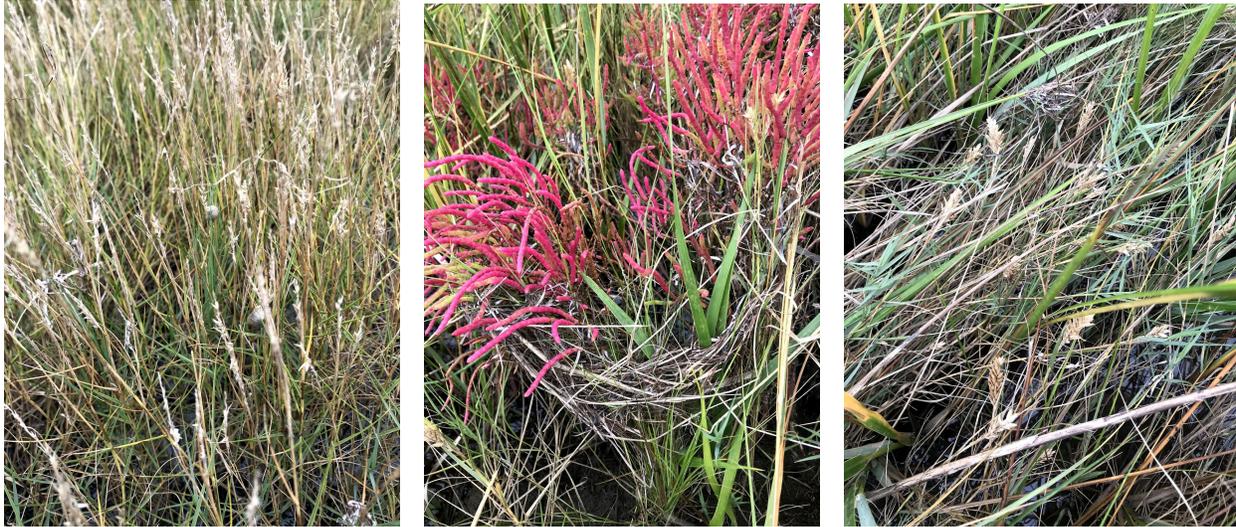
Figure 9: From left to right, *Spartina alterniflora* (smooth cordgrass), *Salicornia depressa* (Virginia Glasswort), and *Distichlis spicata* (saltgrass), three of the four vegetation species observed at SotC.

The majority of plant species observed on land were various types of grasses and sedges. At NotC, where the ground was solid and sandy, the most abundant plant was the *Phragmites australis*. At SotC, where the water level was higher and the mud was softer, *Spartina patens* (salt meadowgrass), *Spartina alterniflora* (smooth cordgrass), *Salicornia depressa* (Virginia Glasswort), and *Distichlis spicata* (saltgrass) were observed (Figure 9).
