RP# 2020-09

# FINAL REPORT

## Monitoring and Modeling Sound-Side Erosion near Oregon Inlet to Support Feasibility Level Transportation Planning

AUGUST 2022

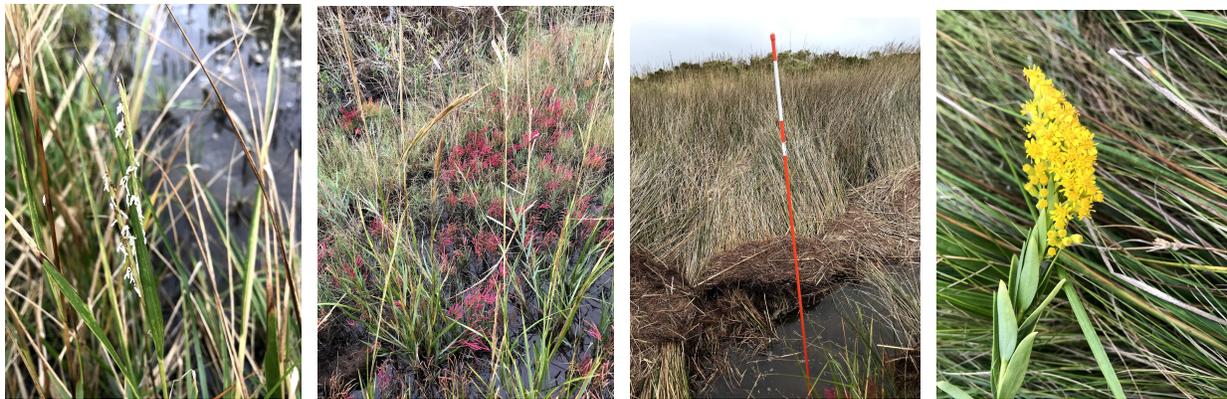
Figure 10: From left to right, *Spartina patens\** (salt meadowgrass), *Salicornia depressa* (Virginia Glasswort), *Juncus roemerianus* (black needlerush), and *Solidago sempervirens* (seaside goldenrod), some of the species observed at TZ. \*Note that the white on the left hand image is larvae not seeds.

The salt meadowgrass was more prevalent farther down the area surveyed, in the Transition Zone. It was also more common at the water's edge. Smooth cordgrass was the most dense plant between the *Phragmites* and the waterline. Sparsely throughout the cordgrass was Virginia Glasswort (Figure 10).

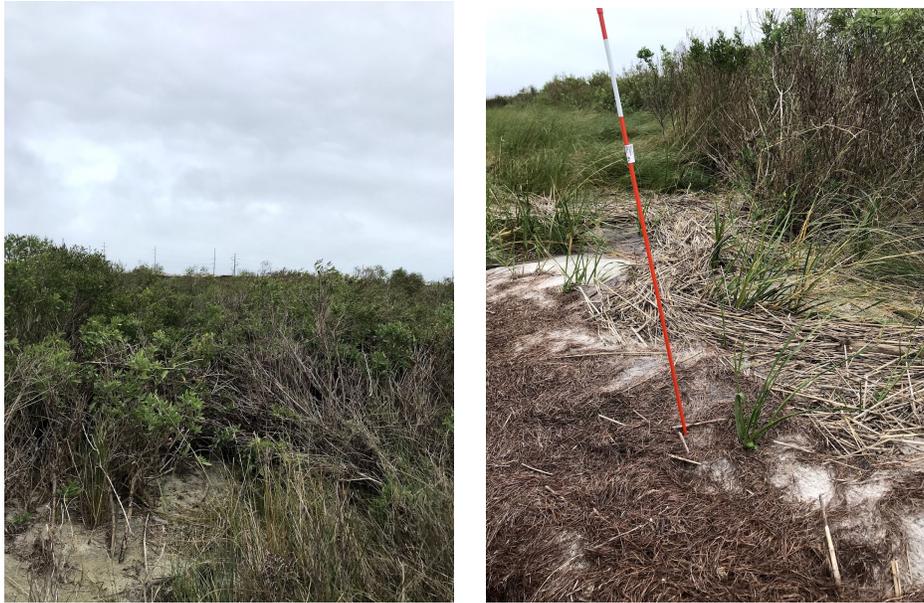
Figure 11: From left to right, *Borrchia frutens* (seaside oxeye) and *Juncus romerianus* (black needlerush), two common species observed at the PB.

Closer to the sandy beach areas (between TZ and PB, Figure 11) *Borrchia frutens* (seaside oxeye) and *Juncus roemerianus* (black needlerush) were observed. Where the ground became more solid, there were

more established plants such as the seaside oxeye and seaside goldenrod (*Solidago sempervirens*). The mats of dead plant washed up on the shore making up the wrack line were primarily black needlerush and smooth cordgrass.

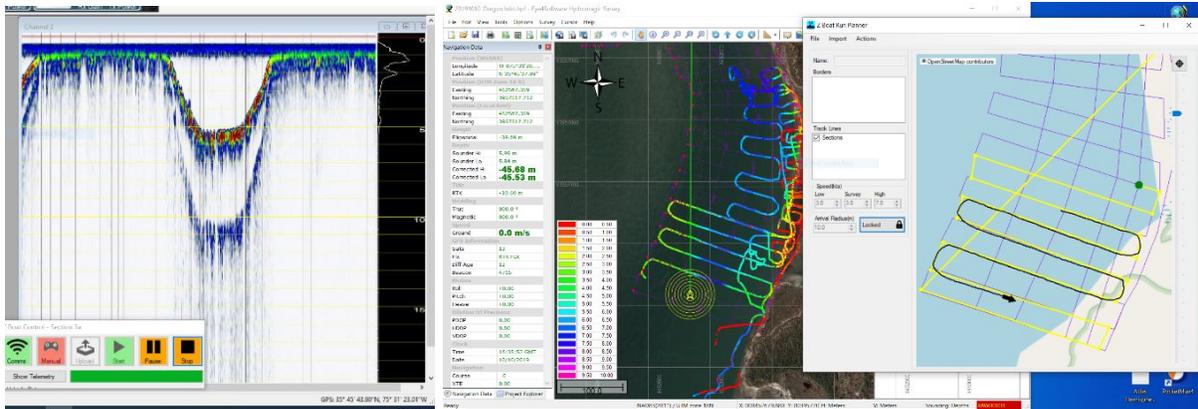
Figure 12. Screenshots from z-boat bathymetry collection showing raw data of the flood channel bathymetry, z-boat actual track (during the first hours of collection), and z-boat planned track .

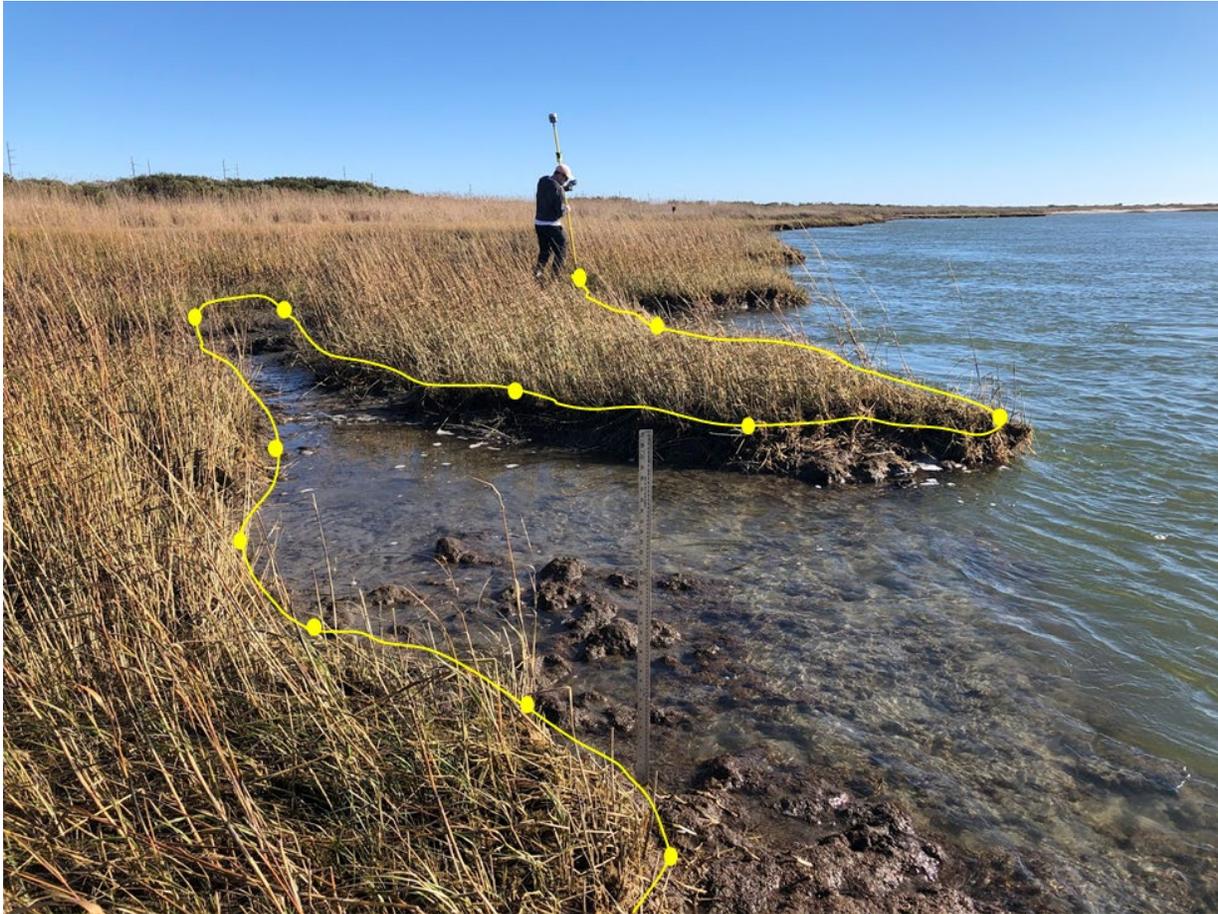
Figure 1. Marsh edge survey in progress, November 25, 2019. Points were surveyed via GPS at approximately 2 m to 25 m spacing, depending on marsh edge morphology.

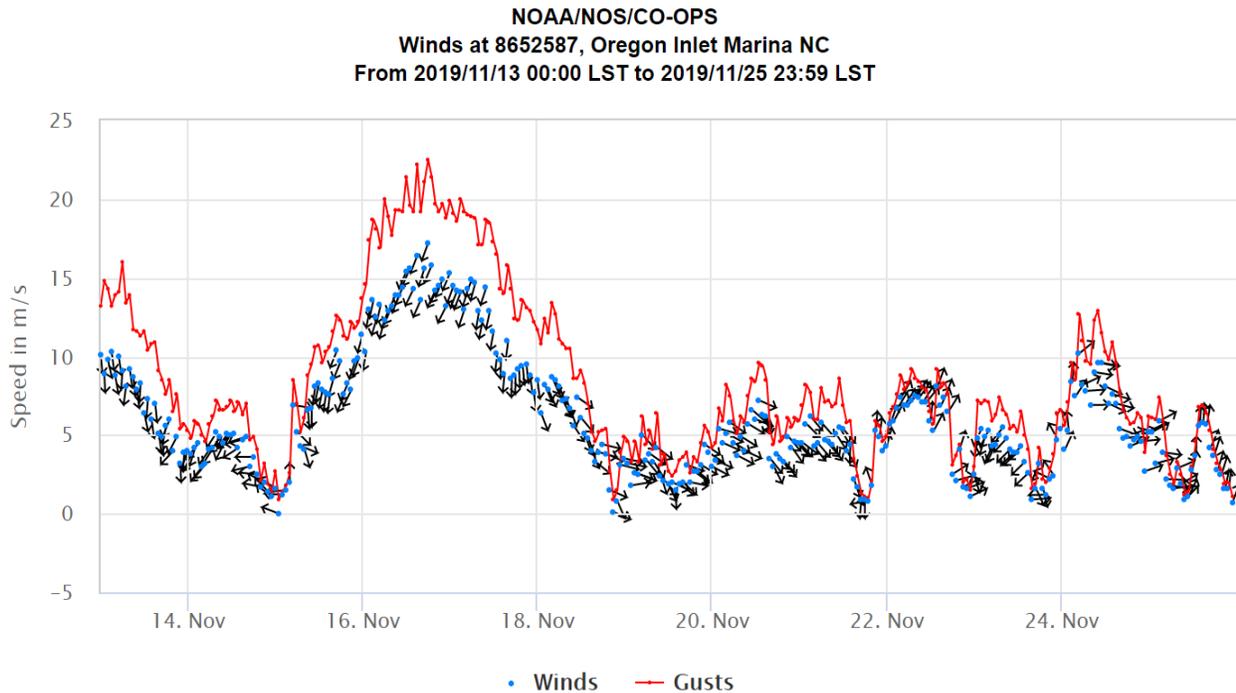
Figure 3. Wind speed, direction, and gust speed measured 2.6 ft. above Mean Sea Level at the Oregon Inlet Marina (NOAA/NOS/CO-OPS 8652587), November 13-25, 2019.

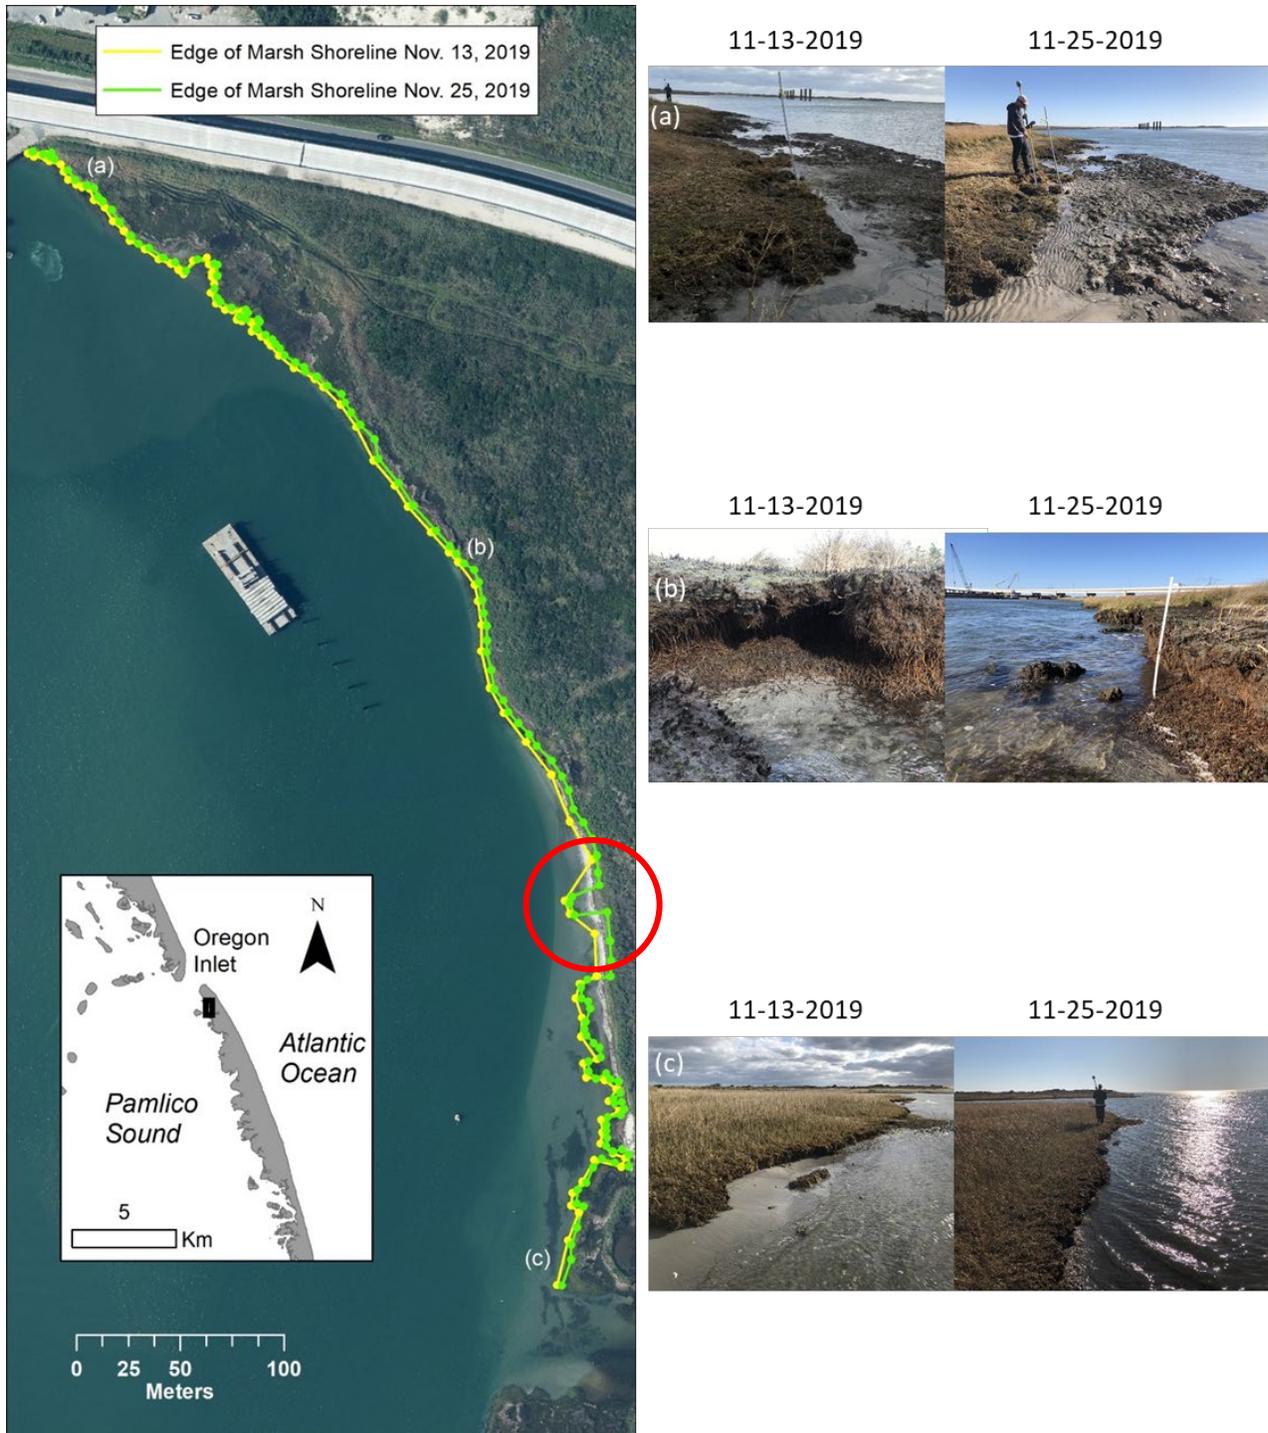
Figure 4. Edge of marsh shoreline survey data (points), November 13 and 25, 2019, shown with background image from August 29, 2019 (NCDOT photo). Lines connecting the surveyed points are also shown. The red circled area was excluded from change analysis due to inconsistent identification of the shoreline in the sandy beach area (in this area on Nov. 13, a wet/dry line in the sand was surveyed, and on Nov. 25, the edge of the marsh vegetation was surveyed). Photos at the indicated areas (a), (b), and (c) are shown at right.

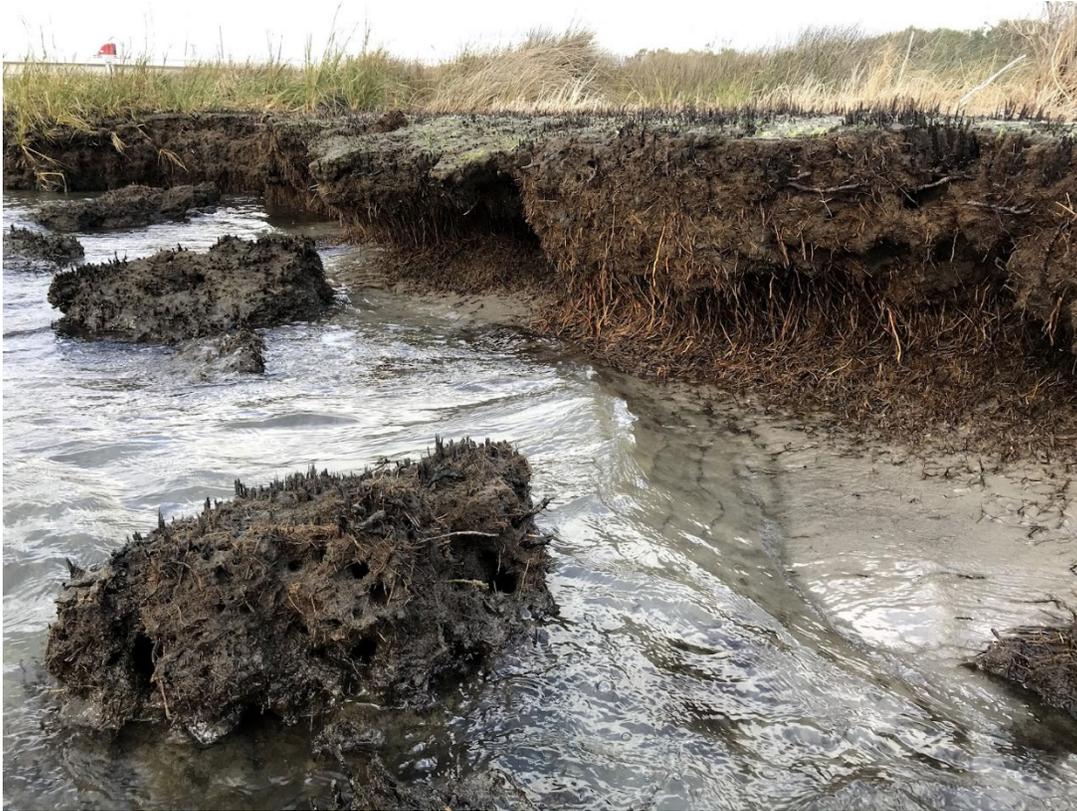
Figure 5. Ongoing marsh erosion observed on November 13, 2019 at location (b) in Fig. 4. Marsh failure is occurring via undercutting and cracking of the marsh platform which then breaks off and falls into the water.

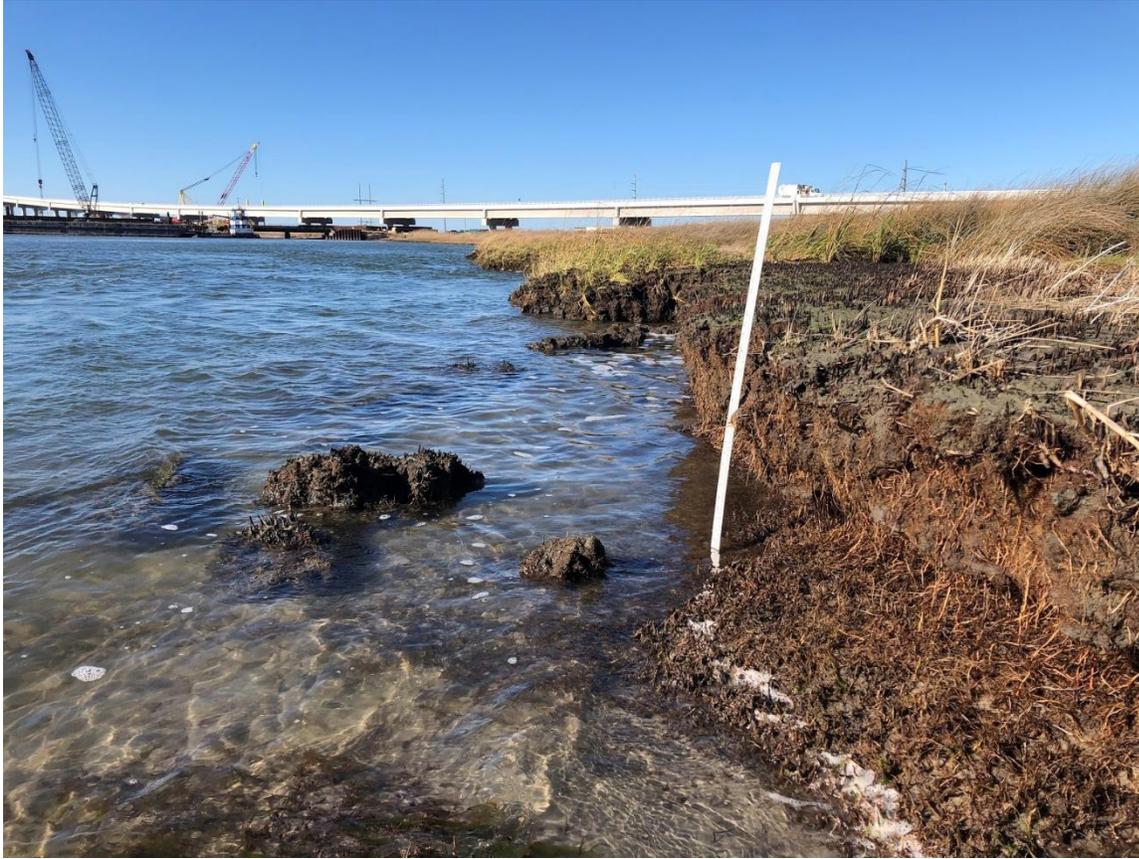
Figure 6. Series of escarpments observed on November 23, 2019 near the location shown in Figure 5. In this location the marsh edge retreated nearly 3 m between the two surveys.

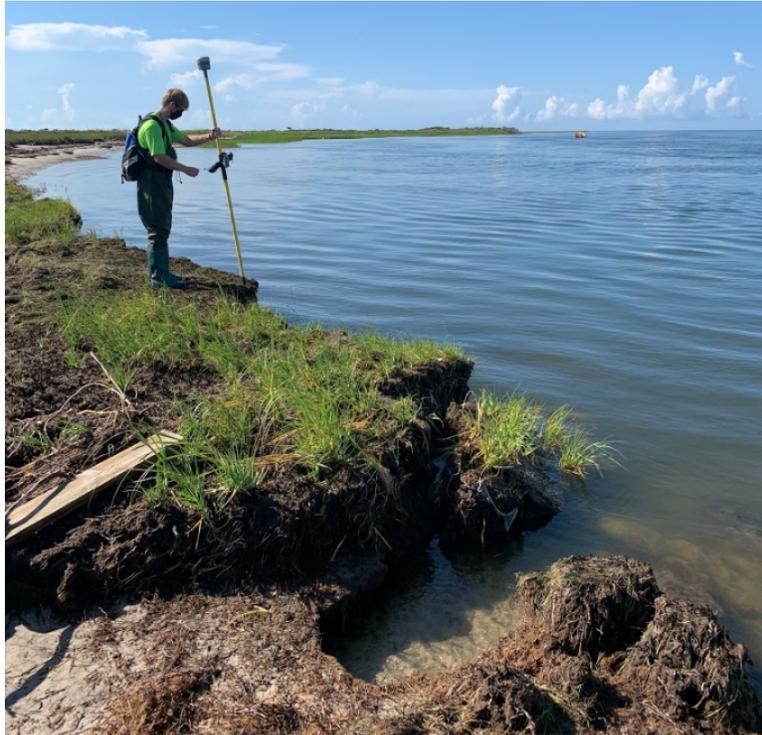
*Erosion following Hurricane Isaias (August 2020)*

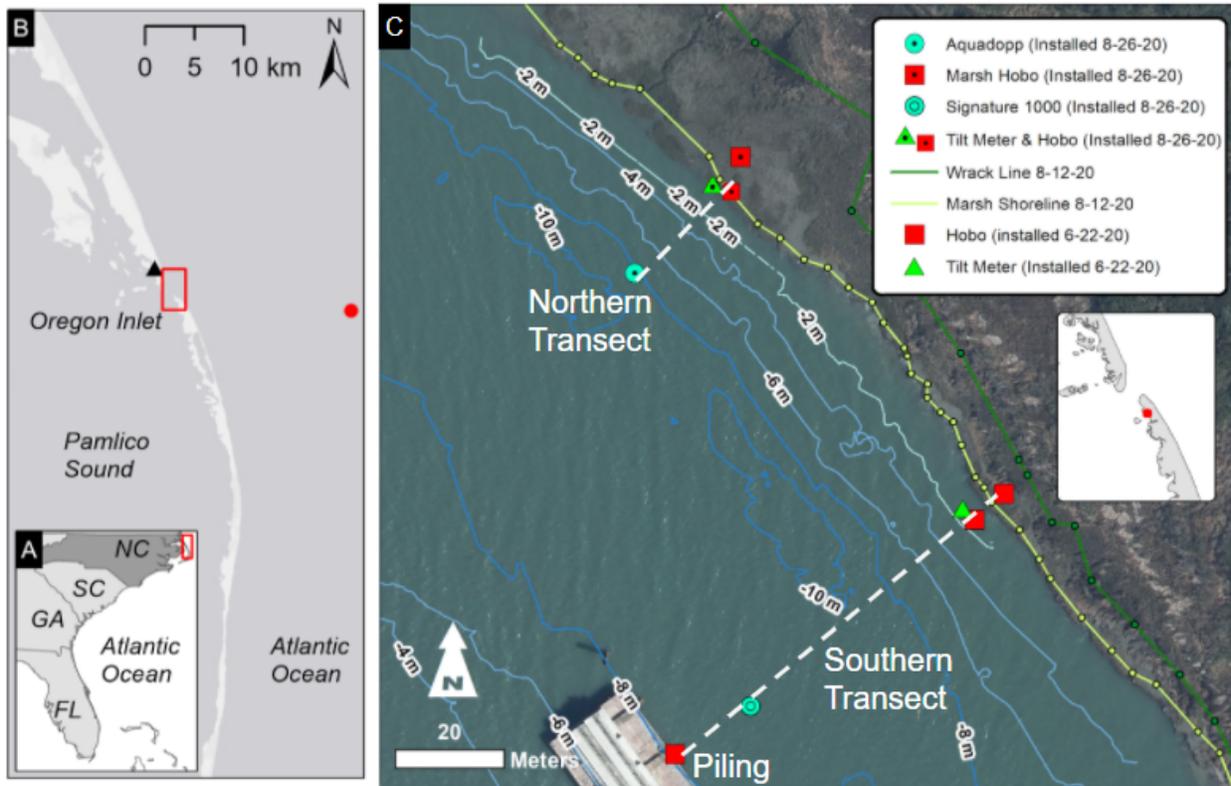
Figure 1. A: USA Southeast coast. B: Northern Outer Banks of North Carolina and nearby tidal gage and meteorological station (black triangle) and waverider buoy (red circle); C: Study site with deployed gages in red and green symbols.

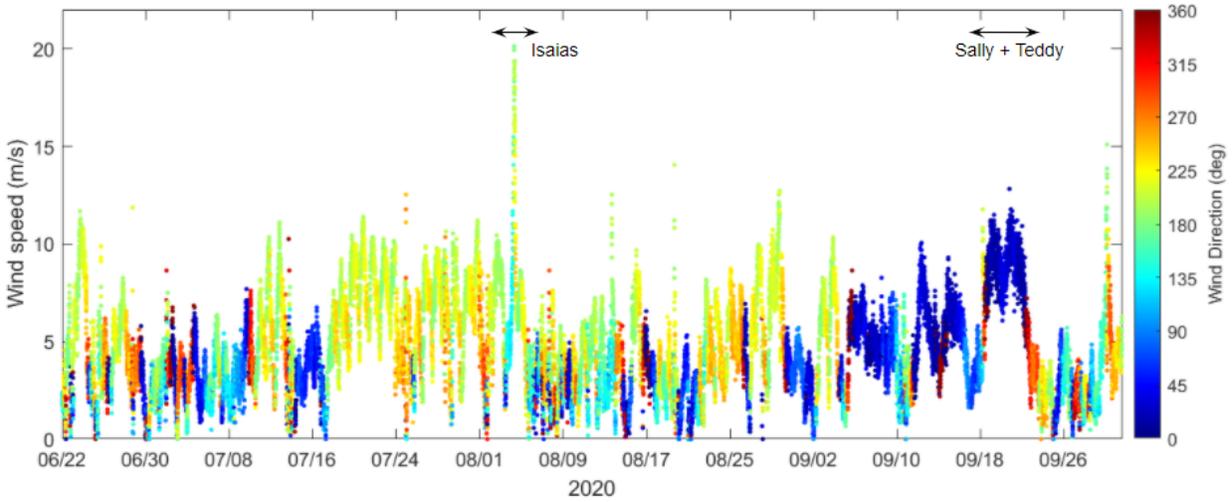
Figure 2. Wind speed corrected to 10 m above sea level (y-axis) and wind direction (symbol color) versus time. Hurricanes Isaias, Sally, and Teddy are noted with the black arrows.

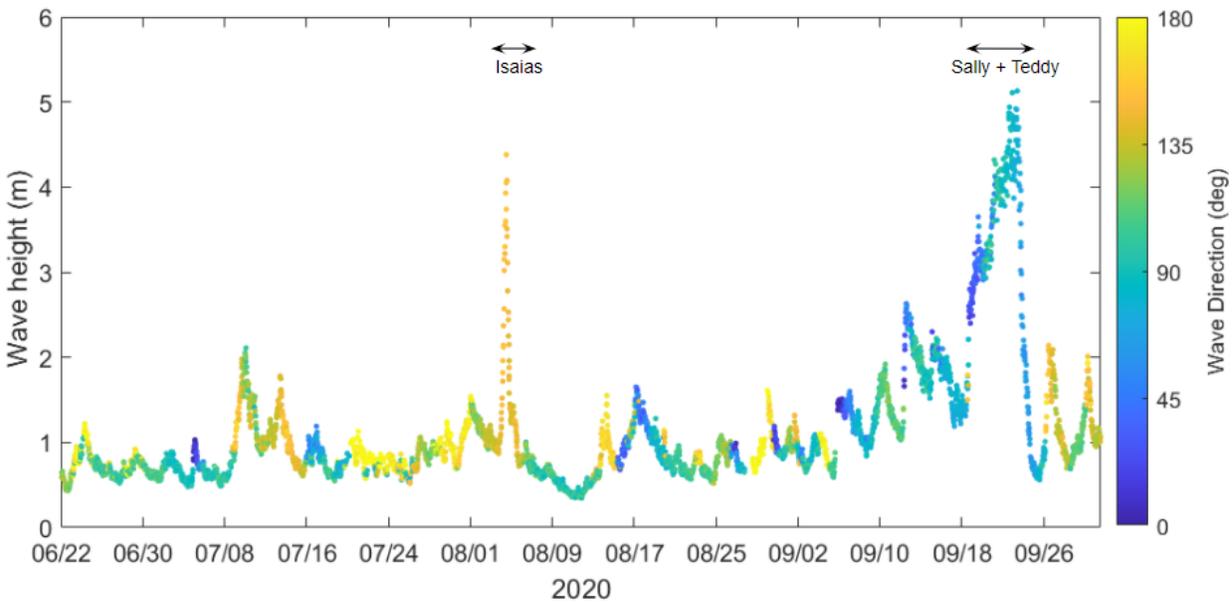
Figure 3. Ocean wave heights (y-axis) and wave direction (symbol color) versus time. Hurricanes Isaias, Sally, and Teddy are noted with the black arrows.

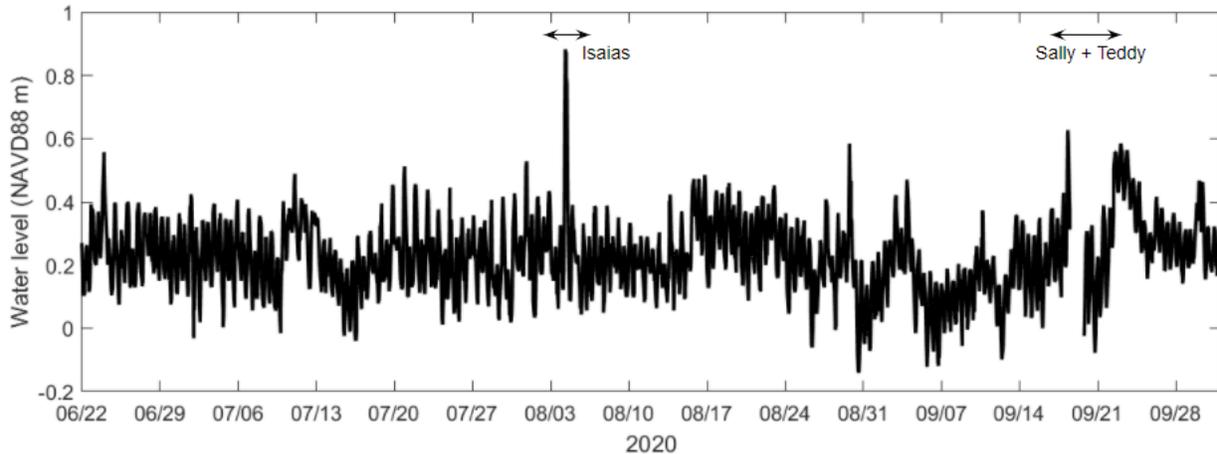
Figure 4. Water levels relative to NAVD88 at the Oregon Inlet Marina station vs. time.

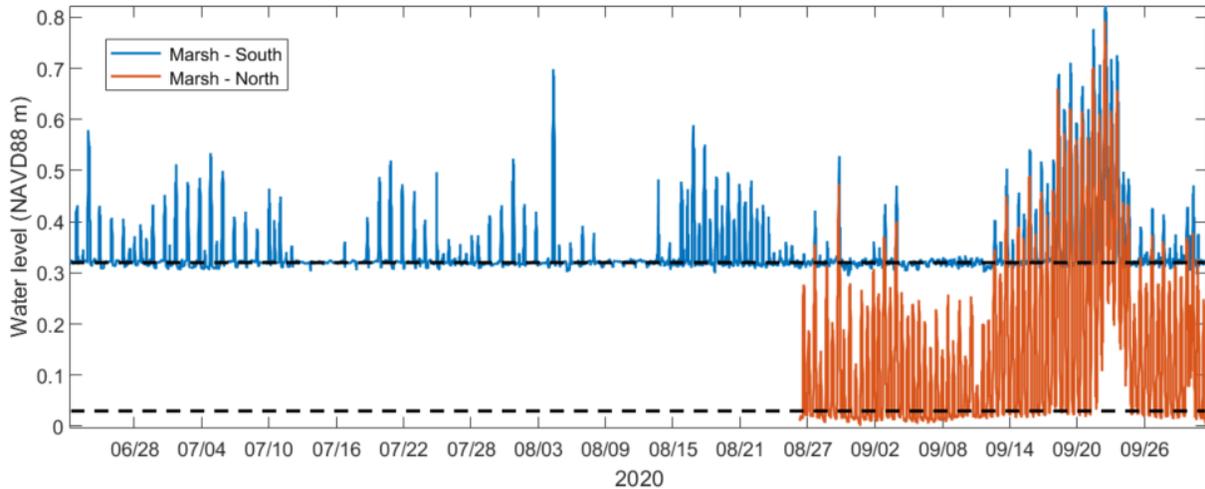
Figure 5. Time series of water level in the southern marsh (blue curve) and northern marsh (red curve) relative to NAVD88. Dashed black lines indicate the topographic elevations of the gages relative to NAVD88.

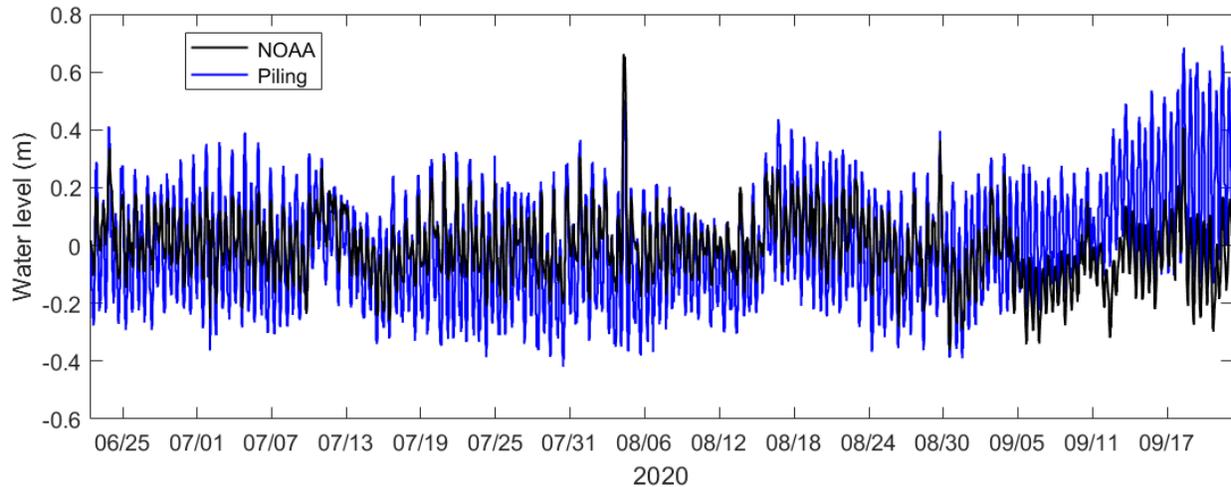
Figure 6. Mean-subtracted water level at the marina (black curve) and the piling (blue curve) vs. time.

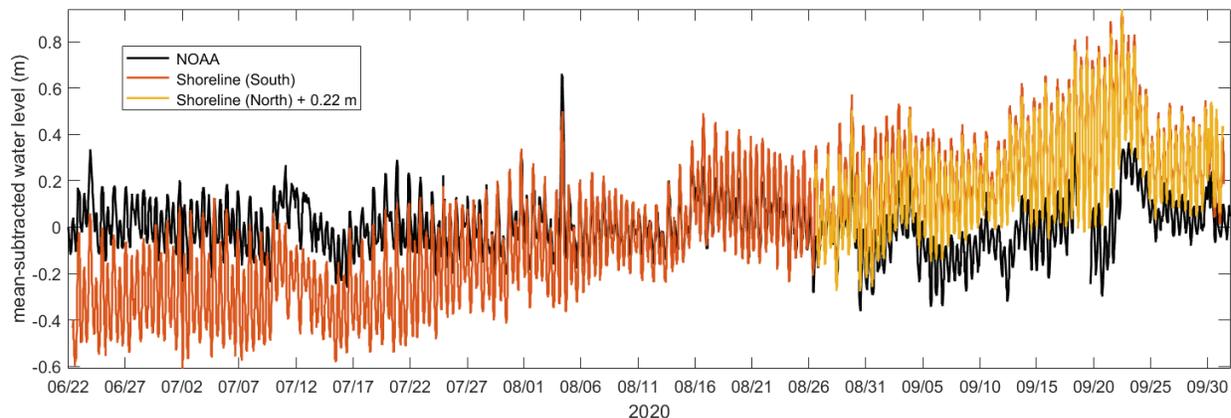
Figure 7. Mean-subtracted water levels at the Oregon Inlet marina (black curve), the southern shoreline transect (red curve), and the northern shoreline transect (yellow curve) vs. time. A constant value of 0.22 m was also added to the northern shoreline transect (yellow curve) in order to roughly align the water levels with those at the southern transect.

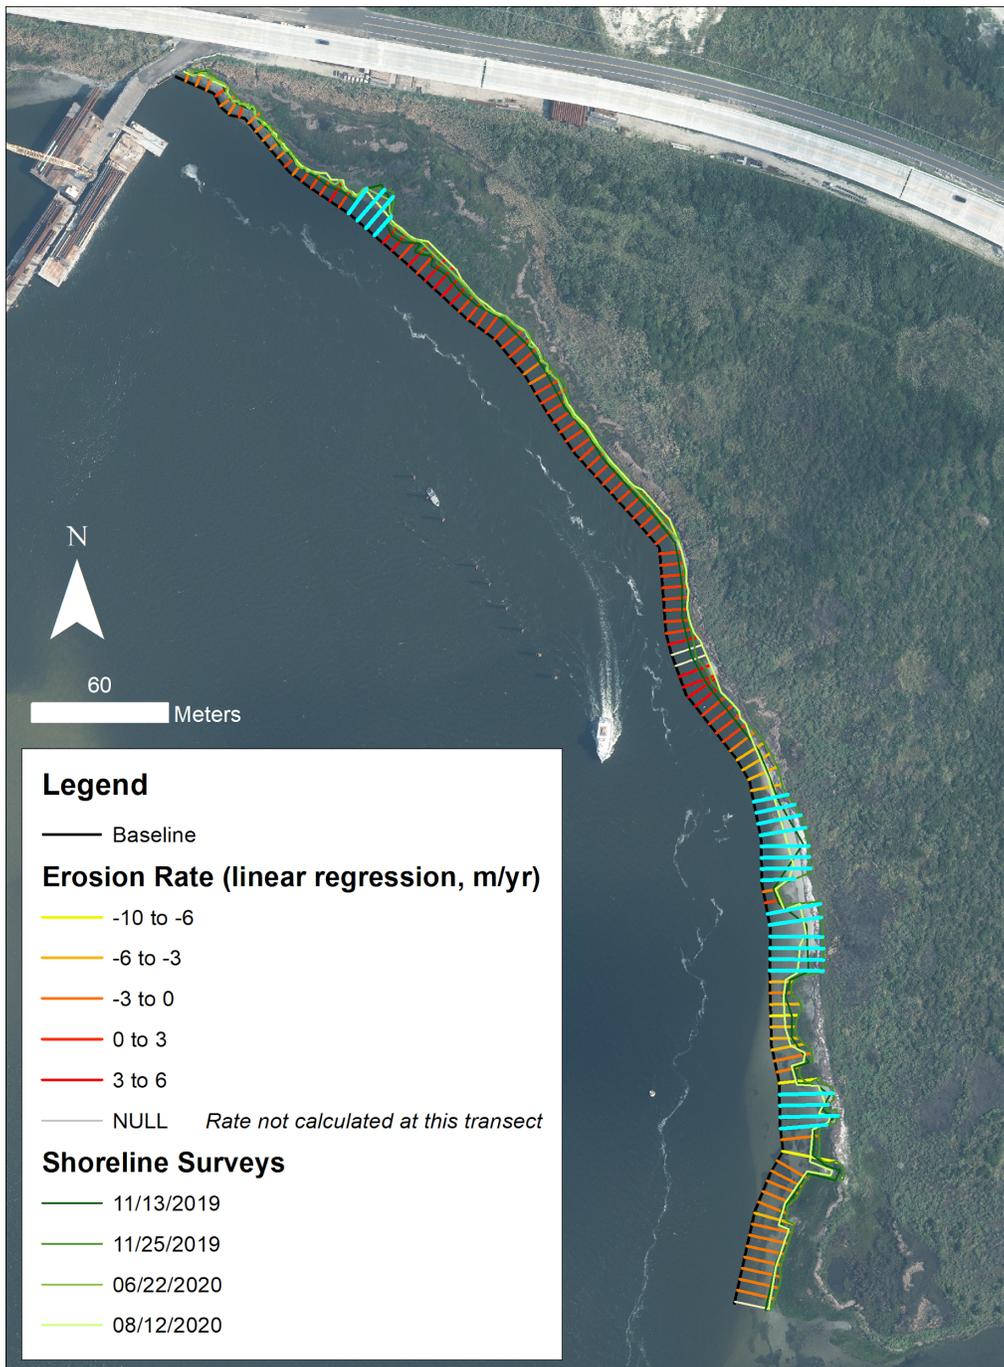
Figure 12. Baseline and transects used to compare all marsh shoreline surveys to date. The areas shown in teal were excluded from analysis due to inconsistent identification of the marsh shoreline feature among surveys.

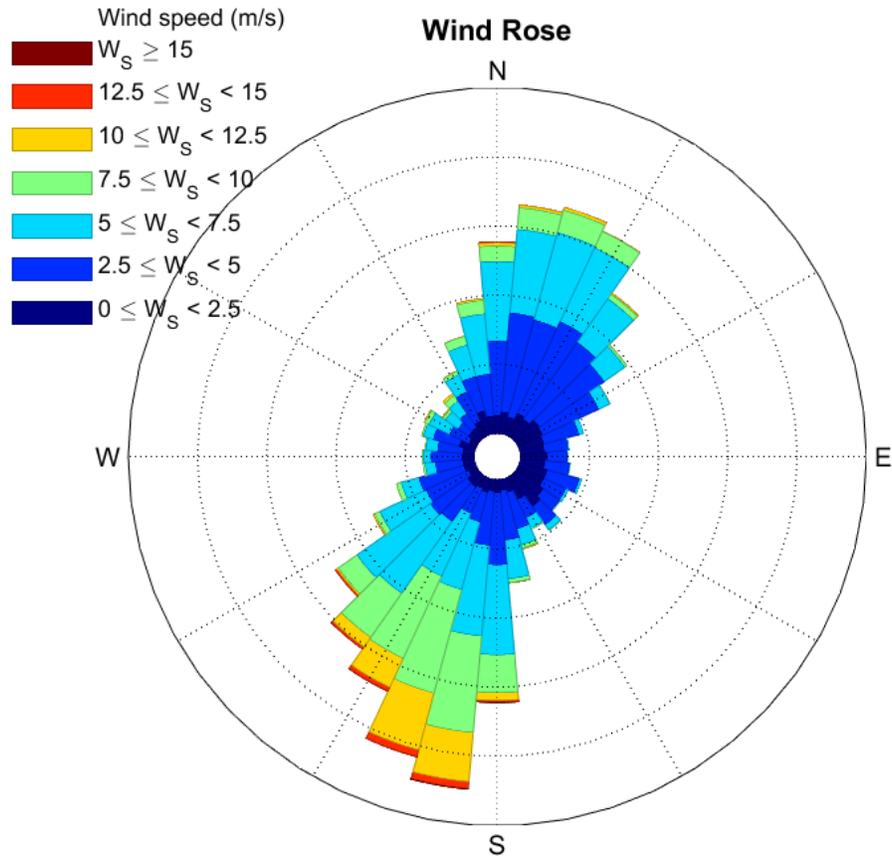
Figure 1. Histogram of wind speeds binned by speed (color contours) and direction (radial position of bin) during the time of the 2021 Pea Island deployments. Wind directions were dominantly out of the NNE and SSW.

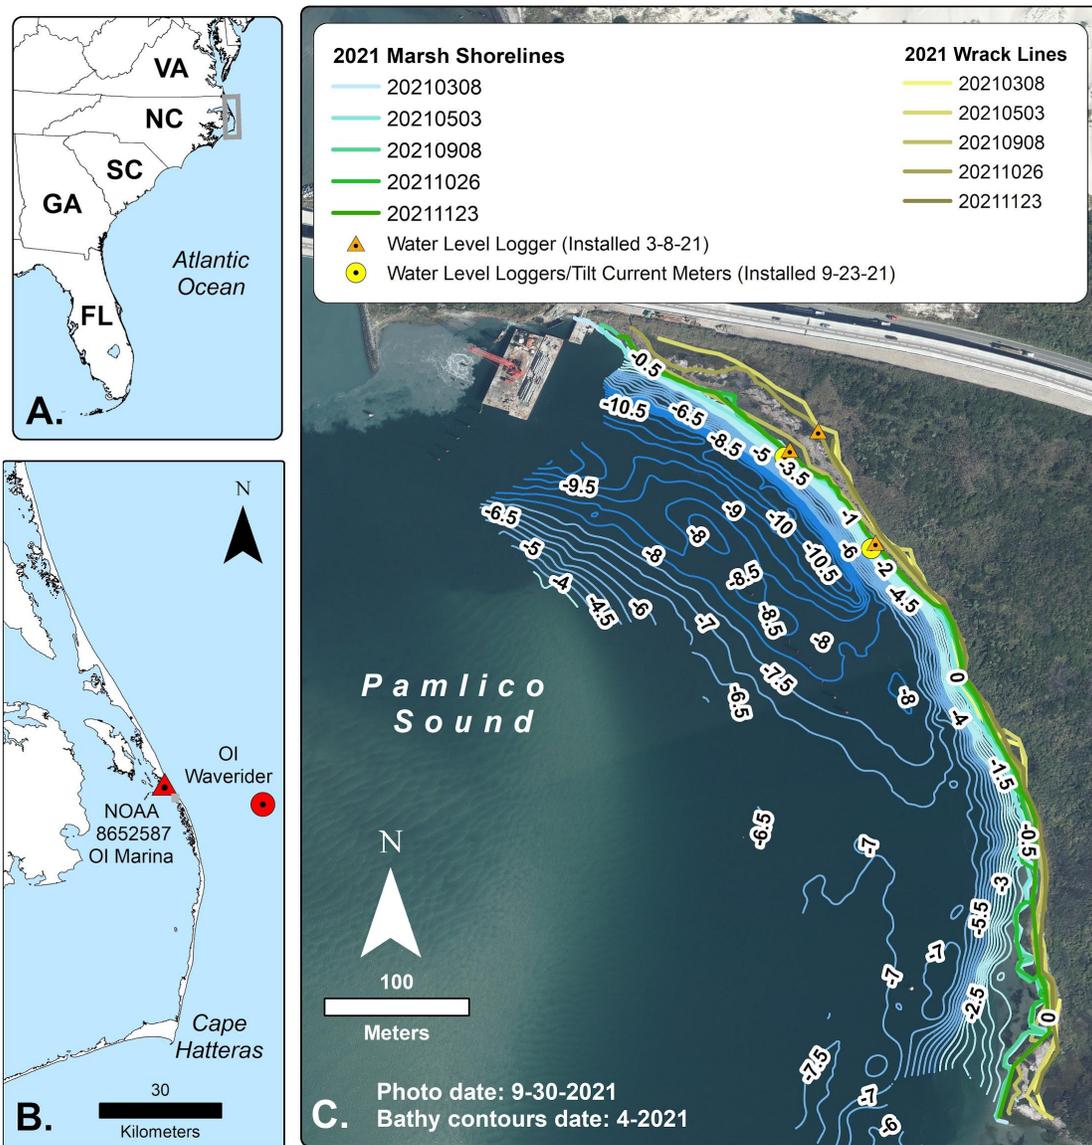
**Figure 5. Map showing locations of permanent and deployed stationary gauges along with 2021 marsh shoreline, wrack line, and bathymetry survey data.**

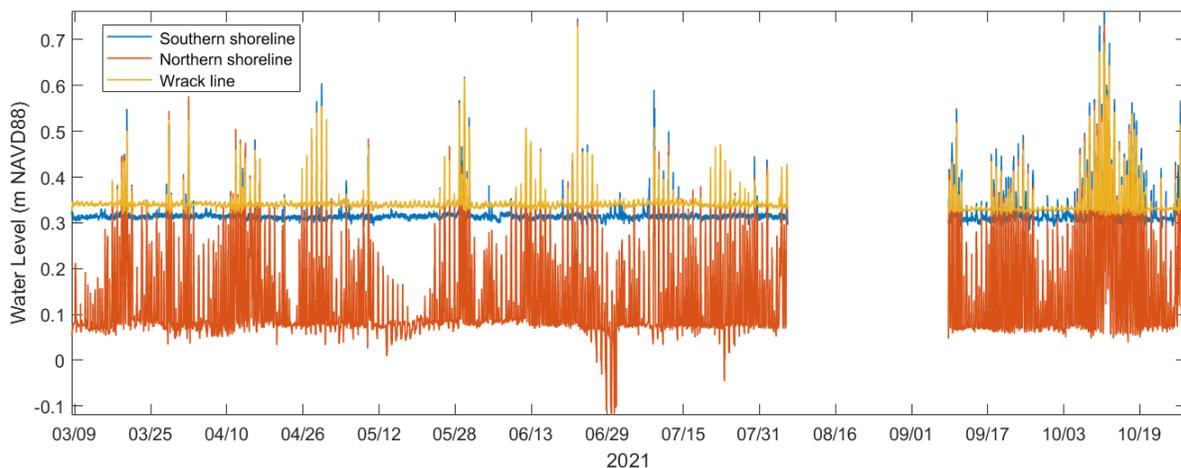
**Figure 6. Water level (meters, NAVD88) corrected for atmospheric fluctuations versus time at the southern shoreline gauge (blue curve), northern shoreline gauge (red curve), and the wrack line curve (yellow curve). To convert pressure to time, a time-varying density assuming a salinity of 23 psu was calculated. This density varied between 1007.2 to 1018.4 kg/m<sup>3</sup>.**

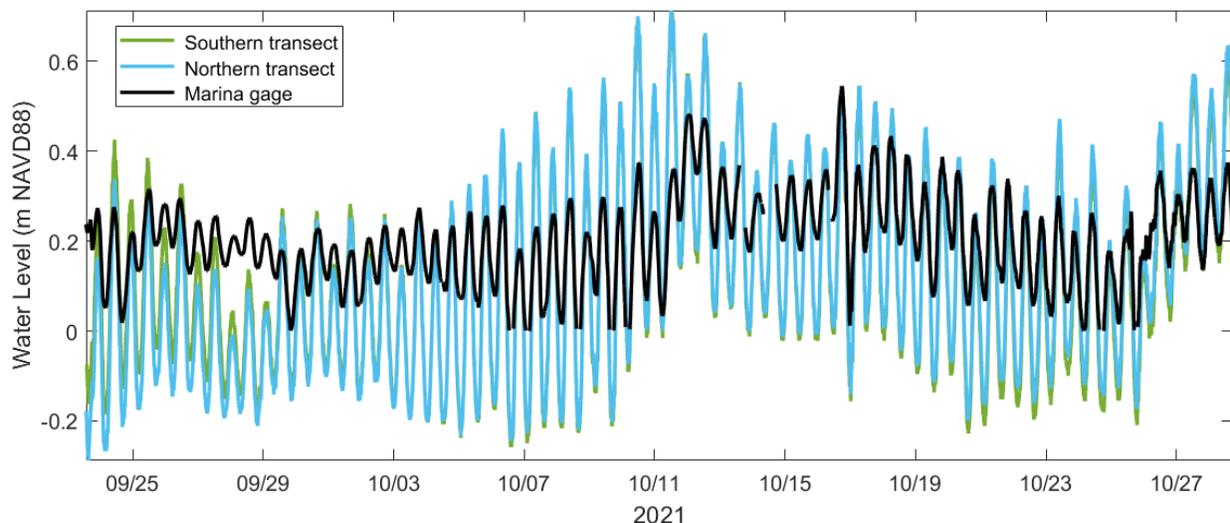
**Figure 7. Water level (meters, NAVD88) at the southern (green curve) and northern transect (blue curve) and at the NOAA tidal gauge (black curve) versus time.**

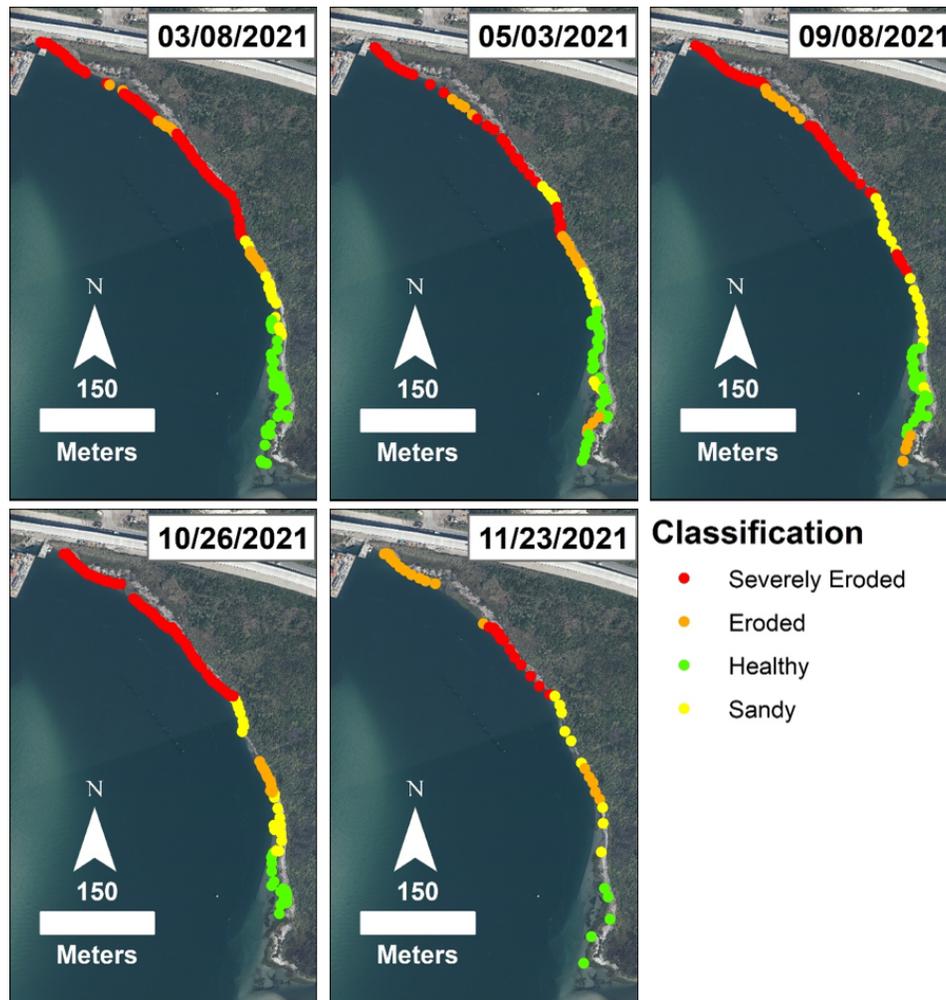
**Figure 8. Shoreline classifications for each of the 2021 marsh shoreline surveys. Due to high water levels some areas were not accessible during the November 23, 2021 survey date, reflected by data gaps. The majority of the northern half of the study area was classified as either eroded or severely eroded for all survey dates. The background image is from September 30, 2021, provided by NCDOT.**

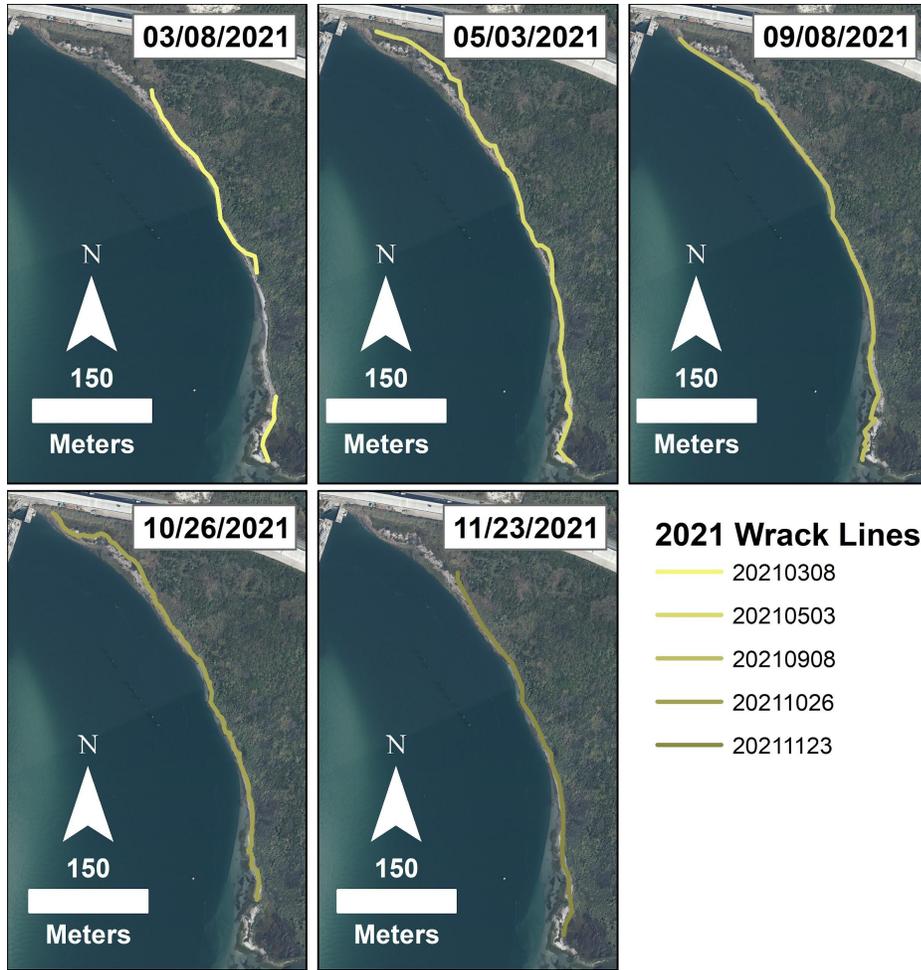
Figure 9. Wrack lines surveyed during 2021. The furthest landward wrack lines were observed in May and October 2021.

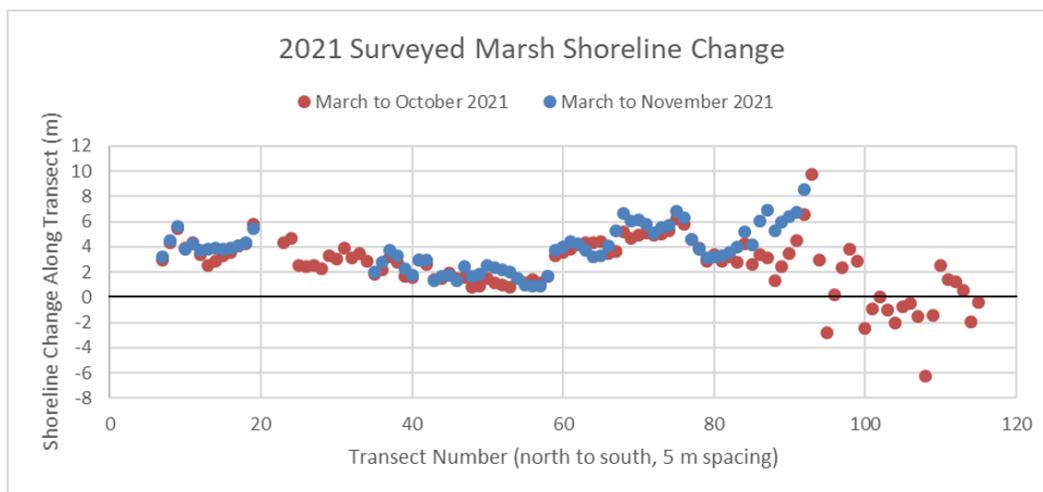
Figure 10. Overall surveyed marsh shoreline changes in 2021. Positive values indicate erosion, and negative values indicate accretion.

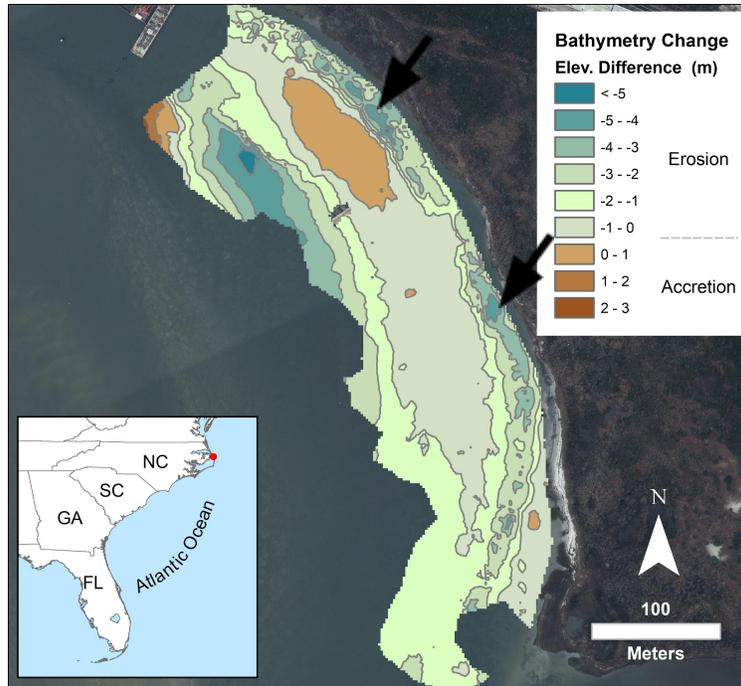
Figure 11. Bathymetry change from October 10, 2019 to April 20, 2021 in meters. Warmer colors indicate accretion and cooler colors indicate deepening. NCDOT image February 6, 2021.

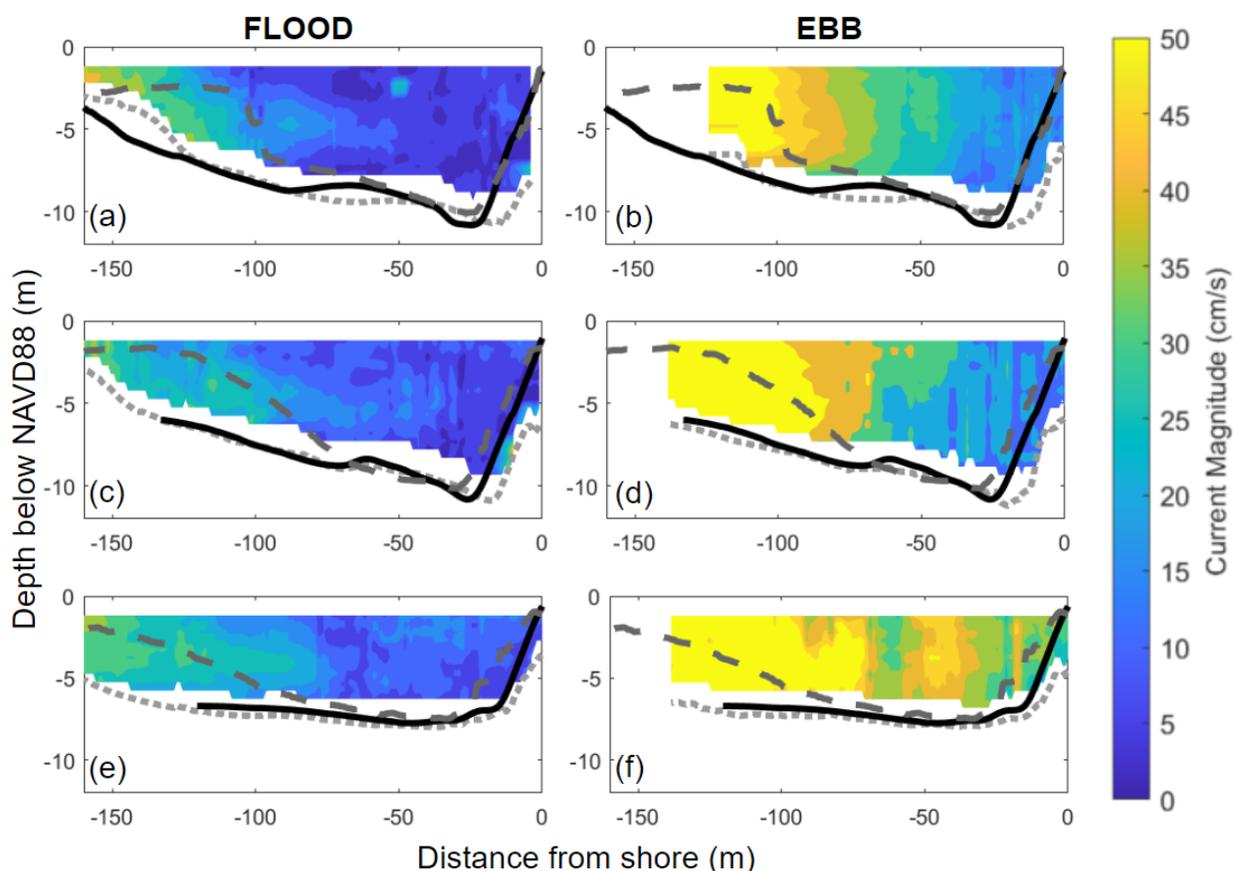
**Figure 13. Current magnitude (color contours) during flood (a, c, e) and ebb (b, d, f) as a function of depth below NAVD88 versus distance from shore at Transect 1 (a, b), Transect 2 (c, d), and Transect 3 (e, f). The solid black line and dashed dark gray line are the transect bathymetry relative to NAVD88 on April 2021 and October 2019, respectively. The dotted light gray line is the approximate bathymetry relative to NAVD88 during the current transects in October 2021.**
