RP# 2020-09

# FINAL REPORT

## Monitoring and Modeling Sound-Side Erosion near Oregon Inlet to Support Feasibility Level Transportation Planning

AUGUST 2022

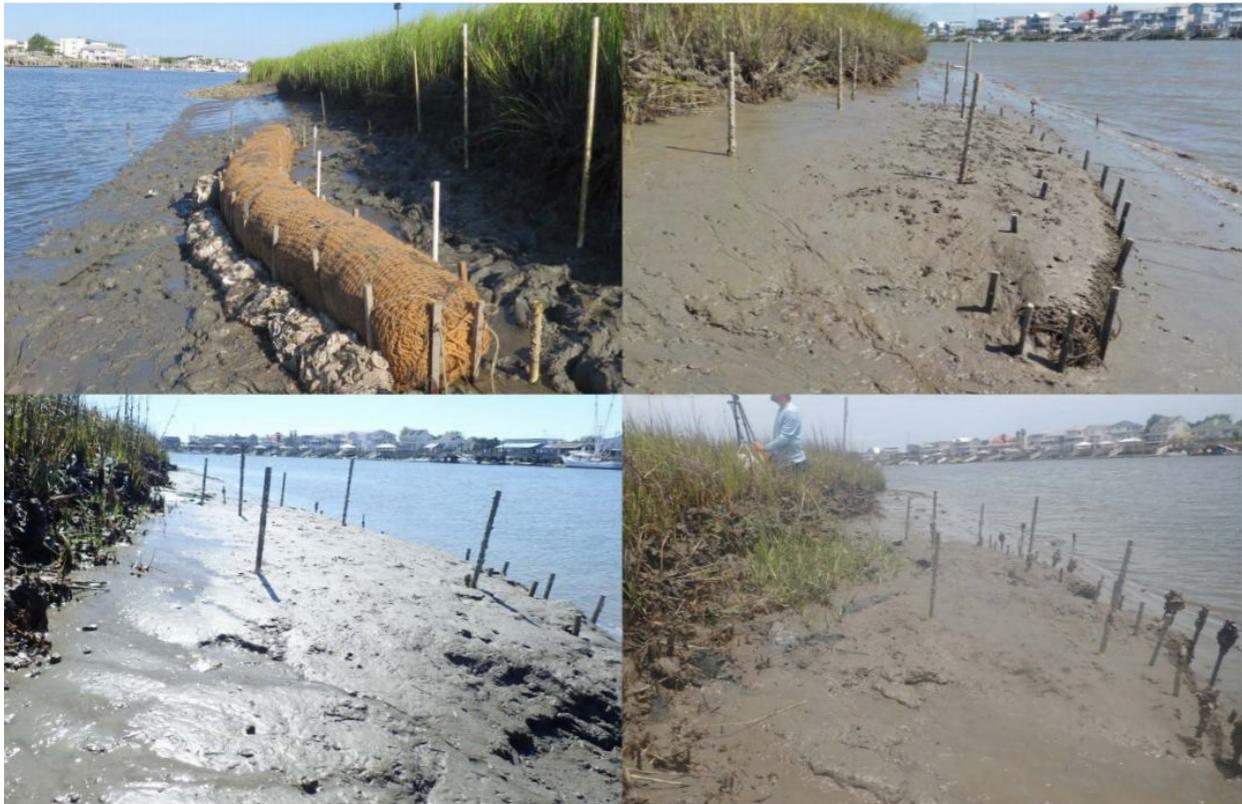
**Figure 3.16.** A single-row coir log treatment at Big Bay Creek (Figure 3.4) in July 2016 (upper left), October 2017 (upper right), September 2018 (lower left), and May 2019 (lower right).

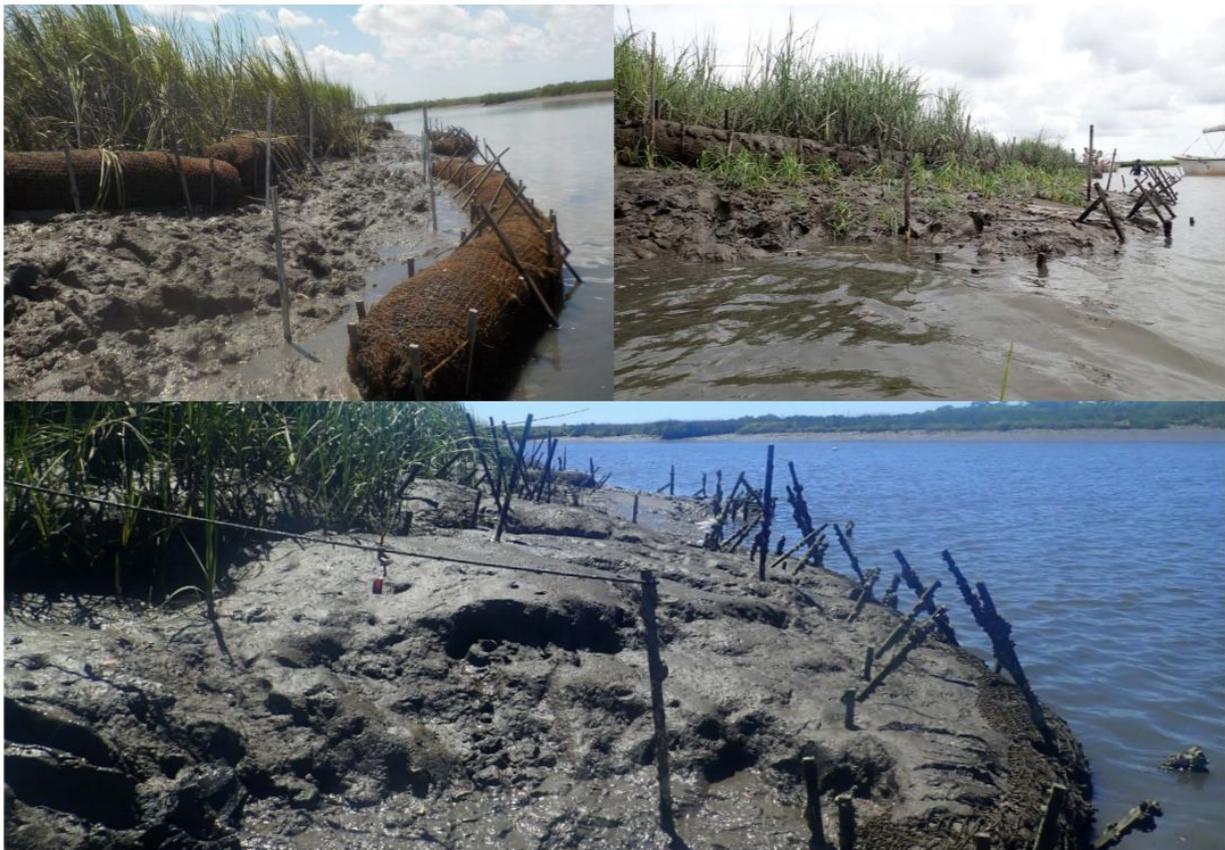
**Figure 3.17.** Double-row coir log treatment at Orangegrove Creek in August 2017 (upper left), May 2018 (upper right), and April 2019 (lower). The upper left coir log went missing at some point between August 2018 and April 2019.

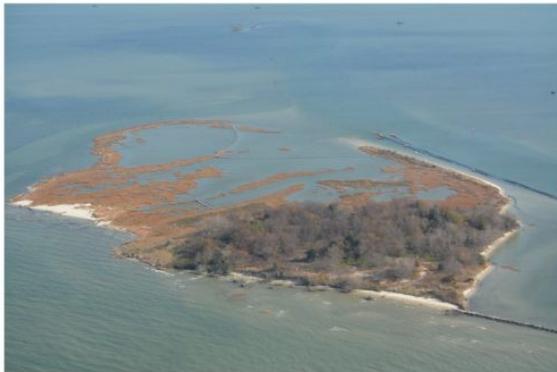
Swan Island before dredge application and planting, 2017. Credit: U.S. Army Corps of Engineers.

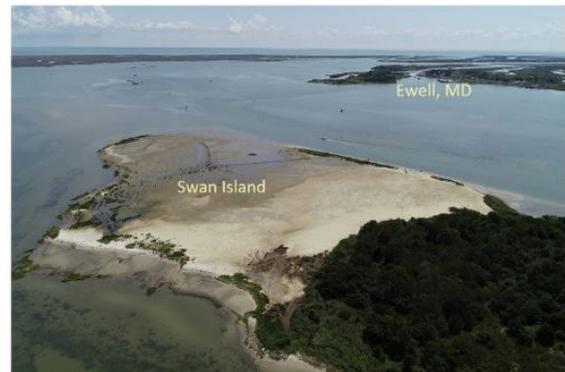
Swan Island after dredge application and planting, 2019. Credit: NOAA's National Centers for Coastal Ocean Science.

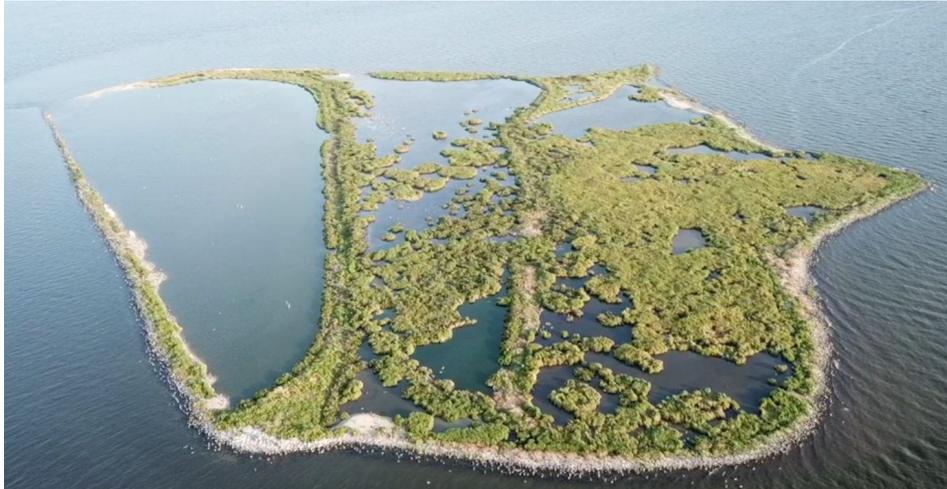
Pre-construction (2019) <https://coastal.la.gov/news/queen-bess/>

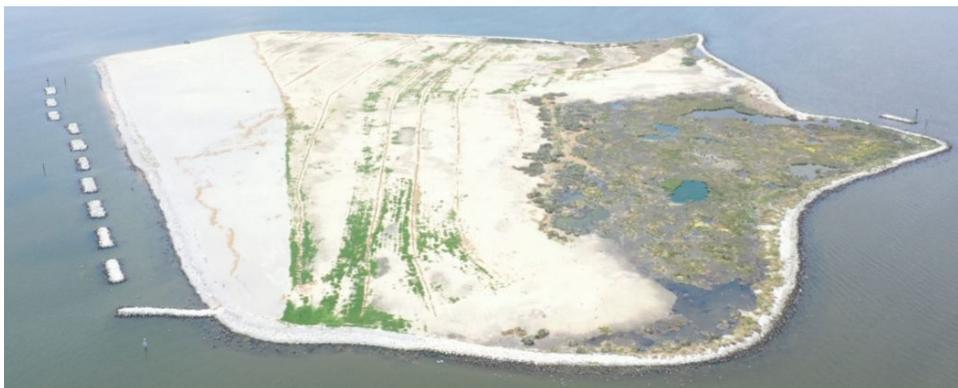
Post-construction (2020) <https://coastal.la.gov/news/queen-bess/>

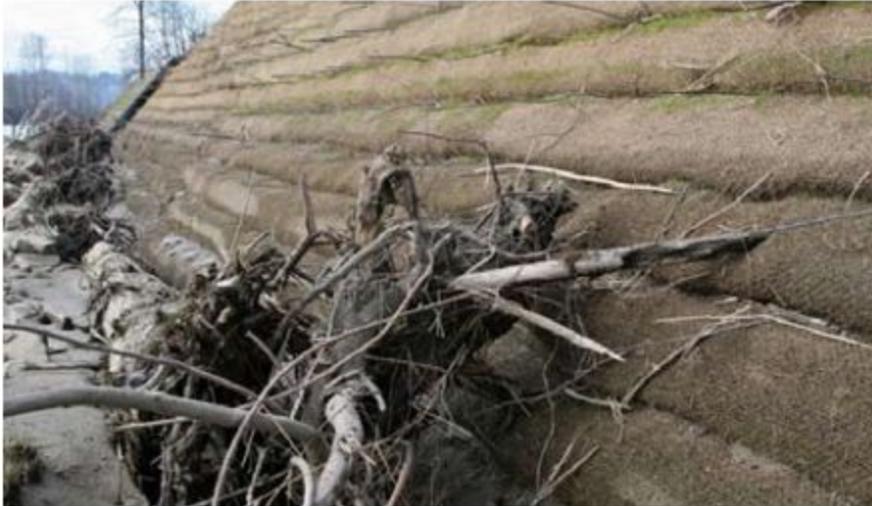
**Image 1:**

**Description:** Bank stabilization project to protect Riverview Road. A structural earth wall made of multiple soil wraps, was built in a step-like geometry starting from the river waterline until the top of the embankment. Each layer is created by a 13-foot wide roll of polypropylene or polyethylene geo-grid fabric filled with compacted gravel. The outer face of the wall was covered with coir fabric and topsoil and all the embankment was planted with vegetation.

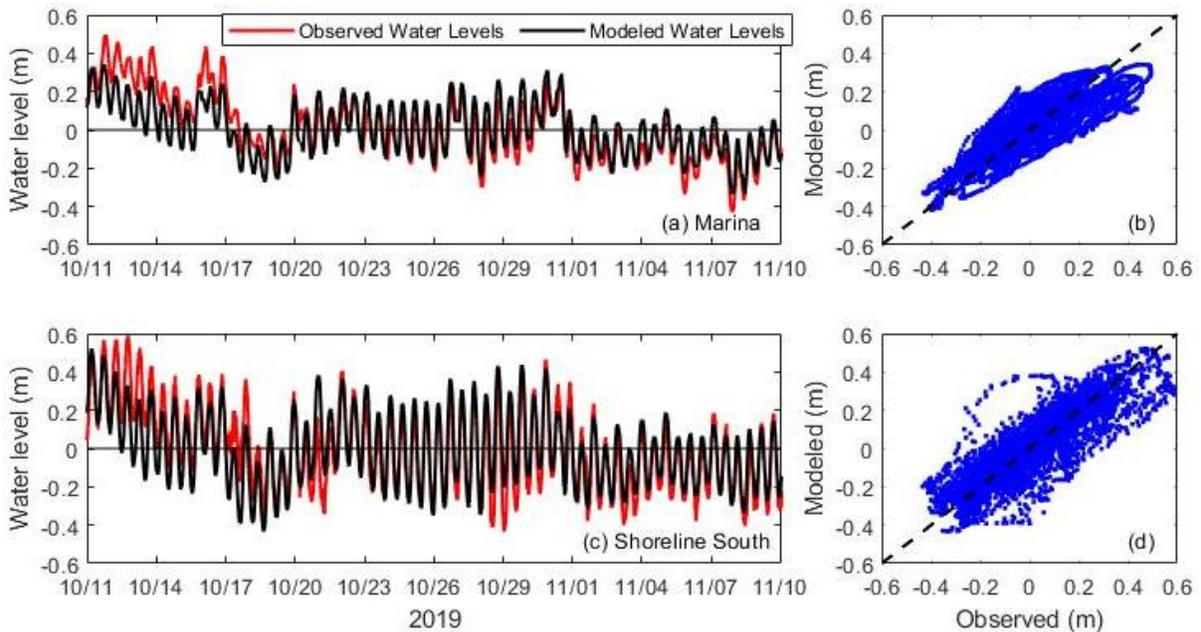
378  
 379 Figure 4. (a, c) Mean-subtracted observed (red curves) and modeled (black curves) water levels versus  
 380 time and (b, d) modeled versus observed mean-subtracted water levels at the (a, b) Marina and at the (b,  
 381 d) Shoreline South. The black dashed line in (b, d) indicates the 1:1 line.

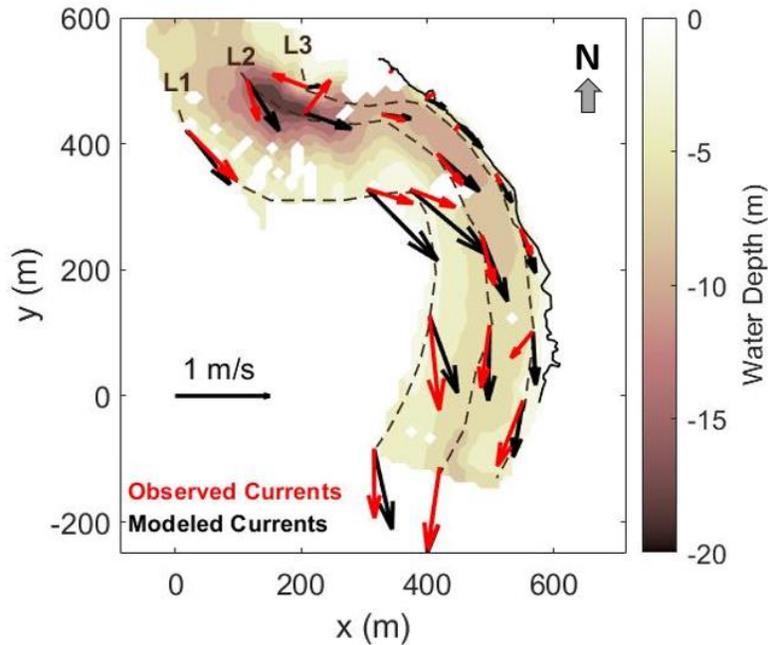
403  
 404 Figure 5. Observed depth-averaged and horizontally-averaged currents (red arrows) and modeled depth-  
 405 averaged currents (black arrows) overlaid on measured water depth (color contours) during the 2019 field  
 406 survey. The reference point (0,0) for the x-y coordinate system is 35°45'41.20"N and 75°31'44.98" W. The  
 407 black arrow at (0,0) is a 1 m/s reference. The black curve on the right hand side of the color contours  
 408 indicates the location of the shoreline edge in November 2019. The dashed brown curves indicate transects  
 409 L1, L2 and L3 (as shown in Figure 2).
