# Load Testing a Temporary Railcar Bridge over Bee Tree Creek in Swannanoa, NC

**NCDOT Project TA2025-13**  
**FHWA/NC/2025-13**  
**May 12, 2026**

**Condition and Behavior of Temporary Railcar Bridges:  
Load Testing a Temporary Railcar Bridge over  
Bee Tree Creek in Swannanoa, NC**

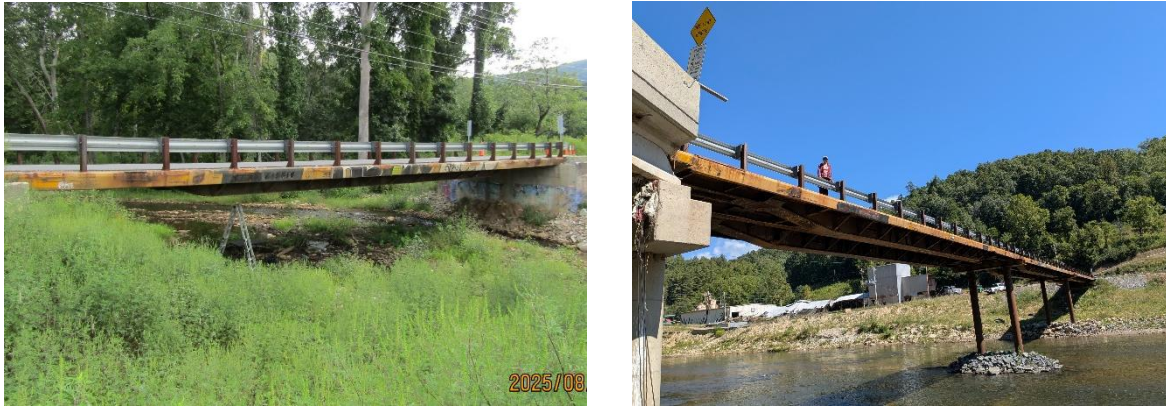
Figure 1. Temporary RRFC bridges in WNC in Swannanoa (left) and near Burnsville (right)

Examples of RRFC bridges in each of those states are reproduced in Figure 2 through Figure 4 below. In reviewing photographs of RRFC bridges in other states, it is important to note how different these bridges are from the RRFCs currently in service in WNC. Prior works on RRFCs, including rating methods, envision RRFC bridges much more similar to examples in the following photos than to the examples in WNC shown in Figure 1.

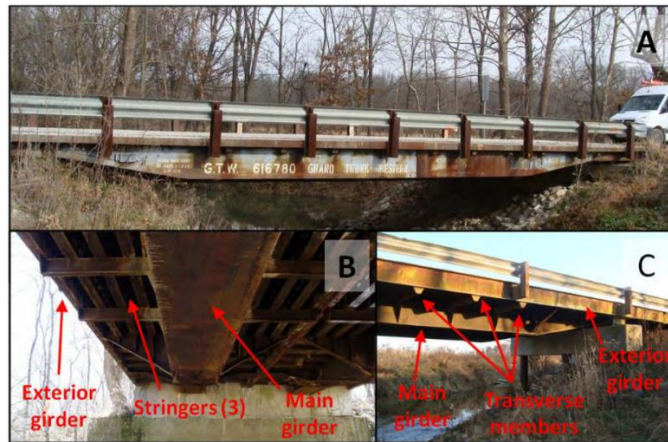
Figure 2. Permanent RRFC Bridge in Indiana Supported at Original Truck Supports (from TR-2-2013)

Note how the cross-section differs from the temporary WNC bridges.

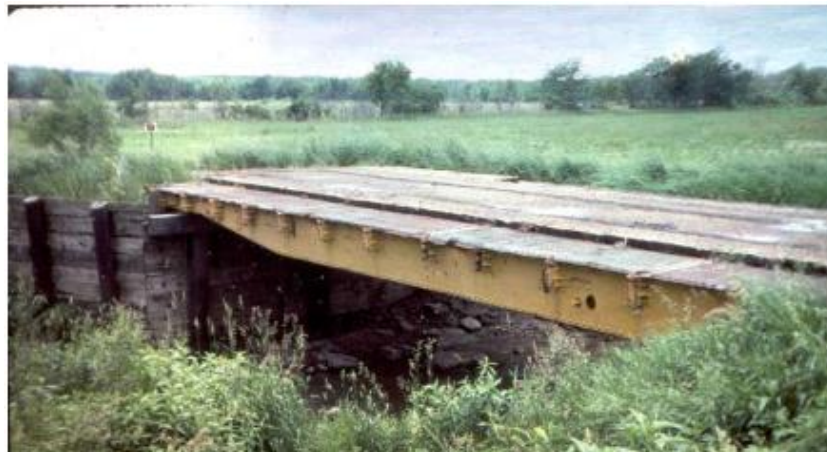
Figure 3. Permanent RRFC Bridge with a Short Span, Timber Deck, and no Railings on an Unimproved Road in Iowa (reproduced from TR-421)

Note the short span, inset bearing locations, and different cross section relative to the WNC temporary RRFC bridges.

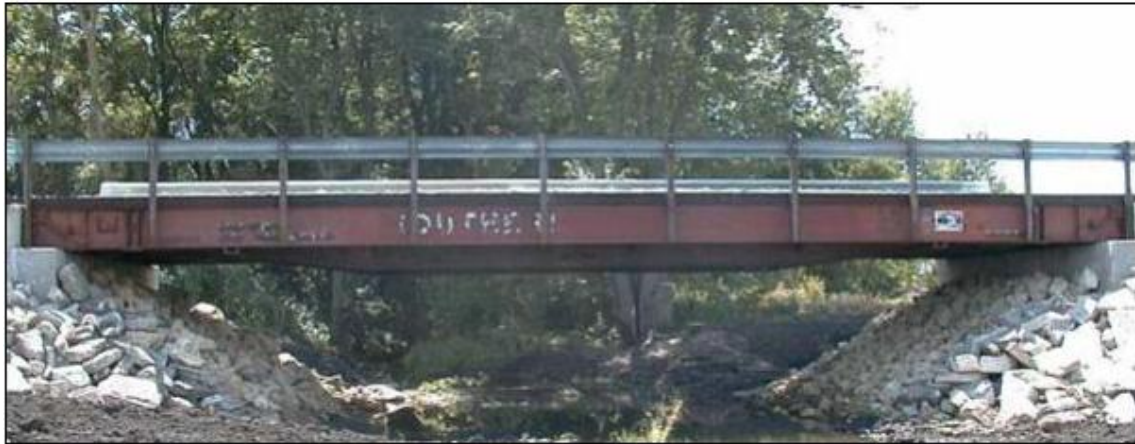
Figure 4. Permanent RRFC Bridge in Iowa Made from a 56' Long V-Deck Flatcar (from TR-498)  
 Note the short span and different cross section relative to the WNC temporary RRFC bridges.

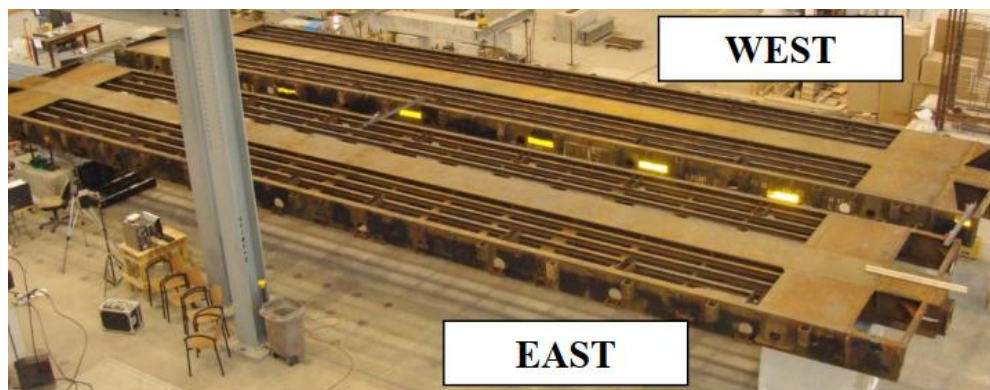
Figure 5. Significant Previous Experiments at Purdue University on Two Adjacent RRFCs, Prior to Adding a Composite Concrete Deck. Reproduced from the 2015 Purdue Phase III Final Report.  
 Note the 47' support span, supports inset at the truck mounts, and lack of an integral deck.

Figure 5 shows an experimental test conducted at Purdue University, reproduced from their 2015 final test report. This laboratory testing represents some of the most detailed and most recent work conducted on RRFC bridges, but considers structures that differ in significant ways from the temporary WNC bridges.

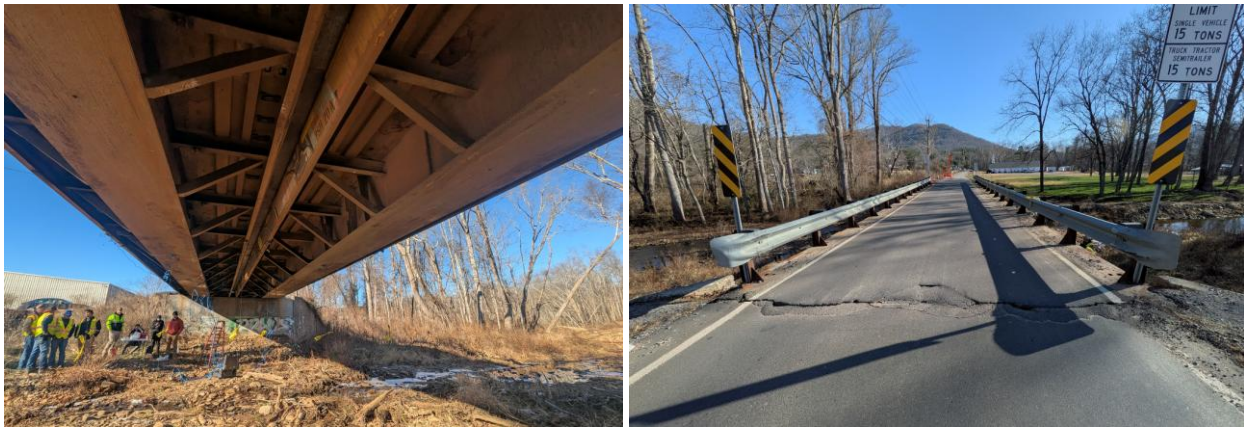
Figure 7. Temporary railcar bridge in Swannanoa, NC (Buncombe #203)

View looking west from below (left); View looking east along Warren Wilson Road (right)

The field-testing program consisted of several load tests of the temporary rail car bridge on Warren Wilson Road in Swannanoa, NC that crosses Bee Tree Creek. This single-lane bridge, shown in Figure 7, consisted of two adjacent railcars spanning 82 feet. Both railcars were supported directly on the original concrete end bents with new concrete filling the original girder pockets. A welded steel jumper plate joined the decks of the two cars with a thin asphalt topping comprising the wearing surface. Steel barrier rails completed the structure which is currently posted at a weight limit of 15 tons. The two flatbed railcars comprising the spanning elements of the structure are identified in this report as the South Car and the North Car based on their positions relative to Warren Wilson Road, which runs generally east-west.

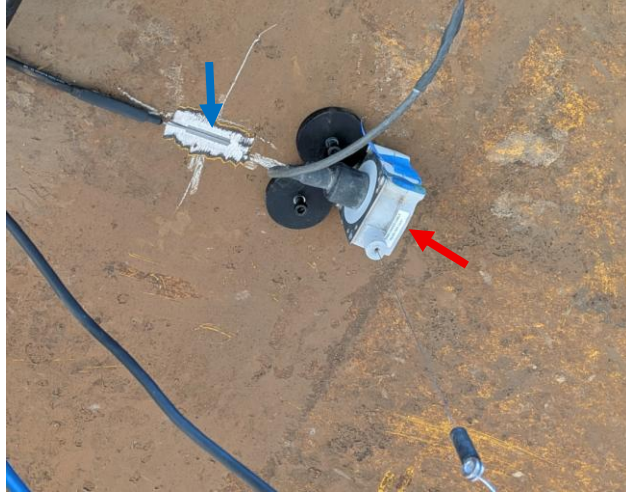
Figure 8. Strain gage (blue arrow) and string potentiometer (red arrow) at a typical measurement location

The bridge was instrumented with string potentiometers to measure the vertical deflection of the structure at selected locations. To determine the displacement profile across the width of the bridge at midspan under different loading conditions, measurements were taken at the center (mid-width) and at each edge of each rail car, for a total of 6 string potentiometers located at the midspan of the bridge. An additional string potentiometer was placed towards the west end of the South Car at the mid-width of this car, where it tapers to a shallower section. Weldable strain gages were installed next to each string potentiometer to measure the longitudinal tensile strain in the extreme fiber at each location of interest. The typical instrumentation and instrumentation layout is shown in Figure 8 through Figure 10.

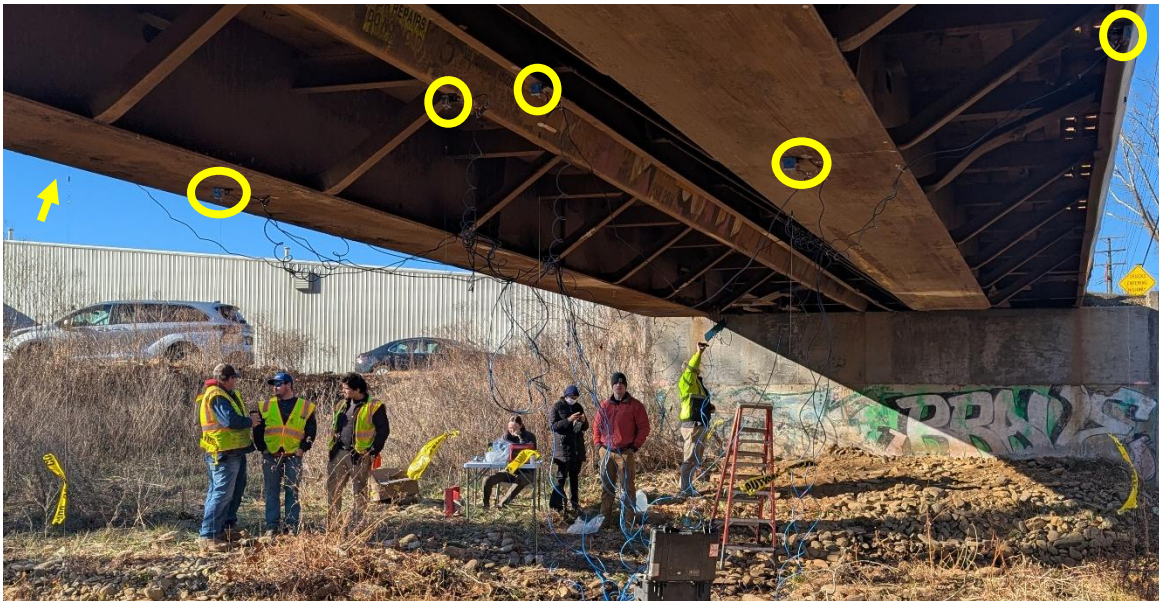
Figure 9. Measurement locations at the structure midspan (yellow circles and one yellow arrow)

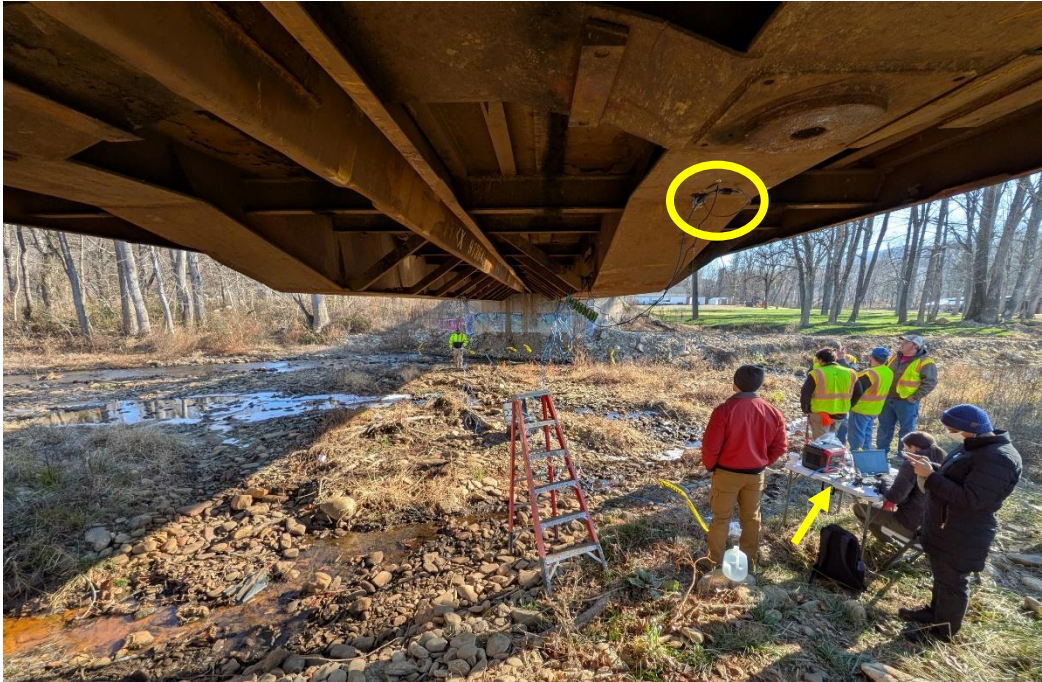
Figure 10. Measurement location at the west end (yellow circle) and arrangement of the data acquisition system (yellow arrow)

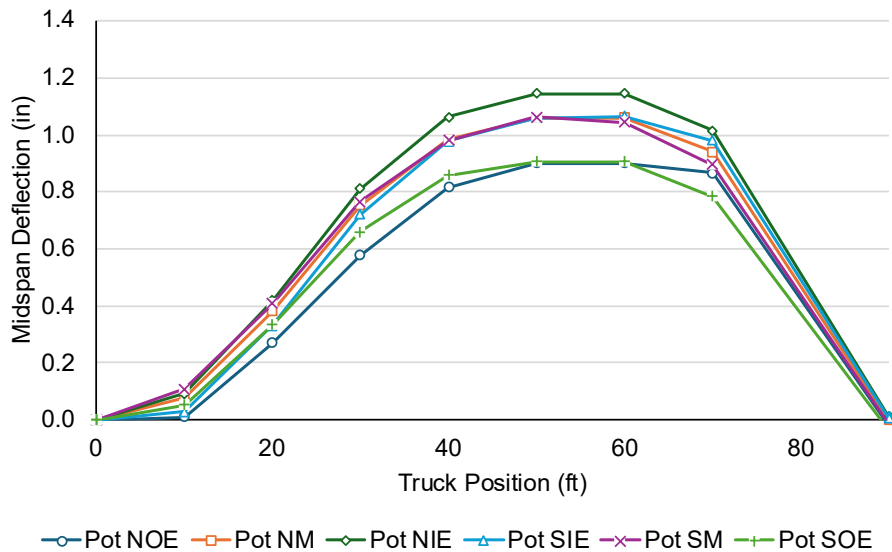
Figure 11. Midspan deflection vs. truck position for the centered run of the truck filled with water

The variation in midspan deflection with each truck position is shown in Figure 11 for the centered run of the truck filled with water. The maximum measured midspan deflection was 1.15 inches as measured at the inside edge of the North Car. This deflection was recorded while the truck's side mirror was located at 50 ft and 60 ft. At these truck positions, the rear axle would have been slightly on each side of the midspan, as shown in Figure 12.

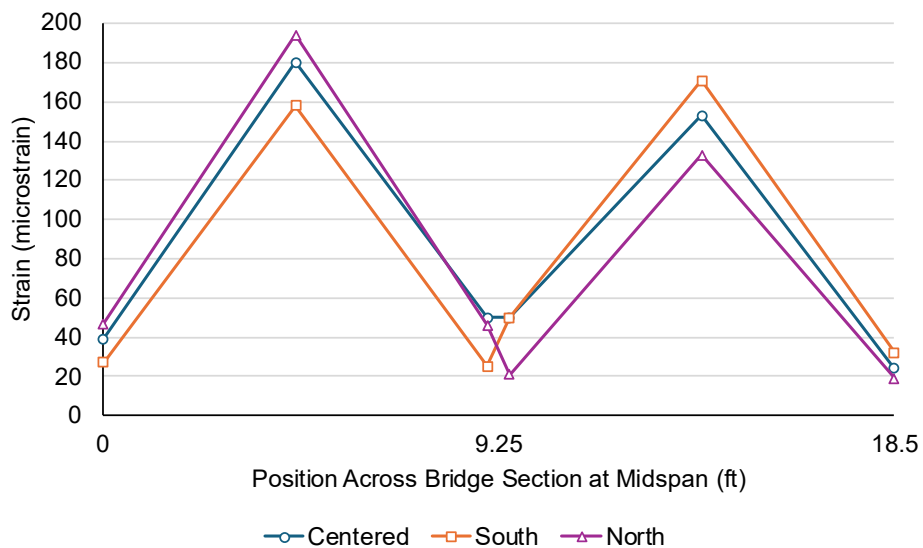
Figure 15. Strain profile for the truck filled with water at 50 ft for all runs

The maximum strain profiles of the bridge midspan cross-section for three runs with the truck filled with water and positioned at 50 ft is shown in Figure 15. The plotted data reveal that the largest tension strains were measured at the mid-width of each railcar, in the main girder with the strain gage located at the deepest point. The maximum strain was around 200 microstrain, indicating that the steel remains elastic at a level equal to approximately 10% of the estimated yield strain. Tension strain levels in the extreme fibers of the edge beams (or “bent plate side sills”) were roughly an order of magnitude lower, indicating that the main central beam is doing the bulk of the work in resisting the tension generated by global flexure.

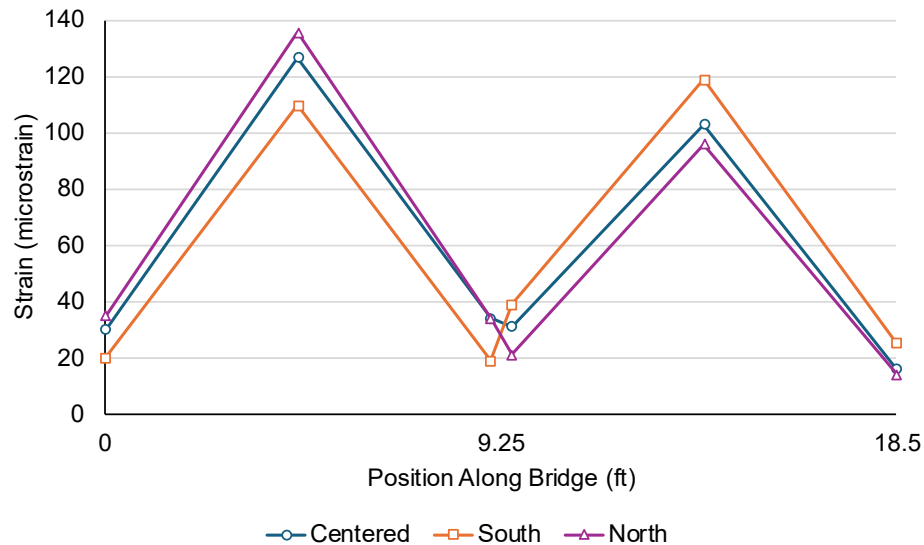
Figure 17. Strain profile for the empty truck at 50 ft for all runs

The maximum midspan deflection and strain profiles for the three runs with the empty truck are shown in Figure 16 and Figure 17. The maximum deflection was reduced to 0.86 inches and the maximum strain was reduced to approximately 140 microstrain, both reductions roughly in proportion with the reduction in vehicle weight, confirming a nominally linear response.
