# Designing an Efficient Nighttime Sign Inspection Procedure to Ensure Motorist Safety

North Carolina Department of Transportation  
Research and Development Group  
Raleigh, NC 27699-1549

Final Report  
Project: 2005 – 08

September 2006

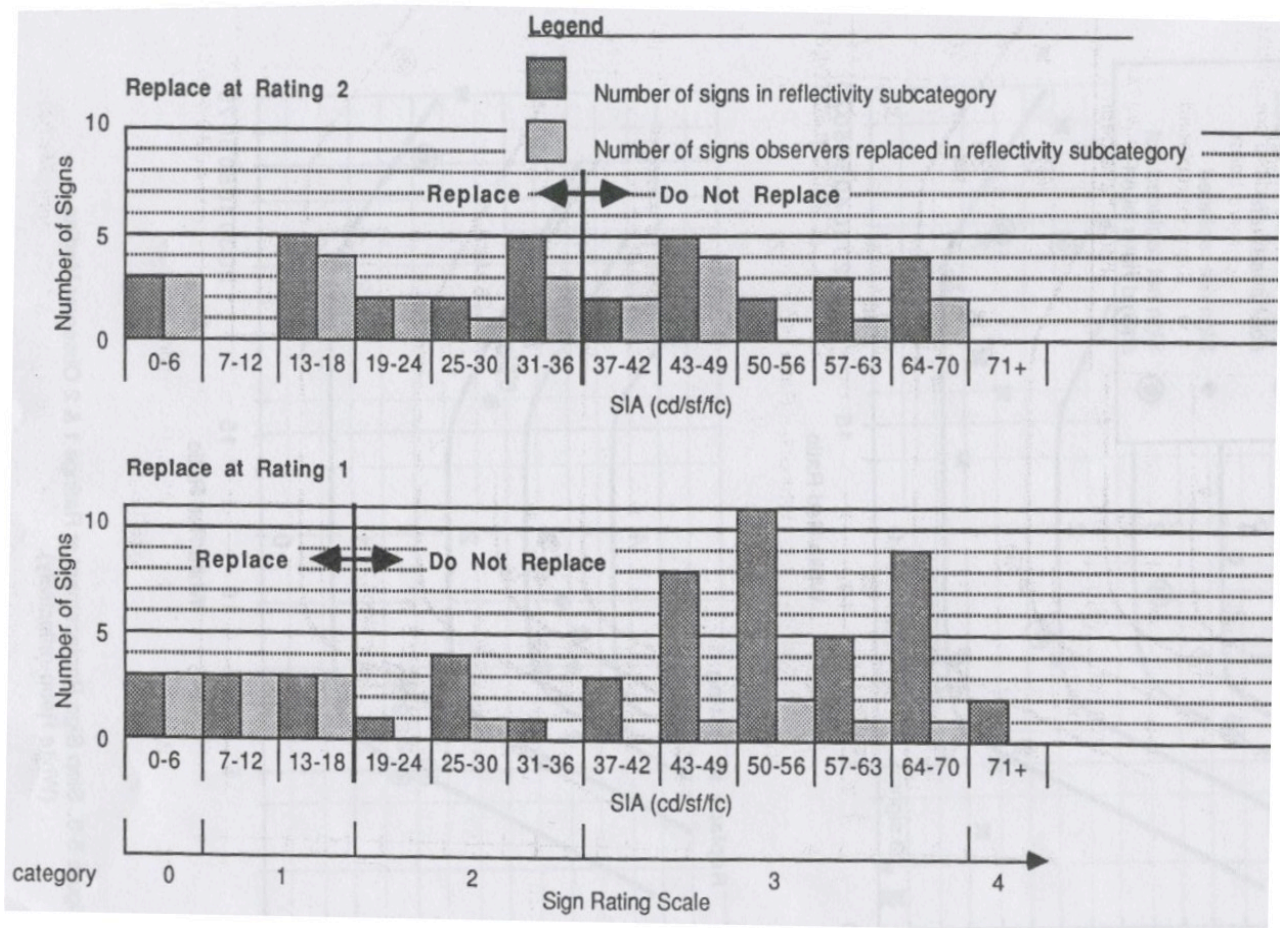
**Figure 2.11. Warning Sign Replacement at Ratings 1 & 2 Observer Median**

Figures 2.11, 2.12, and 2.13 were constructed to determine at what levels of retroreflectivity signs were replaced in the highway experiments. In Figure 2.11 the range of retroreflectivity for the warning signs is partitioned into sub-categories within the limits of each rating category. The Figure is also separated into two graphs for the two different replacement levels. The number of signs in each sub-category is shown as well as the number of signs in each category that were replaced. The graphs show that of the 17 warning signs in the 0 and 1 category, at the two replacement levels, 16 signs were replaced. The observers were very accurate in replacing warning signs at this level. Thirteen of the seventeen signs scheduled for replacement in the 2<sup>nd</sup> category were replaced. The graph also shows unnecessary replacements. At replacement level 1, six unnecessary sign replacements are scattered throughout the remainder of the scale. At replacement level 2, nine unnecessary sign replacement are distributed throughout the three and four range. This means that when a sign is to be replaced at level 2, more signs will be replaced unnecessarily.

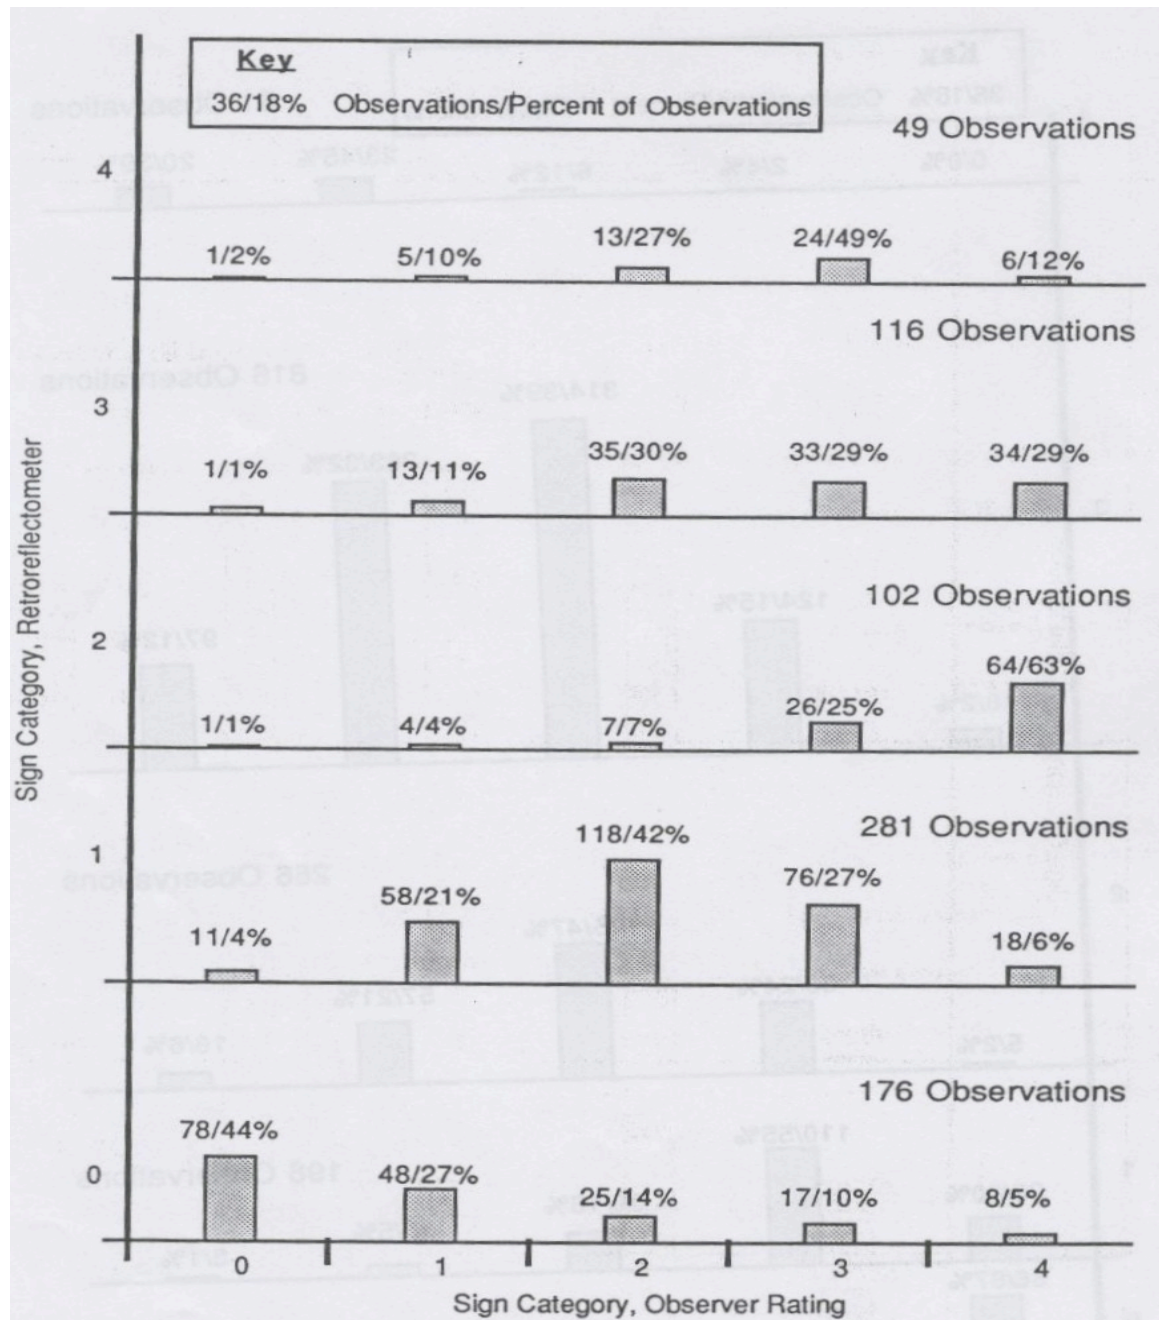
**Figure 2.15. Frequency Distribution Based on Sign Category**

The Figure generally shows that observers have a high accuracy and consistency for signs rating 0 or 1, that the frequency distribution for signs in category 2 is fairly wide, and that the frequency distributions for signs in category 3 and 4 tend to be a little on the low or conservative side. Observers generally rate good signs a little lower than they should, probably due to poor geometries or other factors.

Figure 2.15 shows the frequency distributions of the observer's ratings for the stop sign in each rating category. The correlation between the observer's ratings and the calculated ratings is not

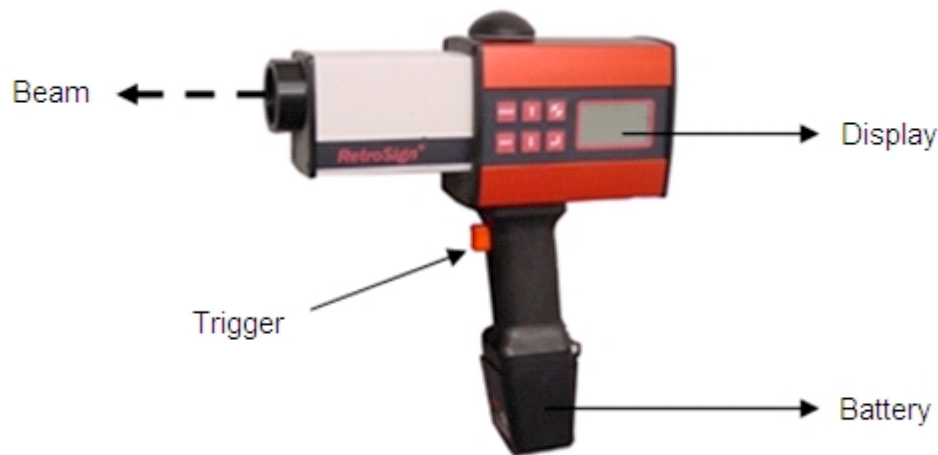
A handheld retroreflectometer is one of the most credible methods to measure retroreflectivity of traffic signs for nighttime drivers. We can assure retroreflectivity of each sign numerically in  $\text{cd/lx/m}^2$ . Figure 4.1 illustrates a handheld retroreflectometer.

**Figure 4.1. A handheld retroreflectometer (RetroSign®4500)**

By pressing a trigger, the device emits a beam toward the a sign sheeting and then it displays retroreflectivity in a few seconds. It has relatively small size of about 360 to 490 inch<sup>3</sup> and weighs about 4.2 to 5 pounds.

Our research team decided to use the RetroSign®4500 which has not only the basic function of reading retroreflectivity without recalibration for changing colors but also has various options such as the extension pole. The company which carries the RetroSign®4500 model is also located in Thomasville, North Carolina, which made repairs convenient.

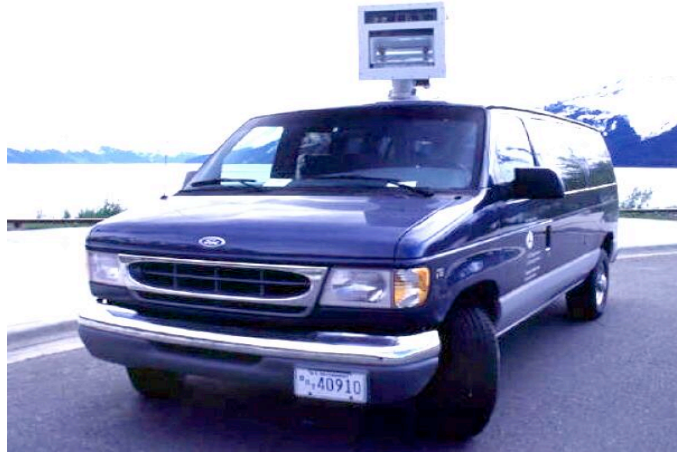
The FHWA developed the SMARTS van to measure the retroreflectivity of traffic signs efficiently, economically, and safely. SMARTS has distinctive capabilities such as measuring the retroreflectivity at highway speeds with an automatic tracking system and it also has significant safety advantages over hand-held devices. Four SMARTS vans were built by FHWA Resource Centers and one of them was evaluated by Alaska Department of Transportation in 2001 [Smith, et. al. 2001]. The SMARTS van is illustrated in Figure 4.2.

**Figure 4.2. SMARTS Van [Smith, et. al. 2001]**

The SMARTS Vans contained the following equipment:

The original intention of the SMARTS van was to allow highway agencies to have the sign retroreflectivity data necessary to schedule timely maintenance on a system wide basis. However a research project by the Alaska Department of Transportation in 2001 showed a different story. The conclusion of the research was that the van's performance was not acceptable. They checked the accuracy of van-collected data and typical sign capture rates under rural and urban conditions. For the accuracy of van-collected data, they used two methods. First, they measured the consistency of multiple retroreflectivity readings for the same signs. The difference in retroreflectivity values for two selected signs was 41 and 72  $\text{cd/lx/m}^2$ , for example, which was not acceptable. The second method was to compare the retroreflectivity value recorded in the van with a reading from a hand-held retroreflectometer (a RetroSign®4500, the same device as our research team used, generally considered as among the most accurate types of available devices). The average differences for sign legends was 351 percent and on backgrounds was 297 percent, which were unacceptable. They also revealed that the sign capture rate, number of sign photos taken divided by number of target signs, was only 36 percent in an urban area and 64 percent in a rural area.

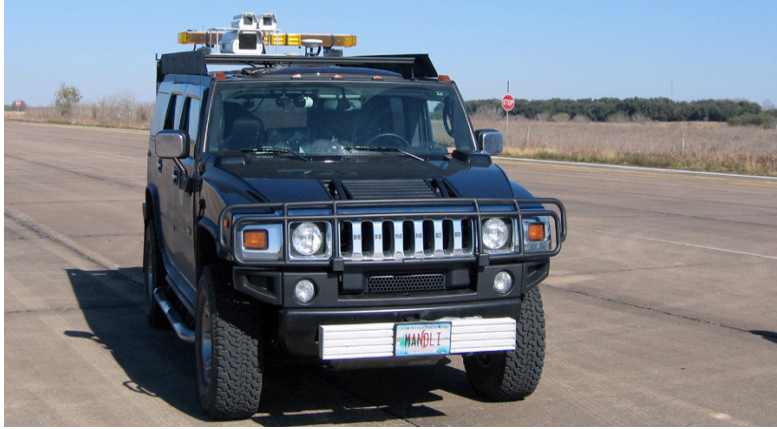
Mandli Communication Inc. has developed the RetroView™ mobile platform, which has the ability to collect the retroreflectivity of traffic signs in a single pass at posted road speeds. It is basically the same concept as the SMARTS van from FHWA but it is expected to show a better outcome than the SMARTS van in collecting data in the field. It can collect not only retroreflectivity data but also digital roadway imagery and GPS data with its Roadview6 software, high resolution color digital camera, engineer grade black and white digital camera, and GPS unit [Mandli Communications, Inc. 2005]. The RetroView™ vehicle is illustrated in Figure 4.3.

**Figure 4.3. RetroView™ vehicle [Mandli Communications, Inc. 2005]**

The company announced that over 5,000 signs per day could be measured with its RetroView™ mobile system at the 2005 Transportation Research Board Annual Meeting. However, the RetroView™ is also at initial stage in some pilot projects with the Tennessee and Texas DOTs and it needs some time to be verified as a cost-effective method to measure the retroreflectivity of signs.

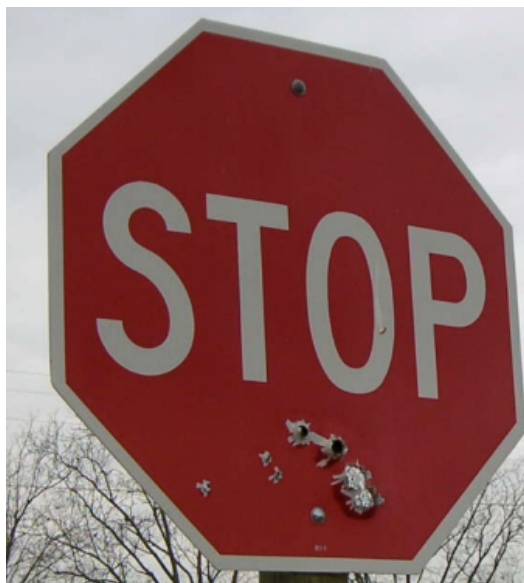
Figure 7.11 shows a stop sign that was shot with a gun. The sheeting is totally damaged and the sign has clearly visible holes in its bottom from the gunshots.

**Figure 7.11. Sign Shot with a Gun**
