# **Rail Corridor Trespass Severity Assessment**

**Institute for Transportation Research and Education (ITRE)  
North Carolina State University**

**NCDOT Project 2017-15  
FHWA/NC/2017-15  
February 2019**

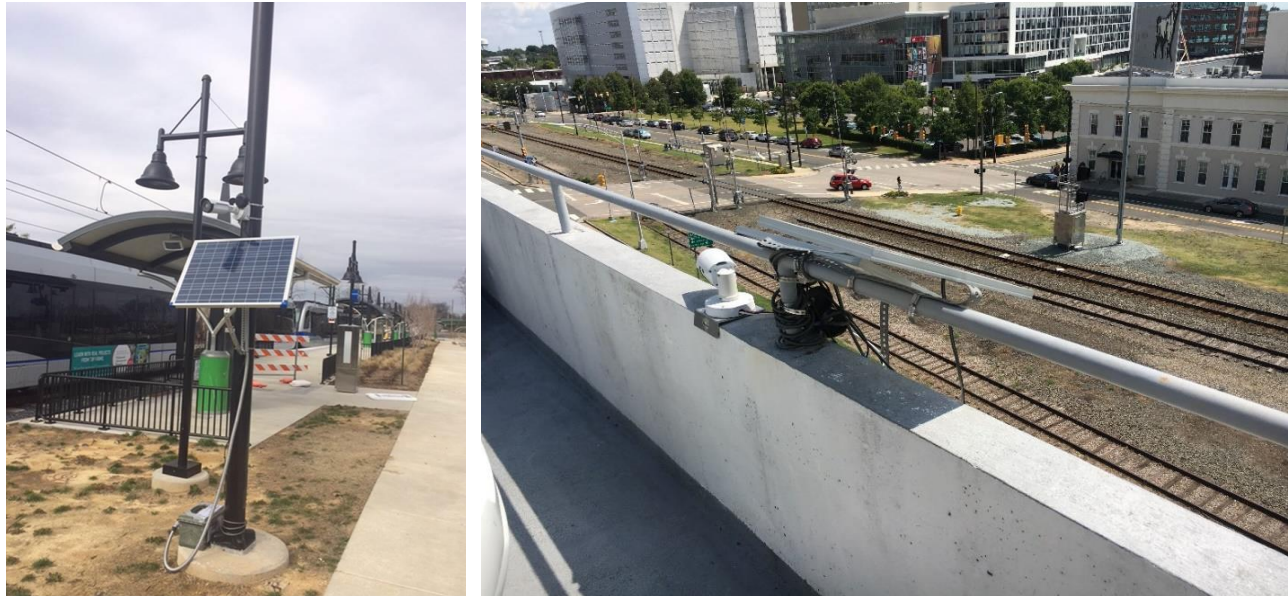
**EXHIBIT 1. TYPICAL STATIC THERMAL DETECTION SYSTEM SETUP**

All system components except for the cabling and the camera itself were housed in a plastic box that was locked in place during data collection. These components include the three batteries, the solar controller, and the cellular modem. The wires from these devices ran outside of the box and through conduit to the camera (power and Ethernet) and the two cellular antennas. A picture of two typical setups is shown below in Exhibit 1.

The cameras can run on PoE (power over Ethernet) or by simply connecting a 12-volt power supply. Originally, a 20-watt solar panel was attached to a double 22 amp-hour battery array in order to keep the batteries charged. However, whereas this setup worked during initial testing in Durham, which was during the summer and on top of a parking deck, the research team quickly learned that this would not suffice during the winter and in areas potentially more obstructed from direct sunlight. Therefore, after trying a setup that included two 20-watt solar panels connected through a solar controller to three batteries, the team eventually chose the current setup of a single 70-watt solar panel attached to a solar controller for power regulation and three batteries.

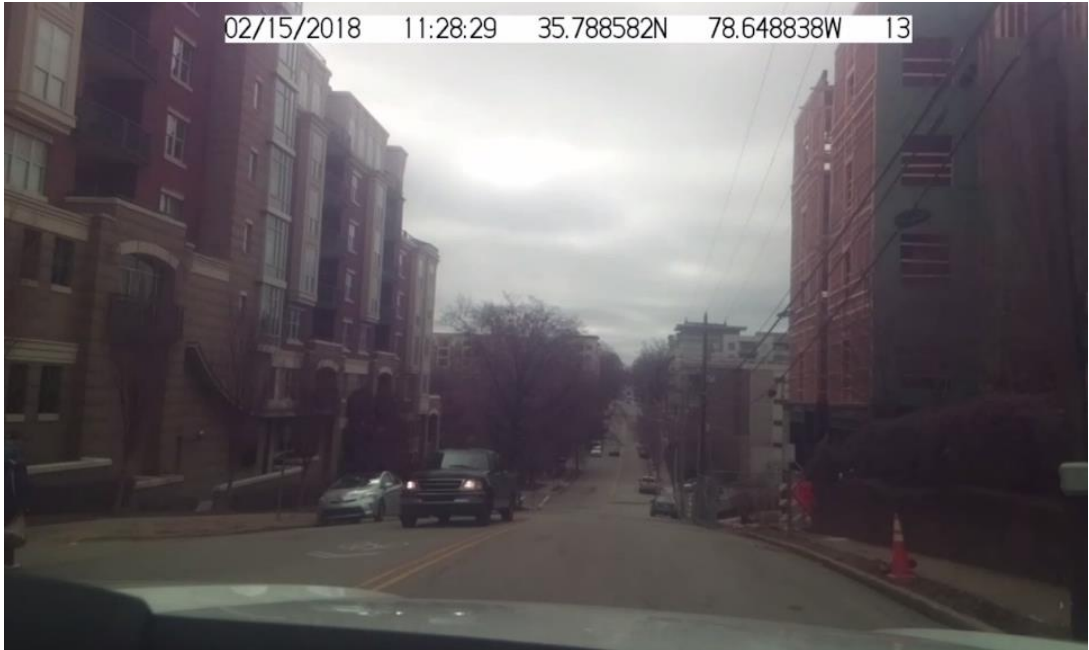
**EXHIBIT 7. VIDEO IMAGE WITH SPATIAL AND TEMPORAL OVERLAY**

At the time of this interim report, the research team has deployed the prototype system several times from the cab of a passenger vehicle for pilot testing purposes. Exhibit 7 provides the results of overlaying the video imagery with spatial and temporal information. Exhibit 8 shows how the data captured with the GPS is stored in a .CSV file and can be plotted to display the position and movement of the camera. Overall, the system components linked together nicely and are very reasonably priced for a total system cost of less than \$500. However, the research team learned that the camera system that is deployed has a wide range of variability in detection.

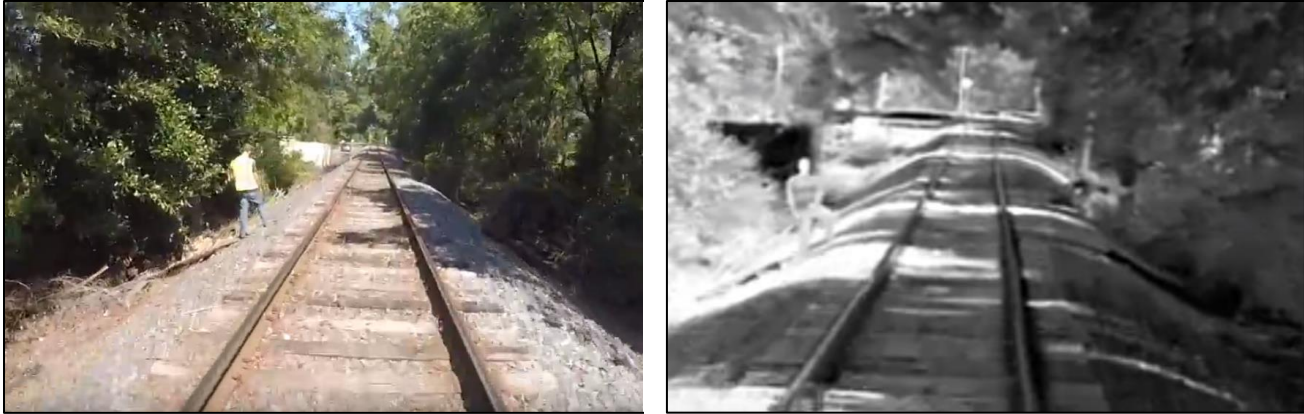
**EXHIBIT 9. FORWARD-FACING VIEW FROM STANDARD CAMERA (LEFT); FORWARD-FACING VIEW FROM AXIS THERMAL CAMERA (RIGHT)**

The ability to capture pedestrian events during day and night without being dependent on light and the possibility of improving the detection algorithm using heat signatures (which are not available in IR or standard cameras) led the research team to test the thermal camera as a stand-alone capturing device. One minor drawback would be the absence of spatial data in the overlay. The research team tested the AXIS camera system used for static detection under dynamic conditions in a variety of scenarios along a two-mile stretch of rail in Star, North Carolina. This test provided a rich video-based dataset with which to develop machine learning algorithms. Exhibit 8 provides a snapshot from both camera views ([standard](#) and [thermal](#)) for one subject scenario of 32 possible scenarios.

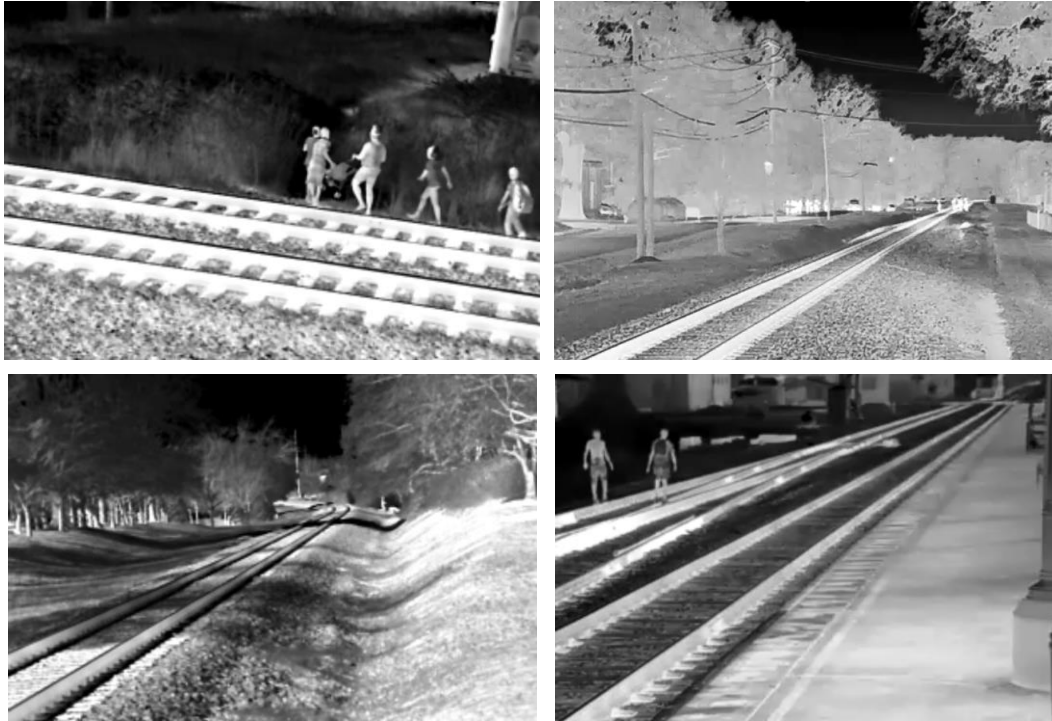
**EXHIBIT 20. TYPICAL TRESPASSING ACTIVITIES AT GREENSBORO (TOP LEFT), ELON (TOP RIGHT), MEBANE (BOTTOM LEFT), AND SALISBURY (BOTTOM RIGHT) SITES**

Exhibit 20 provides still images of typical trespassing behaviors that were captured at the data collection locations. A descriptive summary of trespassing characteristics by site is provided in Exhibit 21. The majority of events across all sites (97%) involved crossing the tracks. Only 3% of events involved activity in the right-of-way without crossing the tracks, and less than 2% of events involved riding or carrying a bicycle. Less than 1% of events across all sites included the presence of a train. The median amount of time on the tracks was 3 seconds.

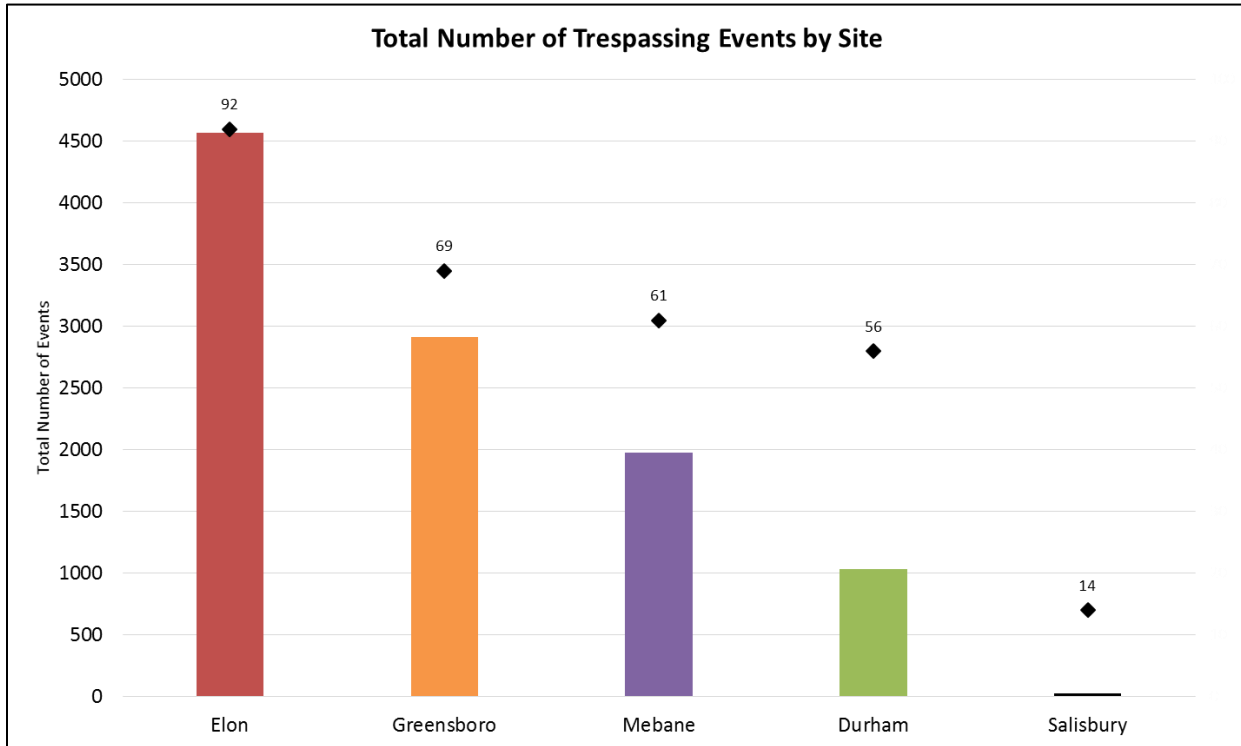
Additional summary statistics are provided in Exhibits 22-25. The average number of trespassing events per day across all sites was 36 with variation between sites shown in Exhibits 23 and 24. The site at Elon University is the most different from the other sites included in the sample. This site experiences the highest average number of trespassing events which typically ramp up on the weekend during months when the university is in session. There is a marked decrease in activity during the summer months when the university is not in session. In addition, the height of fencing along the corridor under observation was changed from 3' to 6' in June 2018, which resulted in an overall decrease in trespassing events when classes resumed for the semester.
