Mechanically-Fastened FRP to Retrofit Existing Prestressed Concrete Bridge Beams

NCDOT Project 2018-16

FHWA/NC/2018-16

June 2022

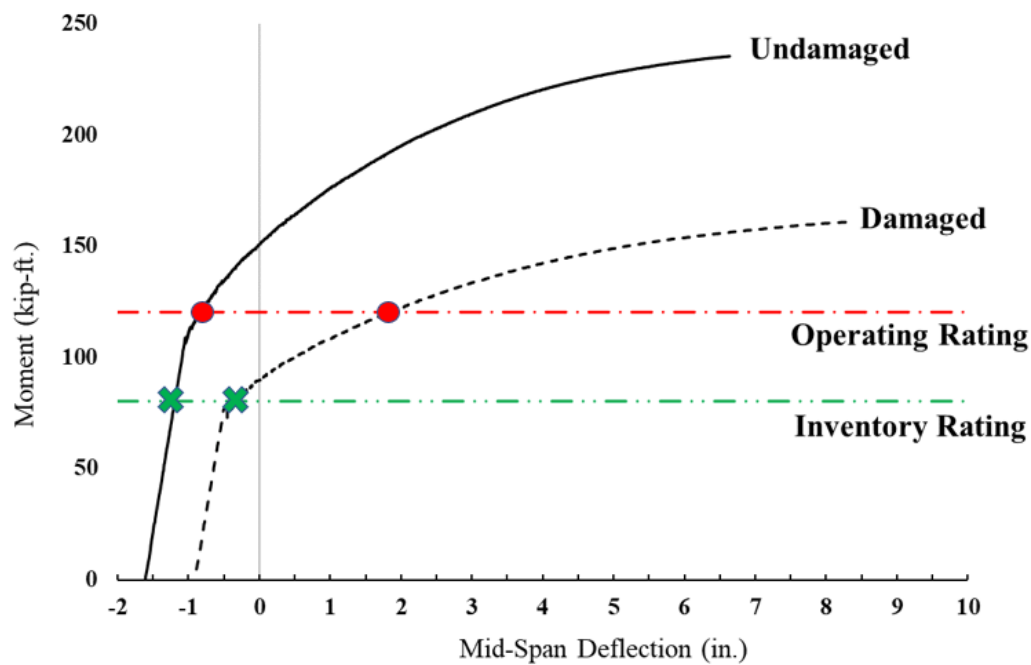
loading. On the other hand, with the deterioration, the operating limit of the damaged beam occurs at a higher deflection level, which leads to more permanent damage accumulated over time. In most cases, the operating rating controls bridge capacity and load restrictions; however, to adequately remove posted load restrictions from deteriorated prestressed concrete bridge superstructures, both operating and inventory rating criteria must be addressed.

Figure 1.2: Moment-deflection response of undamaged and damaged prestressed concrete bridge beams with AASHTO limits.

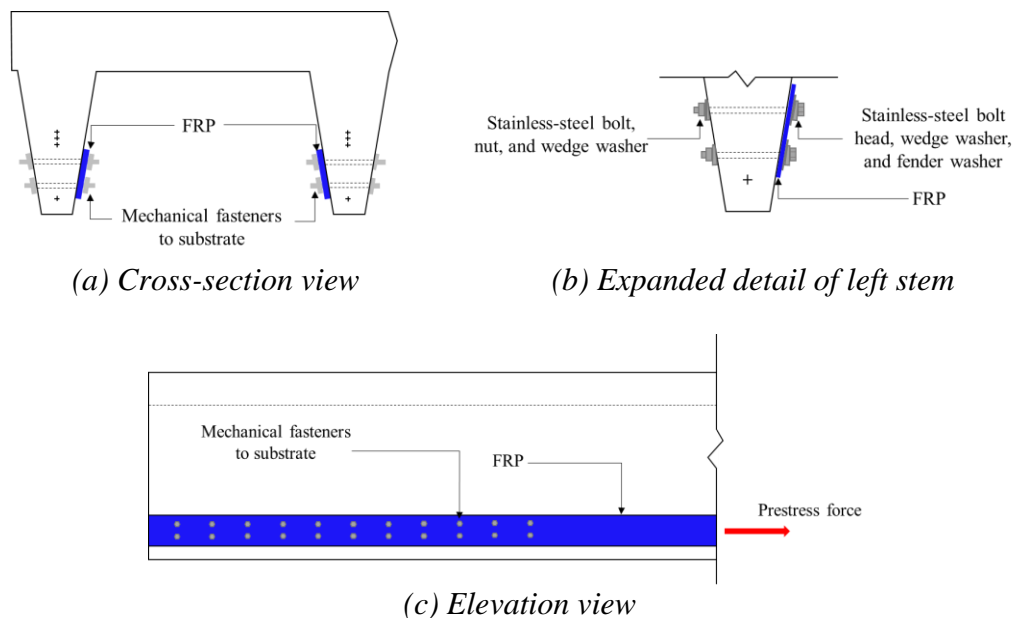
Temporary repair and restoration of prestress losses are necessary to maintain structures' original inventory and operating rating to keep deteriorated bridges functional while replacement is scheduled. The primary objective of this research is to develop a methodology and experimental program that is fundamental to extend the service life of existing infrastructure through rapid restoration of prestress losses in deteriorated prestressed concrete bridge superstructures. The retrofit solution is a mechanically-fastened fiber-reinforced polymer (MF-FRP), which can be applied to deteriorated prestressed concrete bridge superstructures and prestress to a level that prestress losses due to deterioration are restored. Restoration of the prestress losses must result in concrete tensile stresses that are within allowable AASHTO limits permitting the retrofitted bridge to remain open, without posted load restrictions, until member replacement, or complete bridge reconstruction can occur. A concept sketch of the retrofit solution applied to a C-channel beam is presented in Figure 1.4.

Figure 1.4: Prestressed MF-FRP retrofit concept sketch.

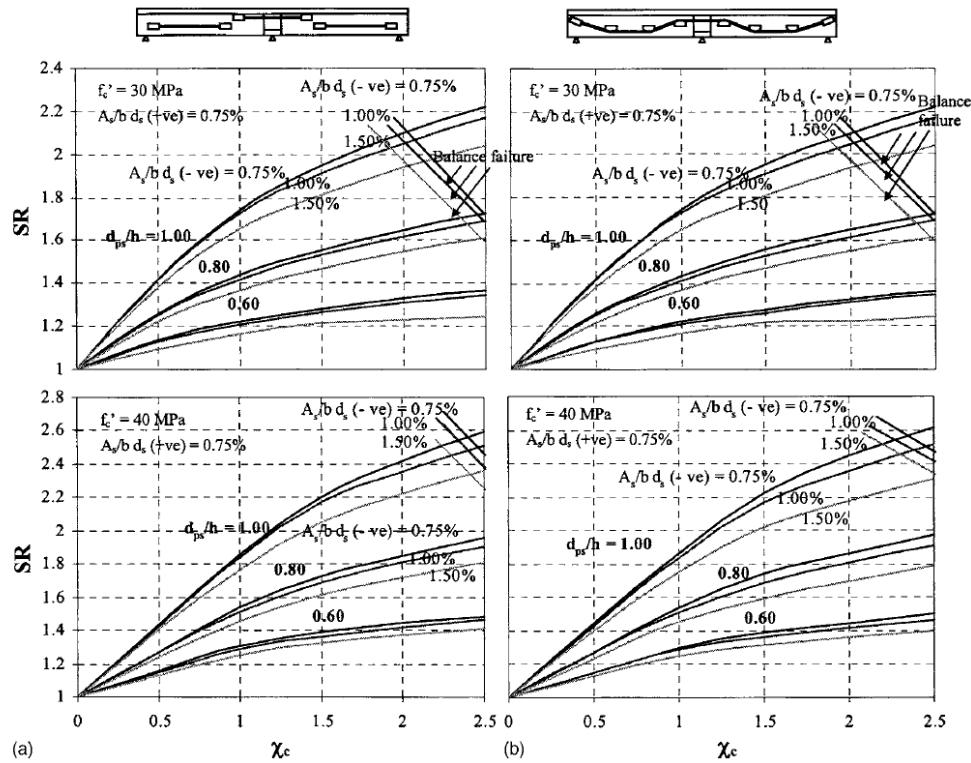
negative moment regions, experienced the best improvement in both ductility and ultimate load-carrying capacity compared to other profiles. Shear distress at the unstrengthened interior region of the beam with anchored parabolic tendons led to a less ductile failure. Specimens with symmetrical applied loading exhibited a higher ultimate load-carrying capacity compared to the beams subjected to the unsymmetrical loading, which underwent an uneven deflection. The design procedure for strengthening a continuous beam using external tendons can be done using charts, as in Figure 2.6, related to the global prestressing index, concrete strength, and tendon effective depth.

Figure 2.6: Design charts for strengthening with external tendons (adapted from Tan et al., 2007).

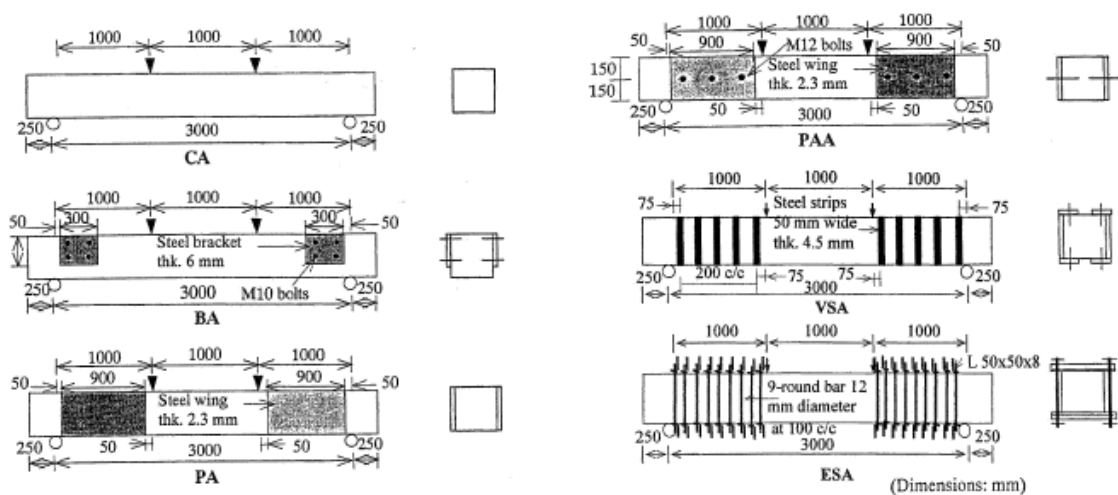
section depth with steel plates. Although the use of thicker plates can increase shear capacity, it was found not as efficient as increasing the depth of the plates. Adhikary and Mutsuyoshi (2005) presented different techniques to enhance the shear capacity, including steel brackets, bonded steel plates, anchored steel plates, and anchored steel strips and stirrups. The specimen with externally anchored stirrups experienced the highest improved shear capacity compared to the other strengthening methods. Figure 2.8 presents the strengthening schemes used to improve beam shear behavior.

Figure 2.8: Shear strengthening schemes (adapted from Adhikary and Mutsuyoshi, 2005).

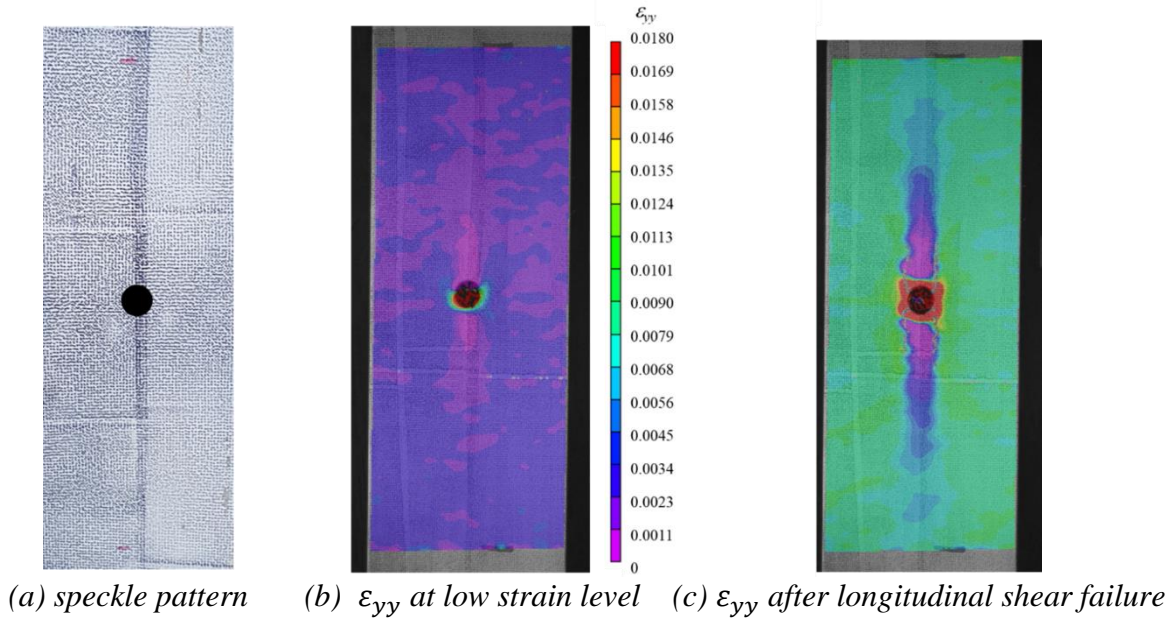
the specimen and the speckle pattern was achieved by painting the material surface with white spray paint before applying the black ink speckle pattern.

Figure 3.2: Example DIC strain field and specimen speckle pattern.

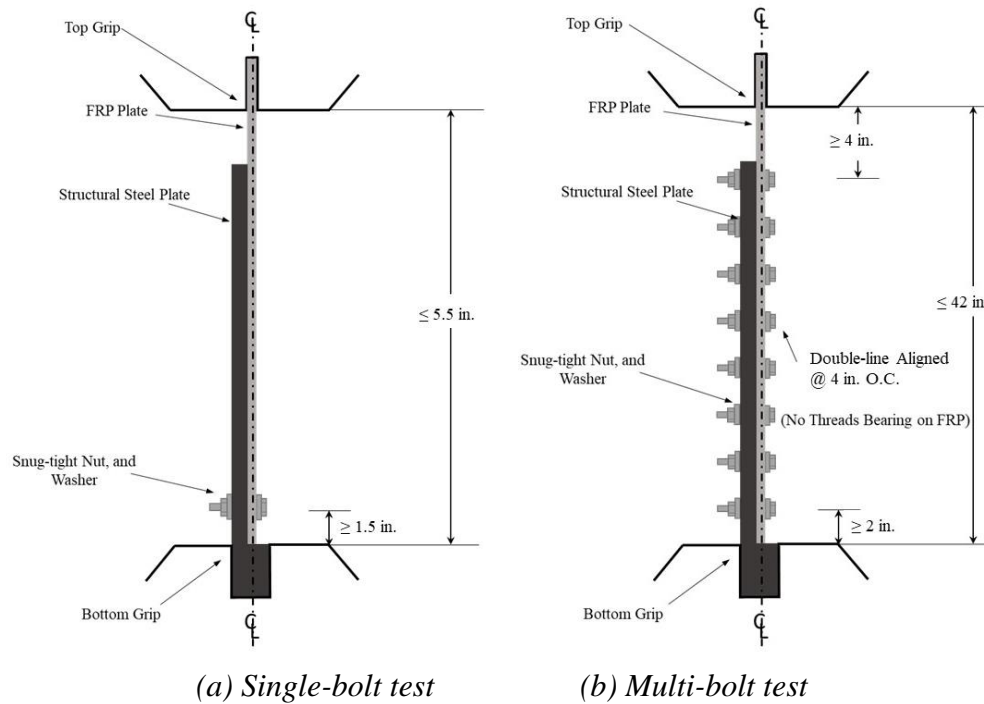
idealization of the bolted connection, the goal of which was to achieve the maximum capacity of the FRP plate with holes. The steel plate is used in place of the concrete substrate to which the MF-FRP will typically be attached; therefore, concrete failure modes, which can be analyzed using traditional design techniques, are not considered in this test.

Figure 3.5: Bolted connection test schematic.

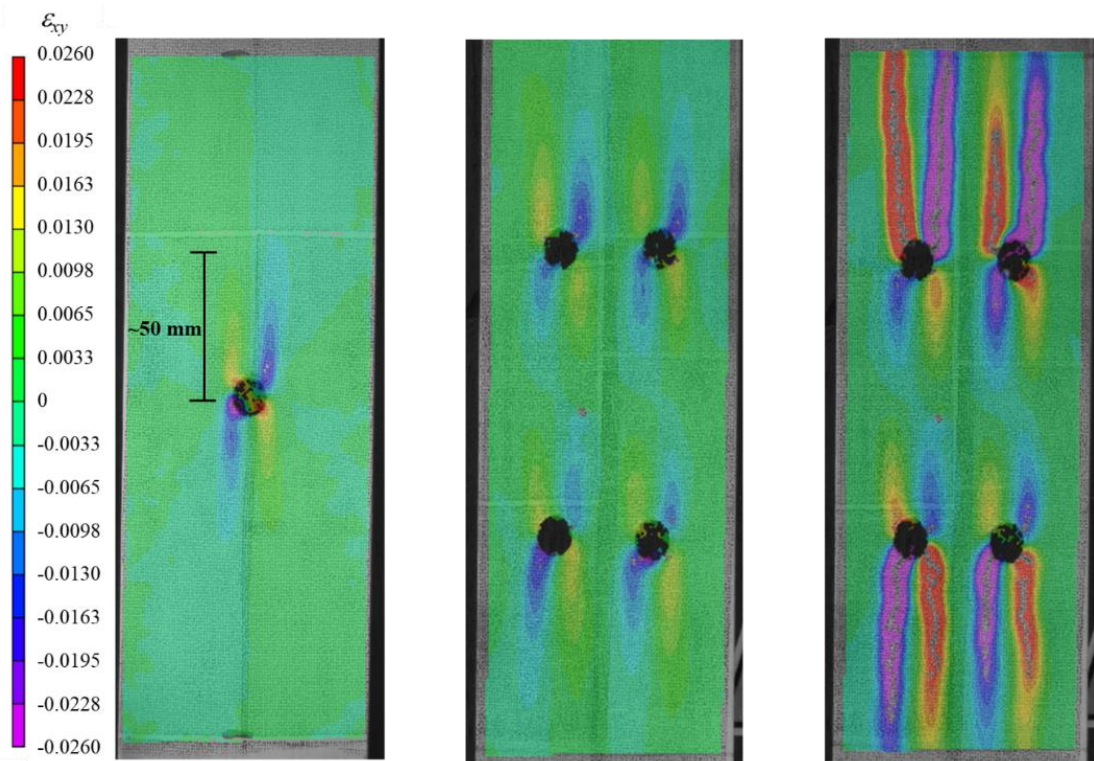
The DIC shear strain results show the development of a disturbed region approximately 2 in. above and below the hole just before a longitudinal shear failure in the glass fibers begins (Figure 3.6(a)). Therefore, the longitudinal spacing between holes for multiple hole test conditions was selected to be 4 in. (Figure 3.3) to minimize interaction between disturbed regions developing at adjacent holes. Longitudinal shear failure of the glass fibers results in shear splitting which propagates and joins from the holes until ultimate failure occurs with complete shear failure of glass fibers along the length of the test specimen.

(a) *S-OH pre-splitting* (b) *DBL4-OH pre-splitting* (c) *DBL4-OH at failure*
Figure 3.6: Shear strain map of disturbed regions and shear failure.

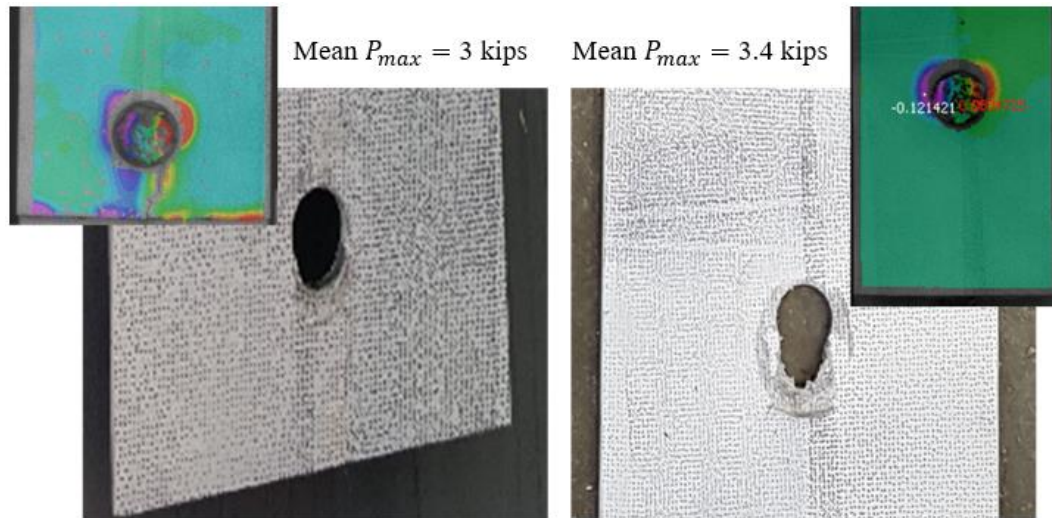
DIC insets in Figure 3.8 are captured at peak load, which occurred just prior to shear failure in the 1.5 in. edge distance group and bearing failure in the 4 in. edge distance group.

(a) *S-B-X-1.5 bearing and shear failure* (b) *S-B-X-4.0 bearing failure*

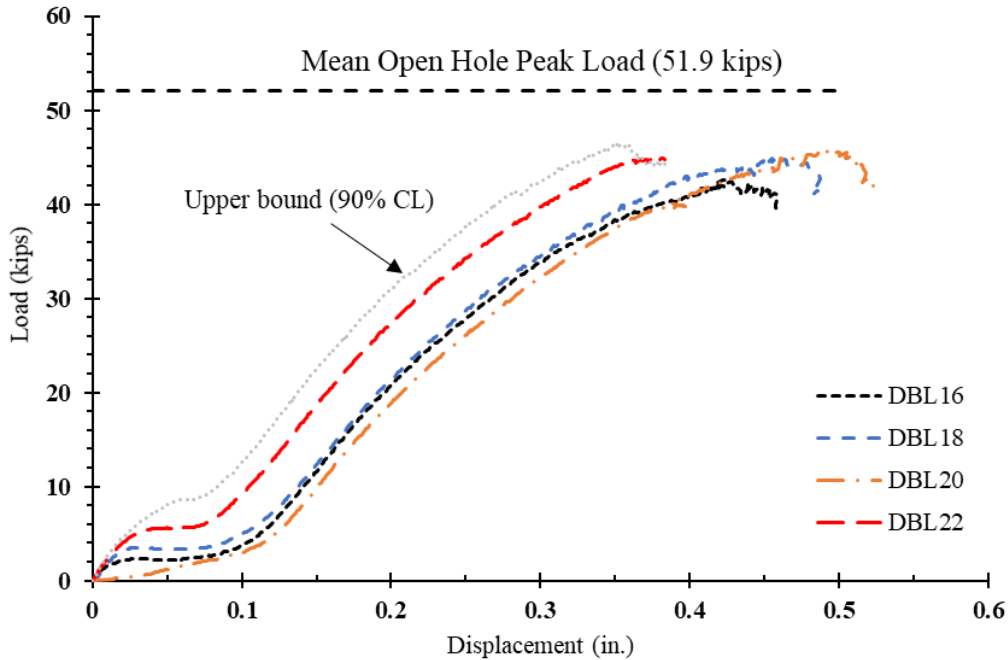
statistically significant at the 90% CL or greater. The upper bound curve shown in Figure 3.10 is the upper limit corresponding to the 90% CL for the population of treatments.

Figure 3.10: Mean multibolt load-displacement curves (DBL series).

The mean open-hole peak load (51.9 kips) in Figure 3.10 is the mean peak load for the open-hole treatment conditions, mean value for peak load of all DBL4 and STG4 results in Table 3.4. As previously discussed, this is the theoretical maximum load for the FRP material tested with holes, which was the peak load goal for the multibolt testing; however, under the current treatment conditions, the mean peak load for the DBL22 treatment is approximately 89% of the theoretical maximum. This difference in the theoretical maximum is due to shear lag effects which cause longitudinal shear failure to propagate in a progressive manner from the first row of bolts (top two holes for each specimen in Figure 3.11(c)), rather than uniform shear failure along the length of the specimen.

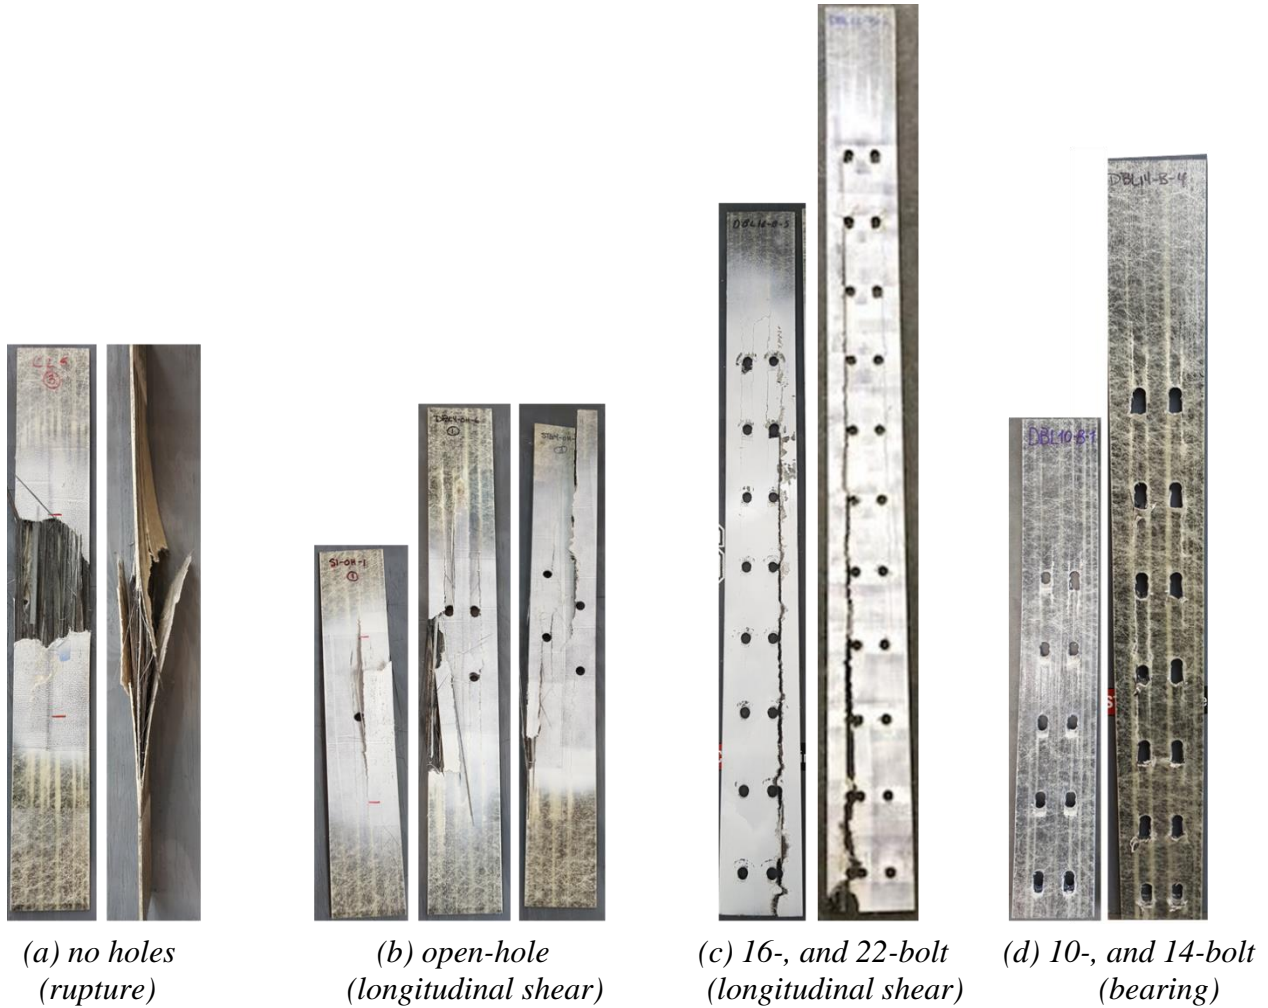
Figure 3.11: FRP failure modes.

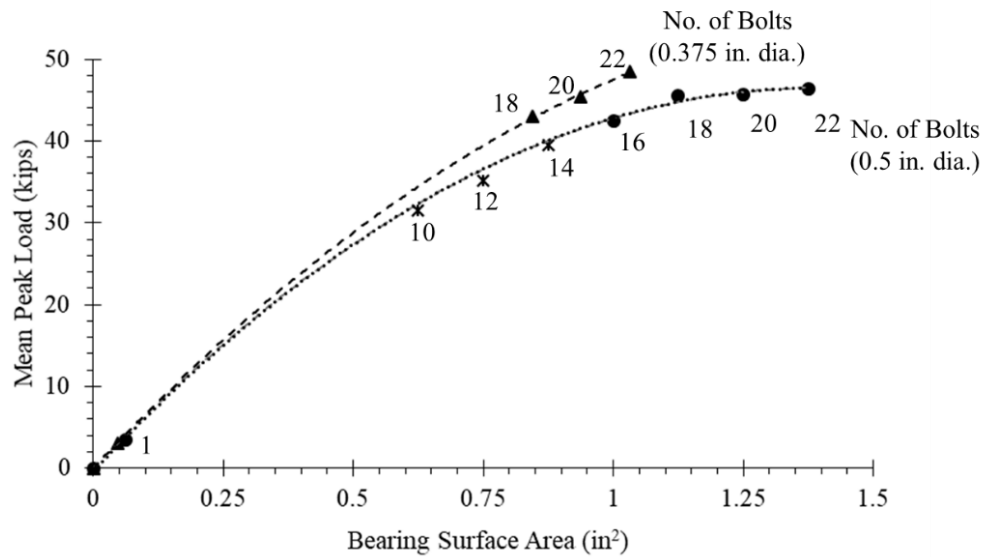
where A_b = total bearing surface area; n_b = number of bolts; d_b = diameter of the bolt; and t_p = thickness of the plate. The trendline shown in Figure 3.12 is established using the S-B-X-1.5 and the 16-, 18-, 20-, and 22-bolt treatment groups. Additional testing was then conducted using the supplementary test matrix in Table 3.9 to determine the validity of the trendline to predict mean peak loads for bolt patterns with less than 16 bolts. The mean peak loads for the 10-, 12-, and 14-bolt treatment groups are within 3.0% of the trendline, indicating the curve in Figure 3.12 is sufficient for predicting the capacity of a connection using 0.5 in. diameter bolts and 4 in. longitudinal spacing over the range of bolts from 1 to 22 at the 90% CL.

Figure 3.12: Variation of mean peak load and FRP failure modes.

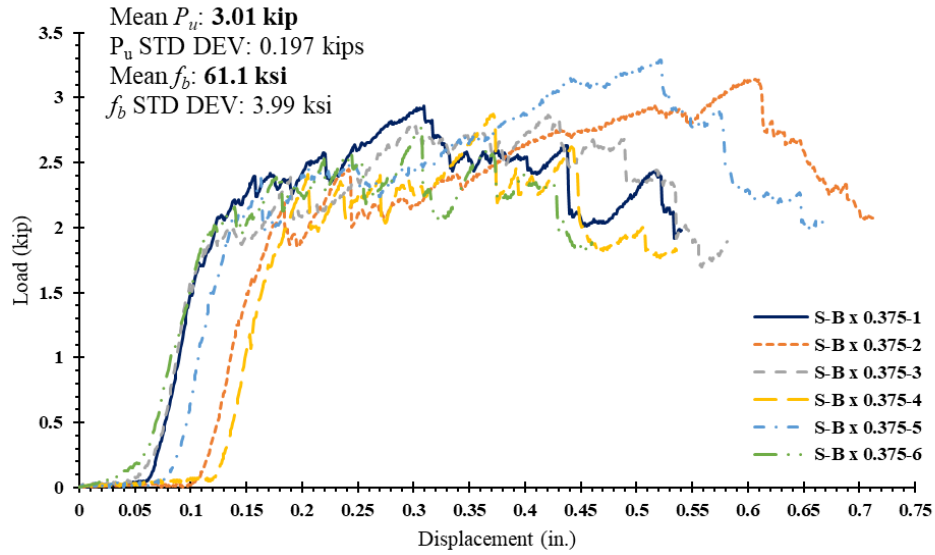
Figure 3.13: S-B-X-0.375 load-displacement curves.

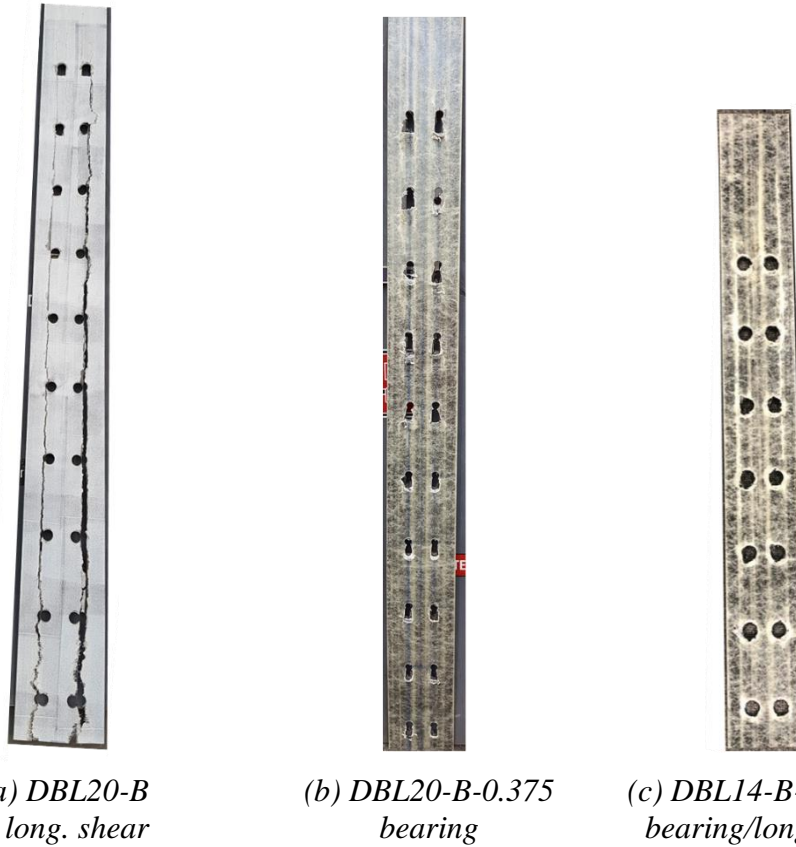
The mean peak loads for the 0.375 in. bolt diameter treatment groups are similar to the 0.5 in. diameter treatment groups, however, the 0.375 in. diameter bolt connections resulted in higher peak stress levels compared to 0.5 in. diameter treatment groups due to the reduced bearing surface area of the 0.375 in. diameter fasteners, which resulted in significant bearing in the FRP prior to longitudinal shear failure. Figure 3.14 shows the bearing failure for the DBL20-B-0.375 treatment group compared to that in the DBL20-B treatment group, and DBL14-B-4-0.75 treatment group (discussed later in this section). In most specimens, the bearing was followed by longitudinal shear failure similar to that which was observed in the 0.5 in. diameter bolt treatments.

Figure 3.14: Failure modes for 0.5 in., 0.375 in., and 0.75 in. diameter treatment groups.

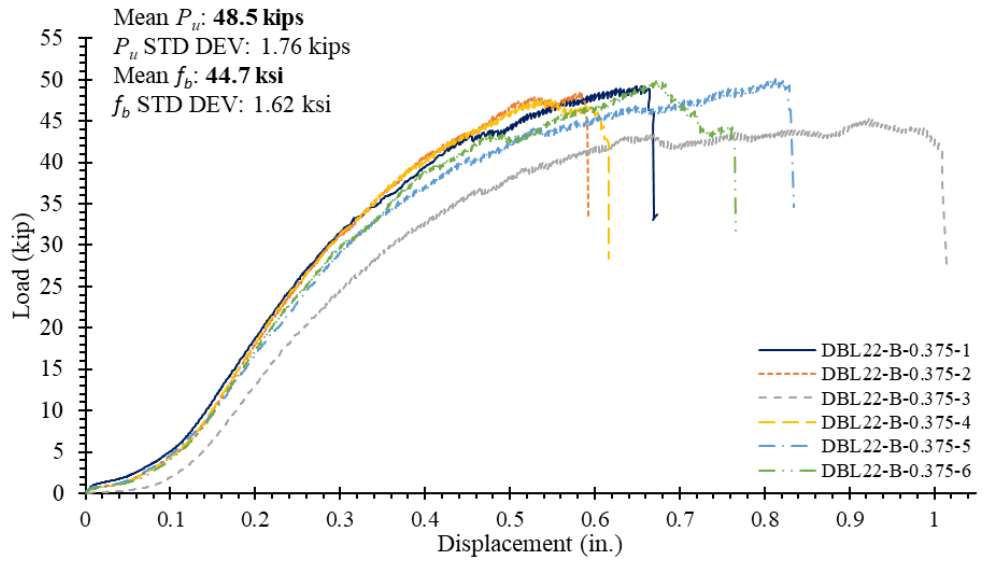
displacement prior to failure, but rather immediate failure at peak load (Figure 3.16(a)) similar to that of the 0.5 in. bolt diameter treatments (Figure 3.16(b)).

(a) DBL22-B-0.375

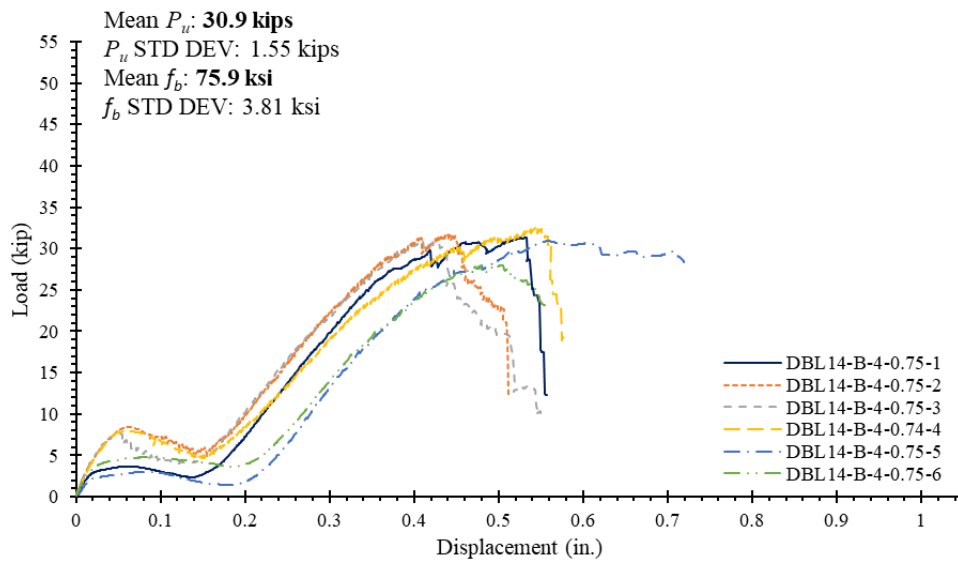
A similar treatment group with greater longitudinal spacing between holes was also examined to determine the effect of increasing the length of the longitudinal shear failure plane. Increasing the longitudinal spacing by 50% (from 4 in. to 6 in.) increased the peak load on the connection by 17.5% (from 30.9 kips to 36.3 kips); therefore, the increased longitudinal shear failure plane does result in a sufficiently higher load capacity of the system. However, the load capacity of both 0.75 in. bolt diameter treatment groups is significantly less than the load capacity of the 0.5 in. and 0.375 in. bolt diameter treatment groups with similar bearing surface areas. Therefore, further investigation of 0.75 in. bolt diameter (or larger) fasteners is not recommended as larger diameters experience reduced FRP performance and decrease the efficiency of the MF-FRP retrofit.

Figure 3.17: Load-displacement behavior for DBL14-B-4-0.75 treatment group.

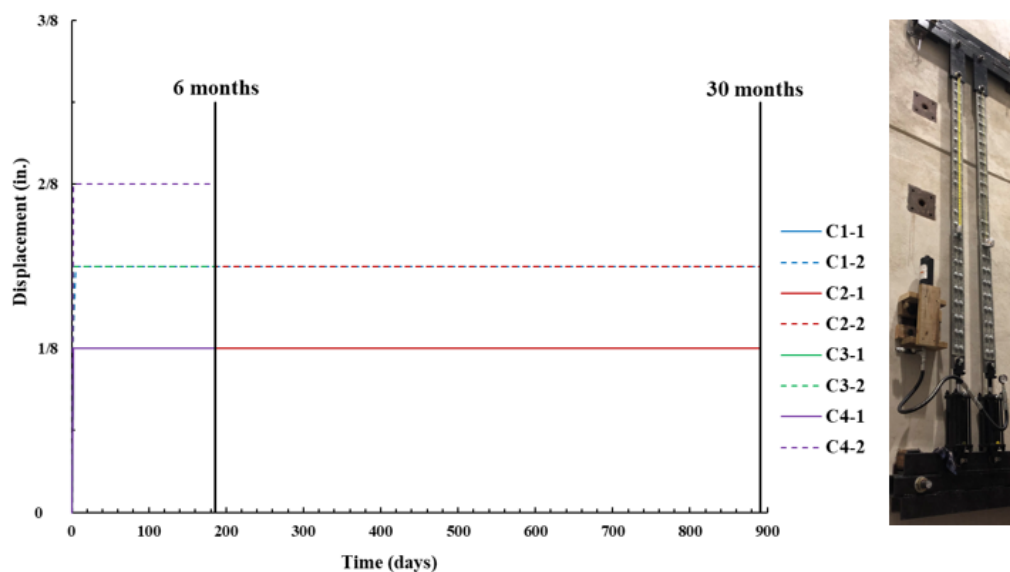
Creep: treating the displacements at day one (day of loading) as the benchmark allowing for (instantaneous elastic deformations), creep is equated to the change in displacement over time. The total level of creep experienced by each specimen is therefore the difference between the maximum displacements reached over the entire testing time (30 months) and the instantaneous elastic deformations and is shown in Table 4.2. For 0.5 in. bolts, all specimens experienced 0.0625 in. of creep over 30 months of sustained loading, except for specimen C4-2, which experienced 0.125 in. of creep. More variation can be seen in the creep levels of the 0.375 in. bolt specimens, with a range covering 0.0625 in. to 0.375 in. after neglecting specimen C3-1, which is taken as an outlier reaching 1 in. of displacement due to bolt bearing on the FRP plate. The arithmetic mean to calculate the average level of creep gives 0.07 in. for 0.5 in. bolts, and 0.152 in. for 0.375 in. bolts. The standard deviation is 0.021 in. for 0.5 in. bolts, and 0.099 in. for 0.375 in. bolts.

Figure 4.9: Displacement over time (0.5 in. bolts).

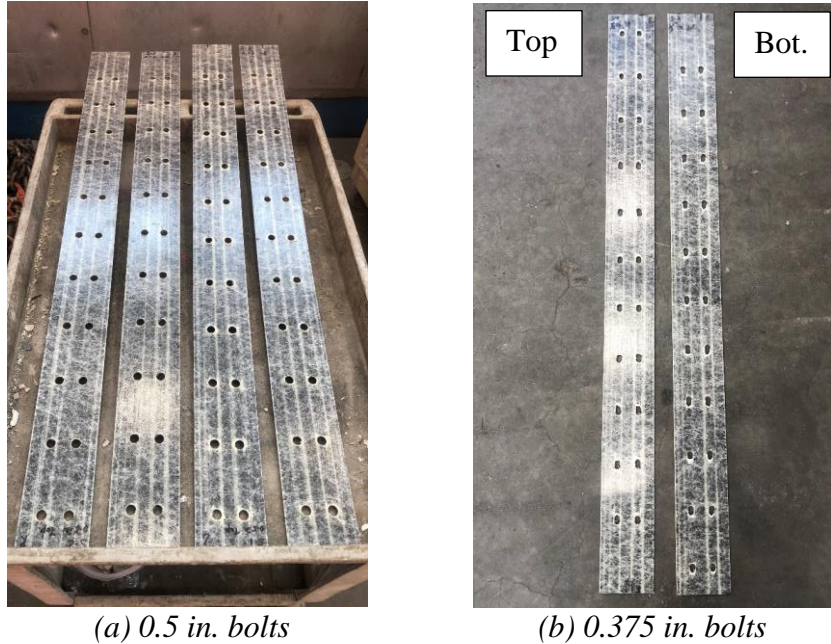
Figure 4.14: State of extracted specimens after 30 months of sustained loading.

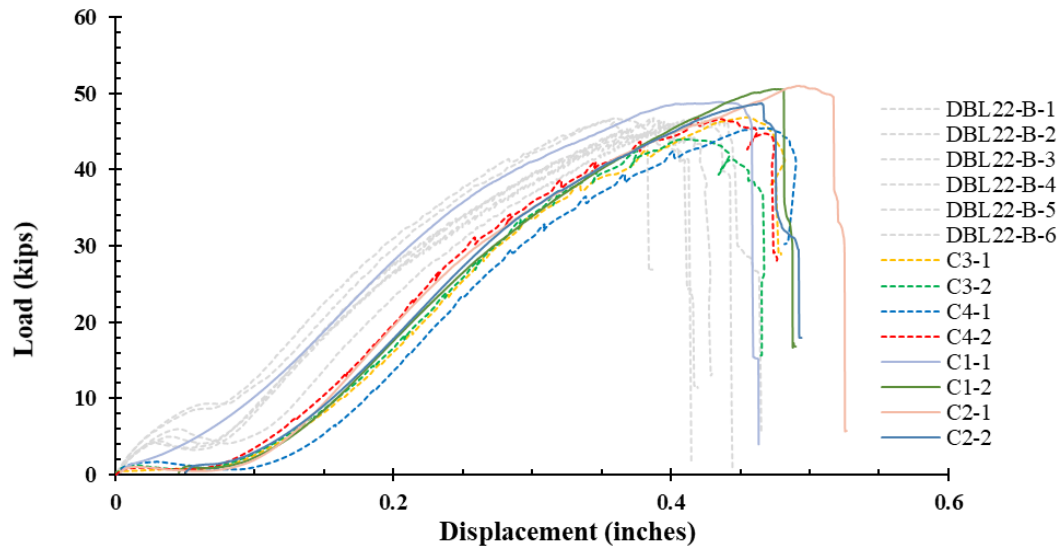
Similarly, for 0.375 in. bolts, the initial slip for each tested specimen is consistent with its respective level of creep from the displacement-over-time results. The significant variance in displacement results for this bolt size is even more evident in this case. Specimens C3-2 and C4-2 fit reasonably well with material tests. Specimen C3-1 exhibits a different loading progression, although it still fits well with the material tests in terms of ultimate displacement. Specimen C4-1, C2-1 and C2-2 do not fit with the material tests, with a much higher ultimate displacement and a different loading progression. That being said, focusing on the peak loads achieved, there is no noticeable loss in capacity for the sustained loading specimens. Table 4.3 presents the result of the uniaxial tension tests of all specimens.

(a) 0.5 in. diameter bolts

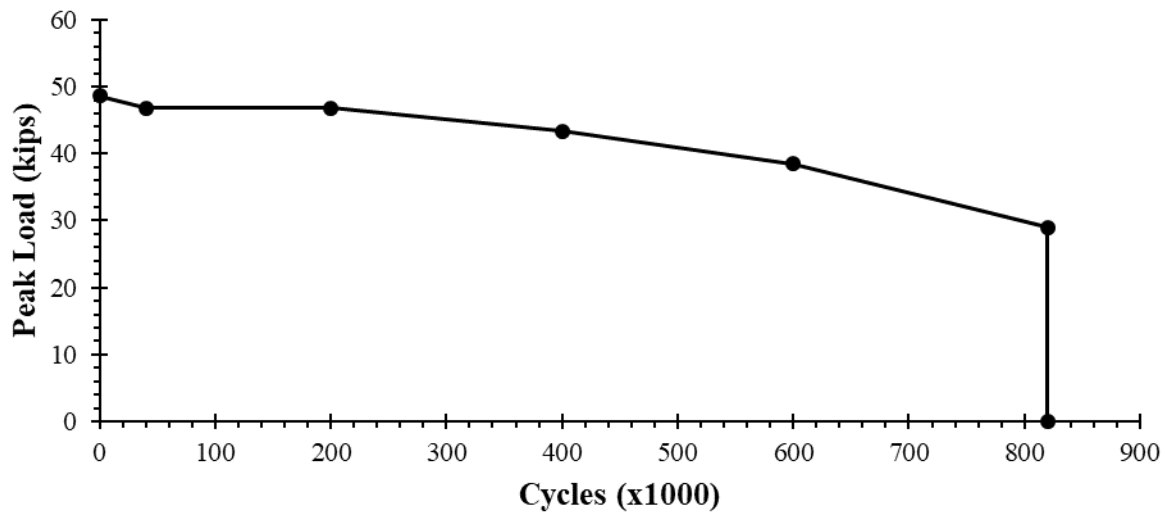
Enough data was available at that instant to develop a failure envelope, which is shown in Figure 4.21. The first point at 48.6 kips (intersecting the y-axis) is taken from Chapter 3 results and represents the mean ultimate capacity of the same 22-bolt MF-FRP connection using 0.375 in. bolts. Some key observations can be made about the rate of capacity loss as a function of number of cycles. Prior to 200000 cycles, there is a plateau region at a capacity of 46.8 kips, which, compared to 48.6 kips, indicates virtually no capacity loss. Beyond 200000 cycles, significant decreases in capacity occur, with the rate of degradation increasing at each increment of cycling. The point of fatigue failure at 820000 cycles marks the limit of this failure envelope.

Figure 4.21: Fatigue failure envelope for 0.375 in. bolts at 30 in.-lbs. of torque.

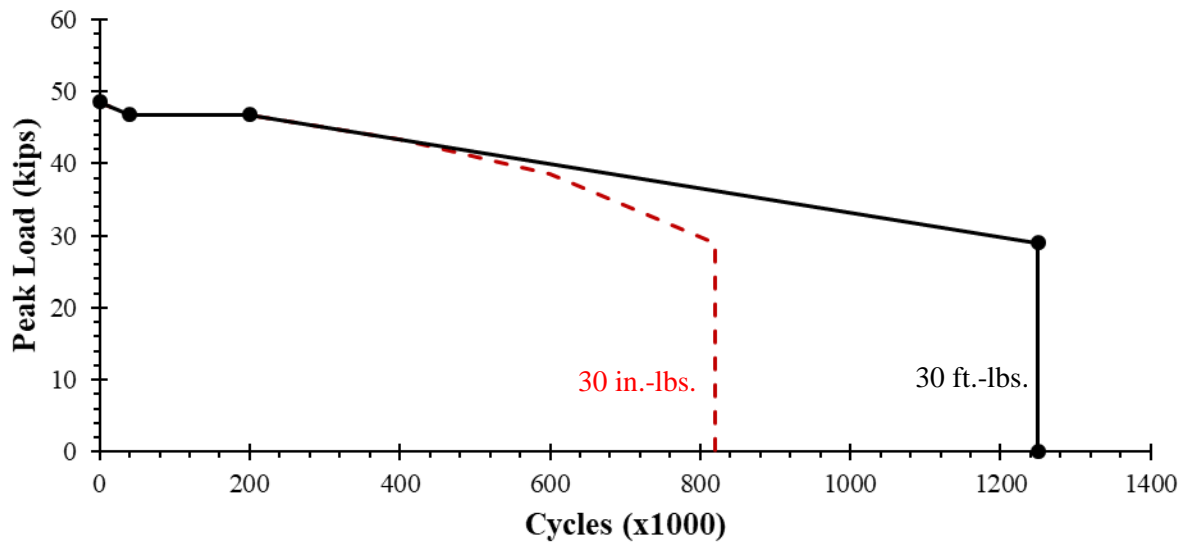
It can be seen that it takes 400000 to 500000 more cycles for the FRP tightened at 30 ft.-lbs. of torque to reach the same displacement as the 30 in.-lbs. torque level.

Figure 4.22: Estimate of fatigue failure envelope for 0.375 in. bolts at 30 ft.-lbs. of torque.

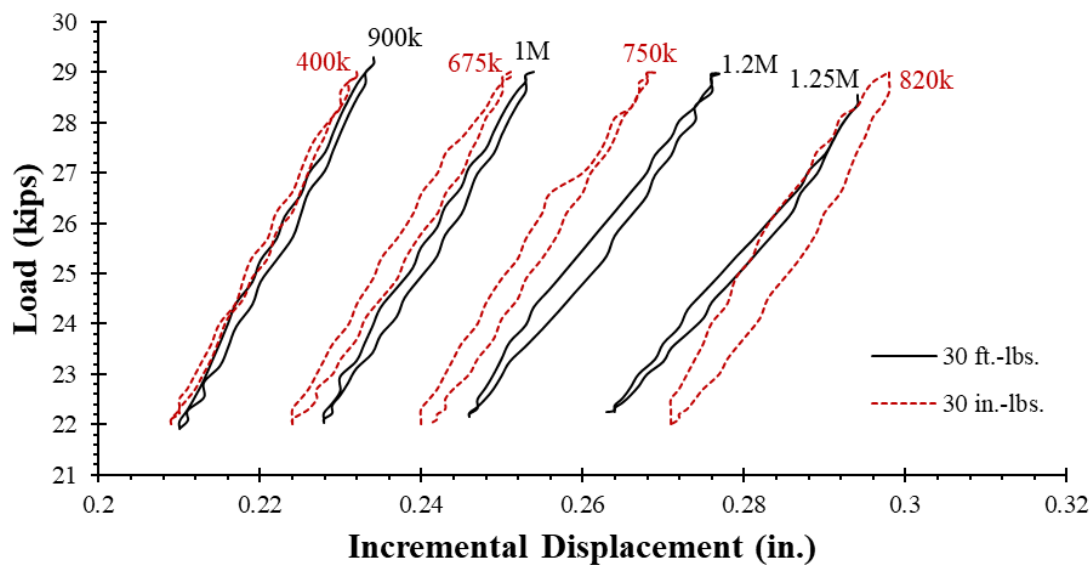
Figure 4.23: Hysteretic load-displacement plots for 0.375 in. bolts.

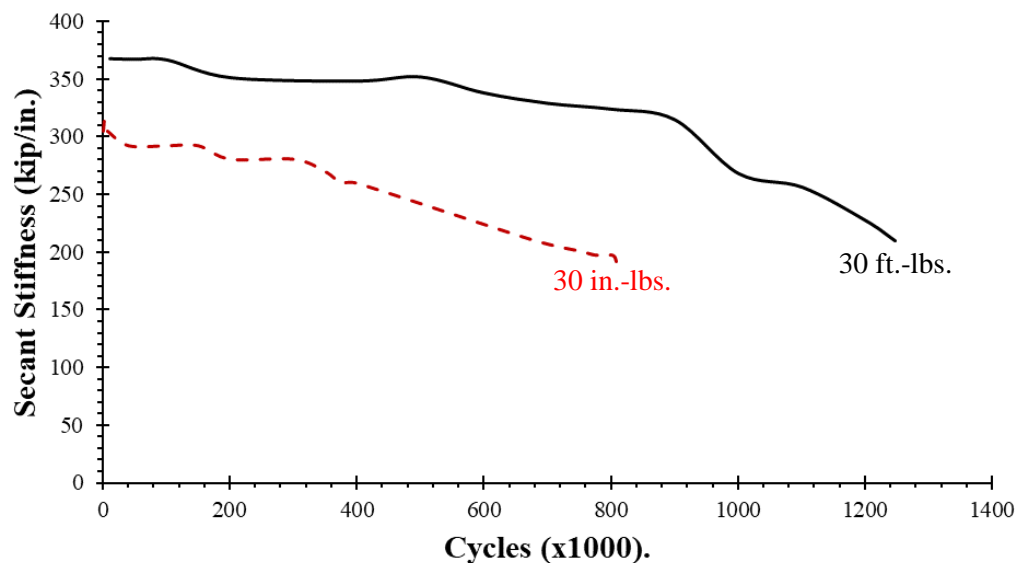
Figure 4.24: Hysteretic secant stiffness per cycle for 0.375 in. bolts.

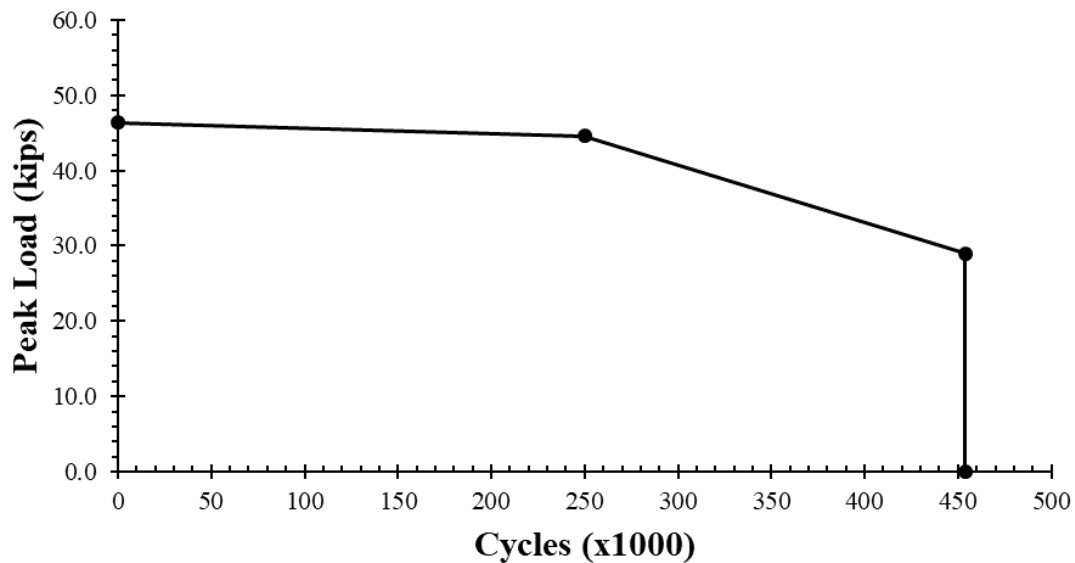
It was decided that specimen F2-3 would be tested all the way to fatigue failure, which occurred at 454000 cycles. The failure modes for 0.5 in. bolts were identical to those of 0.375 in. bolts. With such a short fatigue lifetime compared to 0.375 in. bolts, the results of F2-2 and F2-3 were deemed sufficient to form the failure envelope in Figure 4.26 for 0.5 in. bolts.

Figure 4.26: Fatigue failure envelope for 0.5 in. bolts at 60 ft.-lbs. of torque.

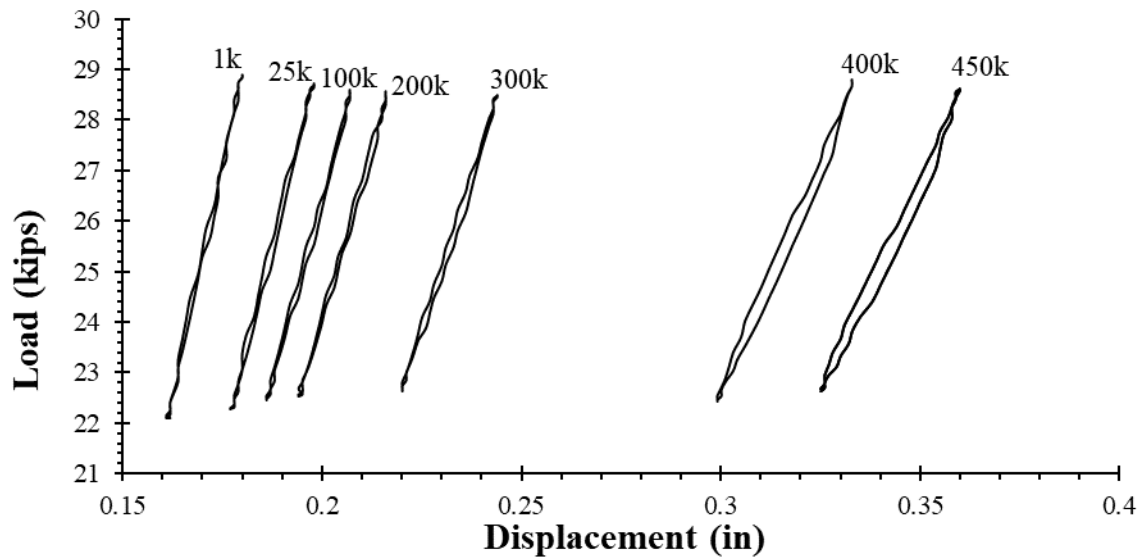
Figure 4.27 displays the load-displacement plot, highlighting the hysteretic behavior of 0.5 in. diameter bolts at 60 ft.-lbs. of torque. From this plot, the secant stiffness degradation per number of cycles can be obtained, and is shown in Figure 4.28.

Figure 4.27: Hysteretic load-displacement plot for 0.5 in. bolts at 60 ft.-lbs. of torque.

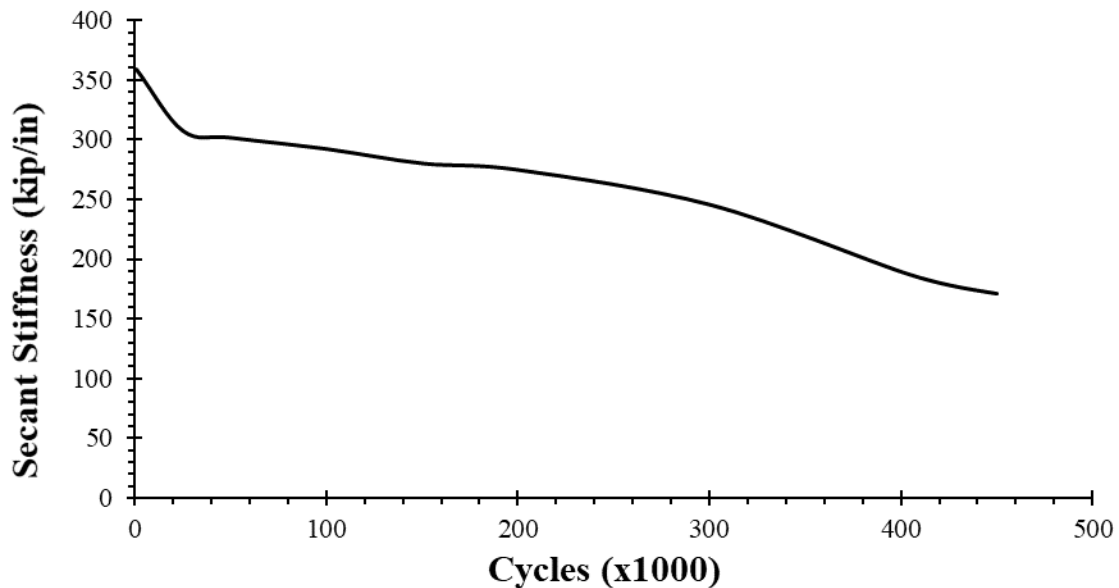
Figure 4.28: Hysteretic secant stiffness per cycle for 0.5 in. bolts at 60 ft.-lbs. of torque.

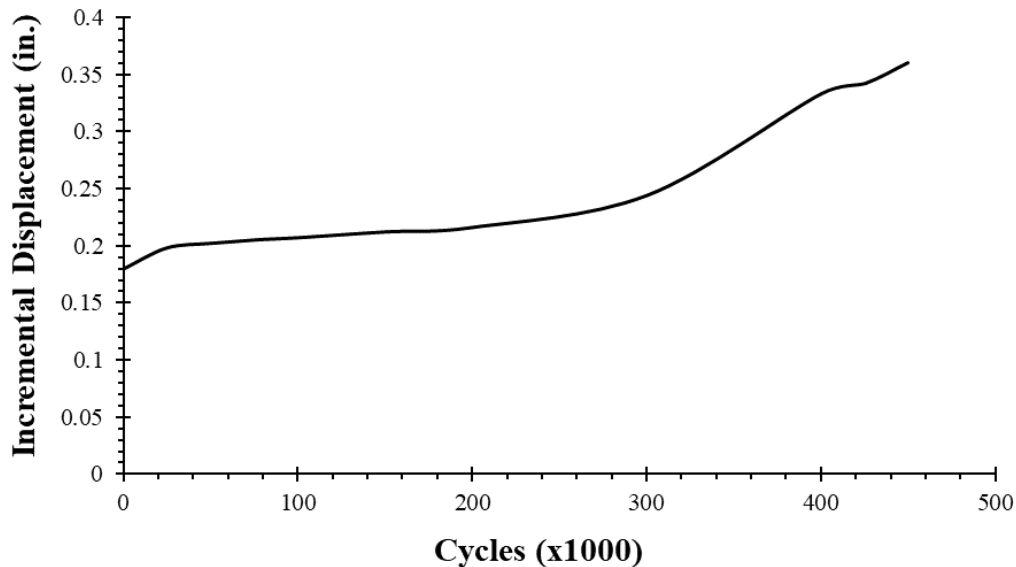
It is clear from comparing the results that the 0.5 in. bolt diameter connections have a shorter fatigue life compared to that of the 0.375 in. bolt diameter connections. Nonetheless, the 0.5 in. bolts are recommended as they are the smallest diameter structural bolt currently specified by the NCDOT, and the expected service life of the retrofit can be calculated according to the tested fatigue life of the bolted connection, as is illustrated in the next Section.

Figure 4.29: Displacement per number of cycles for 0.5 in. bolts at 60 ft.-lbs. of torque.

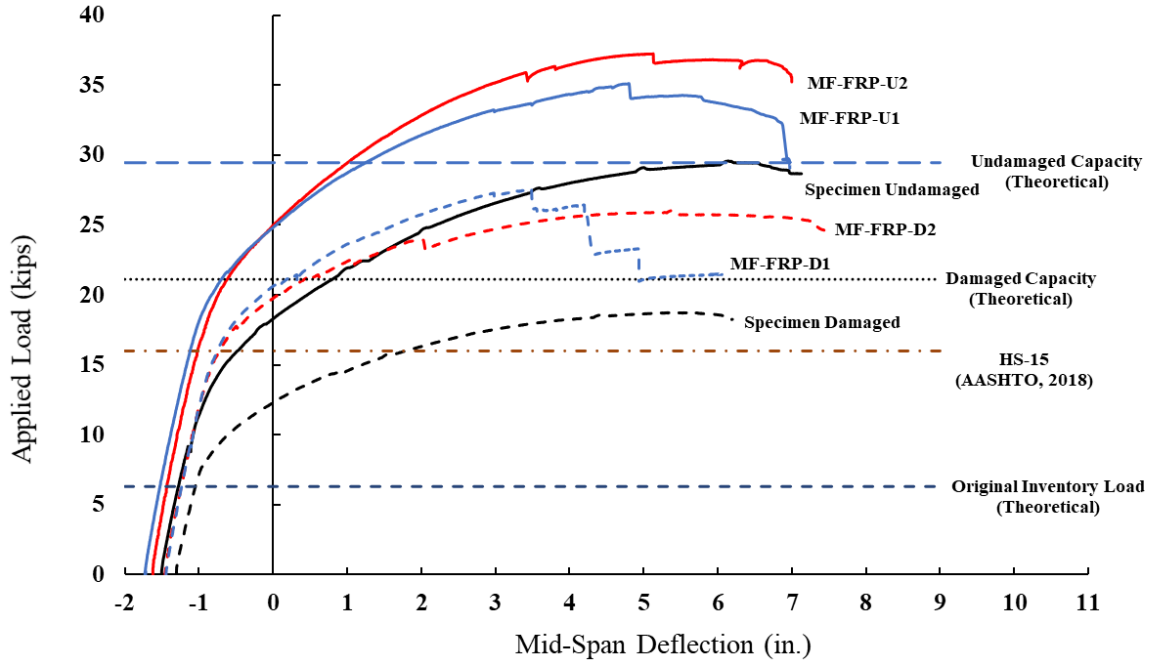
The mid-span load-deflection behavior for all tests is provided in Figure 5.9. Mid-span deflection was determined by averaging the deflection at each stem measured by the two string potentiometers and subtracting the average vertical displacement at the supports measured by the linear potentiometers. The progressive FRP longitudinal splitting and rupture failure of MF-FRP-D1 is visualized in the load-deflection curves (Figure 5.9) with a “stepwise” decrease after ultimate load due to progressive loss in the FRP cross-sectional area. MF-FRP-U1 did not experience incremental FRP rupture but, rather, instantaneous longitudinal splitting and rupture failure just before concrete crushing, which is visualized as an instantaneous drop in load at approximately 7.87 in. of mid-span deflection. The slight drop in load experienced by MF-FRP-D2 at approximately 2 in. of mid-span deflection is likely due slip of the bolted connection between the FRP plate and the FRP connector plate, or the fixed plate and the concrete.

Figure 5.9: Full-scale C-channel beam load-deflection results.
