Mechanically-Fastened FRP to Retrofit Existing Prestressed Concrete Bridge Beams

NCDOT Project 2018-16

FHWA/NC/2018-16

June 2022

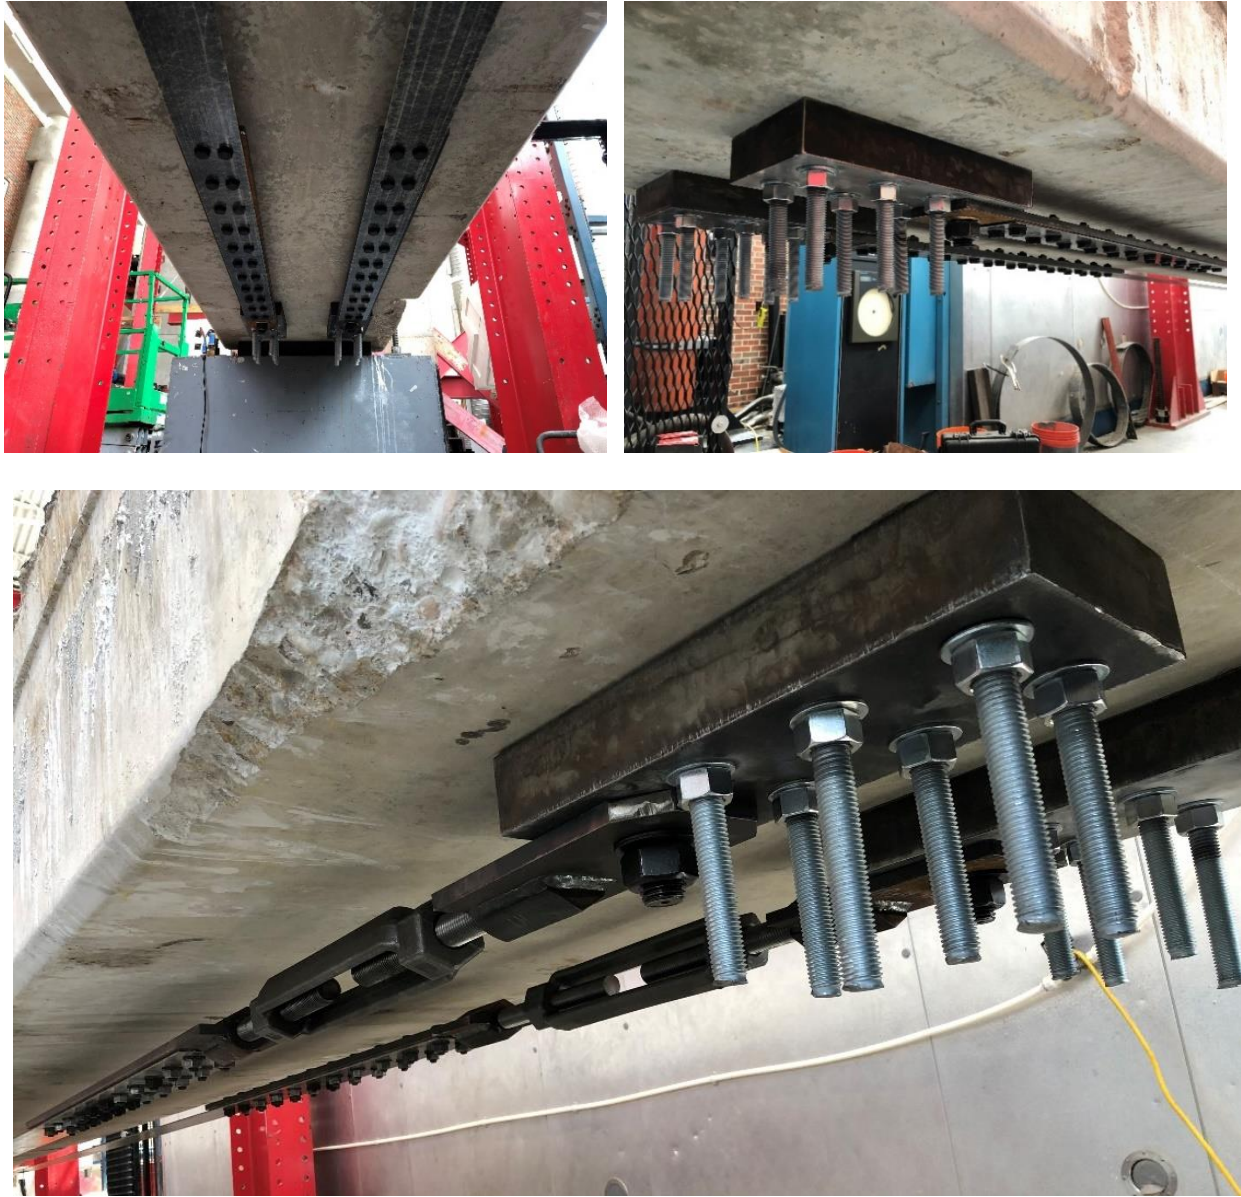
Figure 5.16: MF-FRP retrofit applied on PC cored slab.

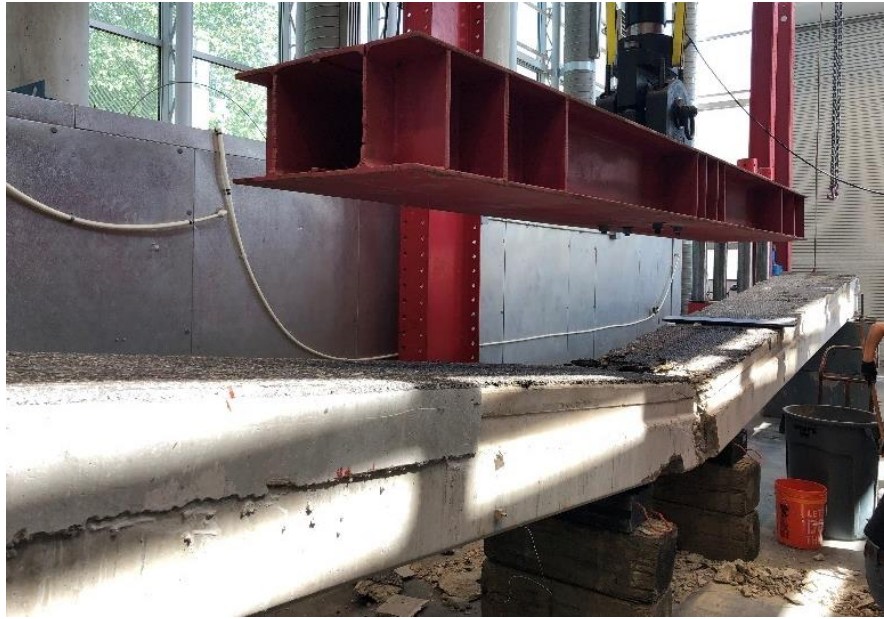
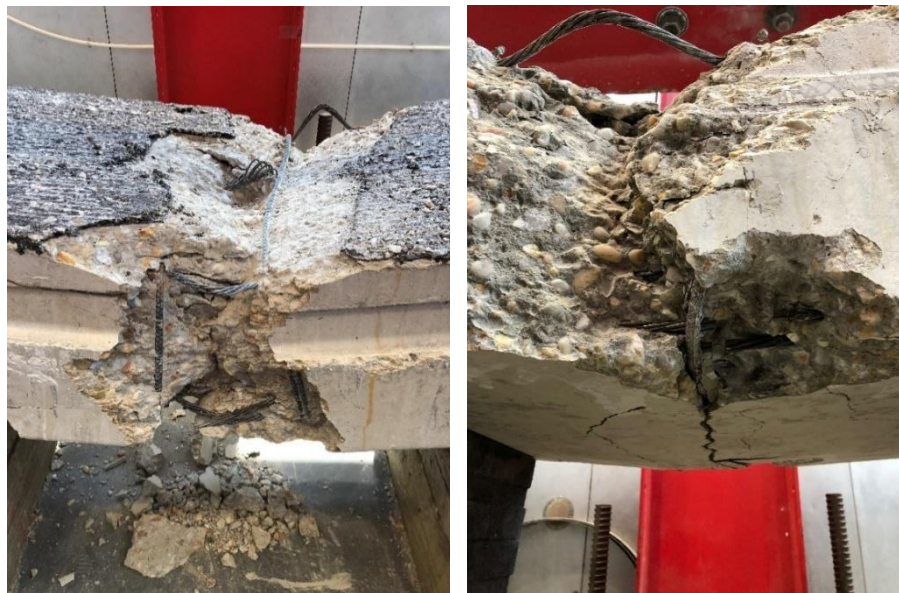
Figure 5.17: Concrete crushing failure.

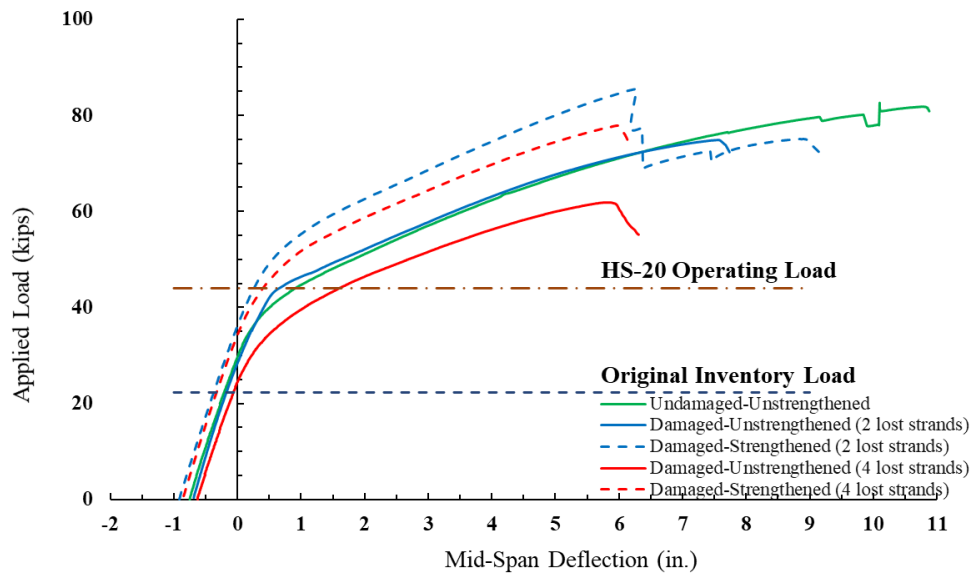
Notes: 1) calculated using Hooke's Law ($E_{FRP} = 9020$ ksi); 2) LS=longitudinal splitting, R=FRP rupture, CC=concrete crushing

**Figure 5.20:** Full-scale experimental results.

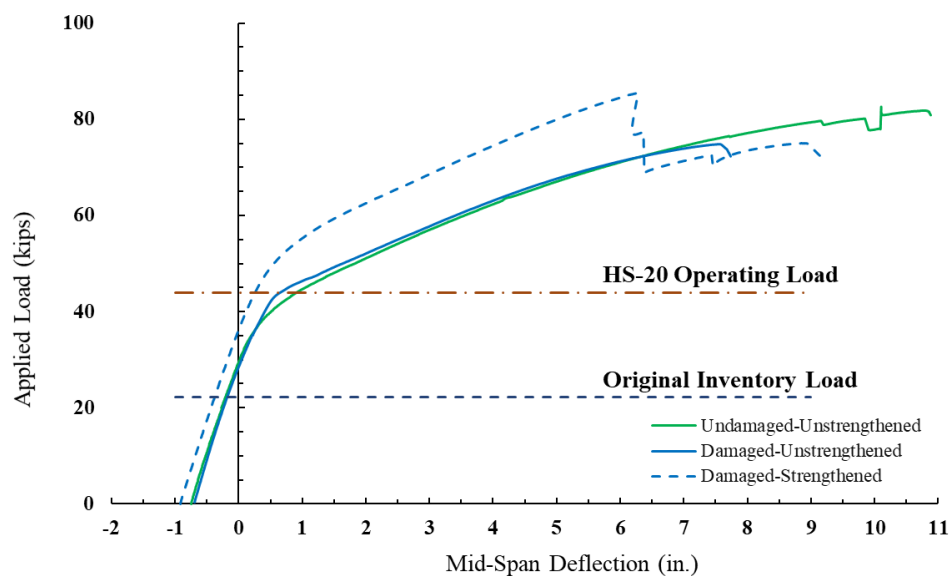
The inventory limit was defined as the point on the load-deflection curve where tensile stresses develop on the bottom concrete layer. For prestressed concrete members, the intersection of the curve with the vertical axis corresponds to the “balanced condition”, where the section is in uniform compression. Some downward deflection needs to occur to “overcome” this compression and before tension is generated at the extreme concrete layers. So, the inventory limit should fall slightly to the right of the vertical axis, at a small positive deflection. This would be the case if the impact factor were to be neglected; consideration of impact shifts the inventory limit down, resulting in it intersecting the load-deflection curve to the left of the vertical axis, at a region of camber. So, in this respect, the limit may seem inconsistent with the definition, but it must be understood that this is due to the impact factor. The most important consideration is that this limit falls well within the elastic region, such that no incremental damage can be incurred by the structure, which is clearly the case here. To facilitate comparison, the graph in Figure 5.20 is separated into two graphs based on level of damage applied (Figure 5.21 and Figure 5.22), each including the control specimen U-U.

Figure 5.21: Full-scale results for 2 lost strands.

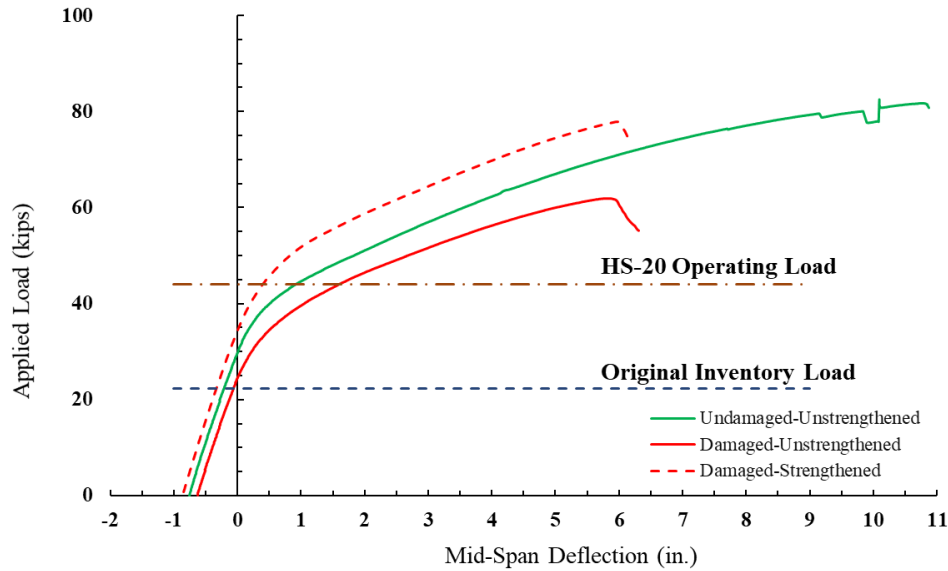
Figure 5.22: Full-scale results for 4 lost strands.

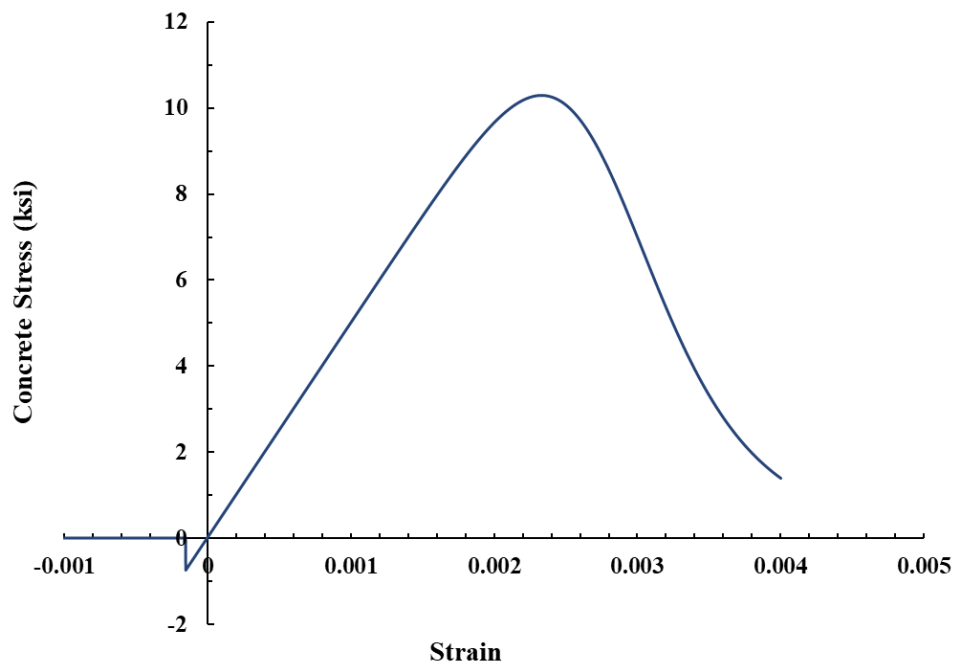
Figure 6.10: Stress-strain relationship for concrete.

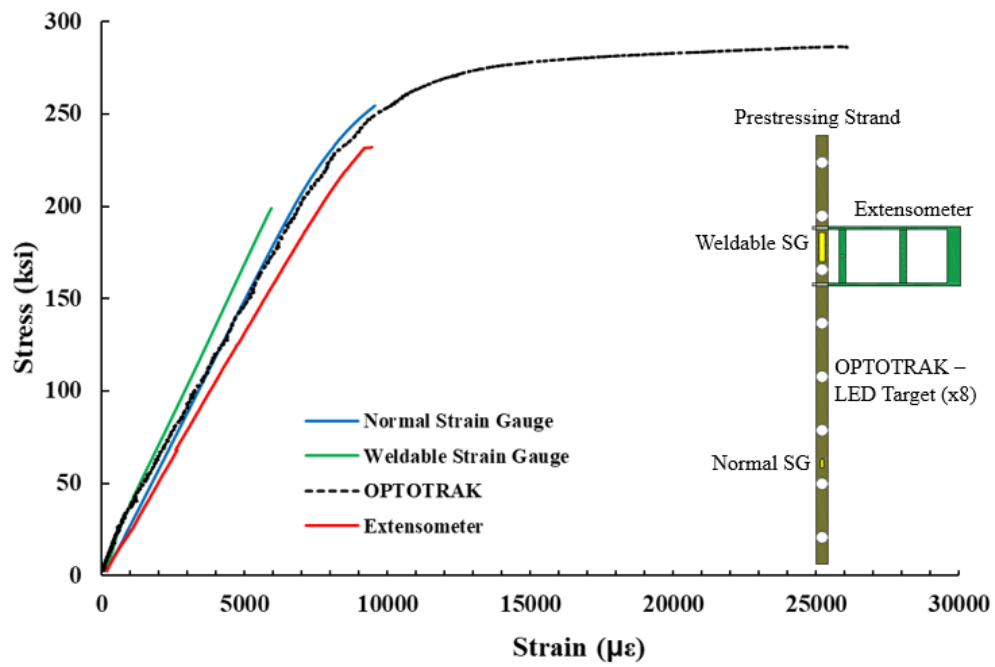
Figure 6.13: Experimental results of one tension test.

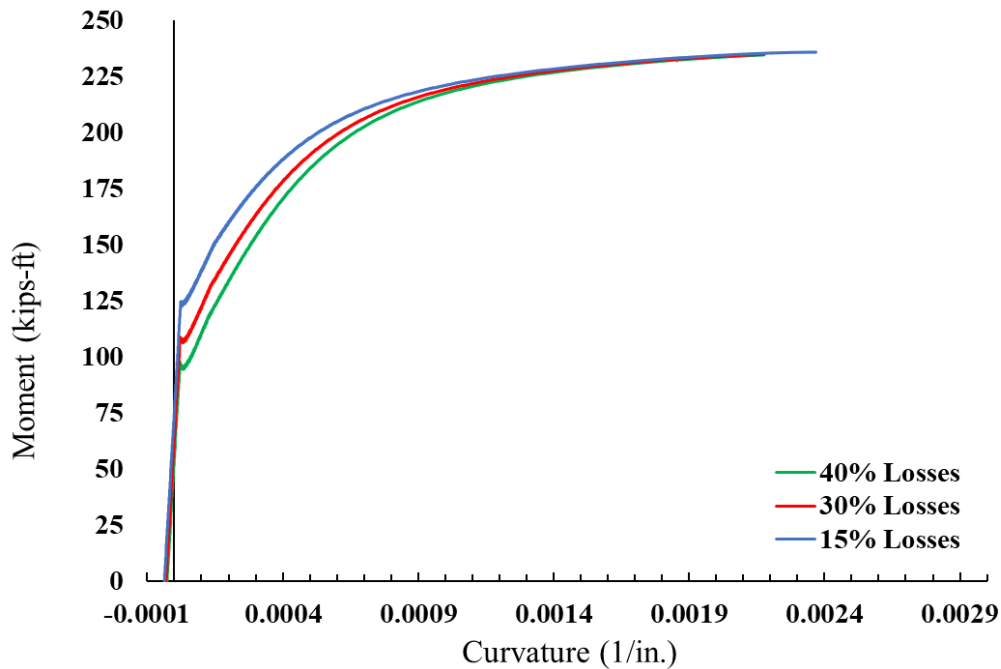
Figure 6.17: Moment-curvature response of mid-span cross-section at different total prestress losses.

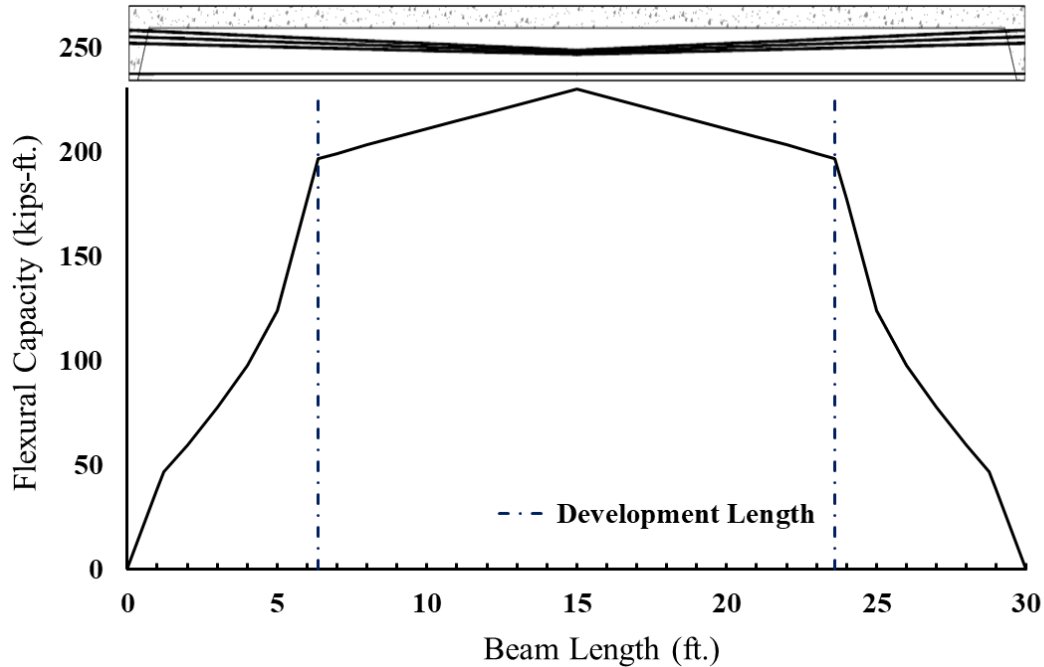
Figure 6.23: Variation of flexural capacity.

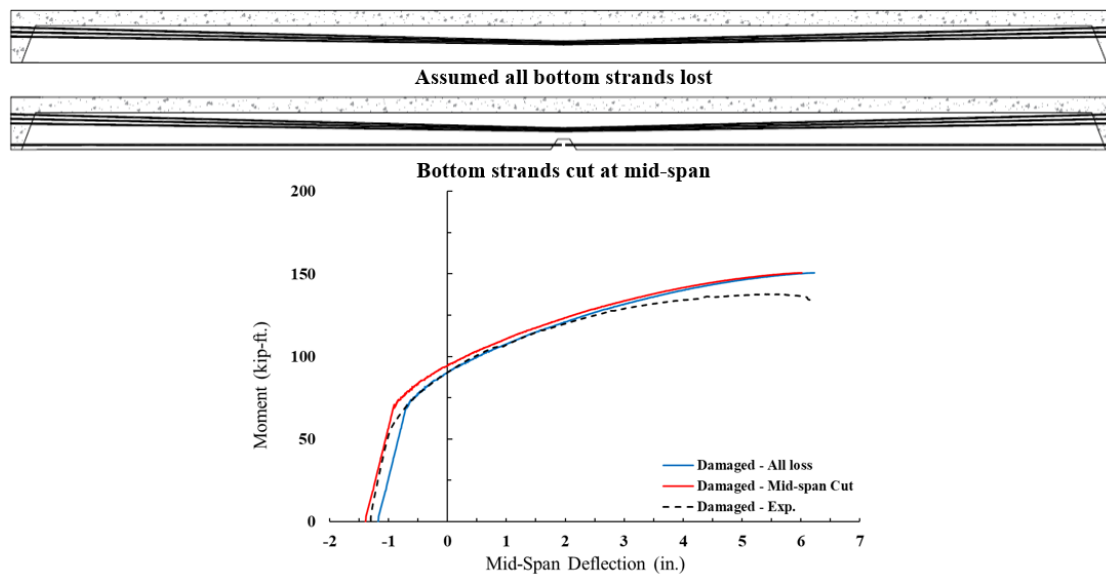
Figure 6.24: Moment-deflection response with different damage conditions.

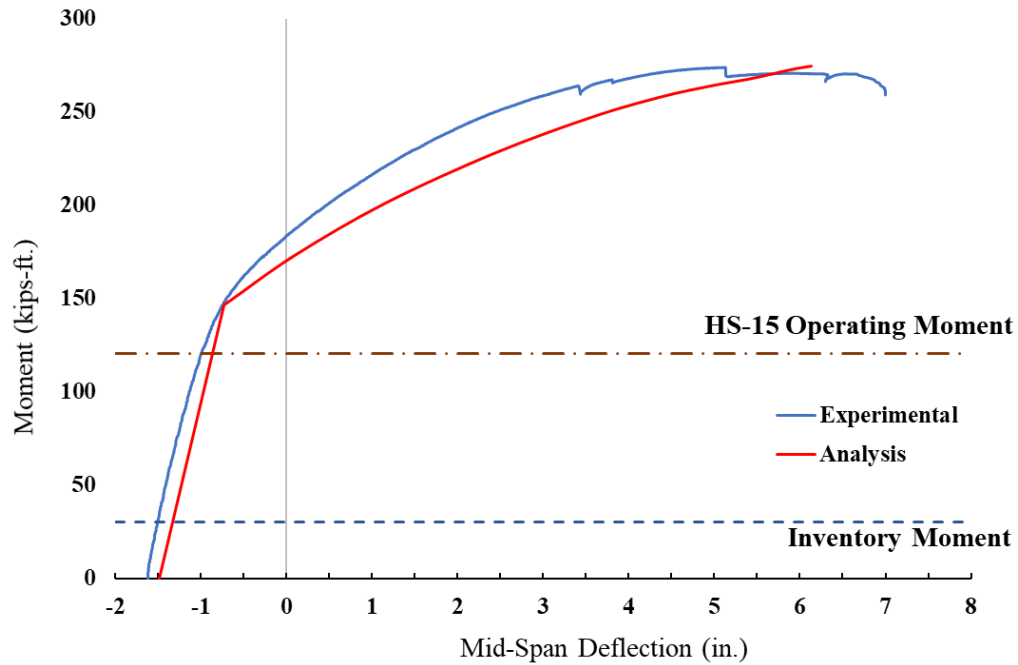
(a) MF-FRP-U2 (repaired, undamaged)

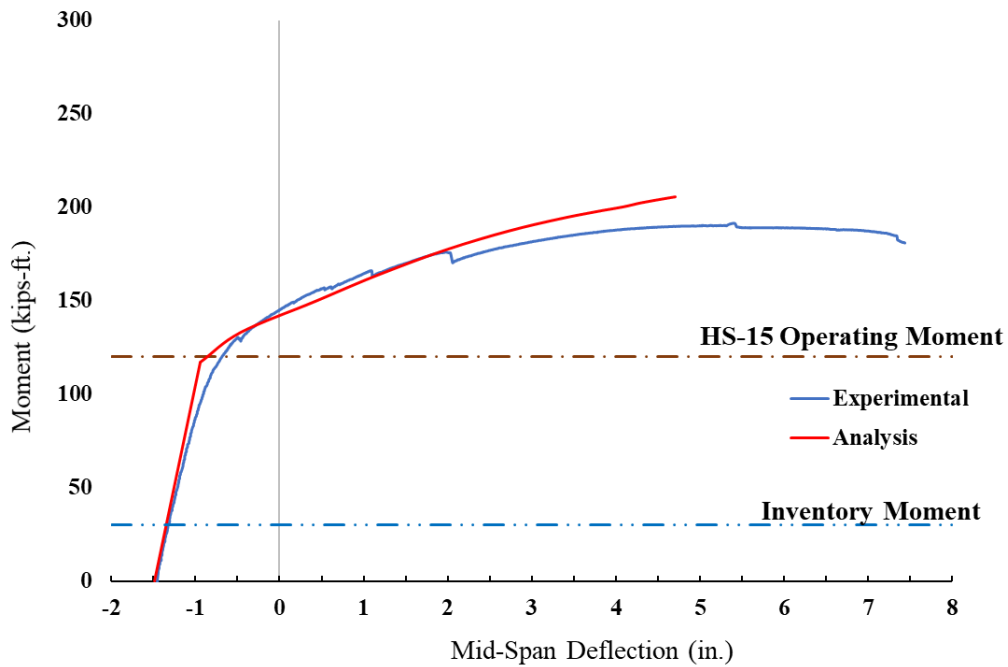
(b) MF-FRP-D2 (repaired, damaged)

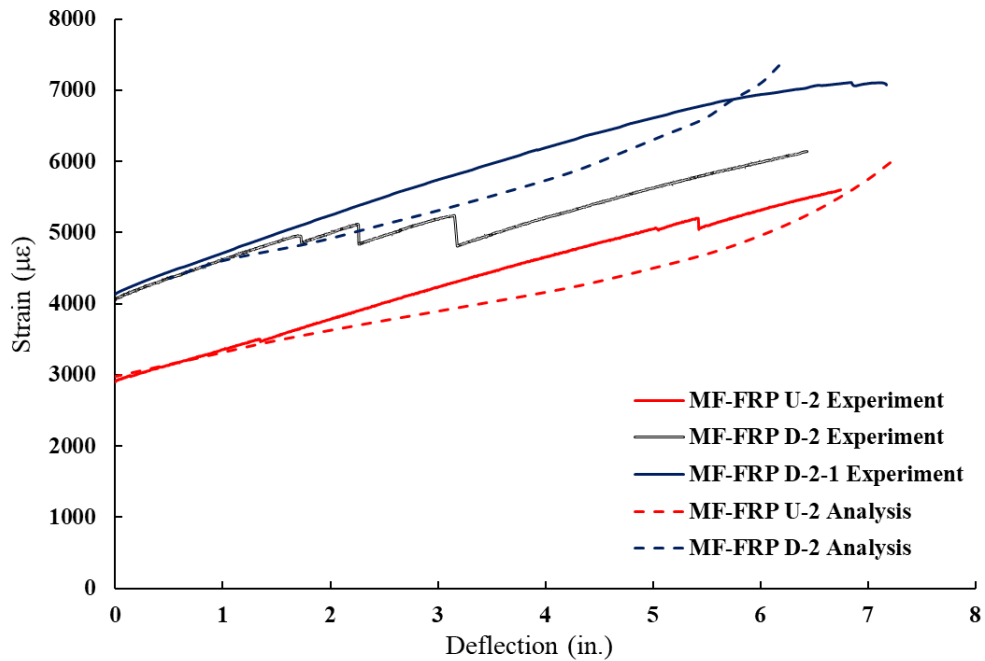
Figure 6.26: MF-FRP strain-to-member deflection relationship of the experimental and analytical results.

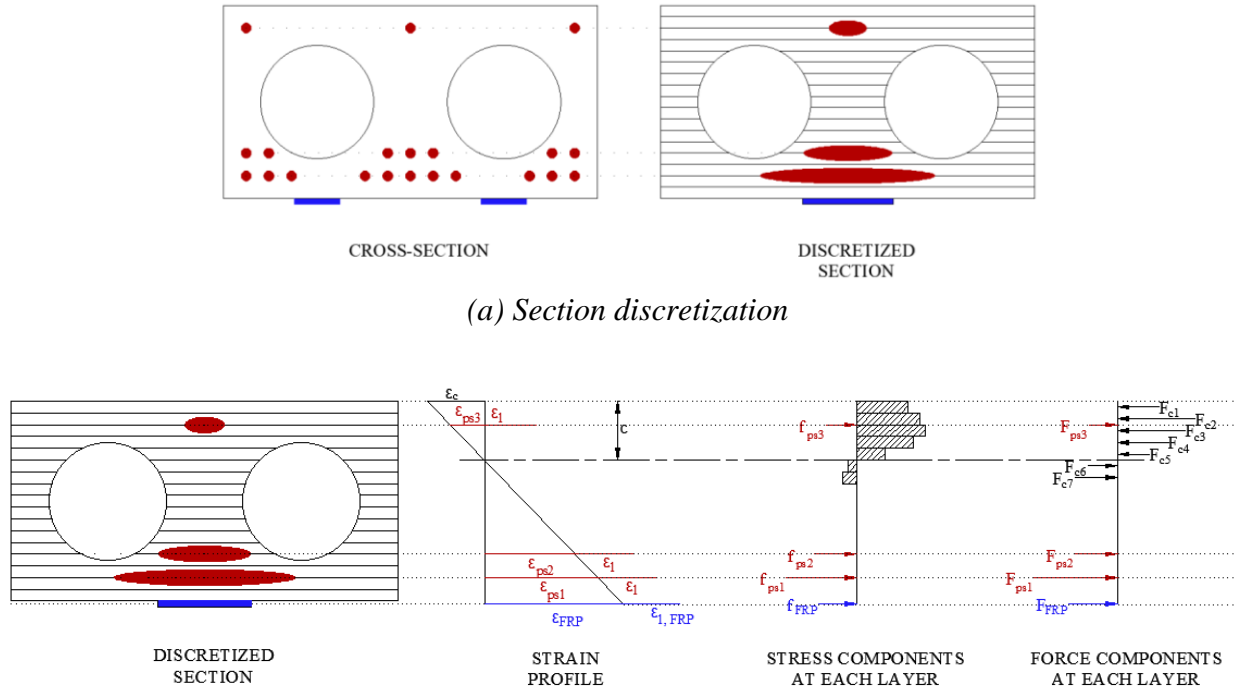
Figure 6.27: Visualization of LSA procedure.

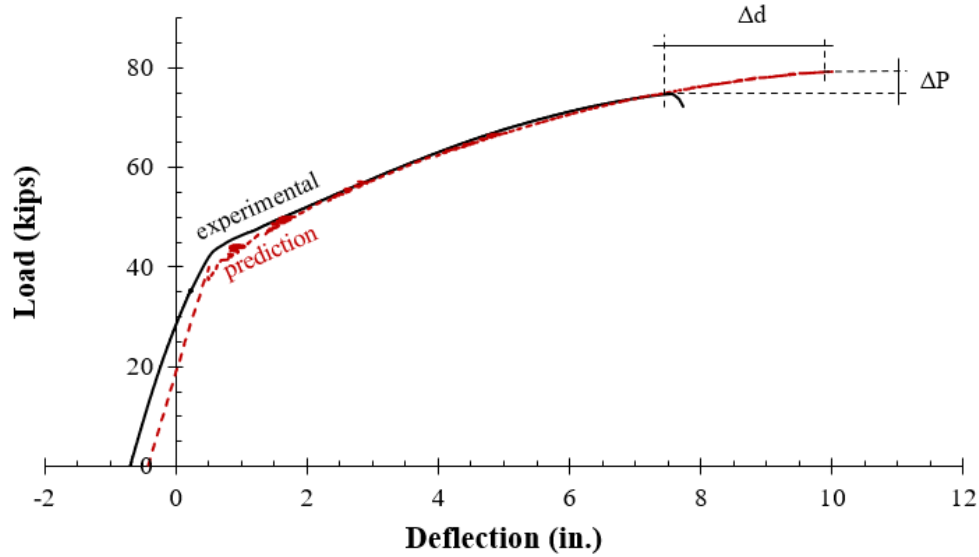
Figure 6.28: Example comparison of experimental result and prediction.

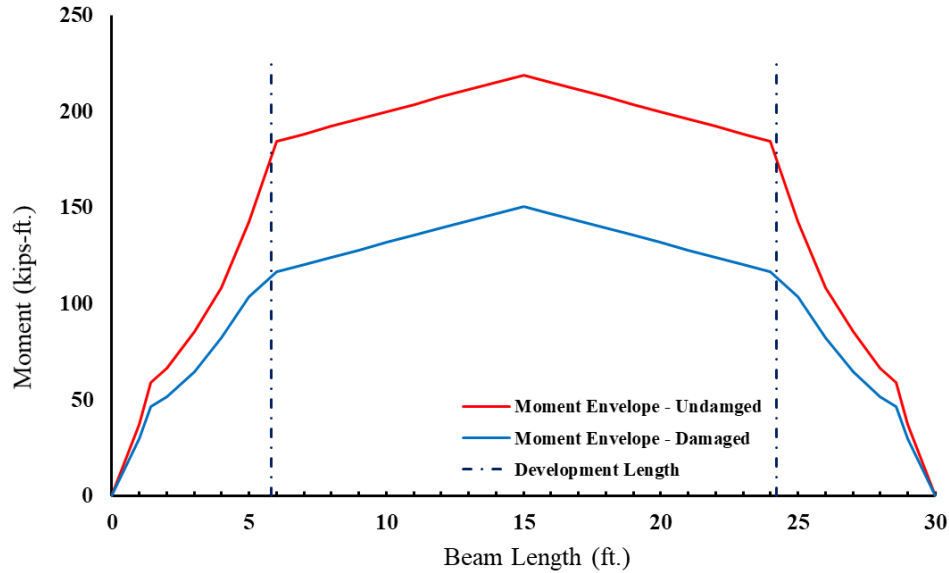
Figure 7.5: Moment envelope of undamaged and damaged C-channel beams.

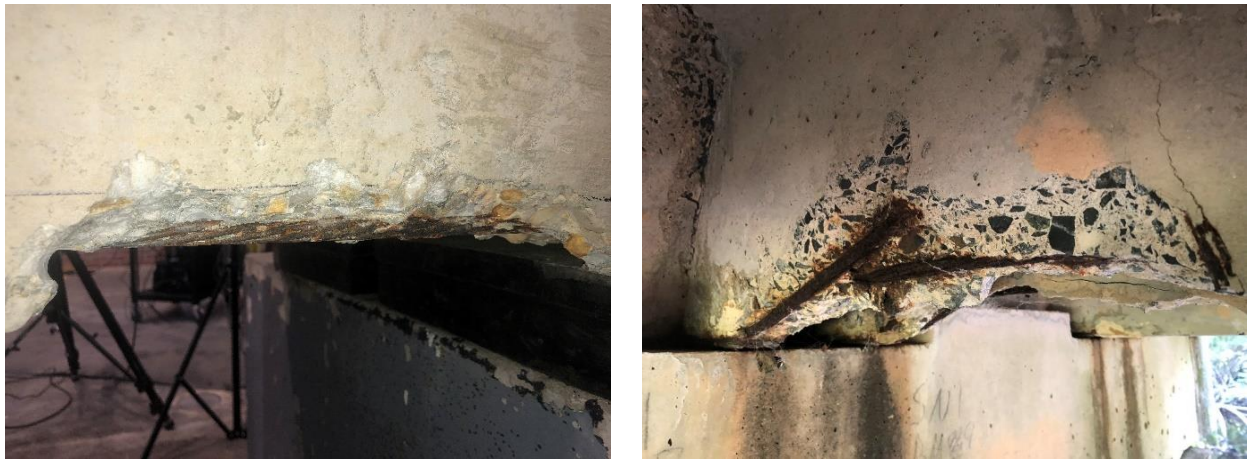
Figure 7.12: Shear damage comparison.

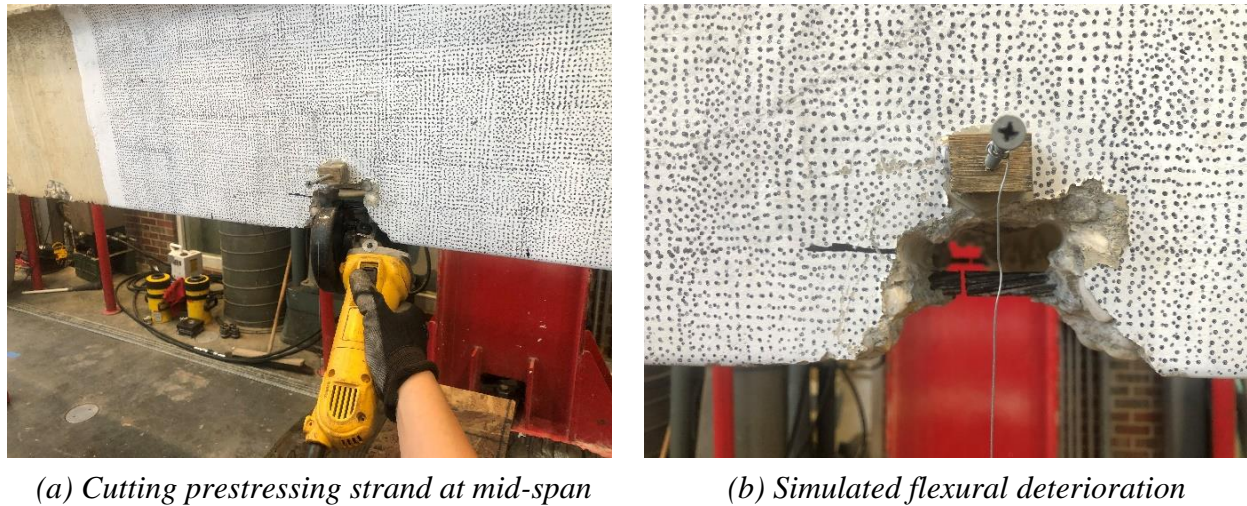
Figure 7.13: Flexural deterioration at midspan.

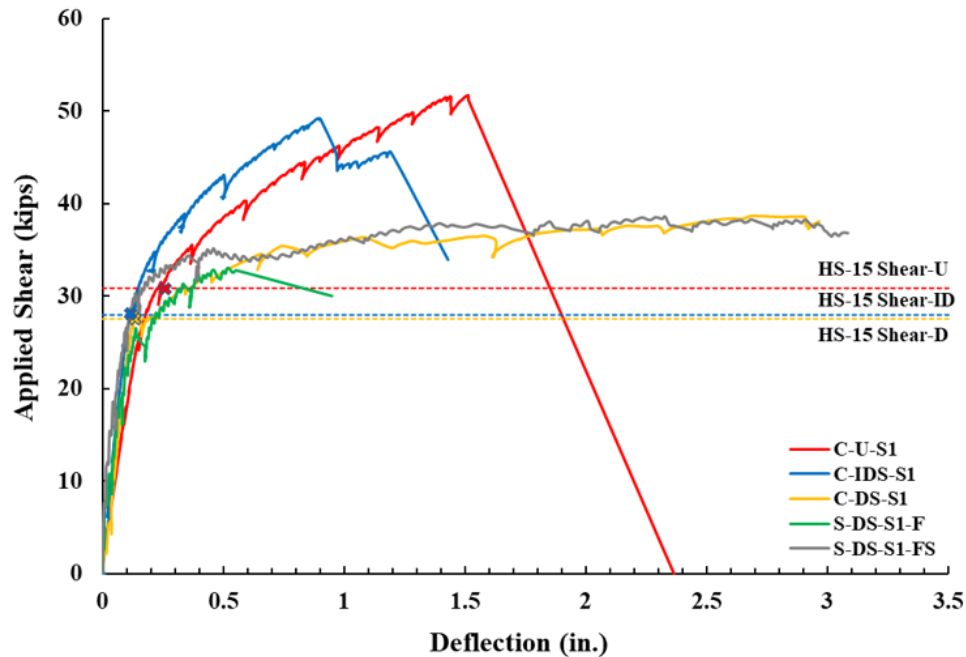
Figure 7.28: Full-scale experimental results (1- point load shear tests).

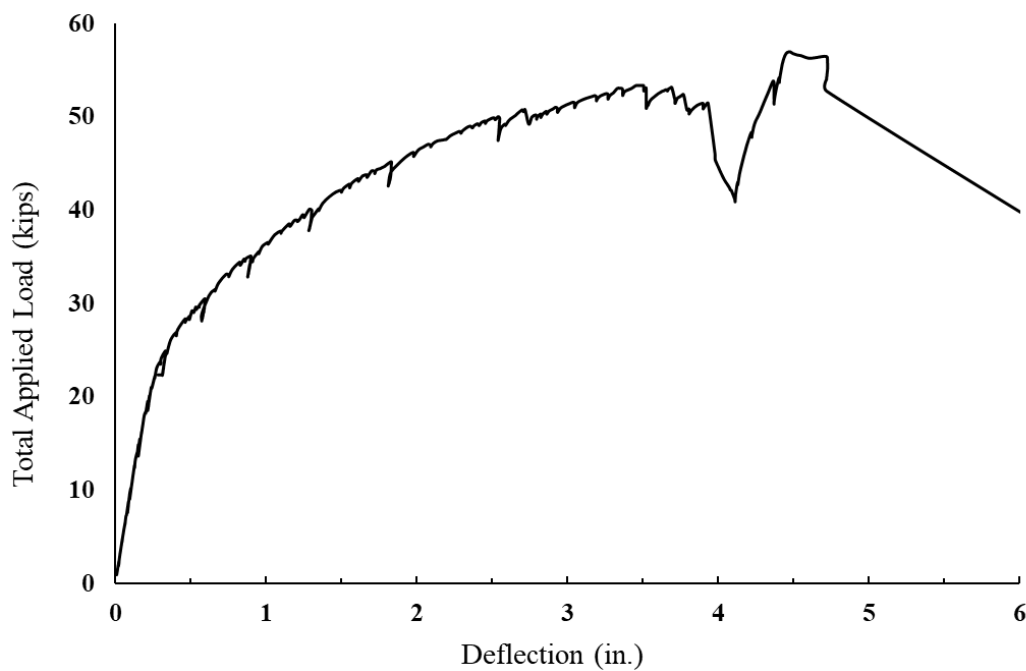
Figure 7.30: Experimental result of C-U-S2.

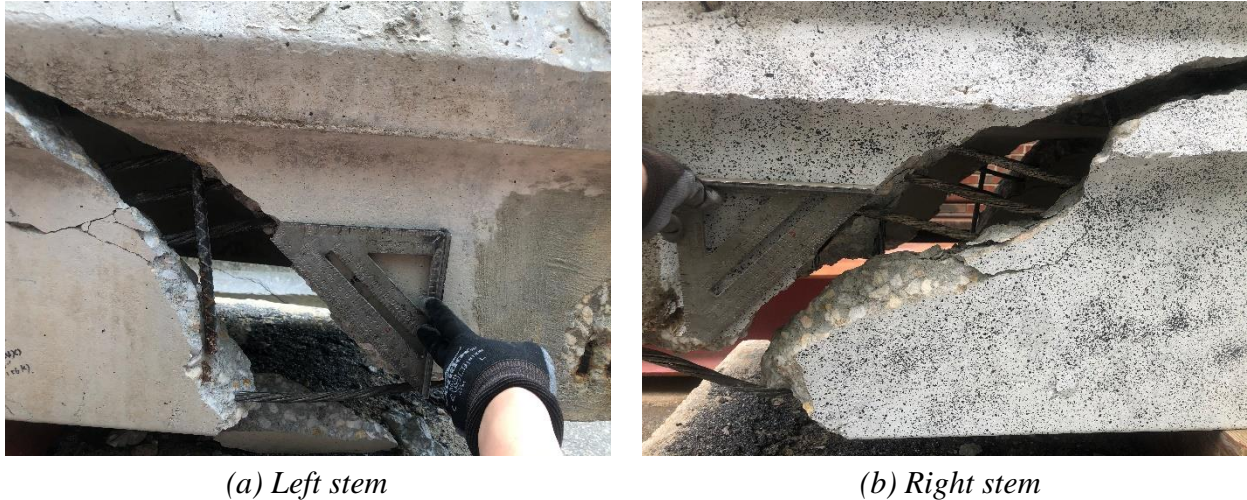
Figure 7.35: Crack angle of C-U-S1 at failure.

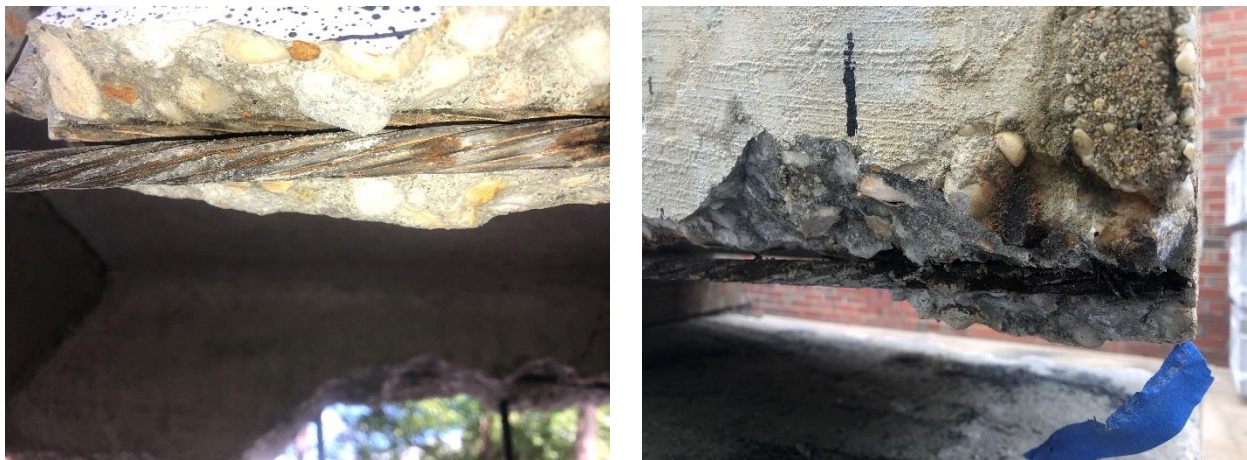
Figure 7.38: Corrosion on the prestressing strand after chipping away the concrete.

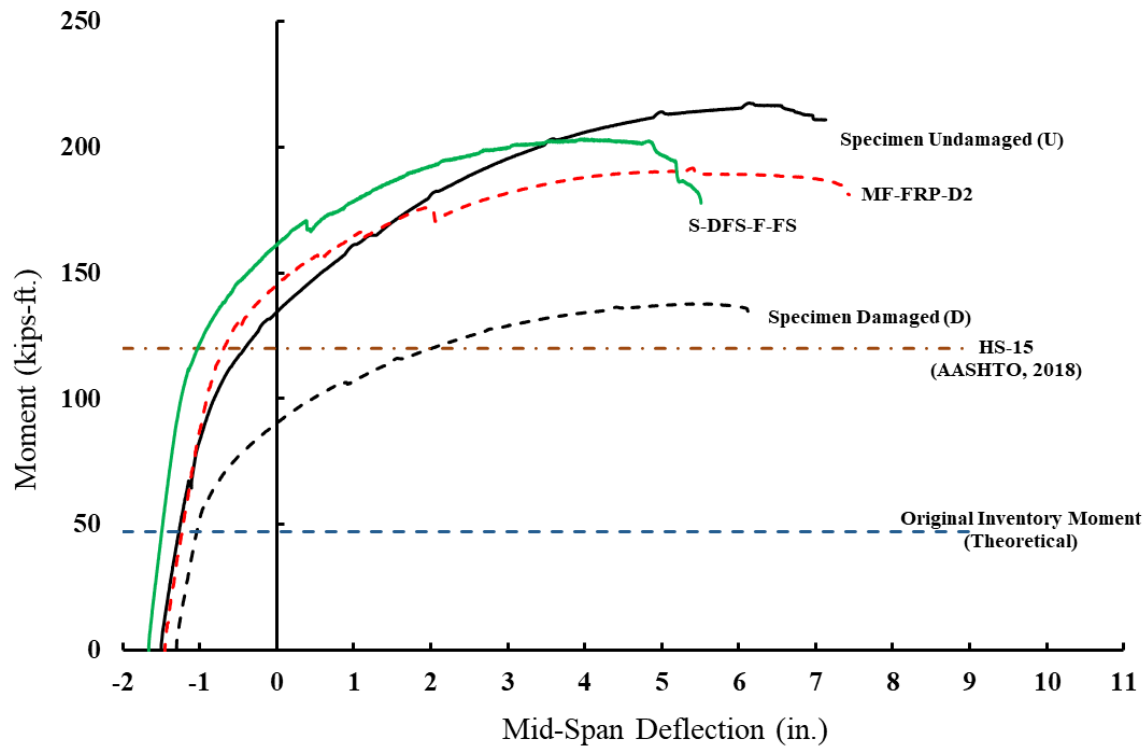
Figure 7.50: Full-scale C-channel beam moment-deflection results.

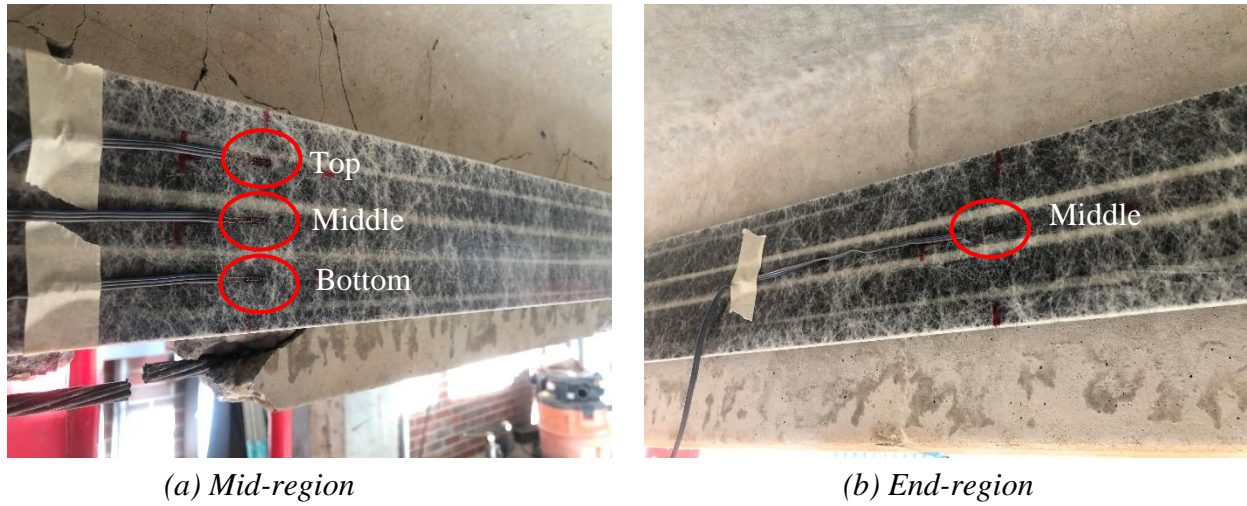
Figure 7.54: Location of strain gauges installed on the FRP plate.

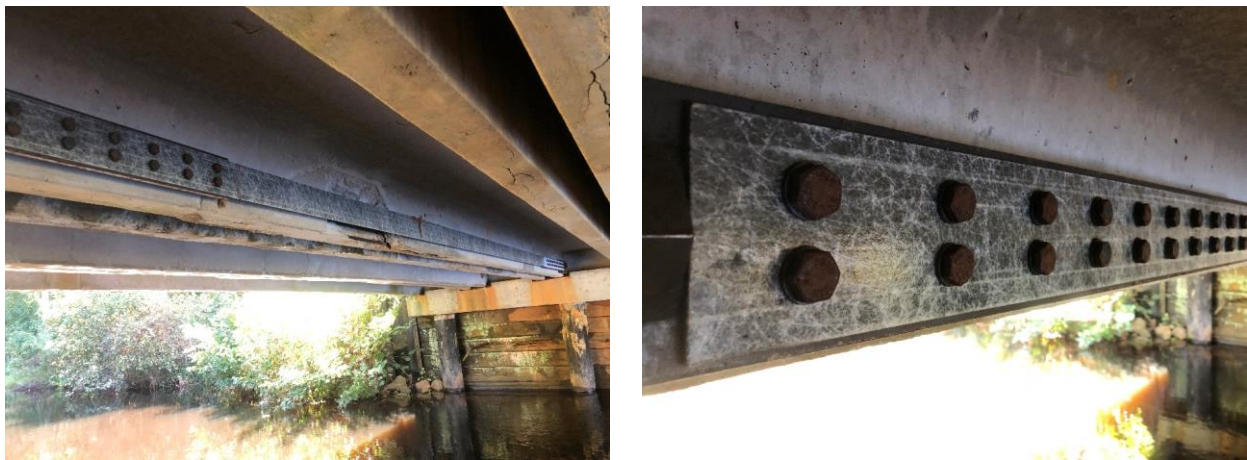
Figure 8.1: Condition of retrofit on Bridge 340080 in Franklin County, NC, after 18 months in-service.

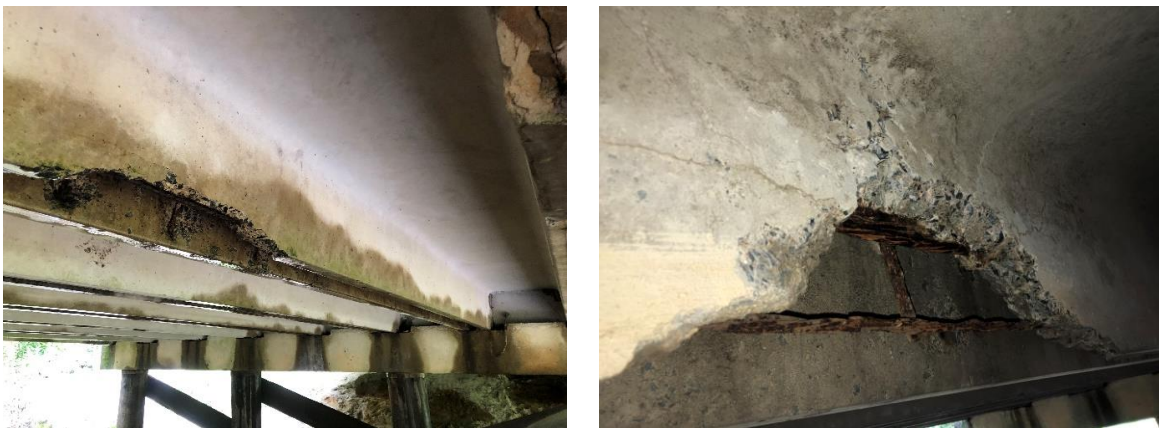
Figure 8.3: Concrete spalling and exposed prestressing strands near mid-span.

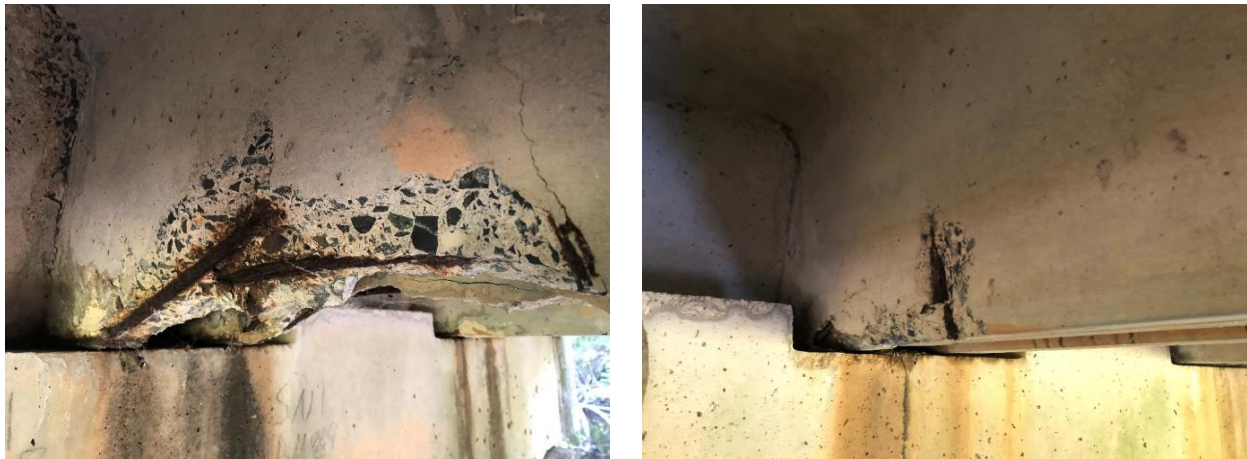
Figure 8.4: Loss of concrete section and exposed prestressing strand and stirrup at end regions.

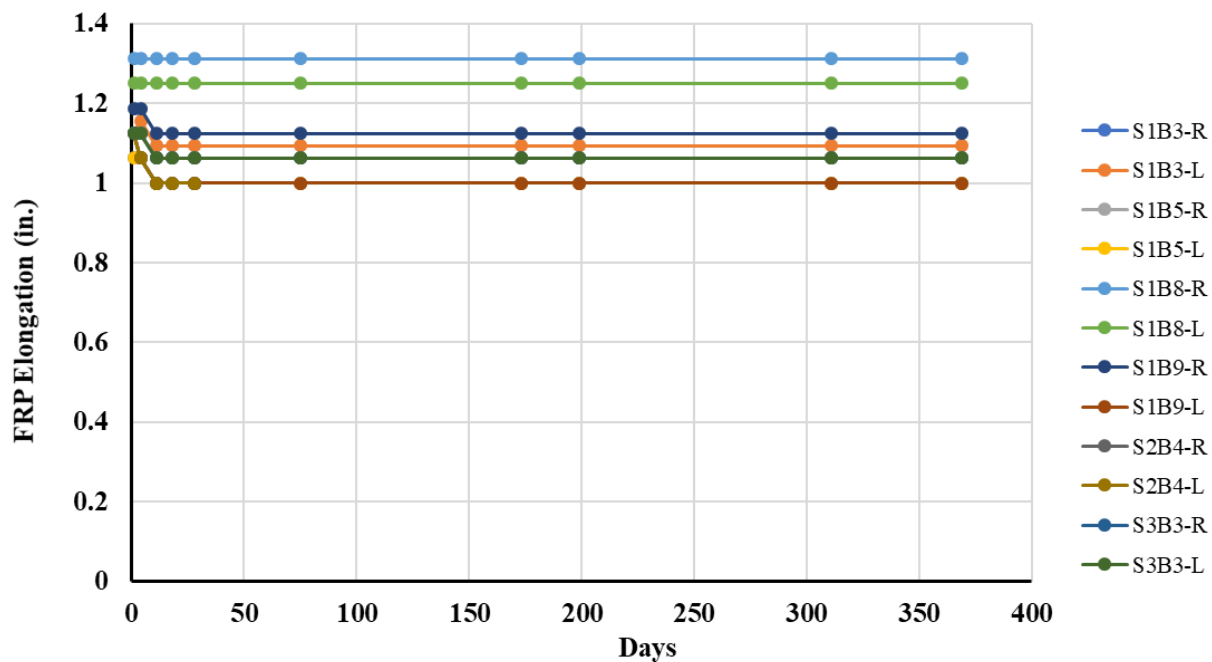
Figure 8.12: Measured FRP elongation after installation.

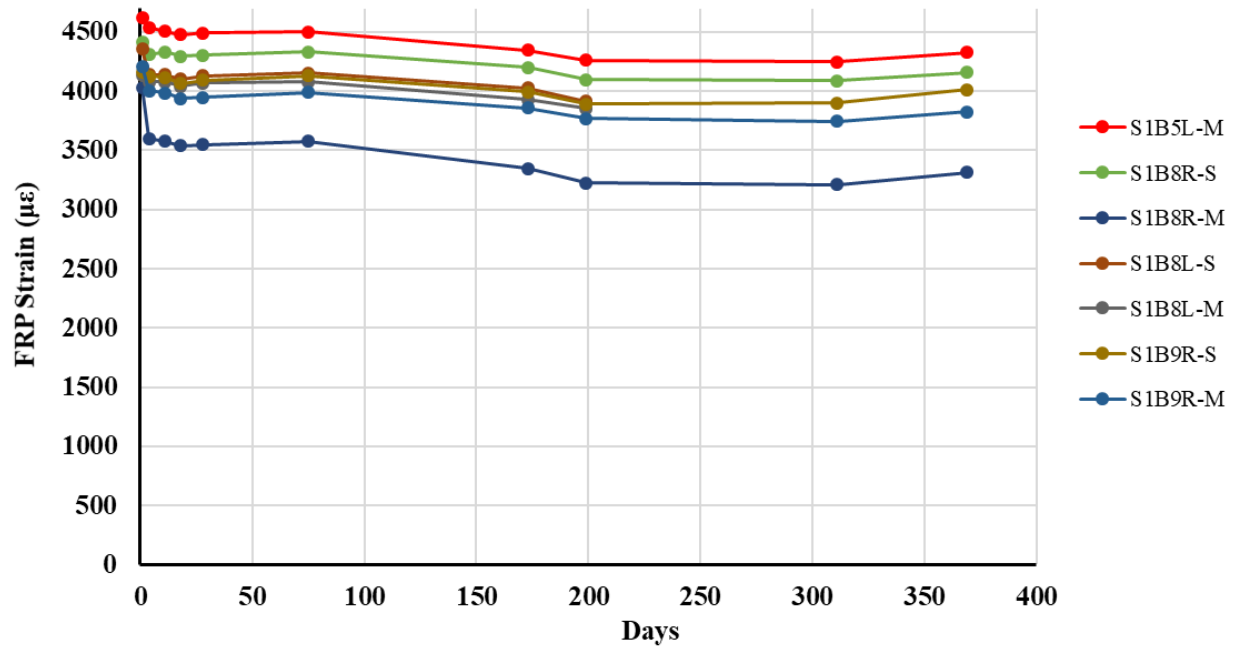
Figure 8.13: Long-term monitoring of FRP strain.

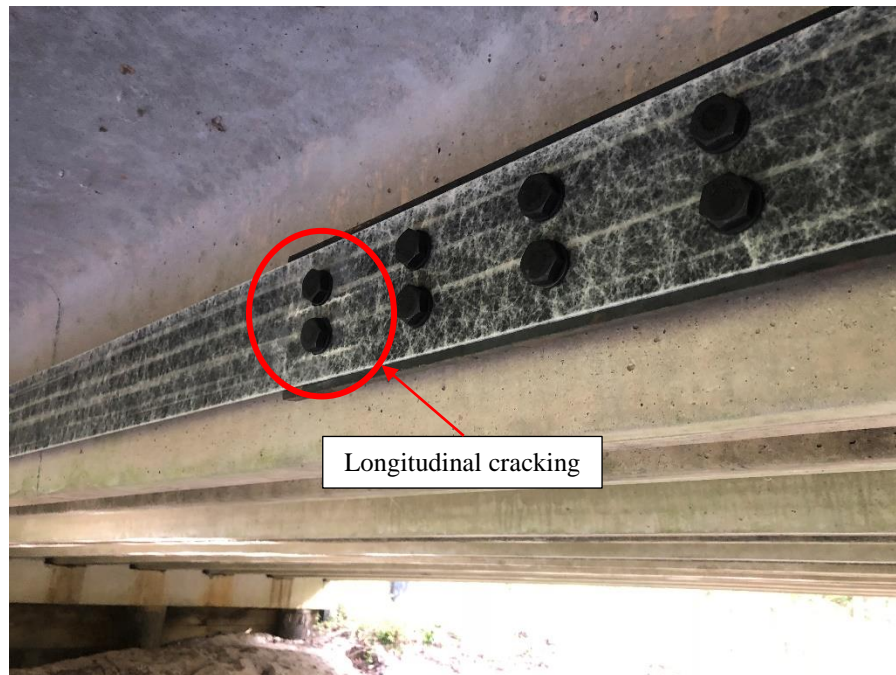
Figure 8.17: Longitudinal cracks on MF-FRP plate.

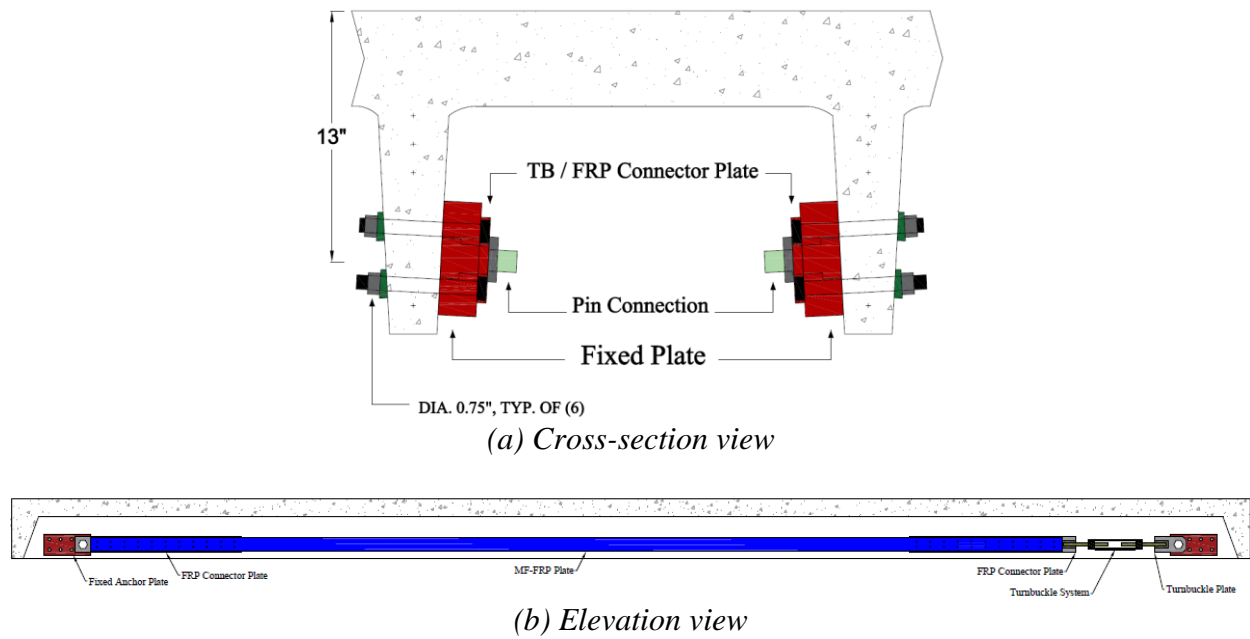
Figure A.1: MF-FRP repair system installed on typical C-channel beam.

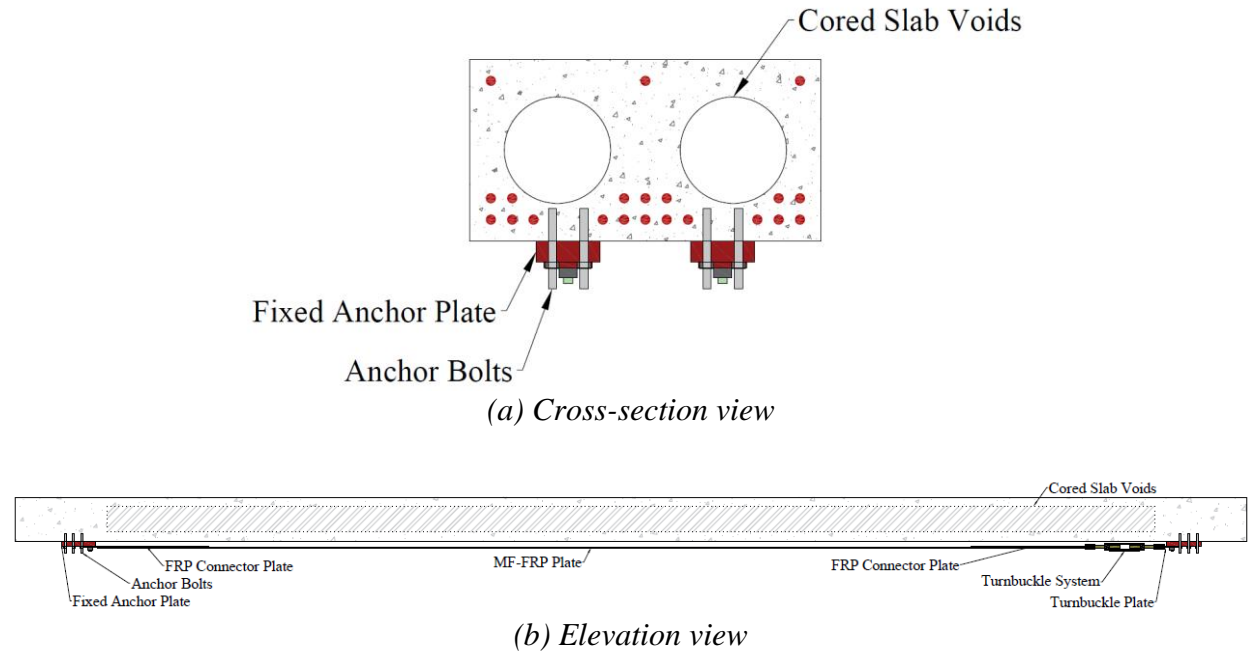
Figure A.2: MF-FRP repair system on typical cored slab.
