Mechanically-Fastened FRP to Retrofit Existing Prestressed Concrete Bridge Beams

NCDOT Project 2018-16

FHWA/NC/2018-16

June 2022

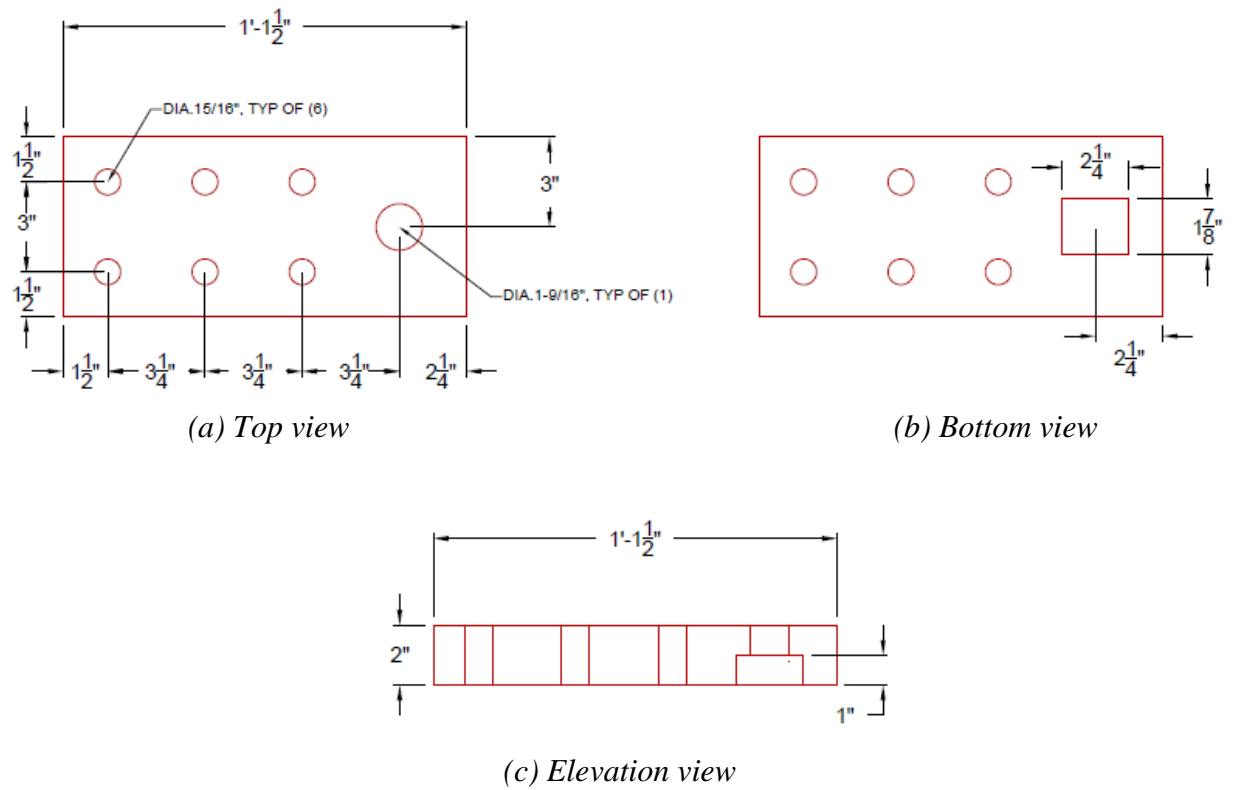
Figure A.3: Fixed anchor plate design detail.

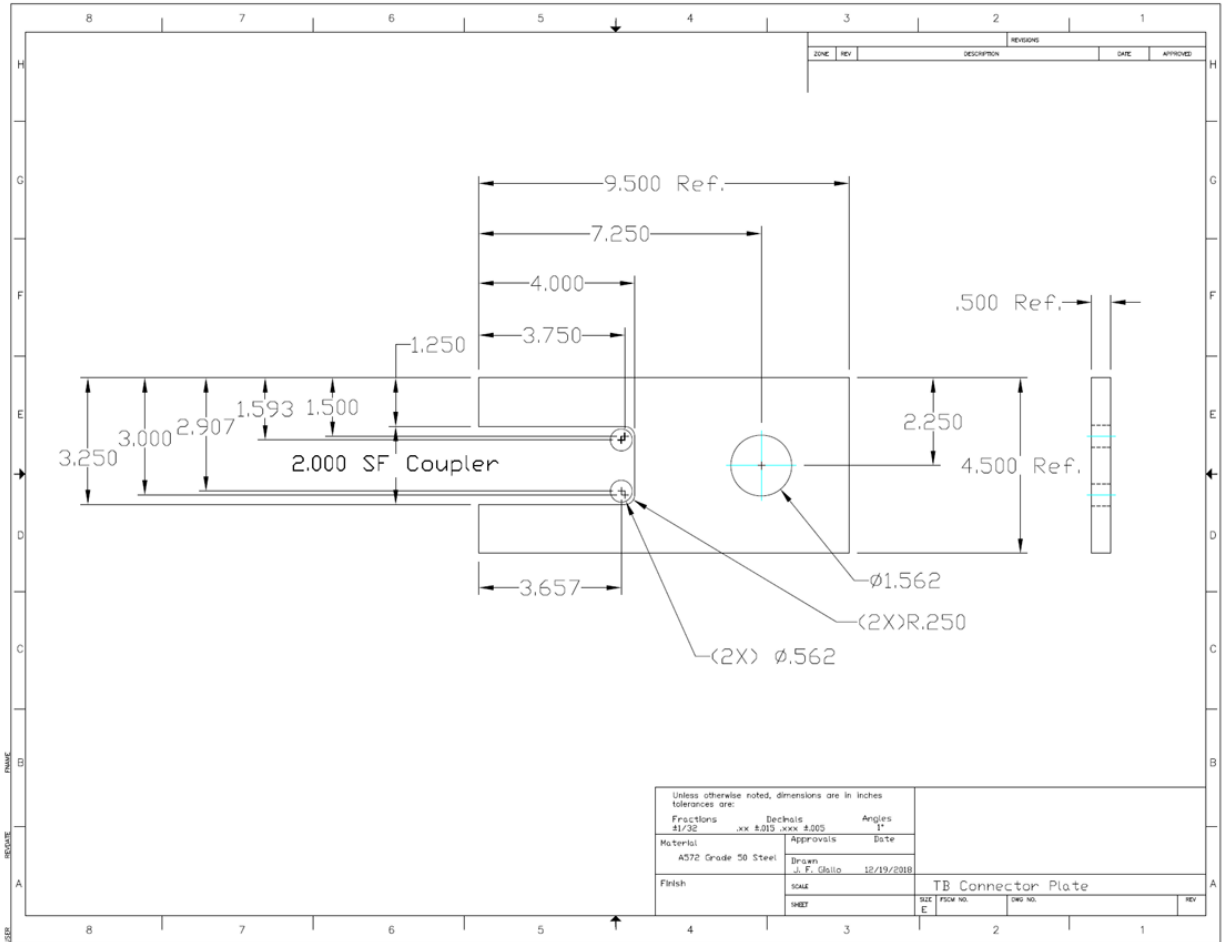
Figure A.14: Turnbuckle (TB) plate machinist as-built drawing.
