TT2019-24 -Work Zone Intrusion Alert System Technology Tests

NCDOT Project TT2019-24 FHWA/NC/2019-24 June 2022 Work Zone Intrusion Alert System Technology Tests

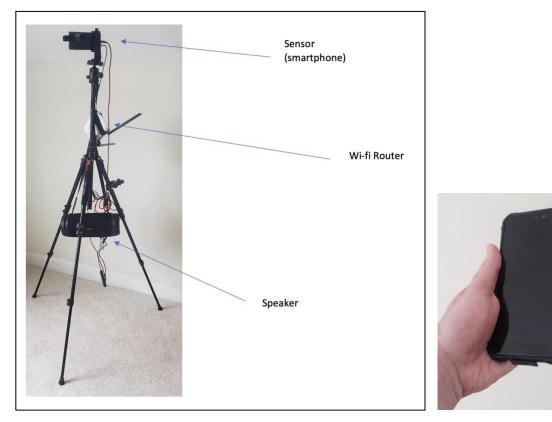
Figure 1 Prototype system and the personal alert device

This chapter describes the prototype system developed by the author and that was tested in this project. The prototype is a portable battery-powered system that detects intrusion events in the selected parts of the work zone and generates audible alarms when intrusion incidents occur. The system also relays alerts to smartphone devices worn by the workers to augment the alarm effectiveness. The prototype's image and the main components are shown in Fig. 1. The components of the system are mounted on a tripod and a portable alert receiver was also included in the tests. The technical characteristics of the prototype are summarized in Table 1.

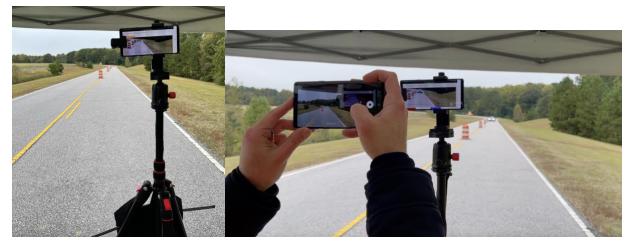
Figure 3 Tests at TIM Training and Development Track

The project team conducted safe intrusion experiments at TIM Training and Development Track that is located on 380 East Tryon Road in Raleigh, North Carolina (Fig. 3) (Ozan, 2020). The facility contains a set of roadways that are isolated from the public traffic. For the purposes of this research report, a safe intrusion experiment is defined as emulation of work zone intrusion incidences in a safe and controlled environment. In such a setting, a simulated intrusion event is created by using a vehicle driven by a crew member, enabling researchers to observe the safety device's reaction under different parameters and scenarios.

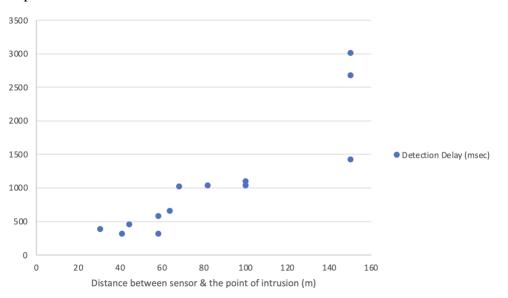
Figure 4 Detection Delay vs. Distance from the Intrusion Incident

The experiments were conducted between 9 AM and 12 PM on November 4, 2021. The weather condition was mostly cloudy with intermittent light rain. Wind and temperature were reported as NE 8 mph and 48/45 F respectively. For the safe intrusion experiments, a work zone was setup. The work zone featured one lane closure on a two-lane roadway. During tests two lengths of road closures were employed: 100 m and 150 m. Intrusion events were simulated with a vehicle travelling at various speeds, ranging between 35 mph and 70 mph, and entering the closed off area at various distances from the sensor. Table 2 shows the detection delays versus distance of the intrusion entry point into the restricted area and the camera. The delays ranged between 320 ms and 3,010 ms. The results showed that for the distances that are longer than 60 m, the device produced long delays. Careful analysis of the findings indicated that the algorithm cannot detect vehicles unless they occupy roughly around 30% of the vertical length of the frame. Therefore,

to reduce the delays to acceptable levels, optimal amount of digital and/or optical zooming must be applied. That ensures sufficiently large images of the intruding vehicles can be captured by the camera. Significant delays in alerts generated on personal devices were observed. Those delays ranged between 1.5 seconds to 2.6 seconds. Analysis of the software code that generates personal device alerts indicated that the delay could be reduced significantly by algorithmic improvements.

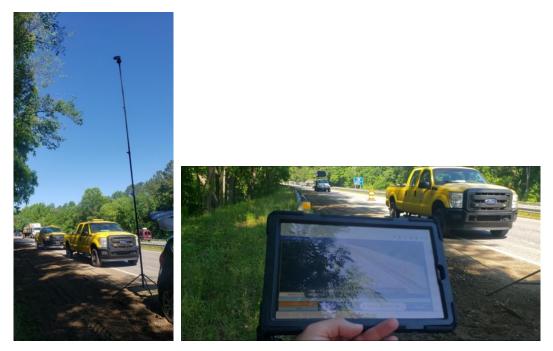
Figure 5 20' tripod stand mount and controlling the sensor via a tablet device

It is not feasible to observe the frequency of missed alarms through actual work site tests since intrusion incidents are relatively rare events. The following provides a summary of the qualitative observations recorded during the tests conducted at work zones. The most critical aspect of the work site is whether the roadway and its surrounding are conducive to establish a camera position where a direct line of sight can be obtained to monitor the target area. During Field Test 2 and Field Test 3, that turned out to be challenging since the camera view of the target segments within the closed-off road segment was obstructed by trees and by work vehicles. This issue is likely to be the case in many work sites. The solution to this problem is to position the camera further away from the active work area, closer to the target monitoring area. However, that solution would require a reliable and effective wireless data connection between the sensor and the alarm unit since alarm should be close enough to workers to ensure audibility. Alternatively, a high-power siren can be used to alert the workers. During the tests, three different camera mounts were employed: a regular tripod; a 20' tripod stand; and a magnet mount. The advantages and disadvantages of each mount type are summarized in Table 12.

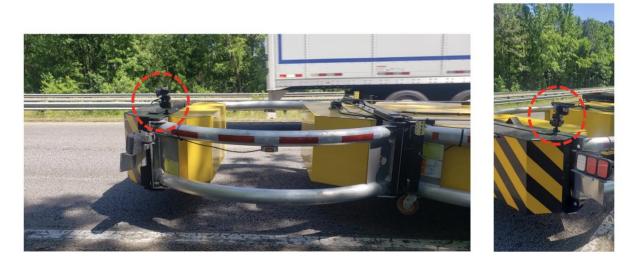
Figure 6 Mounting the sensor on crash attenuator

Magnet based mount proved to be very practical to use. It provided a stable platform, and it was found to be more resistant to winds than tripods. When the magnet was attached on a truck's roof, a secondary device (a tablet) was used to control the camera and setup the polygon. The data connection between the secondary device and the main camera unit worked effectively and allowed the operation of the device from about 20 m maximum. In a moving work project, a magnet mount has benefits. It would not require the setup of the tripod every time crew moves. The camera unit can be mounted on a work vehicle, and it would be moved with other equipment without requiring additional efforts to moving and adjusting the tripod. Fig. 6 and Fig. 7 show two different placement of the magnet mounted sensor: on crash attenuator and a truck.

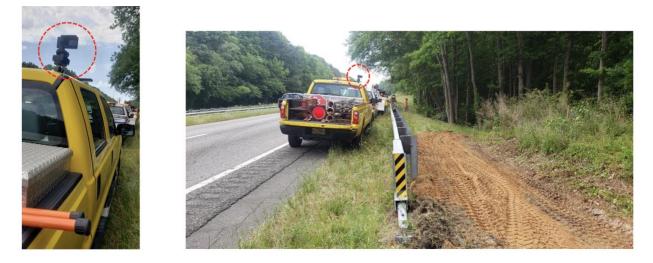
Figure 7 Mounting the sensor on work vehicles

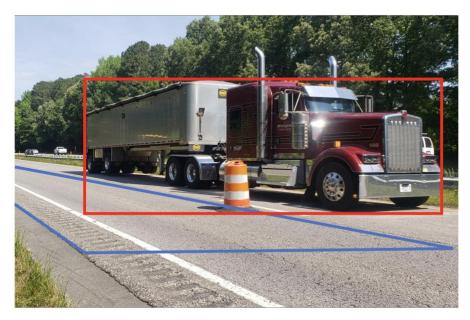
Figure 8 Illustration of a condition triggering a false alarm

Field tests were instrumental in identifying the conditions that trigger false alarms. A typical case where a false alarm is generated is illustrated in Fig. 8. False alarms are possible in the following typical condition. The vehicle detection algorithm of the prototype identifies a rectangular box that encloses the detected vehicle (shown with the red colored rectangle) in the image. In Fig. 8, the blue lines indicate the polygon area that is monitored by the prototype. In the case presented in Fig. 8, an alert is generated because the rectangle area intersects with the polygon area, although the vehicle does not intrude the restricted area. These types of false alarms are more

prominent when the camera target close by vehicles and usually the roadway angled less than 45 degrees as illustrated in the Fig. 8. Recommended usage is to target the roadway portions typically located more than 50 meters away from the sensor, which should alleviate the issue.
