Development of Tools and Guidance for Damage Assessment of Prestressed Concrete Girder Bridges

**NCDOT Project 2023-06
FHWA/NC/2023-06
December 2025**

Nicole Braxtan, Ph.D., et al.
Department of Civil and Environmental Engineering
University of North Carolina at Charlotte

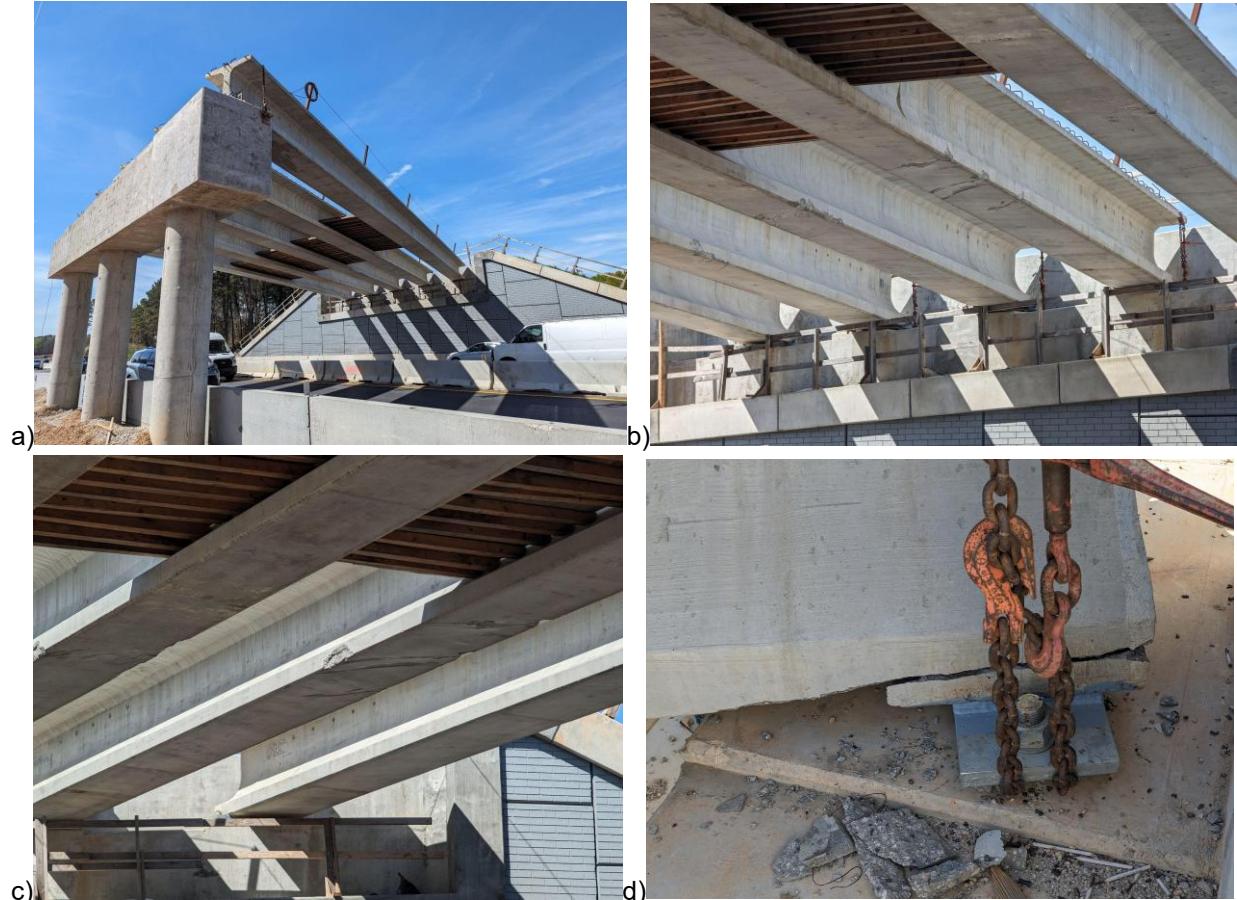
Figure 3.4. Photographs of partially constructed bridge subject to accidental overheight vehicle collision: a) status of bridge construction at time of incident; b) spalling of impacted side of bottom flanges; c) scraping of underside of girder and spalling on rear side of flanges; d) severe damage adjacent to sole plate connections

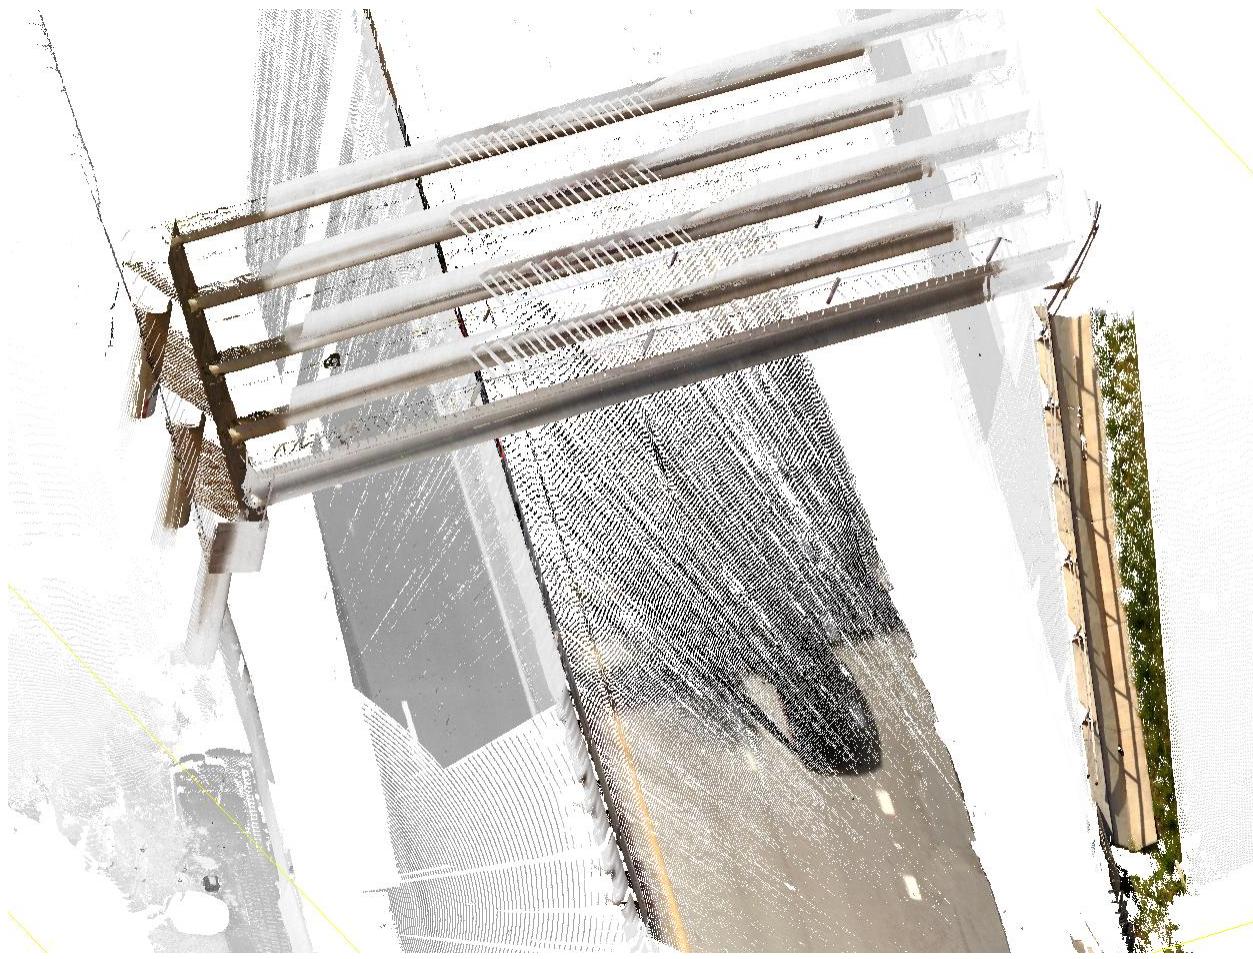
Figure 3.6. Point cloud generated from LiDAR scanning of bridge after incident

subroutines responsible for creating the meshes for the deck, end bent diaphragms, and thru bent diaphragms. During the field visit to the bridge, the research team collected LiDAR scans of the bridge and the roadway underneath the bridge (Figure 3.6). The point cloud data generated from this scanning was analyzed to determine the precise difference in elevation between the surface of the roadway and the underside of the girders at the longitudinal location of the impact. Figure 3.7 presents an image of a slice of the actual point cloud data that has been annotated to indicate the measured elevation of each girder relative to the roadway. In this image, the point cloud is limited to the bottom flange for all but one exterior girder due to line-of-sight restrictions from the scan used. The rightmost girder in the image corresponds to the exterior girder that was first impacted by the raised bed of the dump truck. As can be seen in the elevation difference measurements, the vertical underclearance reduces for each girder, which explains why the shield of the dump truck would have struck multiple girders with significant force even if the impact force from each collision was significant enough to damage the shield. The vertical underclearance measurements obtained from the LiDAR scan were used to prescribe a ground plane in the finite element model to represent the roadway in a way that would be consistent with the actual relative differences in grade. Additionally, the LiDAR scan was used to determine the longitudinal location of the dump truck impact to the bridge girders. Spalling of the interior impacted girders was clearly visible in the point cloud data and was used to establish the location of the impact relative to the end of the girder (Figure 3.8). Furthermore, the location of spalls on the individual girders confirmed that the collision of the dump truck with the bridge girder was an oblique impact with an angle of impact corresponding to the direction of the roadway underneath the structure. The angle between the direction normal to the face of the girder and the direction of travel was approximately 20 degrees and was included in the finite element analysis by orienting the truck for oblique impact at this angle.

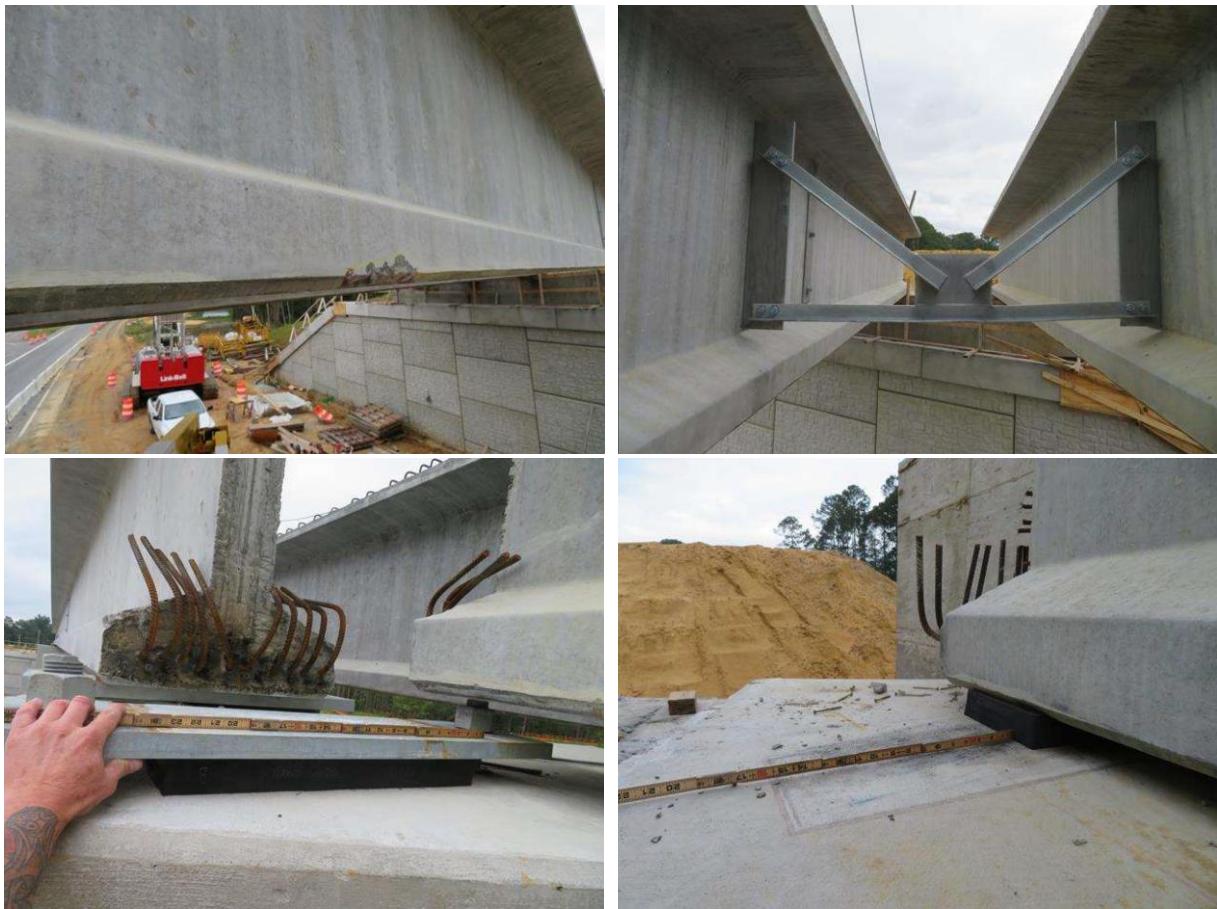
Figure A.1. Damage observed in modified bulb-tee girder of a partially constructed bridge in Wade following overheight impact [Courtesy of North Carolina Department of Transportation]

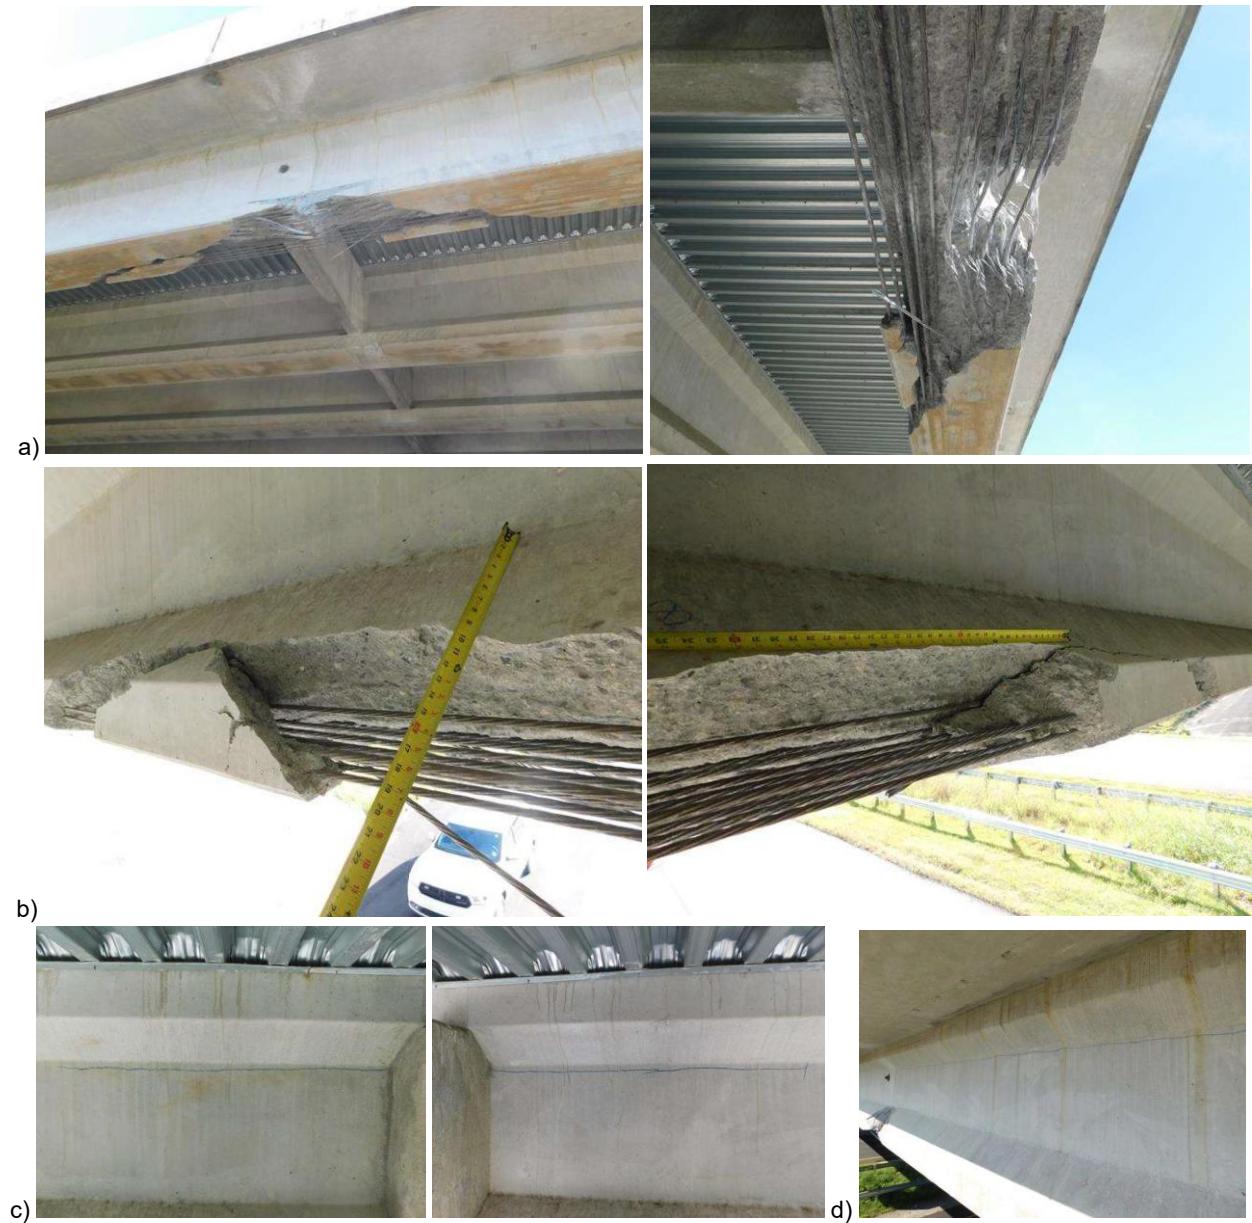
Figure A.3. Damage observed in a Greenville bridge following impact from the boom of an excavator: a) exposed and severed strands and spalling around location of impact; b) spalling across the rear side of the bottom flange; c) horizontal cracking at the web-to-top flange transition present on both sides of the intermediate diaphragm; d) horizontal cracking at the web-to-top flange transition on the impacted side of the girder [Courtesy of North Carolina Department of Transportation]

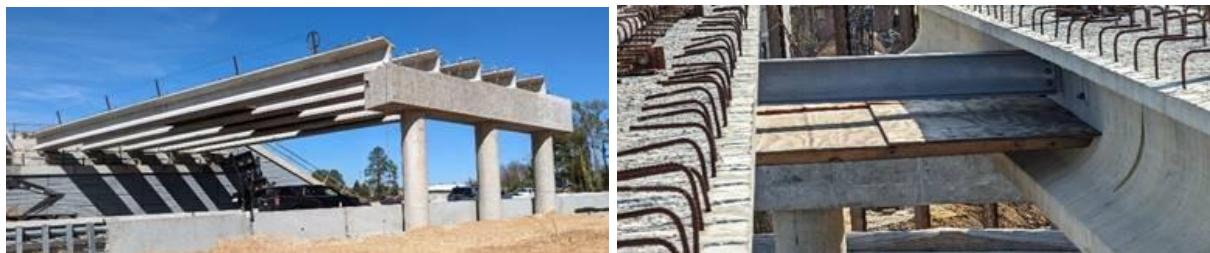
Figure A.4. Partially constructed bridge

On March 15, 2024 a dump truck with a raised bed impacted a bridge under construction in Wake County, NC. The bridge was designed as a two-span prestressed concrete girder bridge with reinforced concrete deck. However, at the time of the incident, only the girders had been placed, along with the mid-span steel MC intermediate diaphragms (Figure A.4). The bridge spans a total of 174.875 ft (Span A is 88.708 ft and Span B is 86.167 ft) and is comprised of five 45-inch FIB prestressed concrete girders with typical girder spacing of 8 ft 8 in. Significant damage occurred at the baseplates at the end bent and interior bent as shown in Figure A.5. The elevation of the exterior girder (girder 1) was slightly higher than that of the other girders, allowing the truck bed to clear the initial girder without making contact. However, subsequent impacts occurred to girders 2, 3, and 4. Spalling occurred near the impact location on the vertical face of the bottom flange as well as the underside of girders 2, 3, and 4 as shown in Figures A.6 and A.7.

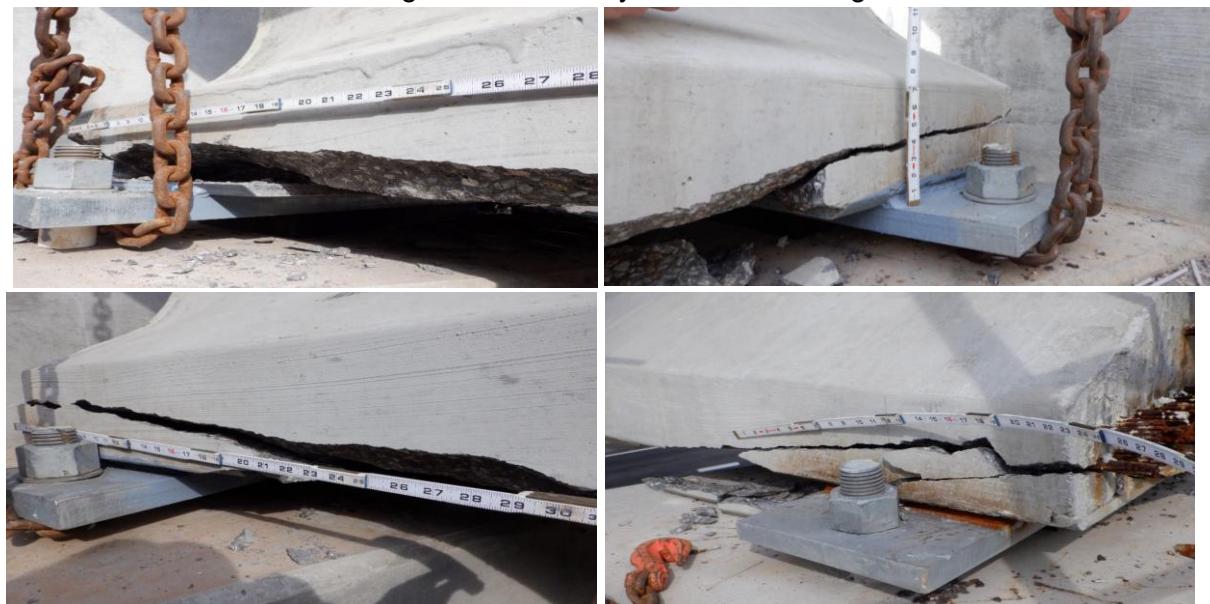
Figure A.5. Typical damage at base plate at bents [Courtesy of North Carolina Department of Transportation]

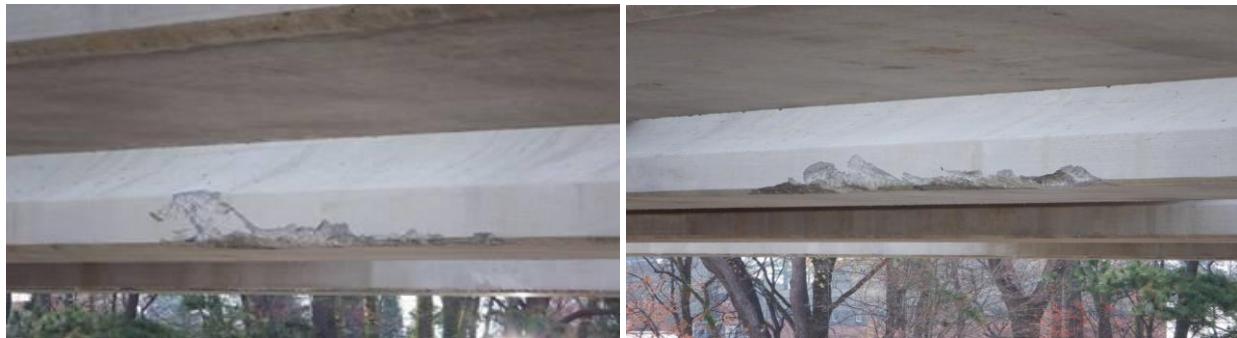
Figure A.6. Spalling at impact location [Courtesy of North Carolina Department of Transportation]

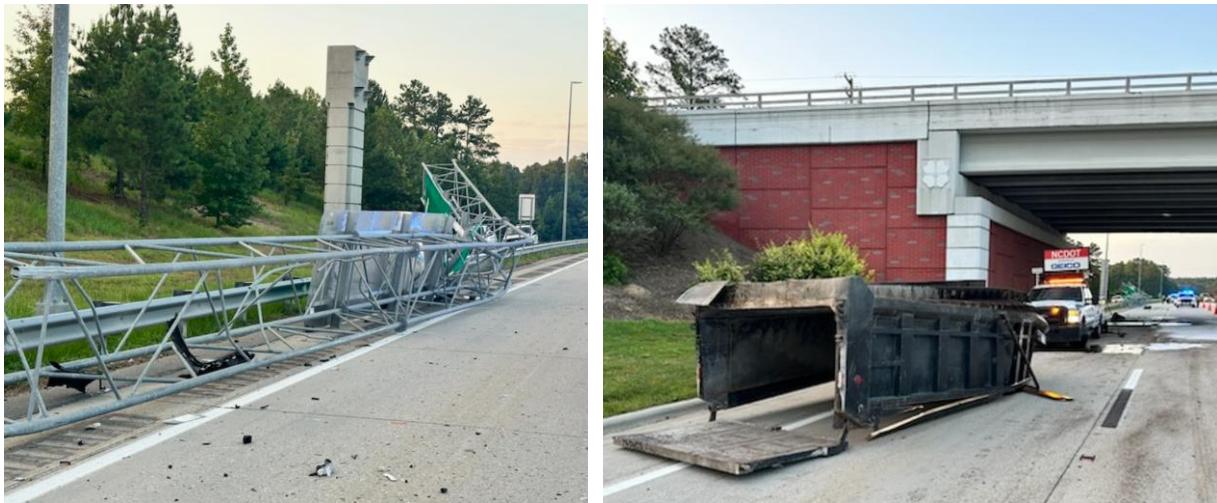
Figure A.8. Sign structure impacted and detached dump truck bed [Courtesy of North Carolina Department of Transportation]

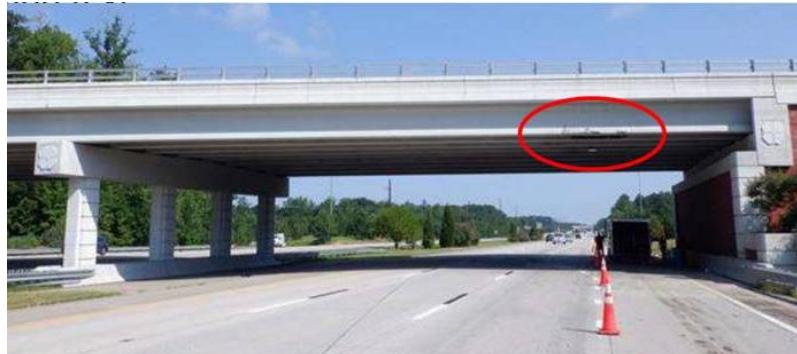
Figure A.9. Location of bridge and impact location [Courtesy of North Carolina Department of Transportation]

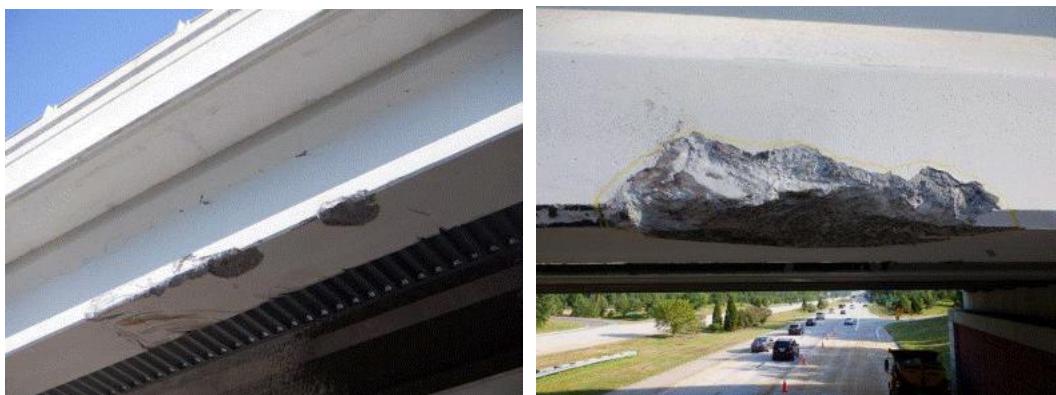
Figure A.10. Exterior girder damage [Courtesy of North Carolina Department of Transportation]

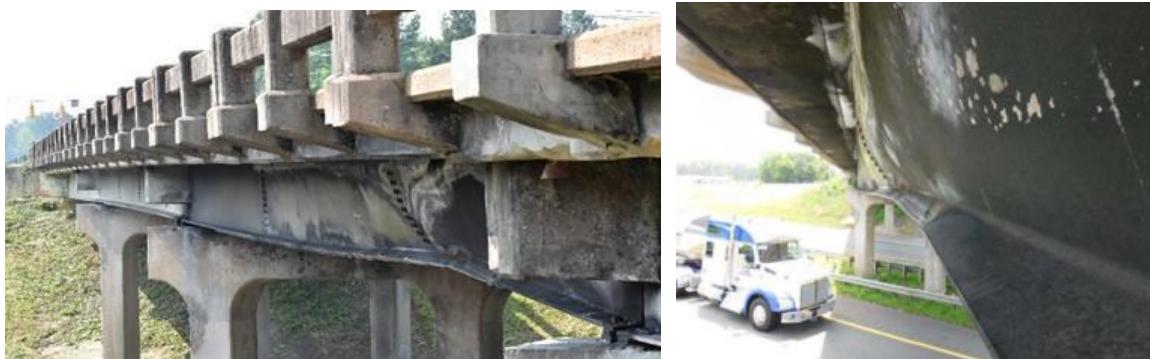
Figure A.12. Overall damage to exterior girder [right photo Courtesy of North Carolina Department of Transportation]

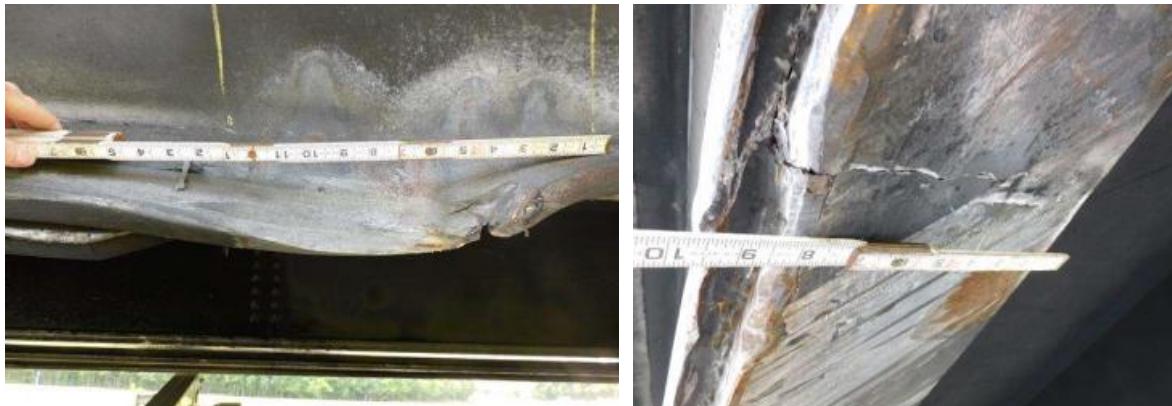
Figure A.14. Rotation and fracture at impact site. [Courtesy of North Carolina Department of Transportation]

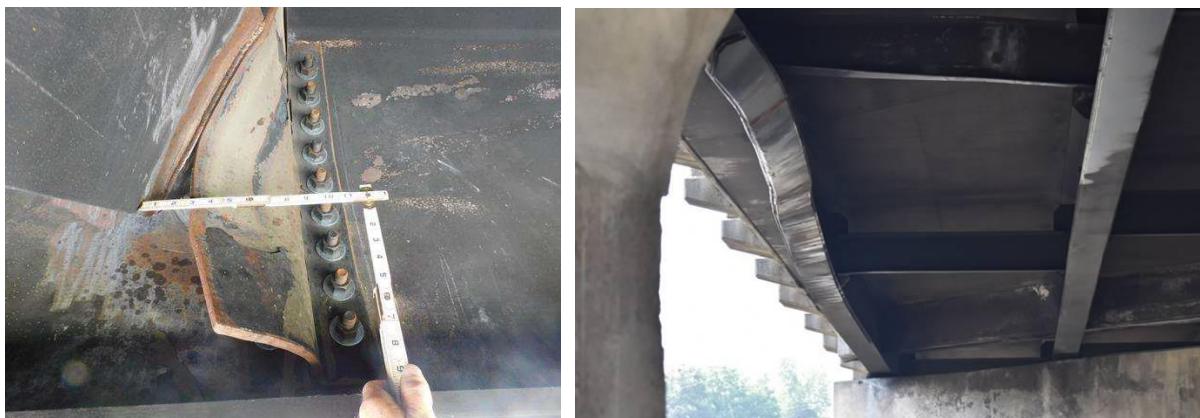
Figure A.15. Broken weld and member rotation at diaphragm [Courtesy of North Carolina Department of Transportation] and deformation in beam 4 looking south

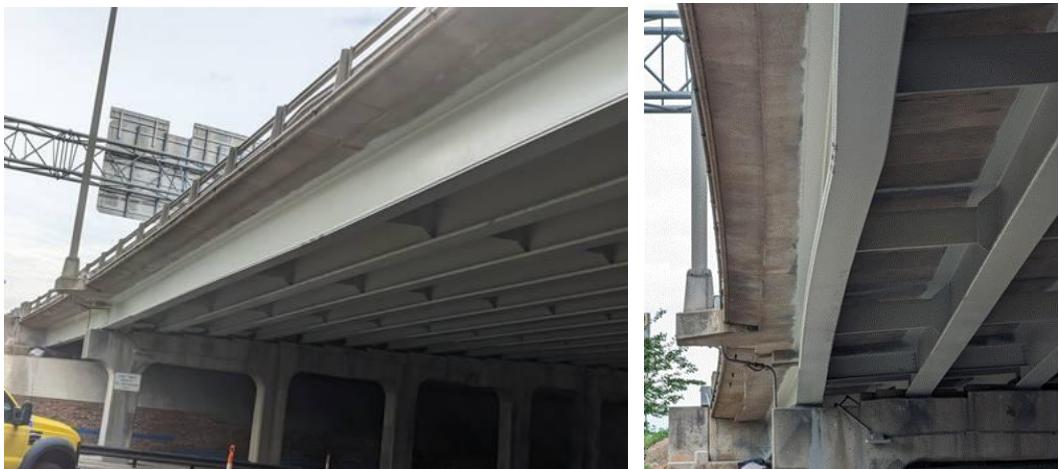
Figure A.17. View of steel girders in bridge and lateral deformation of impacted girder

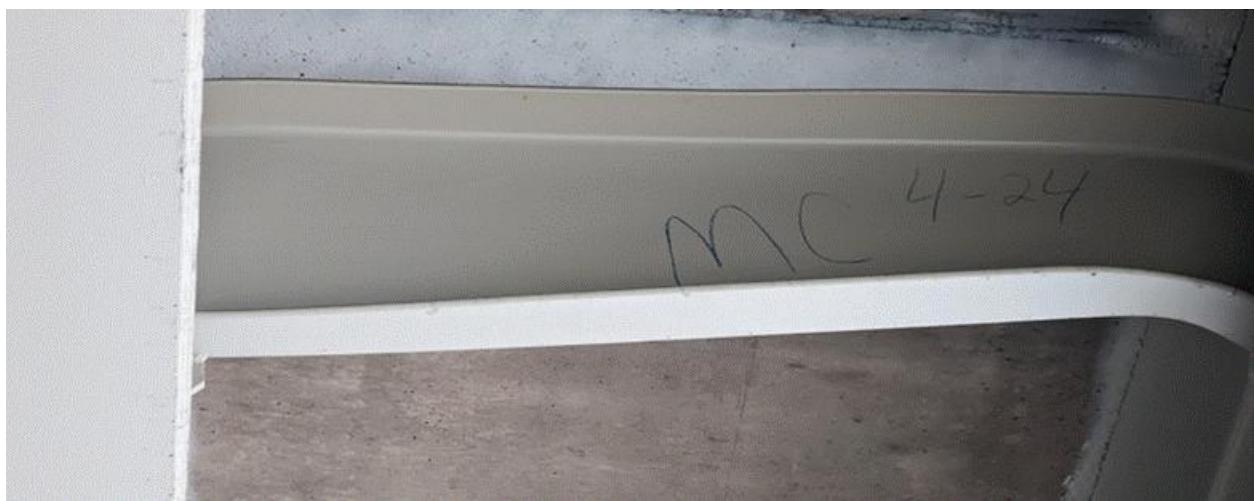
Figure A.18. Buckling intermediate diaphragm closest to impact site

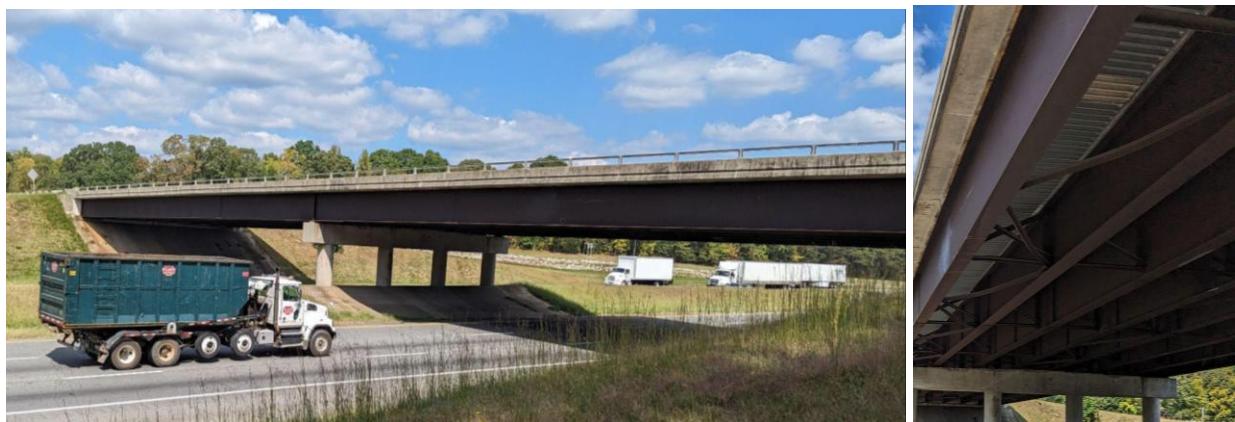
Figure A.19. Bridge view and girder detail

On October 4, 2023, a plate girder bridge in Lexington was struck by the raised bed of a dump truck. News reports indicated that the bed detached from the truck after impact, and video revealed what appeared to be a backwall impact from the truck bed. Figure A.19 shows the bridge and plate girders. The bottom angle member of the intermediate diaphragm closest to the impact location was bent upward nearly 4 in (Figure A.20a) and at least one flange to a connecting bracket partially ruptured, which propagated from the bottom face (Figure A.20b). The cross bracing was shown to exhibit buckling behavior as well (Figure A.20c). Local deformation appeared on the exterior girder face where the cross bracing was bolted nearest to the impact location (Figure A.20d).

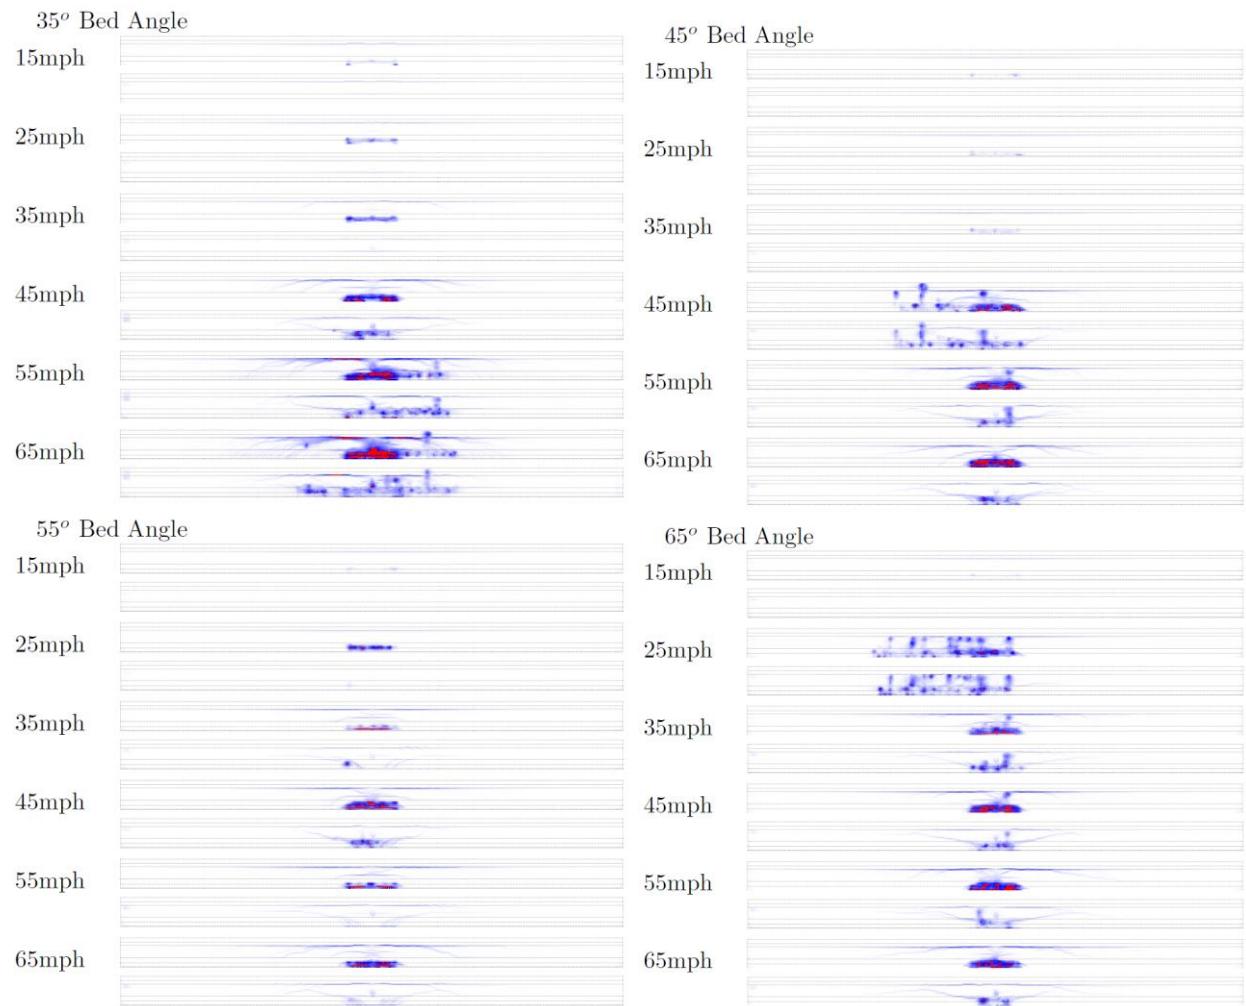
Figure C.7. Maximum principal strain distributions for Scenario 3 impact at midspan (front of exterior girder and rear of exterior girder shown)

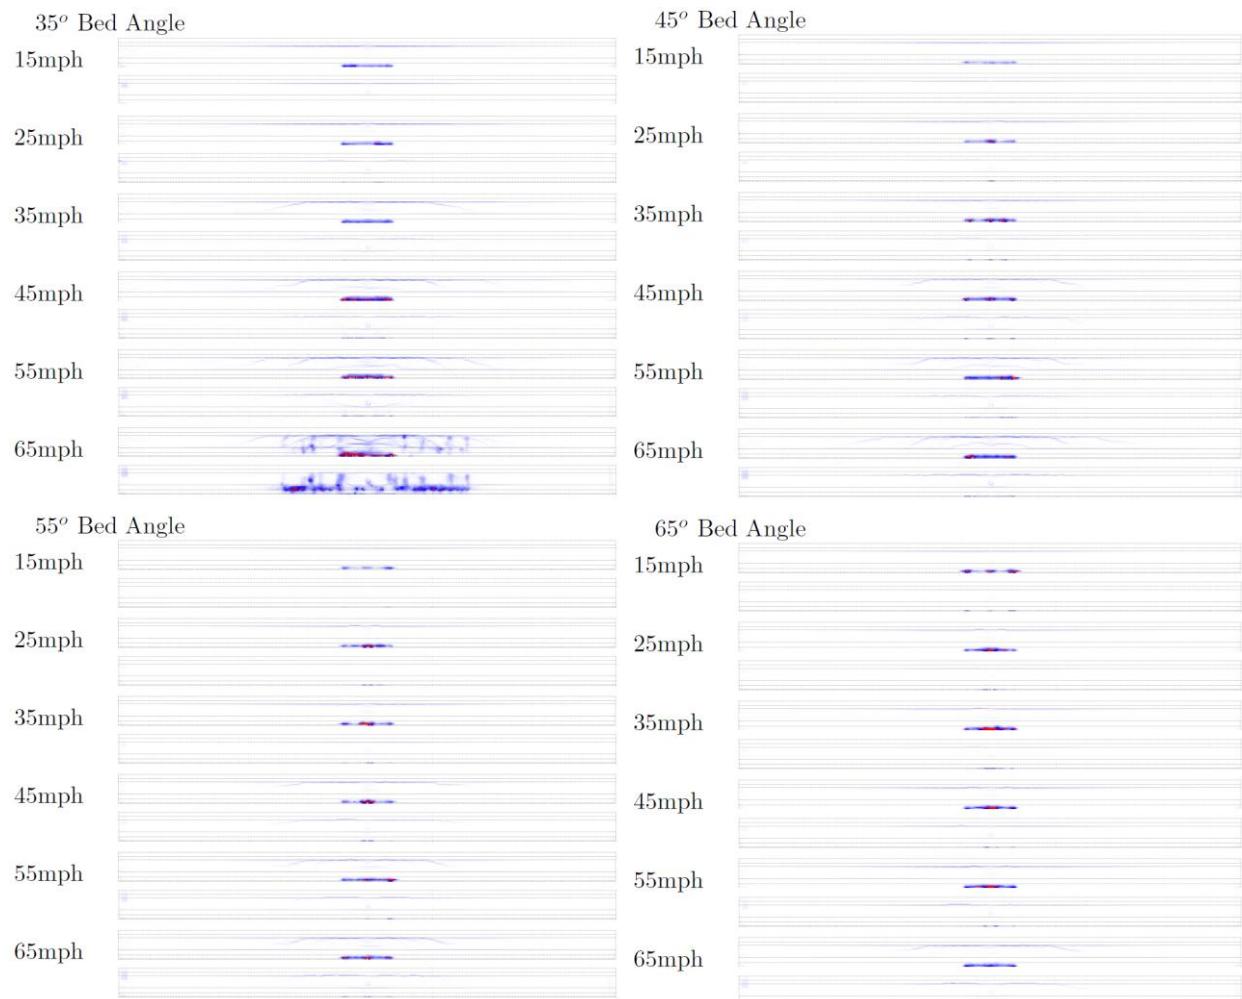
Figure C.10. Maximum principal strain distributions for Scenario 4 impact at midspan (front of exterior girder and rear of exterior girder shown)

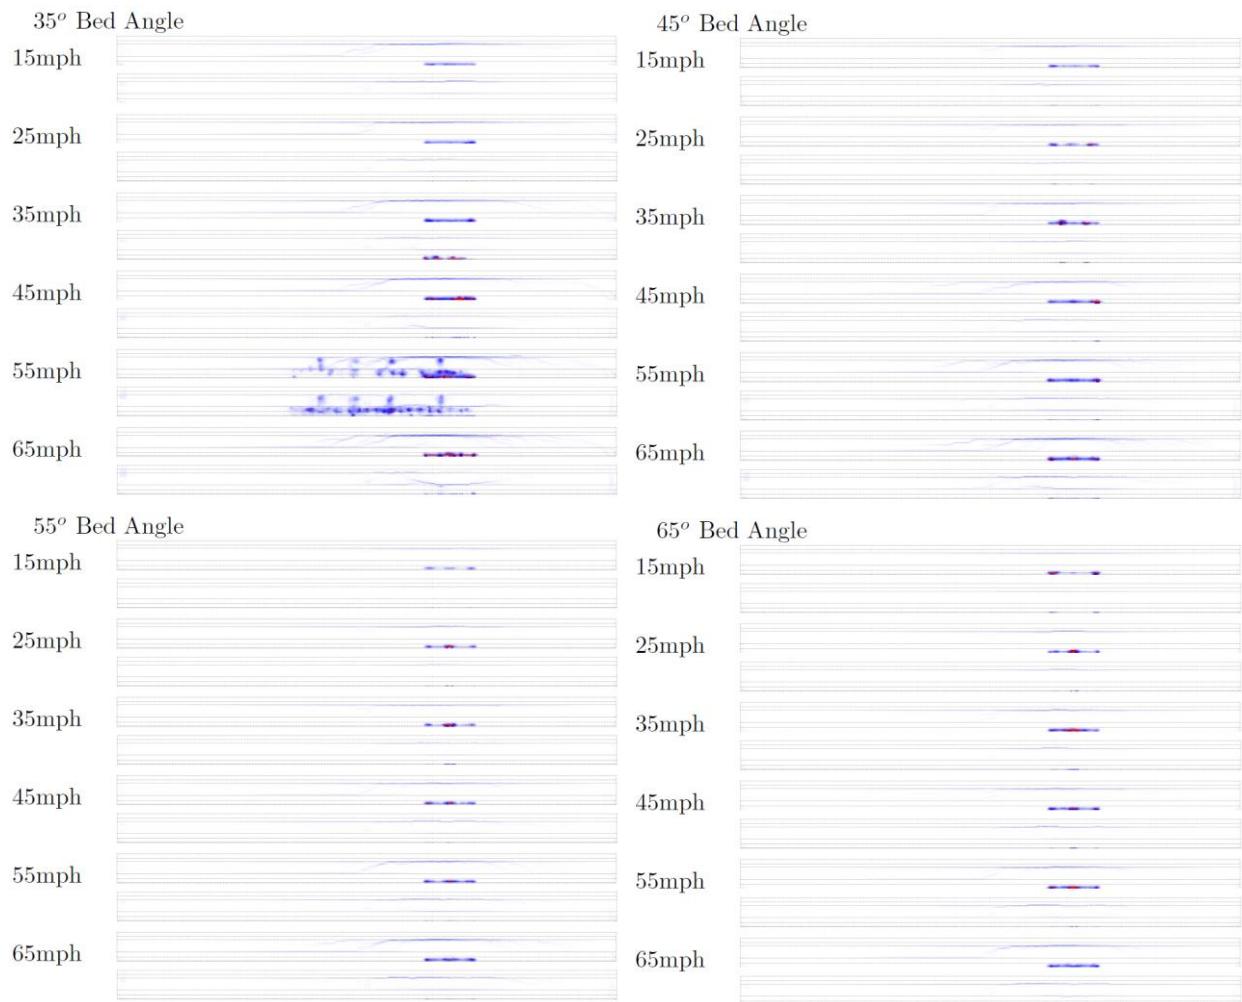
Figure C.11. Maximum principal strain distributions for Scenario 4 impact at third point (front of exterior girder and rear of exterior girder shown)

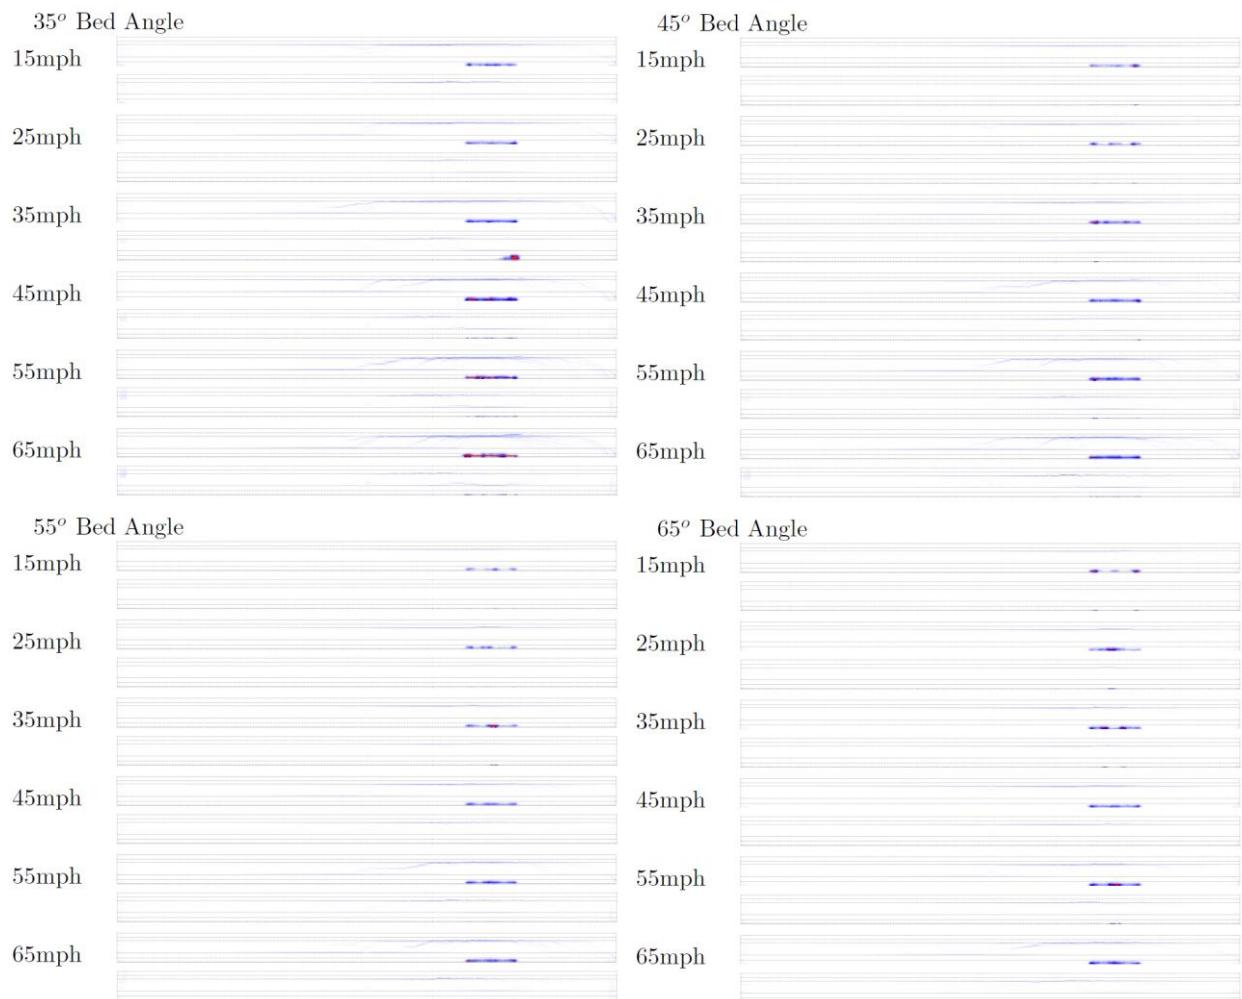
Figure C.12. Maximum principal strain distributions for Scenario 4 impact at quarterpoint (front of exterior girder and rear of exterior girder shown)
