Performance of 54-Year-Old Prestressed Concrete Channel Beams with MF-FRP Repairs after 2 years of Restored Service

NCDOT Project 2024-15
FHWA/NC/2024-15
May 2026

FINAL REPORT

Submitted to:
North Carolina Department of Transportation
Office of Research
(Research Project No. RP2024-15)

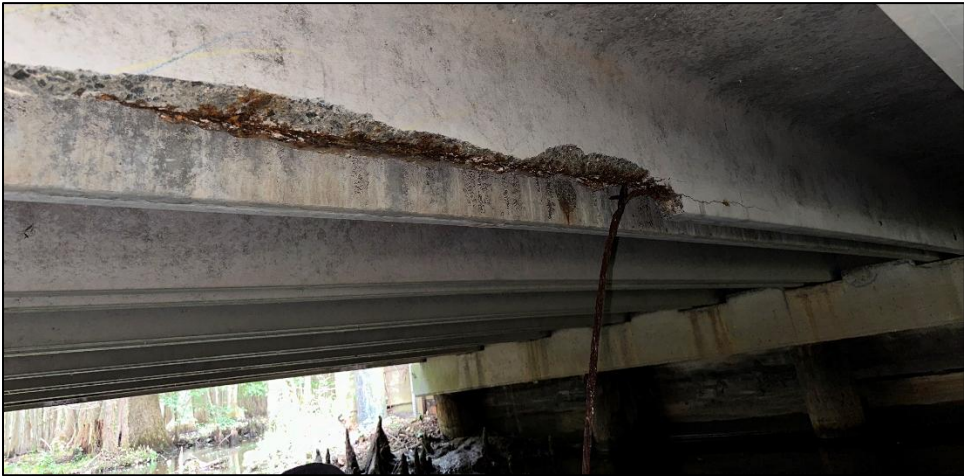
Figure 1-1: Example of a deteriorated prestressed concrete C-channel bridge beam (Bridge No. 070018)

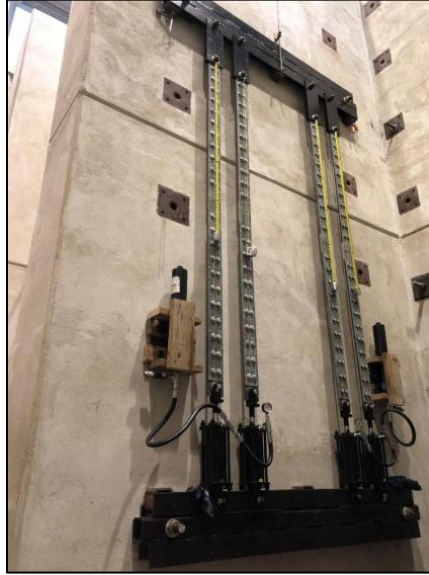
Bourara studied the long-term behavior of the FRP-steel bolted connection under sustained and cyclic loads (Bourara, 2019). The effects of creep on the MF-FRP bolted connection were explored by subjecting two groups of specimens to different periods of sustained loading (6 months and 30 months). The specimens consisted of the 22-bolt pattern with 0.5-inch diameter bolts. It was found that the MF-FRP connection experienced creep within the first 5 days of sustained loading. This sustained load was 22 kips, which is the prestressing force of the system used in this study. A photo of the sustained loading test setup is shown in Figure 2-2. Under this sustained load, the connection experienced an average of 0.07 in. of creep, and the research concluded that the ultimate tensile capacity of the connection was unaffected by creep after 30 months of sustained loading.

Figure 2-2: Sustained loading test setup (adapted from (Bourara, 2019)).

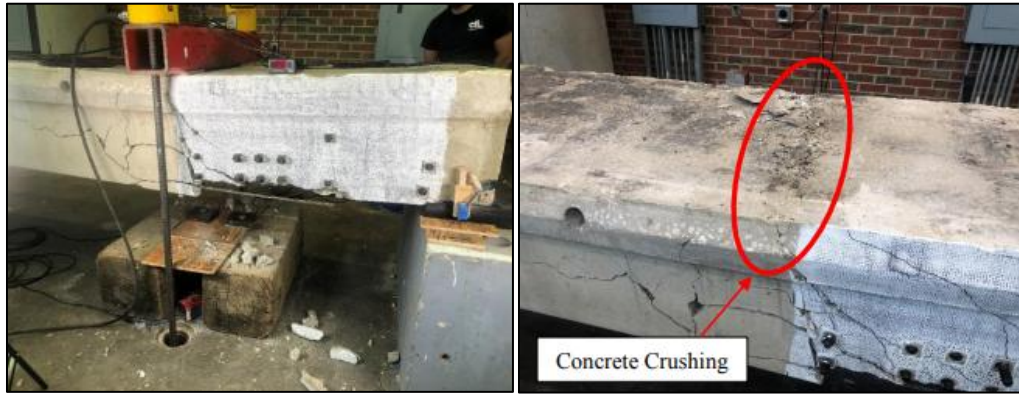
Lin studied and developed a shear-strengthening plate for the end regions of candidate retrofit specimens (Lin, 2021). Through full-scale testing of channel beams in shear and flexure, Lin concluded that repairing specimens with the shear strengthening plate could restore the nominal shear capacity of a severely damaged beam end region to that of an undamaged beam. Implementation of the shear strengthening also caused the shear-deficient specimen to fail in flexure during a shear test, as shown in Figure 2-4. Concrete crushing under the loading apparatus defined this flexure failure.

Figure 2-4: Lin shear test failure mode (adapted from (Lin, 2021))

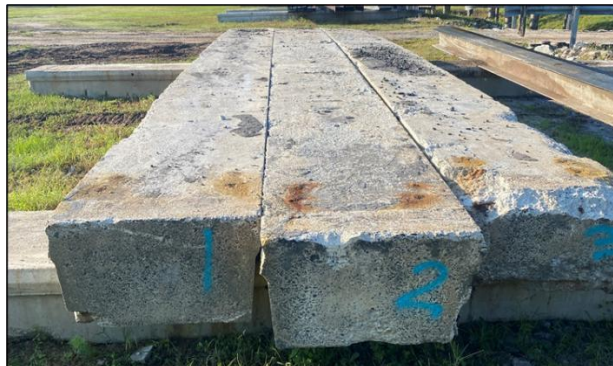
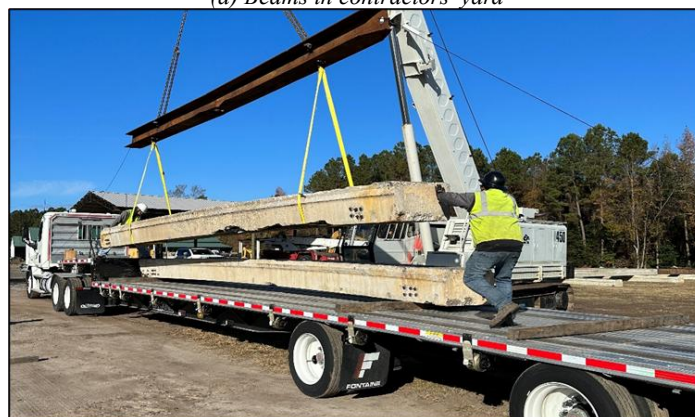
Figure 3-1: Bridge No. 810003 beams

A total of twelve 30-ft. long C-channel beams were obtained for this testing program, with eight coming from Bridge No. 810003 in Sampson County, NC, and four coming from Bridge No. 910180 in Wake County, NC. The eight prestressed concrete channel beams retrieved from Bridge No. 810003, the same bridge retrofitted by (Lin, 2021), consisted of three retrofitted beams and five unstrengthened beams. These beams were removed from the bridge location and hauled to a local contractor's yard in early 2023. Upon visual inspection, the condition of the beams varied, with concrete spalling present at the midspan and supports, prestressing strand corrosion present in multiple locations, and some damage observed to the existing MF-FRP retrofit system on one of the stems. However, the overall condition of the beams was fair. The beams were shipped to the Constructed Facilities Laboratory (CFL) in two loads (November 20th, 2023, and May 9th, 2024). Figure 3-1 shows the beams as they were stored in the contractor's yard and the delivery by truck to the CFL.

(a) Beams in contractors' yard

(b) Loading of beams onto truck

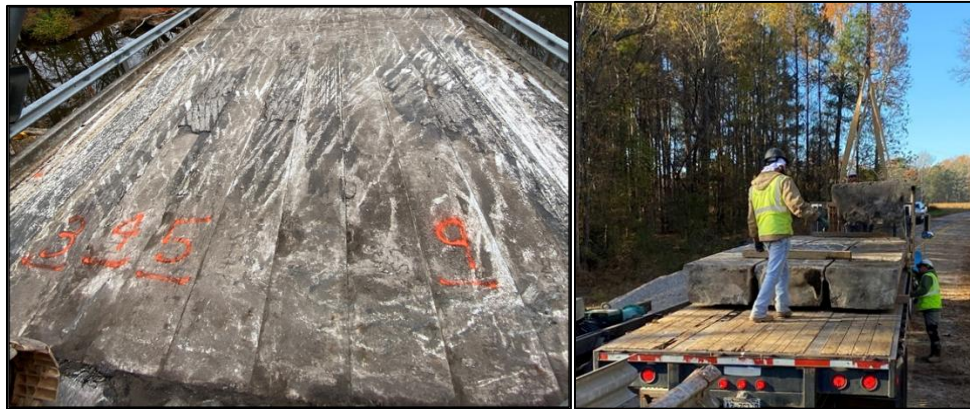
Figure 3-2: Bridge No. 910180 beams

The four C-channel beams retrieved from Bridge No. 910180 consisted of two retrofitted beams and two control beams. These beams were removed from the bridge location and hauled directly to the CFL on May

9th, 2024. Upon visual inspection, the condition of these beams was similar to those retrieved from Bridge No. 810003. Figure 3-2 shows the beams on Bridge No. 910180 prior to their removal, as well as their delivery by truck to the CFL.

(a) Beams prior to removal

(b) Loading of beams onto truck

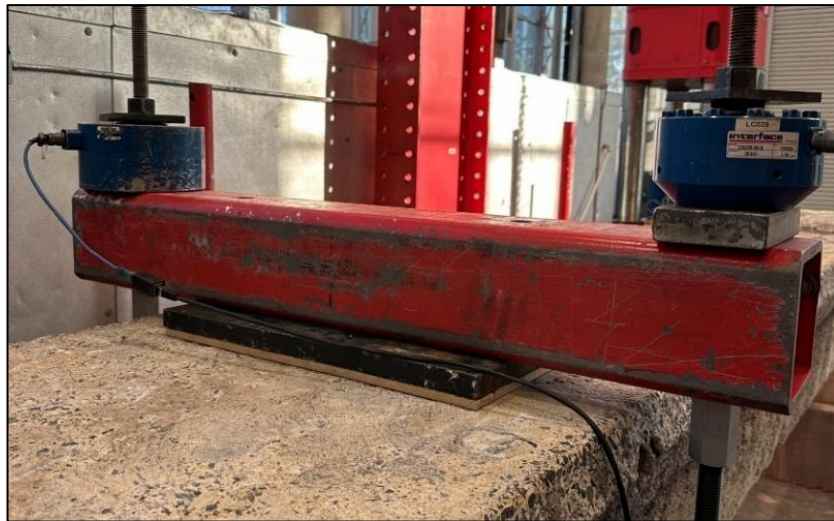
Figure 3-6: Static test loading apparatus

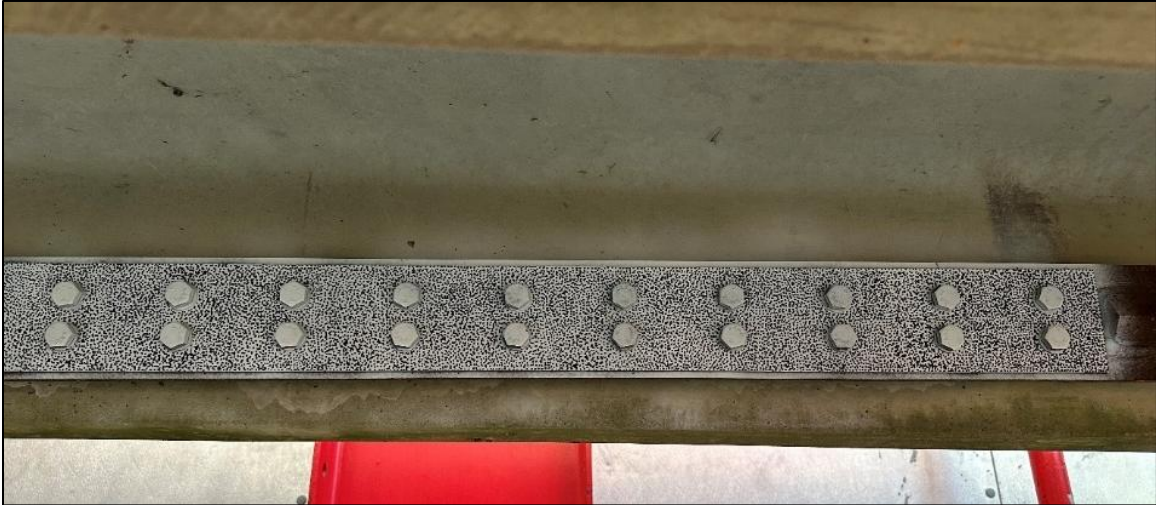
Digital Image Correlation (DIC) was also implemented to measure the strain profile at the steel connector plate-FRP plate interface. For each test, both interfaces of one FRP plate were speckled and monitored during testing. DIC data was used to assess the behavior of the steel connector plate-FRP plate at failure. Figure 3-7 shows the speckling on one interface. The axial strain in the FRP plate was also measured using electrical resistance strain gauges. Three gauges, located at the top, middle, and bottom of each FRP plate, were utilized. Figure 3-8 shows the strain gauges on the FRP plate.

Figure 3-7: DIC speckling pattern

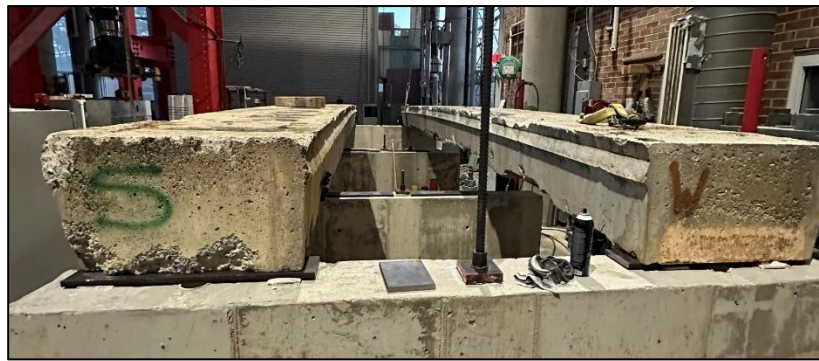
Figure 3-10: Fatigue test setup photo

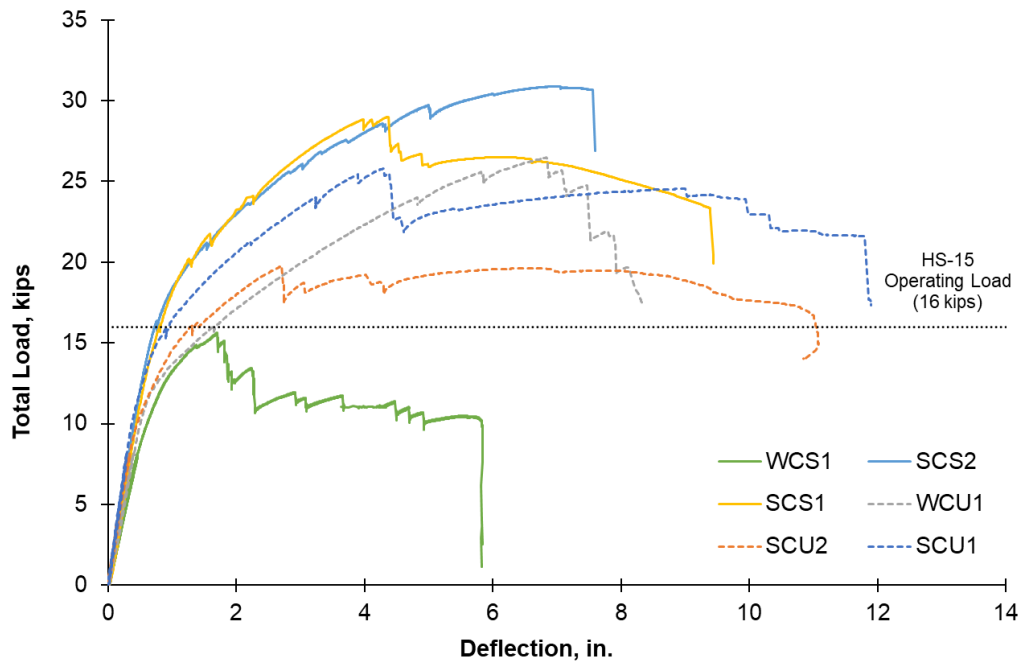
Figure 4-1: Load versus midspan deflection behavior for six static tests

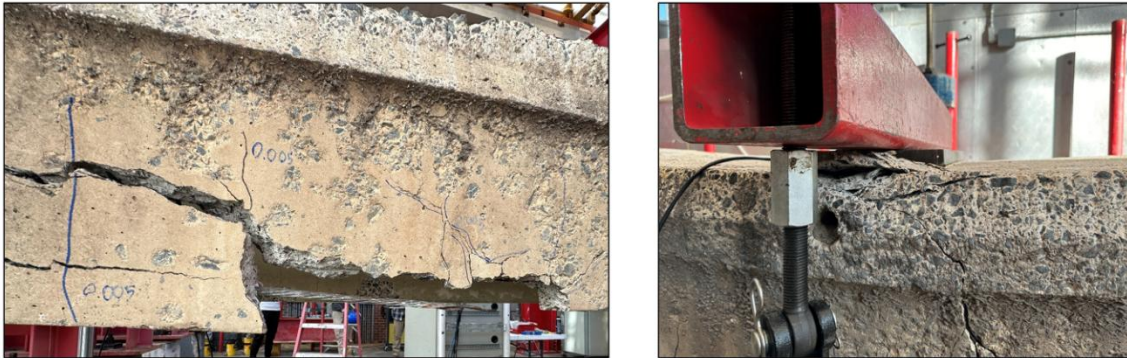
Specimen SCU1 failed at a peak applied load of 25.8 kips and corresponding deflection of 11.9 in. During testing, the specimen experienced minor concrete spalling and heavy crack formation, as well as rupture of the bottom prestressing strand. The primary mode of failure for this specimen was concrete crushing, which occurred at the top mid-span section. The failure mode of the specimen is shown in Figure 4-2.

Figure 4-2: Specimen SCU1 at failure

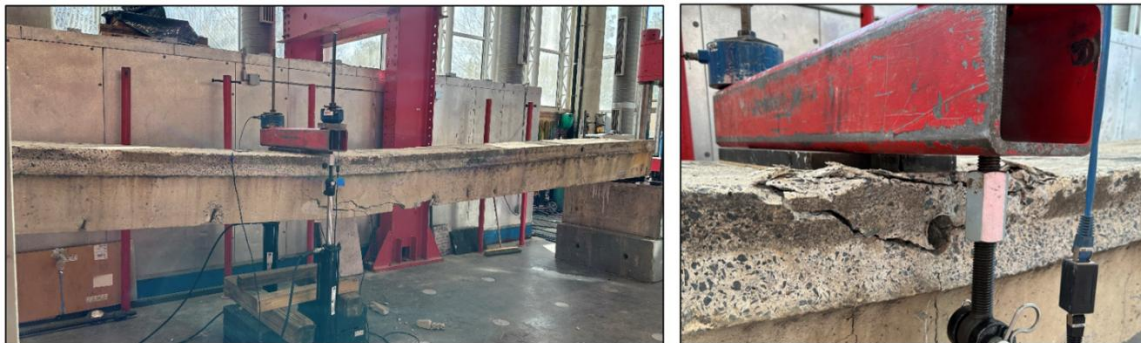
Specimen SCU2 failed at a peak load of 19.8 kips with a corresponding maximum vertical deflection of 11.1 in. During testing, the specimen experienced significant concrete spalling and cracking. The failure mode for this specimen was concrete crushing at the top mid-span section, as shown in Figure 4-3.

Figure 4-3: Specimen SCU2 at failure

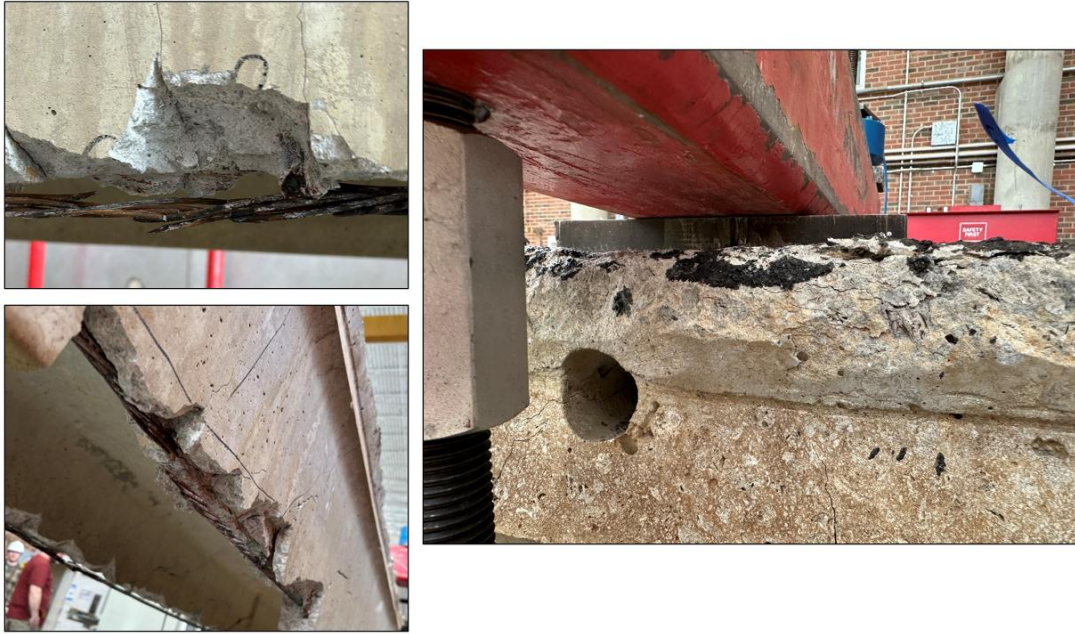
Specimen WCU1 failed at a peak load of 26.5 kips with a maximum corresponding deflection of 8.32 in. During testing, the beam experienced concrete cracking, concrete spalling, and rupture of the bottom prestressing strand in both stems. The load dropped after each strand rupture; however, the beam recovered and the applied load increased with increasing displacement. The primary failure mode for this specimen was crushing of concrete at the top mid-span section, as shown in Figure 4-4. The load did not increase after concrete crushing initiated, confirming this was the controlling failure mode.

Figure 4-4: Specimen WCU1 at failure

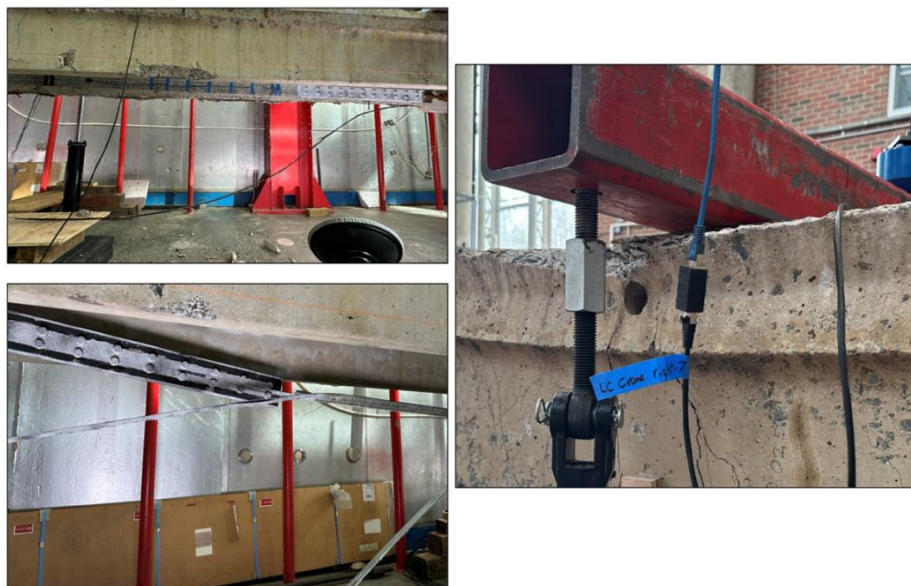
Specimen SCS1 failed at a peak load of 29.0 kips with a maximum vertical deflection of 9.44 in. During testing, the specimen experienced concrete spalling and prestressing strand rupture. The bottom right prestressing strand exhibited a wire rupture at an applied load of 21 kips. After that, more wires ruptured as the prestressing strands relaxed, but the load climbed steadily to the peak load. At the peak load, the bottom right prestressing strand completely ruptured. Substantial concrete spalling from the left stem also occurred at this point. The load dropped to 26.5 kips as the concrete at the top midspan section started to crush. The load began to slowly decrease as deflection increased. At 23 kips and over 9 inches of deflection, the MF-FRP plate on the right side of the beam ruptured, ending the test. Images of the tested specimen are shown in Figure 4-5.

Figure 4-5: Images of SCS1 at failure

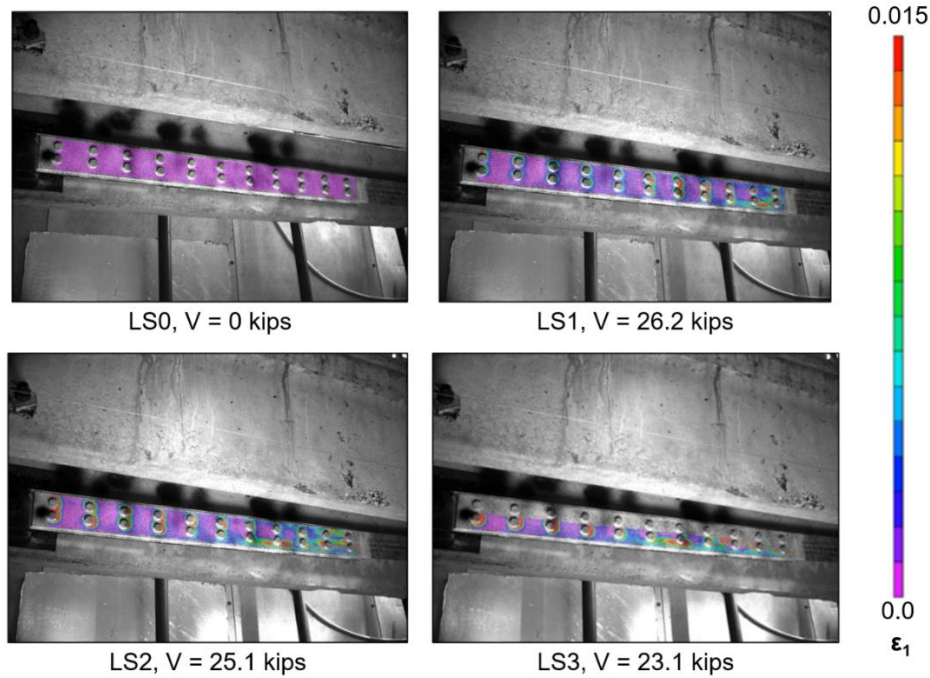
The development of failure in the FRP strap of Specimen SCS1 may be seen in Figure 4-6, which highlights the principal tensile strains in the strap as captured by the image correlation system at the peak load immediately prior to failure. The snapshots shown are labeled LS1, LS2, and LS3, which are snapshots taken seconds apart to demonstrate the propagation of failure in the FRP strap. At an applied load of 26.2 kips, the development of tensile strains is evident at each bolt location, with a crack forming along the right side of the bottom row. This results in a drop in sustained applied load to 25.1 kips, at which point the propagation of the bottom row crack is observed. Applied load continues to drop as deflections increase, and at an applied load of 23.1 kips, longitudinal splitting along both the top and bottom row of bolts is evident, with the crack unzipping to the end of the plate, triggering final failure of the test specimen.

Figure 4-6: Principal tensile strains of SCS1

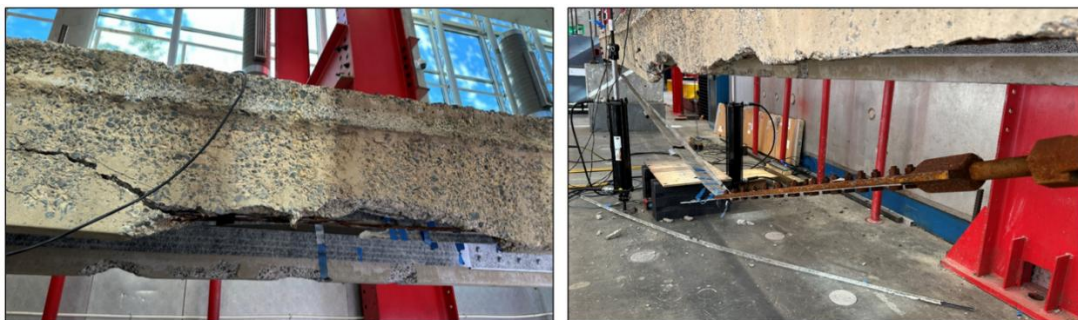
Specimen SCS2 failed at a similar peak load to Specimen SCS1 at 30.9 kips with a maximum deflection of 7.64 in. The specimen exhibited cracking, longitudinal splitting, and spalling of the concrete of both stems during the test. The specimen sustained a load of 29.7 kips when the left MF-FRP plate developed a significant longitudinal crack that propagated along the line of the initial crack. The load continued to increase slightly from this point, peaking immediately before the left MF-FRP plate ruptured, ending the test, as shown in Figure 4-7.

Figure 4-7: Specimen SCS2 at failure

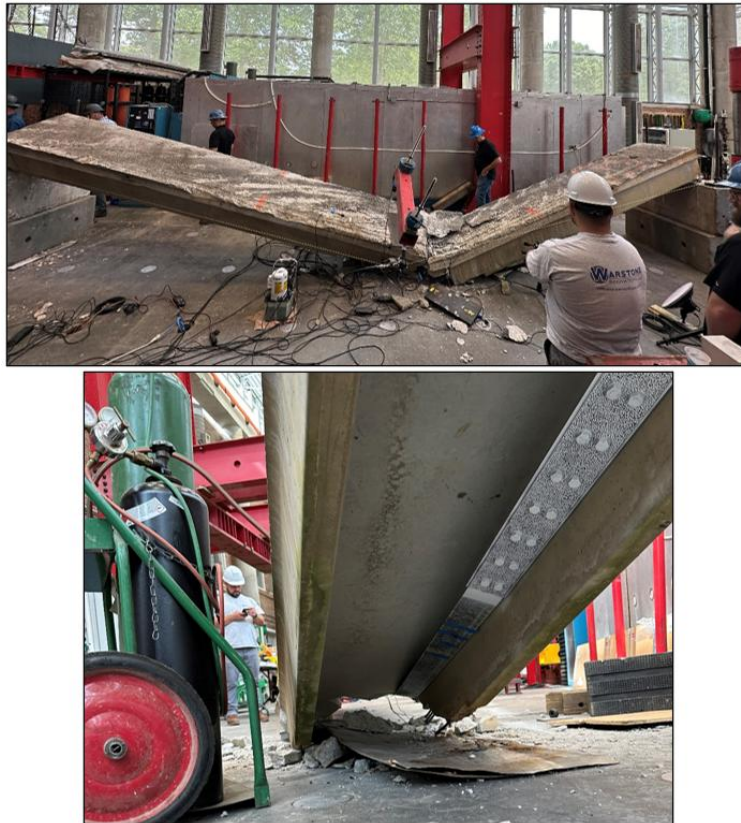
Specimen WCS1 failed at a peak load of 15.6 kips with a corresponding maximum deflection of 5.84 in. As a result, this specimen did not achieve the HS-15 operating load of 16 kips. The specimen experienced cracking and spalling of concrete throughout the test. At the peak load, significant concrete spalling was observed. This heavy spalling correlated with a drop in load capacity that continued until the midsection of the beam ultimately crushed, resulting in the catastrophic failure shown in Figure 4-8. However, after inspection, the MF-FRP system on the repaired stem remained intact, indicating that failure was heavily influenced by the unstrengthened stem. During the test, stress on the unstrengthened stem was observed as greater vertical deflection relative to the repaired stem during loading, and a torsion of the specimen towards the unstrengthened stem was evident near and at failure.

Figure 4-8: Images of WCS1 at failure

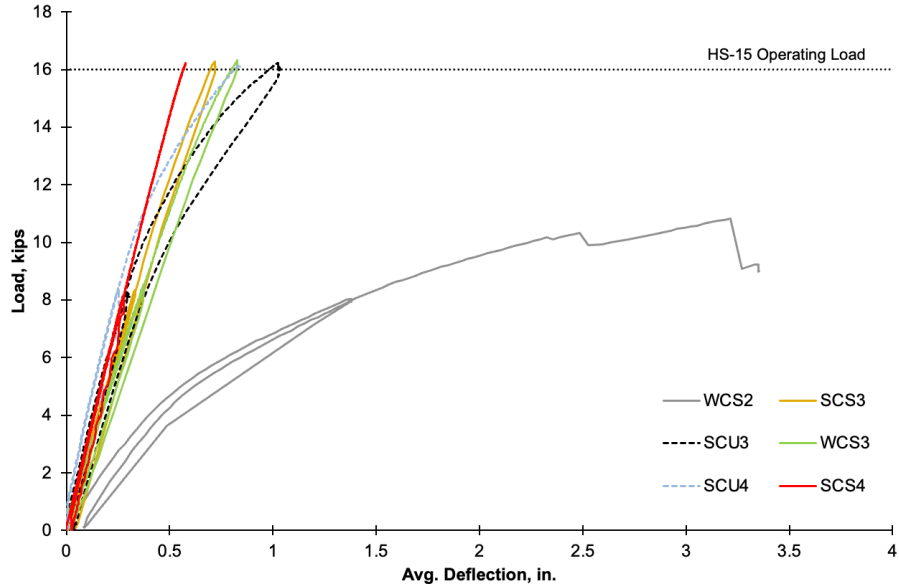
Figure 4-9: Load versus deflection graph for static proof tests

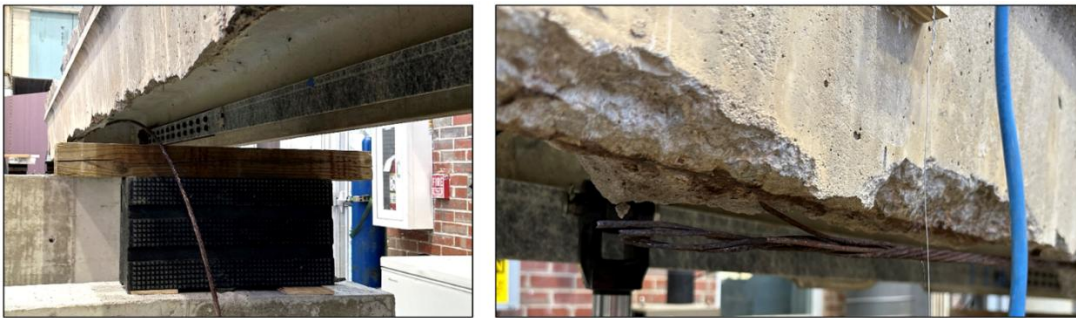
WCS2 was the first static proof test performed; recall, this member only had one stem strengthened. As mentioned in Section 3.4.4, the as-received condition of this beam, judged by visual inspection, was poor. As shown in Figure 4-9, WCS2 did not reach the operating load of 16 kips. WCS2 failed due to rupture of the bottom right prestressing strand in the unstrengthened stem (see Figure 4-10) at a maximum applied load of 10.8 kips with a corresponding maximum deflection of 3.35 in. As it is unlikely the unstrengthened stem was in such bad condition at the time of the retrofit, this finding confirms deterioration of the concrete section continued throughout the 2-year service life of the retrofit.

Figure 4-10: WCS2 bottom right prestressing strand rupture

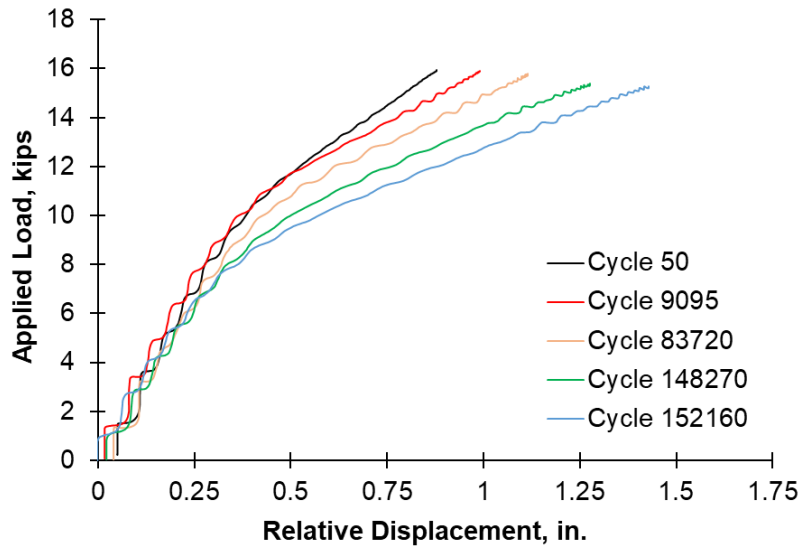
load it could sustain within the predetermined cycle frequency decreased. The test was concluded once it was observed that the member with degraded stiffness was no longer able to achieve the 16-kip applied load with available equipment at a realistic rate of loading and without significant deflection. Relative deflections ranged from approximately 0.90 in. at 50 cycles to 1.43 in. at 152,160 cycles.

Figure 4-14: Load-displacement response of SCU4 with increasing cycles

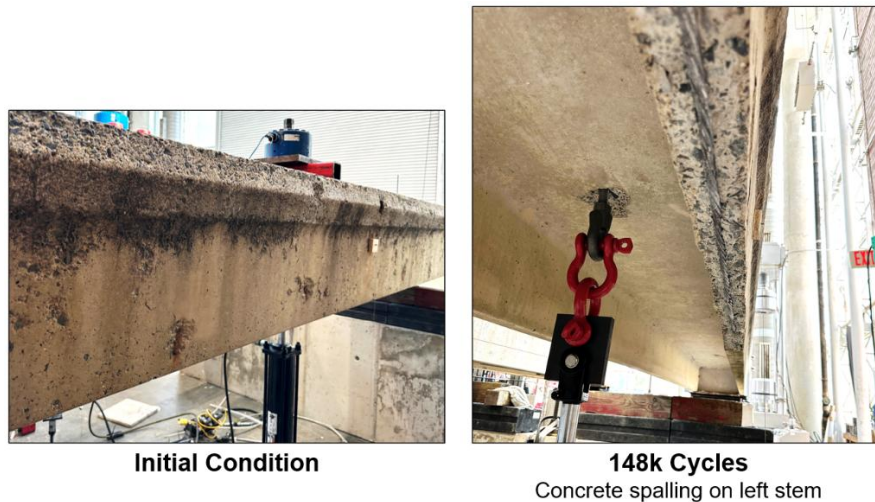
Figure 4-15 shows the member in its initial condition and at 148,250 cycles. The member did not exhibit significant signs of distress until approximately 148,250 cycles, at which point concrete spalled from the left stem, exposing the bottommost strand; the strand did not show signs of corrosion. As load was continuously applied, the response of the member continued to soften, prompting the conclusion of fatigue cycles.

Figure 4-15: Images of SCU4 at various stages of loading

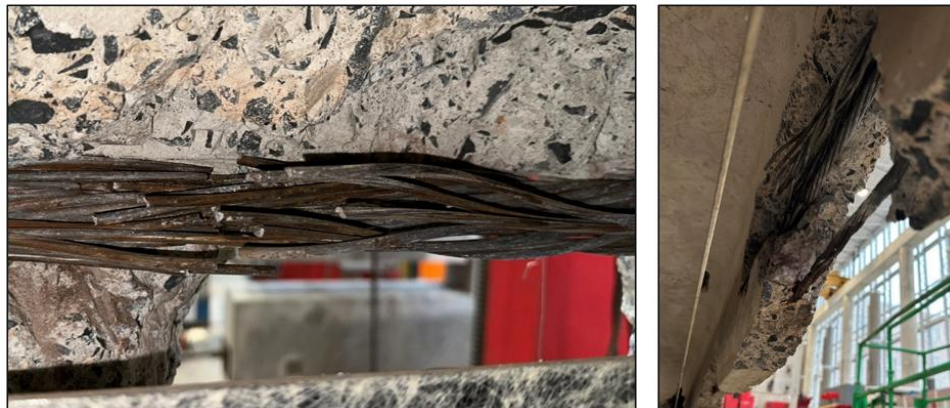
Between cycles 160,000 and 180,000, existing flexural cracks propagated, and longitudinal splitting was observed along the concrete at the bottom layer of the prestressing strand. Between cycles 180,000 and 190,000, the longitudinal splitting propagated, and concrete chunks continued to spall off. From cycles 190,000 to 200,000, concrete spalling, flexural crack propagation, and longitudinal splitting continued to develop and expand. In addition, the bottom right 7-wire prestressing strand had several wires rupture. Between cycles 200,000 and 200,200, major concrete spalling along both stems occurred. This spalling exposed the bottom prestressing strand on the left stem and the higher three prestressing strands on the right stem. Concrete spalling and longitudinal splitting continued until the top three prestressing strands in the right stem ruptured (shown in Figure 4-19), ending the test at 200,200 cycles. Note that while the member had not collapsed at the end of fatigue cycling, because of the severe degradation in the last few cycles, this member was not tested statically to failure.

Figure 4-19: SCS3 at the end of fatigue testing.

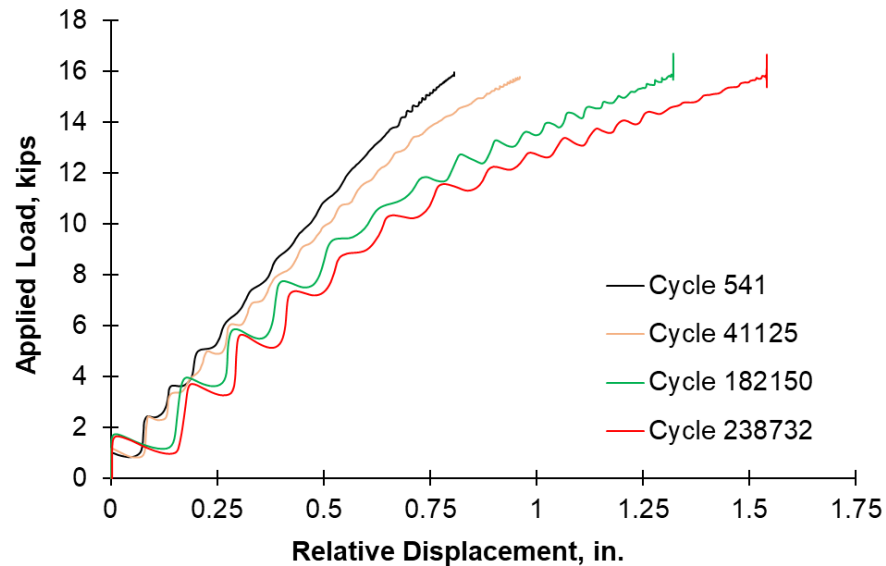
Figure 4-20: WCS3 load-displacement response with increasing cycles

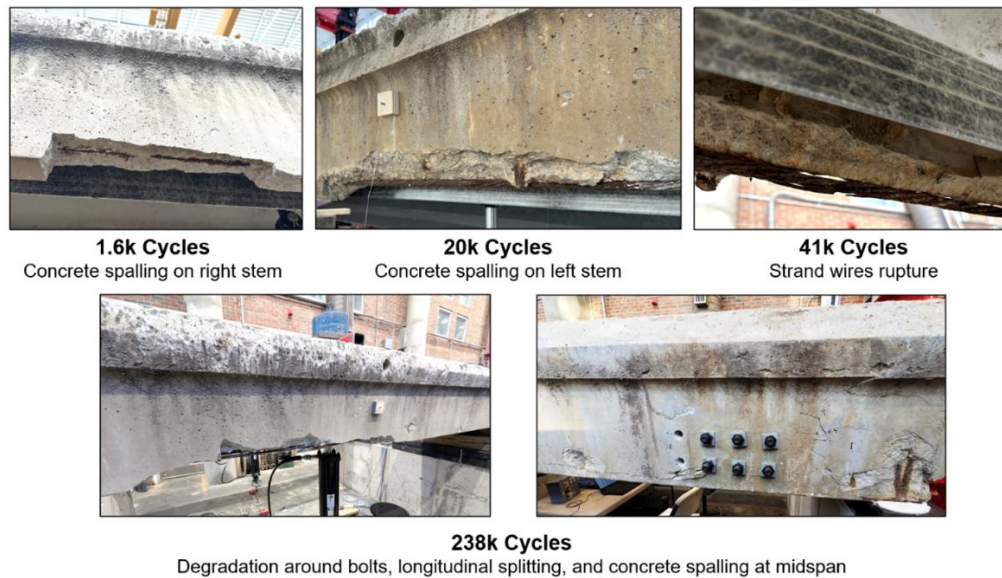
Figure 4-21: Images of WCS3 at various stages of loading

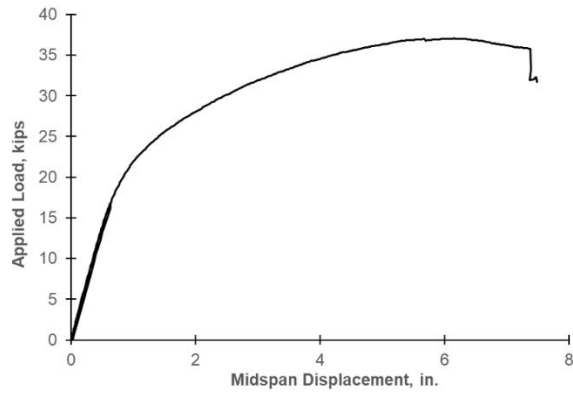
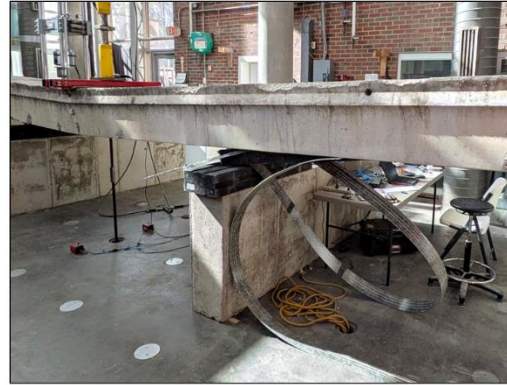
Figure 4-25: Load-displacement response and image of SCS4 at failure

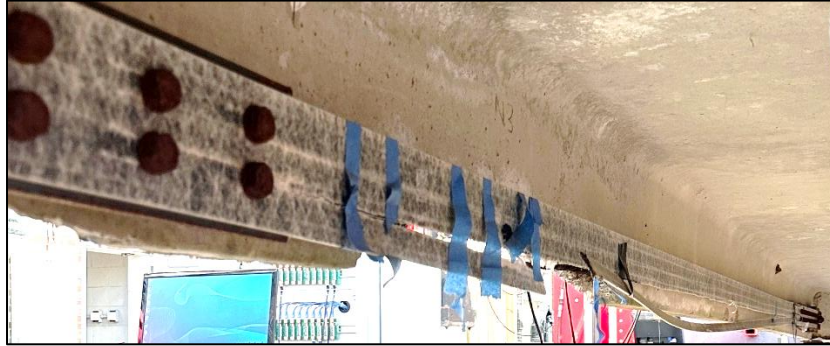
Figure 5-1: FRP plate damage prior to testing in SCS2

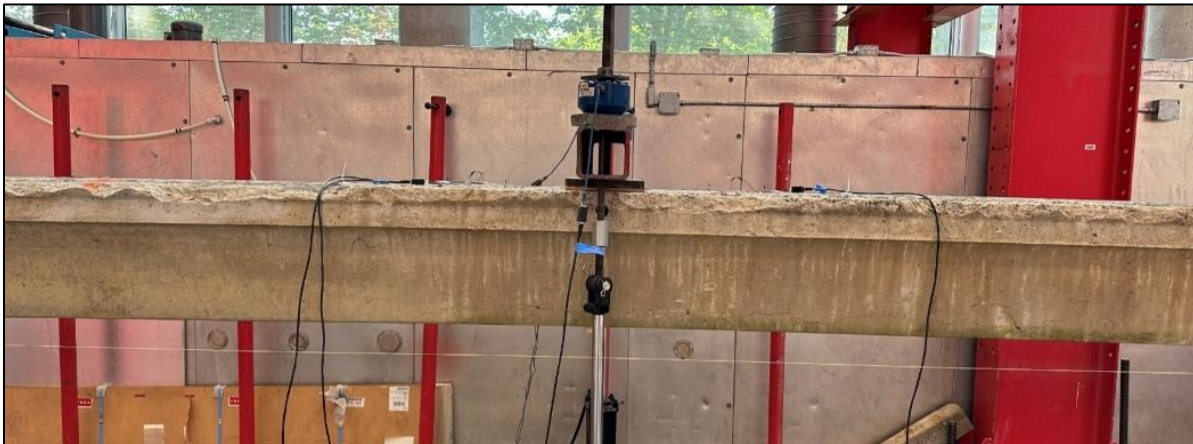
Figure 5-2: WCS1 unstrengthened stem initial condition

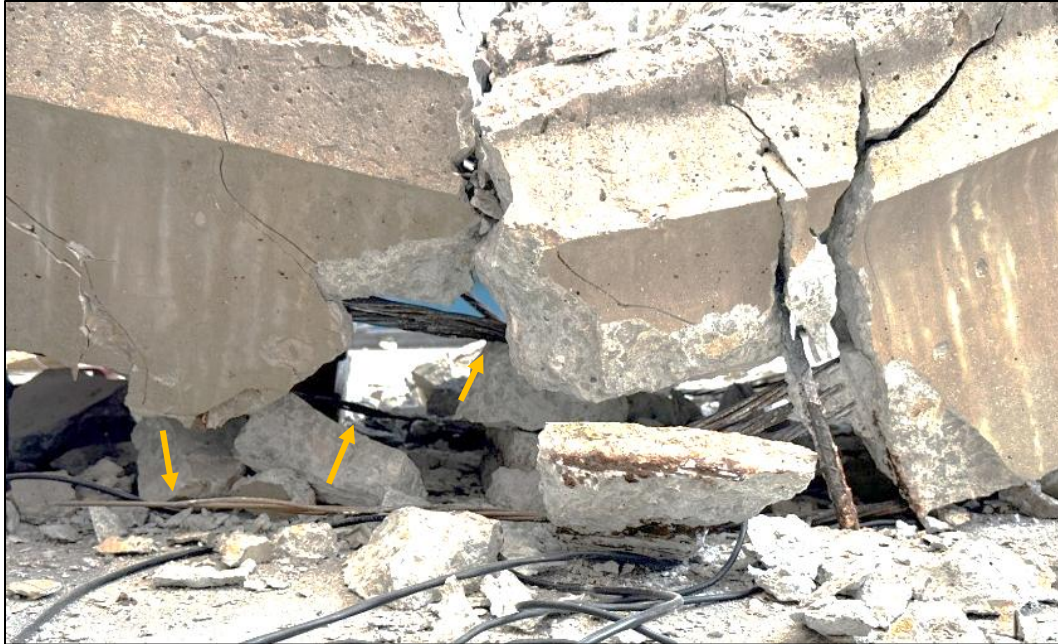
Figure 5-3: WCS1 internal prestressing strand corrosion

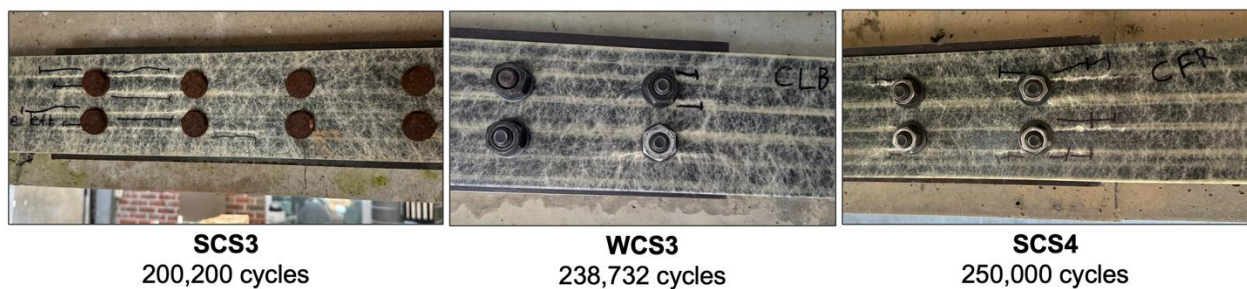
Figure 5-5: Condition of FRP straps at the conclusion of fatigue cycles

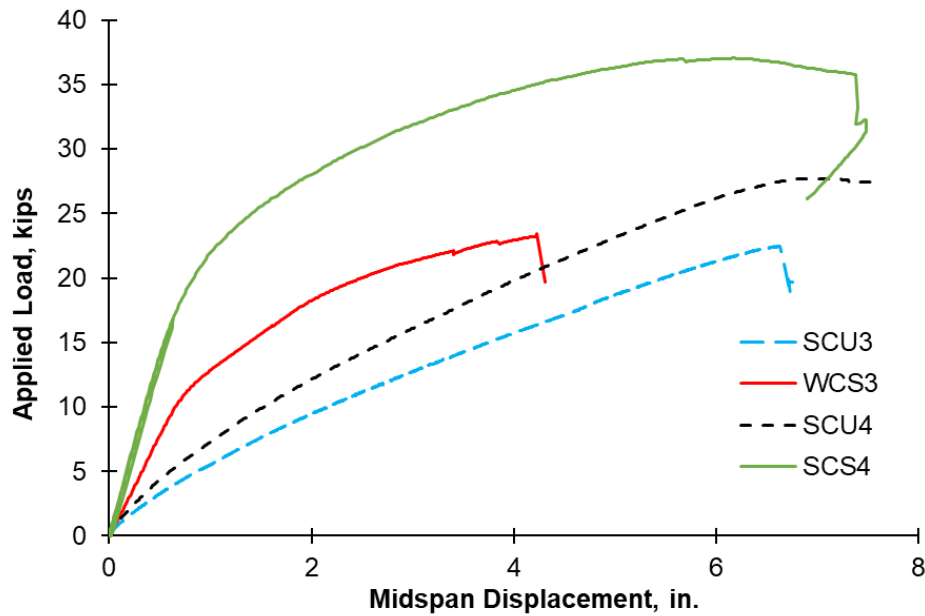
Figure 5-6: Results of static tests to failure at the conclusion of fatigue testing

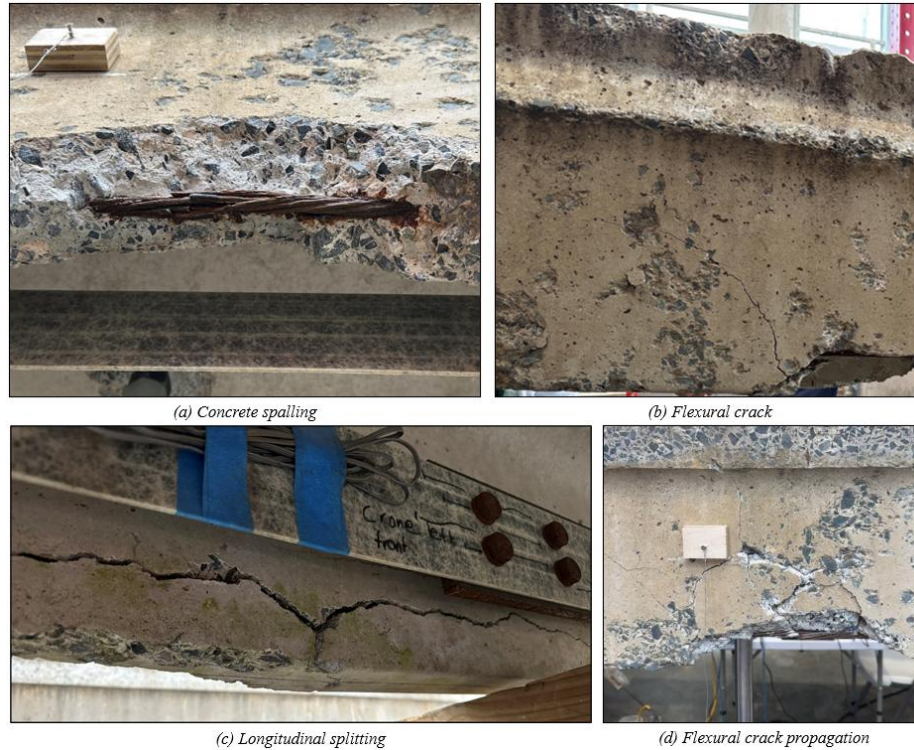
Figure 5-7: Damage signifying nonlinearity in a strengthened channel beam

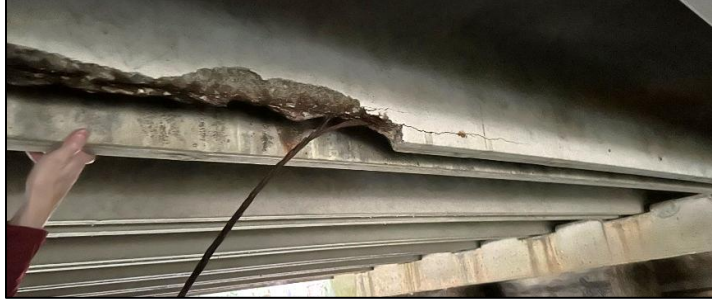
Figure 5-8: Bridge No. 070018 with a ruptured prestressing strand

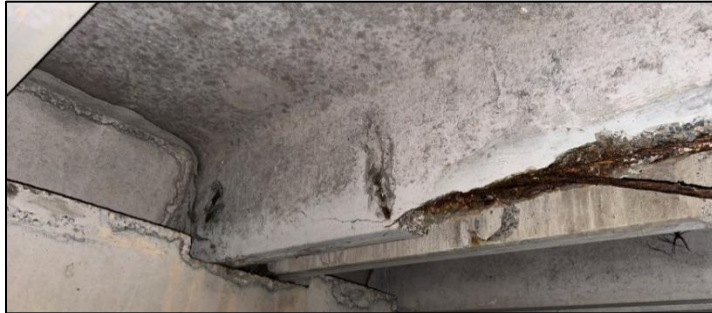
Figure 5-9: Bridge No. 070018 end region deterioration
