# Dynamics, Drivers, and Mitigation of Submerged Aquatic Vegetation (SAV) and Shoreline Change: Data Needs Associated with the Mid-Currituck Bridge

**NCDOT Project 2025-24**  
**FHWA/NC/2025-24**  
**September 2025**

**FINAL REPORT**

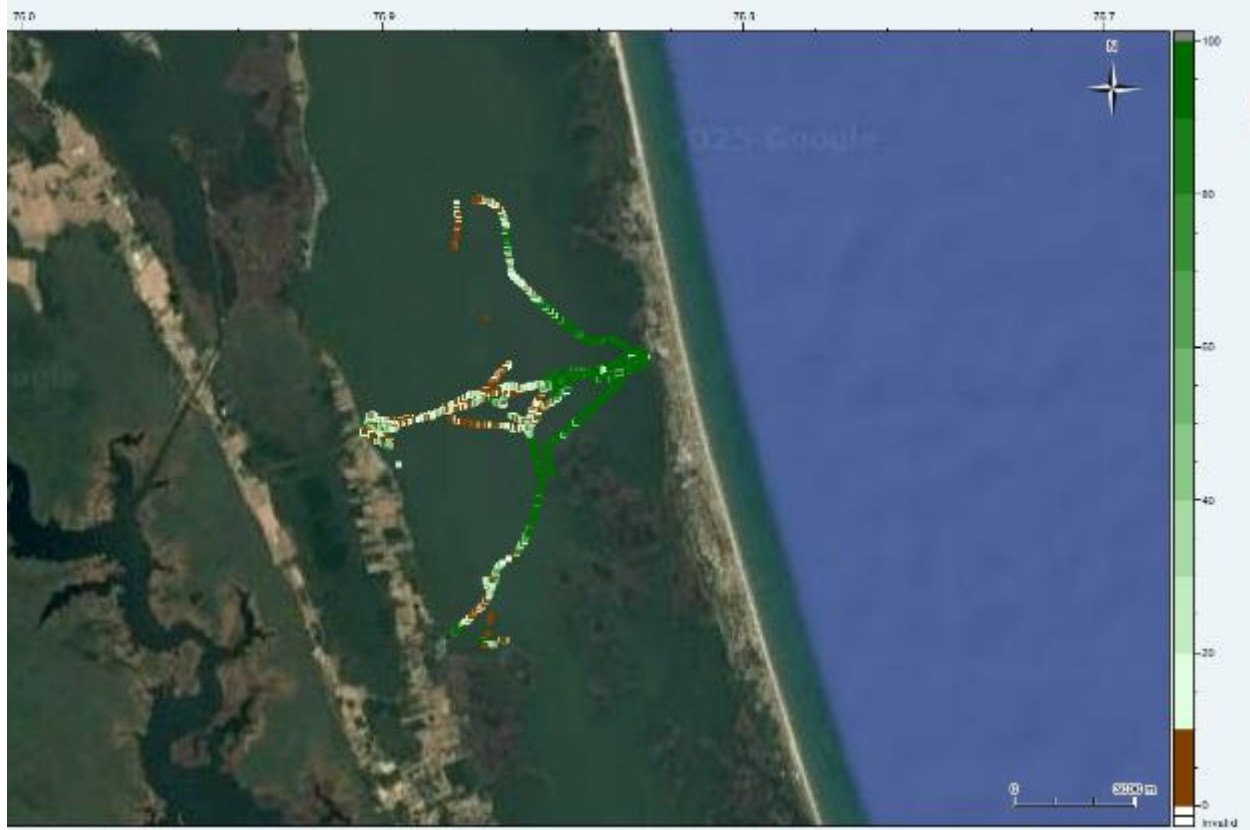
**Figure 12:** SAV cover in Currituck Sound. Green colors indicate SAV, while the intensity indicates % cover. Generally, our surveys show patchy SAV along the Western Coast, before a rapid depth increase 600 meters from the western shore a zone of deep unvegetated benthic habitat, ultimately giving way to patchy SAV and ultimately a broad shallow SAV-dominated eastern shore.

The plant detection settings were constrained to plant heights  $\geq 15$  cm above the bottom. Plant percent cover was calculated as the number of pings with a positive plant signal divided by the total number of pings in a survey point (10 pings) and was extracted at 10% cover intervals. Although percent cover was considered, most of the analyses using the hydroacoustic data focused on a simple presence/absence protocol (i.e., presence =  $\geq 10\%$  cover, absence = <10% cover).

Hydroacoustic monitoring provides essential information about water depth, bottom type, and SAV presence and structure. However, some uncertainty is inherent in interpreting hydroacoustic data. Our resulting surveys clearly identify widespread SAV dominance in depths of 0.5 to 1.2 meters and clearly identify patches of SAV in deeper water, with identification confirmed and widespread as deep as 2.4 meters (Figure 11). However, isolated SAV patches appear in depths up to 2.7 meters. These deep, isolated SAV patches will be another area of focus in year 2 of this study. Due to the previous depth limitation identified at 1.8 m, indication of potential range expansion providing an extensive area for potential mitigation.

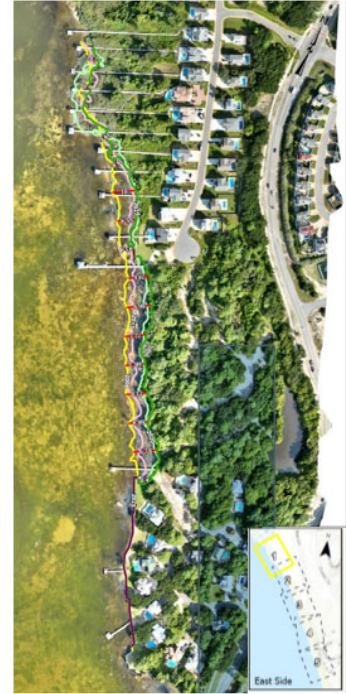
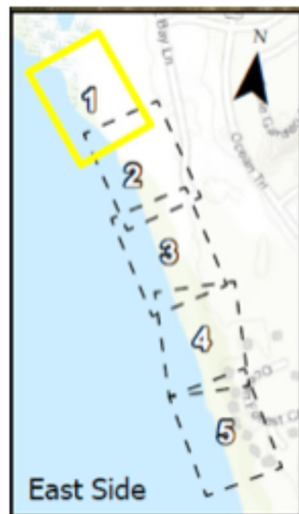
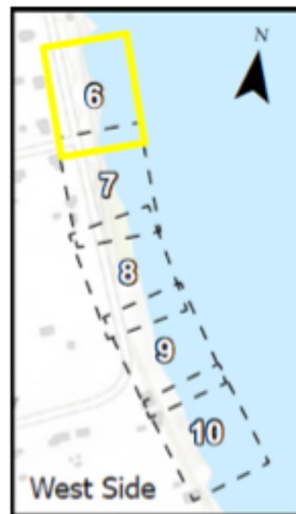
- Change of non-engineered shorelines
  - Mean:  $-3.1 \pm 1.6$  ft/yr
  - Range:  $-5.1 - 0.3$  ft/yr
- % Engineered: 26%
- Mean Sinuosity:  $1.17 \pm 0.11$
