SOUTH FORK BIG PINE CREEK – CHARLES/MCGINNIS INSPECTION REPORT

MITIGATION SITE NAME South Fork Big Pine Creek – Charles/McGinnis	TIP # A-10WM	WBS # 34634.2.13	INSPECTION DATE 10/16/13
--	-----------------	---------------------	-----------------------------

COUNTY Madison	# ACRES 1.11
-------------------	-----------------

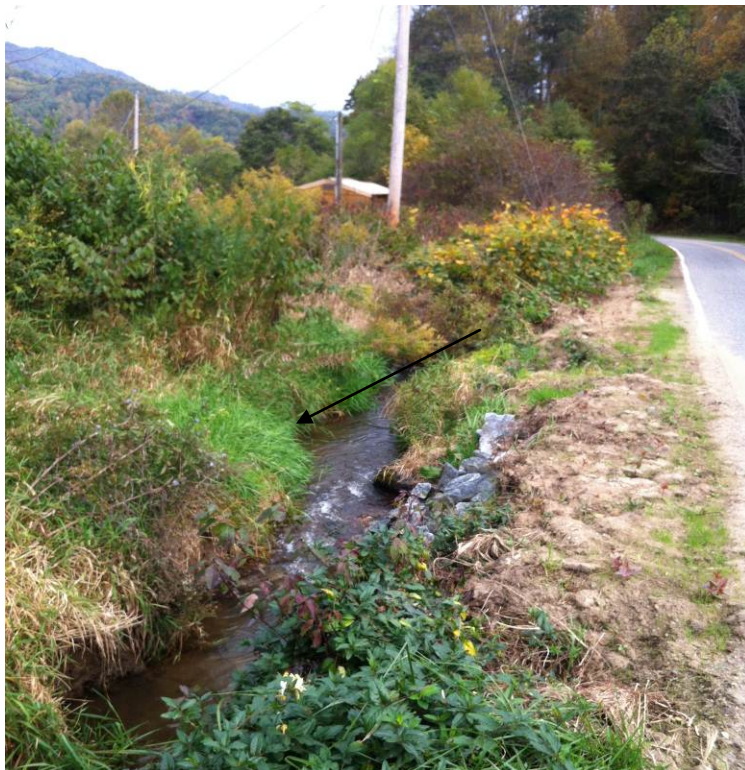
Where the stream skirts the road, evidence of road work and additions of rip-rap were noted (see photo).

Evidence of stream side rip-rap additions and earth moving activities, honeysuckle in foreground

REQUEST FOLLOW-UP BY PROGRAM MANAGER FOR POSSIBLE VIOLATIONS.

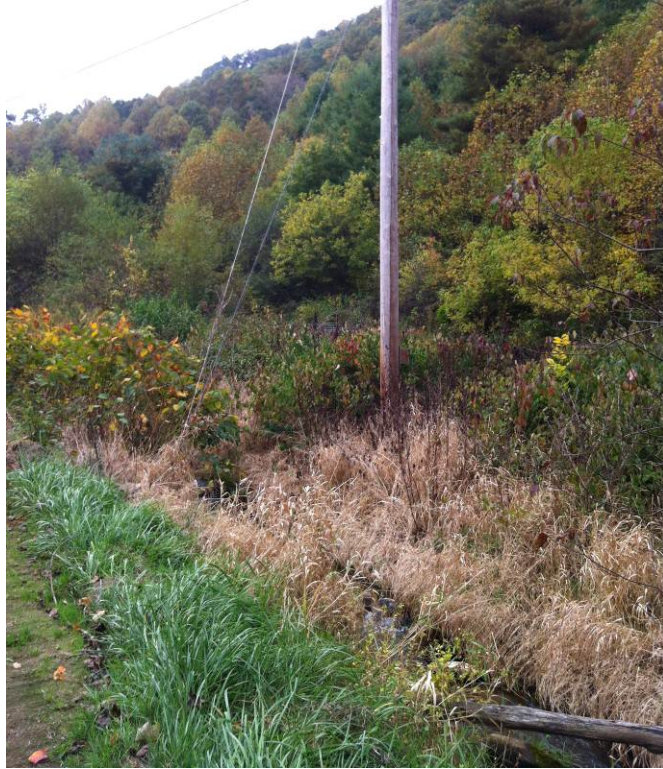
Fork Mountain Farms reported the utility company spraying along the stream and their property (see photo).

Evidence of herbicide spraying by utility company

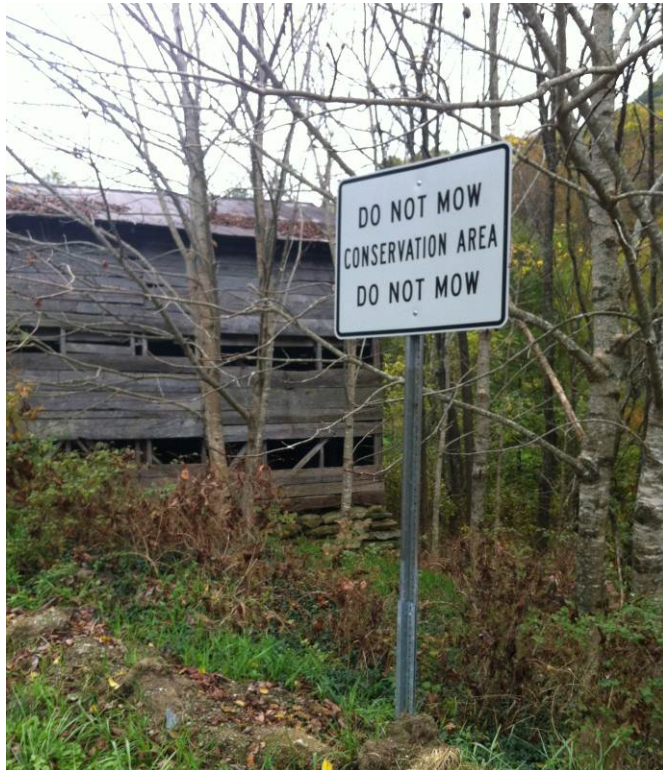
"Do Not Mow" signs

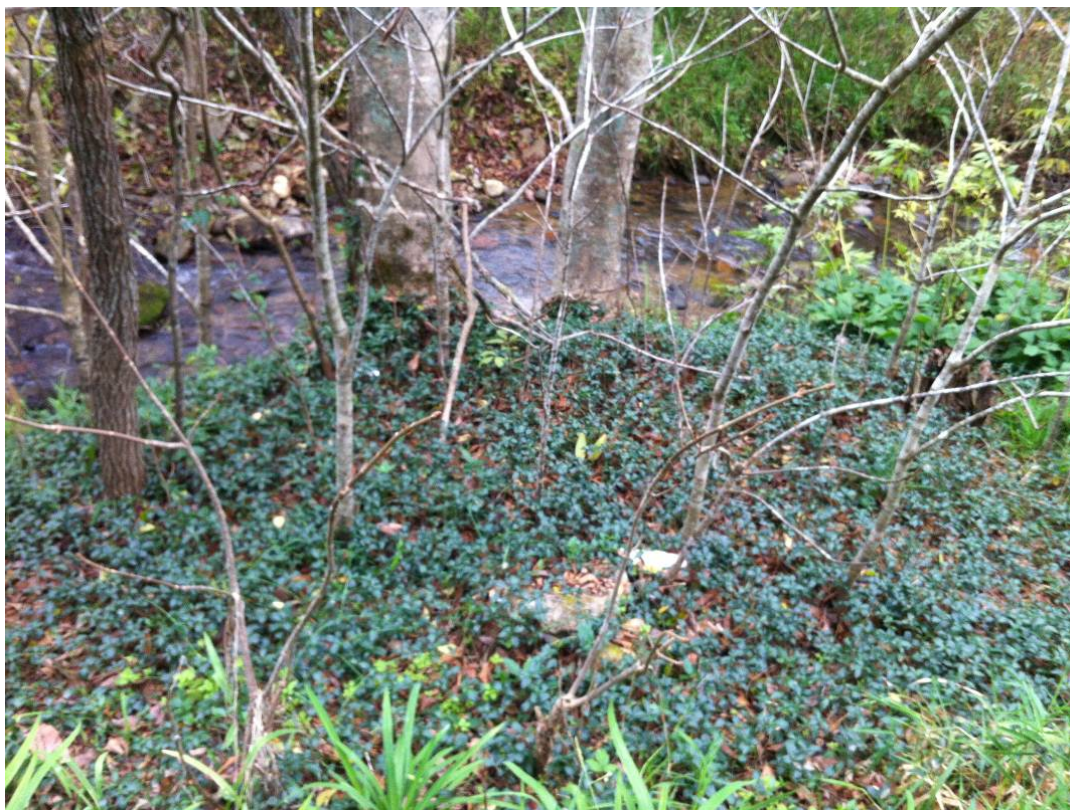
<input type="checkbox"/> FLOODING	<input type="checkbox"/> FIRE	<input type="checkbox"/> STORM	<input type="checkbox"/> EARTH MOVEMENT
<input checked="" type="checkbox"/> INVASIVE EXOTIC VEGETATION	<input type="checkbox"/> INSECT INFESTATION	<input type="checkbox"/> ANIMAL ACTIVITY	<input type="checkbox"/> OTHER ACTIVITIES/ CHANGES? (Please Explain)
<input checked="" type="checkbox"/> NO CHANGE			
EXPLAIN: Honeysuckle, knotweed and big leaf periwinkle were found growing along parts of the boundary.

Bigleaf periwinkle seen in portions of the of stream banks
