# NCDOT Historic Architecture Group Procedures and Work Products

*OCTOBER 2015*

# Screening for Programmatic Agreement Documents

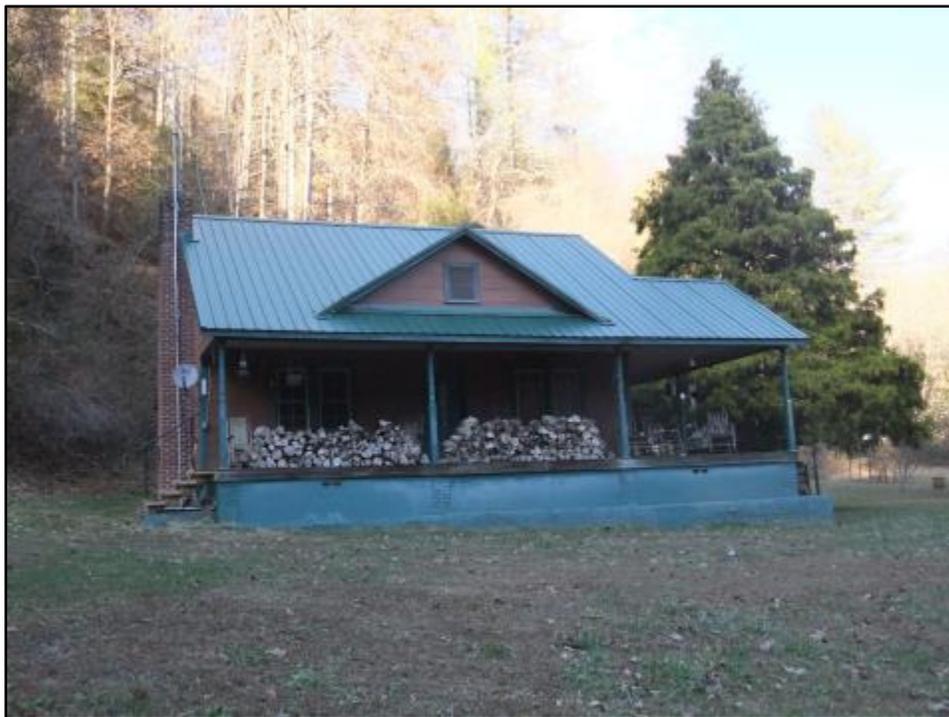
**Figure 3. Façade of Site 1 (6890 Stone Mountain Road), facing east-northeast.**

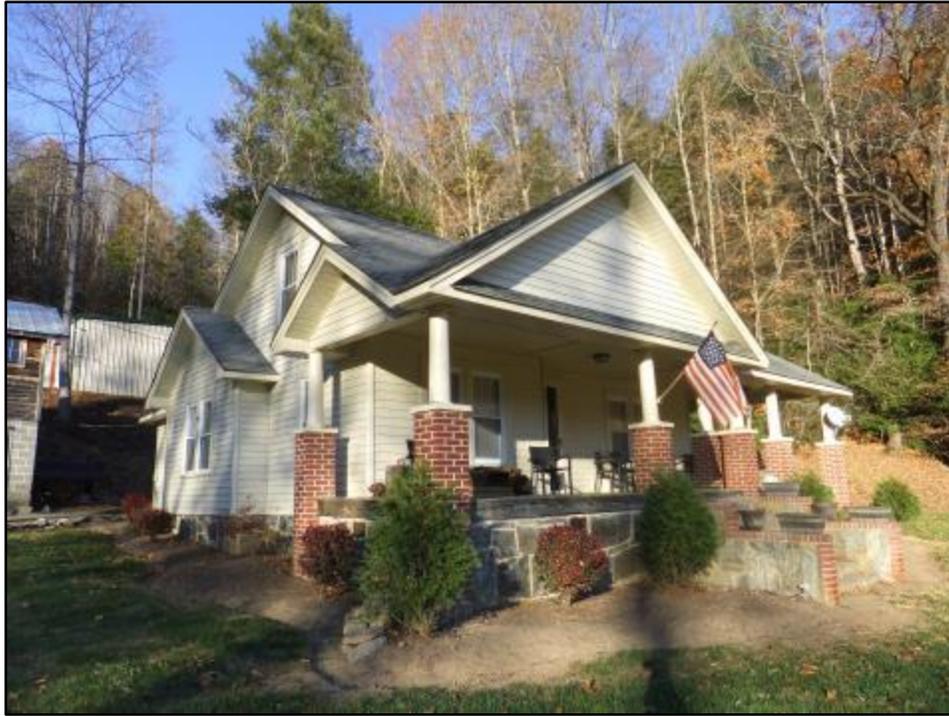
**Figure 7. Façade and west elevation of Site 2 (6936 Stone Mountain Road), facing east-northeast.**

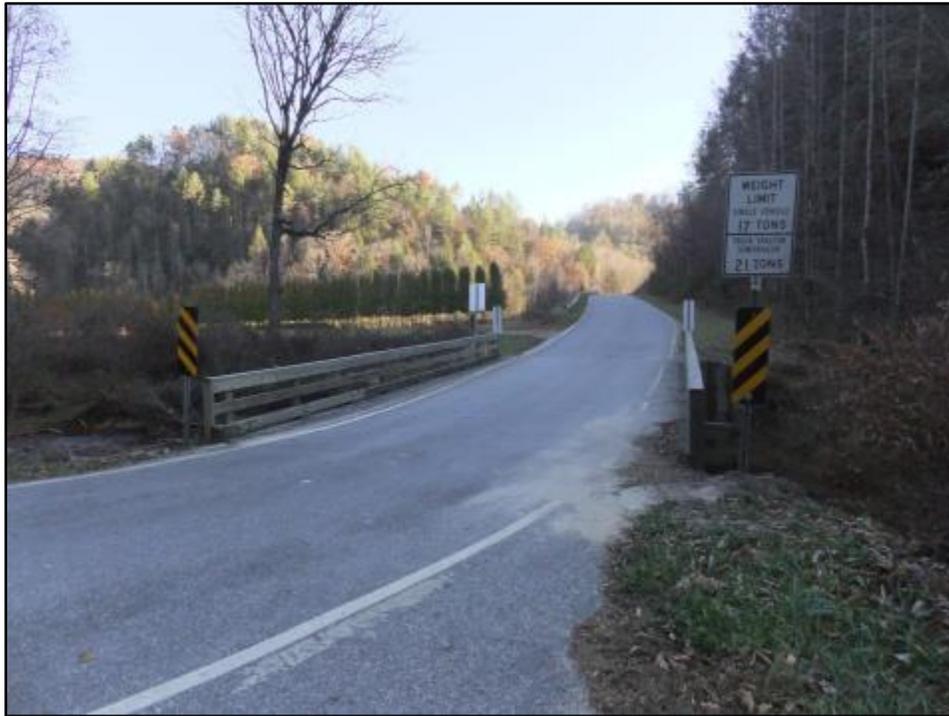
Figure 12. Overview of the deck of Site 3 (Bridge No. 164) facing southwest.

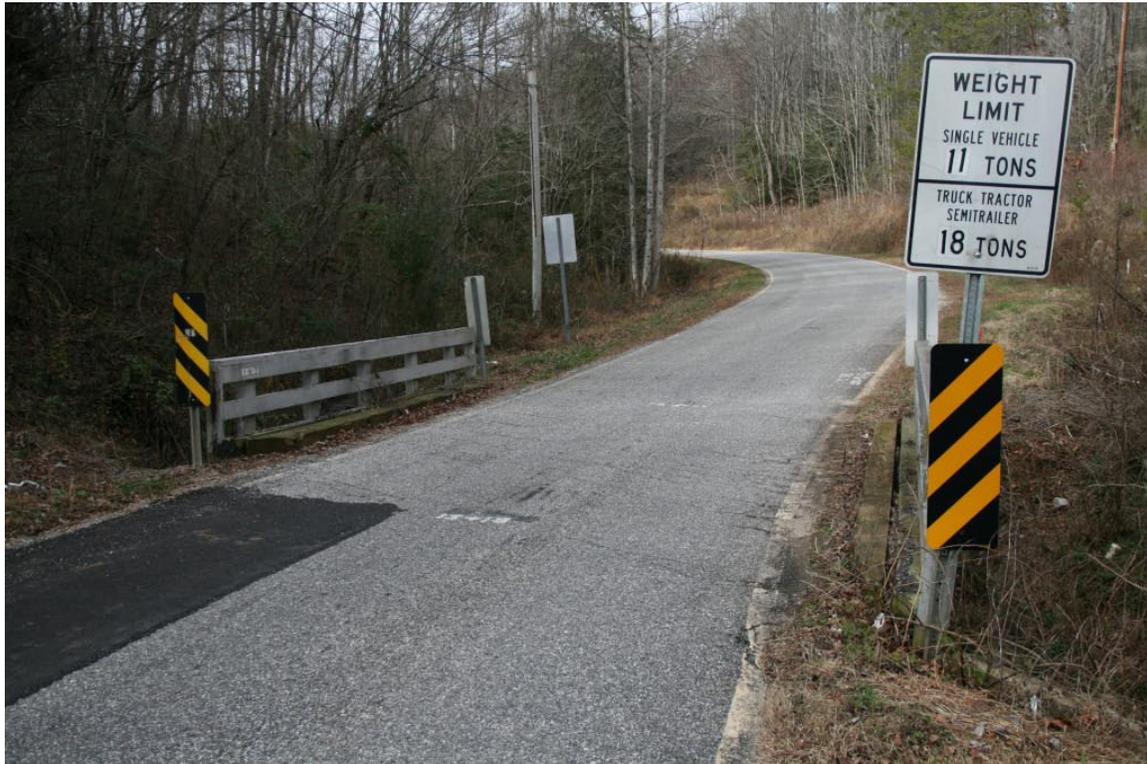
1. Bridge No. 167 on SR 1746 over creek, view to northwest

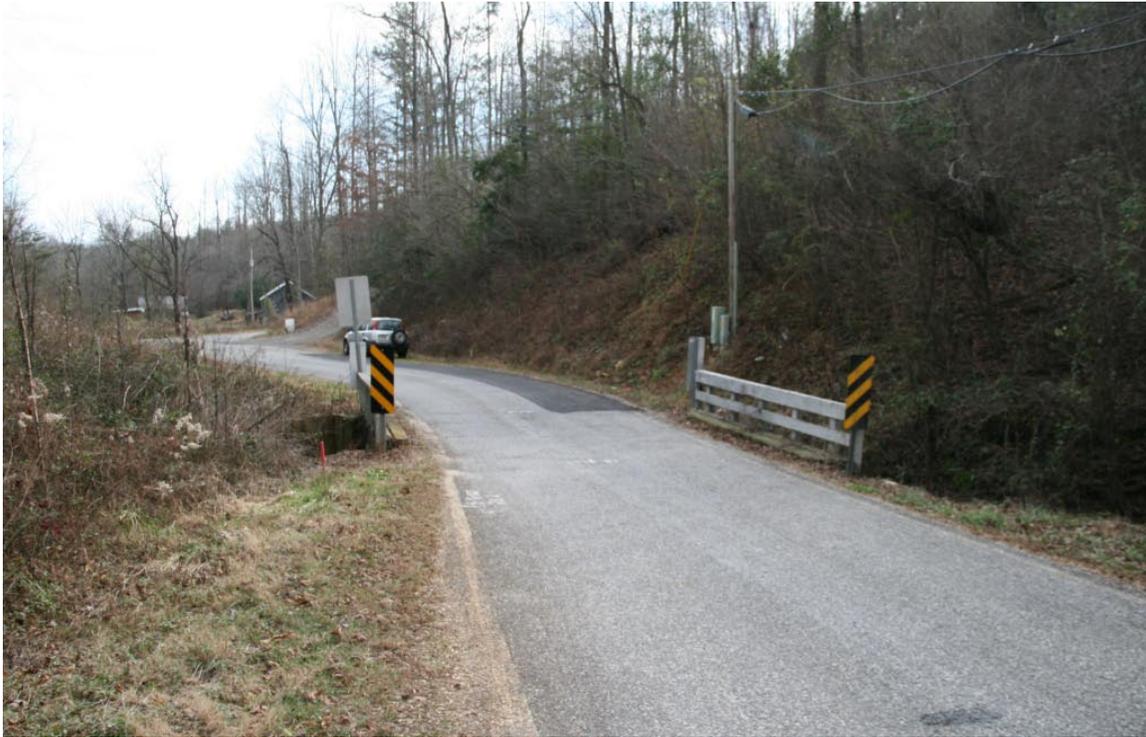
2. Bridge No. 167 on SR 1746 over creek, view to southeast

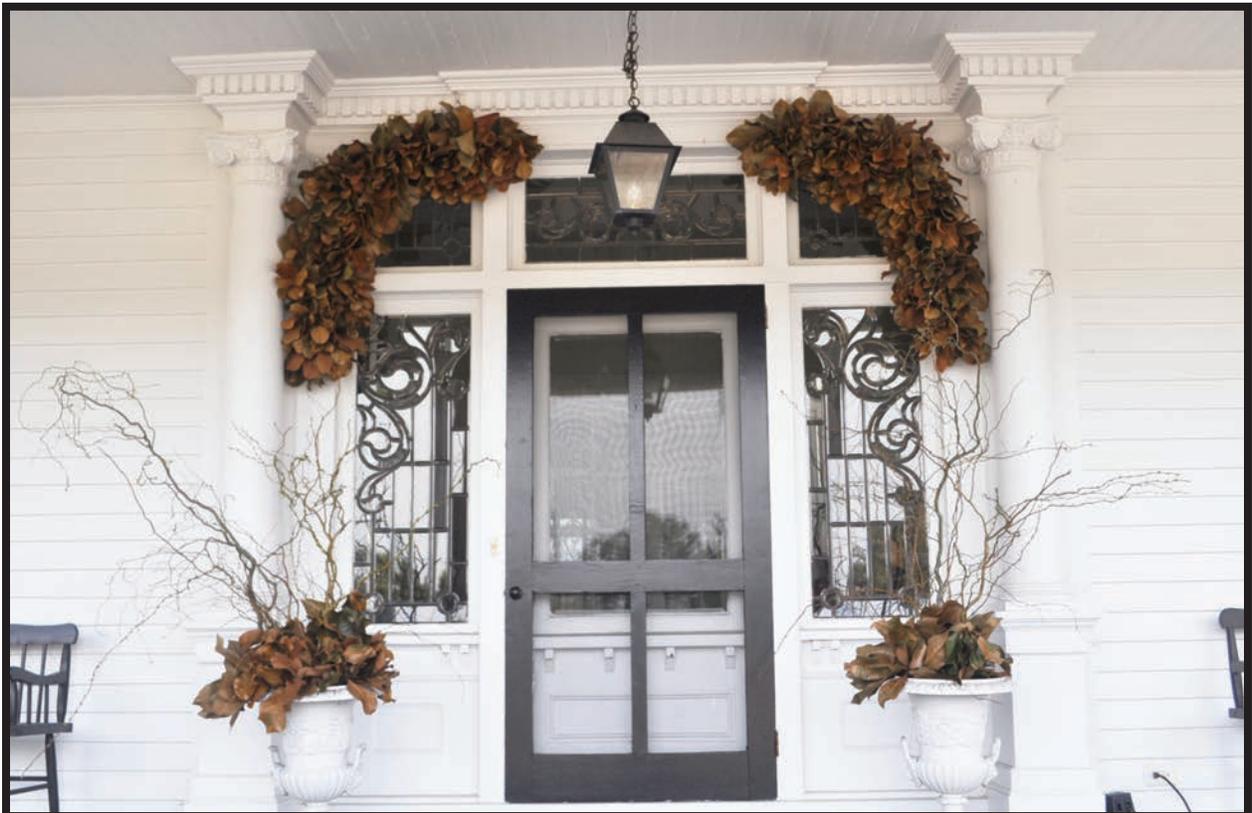
*Figure 13. Second Story Balcony Door with Stained Glass and Louvered Storm Door*

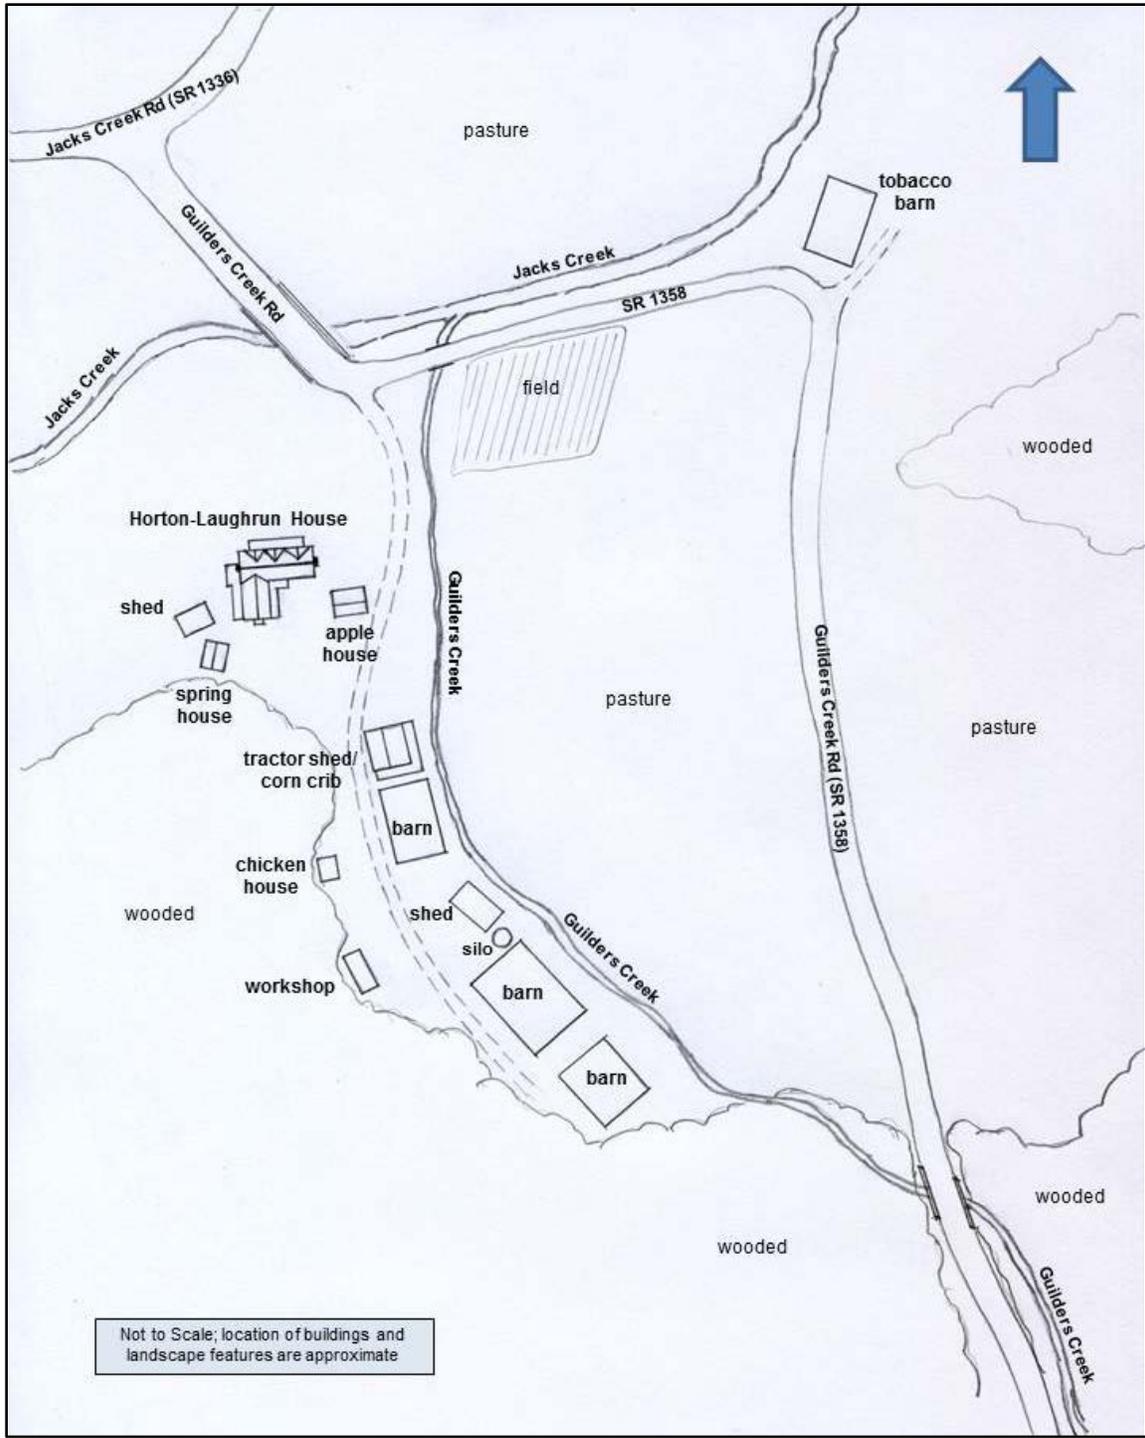
**Site Plan – Horton-Laughrun Farm, 34 Guilders Creek Road**

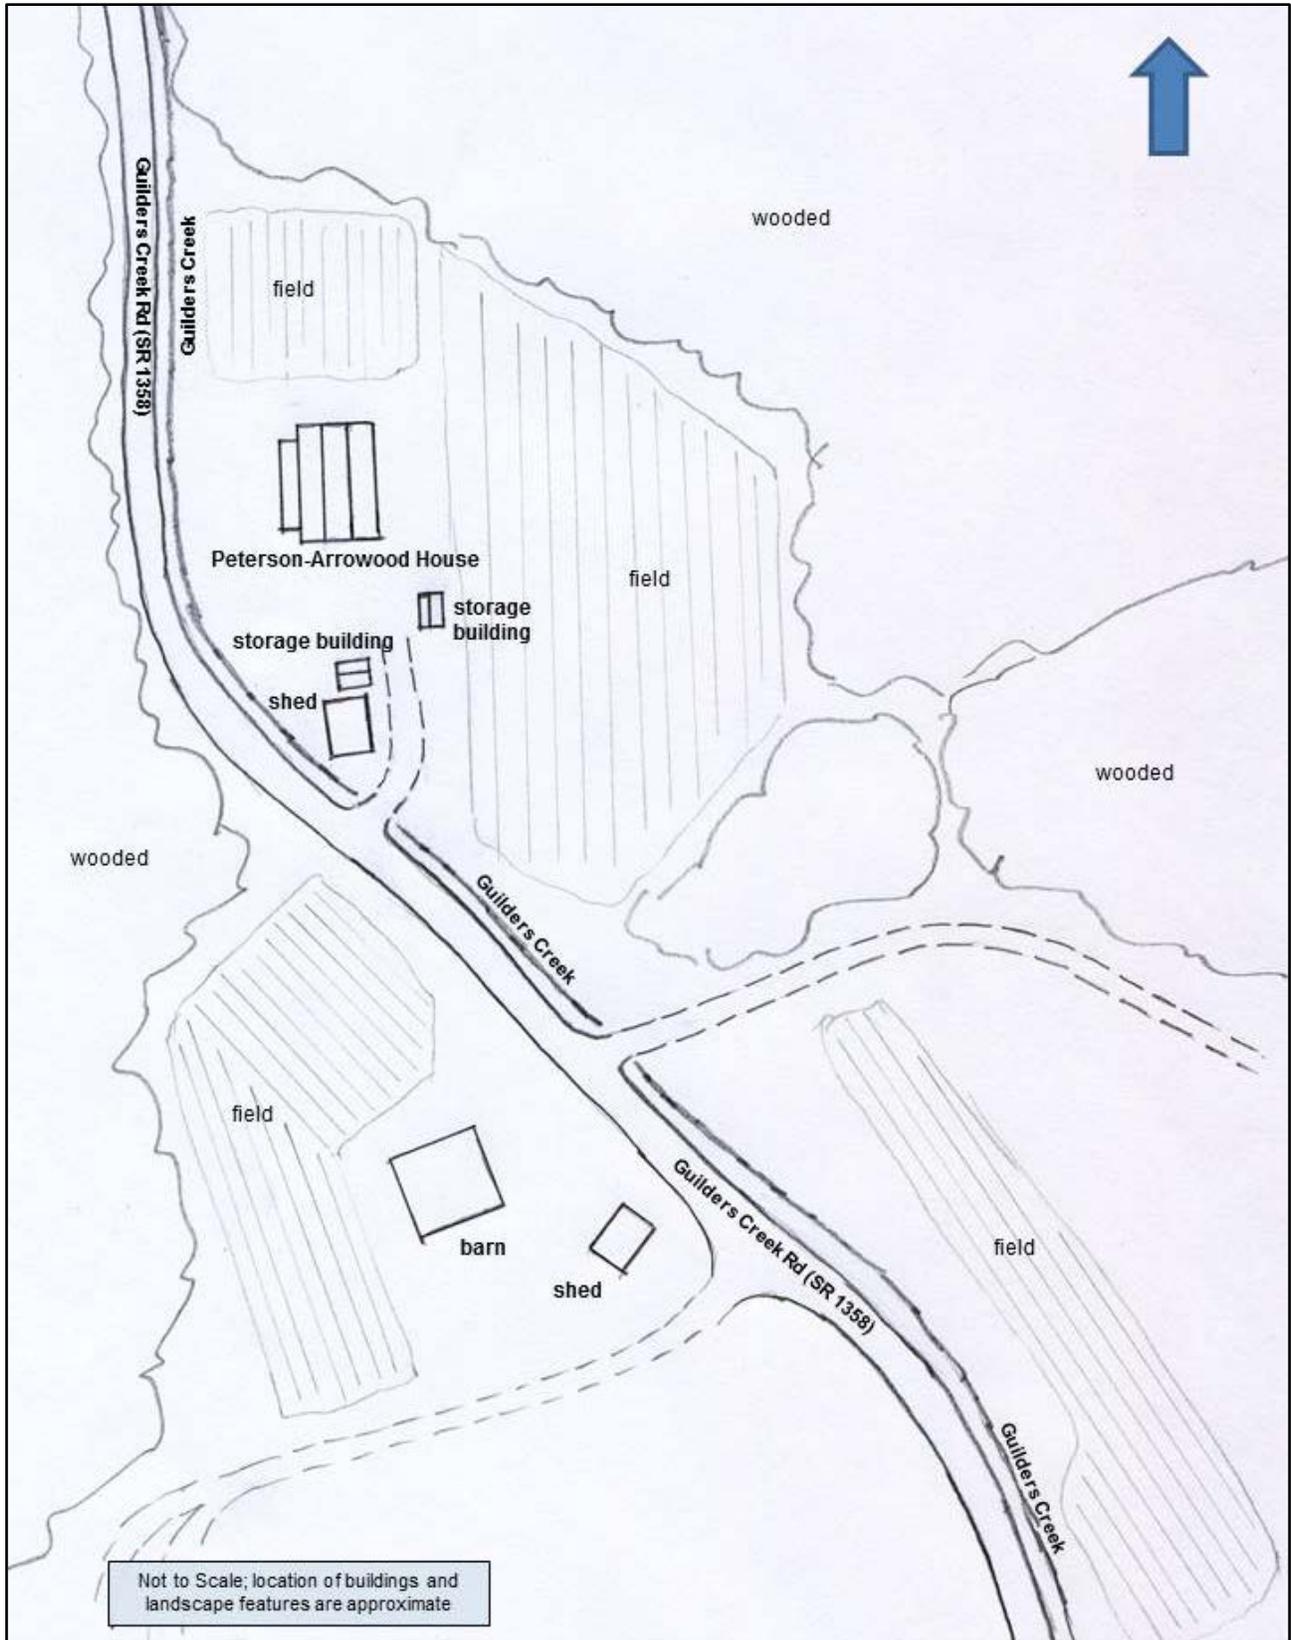
**Site plan – Peterson-Arrowood House, 325 Guilders Creek Road**

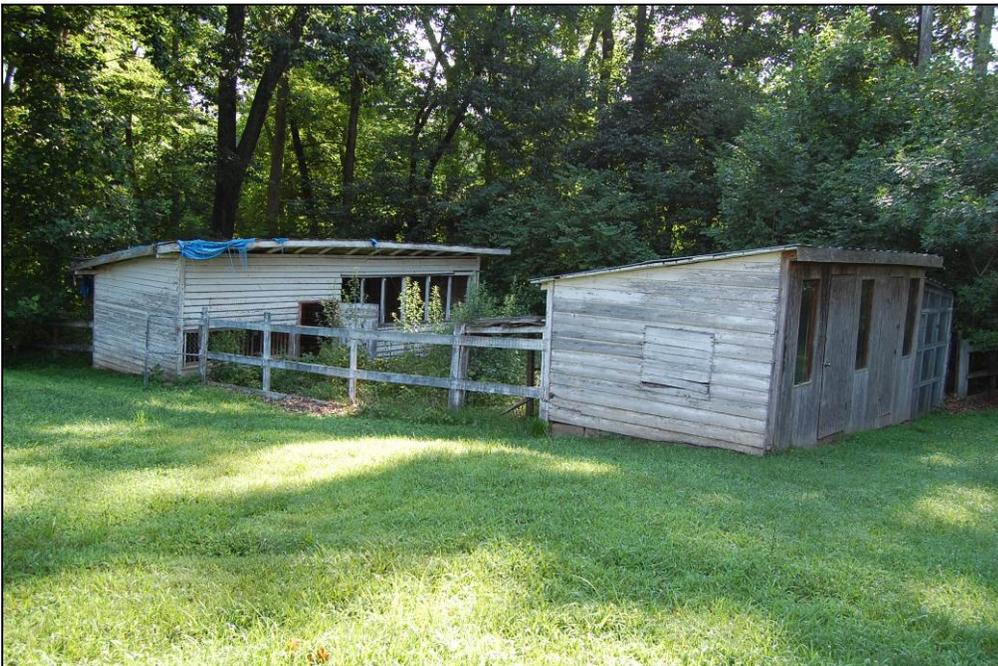
Just east of the Frank Morgan House stand two vacant chicken houses that share a fenced chicken yard (Figure 33). The yard is overgrown and the houses are vacant, but they are in fair condition. Both are built of frame with seamed metal, shed roofs and multiple openings. According to Bob Morgan (2015), they may date from 1937 or 1938. The chicken houses are in fair condition and retain their integrity.

**Figure 33. Looking northwest at chicken houses with chicken yard between**

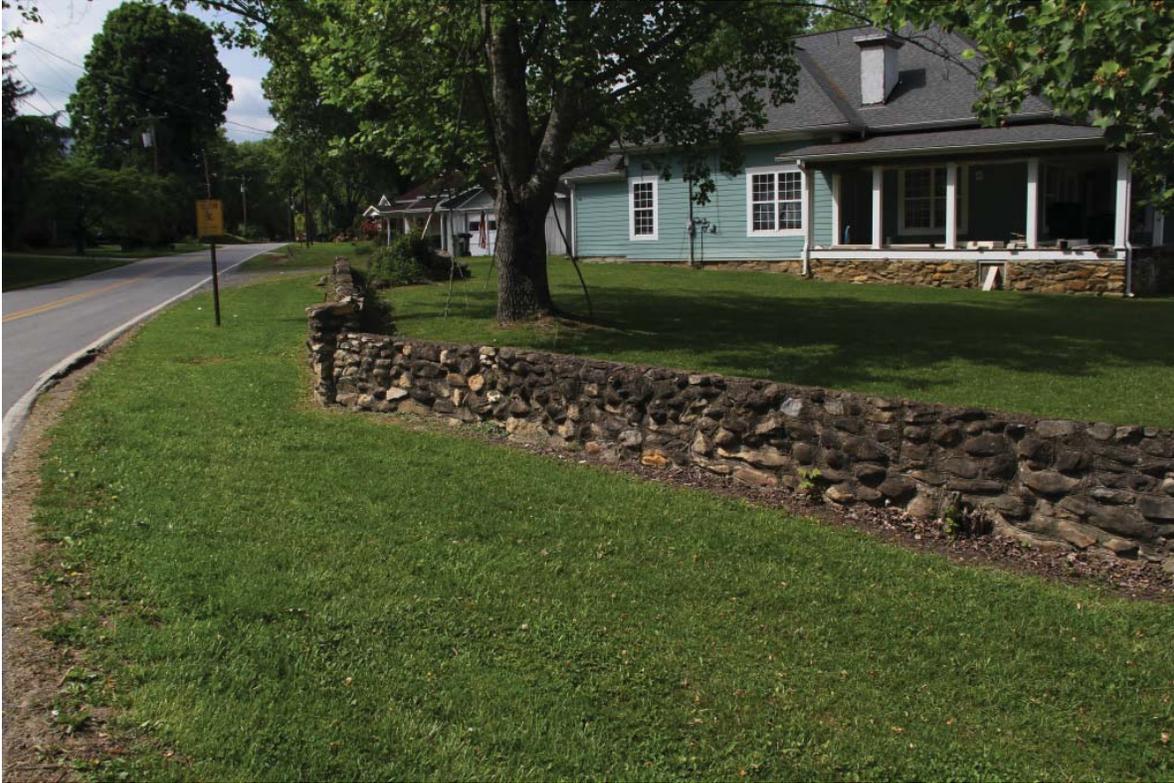
In addition to the stone landscape elements found at the Bristol House, several other stone and concrete border walls were observed in close proximity to the Bristol House, including the low concrete wall located approximately six feet from the edge of pavement at 230 Bristol Avenue. A decorative stone wall wraps around the edge of the property that contains the house at 17 Sixth Street, in the southwest quadrant of the intersection of Sixth Street and Bristol Avenue. A stone retaining wall forms the south edge of the driveway of the Brady House at 455 Bristol Avenue and extends for approximately 200 feet along the east side of the road. These types of landscape elements appear to be relatively common throughout Andrews' residential sections.

**House, 17 Sixth Street, stone wall, view to south along Bristol Avenue**

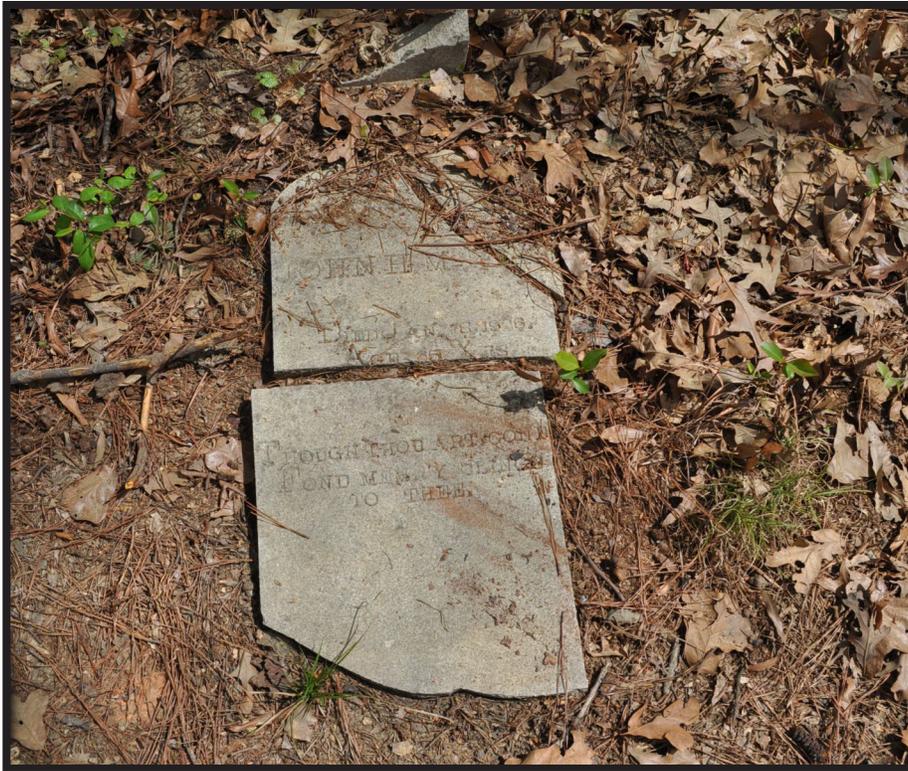
*Figure 71. Broken Concrete Marker*

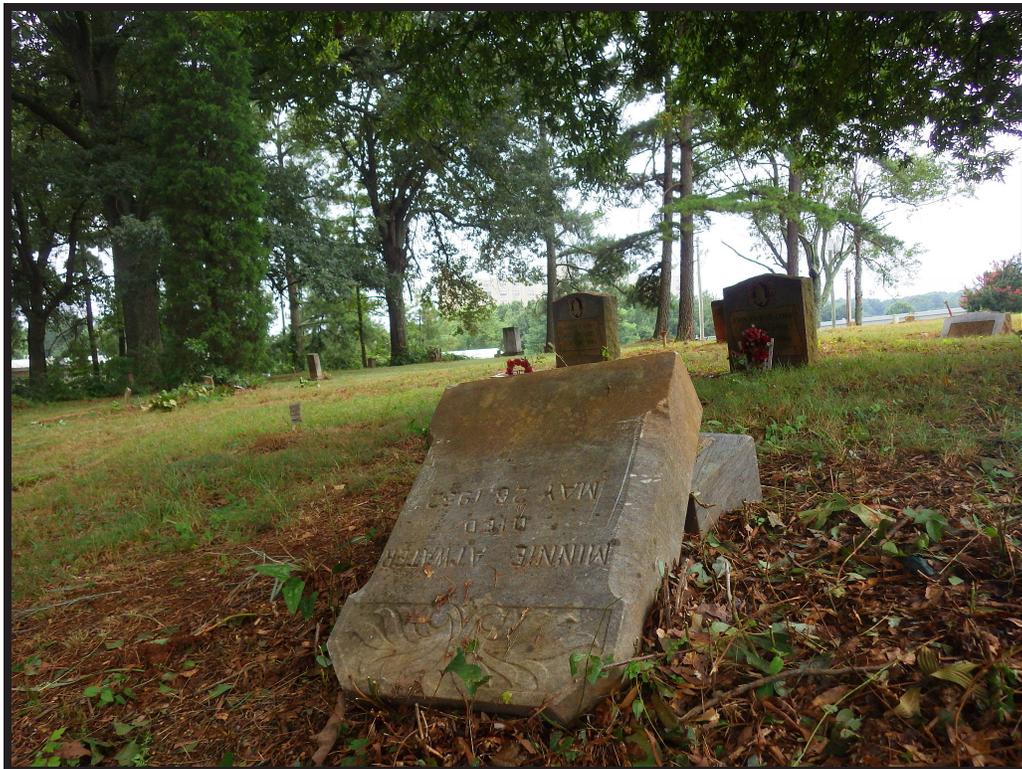
*Figure 72. Toppled Granite Marker*
