WETLAND MITIGATION PLAN

Beane Property Wetland Mitigation Site
New Hanover County, North Carolina

Contract Number: 7000016058
WBS Element: 40237.4.sl
TIP Number: R-3300
USACE Action ID No. SAW-2007-01386

December 2021

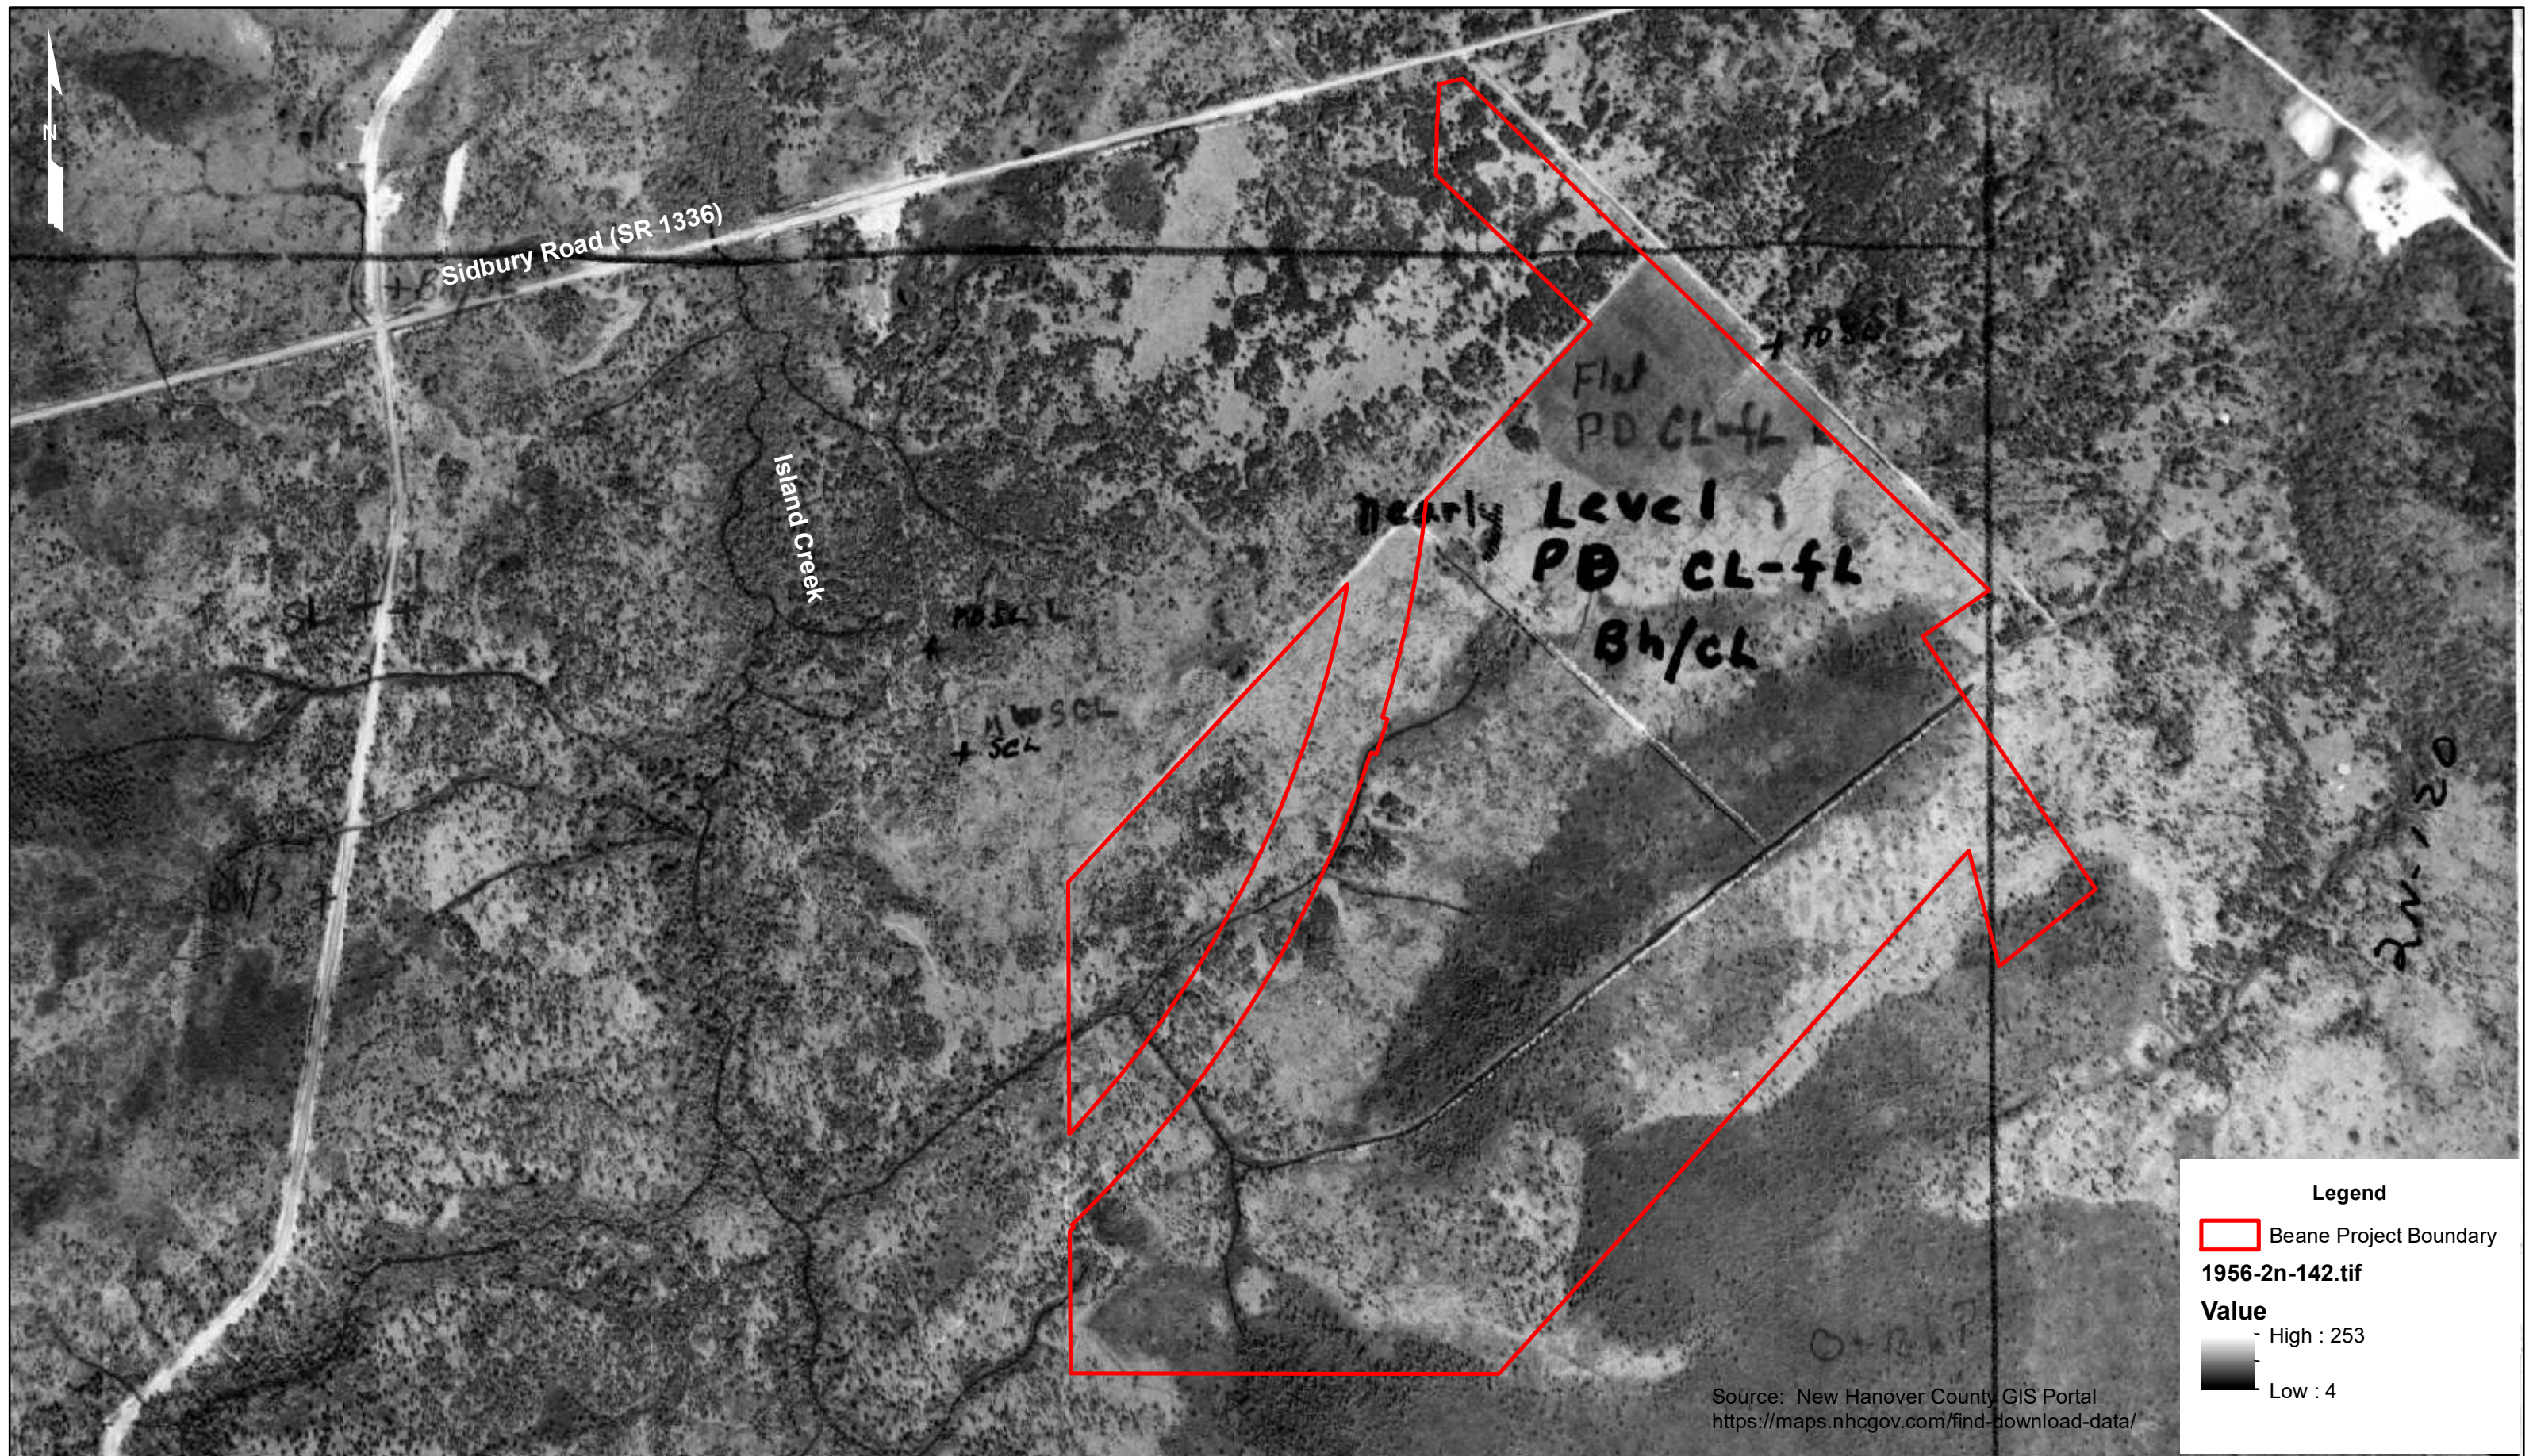
Beane Wetland Mitigation Site
1956 Aerial Photography Map
New Hanover County, NC

The Site hydrology has been significantly altered because of ditching dating back to the late 1940s and early 1950s (Figures 2 and 3). These ditches result in a lateral drawdown effect on the surrounding wetlands, negatively influencing their overall wetland hydrology. The method used to determine lateral effect was developed by R.W. Skaggs and was used on the Site to estimate the distance of hydrologic influence of a drainage ditch through a wetland. This distance of influence is the width of the area immediately adjacent to the ditch that is drained or influenced to a degree that the water table is no longer within 1.0 foot of the surface. It was estimated that approximately 33% (54.3 acres) of on-site wetlands were affected by lateral effect and were removed from the final potentially jurisdictional wetlands list. A field review meeting conducted on November 19, 2014, with personnel from NCDOT, DWR, USACE, and CALYX confirmed that hydrology was absent within the lateral effect zones. Additional lateral effect was determined for the southern perimeter ditch in January 2021 following reviews by USACE. These additional lateral effects are included in the final jurisdictional determination letter in Appendix 1 and acreages shown in Table 5. Figure 6 shows the portion of the Site affected by the lateral effects.

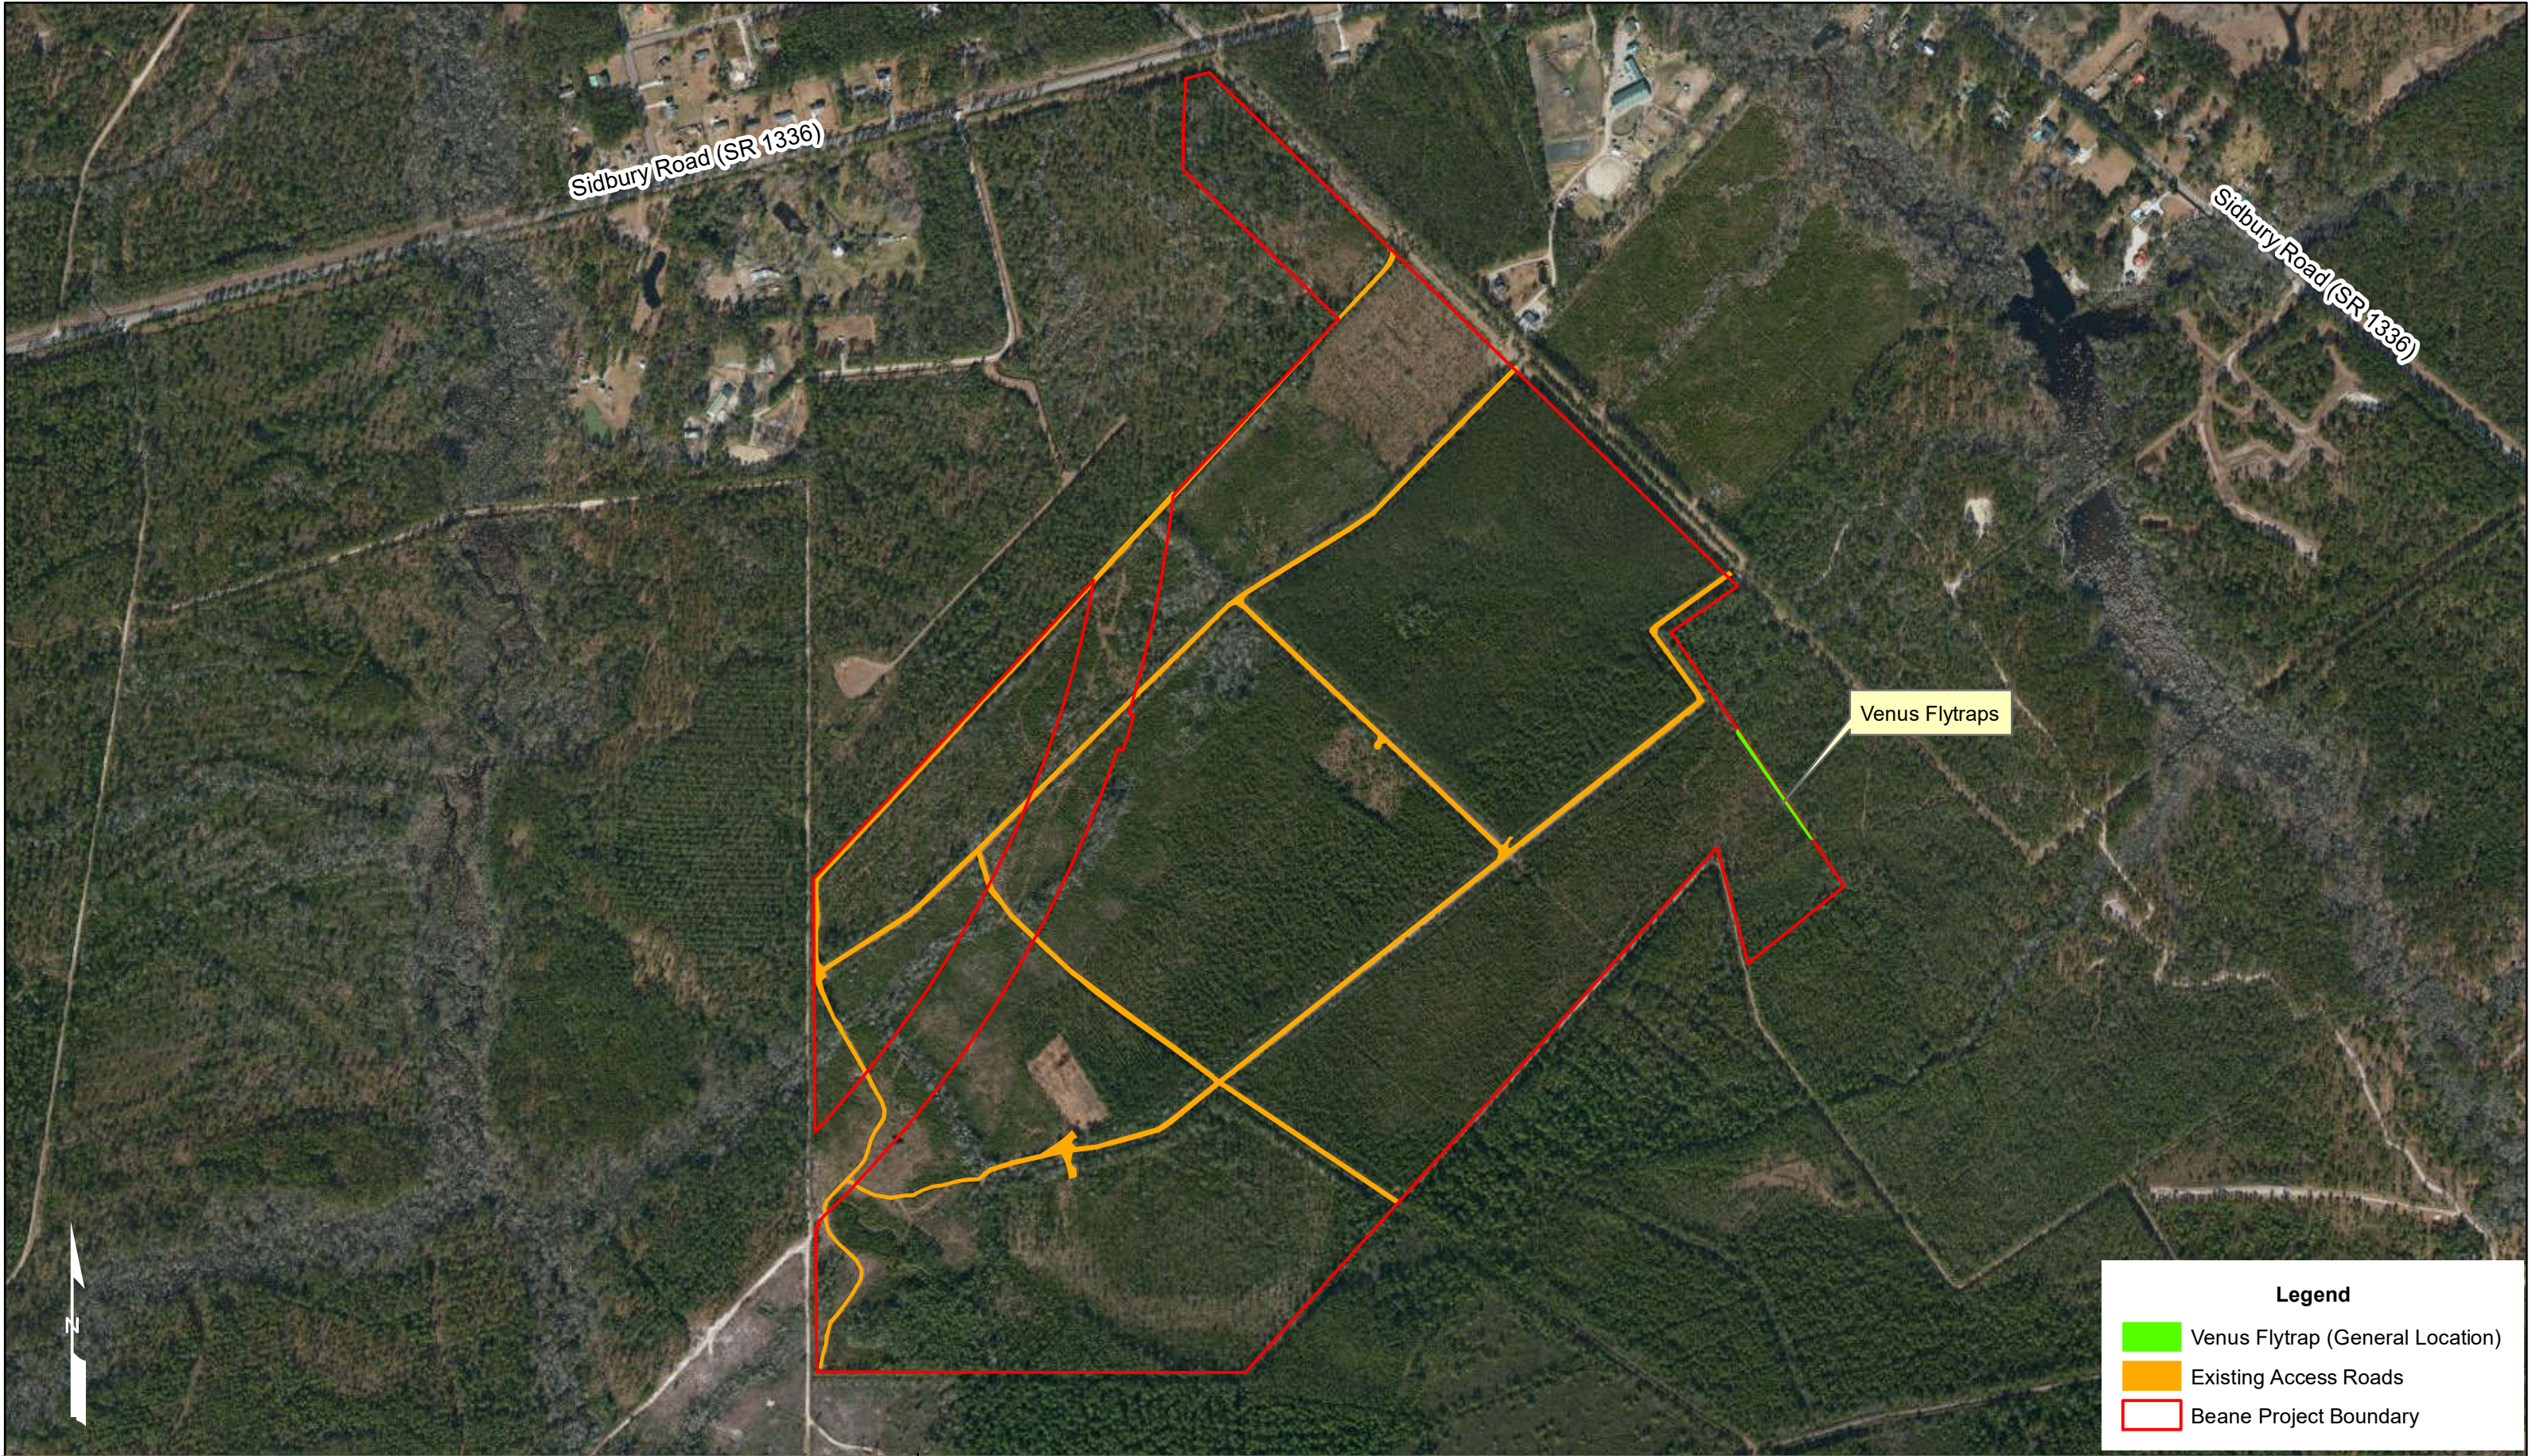
Figure
9

Beane Wetland Mitigation Site
State Listed Species Map
New Hanover County, NC

Multiple plants of *Dionaea muscipula* (Venus flytrap) have been observed along the eastern boundary of the Site (Figure 9). These plants exist along an ecotone / access path that has been regularly maintained through mowing over the last decade (Barrett, 2021). The plant species is listed as State Threatened by the NCNHP (NCNHP, 2021).

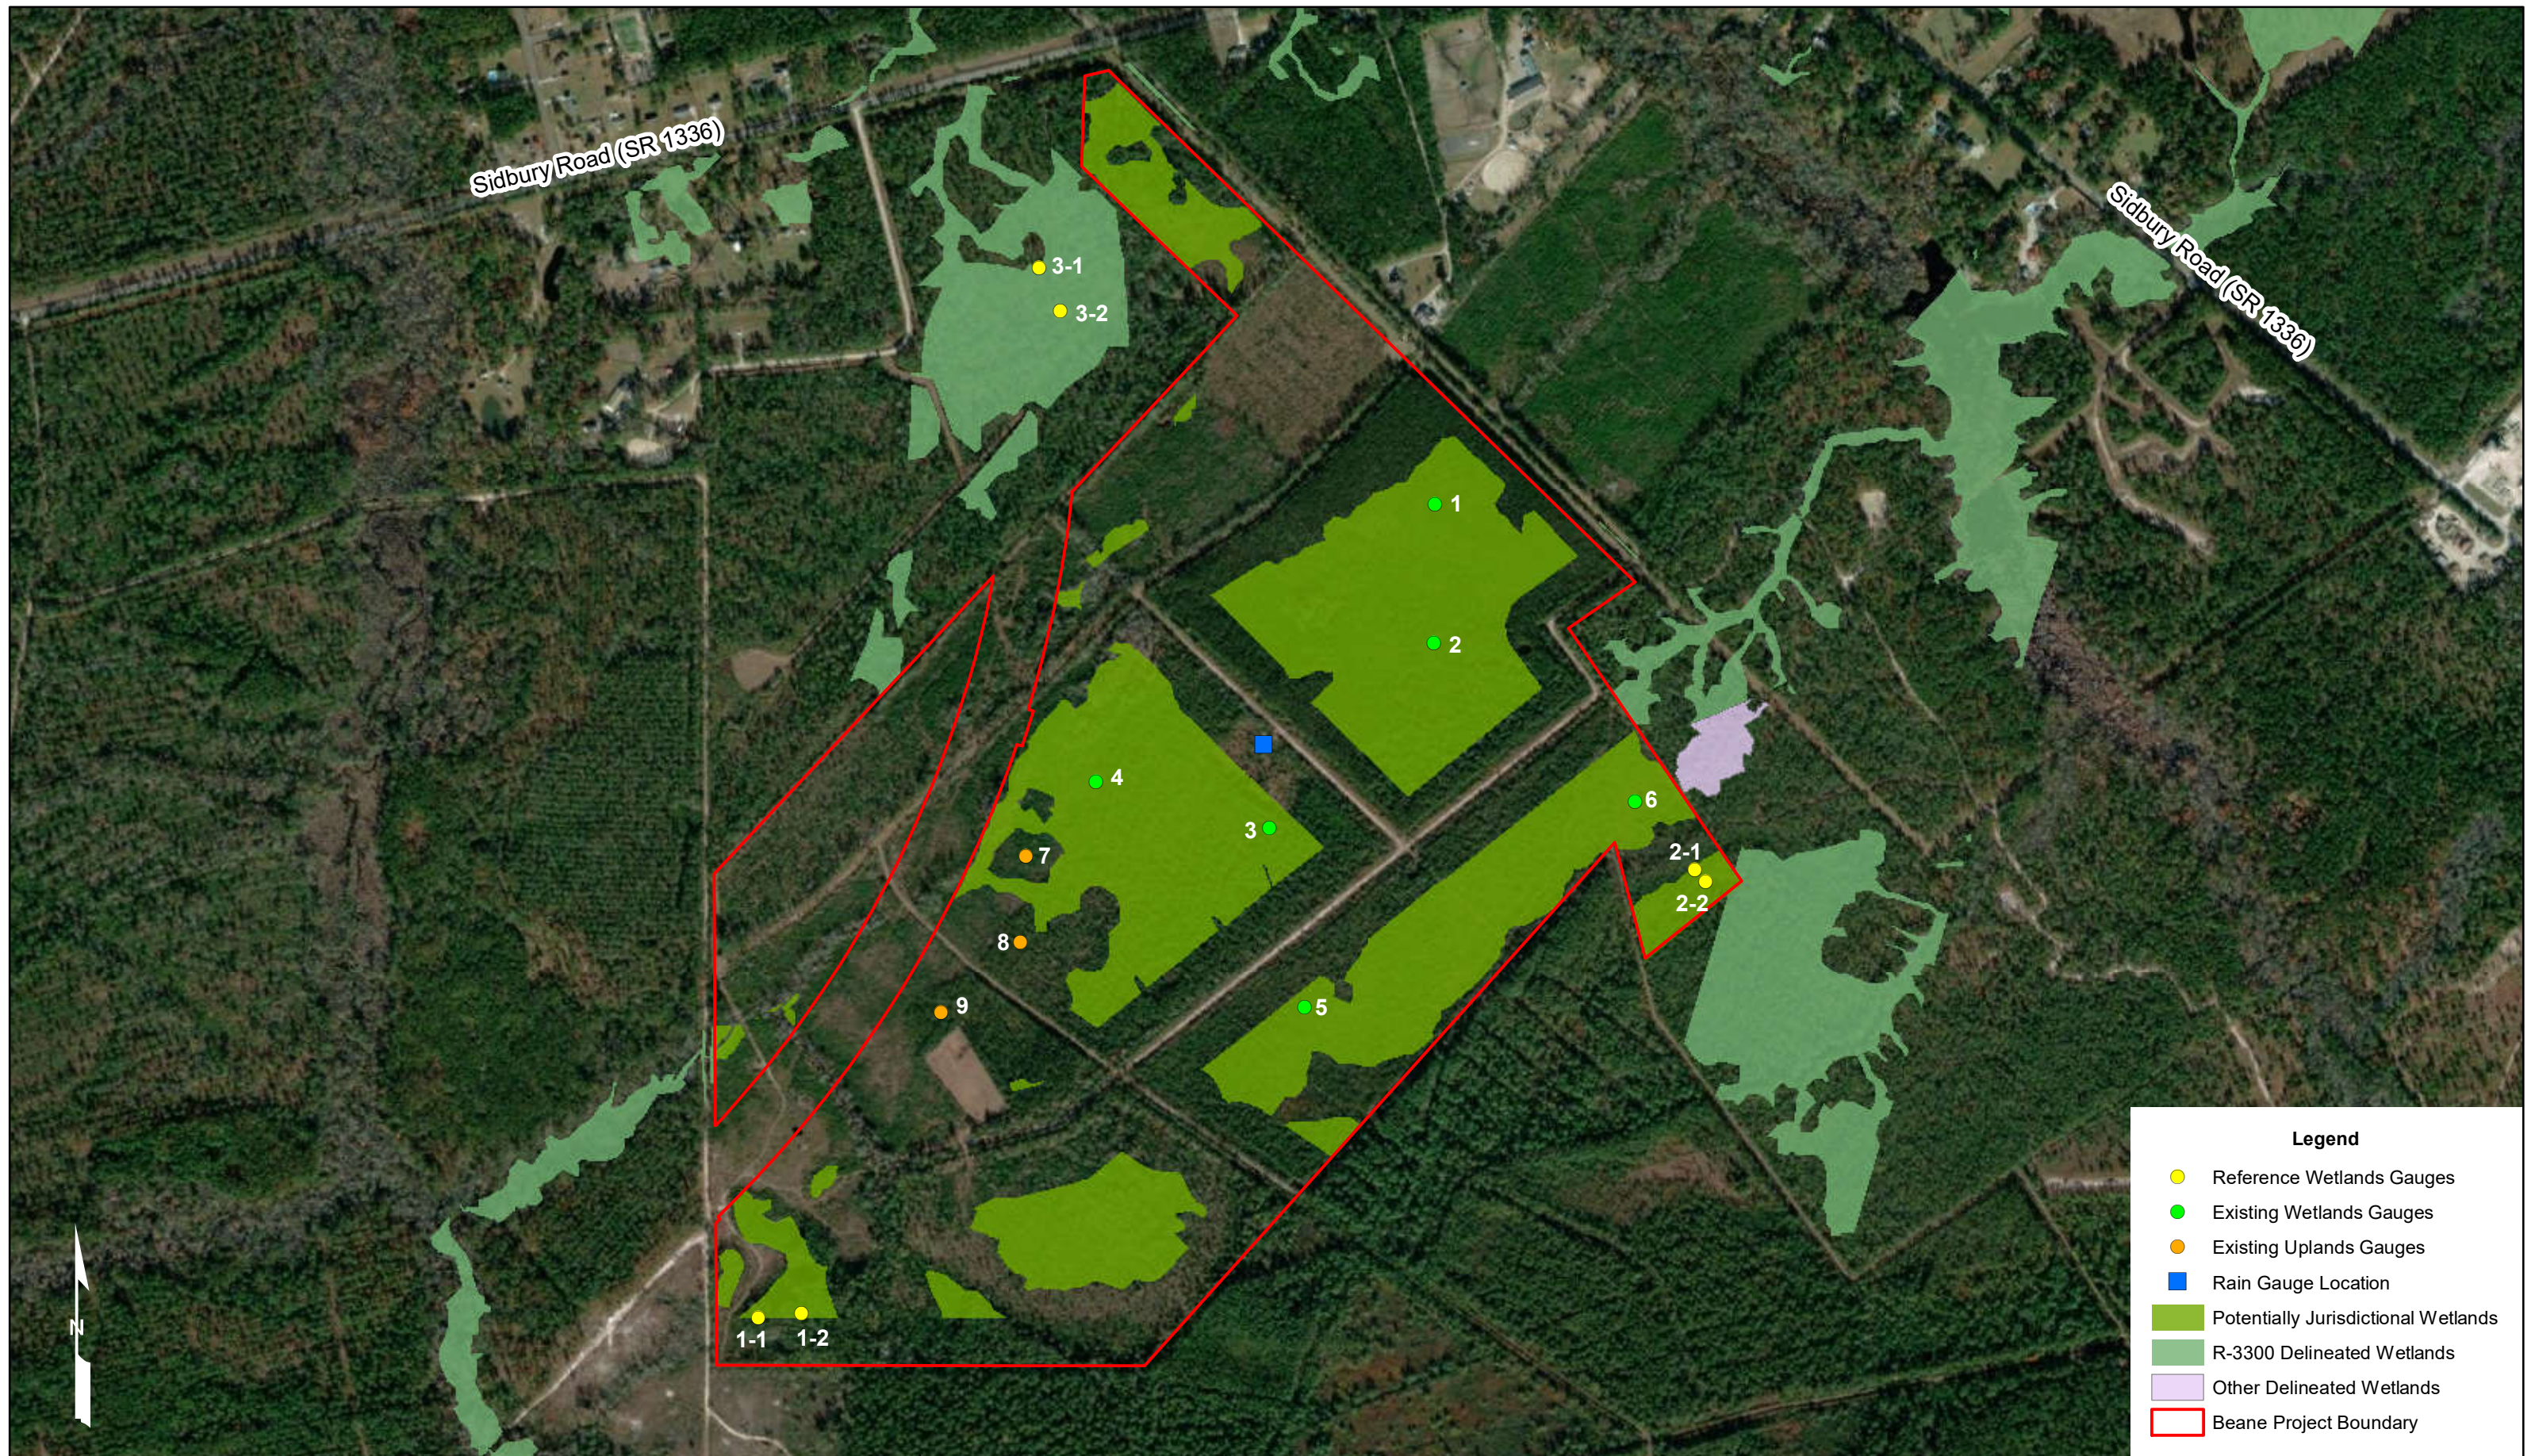
Figure
11

Beane Wetland Mitigation Site
2015 Hydric Soils Investigations
New Hanover County, NC

features, indicating the potential for restoration. The locations of these soil investigations are shown on Figure 11.

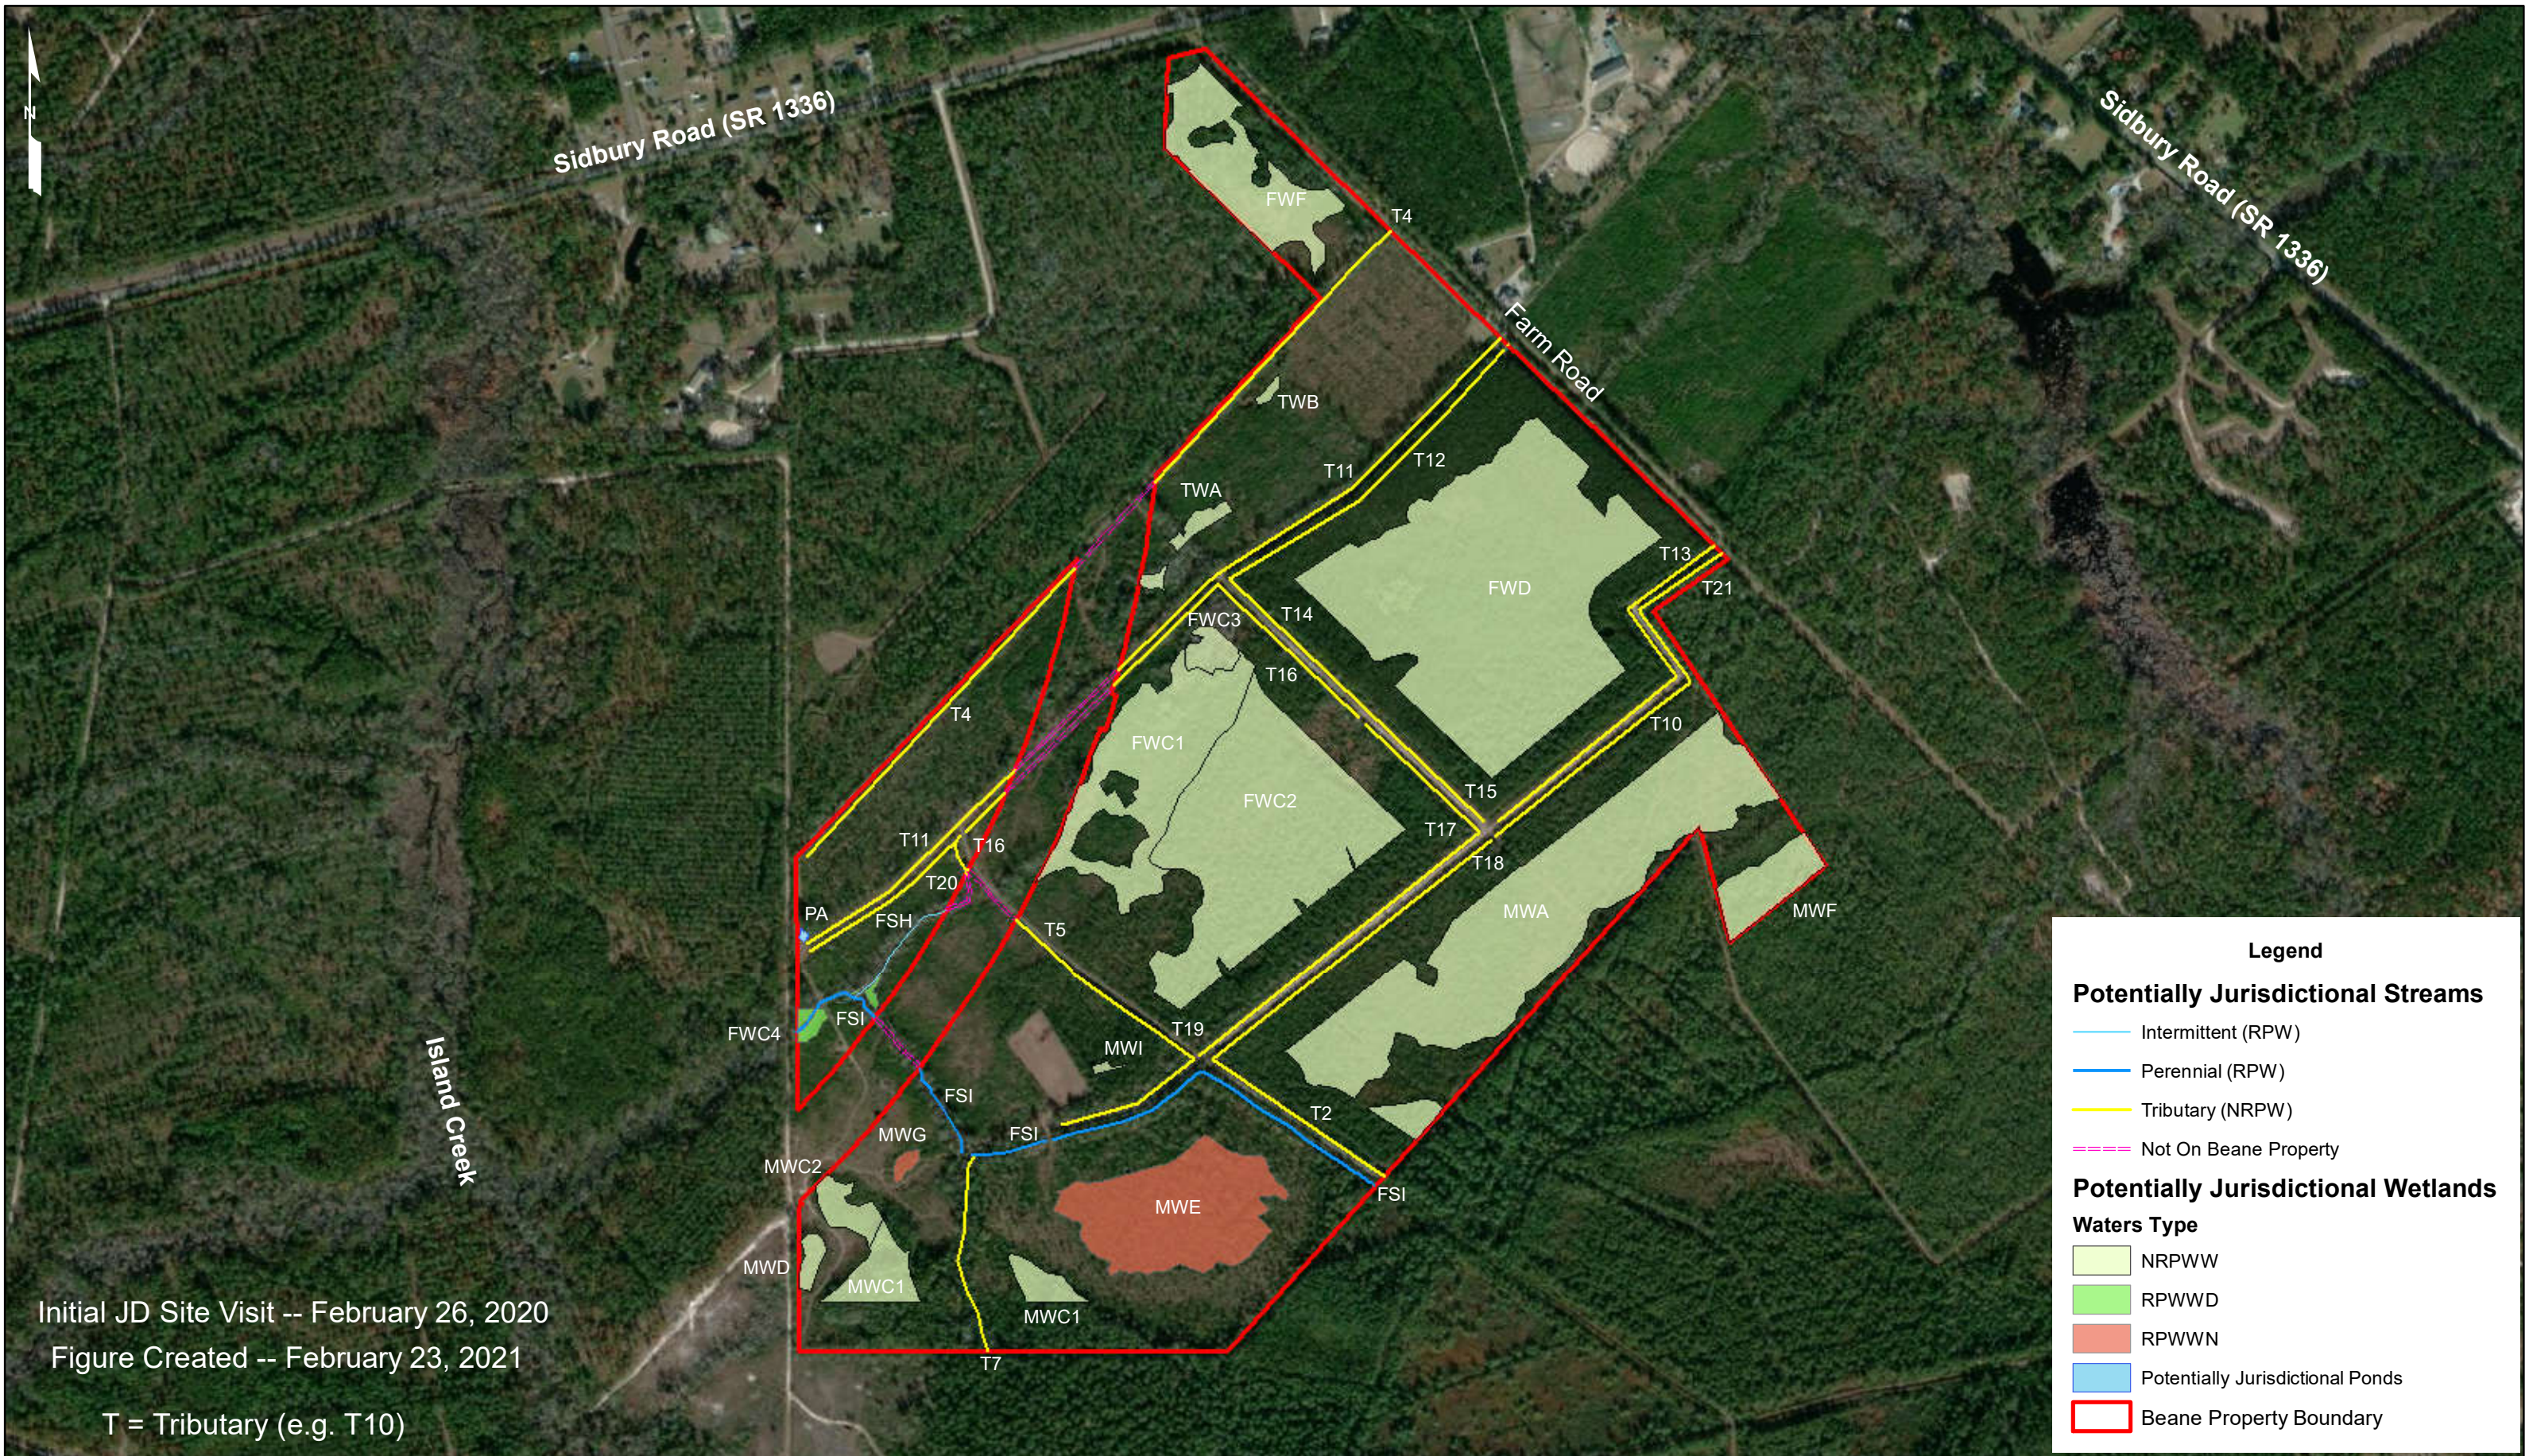
Figure
1a

Beane Property
Potentially Jurisdictional Features - Index / Overview Map
New Hanover County, NC

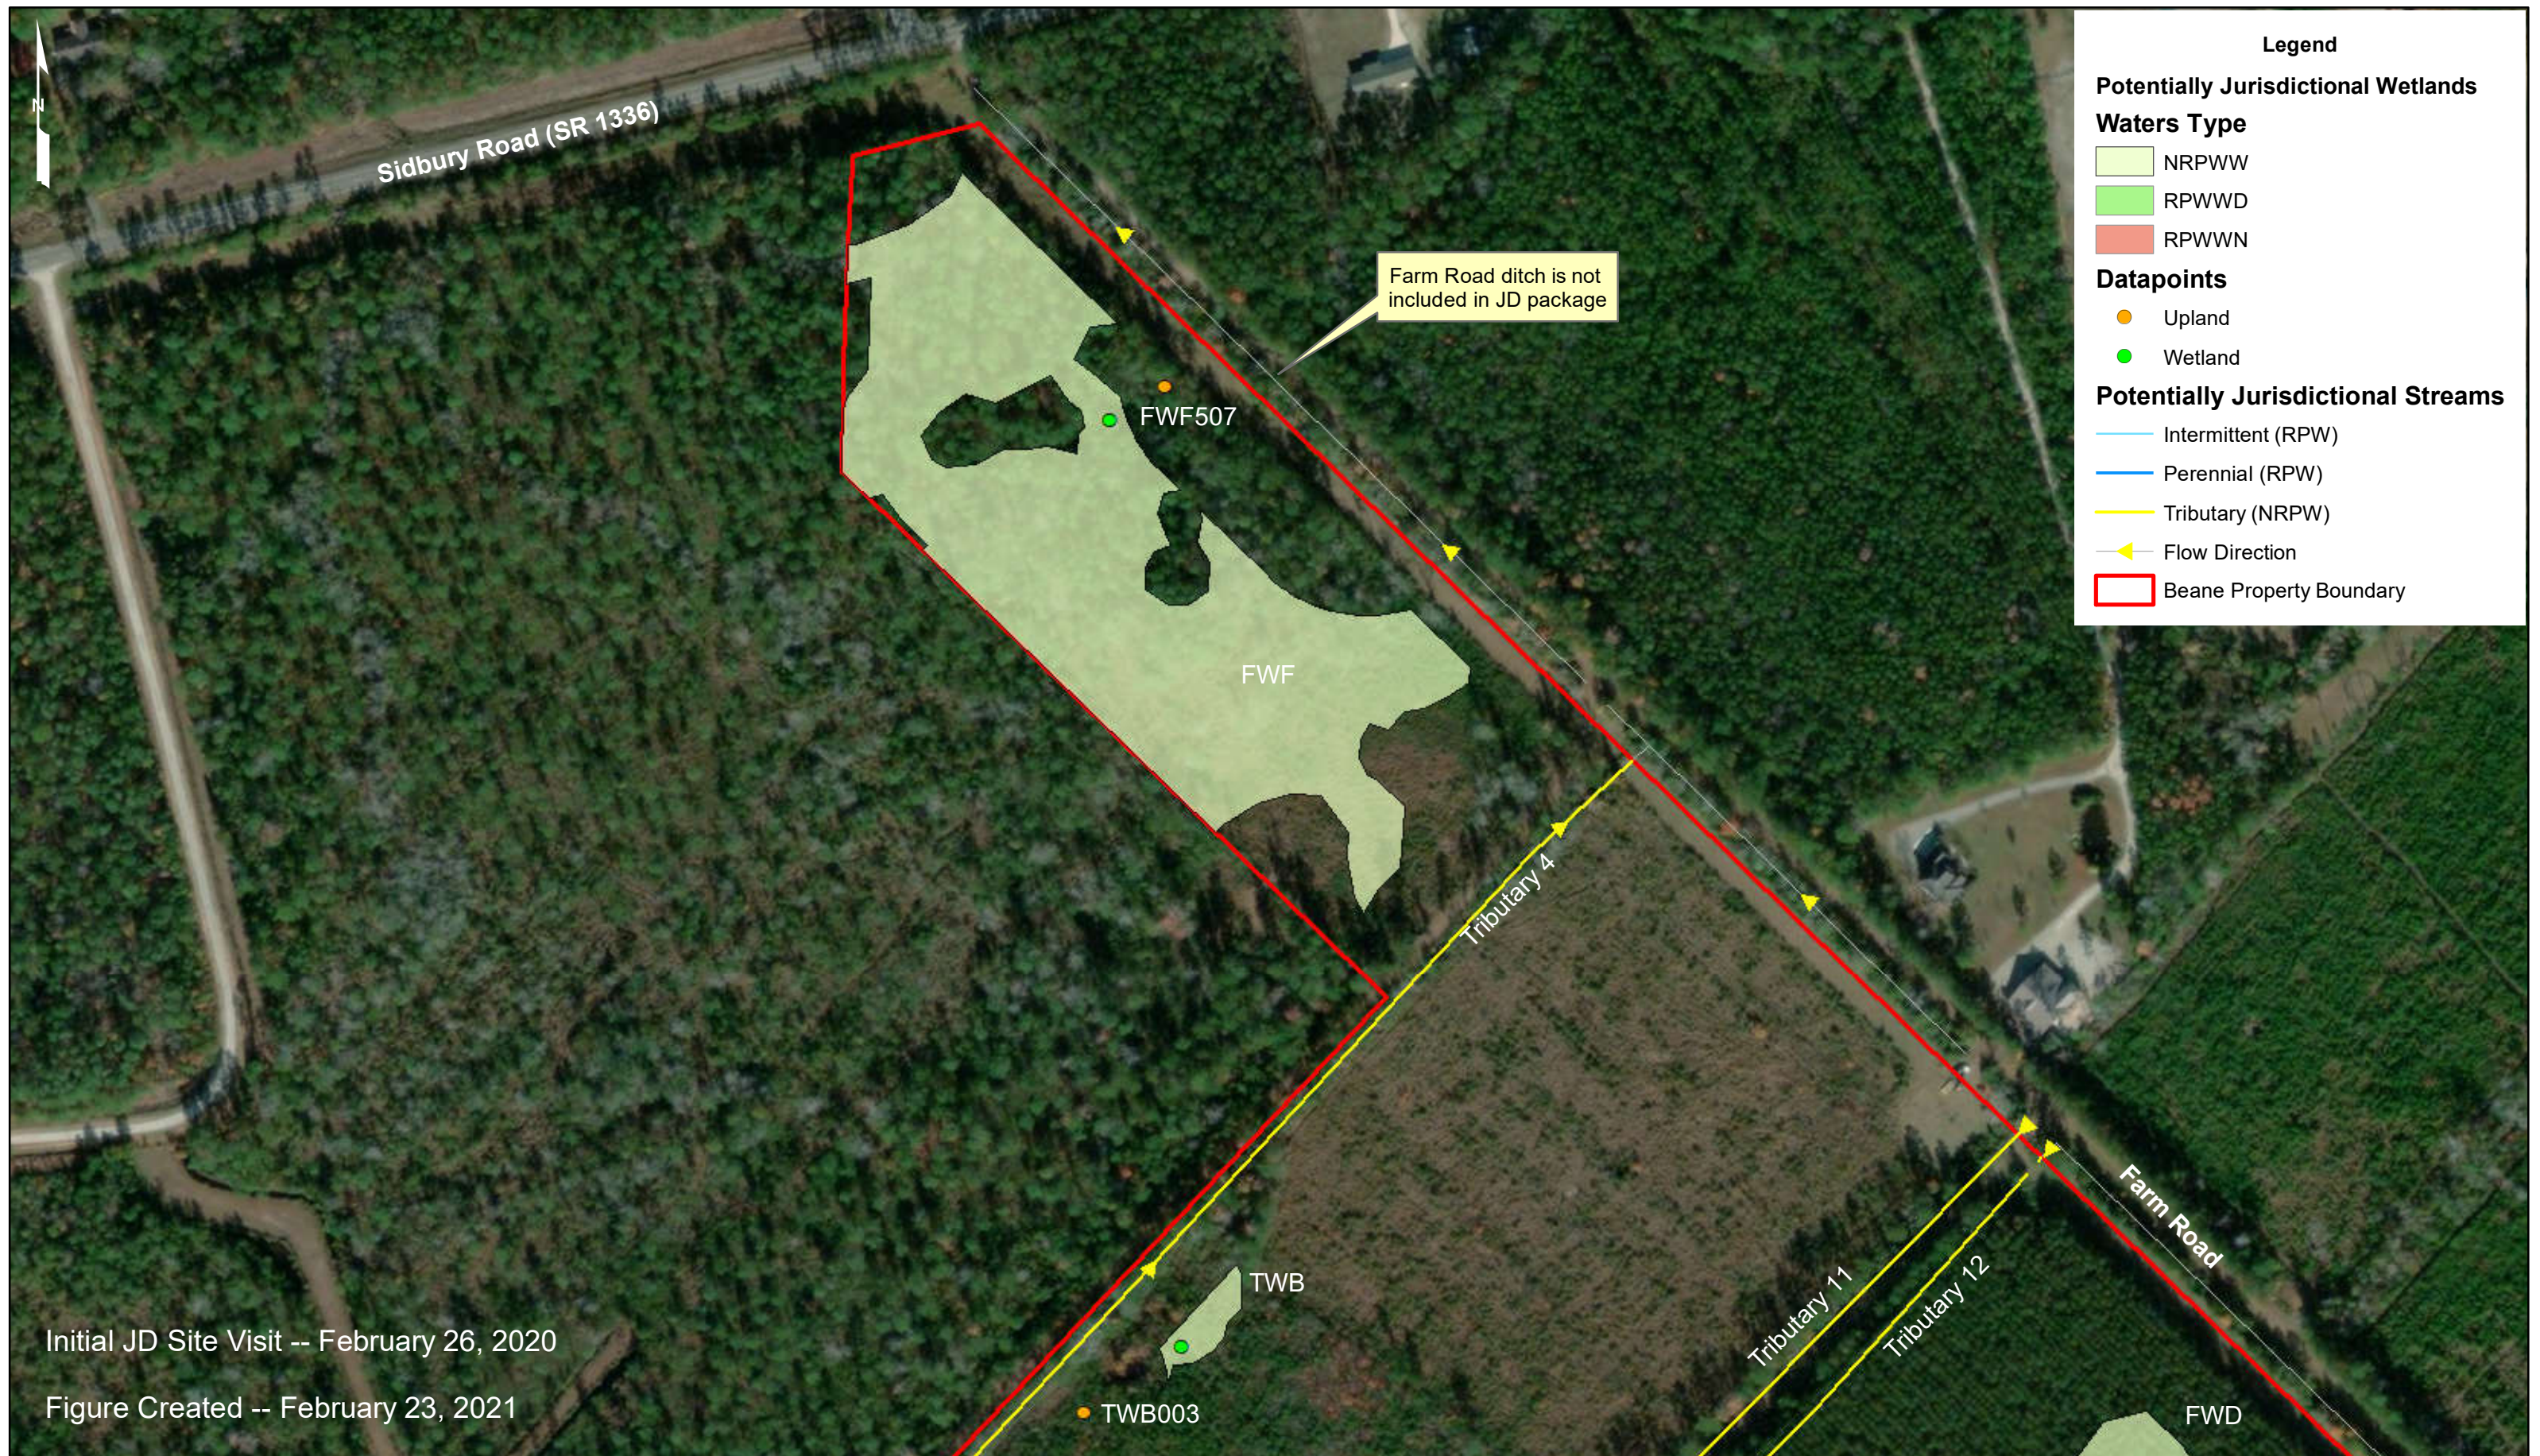
Figure
2

Beane Property
Potentially Jurisdictional Features - Overview Map
New Hanover County, NC

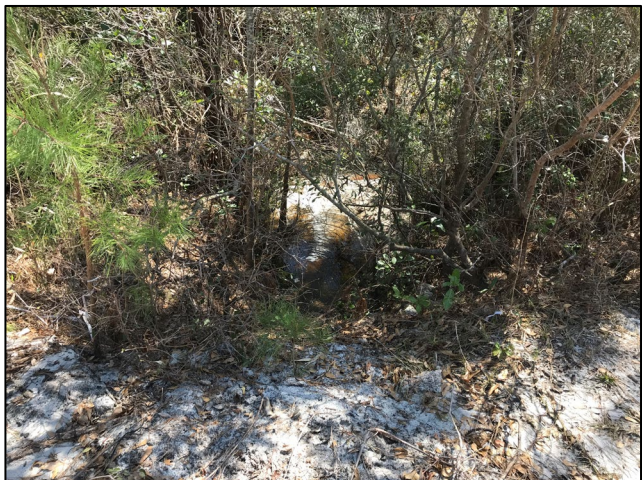
PHOTO 5. VIEW SOUTH OF 42-INCH CULVERT WHERE IT CROSSES UNDER ROAD #3A AND ENTERS STREAM FSI (JULY 2019).

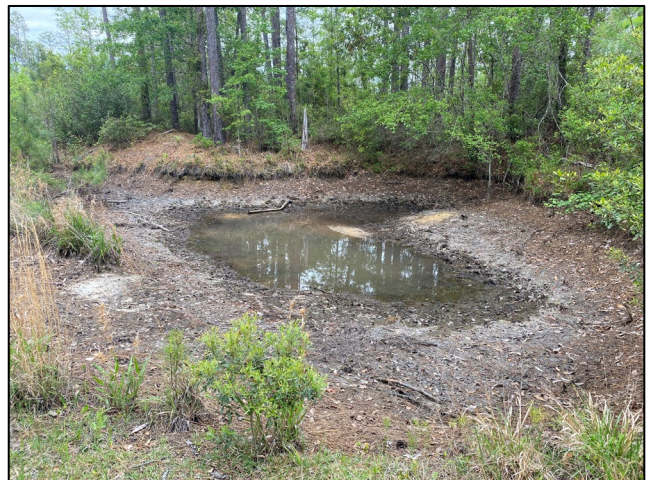
PHOTO 6. VIEW LOOKING NORTH AT POND A THAT RECEIVES WATER FROM TRIBUTARY 4 AND IS BORDERED BY ROAD #6 AND ROAD #2 (MAY 2021).

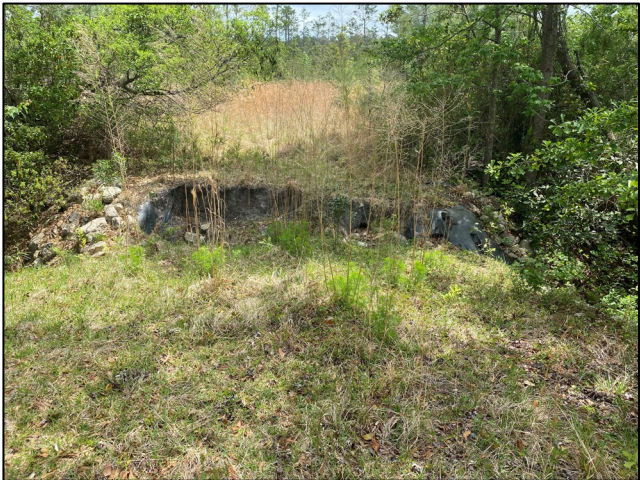
PHOTO 9. VIEW LOOKING SOUTH SHOWING 2 – 48-INCH CULVERTS (DAMAGED) AT STREAM FSI NEAR ROAD #3A (MAY 2021).

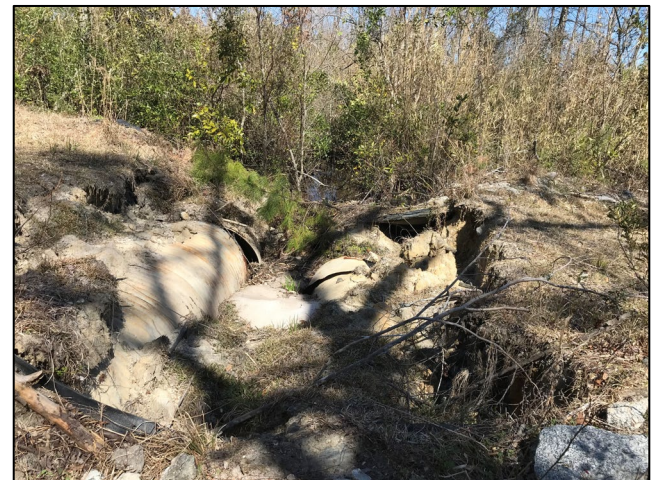
PHOTO 11. VIEW NORTHEAST ALONG STREAM FSI BETWEEN 60-INCH CULVERT AND R-3300 RIGHT OF WAY (MARCH 2019).

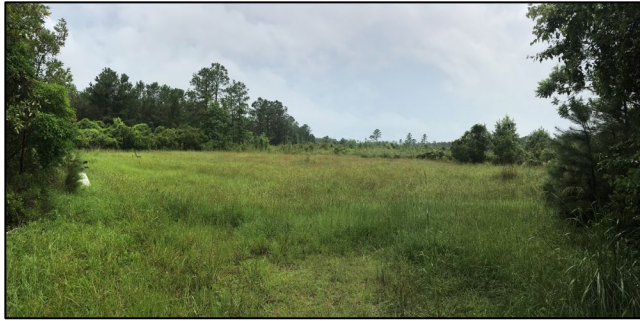
PHOTO 1. PANORAMIC VIEW OF FIELD #1 LOOKING
SOUTHWEST FROM GAS LINE EASEMENT (JULY 2019).

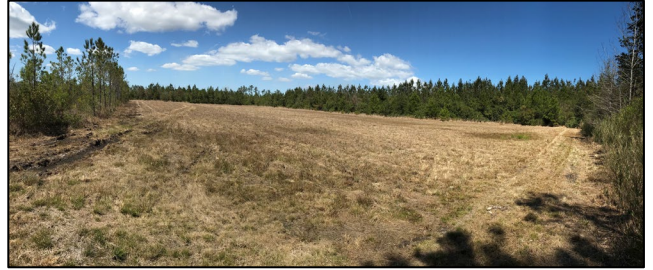
PHOTO 2. PANORAMIC VIEW OF FIELD #2 VIEW LOOKING
NORTHEAST NEAR ENTRANCE TO FIELD FROM ROAD #3A
(MARCH 2019).
