FINAL MITIGATION PLAN

CROATAN WETLAND MITIGATION BANK Craven County, North Carolina

TIP No. R-1015 WM

The North Carolina Department of Transportation
Raleigh, North Carolina

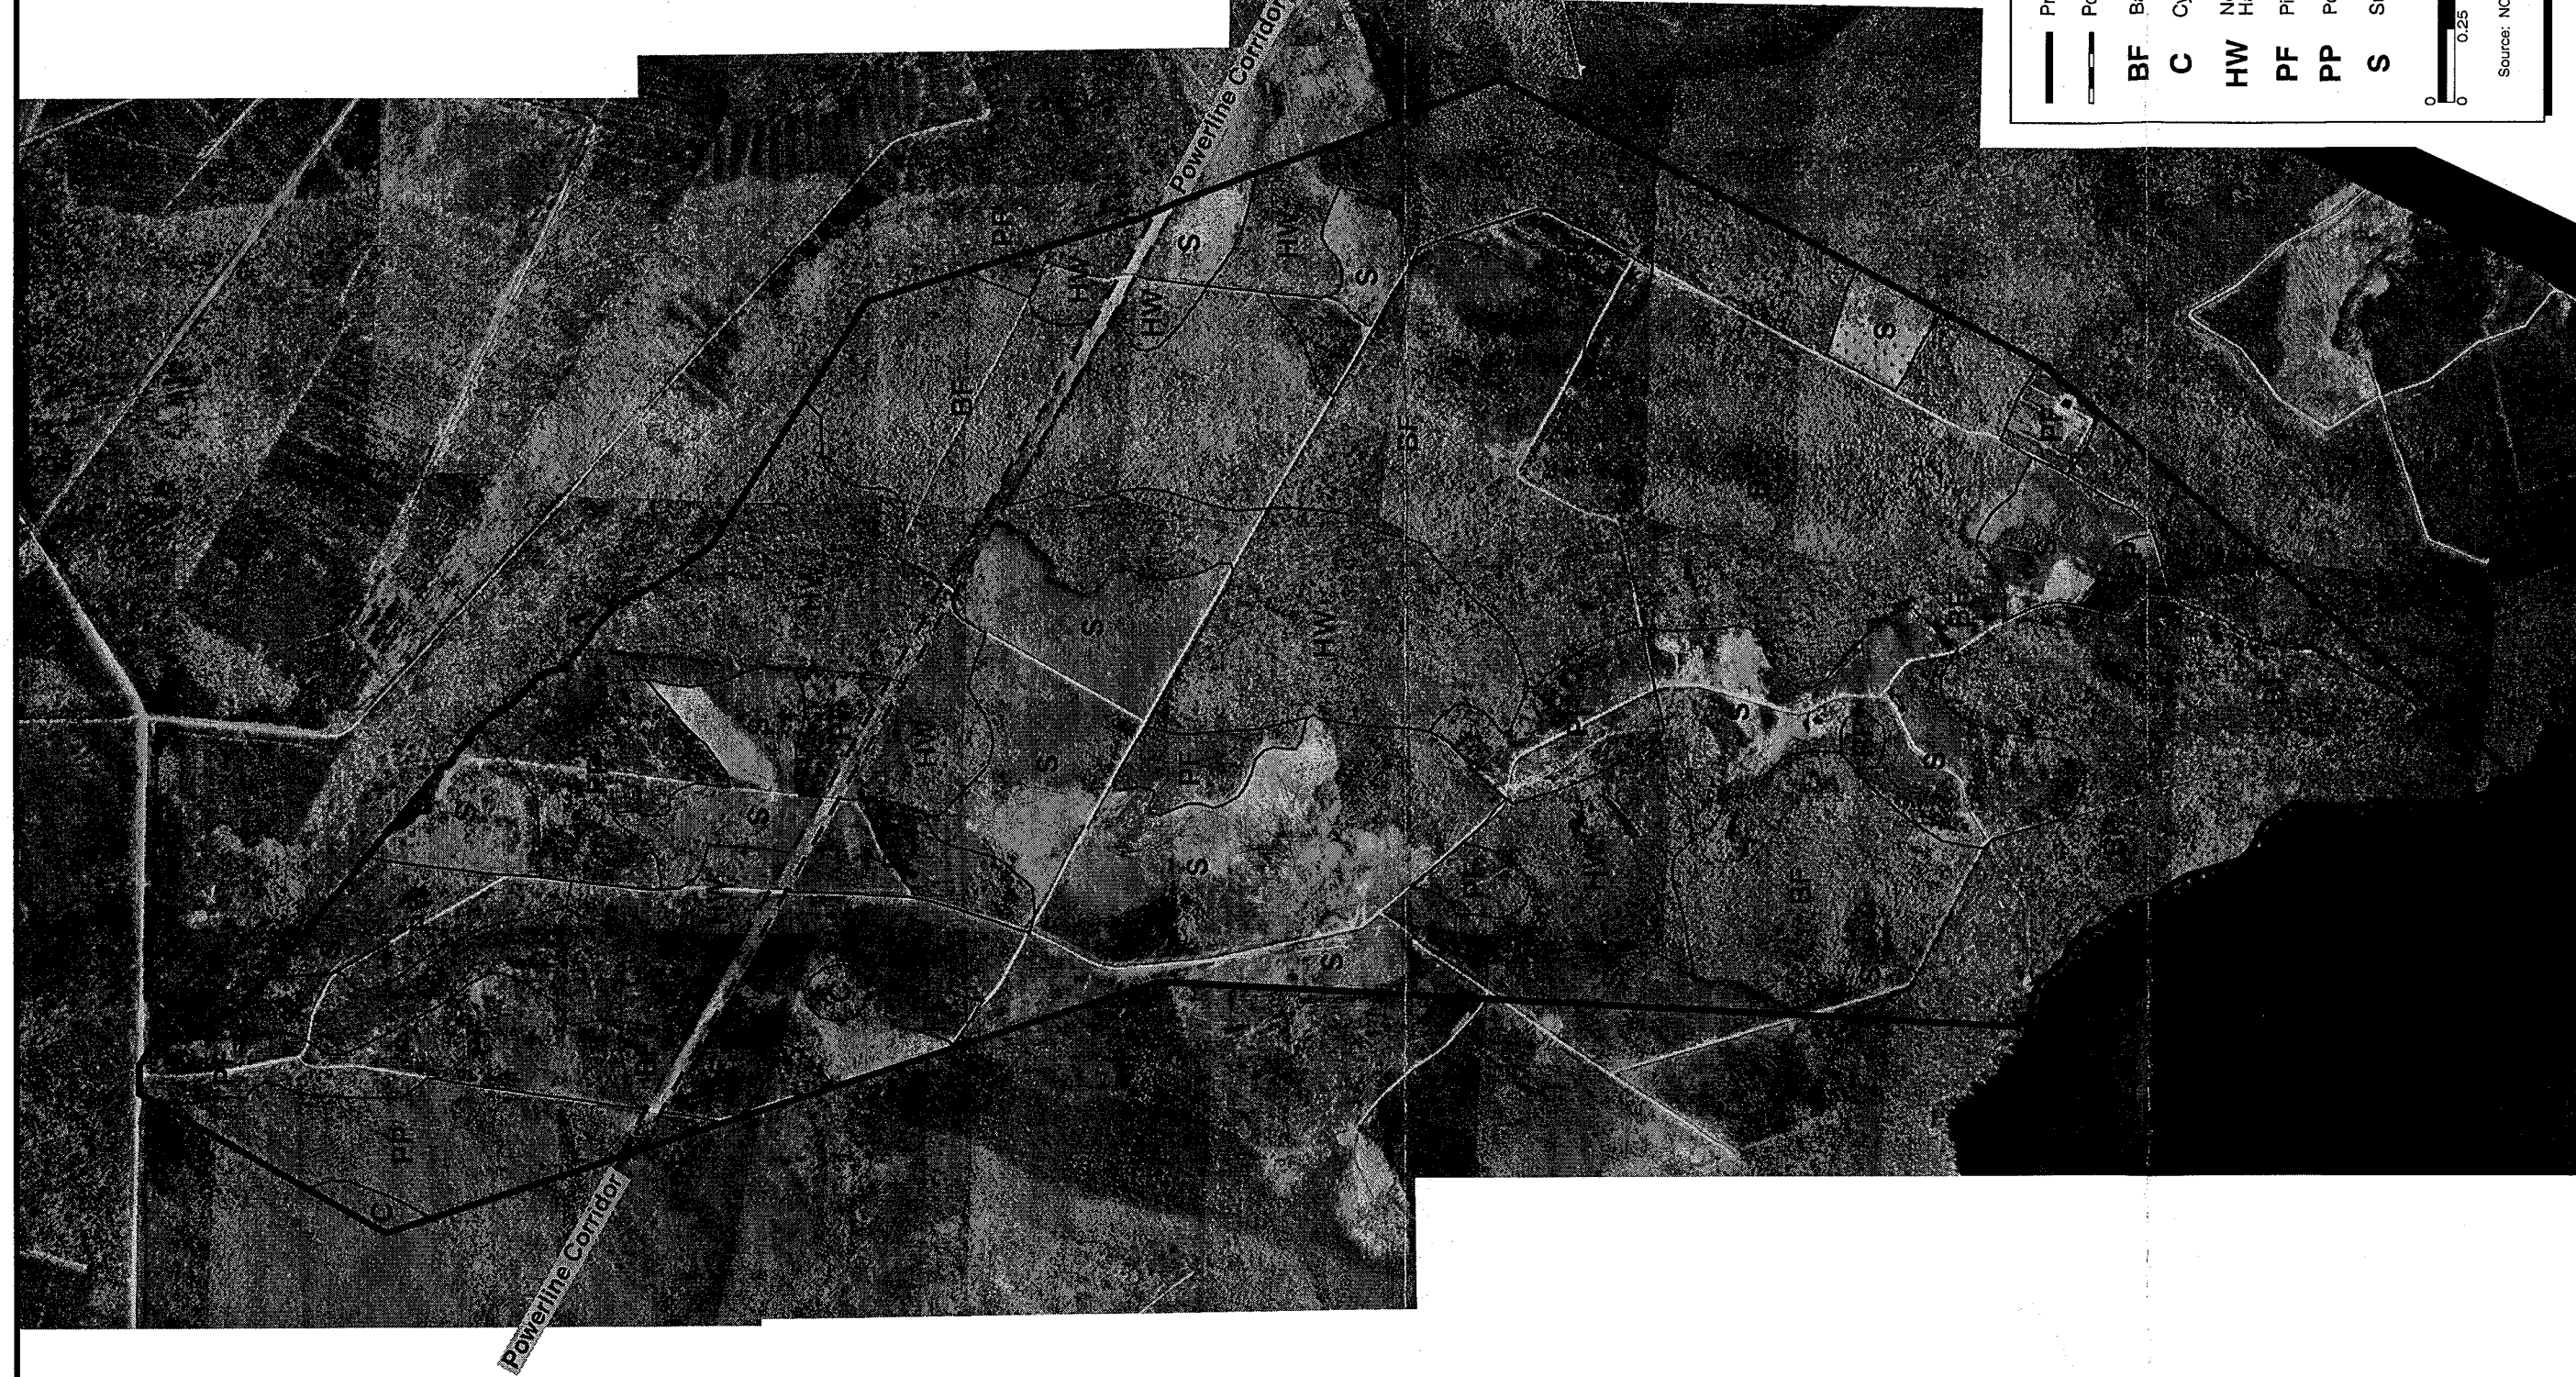
Figure: 3-3
Project: R-1015WM
Date: April 2002

Existing Vegetation
Croatan Wetland Mitigation Bank
Craven County, North Carolina

this period (and prior to this period), most of the desirable hardwood species were removed. Successional, opportunistic hardwoods such as sweetgum (*Liquidambar styraciflua*) and red maple (*Acer rubrum*) along with swamp red bay (*Persea palustris*) have achieved dominance in stands that under natural conditions should be dominated by bald cypress (*Taxodium distichum*), swamp tupelo (*Nyssa biflora*), Atlantic white cedar (*Chamaecyparis thyoides*), and a mixture of hydrophytic oaks (*Quercus* spp.). The CWMB presently contains a mix of forested stands of varying degrees of disturbance, regenerating cut-overs, and recent clear cuts. Figure 3-3 presents a recent (March 1997) aerial photograph of the CWMB with the existing vegetation communities.

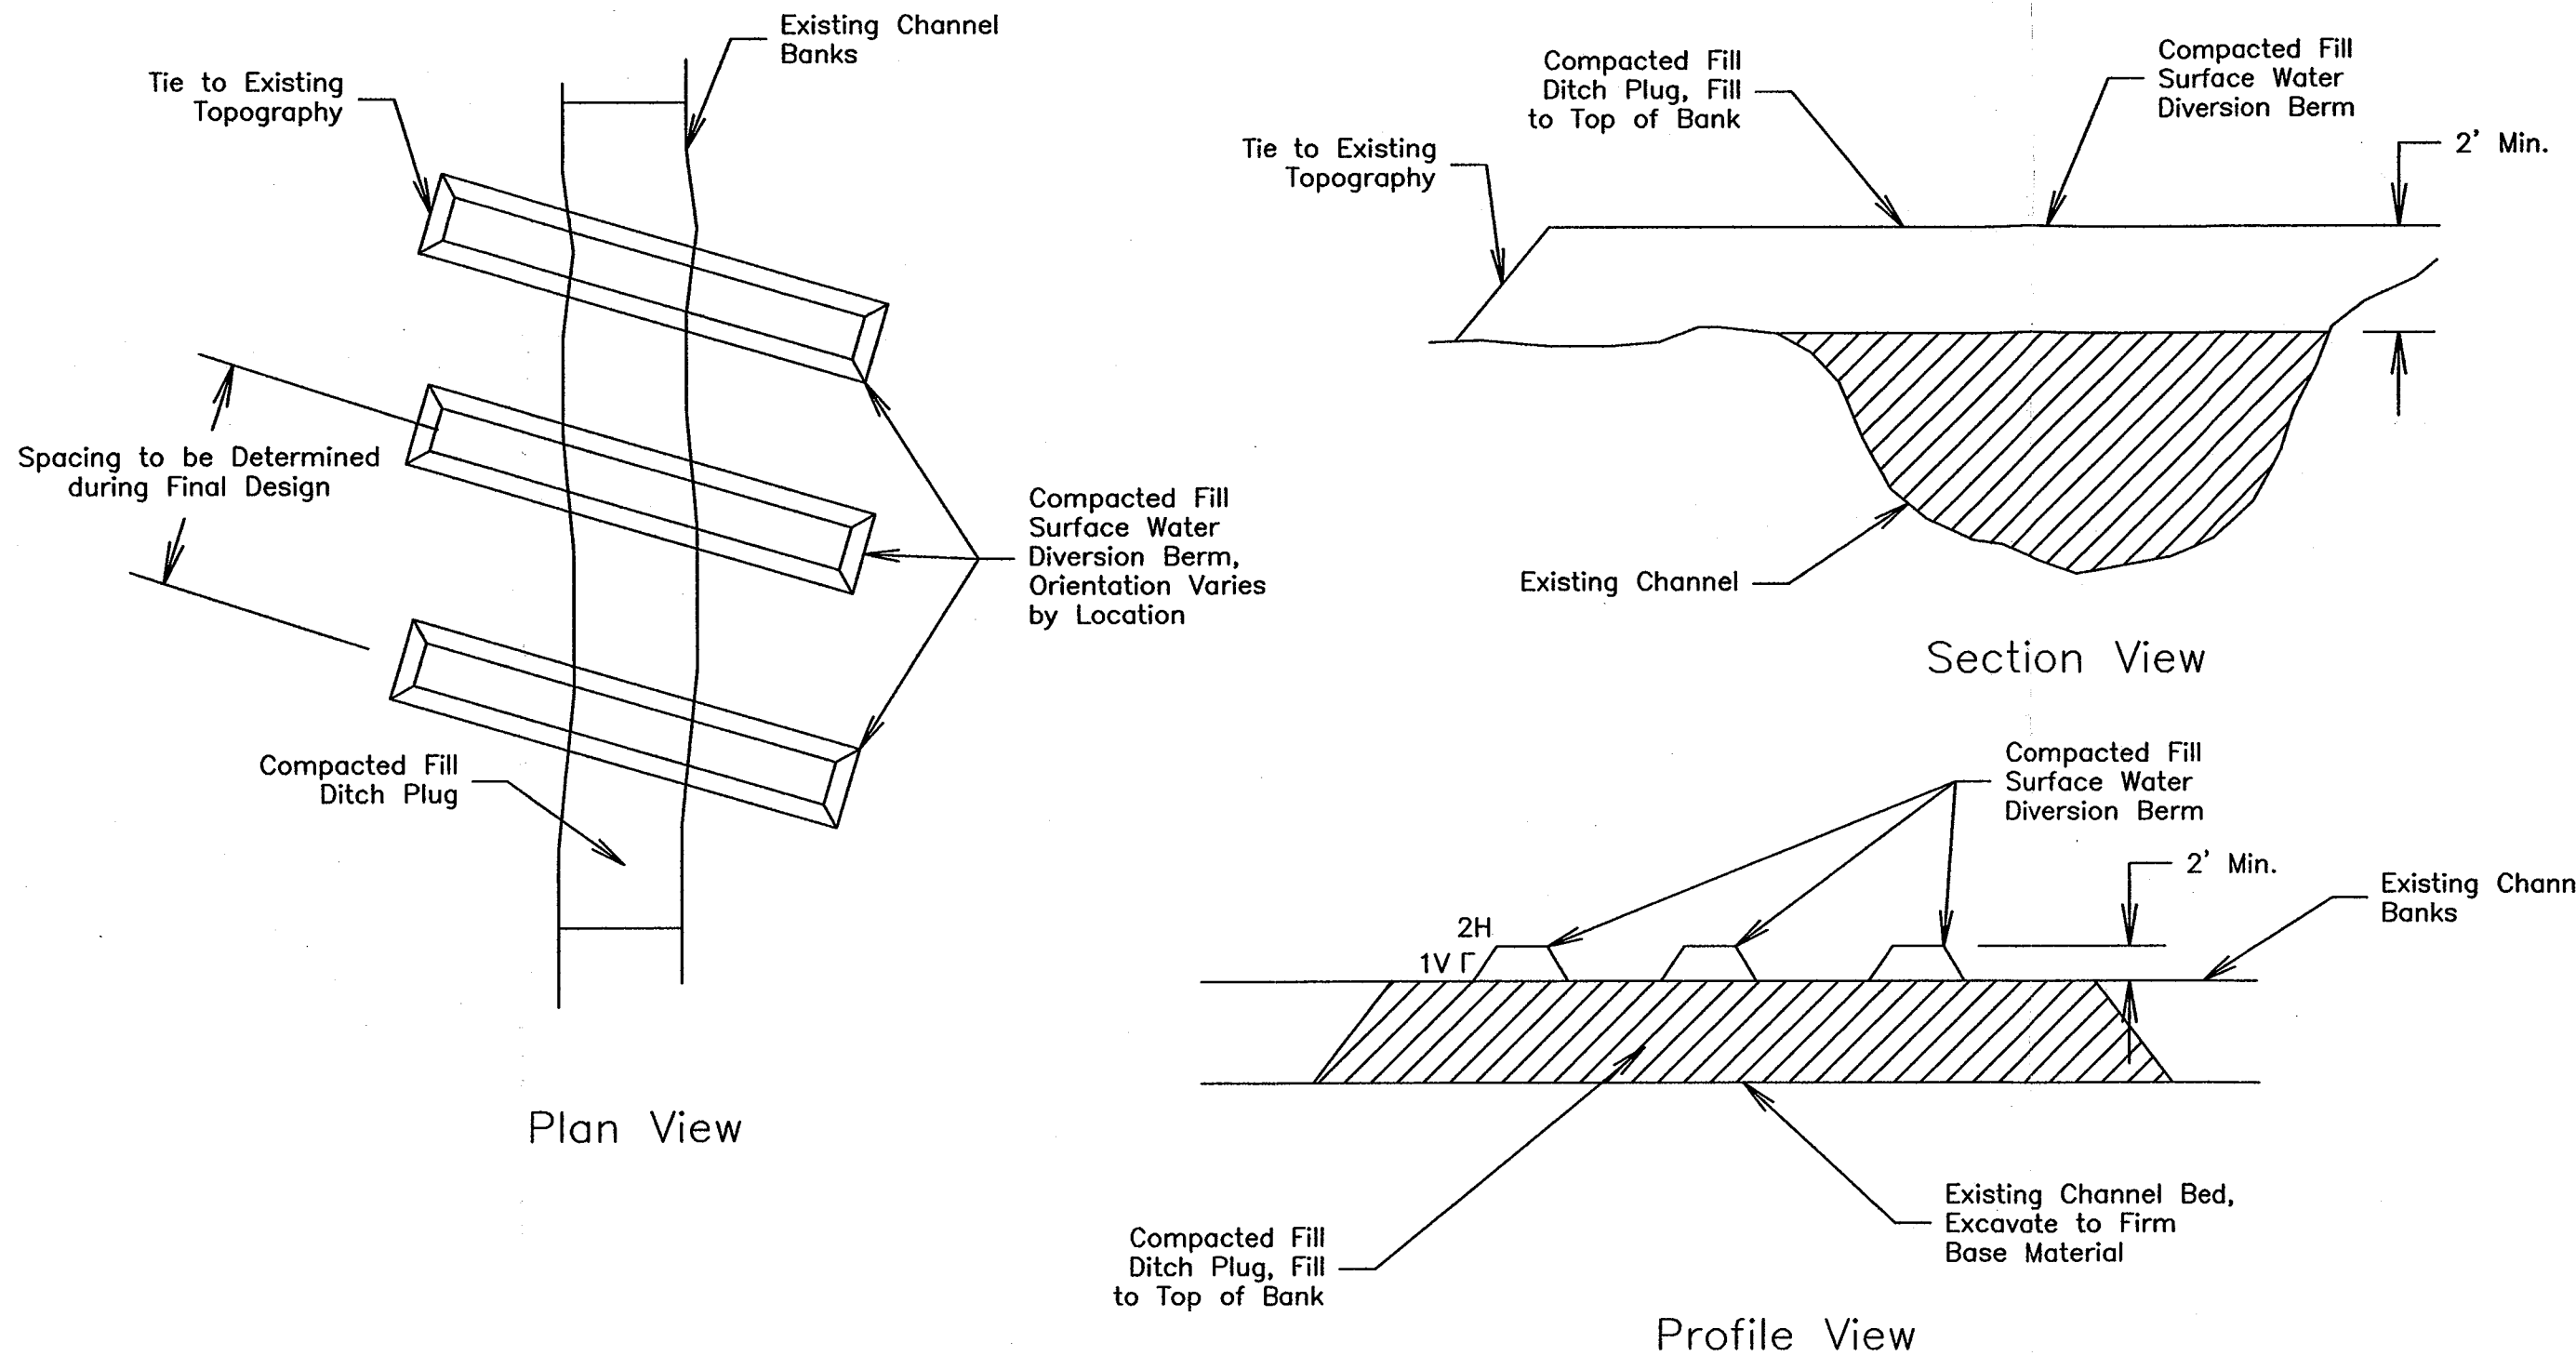
PROPOSED REACH DITCH PLUGS &
SURFACE WATER DIVERSIONS

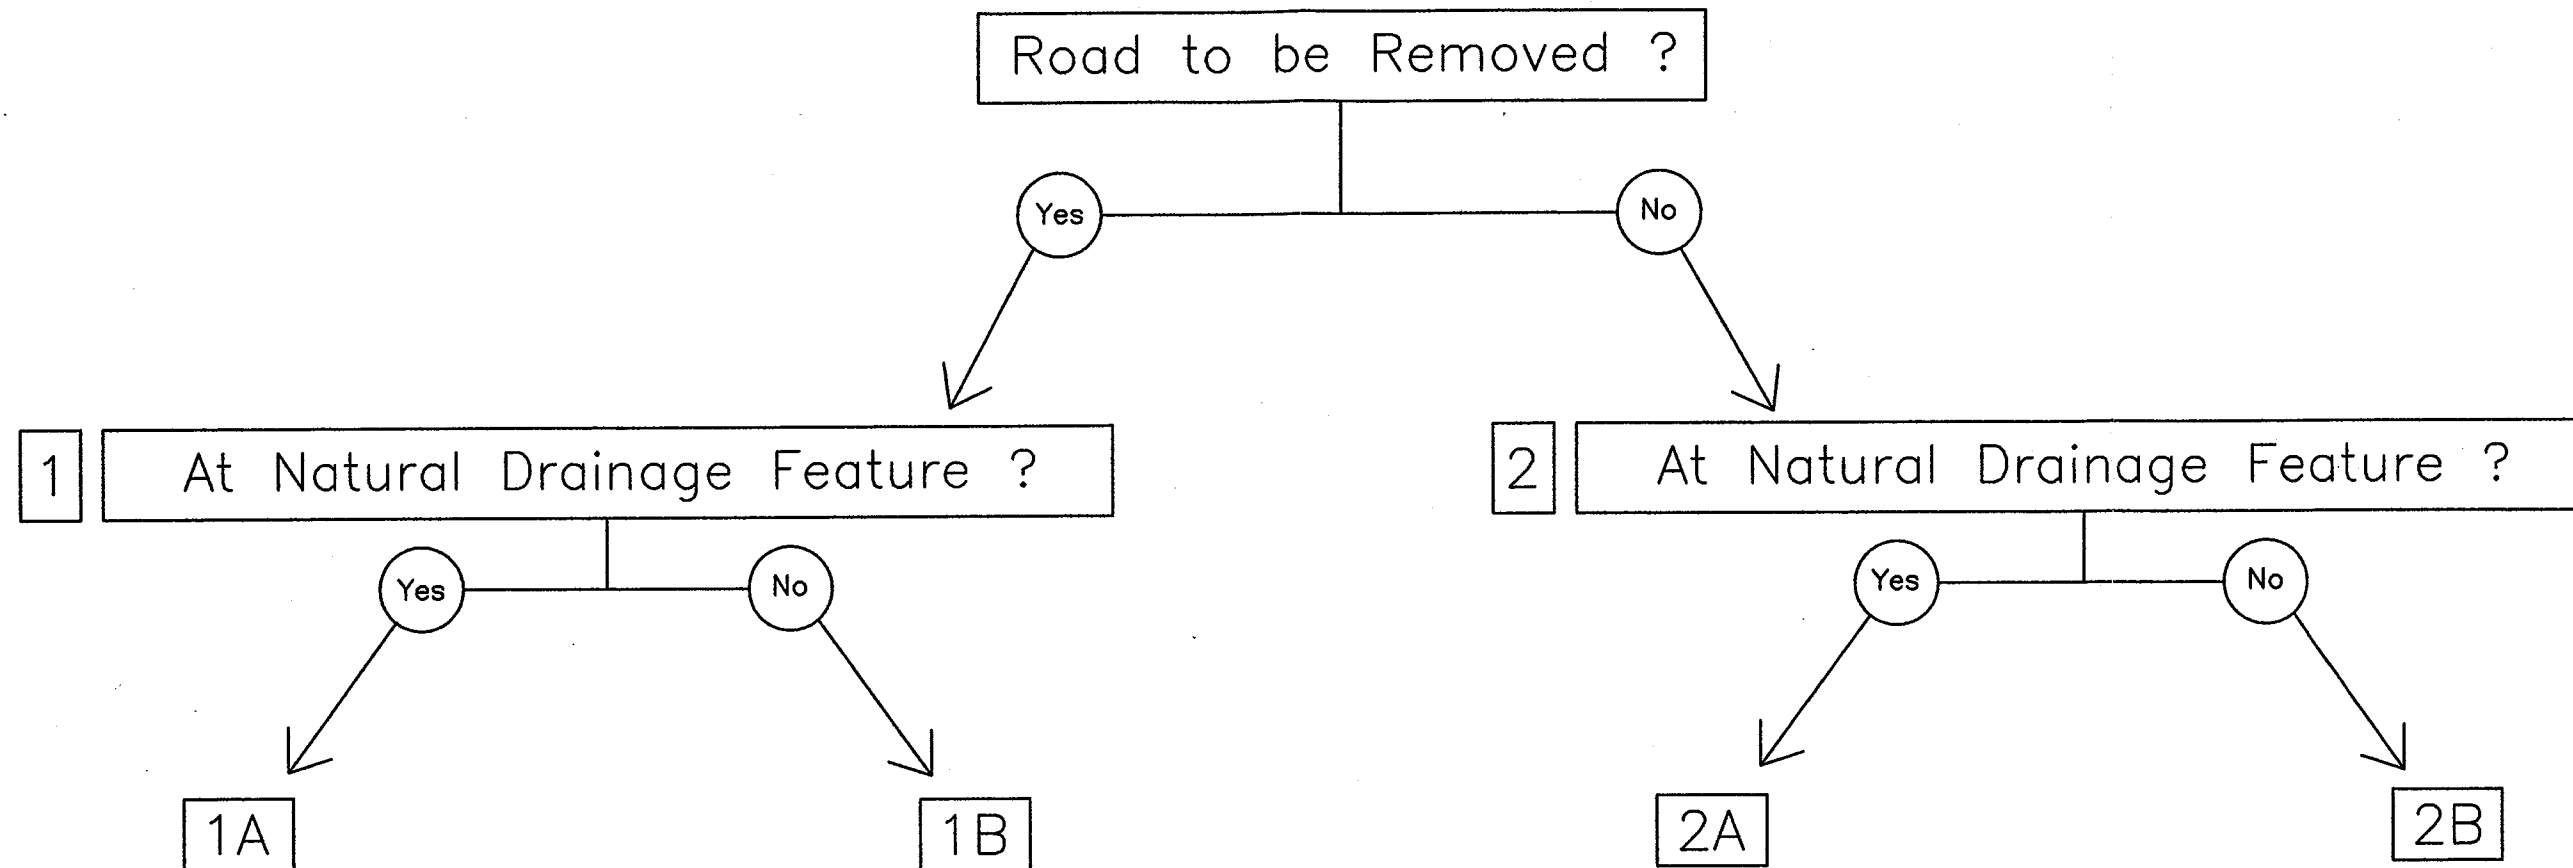
PROPOSED TREATMENT FLOW CHART

1A1. Fill in Ditches with Road Material.
 1A2. Remove Fill Material to Allow for Natural Surface Water Flow Along Drainage Feature.
 1A3. Scarify with Deep Rippers in Direction Transverse to Ditch/Road or Parallel to Proposed Flow.
 1A4. Install Surface Water Diversions Depending on Site Conditions.

1B1. Fill in Ditches with Road Material.
 1B2. Scarify with Deep Rippers in Direction Transverse to Ditch/Road or Parallel to Proposed Flow.
 1B3. Install Surface Water Diversions Depending on Site Conditions.
