## DOT MITIGATION STEWARDSHIP INSPECTION REPORT

COUNTY Macon	Division 14	# ACRES 38.93
-----------------	----------------	------------------

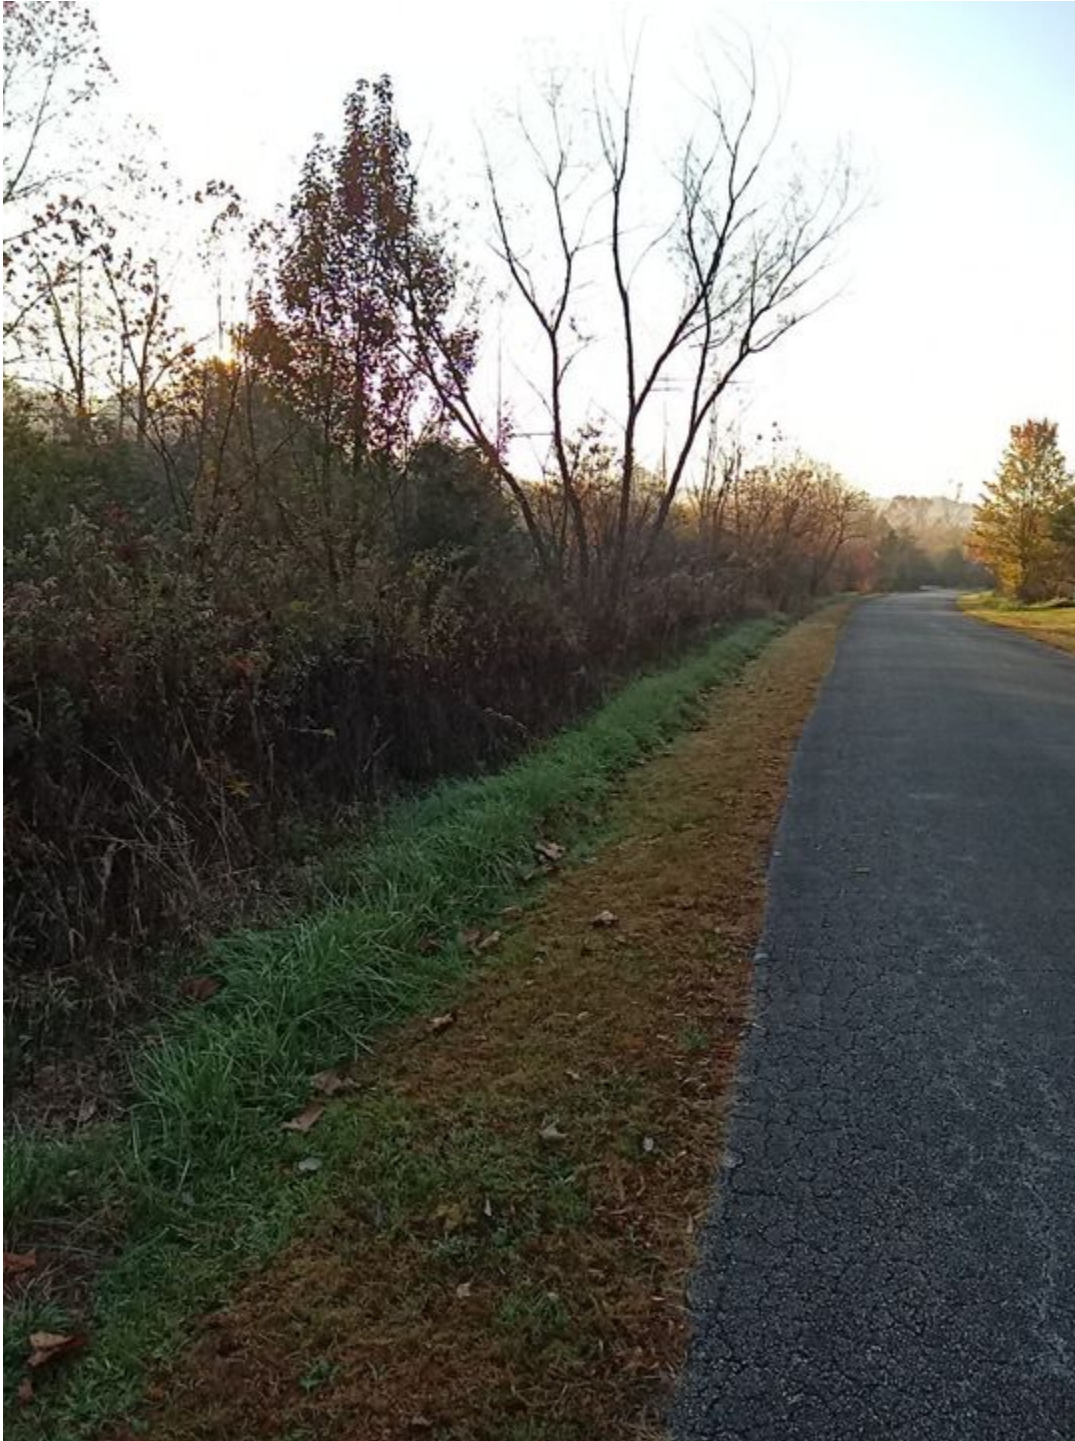
Date & Time: November 7, 2025 7:53 AM  
Location: 35.201923, -83.343015  
Photo Direction: Southeast

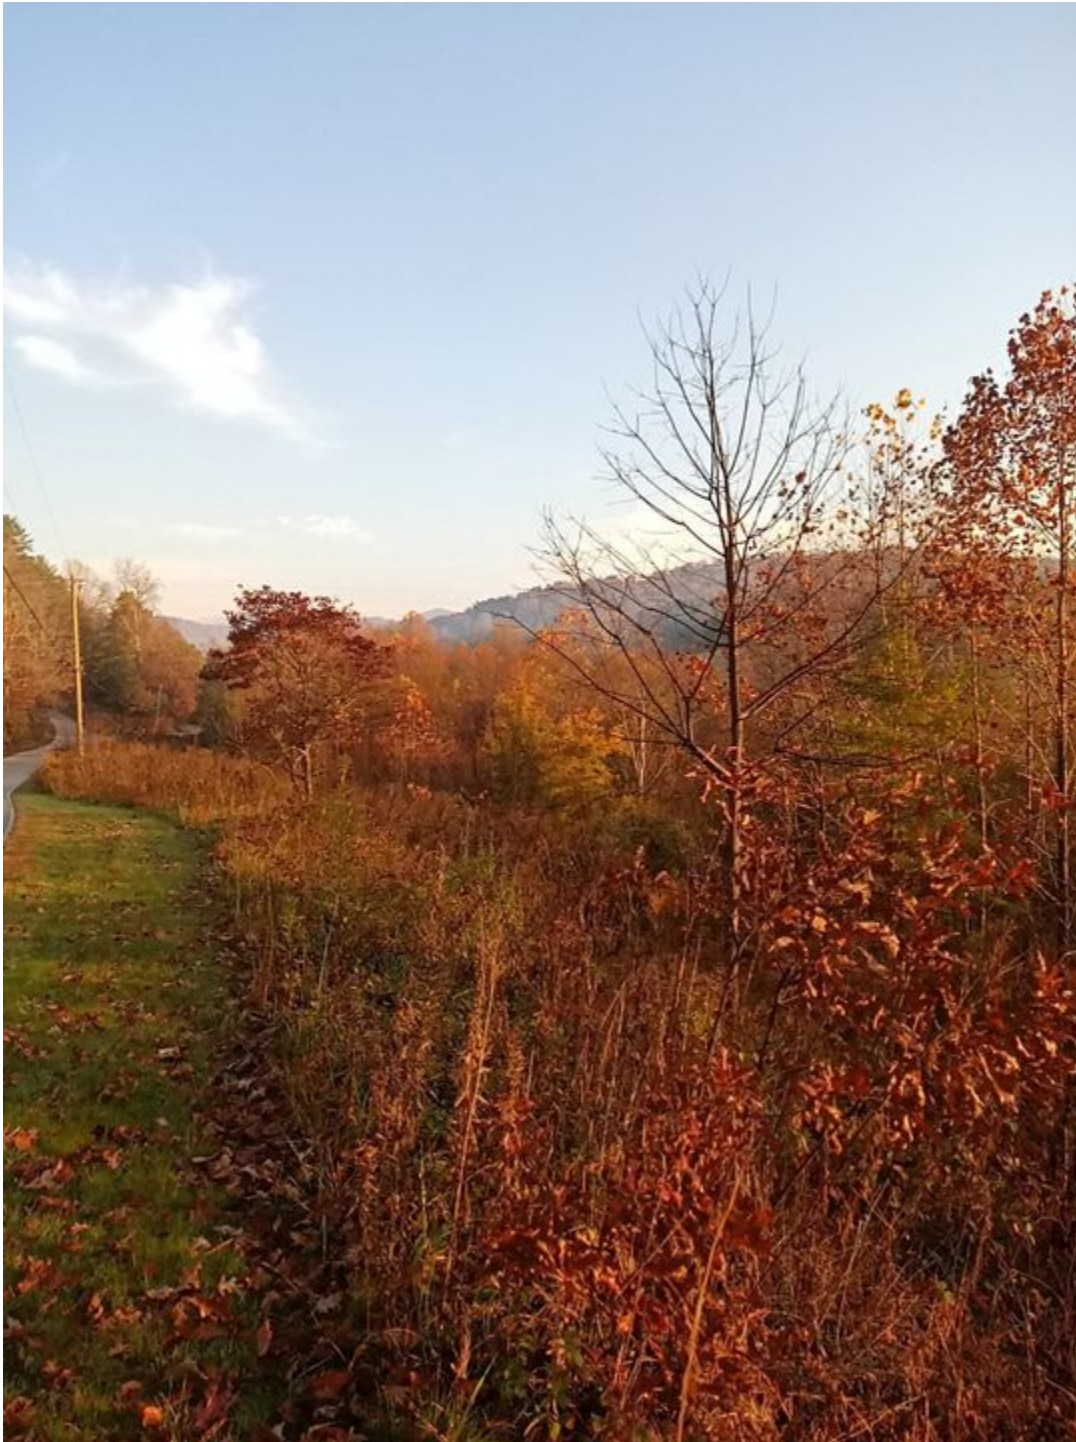
Date & Time: November 7, 2025 7:49 AM

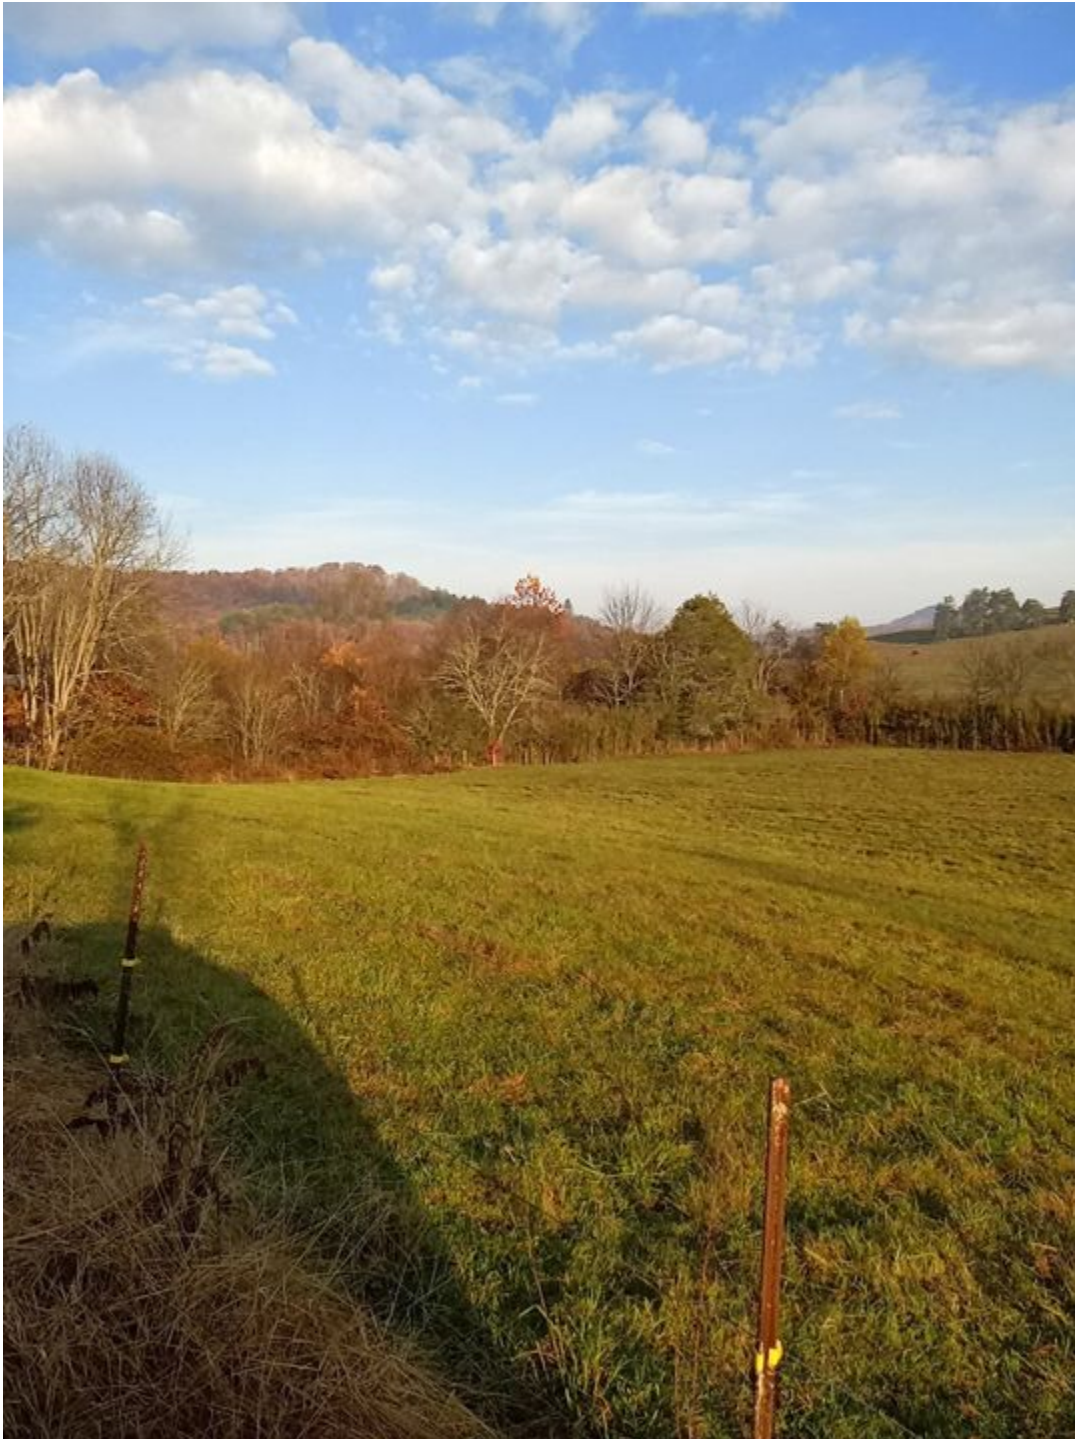
Date & Time: November 7, 2025 8:10 AM

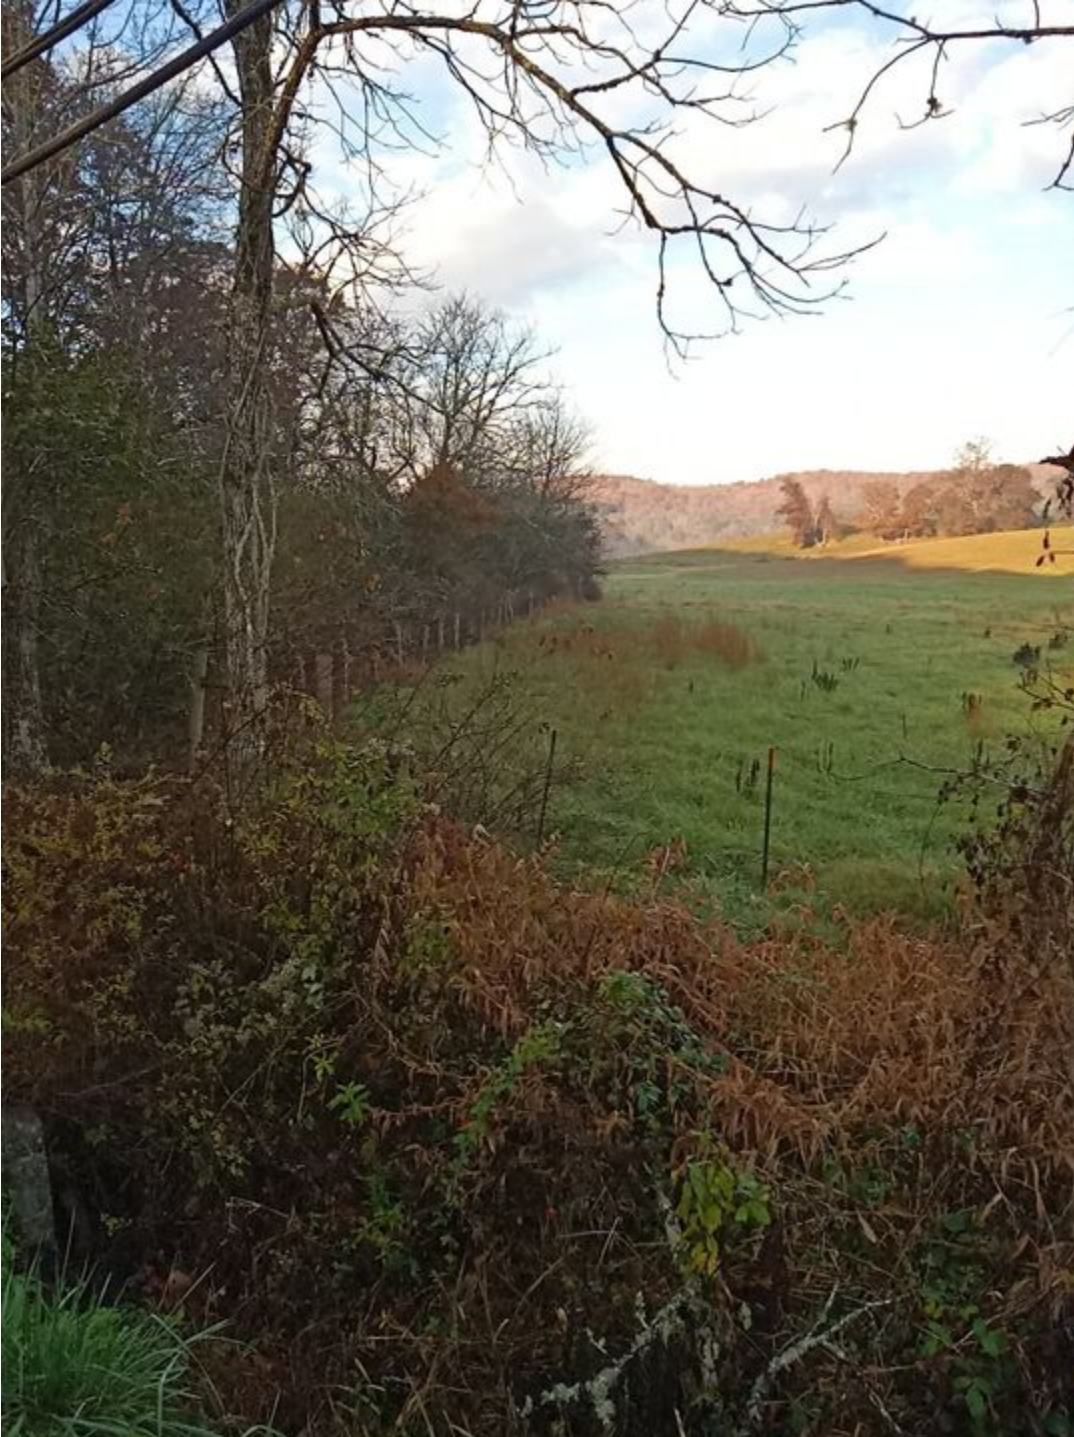
Date & Time: November 7, 2025 8:08 AM

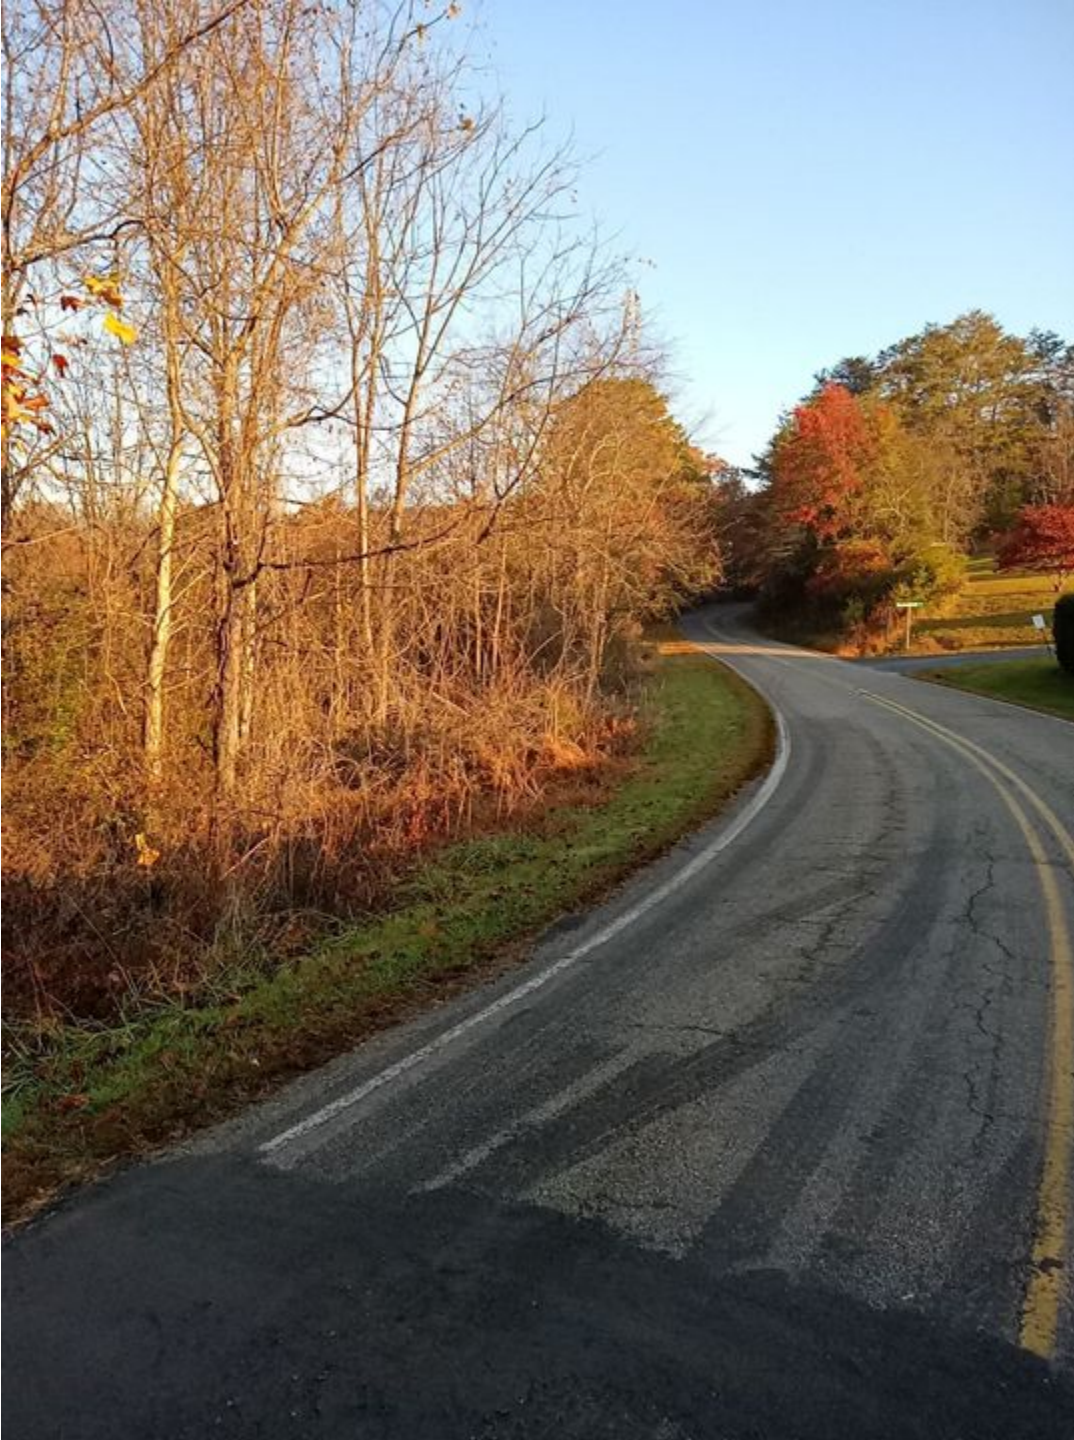
Date & Time: November 7, 2025 8:03 AM
