## DOT MITIGATION STEWARDSHIP INSPECTION REPORT

MITIGATION SITE NAME Plemmons Kirkpatrick Creek Site	TIP # A-0010	ONEID 057-026	INSPECTION DATE November 6, 2025
---	-----------------	------------------	-------------------------------------

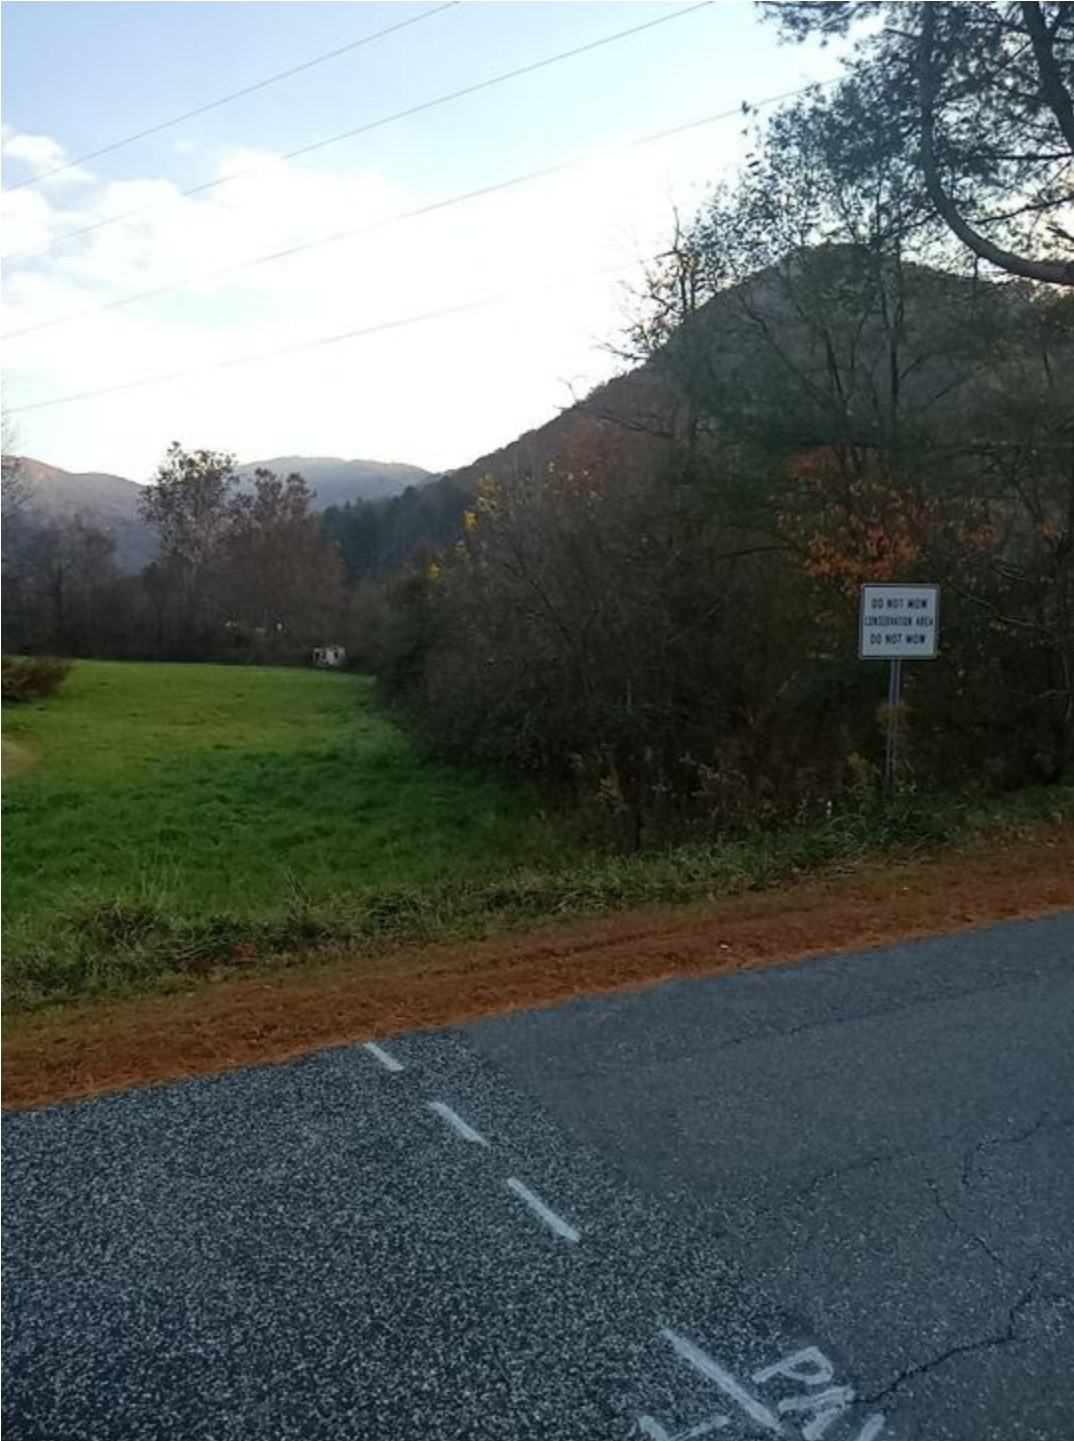
Date & Time: November 6, 2025 8:08 AM  
Location: 35.791915, -82.863895  
Photo Direction: East

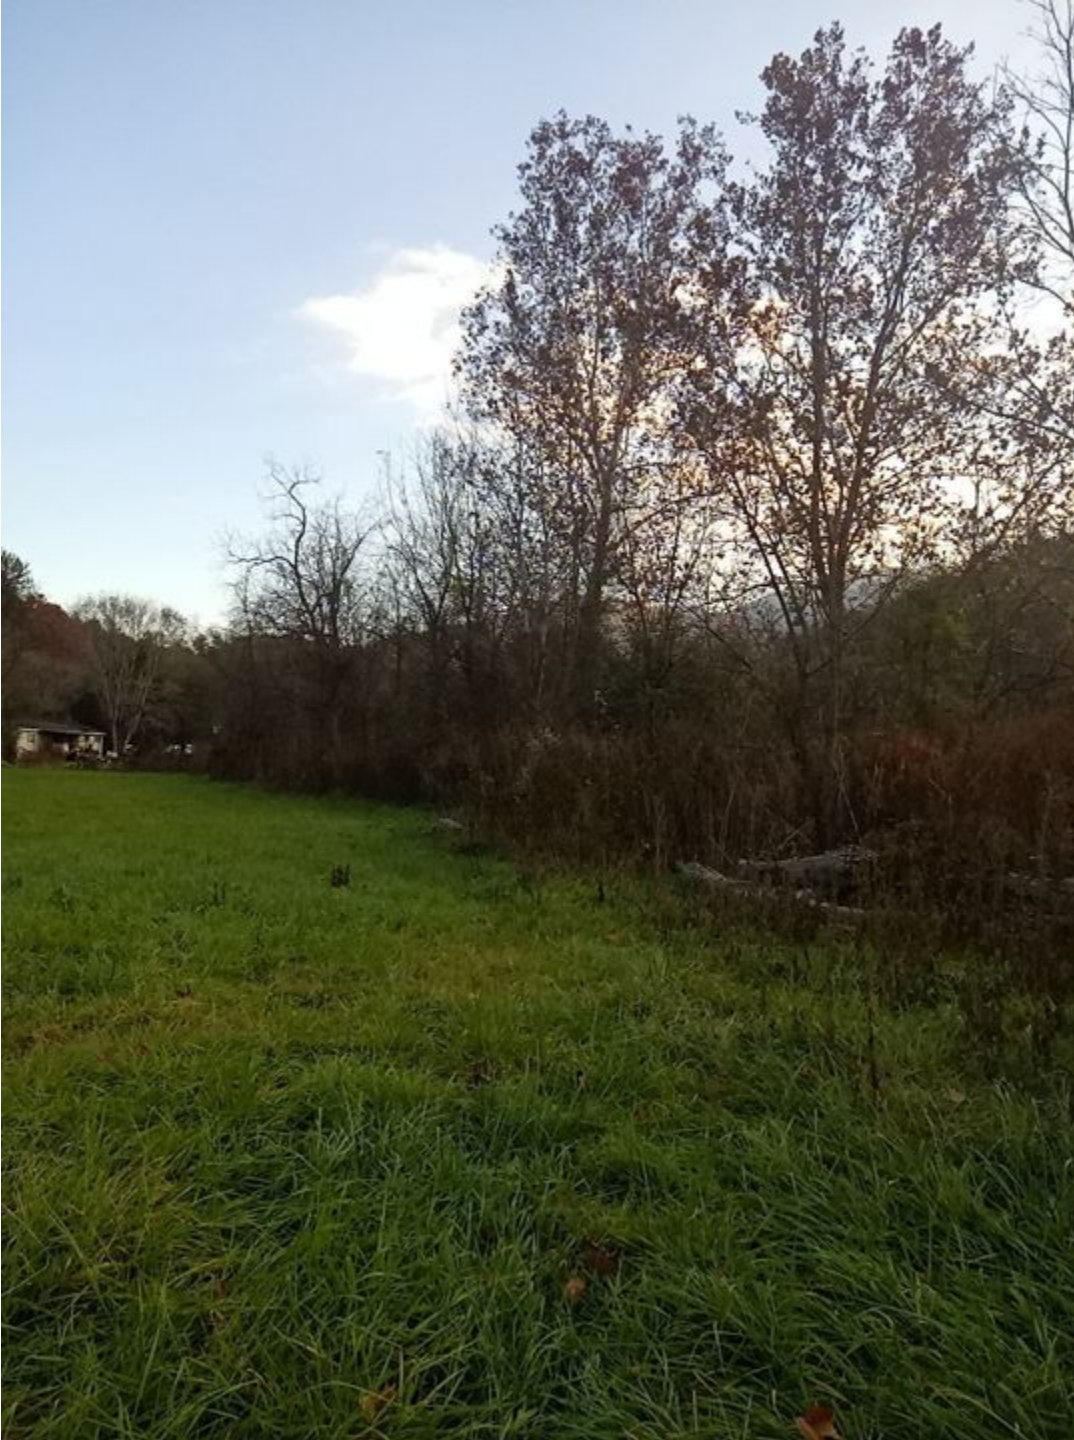
Date & Time: November 6, 2025 8:11 AM

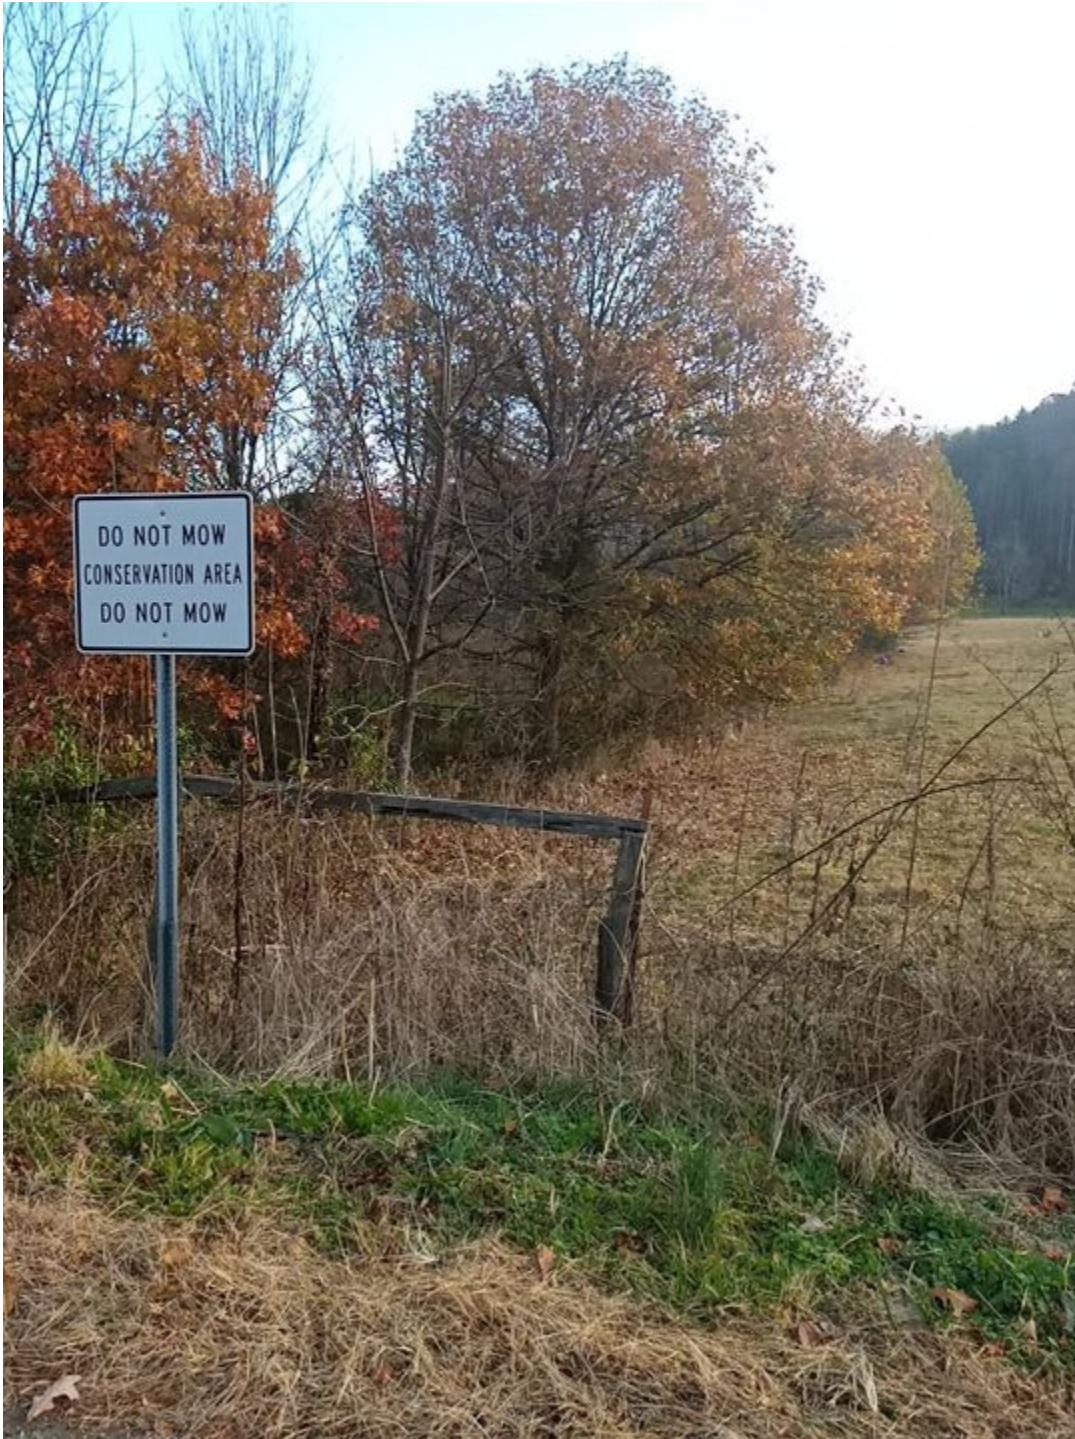
Date & Time: November 6, 2025 8:14 AM
