ANNUAL REPORT FOR 2025

UT to Blair Creek (Sites 10, 11, 12, 15, & 17)
Clay County
TIP No. A-0011C
COE Action ID: SAW-2019-00437
NCDWR Project #: 2019-0210

Prepared By:
Roadside Environmental Unit and Environmental Analysis Unit
North Carolina Department of Transportation
September 2025

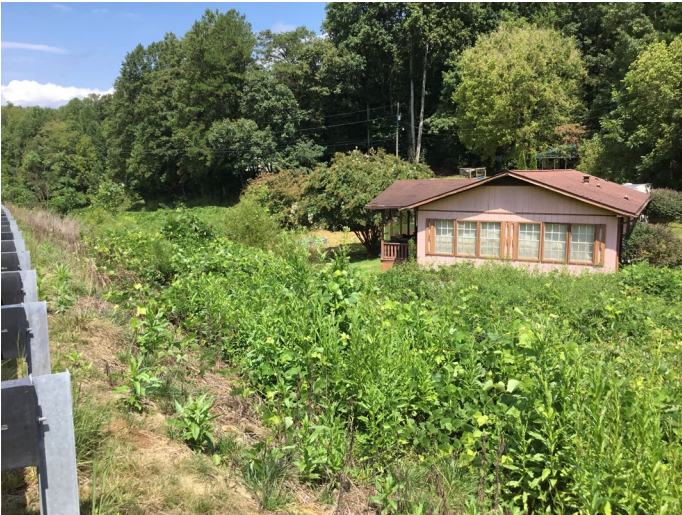
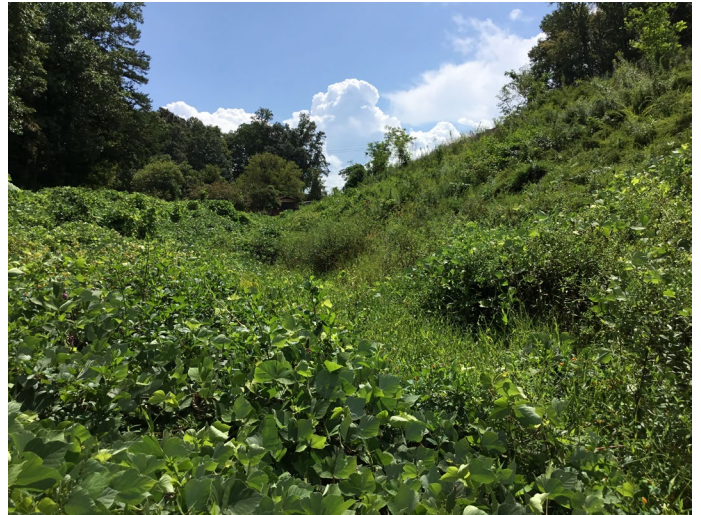
Site 10 Photo Point #1 (Downstream)

Sites 10 and 11: Some of the planted live stakes were observed surviving along the streambanks but kudzu was overgrown at these sites.

Div. 14 Roadside completed an invasive species herbicide application at all sites on September 23, 2025.

The UT to Blair Creek mitigation sites have met the required monitoring protocols for the third formal year of monitoring. The channels throughout the stream sites are stable at this time. Majority of the planted vegetation is surviving, except for, Sites 10 and 11. NCDOT will evaluate the planted vegetation at these sites after herbicide treatments are completed to see if any remedial planting is needed.

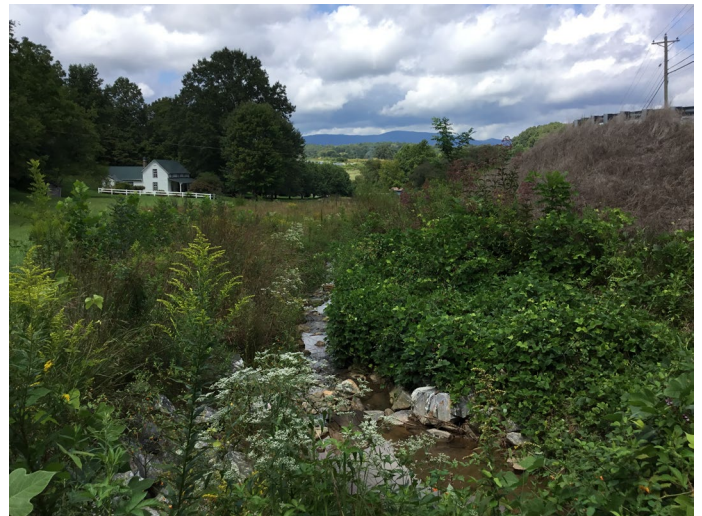
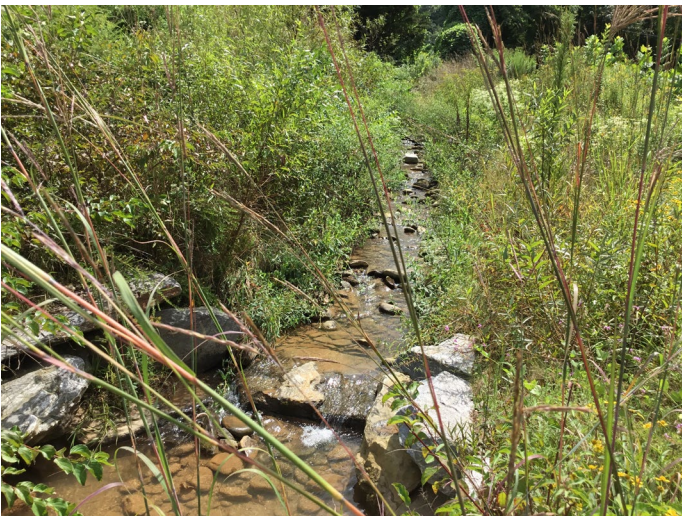
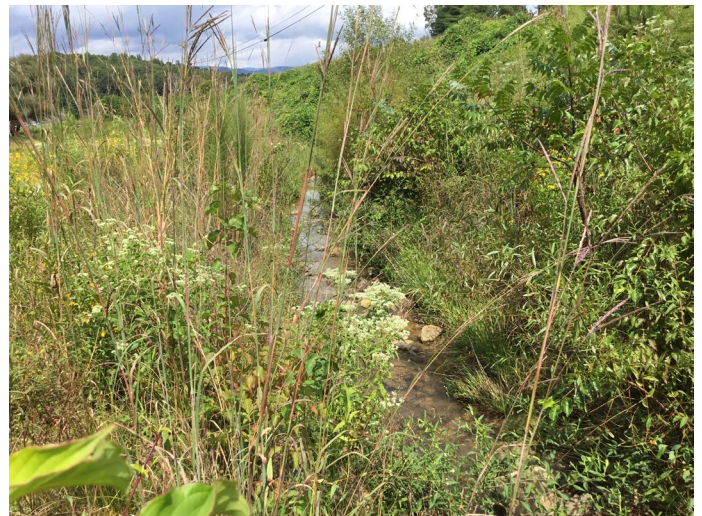
Site 12 Photo Point #1 (Downstream)

Site 12: Live stakes and buffer trees were surviving throughout the stream relocation. Kudzu was noted at the beginning and end of the stream relocation.

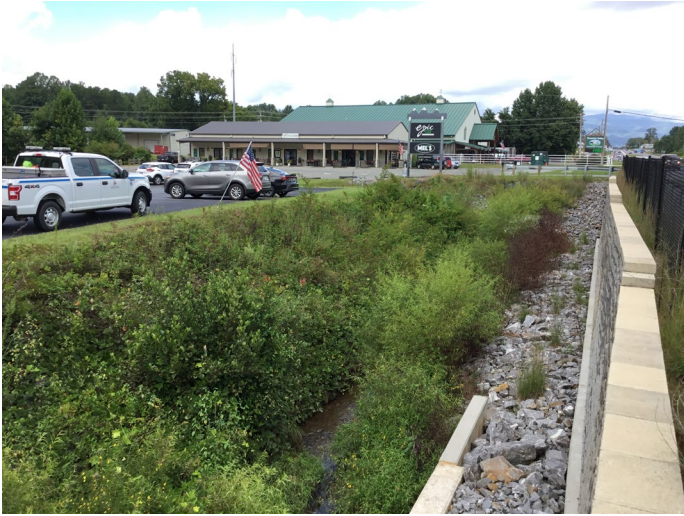
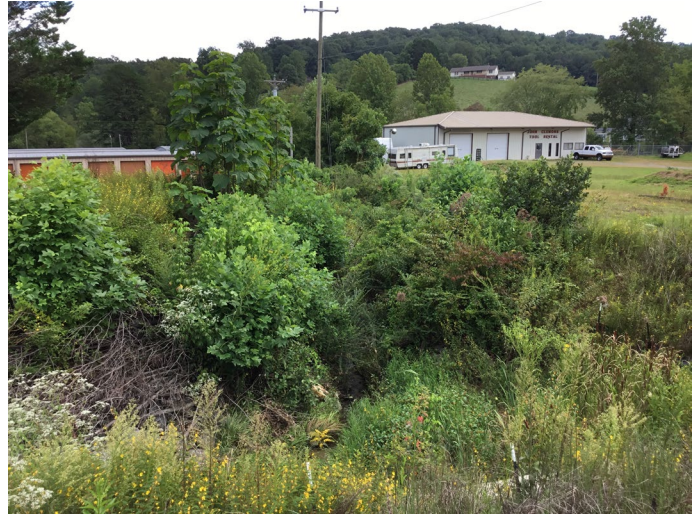
Site 15 Photo Point #1 (Upstream)

Site 15: Live stakes were surviving. Some kudzu and privet was noted.

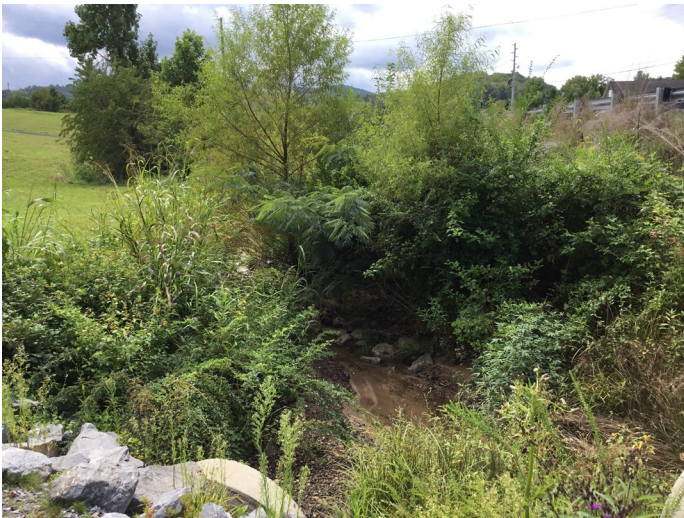
Site 17 Photo Point #1 (Downstream)

Site 17: Planted vegetation was observed surviving. A small amount of multiflora rose was observed.
