ANNUAL REPORT FOR 2025

**Br. 138 and 139 over Neuse River and Neuse River Overflow on
Maple Cypress Road Temporary Impact Site
Craven County
TIP No. B-4484
COE Action ID: SAW-2017-00829
DWR Project #: 20200142
CAMA Permit #: 45-20**

Prepared By:
Roadside Environmental Unit and Environmental Analysis Unit
North Carolina Department of Transportation
August 2025

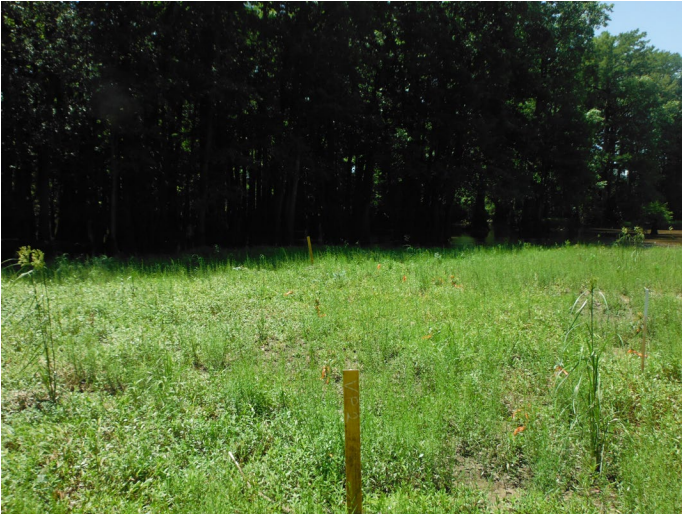
Vegetation Plot #2

Buffer Restoration Area - The Neuse River buffer restoration area is meeting the success criteria for Year 3 while the Neuse River Overflow buffer restoration area is showing a low stem density. The Neuse River Overflow planted area had been inundated for quite a while based on current site observations. Other species noted within this area included sweetgum, green ash, river birch, persimmon, volunteer baldcypress, and various grasses.

NCDOT proposes to complete a supplemental planting of the Neuse River Overflow buffer during the 2025/2026 planting window. NCDOT will continue monitoring the buffer restoration areas at the Maple Cypress Road Temporary Impact Site in 2026.
