HE-0001 Year 2 Stream Monitoring Report

January, 2026

Buncombe County, NC

Ecosystem Planning and Restoration

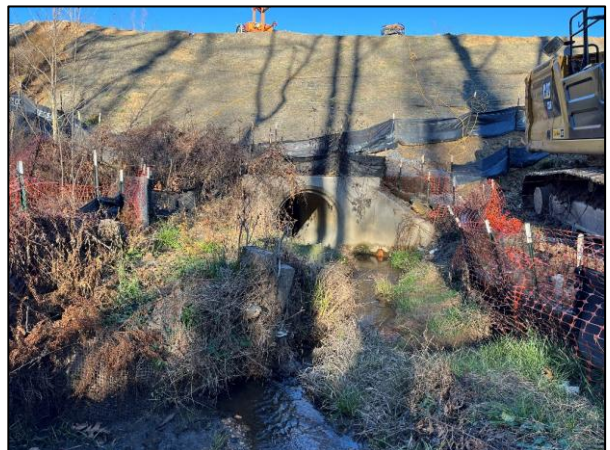
Photo Point 30 (UTFBR Reach 4, facing downstream, I-26 culvert)

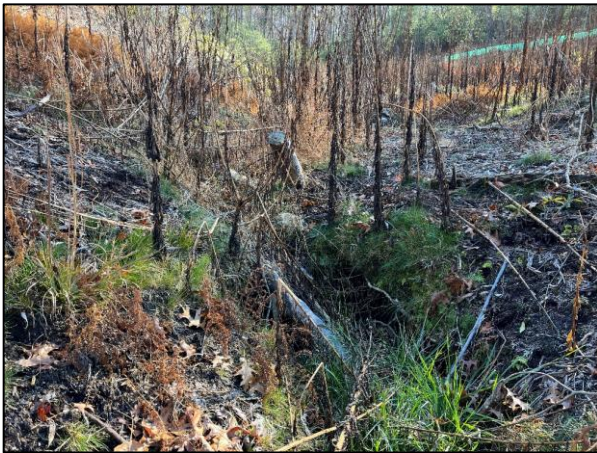
Photo Point 35 (UT2 facing upstream at head cut)

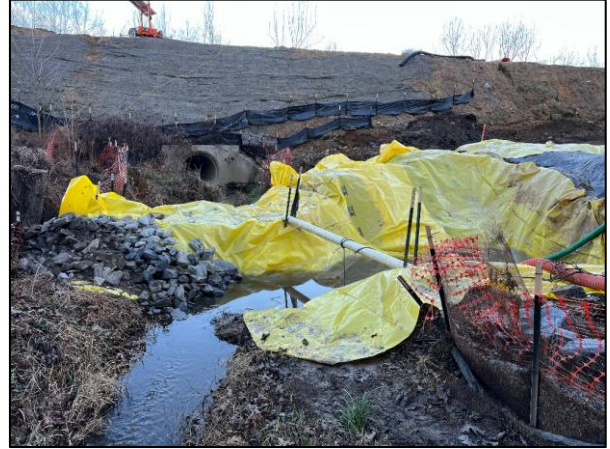
The longitudinal profile for Reach 4 was shortened to station 220.0 because of active construction from the ongoing I-26 widening project. A retaining wall is being added to the roadway causing the downstream culvert to extend approximately 40 feet upstream. A pump around system was installed on

the day of the field survey, so this downstream section of the assessment reach was not available and will not be moving forward.

Construction stream diversion (lower Reach 4)

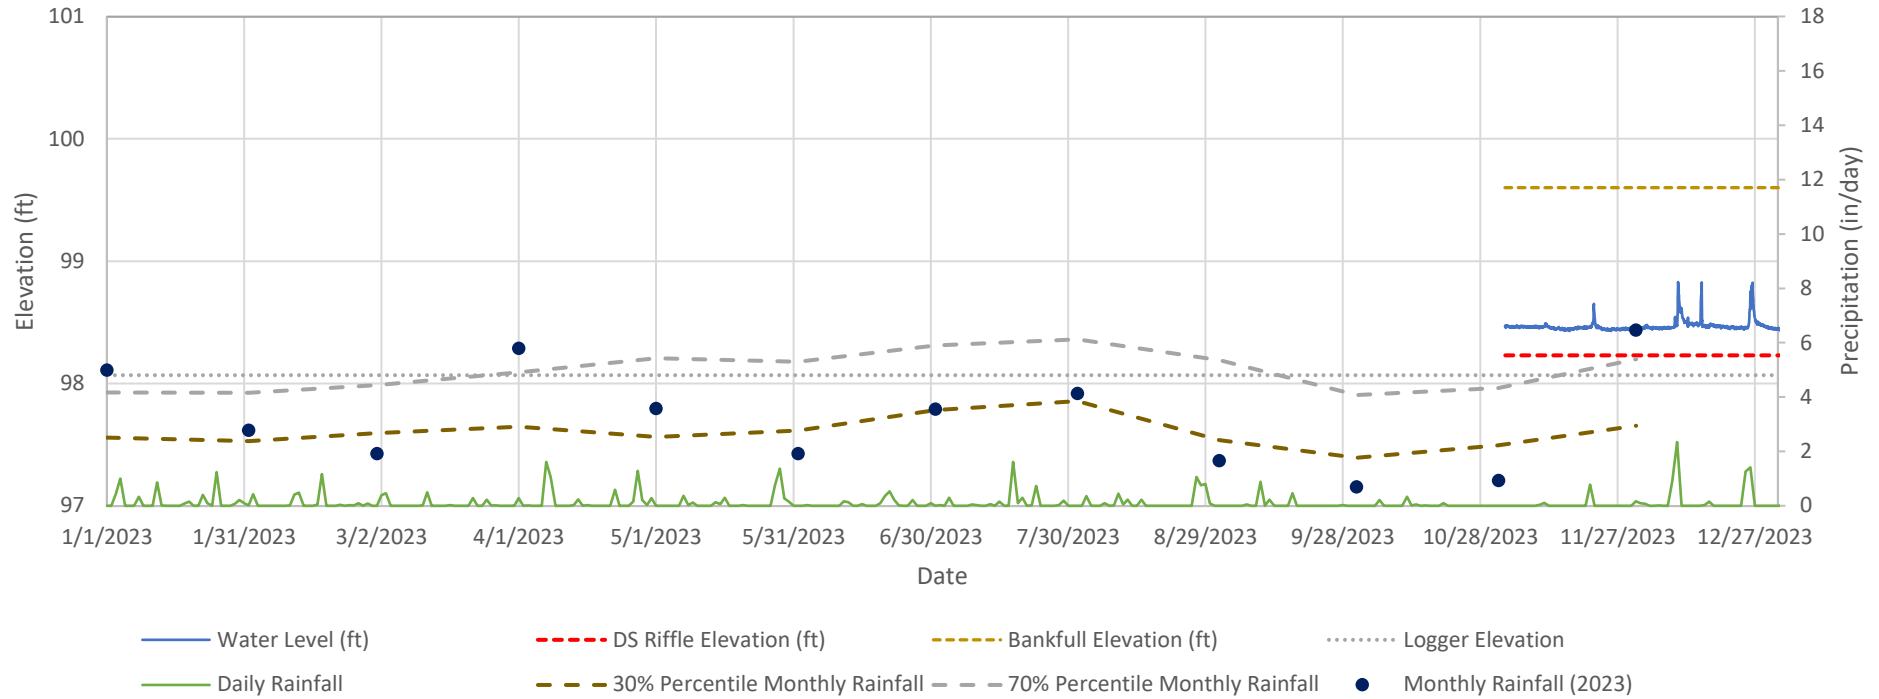
2023 Existing Conditions Streamflow Data	
Gauge ID	UTFBR SG Baseline
Start Date	11/3/2023
End Date	12/31/2023
Recordings Per Day	24
Logger Elevation (ft)	98.07
Controlling Grade Elevation (ft)	98.23
Bankfull Elevation (ft)	99.60
Most Consecutive Days of Flow	60
Total Days of Flow	59
Max High Water Elevation	0.60
Bankfull Events	0

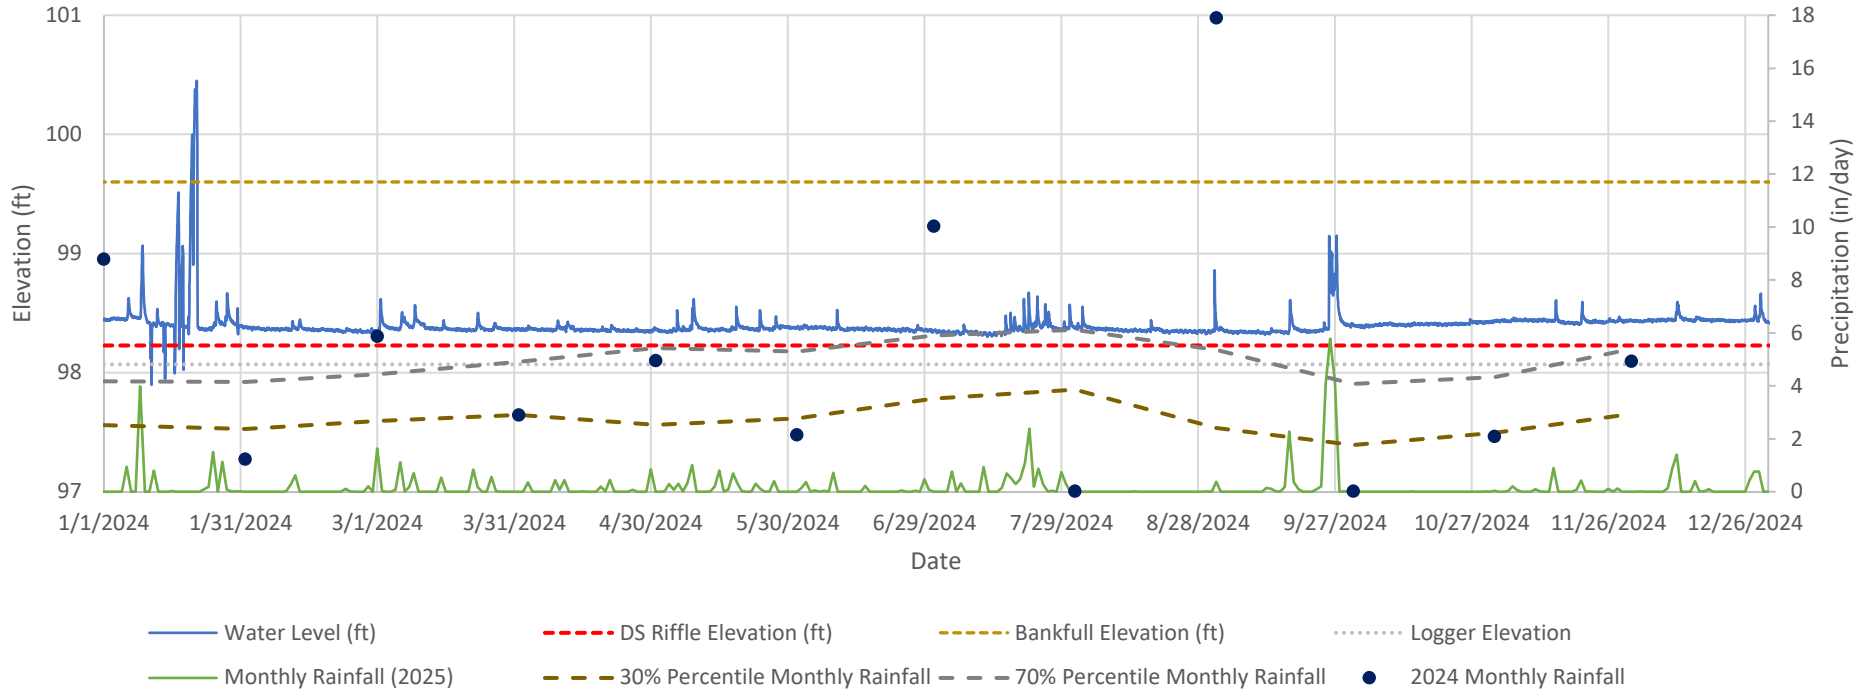
Note: All elevations are relative to surveyed iron which was assigned an assumed elevation of 100.00 ft
 *Rainfall data from Gauging Station ASH Regional Airport 5 miles SE <https://agacis.rcc-acis.org/?fips=37021>
 *Data was corrupted from 1/11-1/21 from freezing temperatures

2024 Existing Conditions Streamflow Data	
Gauge ID	UTFBR SG Year 1
Start Date	1/1/2024
End Date	12/31/2024
Recordings Per Day	24
Logger Elevation (ft)	98.07
Controlling Grade Elevation (ft)	98.23
Bankfull Elevation (ft)	99.60
Most Consecutive Days of Flow	365
Total Days of Flow	365
Max High Water Elevation	0.92
Bankfull Events	0

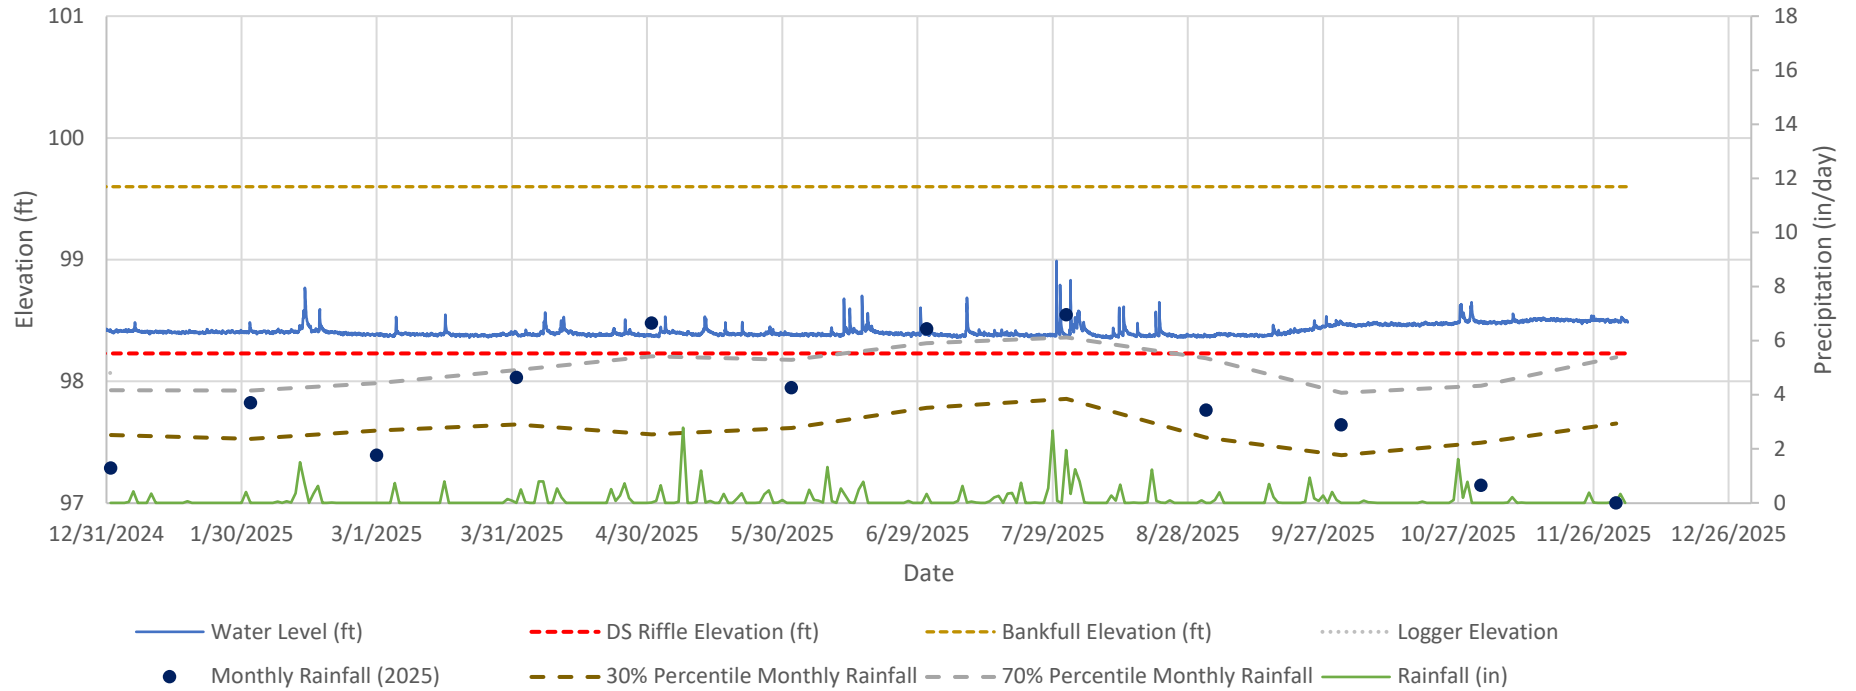
changed compared to Year 1 Monitoring. The gauge collected 336 days of consecutive flow, indicating UTFBR is a perennial stream at the location of the gauge. Note that the gauge was last downloaded on 12/3/2025 so no data was available for the remainder of December. These data will be presented in the Year 3 report. No bankfull events were recorded during Year 2 monitoring.

2025 Existing Conditions Streamflow Data	
Gauge ID	UTFBR SG Year 2
Start Date	1/1/2025
End Date	12/3/2025
Recordings Per Day	24
Logger Elevation (ft)	98.07
Controlling Grade Elevation (ft)	98.23
Bankfull Elevation (ft)	99.60
Most Consecutive Days of Flow	336
Total Days of Flow	336
Max High Water Elevation	0.76
Bankfull Events	0

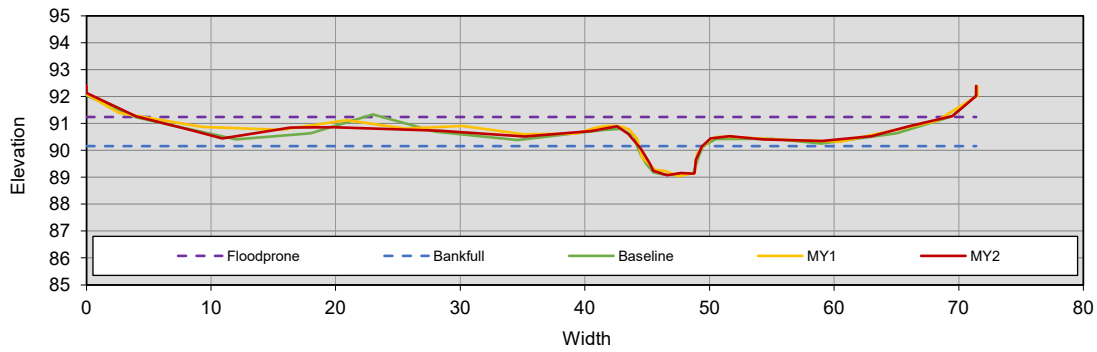
Cross Section 3 - XS3

Sta. 0 + 28 UTFBR - Reach 2 - MY2 (Dec. 2025), Riffle

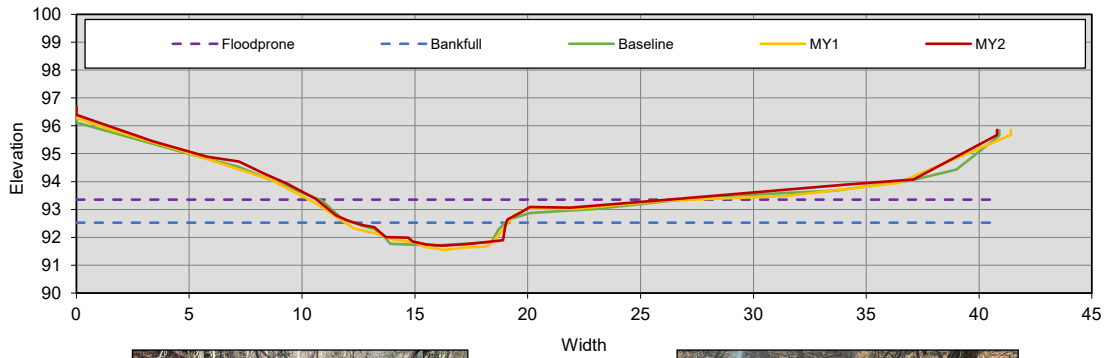
Cross Section 4 -XS4

Sta. 1+60.1 UTFBR - Reach 2 - MY2 (Dec. 2025), Riffle

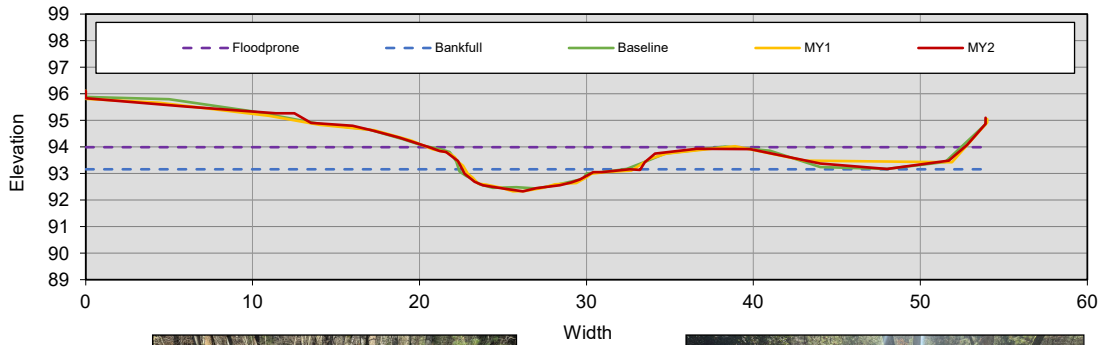
Cross Section 5 - XS5

Sta. 0 + 49.2 UTFBR - Reach 3 - MY2 (Dec. 2025), Riffle

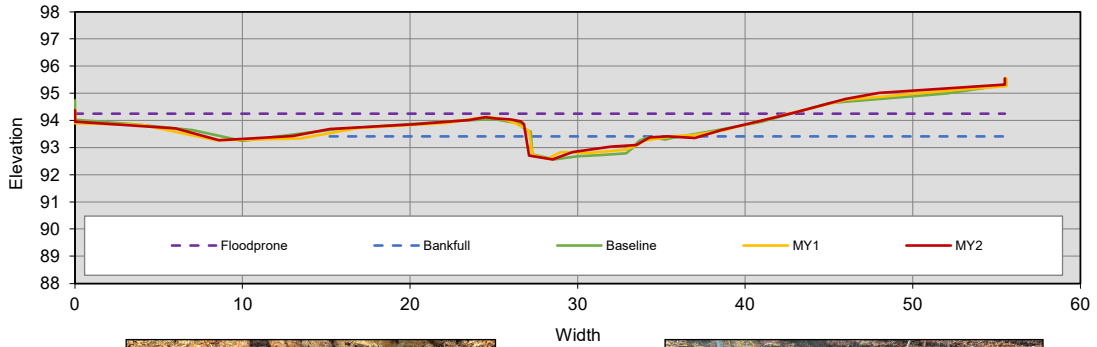
Cross Section 6 -XS6

Sta. 1 + 26.9 UTFBR - Reach 3 - MY2 (Dec. 2025), Riffle

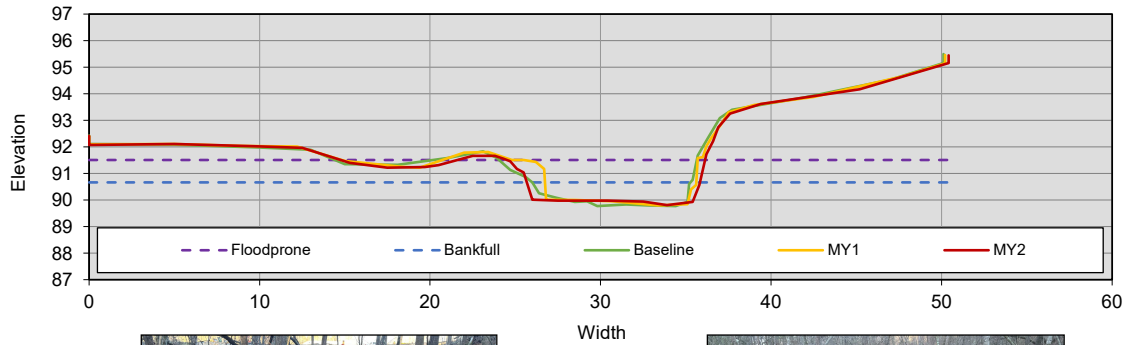
Cross Section 7 - XS7

Sta. 0 + 77.5 UTFBR - Reach 4 - MY2 (Dec. 2025), Riffle

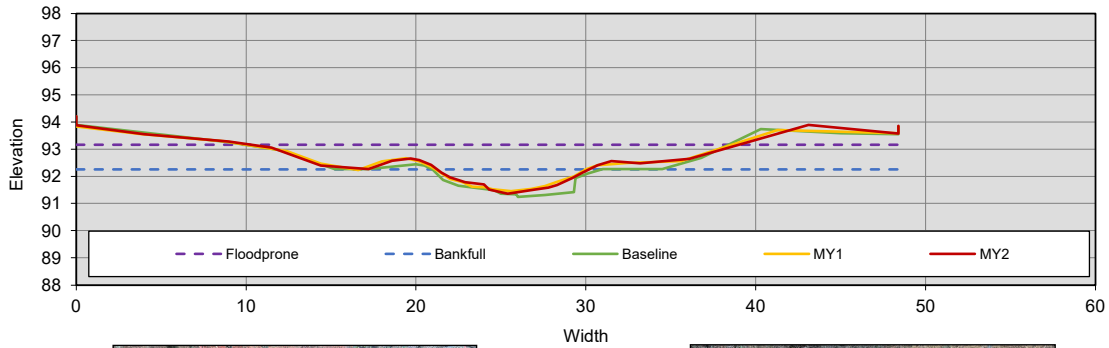
Cross Section 8 -XS8

Sta. 1 + 77 UTFBR - Reach 4 - MY2 (Dec. 2025), Riffle

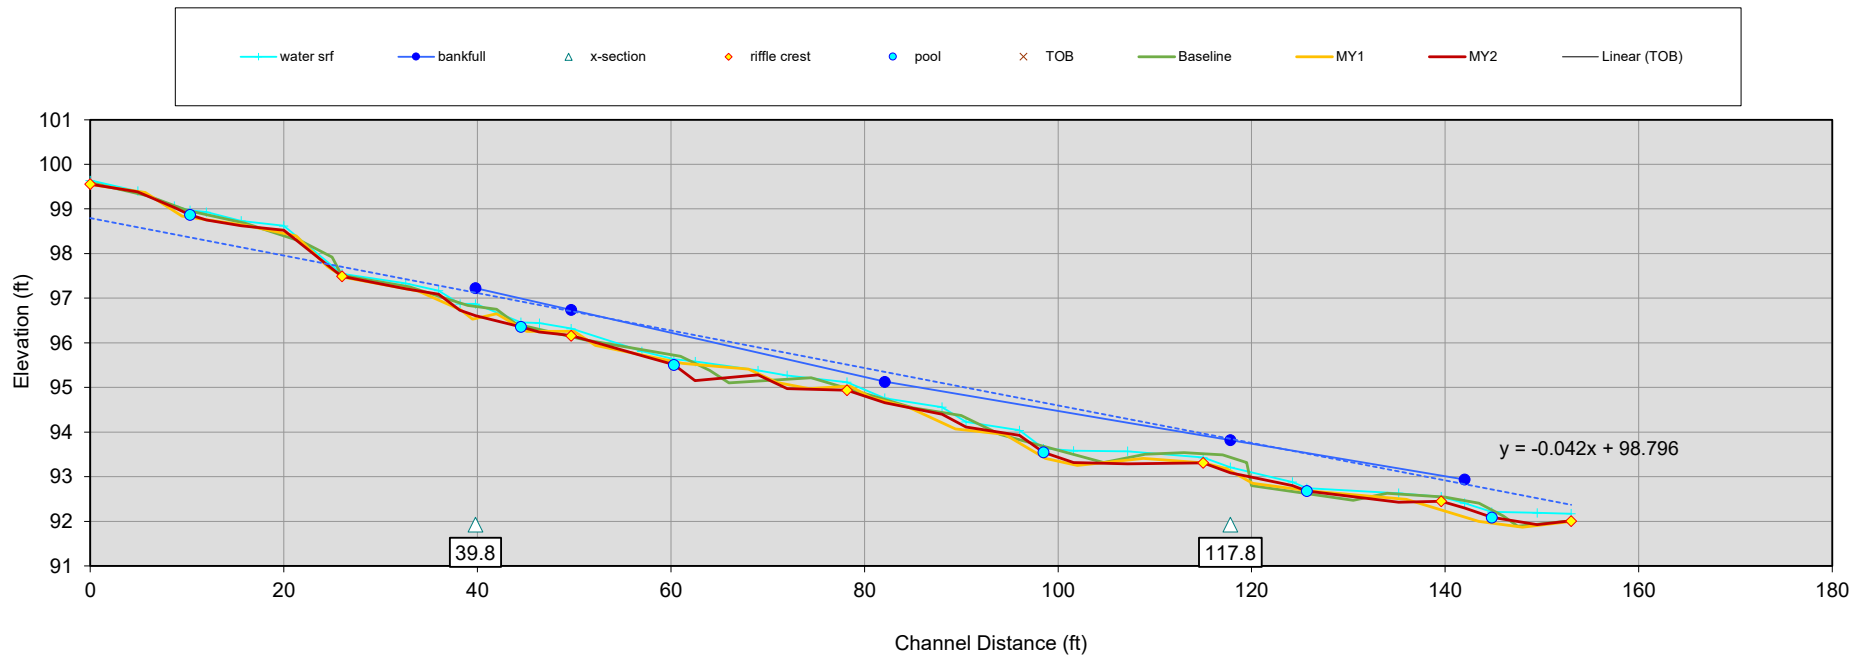
UTFBR - Reach 1 - MY2 (Dec. 2025)

In general, the longitudinal profile survey data for all four reaches indicate that UTFBR has not incised or aggraded significantly and has retained appropriate bedform diversity compared to the Year 1 survey. Some of the bedform features (head of riffles and pools) have migrated slightly on a few of the reaches and the profiles on Reaches 2, 3 and 4 no longer begin at the head of riffle. The surveyed channel slopes ranged from 0.049 ft/ft (Reach 1) to 0.019 ft/ft (Reach 3), and the ratios for each parameter are close to what would be expected under reference conditions, although there were some outliers in each reach. Reach 4, which was slightly incised in the Baseline survey, has stayed mostly consistent though Years 1 and 2 although some riffles have adjusted. Reach 3 appears to have stabilized since its shift from Baseline to Year 1. Some minor pool and riffle adjustment occurred after Hurricane Helene, but the Year 2 profile indicates that the stream has adjusted to near the baseline conditions.

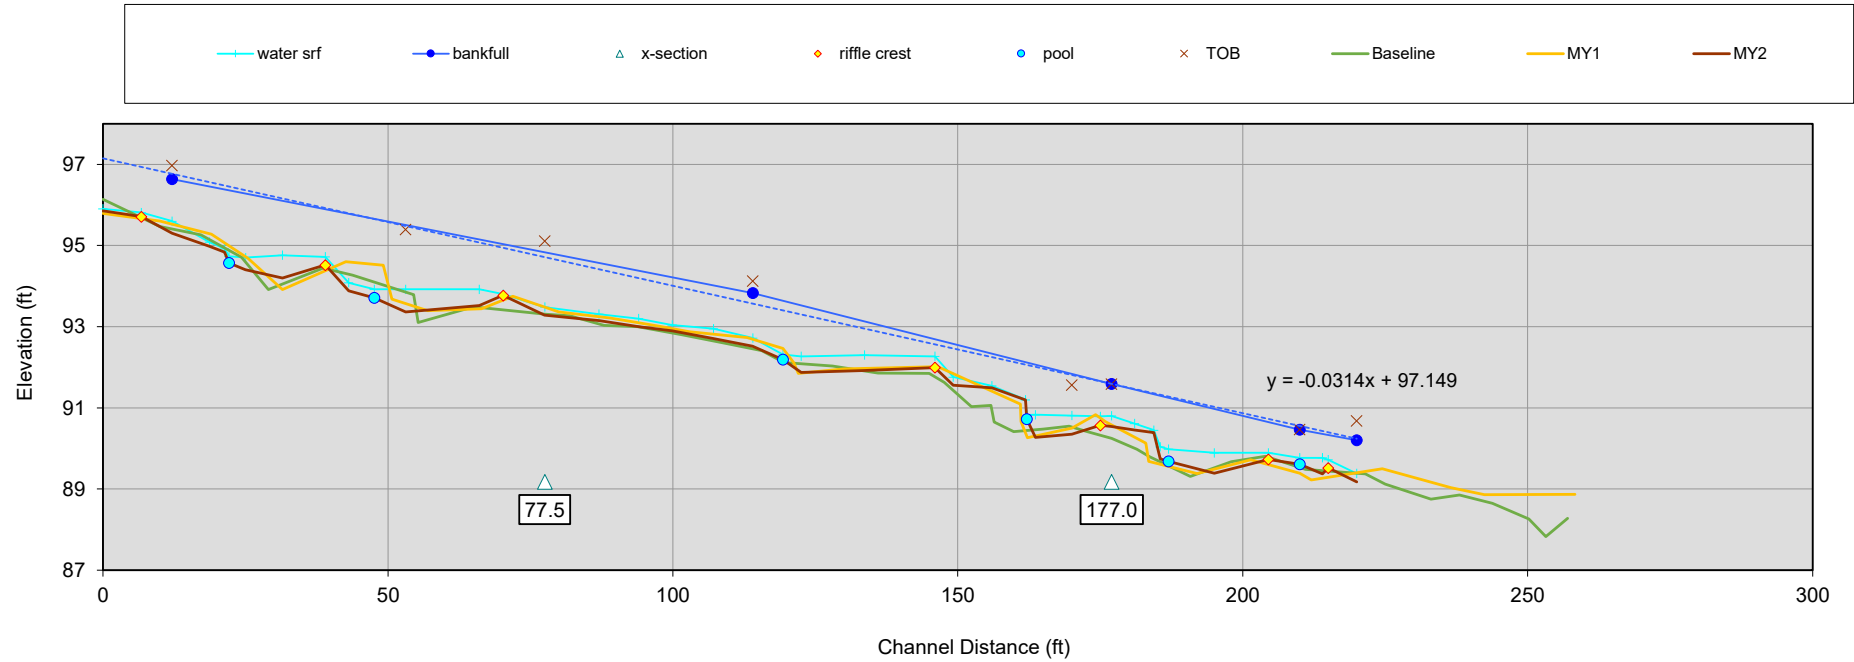
UTFBR - Reach 4 - MY2 (Dec. 2025)

NOTE: The last ~38' of the profile was removed from profile because of ongoing road construction on I-26.

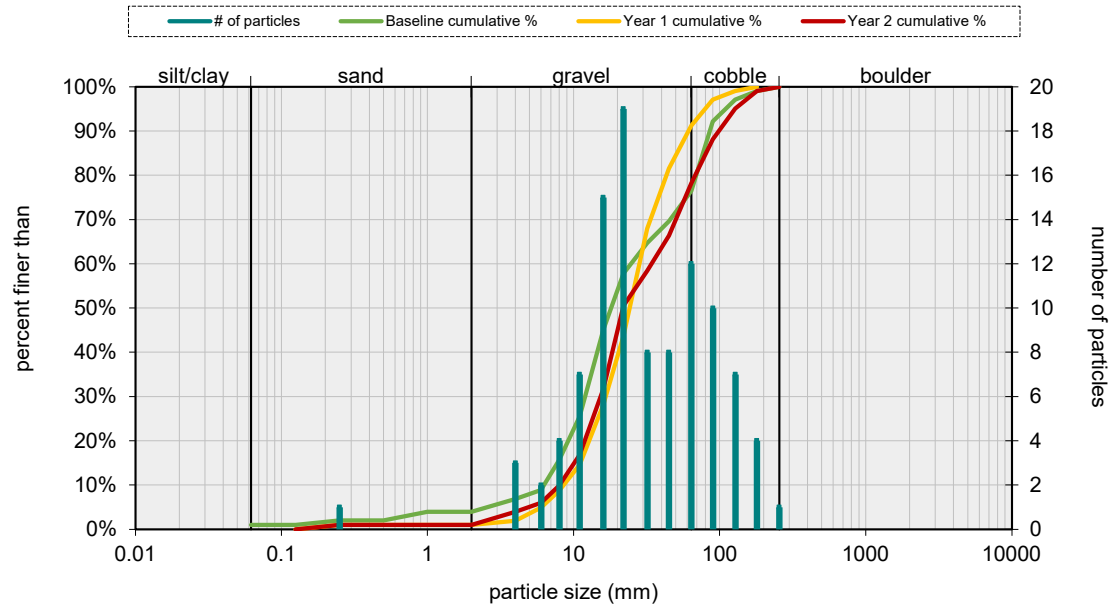
Riffle Surface Pebble Count, UTFBR - Reach 1 - MY2 (Dec. 2025)

D16	11
D35	17
D50	22
D65	42
D84	78
D95	130

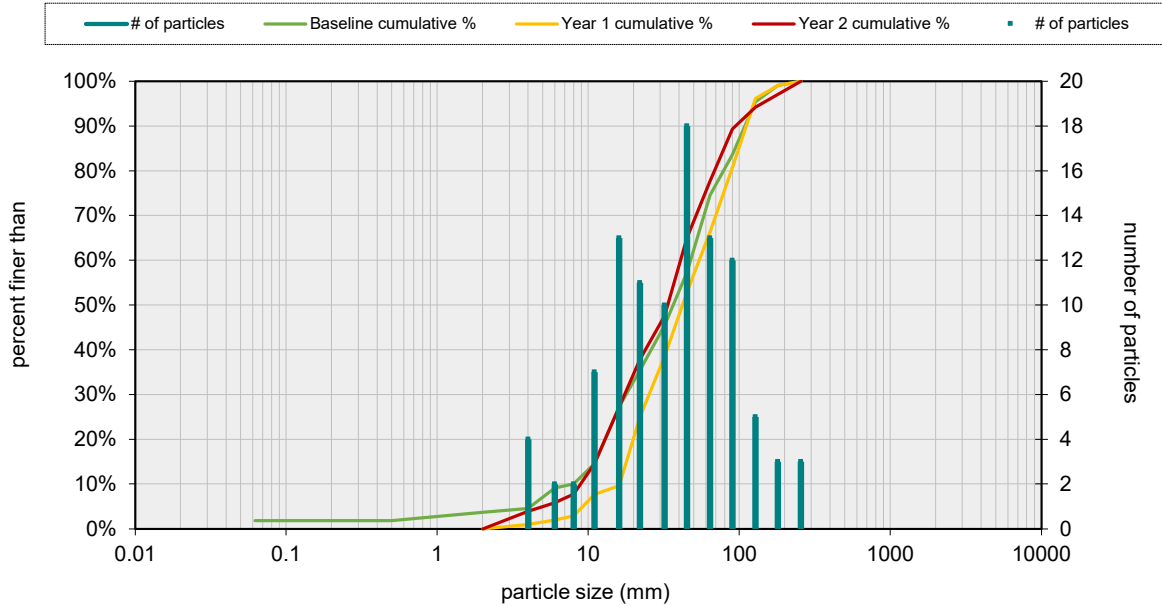
Riffle Surface Pebble Count, UTFBR - Reach 2 - MY2 (Dec. 2025)

Size (mm)	
D16	11
D35	20
D50	34
D65	45
D84	77
D95	140

Size Distribution	
mean	29.1
dispersion	2.7
skewness	-0.07

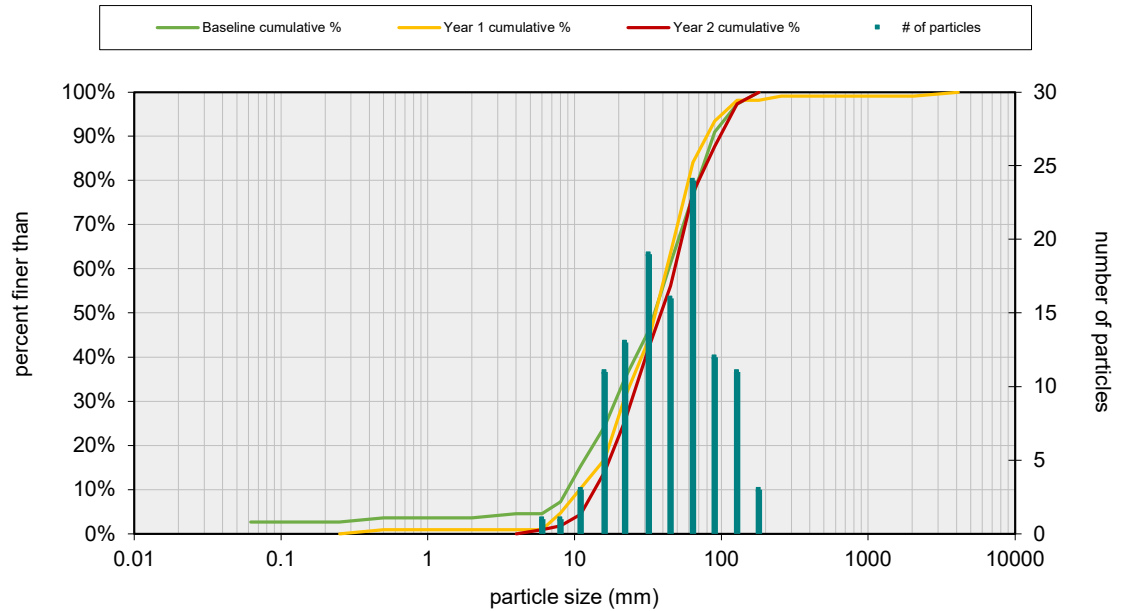
Riffle Surface Pebble Count, UTFBR - Reach 3 - MY2 (Dec. 2025)

Size (mm)	
D16	17
D35	27
D50	39
D65	52
D84	80
D95	120

Size Distribution	
mean	36.9
dispersion	2.2
skewness	-0.03

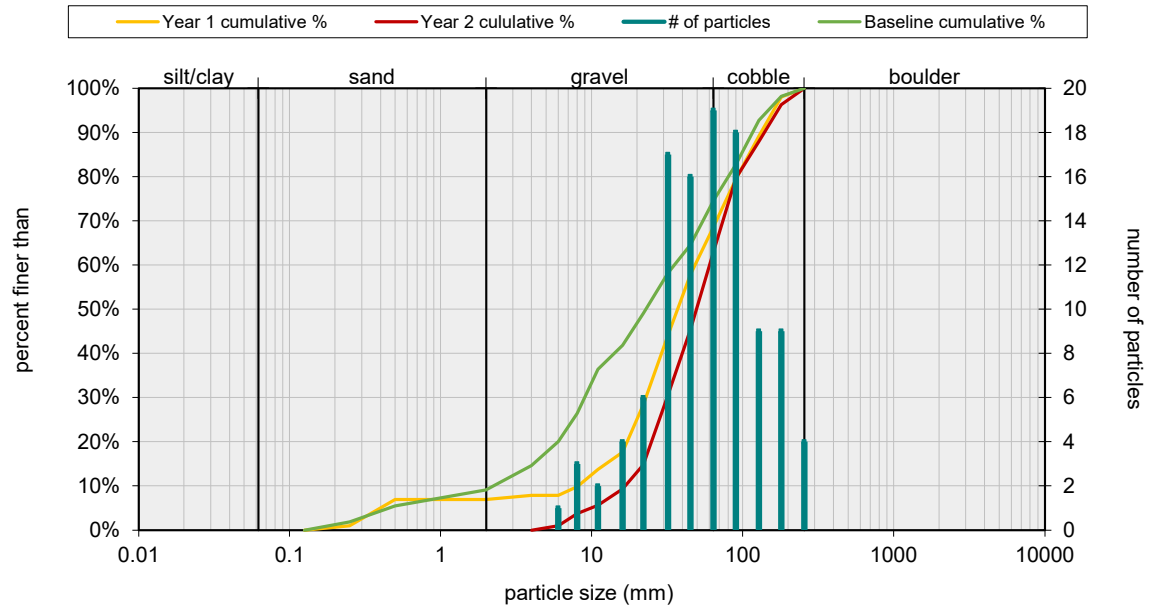
Riffle Surface Pebble Count, UTFBR - Reach 4 - MY2 (Dec. 2025)

Size (mm)	
D16	23
D35	35
D50	49
D65	67
D84	110
D95	170

Size Distribution	
mean	50.3
dispersion	2.2
skewness	0.01

The pebble count data indicates that the sediment type in UTFBR is predominantly gravel (61%-78%) with some intermixed cobble (22%-36%). Reach 4 has some exposed bedrock. This substrate size distribution is characteristic of a high gradient, headwater stream in the Southern Appalachians. Compared to Year 1 monitoring pebble count data, the D50 decreased back to near baseline conditions on Reach 1 and Reach 2. Sampled sediment in Reach 3 has remained consistent throughout monitoring. Sediment in Reach 4 has consistently coarsened since Baseline, from a D50 of 23 to 37 and then to 49 mm.
