ANNUAL REPORT FOR 2024

R-2413A&B UT to Reedy Fork Creek - Site #2
Guilford County
TIP No. R-2413A&B
USACE Action ID: SAW-2013-00557
DWR Project #: 20130517 v.5

Prepared By:
Environmental Analysis Unit & Roadside Environmental Unit
North Carolina Department of Transportation
December 2024

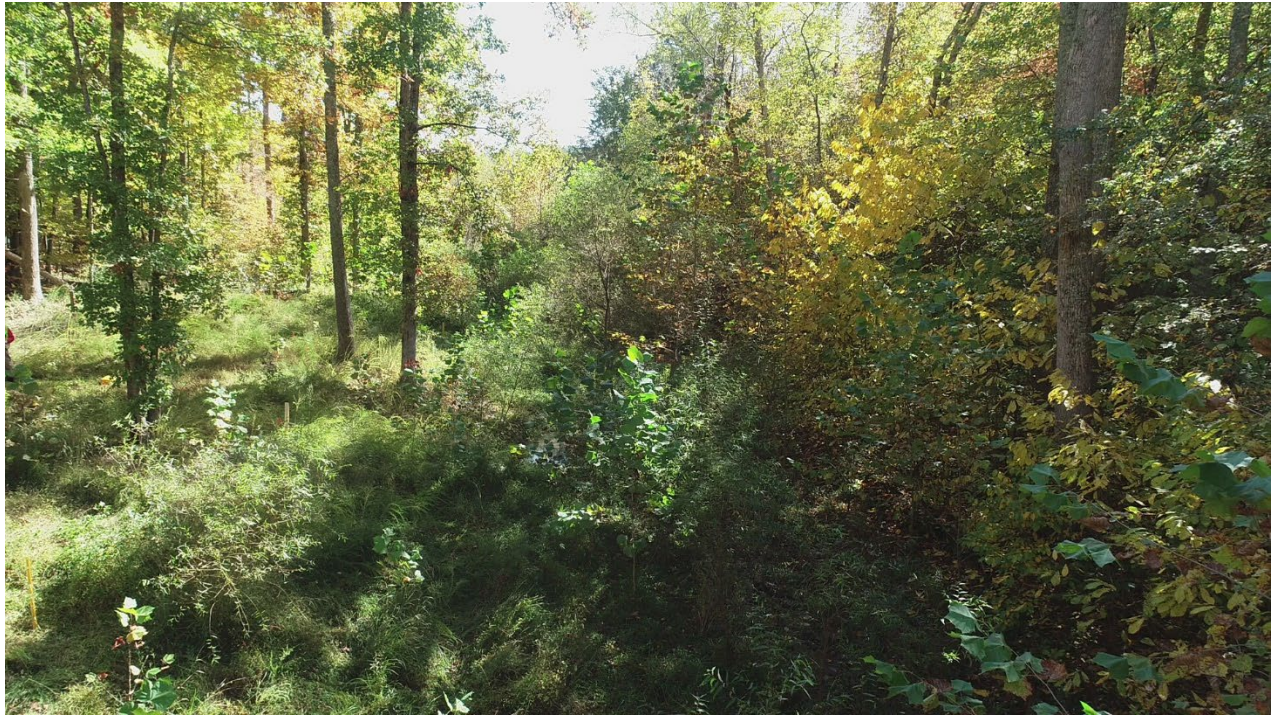
Site overview looking upstream from 2022 to demonstrate vigorous vegetative growth.

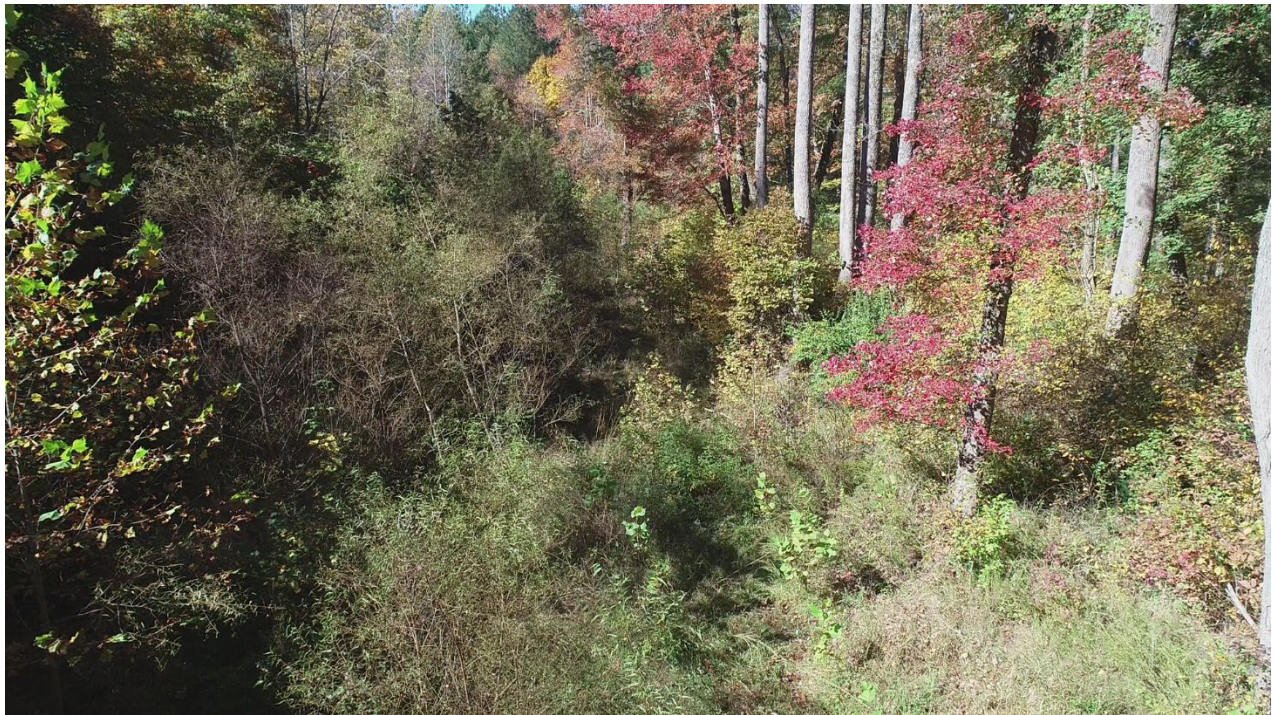
Site overview looking downstream from 2022 to demonstrate vigorous vegetative growth.
