ANNUAL REPORT FOR 2025

UT to Chatuge Lake (Sites 2, 3A, 3B, & 4)
Clay County
TIP No. R-5742
COE Action ID: SAW-2016-01118
NCDWR Project #: 20180823

Prepared By:
Roadside Environmental Unit and Environmental Analysis Unit
North Carolina Department of Transportation
September 2025

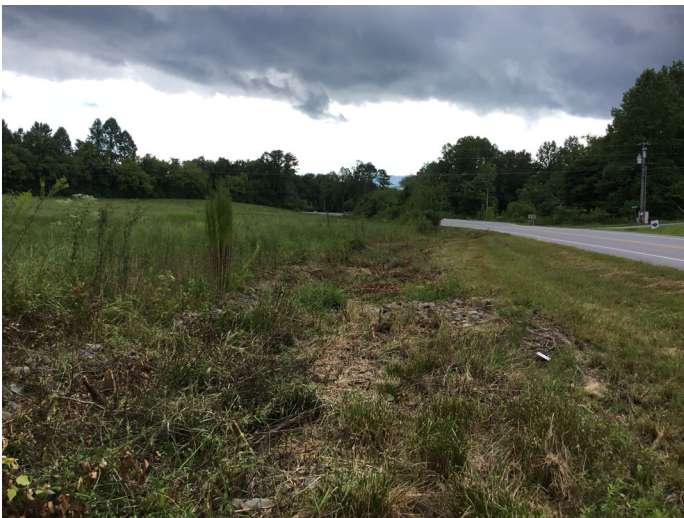
Site 3B Photo Point #1 (Downstream)

Streambank & Buffer Vegetation: Black Willow and Silky Dogwood live stakes were noted surviving. Other vegetation noted included River Birch, Elderberry, and Tag Alder. Site 3B planted vegetation had been cut back by a side arm mower cutting vegetation back from the roadway. This cut planted vegetation should sprout moving forward.

The UT's to Chatuge Lake have met the required monitoring protocols for the third formal year of monitoring, except for, Site 3B. The channels throughout the stream sites are stable and planted vegetation is surviving at this time. We will monitor Site 3B for resprouting of the planted vegetation and replant this if necessary in the future.
