ANNUAL REPORT FOR 2025

**U-2579BA Smith Creek
Forsyth County
TIP No. U-2579BA&B
USACE Action ID: SAW-2008-03183
DWR Project #: 20140090 v7**

Prepared By:
Environmental Analysis Unit & Roadside Environmental Unit
North Carolina Department of Transportation
December 2025

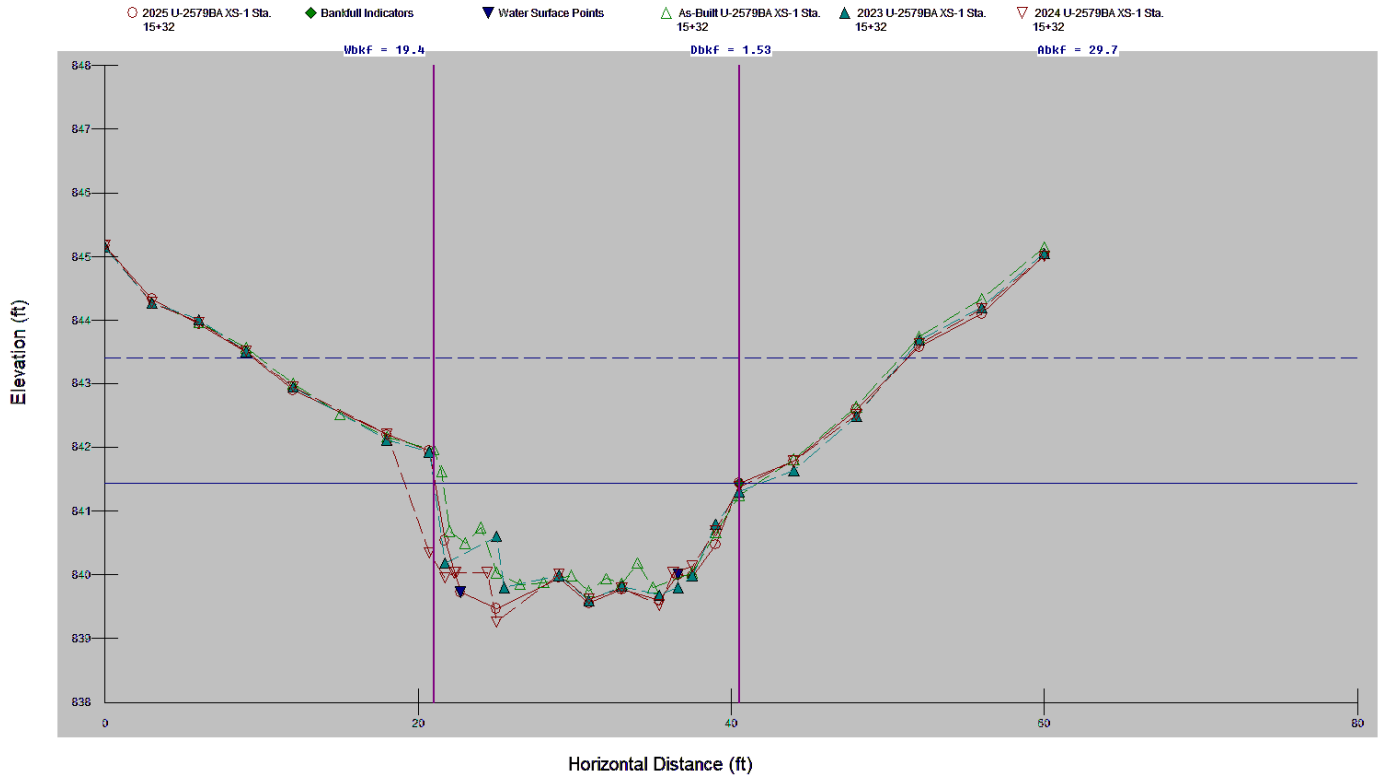
2025 U-2579BA XS-1 Sta. 15+32

U-2579BA Smith Creek (Fishponds): Cross-Section #1 (Riffle) Abbreviated Morphological Summary

Variable	As-built	MY1 (2023)	MY2 (2024)	MY3 (2025)	MY4 (2026)	MY5 (2027)
Width of the Floodprone Area (ft)	34.83	38.0	42.4	41.9		
Bankfull Width (ft)	18.8	19.4	21.3	19.4		
Entrenchment Ratio	1.85	2.0	2.0	2.15		
Bankfull Mean Depth (ft)	1.09	1.2	1.4	1.5		
Maximum Bankfull Depth (ft)	1.5	1.7	2.1	2.0		
Width/Depth Ratio	17.25	15.9	15.4	12.7		
Bankfull Cross Sectional Area (ft ²)	20.53	23.6	29.3	29.7

Based on visual assessment and comparisons of the as-built, MY3 (2025), riffle cross sections #1, #3 and #5 are all stable and within expected thresholds for a C5 type stream. Channel dimension survey was not required for the UT to Smith Creek and by visual inspection appears stable in the third year of monitoring with no areas of concern. Sediment levels in the lower reach of Smith Creek have persisted since MY2. MY3 cross section surveys indicate that bank height has increased accordingly indicating the system continues to move toward equilibrium. Pebble counts were not required in accordance with the permit conditions and therefore were not completed. The longitudinal profile survey was conducted from Sta. 10+00 through 31+00, stopping at the approximate limits of DOT ROW. Results of the longitudinal profile survey for both Smith Creek and the UT are similar to MY2 and there are no concerns of aggradation or active erosion.

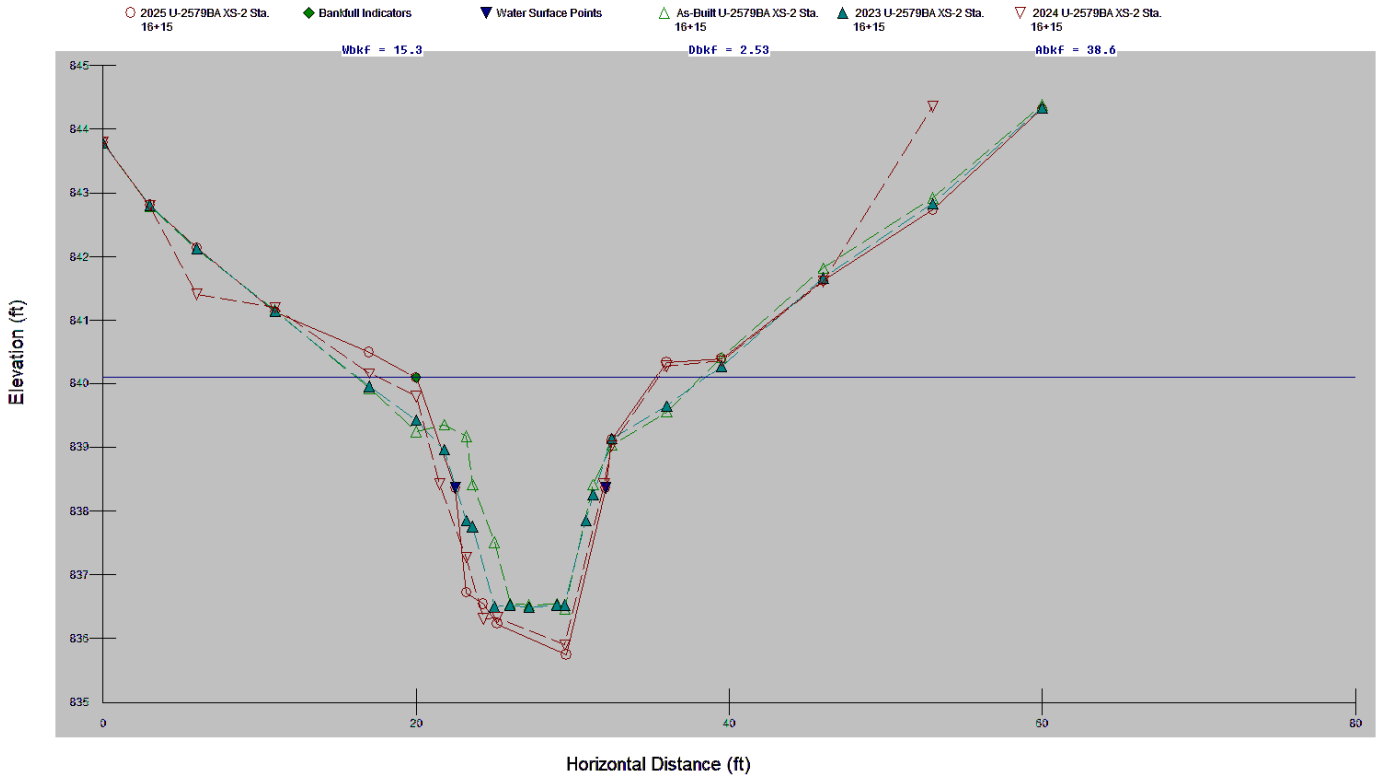
2025 U-2579BA XS-2 Sta. 16+15

U-2579BA Smith Creek (Fishponds): Cross-Section #2 (Pool) Abbreviated Morphological Summary						
Variable	As-Built	MY1 (2023)	MY2 (2024)	MY3 (2025)	MY4 (2026)	MY5 (2027)
Bankfull Width (ft)	15.1	10.5	14.6	15.3		
Bankfull Mean Depth (ft)	1.3	1.7	2.4	2.5		
Maximum Bankfull Depth (ft)	2.9	2.5	3.9	4.3		
Bankfull Cross Sectional Area (ft ²)	19.1	18.0	34.5	38.6

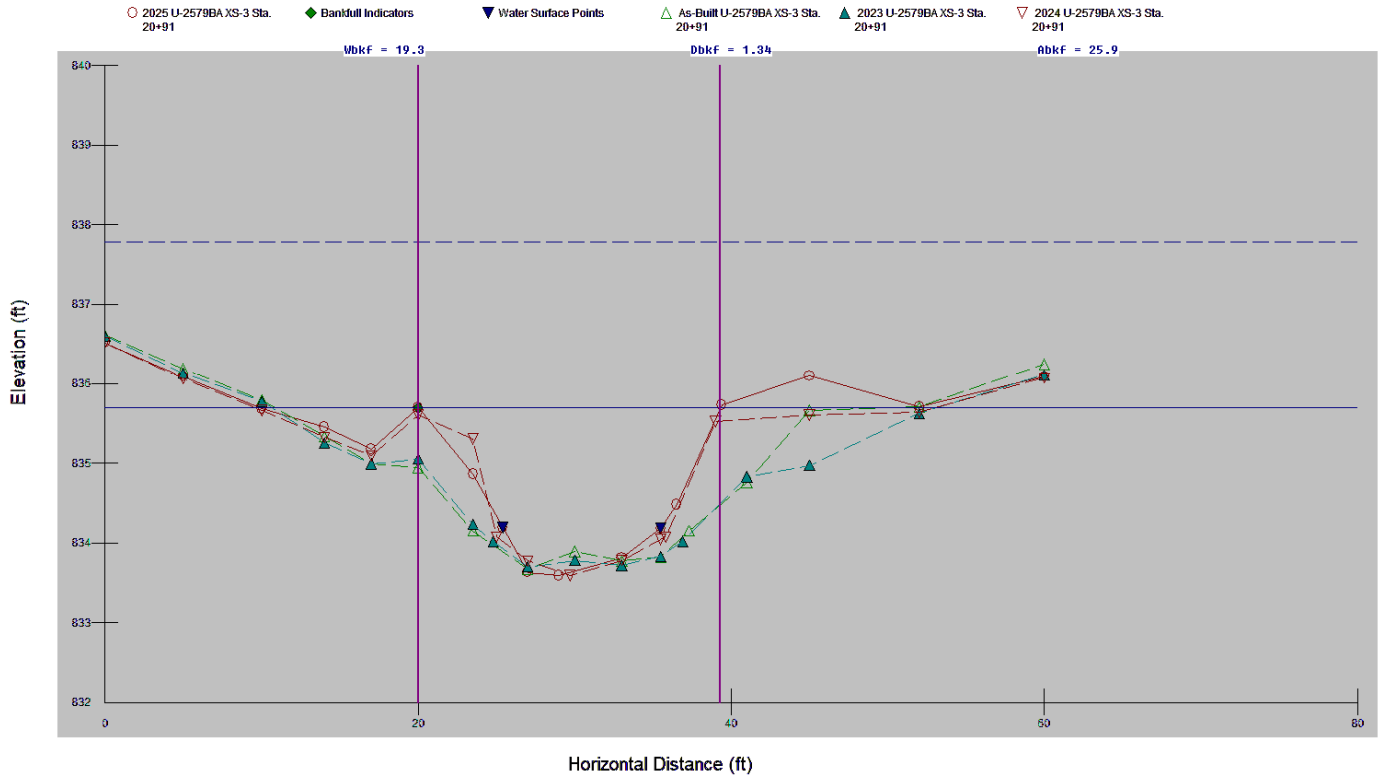
2025 U-2579BA XS-3 Sta. 20+91

U-2579BA Smith Creek (Fishponds): Cross-Section #3 (Riffle) Abbreviated Morphological Summary

Variable	As-built	MY1 (2023)	MY2 (2024)	MY3 (2025)	MY4 (2026)	MY5 (2027)
Width of the Floodprone Area (ft)	54.65	50.2	60.0	60		
Bankfull Width (ft)	21.8	20.0	18.0	19.3		
Entrenchment Ratio	2.51	2.5	3.3	3.1		
Bankfull Mean Depth (ft)	0.84	0.8	1.3	1.3		
Maximum Bankfull Depth (ft)	1.27	1.1	1.9	2.1		
Width/Depth Ratio	25.95	25.4	14.4	14.4		
Bankfull Cross Sectional Area (ft ²)	18.25	15.9	22.5	25.9

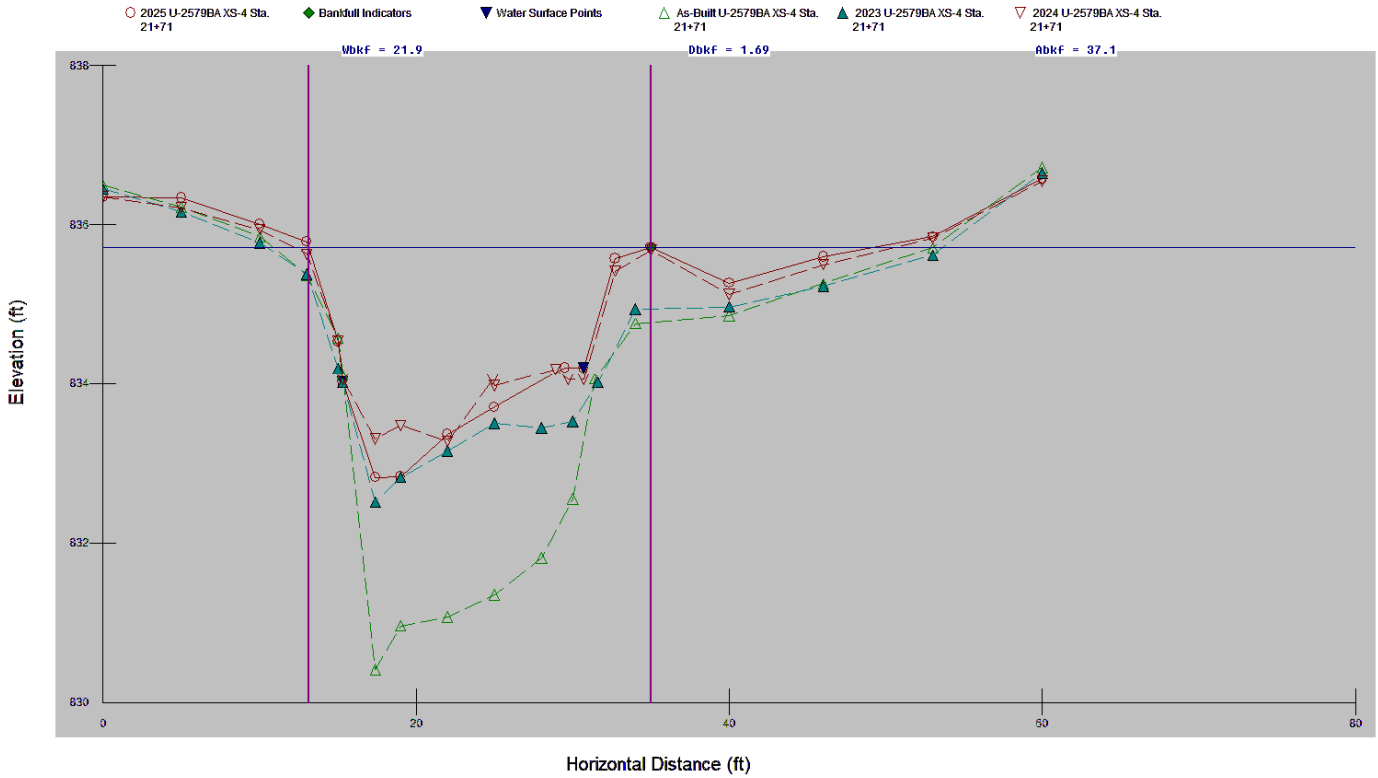
2025 U-2579BA XS-4 Sta. 21+71

U-2579BA Smith Creek (Fishponds): Cross-Section #4 (Pool) Abbreviated Morphological Summary						
Variable	As-Built	MY1 (2023)	MY2 (2024)	MY3 (2025)	MY4 (2026)	MY5 (2027)
Bankfull Width (ft)	19.5	20.3	22.5	21.9		
Bankfull Mean Depth (ft)	2.7	1.4	1.5	1.7		
Maximum Bankfull Depth (ft)	4.4	2.4	2.4	2.9		
Bankfull Cross Sectional Area (ft ²)	51.5	29.0	33.5	37.1

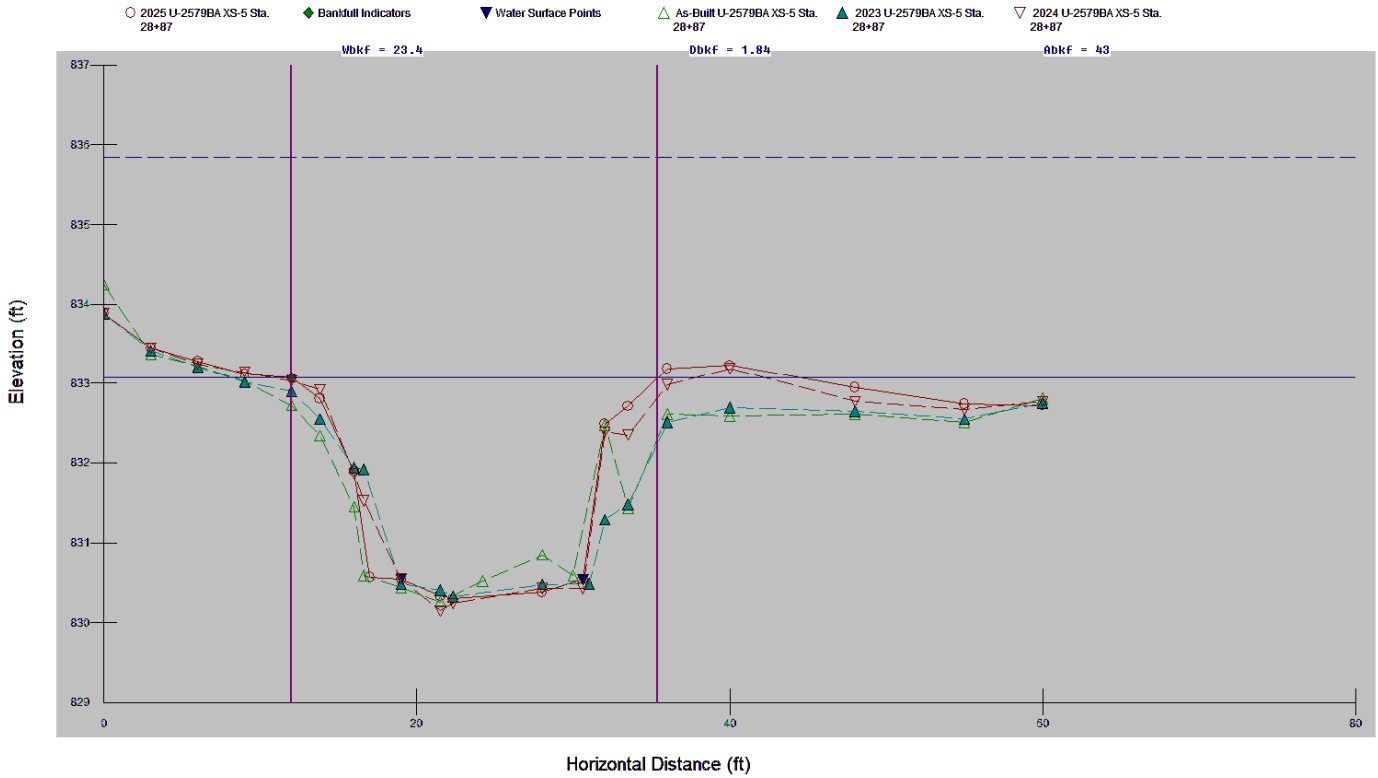
2025 U-2579BA XS-5 Sta. 28+87

U-2579BA Smith Creek (Fishponds): Cross-Section #5 (Riffle) Abbreviated Morphological Summary						
Variable	As-built	MY1 (2023)	MY2 (2024)	MY3 (2025)	MY4 (2026)	MY5 (2027)
Width of the Floodprone Area (ft)	60	60	60	60		
Bankfull Width (ft)	22.52	22.0	23.2	23.4		
Entrenchment Ratio	2.66	2.7	2.6	2.6		
Bankfull Mean Depth (ft)	1.42	1.5	1.8	1.8		
Maximum Bankfull Depth (ft)	2.21	2.2	2.8	2.8		
Width/Depth Ratio	15.86	14.5	13.0	12.7		
Bankfull Cross Sectional Area (ft ²)	31.87	33.6	41.2	43.0

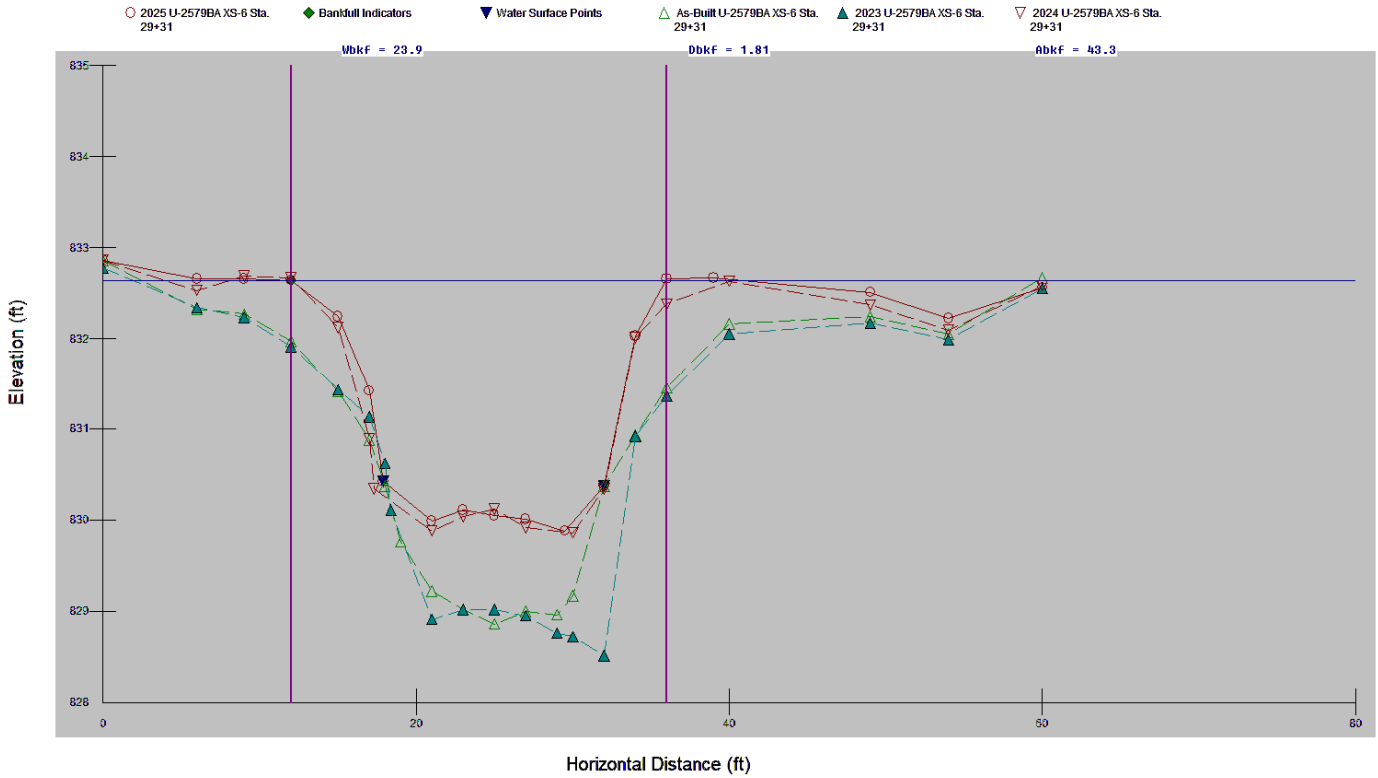
2025 U-2579BA XS-6 Sta. 29+31

U-2579BA Smith Creek (Fishponds): Cross-Section #6 (Pool) Abbreviated Morphological Summary						
Variable	As-Built	MY1 (2023)	MY2 (2024)	MY3 (2025)	MY4 (2026)	MY5 (2027)
Bankfull Width (ft)	33.9	31.6	31.5	23.9		
Bankfull Mean Depth (ft)	1.6	1.7	1.5	1.8		
Maximum Bankfull Depth (ft)	3.3	3.5	2.8	2.8		
Bankfull Cross Sectional Area (ft ²)	52.4	18.5	46.3	43.3

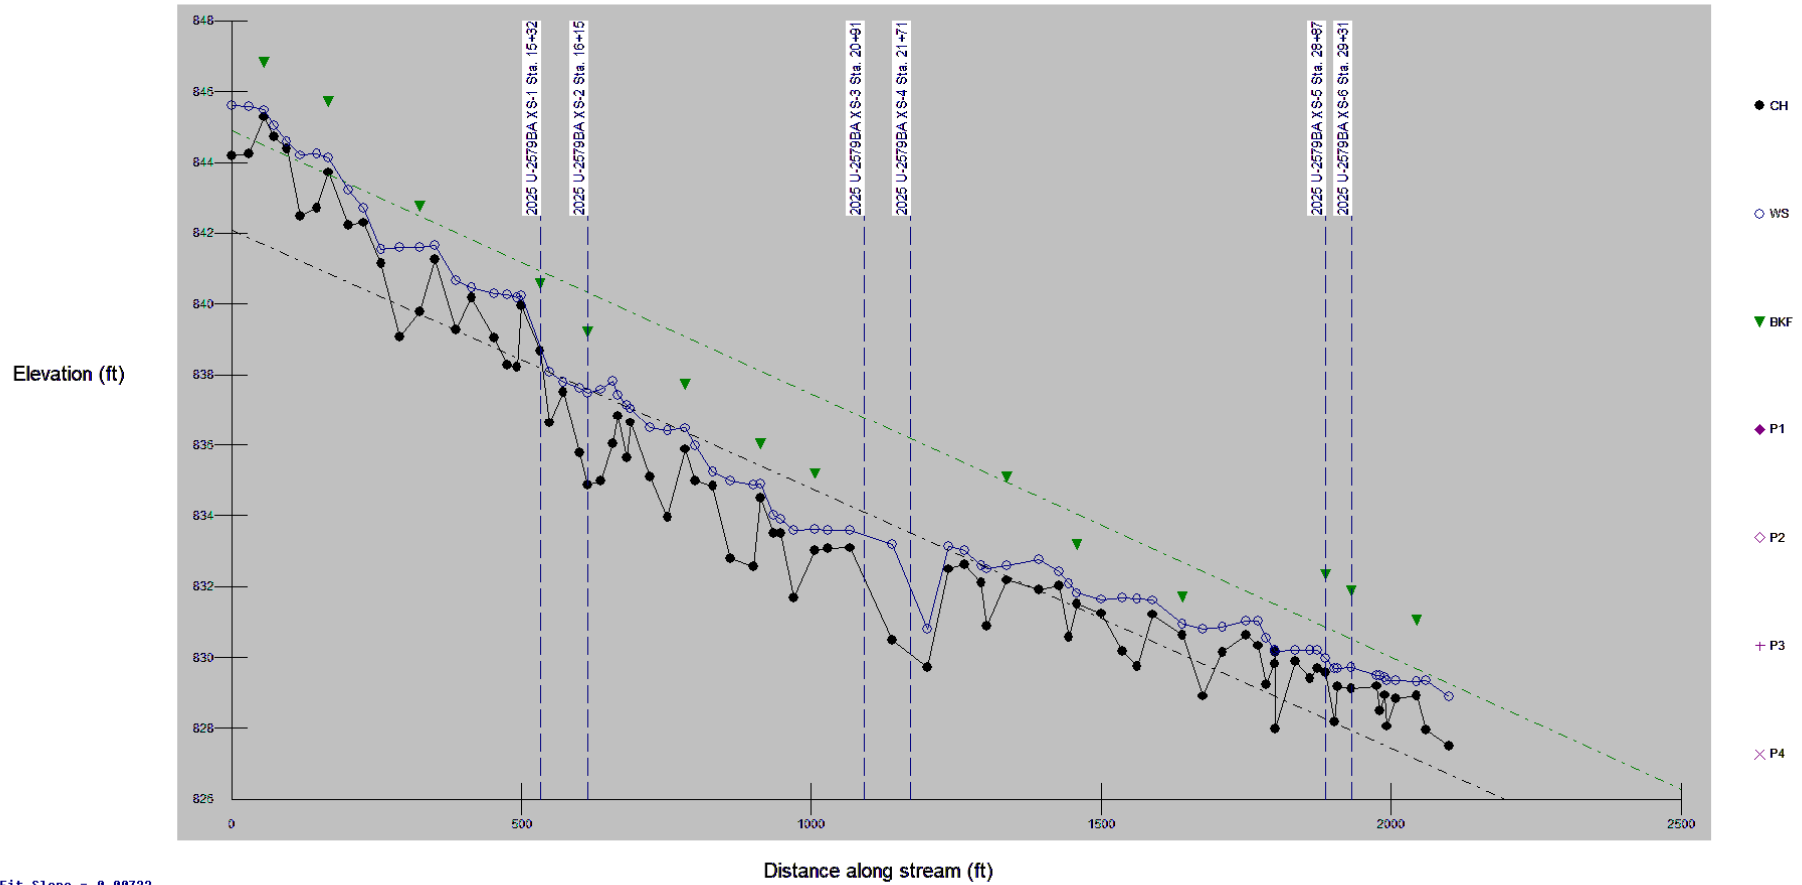
2025 U-2579BA Main Channel Longitudinal Profile

CH Best Fit Slope = 0.00732
BKF Best Fit Slope = 0.00745

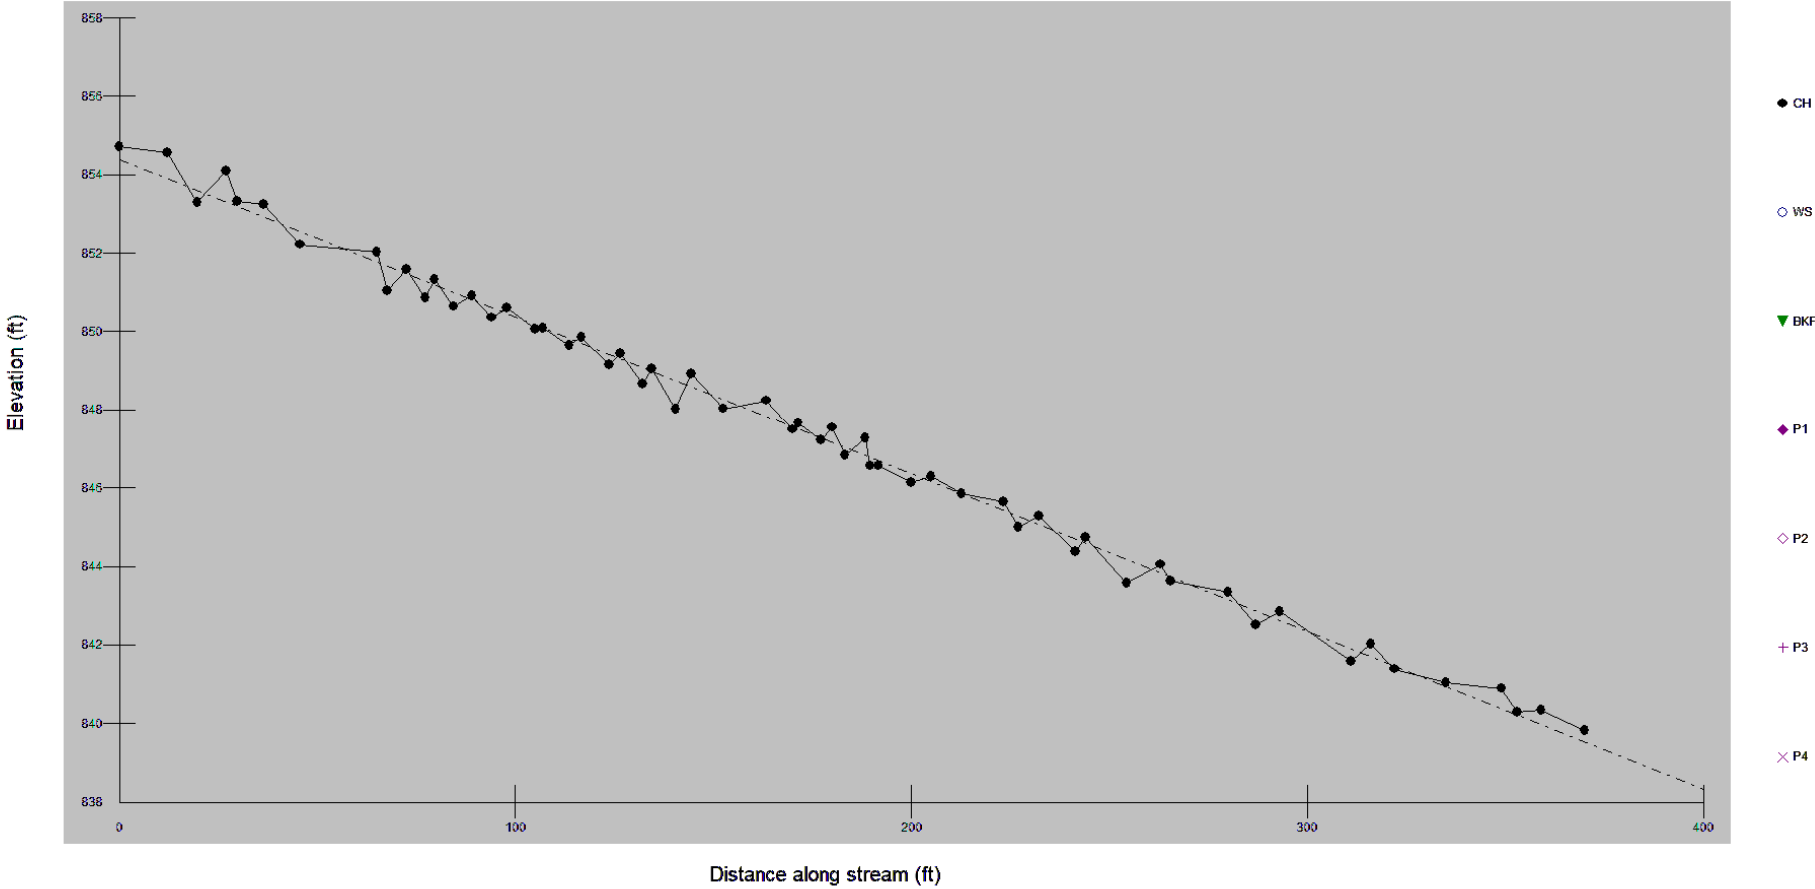
2025 U-2579BA Longitudinal Profile - UT1

CH Best Fit Slope = 0.04015

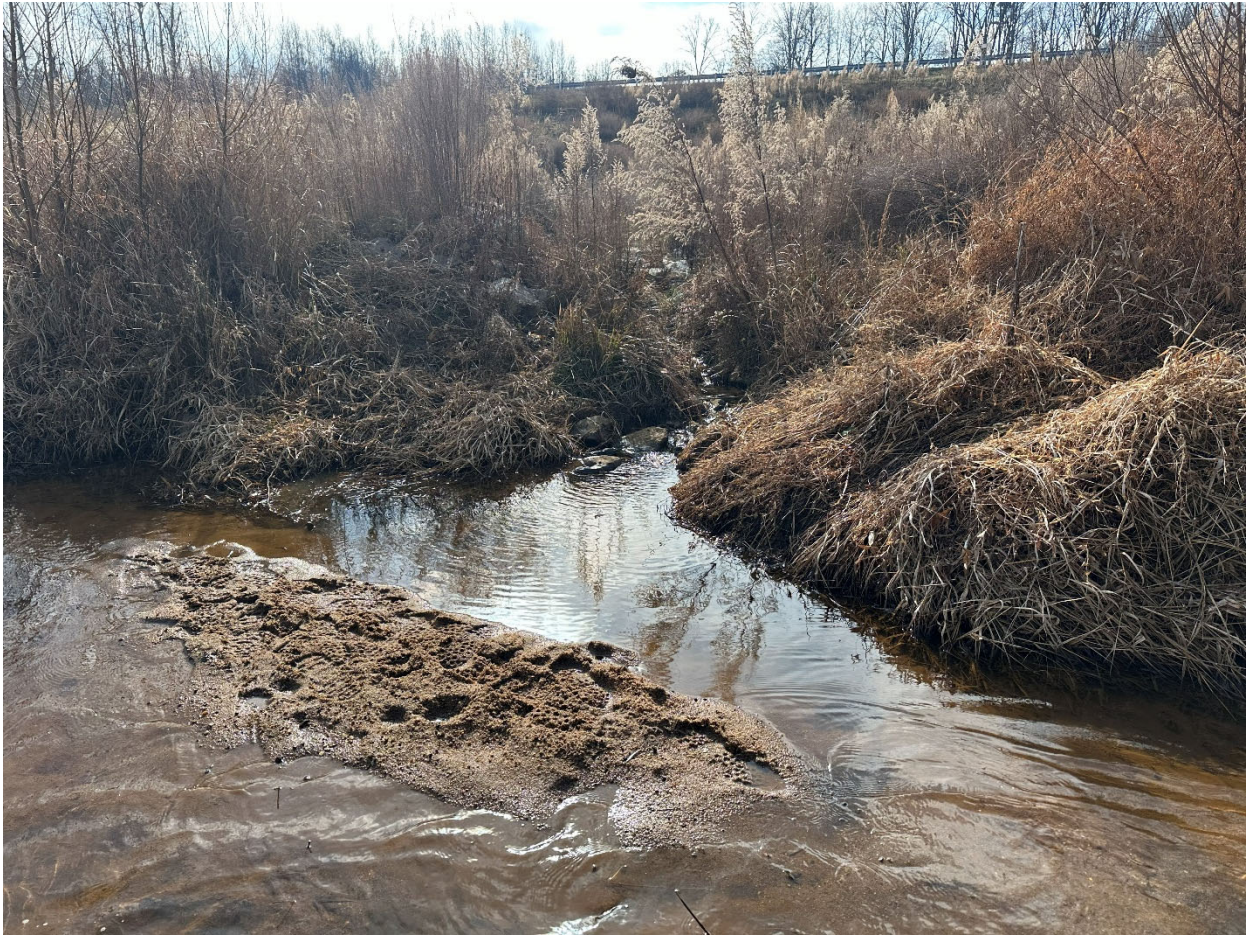
As noted in previous reports a left-channel bar remains at the confluence of a lateral ditch and Smith Creek near Sta. 28+00. The channel bar has not increased in magnitude since

MY2 and does not seem to be contributing appreciable sediment into the system at this time. A supplemental photo has been provided in Appendix B. NCDOT will continue to monitor this area in 2026.

Supplemental Photo: Lateral ditch confluence with left bank. Left Channel bar formed.

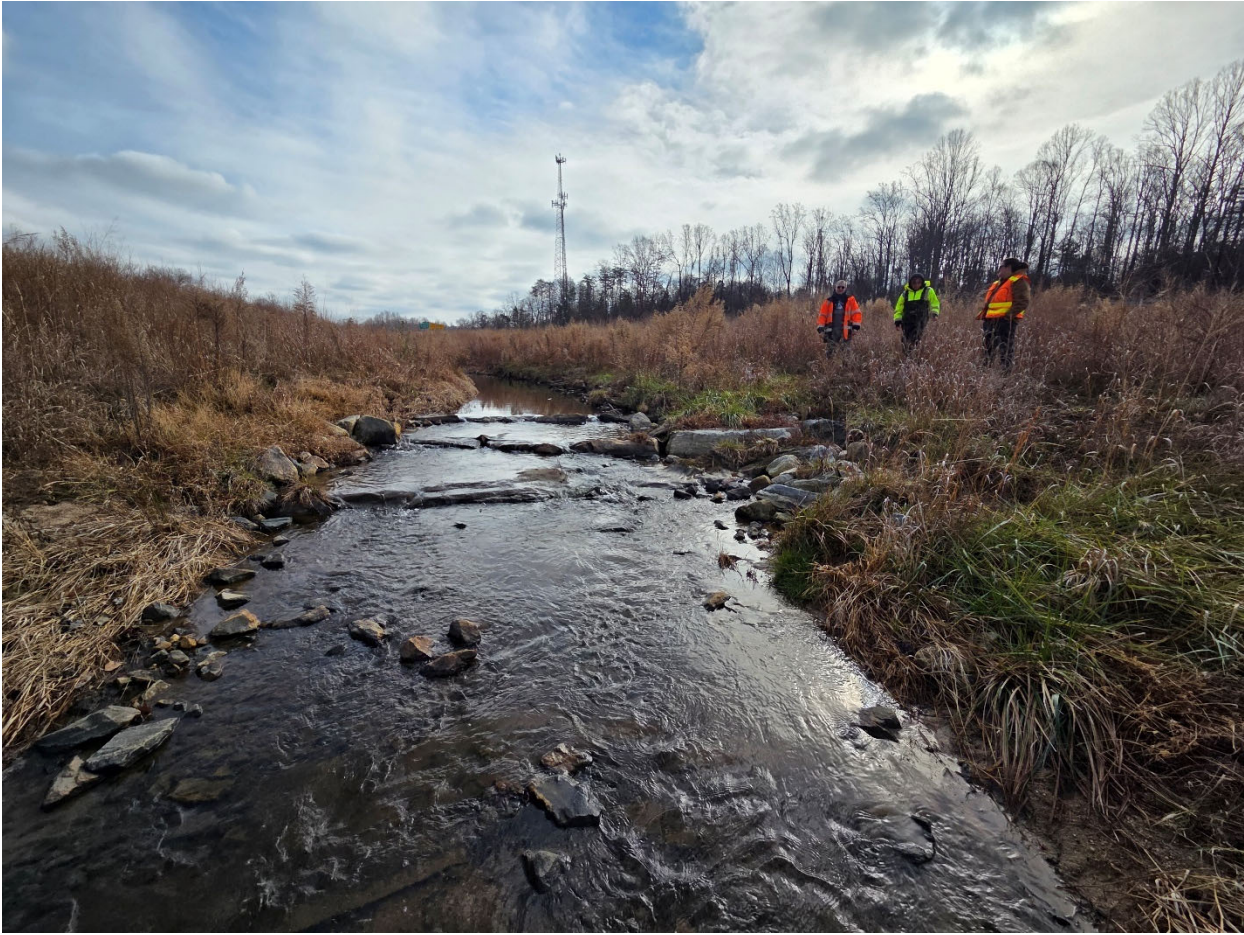
A small area of left bank erosion was noted at approximately Sta. 19+25. The scour occurred mid-point of the riffle and resulted in the stream piping under a mid-riffle sill of the Rock-n-Roll Riffle. Footer rocks under the sill seem to have abated any erosion in this area for now. Photo and video documentation was collected by NCDOT during MY 3 survey. A supplemental image is provided in Appendix B. NCDOT will continue to monitor bank stability in this area in 2026.

Supplemental Photo: Upstream view @ Sta. 19+25; left bank erosion, stream piping under mid-rock and roll riffle sill end
