ANNUAL REPORT FOR 2025

**UT to Stony Creek Mitigation Site
Nash County
TIP Nos. U-5026 & R-5720
COE Action ID: SAW-2017-02491
NCDWR Project #: 20201086 ver. 2**

Prepared By:
Roadside Environmental Unit and Environmental Analysis Unit
North Carolina Department of Transportation
October 2025

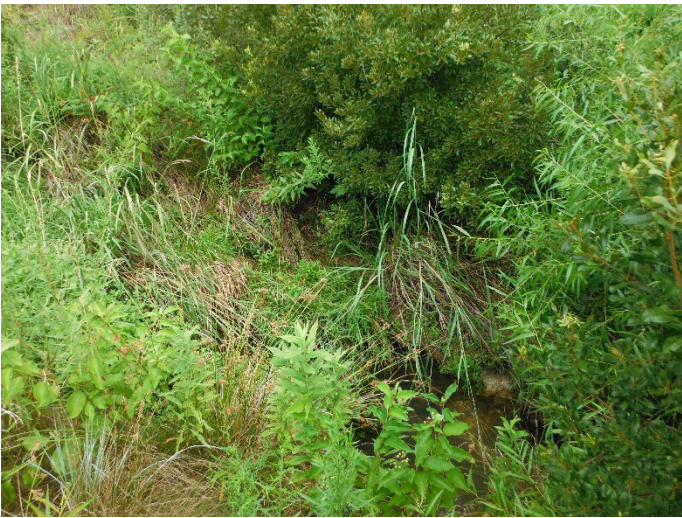
The visual assessment of the stream channel noted that it is stable at this time. The headcut previously noted within the upper reach has stabilized. This area is highly vegetated at this time. In the July 2025 agency review onsite meeting the agencies requested further stabilization efforts to occur along the lower reach at the scoured pool sections at the pipe inlet. On July 31, 2025, the roadway contractor installed a sill (8' x 4' steel plate – ¼" thick) just upstream of scoured pools. The channel was lined with riprap from the sill to the pipe inlet to stabilize this area.

Headcut downstream of Photo Point #1 is stable

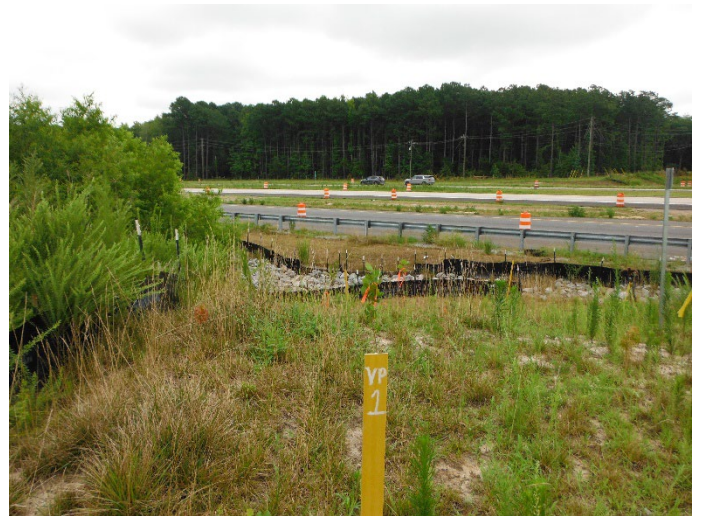
Vegetation Plot #1

There was one vegetation monitoring plot established within the stream buffer area. The 2025 vegetation monitoring of the site revealed an average tree density of 587 trees per acre. This average is above the minimum success criteria of 320 trees per acre for the second year of vegetation monitoring.

Plot #	River Birch	Sycamore	Overcup Oak	Swamp Chestnut Oak	Tulip Poplar	Willow Oak	Total (Year 2)	Total (at planting)	Density (Trees/Acre)
1		10	2	1	6		19	22	587
Year 2 Average Density (Trees/Acre)									587
Year 1 Average Density (Trees/Acre)									36

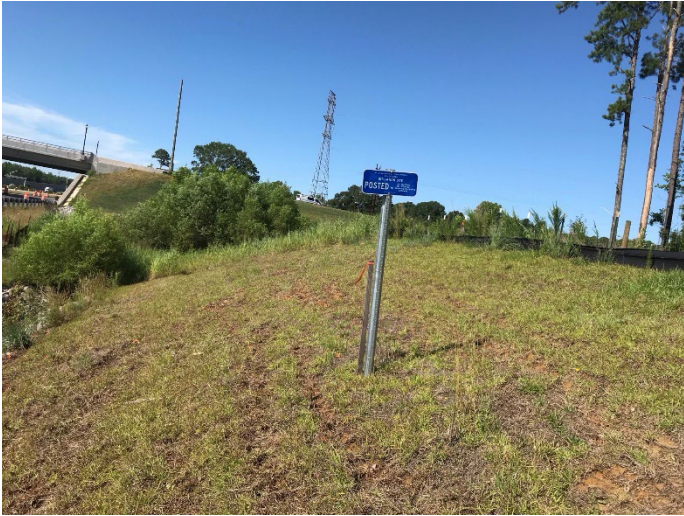
In June 2025, NCDOT inspector notified REU that a small portion of buffer along the I-95 back slope had been mowed. (See Appendix A for photo.)

Site Notes: The upper reach planted vegetation is surviving well with noted diversity throughout the reach. A small portion of the upper reach buffer had been mowed along the I-95 back slope. The lower reach is dominated by loblolly pines throughout with noted hardwood trees and live stakes sporadically

Mowed buffer along I-95 S back slope

Based on the overall conclusions of monitoring at the UT to Stony Creek, it has met the required monitoring protocols for the second formal year of monitoring on the stream. The channel throughout the stream site is stable at this time. The streambank planted vegetation was surviving well but a small portion of the planted buffer area within the upper reach had been mowed again as stated previously. This area will be replanted during the 2025/2026 planting window.

NCDOT proposes to replant the mowed buffer area within the upper reach and supplemental seed and reforest areas along the lower reach as discussed in the July 29, 2025 onsite Agency review meeting. NCDOT will continue stream and vegetation monitoring at the UT to Stony Creek Mitigation Site in 2026.

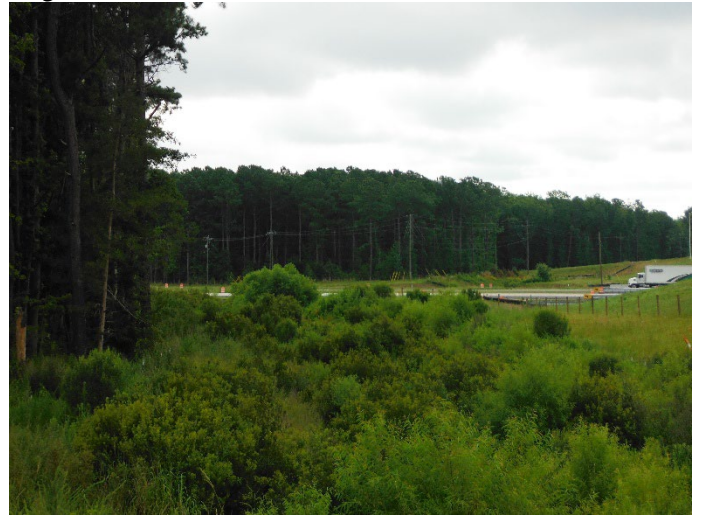
Overview photo looking downstream from pipe outlet at Freight Road

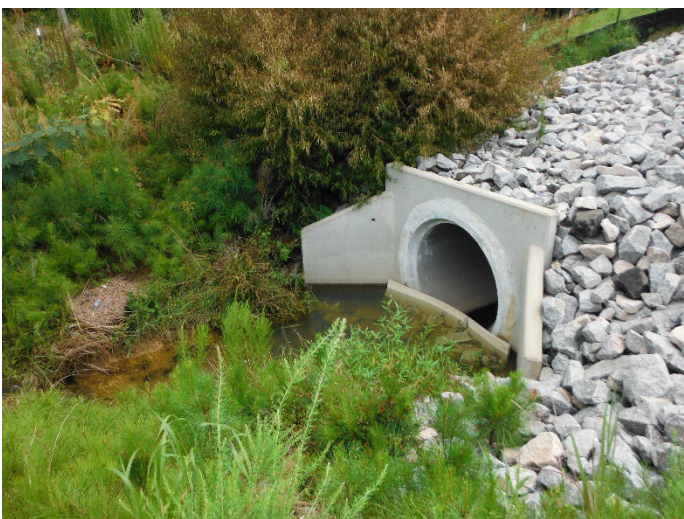
On July 29, 2025, an agency review meeting was held onsite to review this stream relocation. Based on this review the agencies were pleased with the upper reach if the mowed buffer gets replanted. They requested the lower reach get further stabilization at the pipe inlet scoured pool sections. A sill is to be installed upstream of the scoured pools and riprap placed between the sill and pipe inlet. Supplemental seeding and reforestation was requested at the west end of the lower reach along the left cut slope. Supplemental seeding was also requested at the east end of the lower reach along the right slope above the stream relocation.

Lower reach pipe inlet prior to add. remediation
July 9, 2025

On July 31, 2025, the roadway contractor installed a sill (8' x 4' steel plate – ¼" thick) just upstream of scoured pools. The channel was lined with riprap from the sill to the pipe inlet. (See Appendix A for photo.)

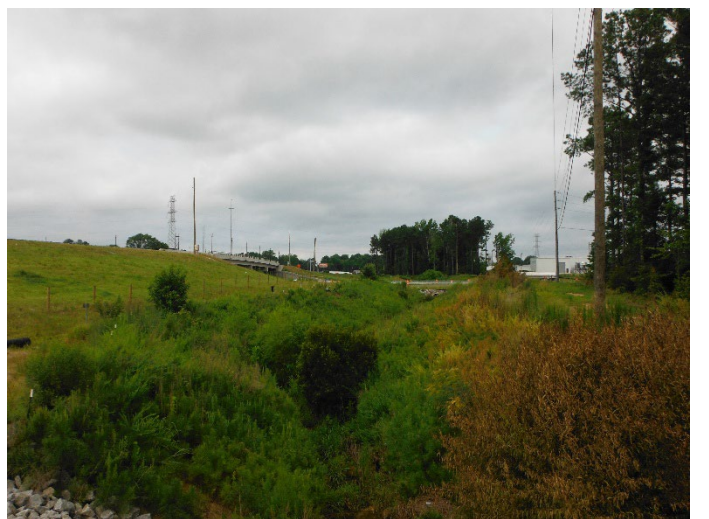
Overview of lower reach looking upstream from pipe inlet

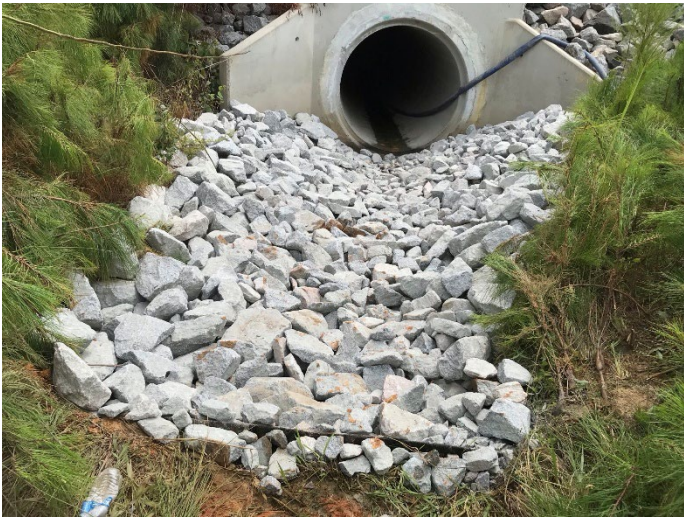
Lower Reach Additional Remediation – Sill and placed riprap at the pipe inlet (July 31, 2025)

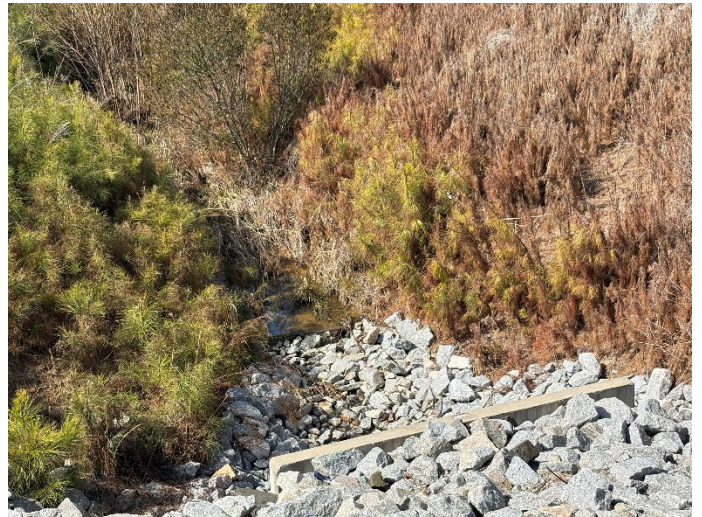
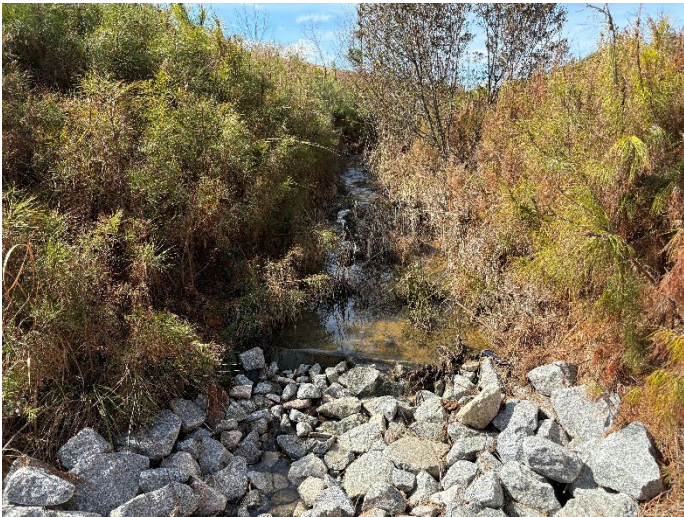
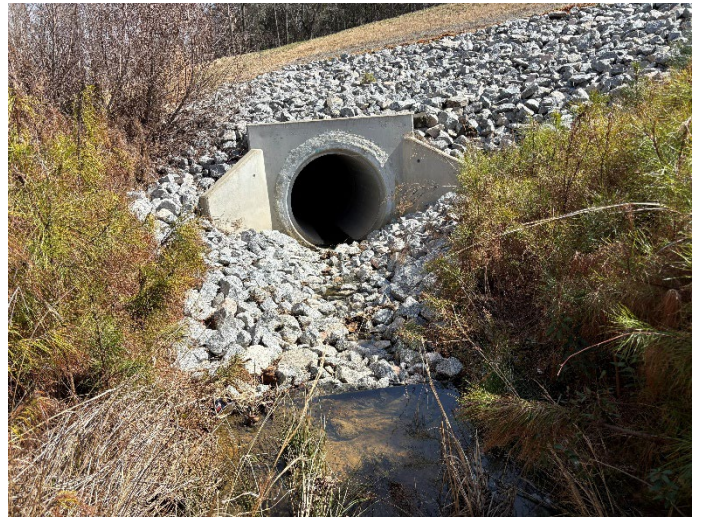
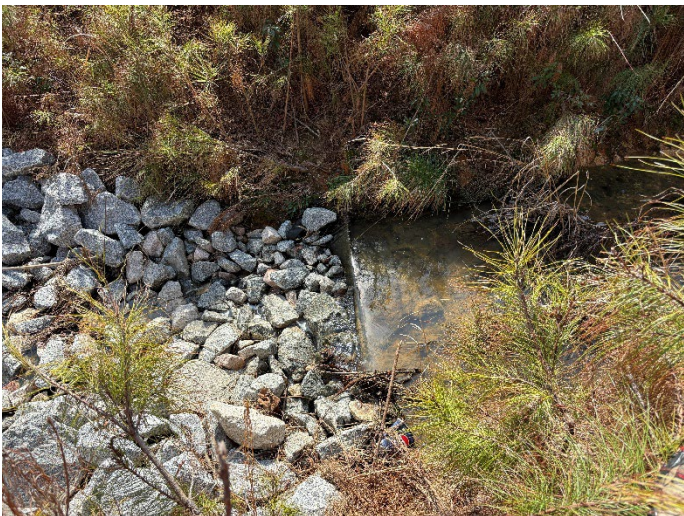
Lower Reach Additional Remediation (Feb. 23, 2026)
